C-1981-008 New Horizon November Partial Inspection Report

Permit Number: C-1981-008 Mine Name: New Horizon Mine Operator: Elk Ridge Mining and Reclamation, LLC Operator Address: Mr Tony Tennyson P.O. Box 628 27646 West 5th Avenue Nucla, CO 81424	County: Montrose Operation Type: Surface Permit Status: Active Ownership: Private
	Operator Representative Present: None
Operator Representative Signature: (Field Issuance Only)

Inspection Start Date: November 12, 2024 Inspection Start Time: 10:00 Inspection End Date: November 12, 2024 Inspection End Time: 10:24	Inspection Type: Coal Partial Inspection Inspection Reason: Normal I&E Program Weather: Clear
Joint Inspection Agency: None	Joint Inspection Contacts:
Post Inspection Agency: None	Post Inspection Contacts:
Inspector(s): Lucas West	Inspector's Signature:

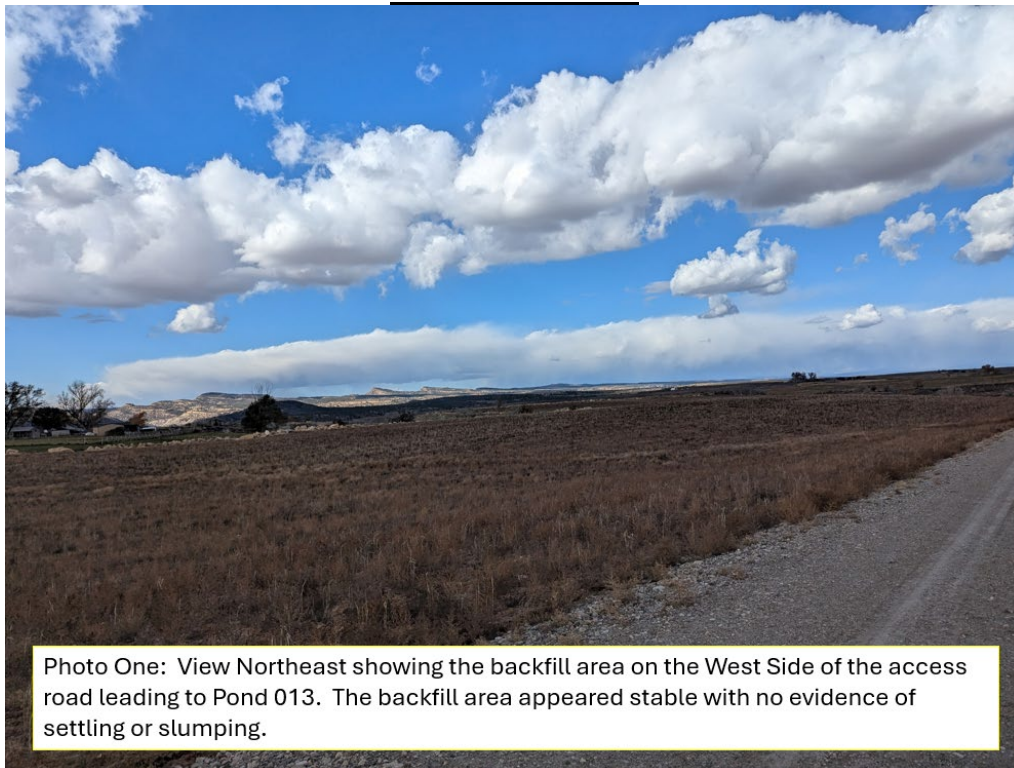
The recently backfilled and graded area on both sides of the access road leading to Pond 013 North of BB road was observed to be in good condition. No evidence of settling or slumping was noted and no signs of erosion was observed. The area, seen in Photo One, is well vegetated and appeared stable during the inspection. The vegetative cover is mostly annual weeds; however reclamation species were noted.

Photo One: View Northeast showing the backfill area on the West Side of the access road leading to Pond 013. The backfill area appeared stable with no evidence of settling or slumping.

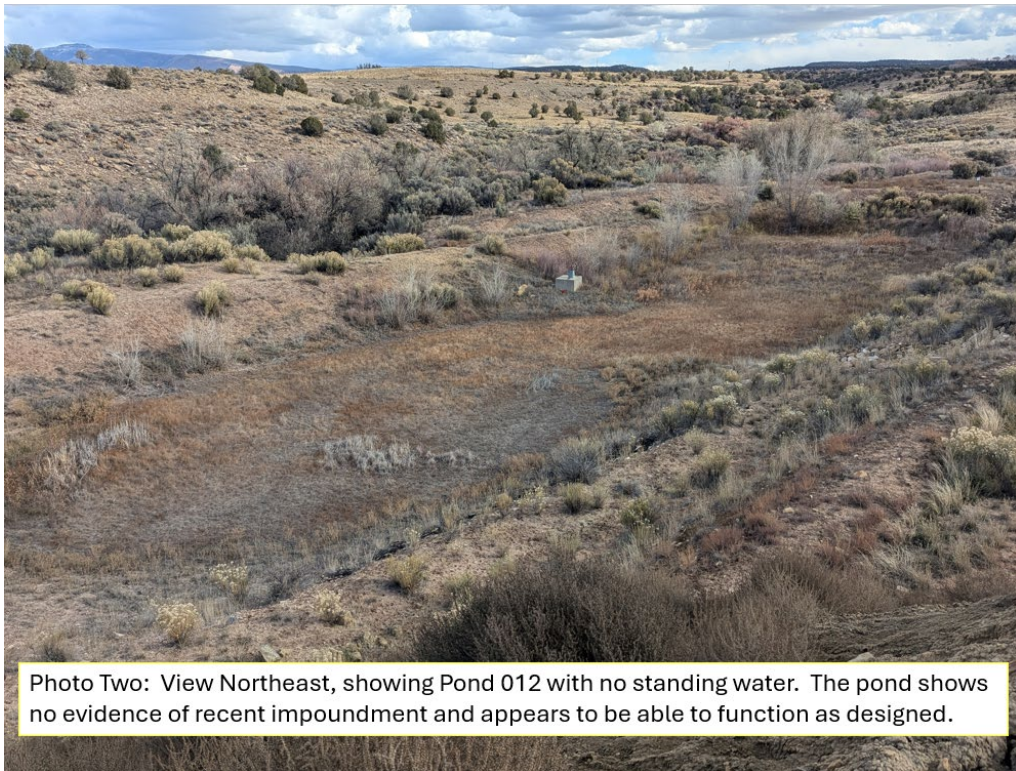
During this inspection Ponds 012, 013 and 016 were observed. Pond 012, shown in Photo Two, is in good condition and contained no standing water. The contributing ditch, an example of which can be seen in Photo Three, was also in good condition and appeared stable. The ditch shows no evidence of recent flows and appears to be able to function as designed.

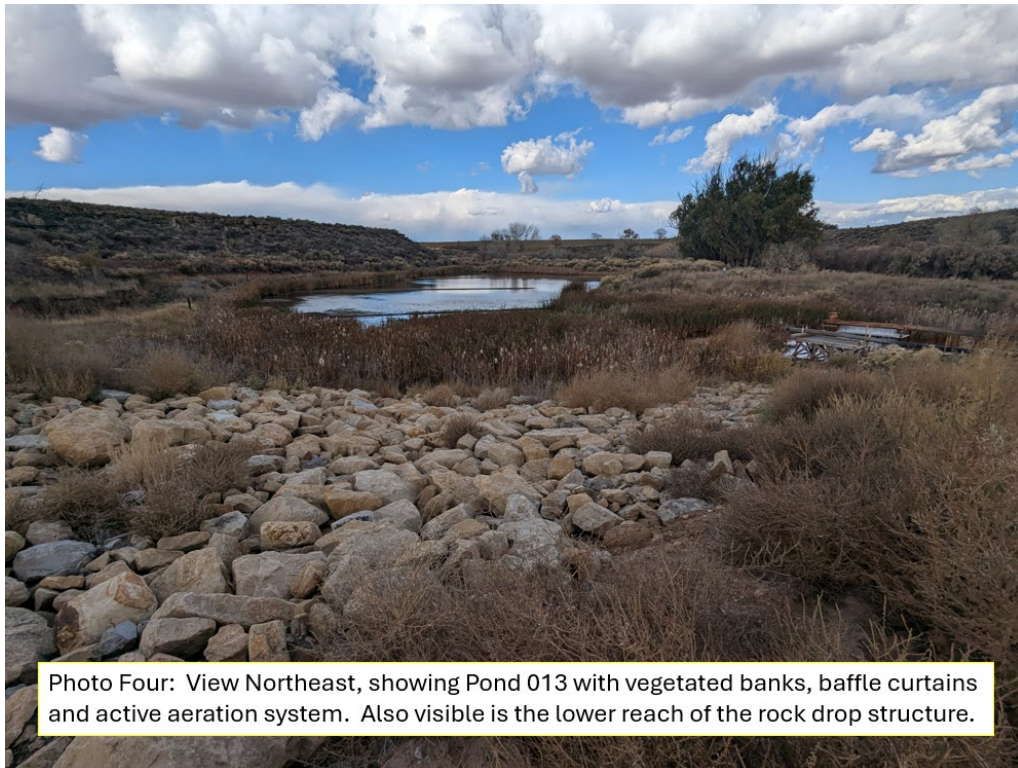
Pond 013 is in similar condition to the Division's previous inspection. Visually, the water level appears to be the same as during previous inspections with water inflowing from the aeration structure. The pond can be seen in

Photo Four with well vegetated banks, and the baffle curtains functioning as designed. The rock lined drop structure leading from the backfill area to Pond 013 is noted to be in excellent condition with no evidence of recent flow. The drop structure can be seen in Photo Five.

Photo Four: View Northeast, showing Pond 013 with vegetated banks, baffle curtains and active aeration system. Also visible is the lower reach of the rock drop structure.

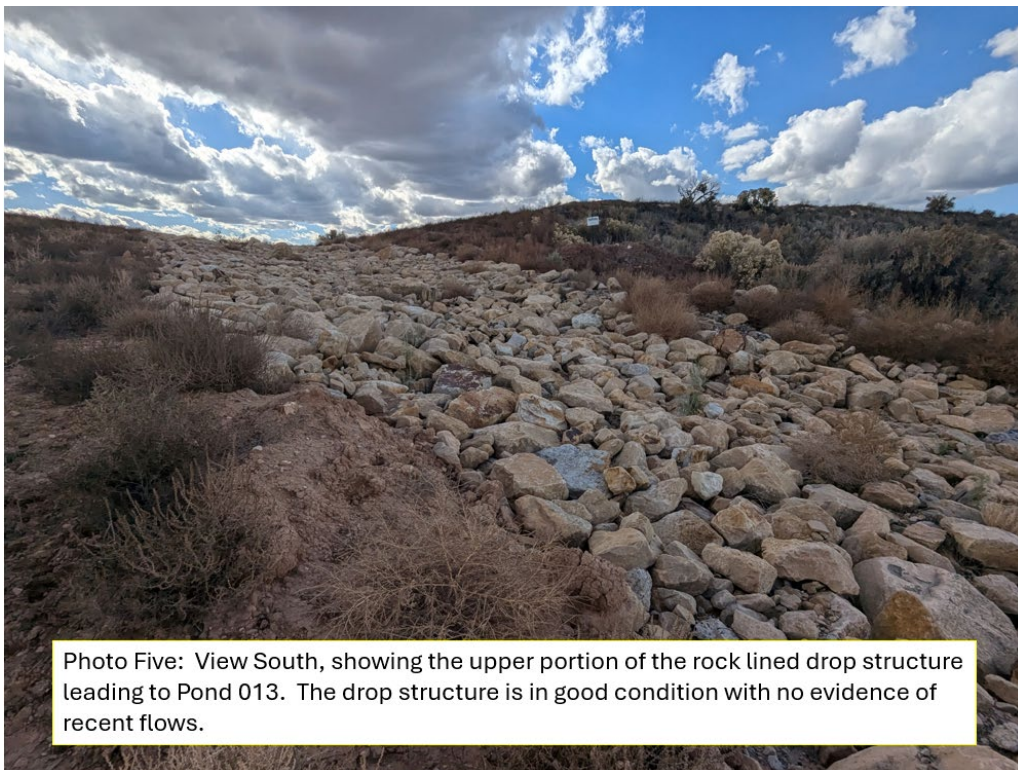
Photo Five: View South, showing the upper portion of the rock lined drop structure leading to Pond 013. The drop structure is in good condition with no evidence of recent flows.

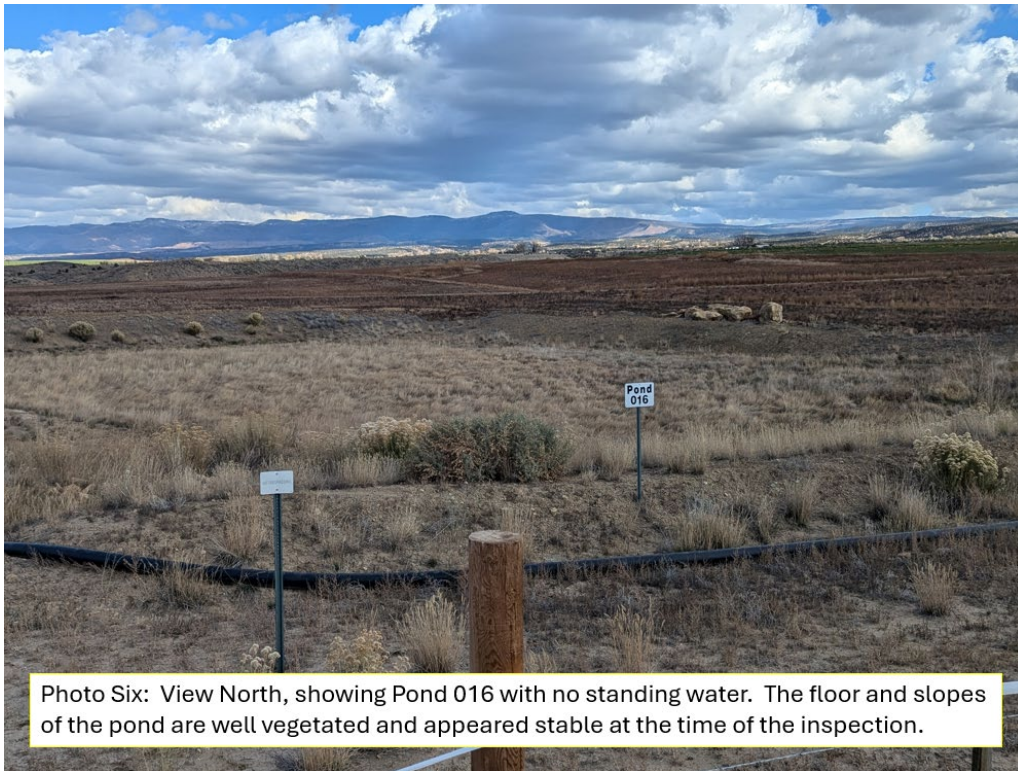
Pond 016, adjacent BB Road, remains dry with no evidence of recent water impoundment. The floor and banks of the pond are well vegetated and appeared stable at the time of the inspection. Pond 016 can be seen in Photo Six.

Photo Six: View North, showing Pond 016 with no standing water. The floor and slopes of the pond are well vegetated and appeared stable at the time of the inspection.

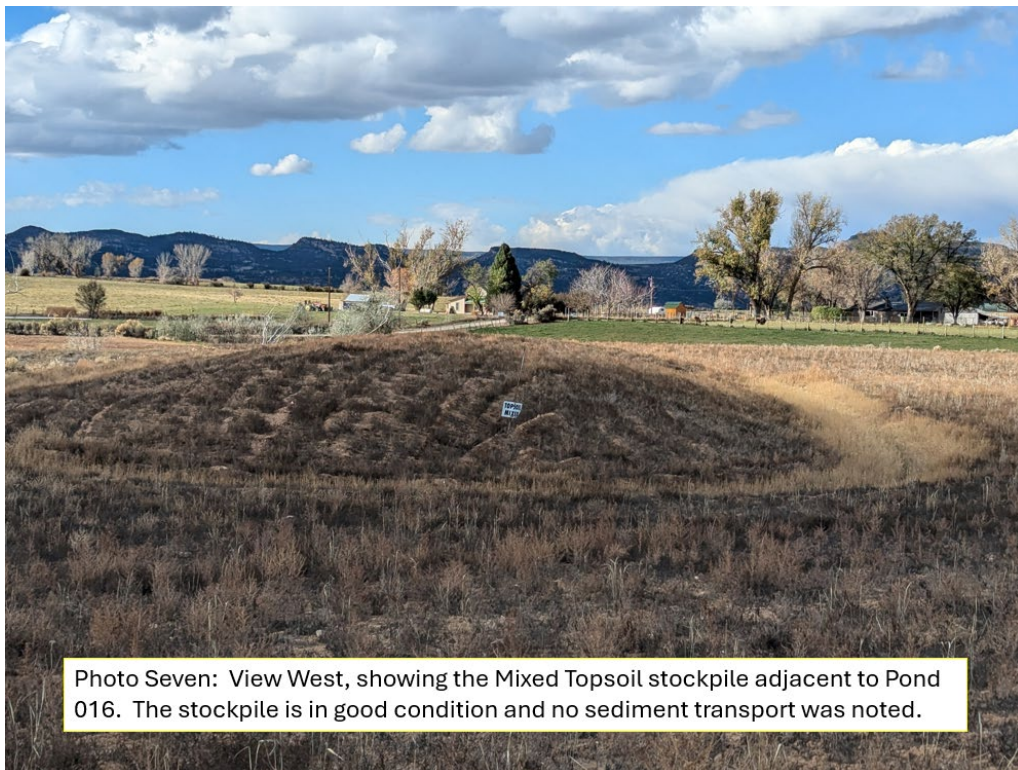
Also observed during this inspection were the topsoil stockpiles located adjacent to Pond 012, 016 and at the Morgan Property Topsoil storage area. The Mixed Topsoil stockpile adjacent to Pond 016 is in excellent condition, well vegetated with the ring berm functioning as designed. The stockpile, seen in Photo Seven, shows no signs of erosion or sediment transport.

Photo Seven: View West, showing the Mixed Topsoil stockpile adjacent to Pond 016. The stockpile is in good condition and no sediment transport was noted.

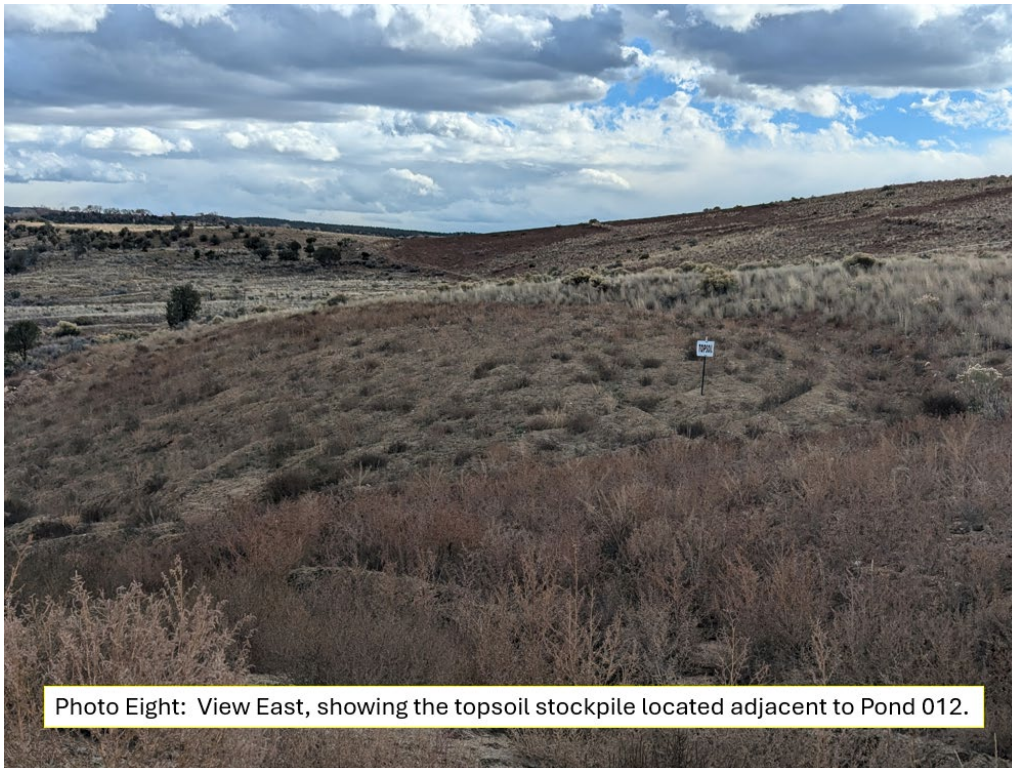
Located adjacent to Pond 012 lies a topsoil and Bench One stockpile. Both stockpiles appeared to be stable during the inspection and showed no signs of erosion or sediment transport. The topsoil stockpile can be seen in Photo Eight.

Photo Eight: View East, showing the topsoil stockpile located adjacent to Pond 012.

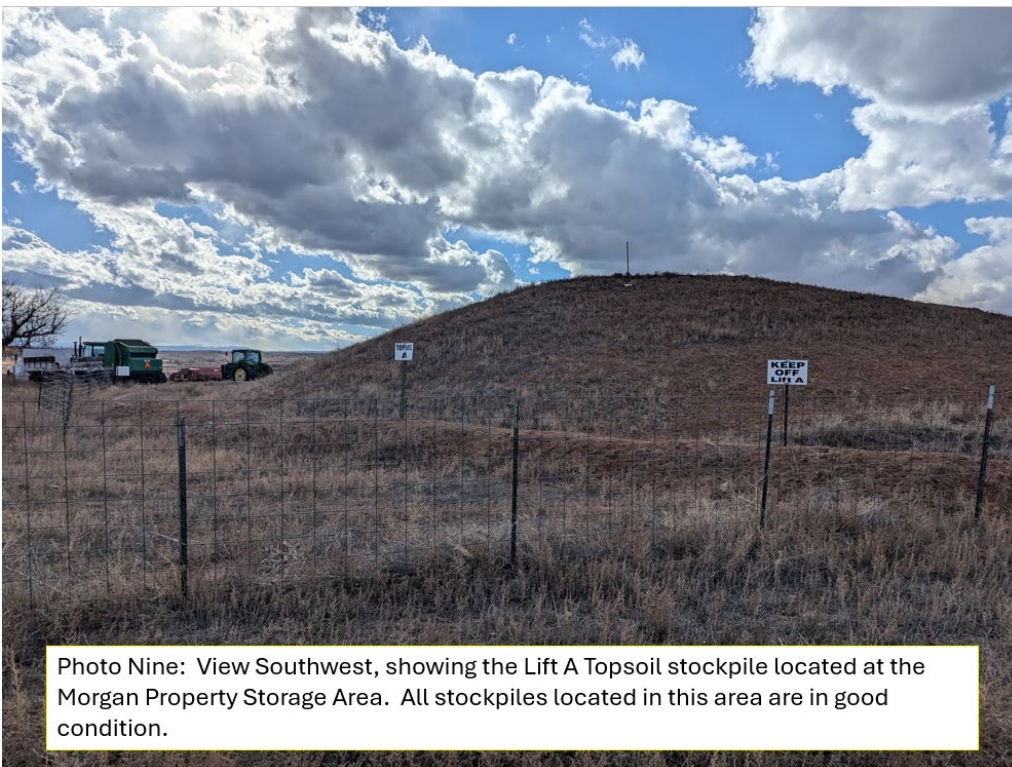
All topsoil stockpiles located at the Morgan Property Topsoil storage area were observed to be in good condition. The stockpiles are in good condition, well vegetation and showed no signs of erosion or sediment transport. An example of the Lift A stockpile can be seen in Photo Nine.

Photo Nine: View Southwest, showing the Lift A Topsoil stockpile located at the Morgan Property Storage Area. All stockpiles located in this area are in good condition.
