## C-1981-035 King November Partial Inspection Report

<b>Permit Number:</b> C-1981-035 <b>Mine Name:</b> King Coal Mine <b>Operator:</b> GCC Energy, LLC <b>Operator Address:</b> Mr Jordan McCourt 6473 County Road 120 Hesperus, CO 81326	<b>County:</b> La Plata <b>Operation Type:</b> Underground <b>Permit Status:</b> Active <b>Ownership:</b> Private
	<b>Operator Representative Present:</b>  Wade Wymore
<b>Operator Representative Signature: (Field Issuance Only)</b>

<b>Inspection Start Date:</b> November 12, 2024 <b>Inspection Start Time:</b> 13:24 <b>Inspection End Date:</b> November 12, 2024 <b>Inspection End Time:</b> 14:58	<b>Inspection Type:</b> Coal Partial Inspection <b>Inspection Reason:</b> Normal I&E Program <b>Weather:</b> Clear
<b>Joint Inspection Agency:</b>  None	<b>Joint Inspection Contacts:</b>
<b>Post Inspection Agency:</b>  None	<b>Post Inspection Contacts:</b>
<b>Inspector(s):</b>  Lucas West	<b>Inspector's Signature:</b>

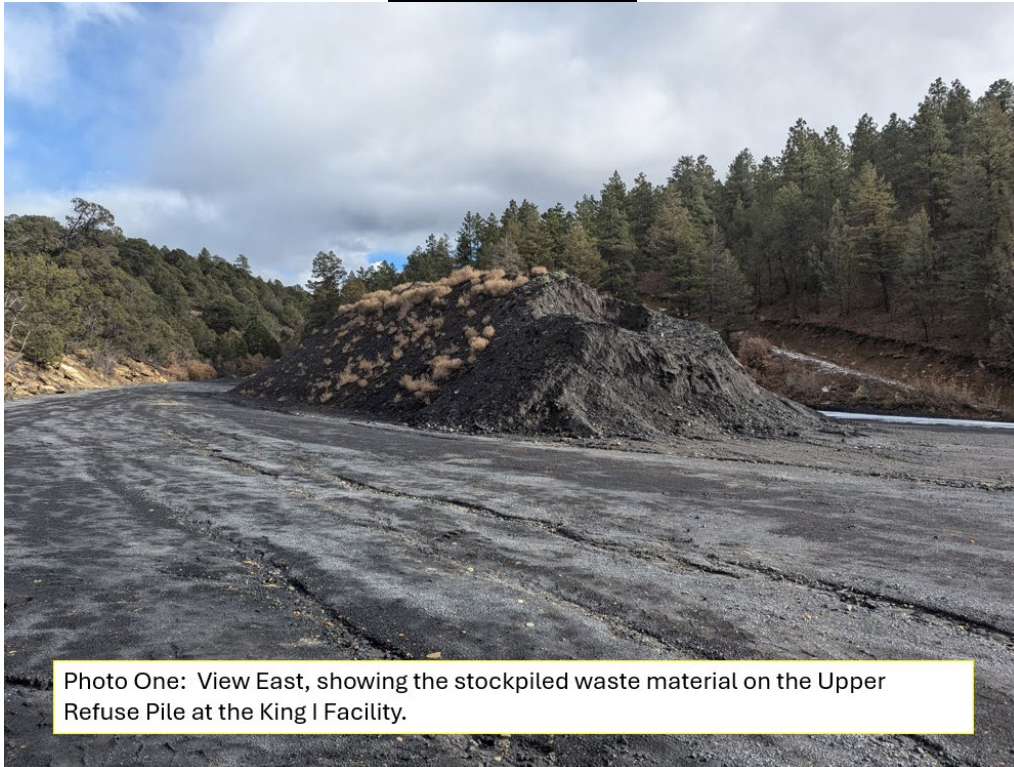
Photo One: View East, showing the stockpiled waste material on the Upper Refuse Pile at the King I Facility.

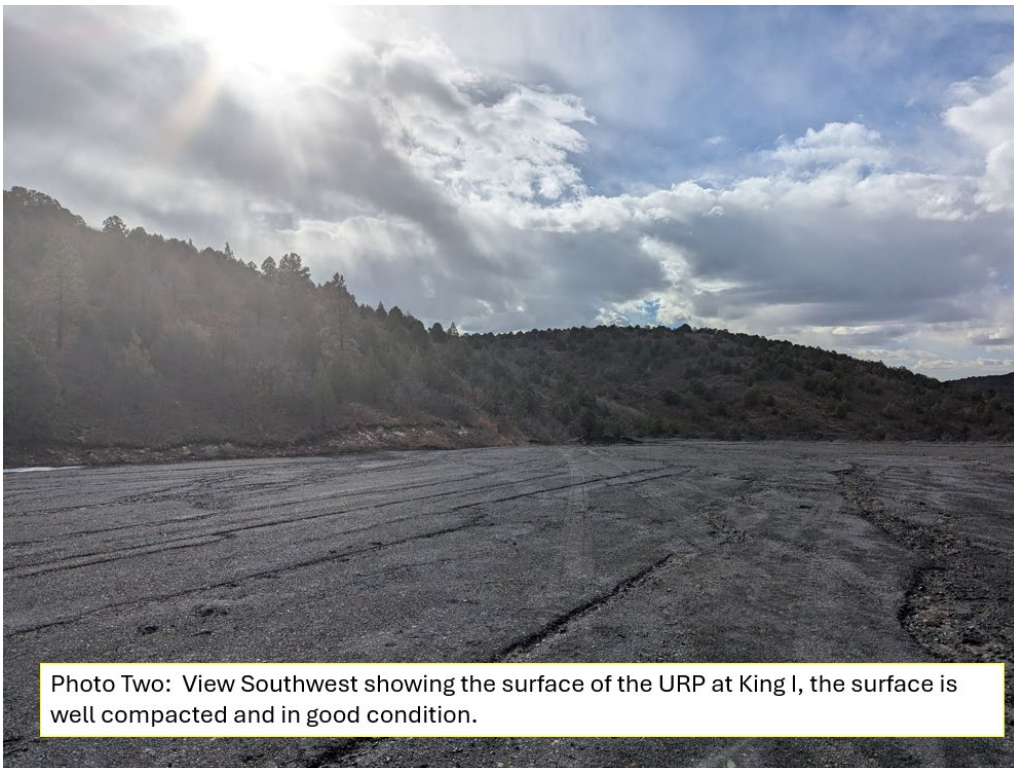
Photo Two: View Southwest showing the surface of the URP at King I, the surface is well compacted and in good condition.

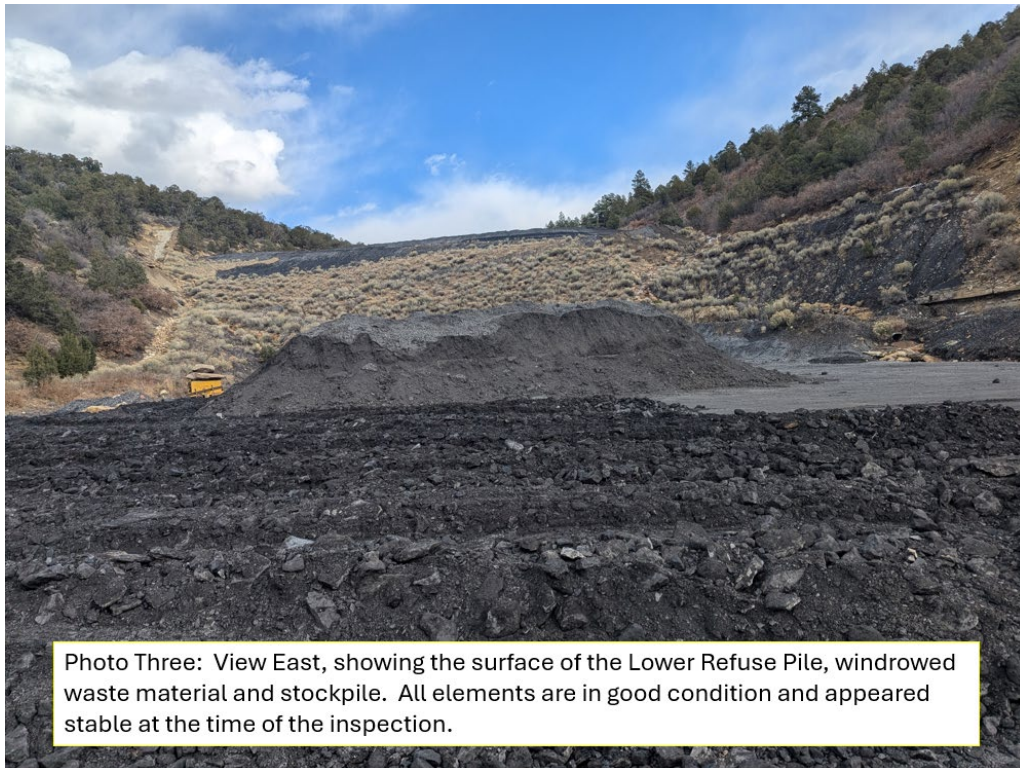
Photo Three: View East, showing the surface of the Lower Refuse Pile, windrowed waste material and stockpile. All elements are in good condition and appeared stable at the time of the inspection.

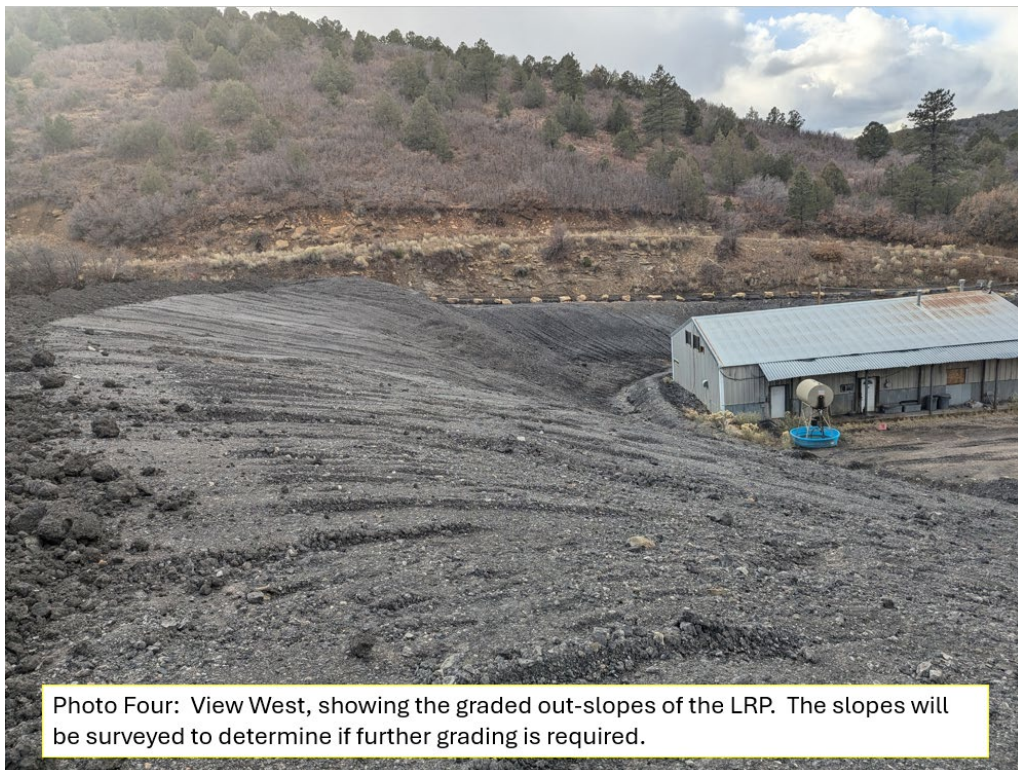
At the King I Facility both the Upper Refuse Pile (URP) and Lower Refuse Piles (LRP) were observed. At the time of the inspection no activity was taking place at either one of the Refuse Piles. The URP was observed to be in good condition and appeared stable at the time. The surface of the pile is well compacted and appears consistent with the design specifications. No evidence of settling or slumping was noted on the surface of the pile. At the East end of the pile, the stockpiled waste material awaiting compaction is in good condition and shows evidence of recent hauling and placement on the surface. The stockpile can be seen in Photo One and Surface of the pile can be seen in Photo Two. The LRP was also observed to be in good condition, well compacted and consistent with the design specifications. A lift of windrowed material has been placed on the surface for temporary storage. The surface of the pile can with stockpile and windrowed material can be seen in Photo Three. Both the surface and the stockpile are in good condition. Recent work has been focused on the outslopes of the pile, where the slope had been advanced and compacted. The face of the slope has been shaved back to reach design level but has not been confirmed with aerial topographic survey. Once the survey is completed, the Operator will assess if more material needs to be removed to reach the appropriate slope. In the interim the slope is in excellent condition and appeared stable at the time of the Inspection. No evidence of settling or erosion was noted along the slope, which can be seen in Photo Four.

Photo Four: View West, showing the graded out-slopes of the LRP. The slopes will be surveyed to determine if further grading is required.

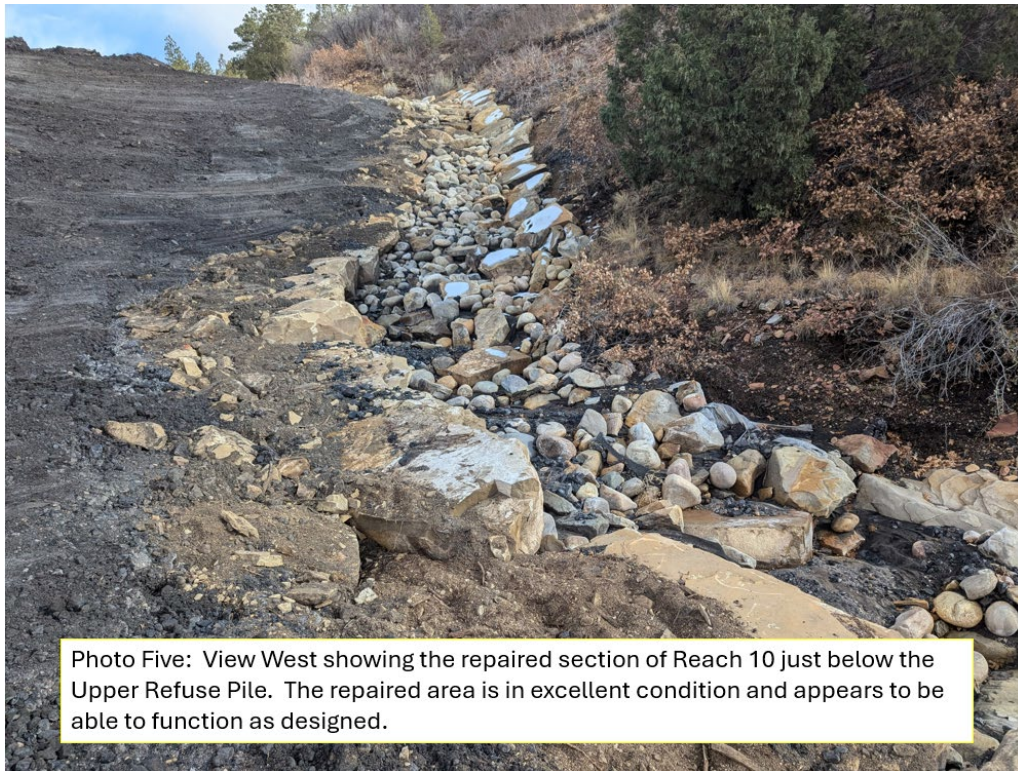
At the King I Facility, the culverts and ditches that make up the internal drainage system between the LRP and the URP were observed. All ditches observed were free from obstruction and appeared able to function as designed. Along Reach 10, just below the shoulder of the URP, the ditch had recently suffered a minor blow out in response to a precipitation event. The flow had scoured the rock lining and bunched up the geotextile beneath the rocks. The flow did not compromise the ditch, nor any other feature in the area, but needed repair. The Operator has repaired the reach by re-aligning the geotextile and keying in more angular rocks to promote stability. The repair is in excellent condition and can be seen in Photo Five. The remaining ditches and culverts observed at the King I Facility appear to be operational.

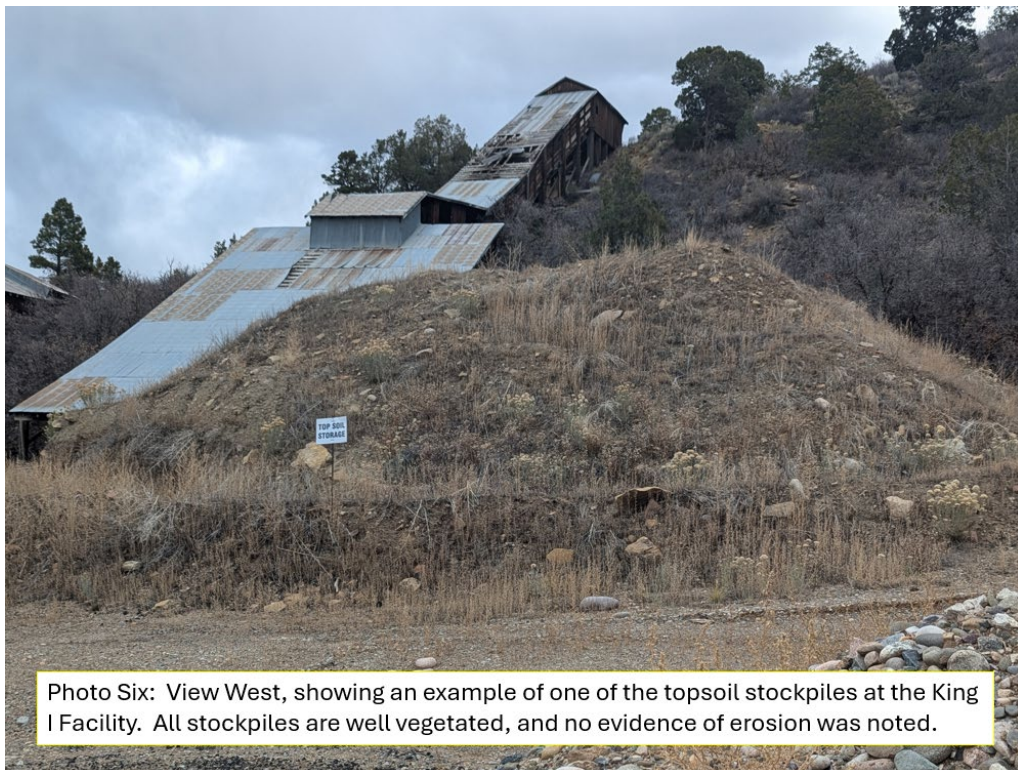
Three Topsoil Stockpiles are located at the King I Facility. One stockpile is located at the East end of the URP and Two others are located near the old bath house, below the LRP. All three stockpiles were observed, and found to be in good condition with dense and diverse vegetative cover for stability. An example of the three stockpiles can be seen in Photo Six. The stockpiles showed no signs of erosion or sediment transport at the time of the inspection.

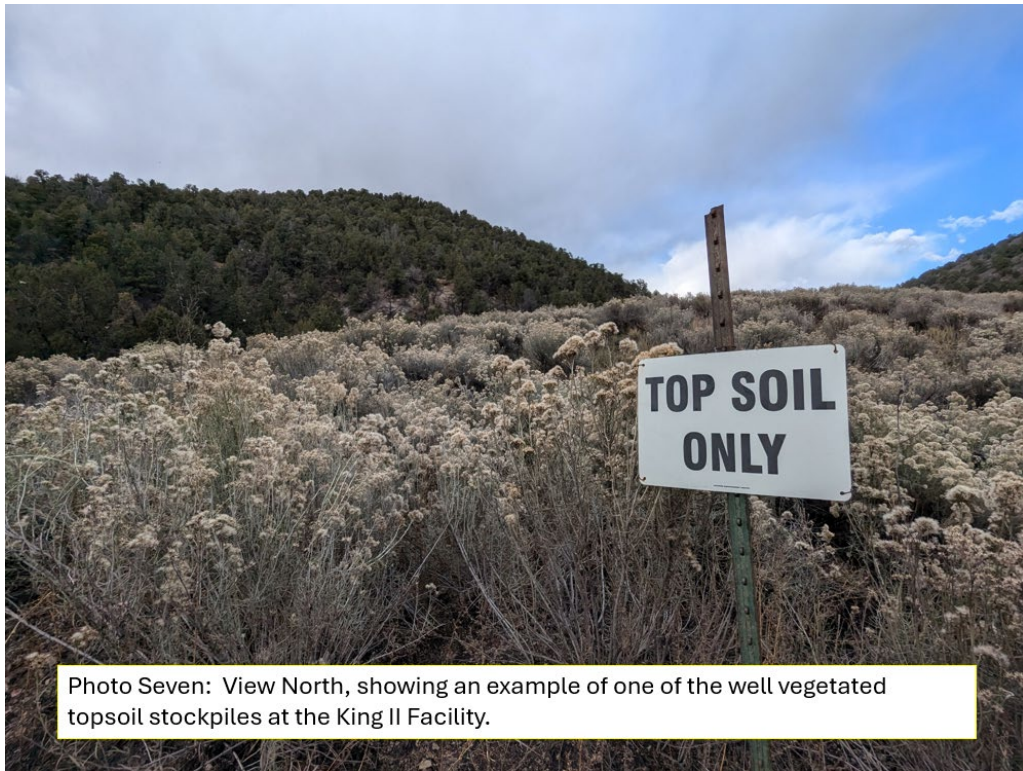
Two Topsoil Stockpiles are located at the King II Facility. One stockpile is located along the access road, between the road and the main sediment pond, the other is located east of the Number 2 stacker, downstream of the processing area. Both stockpiles were also found to be in good condition and stabilized with a dense and diverse vegetative cover. No evidence of erosion nor state listed noxious weeds were identified on the piles. An example of the King II stockpiles can be seen in Photo Seven.
