## November 2024 New Elk Mine C-1981-012 Inspection Report

### PERMIT INFORMATION

<b>Permit Number:</b> C-1981-012 <b>Mine Name:</b> New Elk Mine <b>Operator:</b> New Elk Coal Company, LLC <b>Operator Address:</b> Mr. John Terry 12250 Highway 12 Weston, CO 81091	<b>County:</b> Las Animas <b>Operation Type:</b> Underground <b>Permit Status:</b> Active <b>Ownership:</b> Private
	<b>Operator Representative Present:</b>  None
<b>Operator Representative Signature: (Field Issuance Only)</b>

<b>Inspection Start Date:</b> November 6, 2024 <b>Inspection Start Time:</b> 09:31 <b>Inspection End Date:</b> November 6, 2024 <b>Inspection End Time:</b> 10:13	<b>Inspection Type:</b> Coal Partial Inspection <b>Inspection Reason:</b> Normal I&E Program <b>Weather:</b> Snowing
<b>Joint Inspection Agency:</b>  None	<b>Joint Inspection Contacts:</b>
<b>Post Inspection Agency:</b>  None	<b>Post Inspection Contacts:</b>
<b>Inspector(s):</b>  Amber M. Gibson	<b>Inspector's Signature:</b>

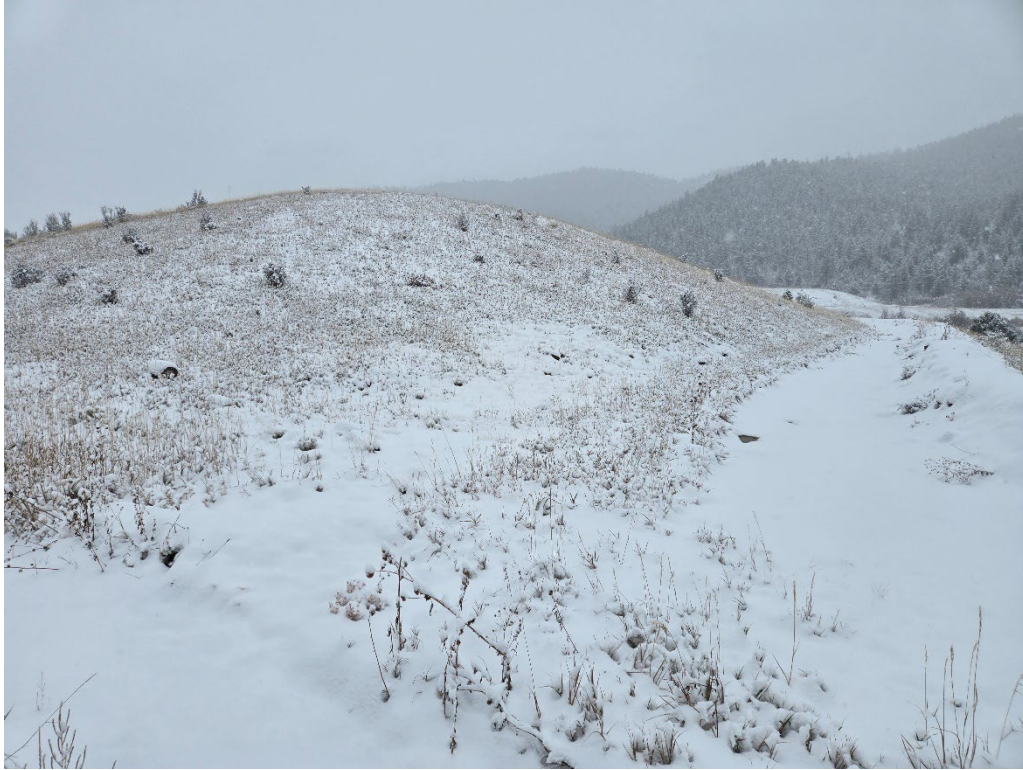
- The ditch along the west side of DWDA #1 (D3) was clear of obstructions (Photo 1) and the berm appeared to be stable and functional. No apparent structural issues were observed.
- The ditch along the south side of DWDA #1 (D14) was clear of obstructions (Photo 2) and the berm appeared to be stable and functional. No apparent structural issues were observed.
- The ditch along the east side of DWDA #1 (D2) was clear of obstructions (Photo 3) and the berm appeared to be stable and functional. No apparent structural issues were observed.
- The DWDA #1 appeared to be well vegetated and stable at the time of the inspection (Photo 3).

*Photo 1: Looking along the west side of DWDA #1 at D3.*

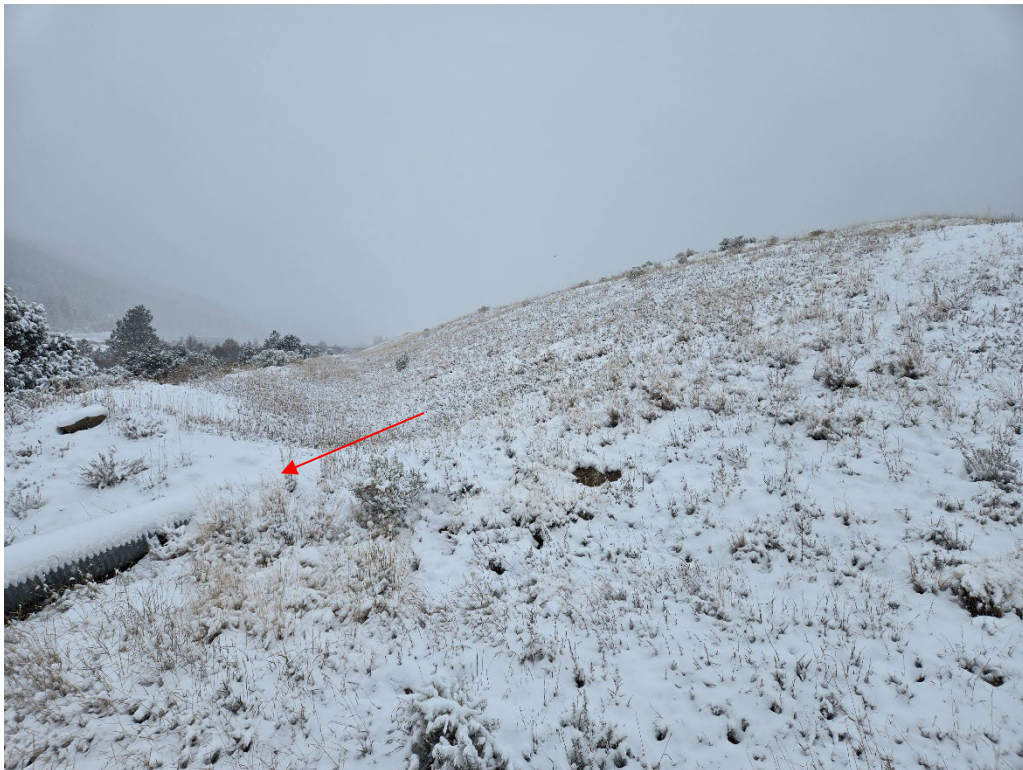
*Photo 2: Looking west across the south side of DWDA #1. Arrow indicates inlet for Culvert C7.*

- The inlet for Culvert C7 (in the bottom left side of Photo 2) was free of obstructions.
- The inlet for Culvert C22 (Photo 4) was free of obstructions.
- Ditch D32B along the west side of Pond 006a was clear of obstructions (Photo 4).
- Ditch D23 was clear of sediment and obstructions.
- The outlet for Culvert C13 (Photo 5) was free of obstructions.

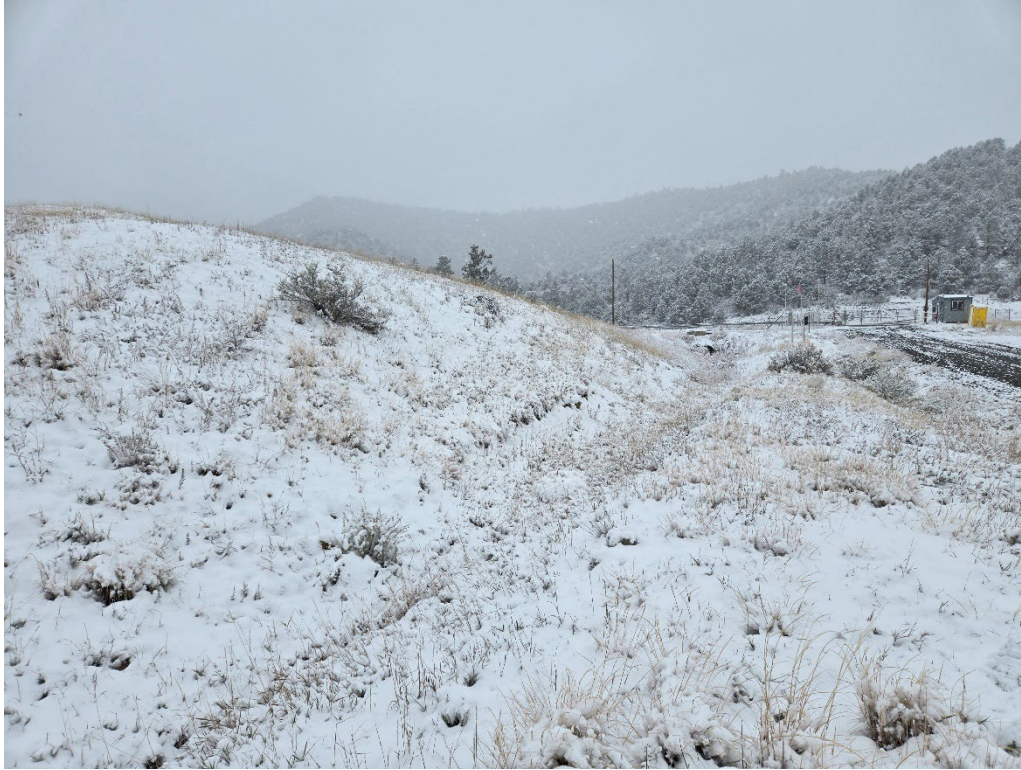
*Photo 3: Looking north along the east side of DWDA #1 at D2.*

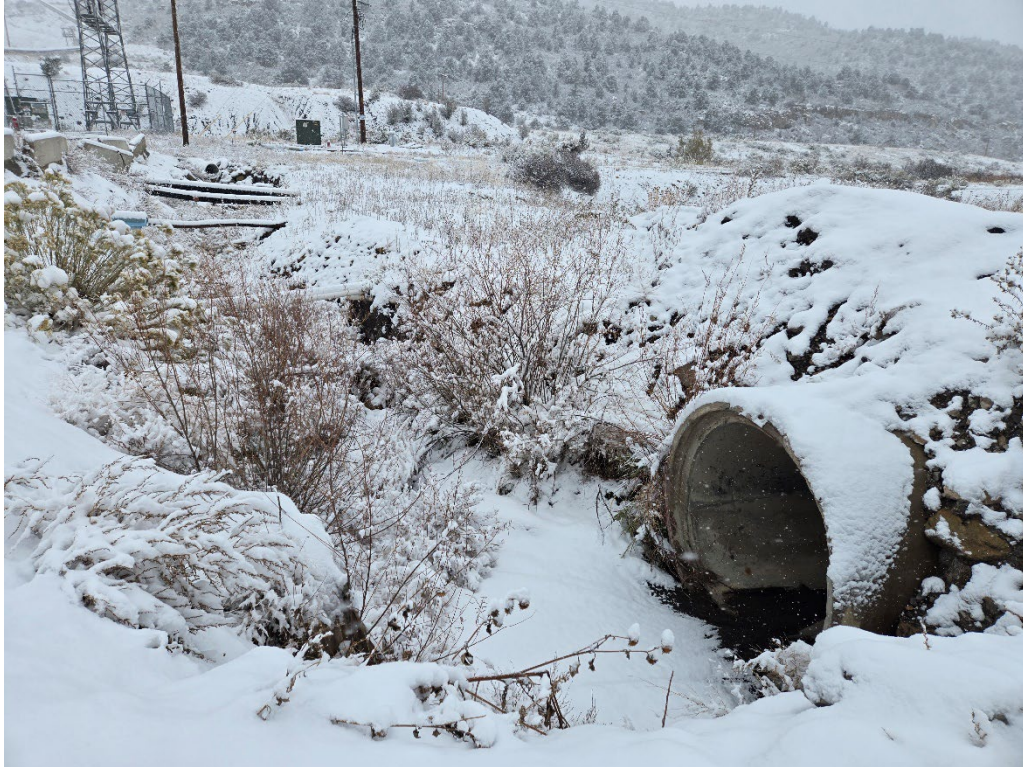
*Photo 4: Ditch D32B and the inlet for Culvert C22.*

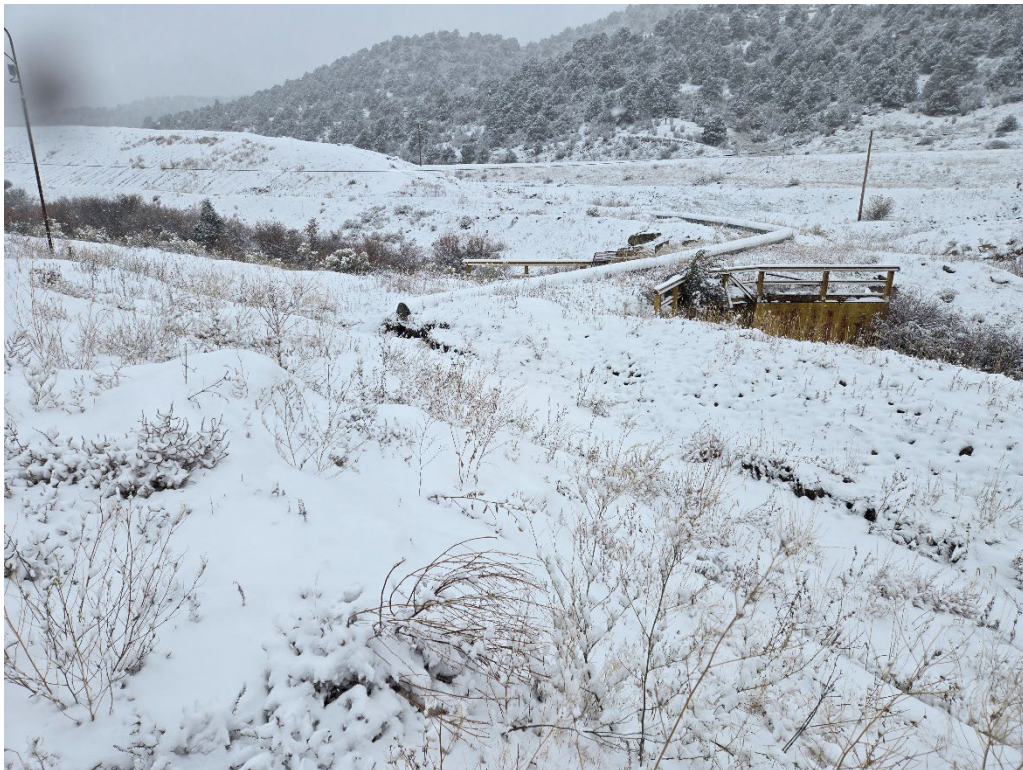
*Photo 5: Looking northeast at the outlet for C13.*

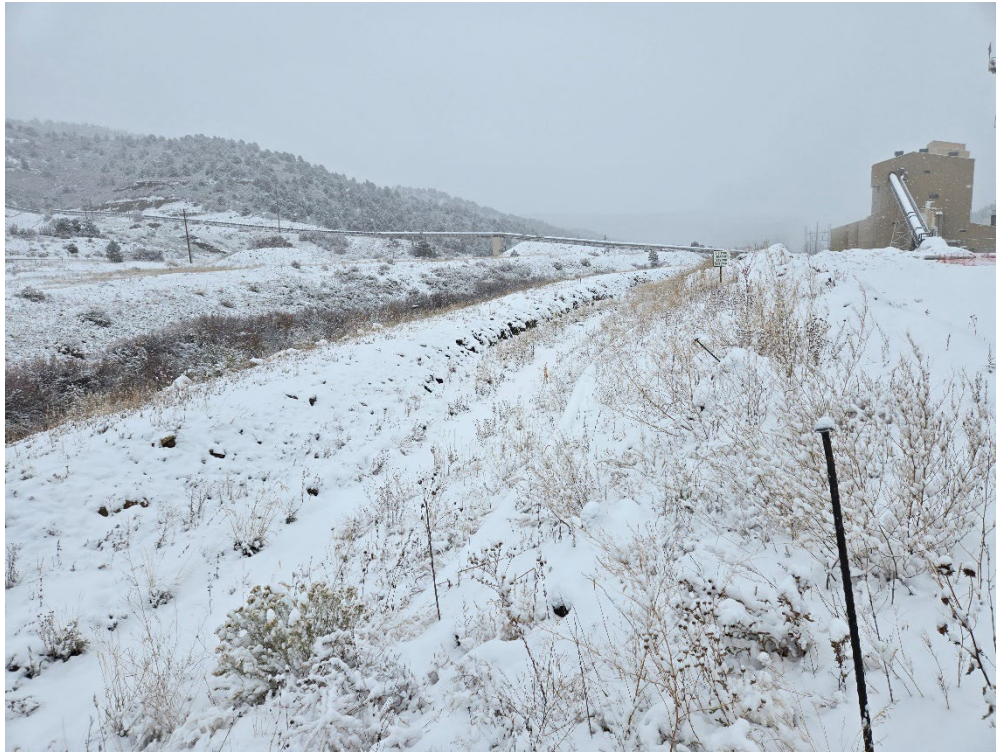
- Ditch D32 was clear of obstructions (Photo 6).

*Photo 6: Looking east along Ditch D32.*

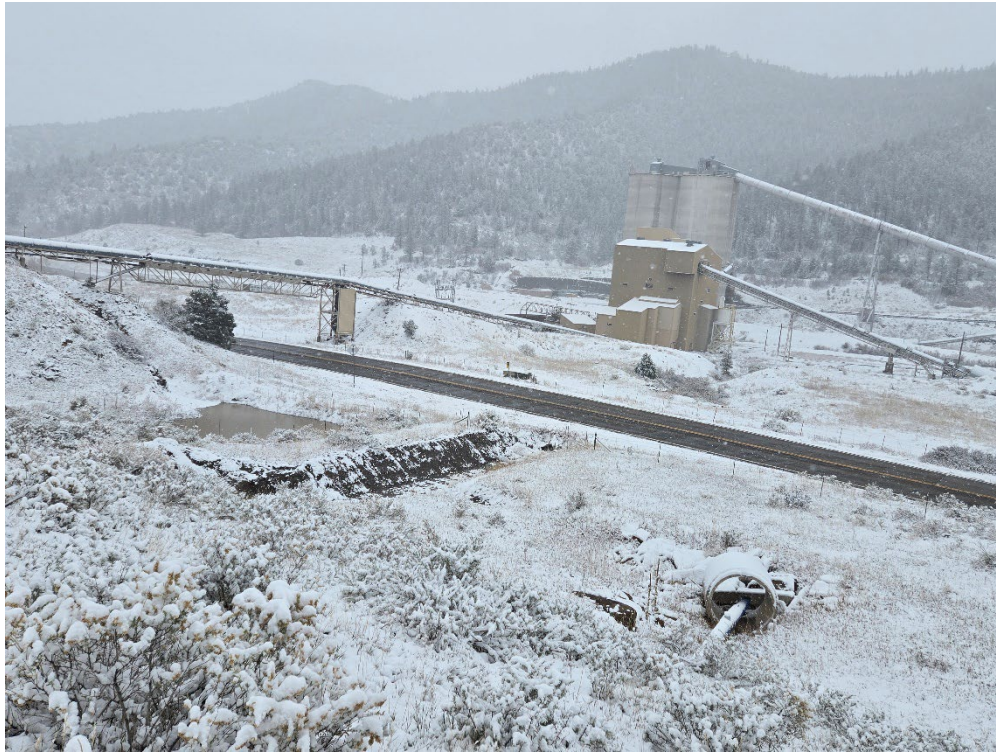
- Containment area #5 appeared to contain less water than at the time of the Division's October 2024 inspection (Photo 7).

*Photo 7: Looking south at Containment #5 and at the discharge point for Pond 08.*

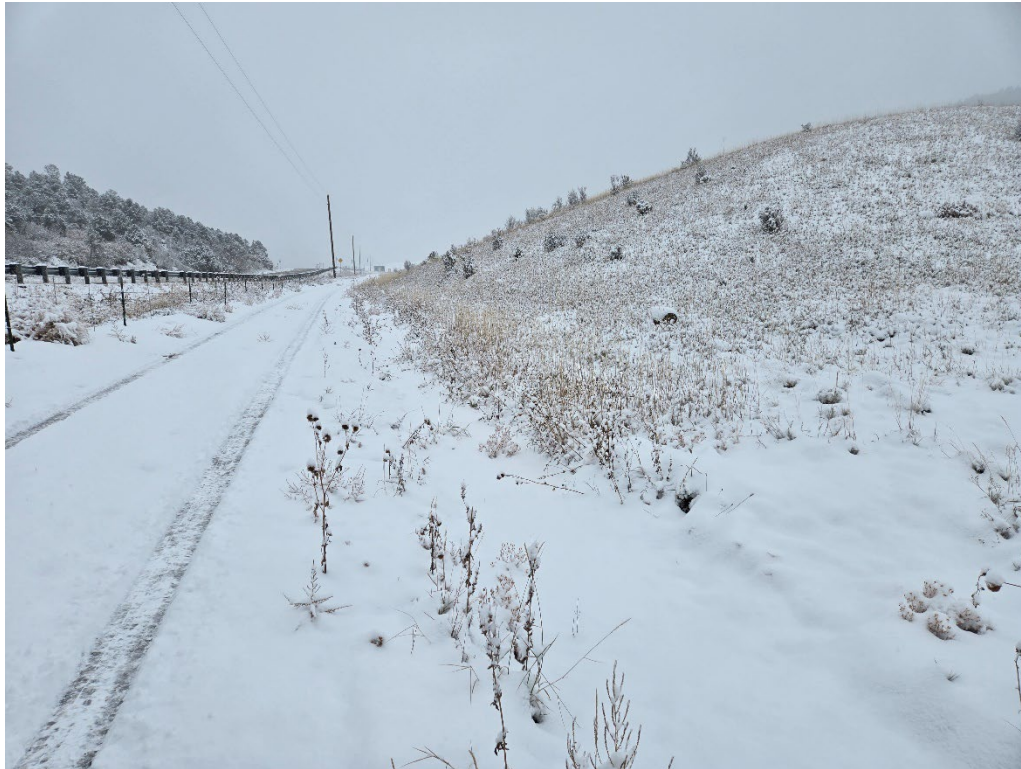
- Ditch D2, located to the north of DWDA #1, contained snow at the time of the inspection (Photo 8). During the October 2024 inspection, it was noted that areas along D2 had begun to fill with sediment and that some erosion along the road leading to Pond 004A was also observed. **The Operator shall monitor this area after the snow clears, clean this ditch, and stabilize the road.**

*Photo 8: Looking east along D2.*

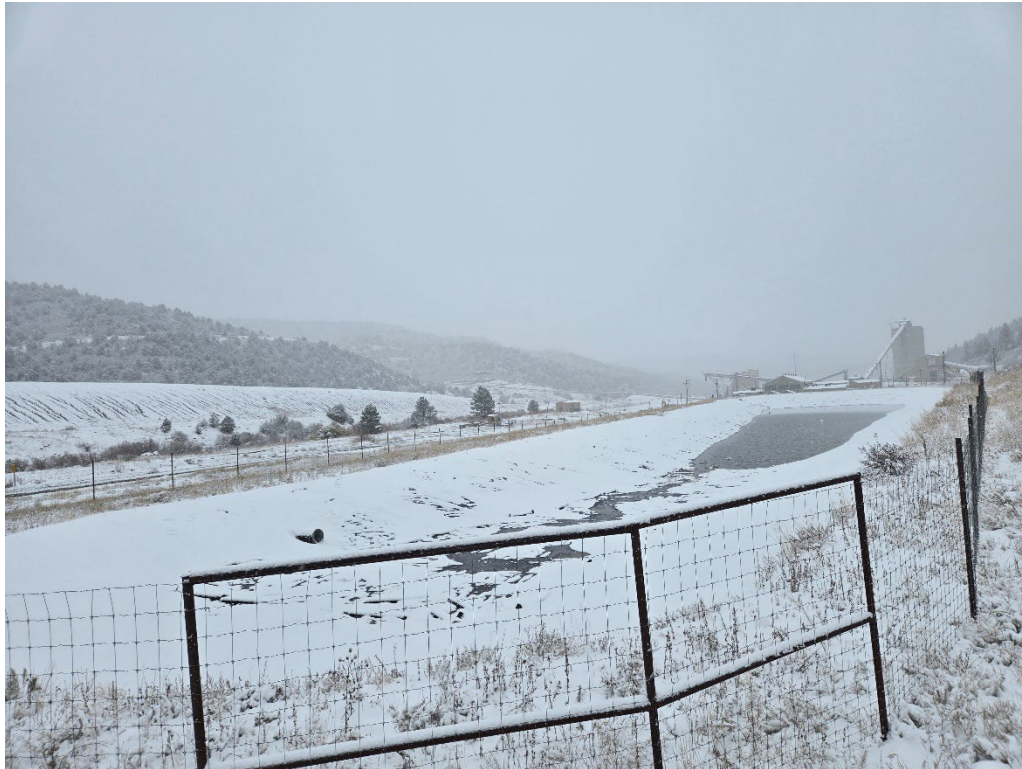
*Photo 9: Pond 001a*

- Pond 001A held some water at the time of the inspection and was not discharging (Photo 9).
- Pond 004A contained a small amount of water (Photo 10). The bank appeared to be stable.

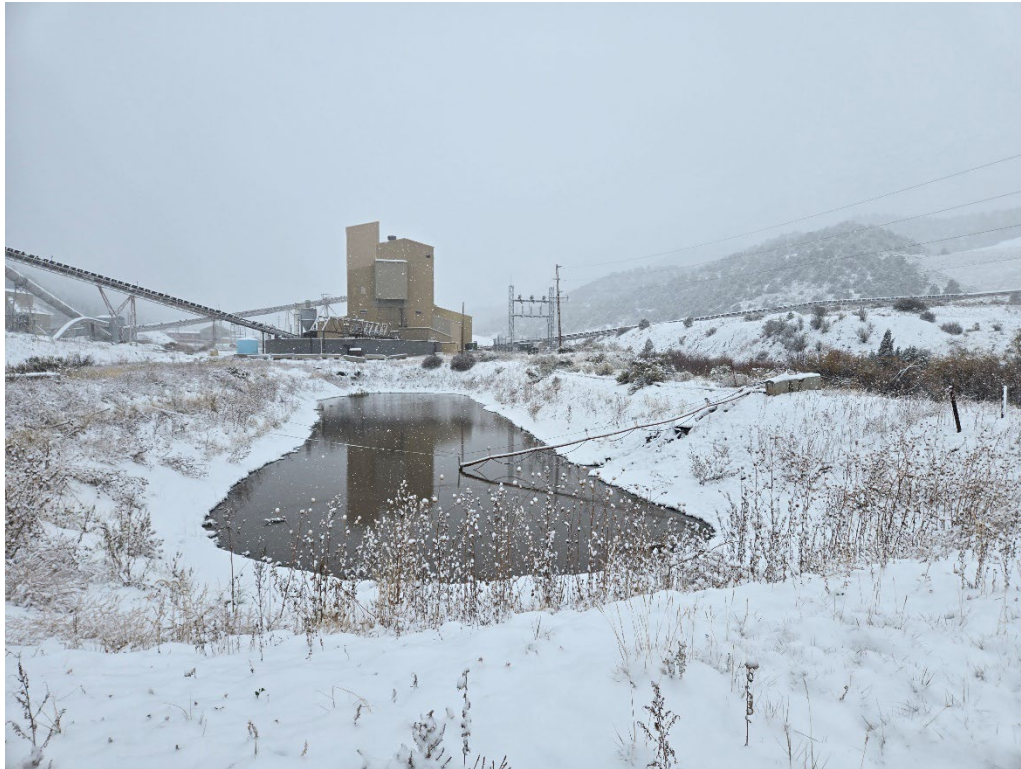
*Photo 11: Pond 006a*

- Pond 006A contained some water at the time of the inspection (Photo 11). The banks of the pond appeared to be stable.
- Pond 007A contained water at the time of the inspection. The water level was up to the lower portions of the primary spillway (Photo 12), but the pond was not discharging (Photo 13). The emergency spillway was free of obstructions and the embankment appeared to be stable.

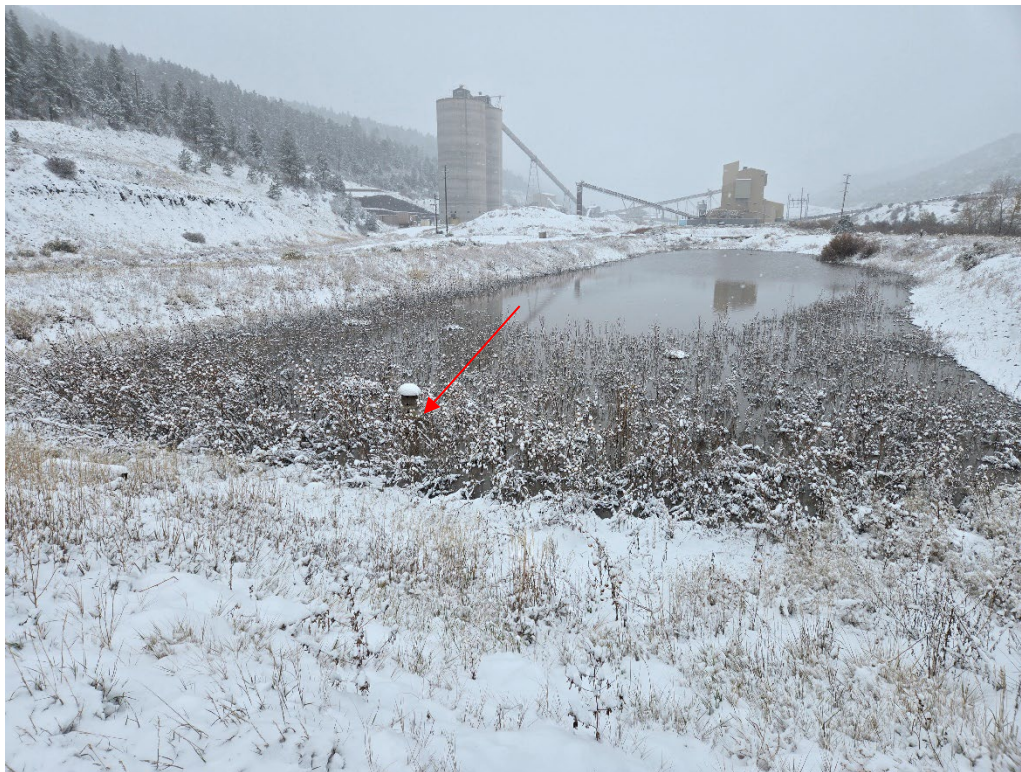
*Photo 12: Pond 007a. Arrow points to principal spillway.*

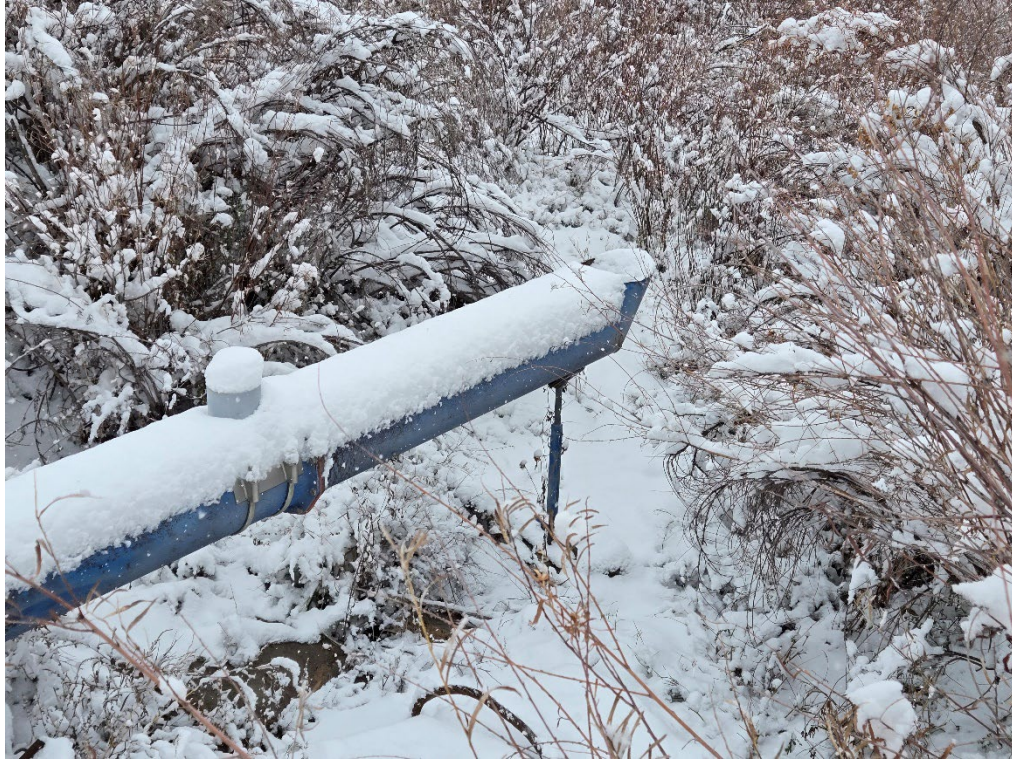
*Photo 13: Discharge point for Pond 007a.*

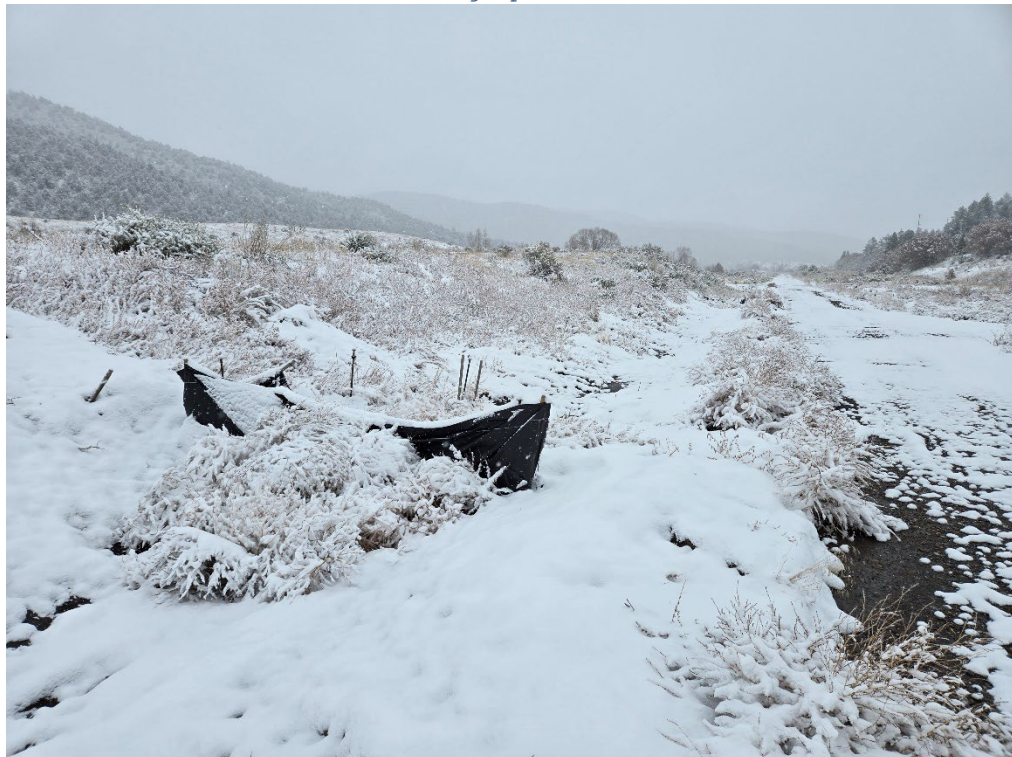
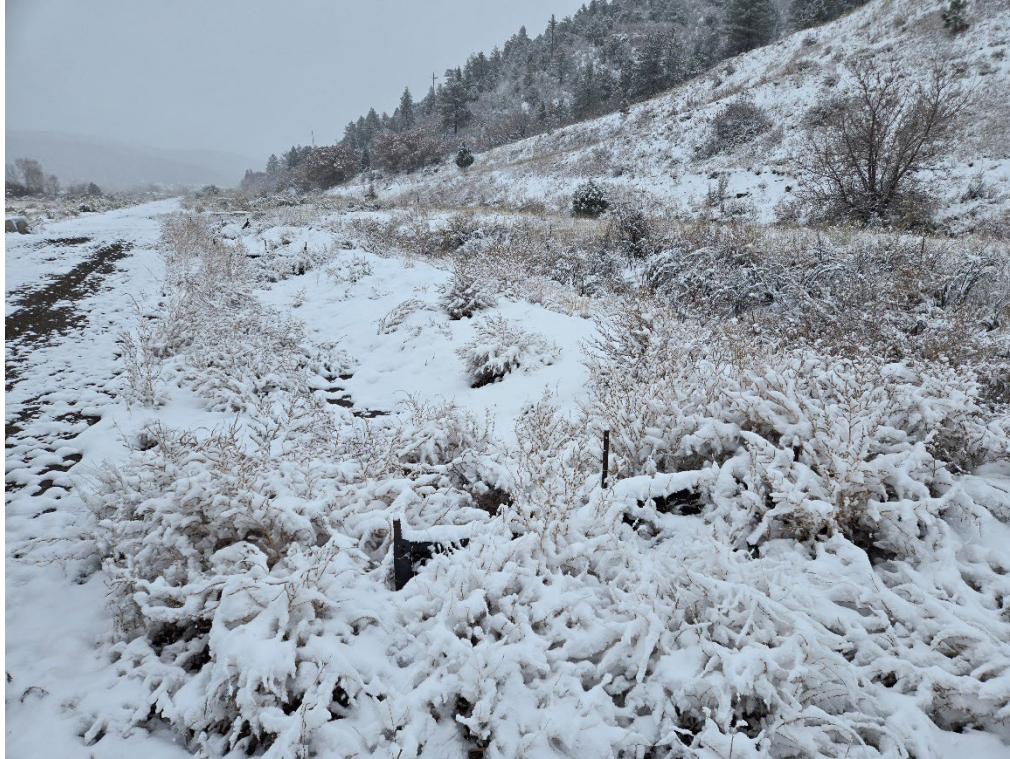
- The silt fences along the road leading to Pond 007a, within the S.A.E., are full of tumbleweeds and appear to be damaged (Photos 14-15). **The Operator shall clear the silt fences of vegetation/debris and repair the fences.**

*Photo 14: Looking east at the silt fences in the S.A.E, located on the north side of the road leading to Pond 007a.*

*Photo 15: Looking east at the silt fences in the S.A.E, located on the south side of the road leading to Pond 007a.*

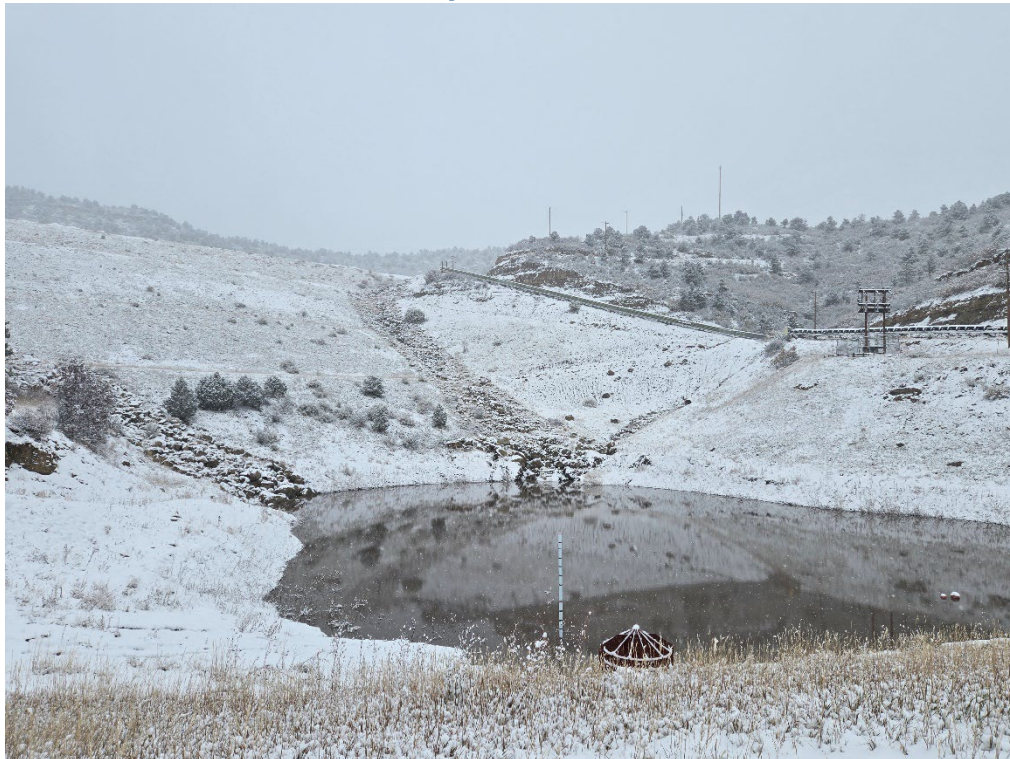
*Photo 16: Pond 08*

- Pond 08 contained water at the time of the inspection and was below its capacity (Photo 16). The spillways appeared clear, and the banks were stable. Pond 08 was not discharging.

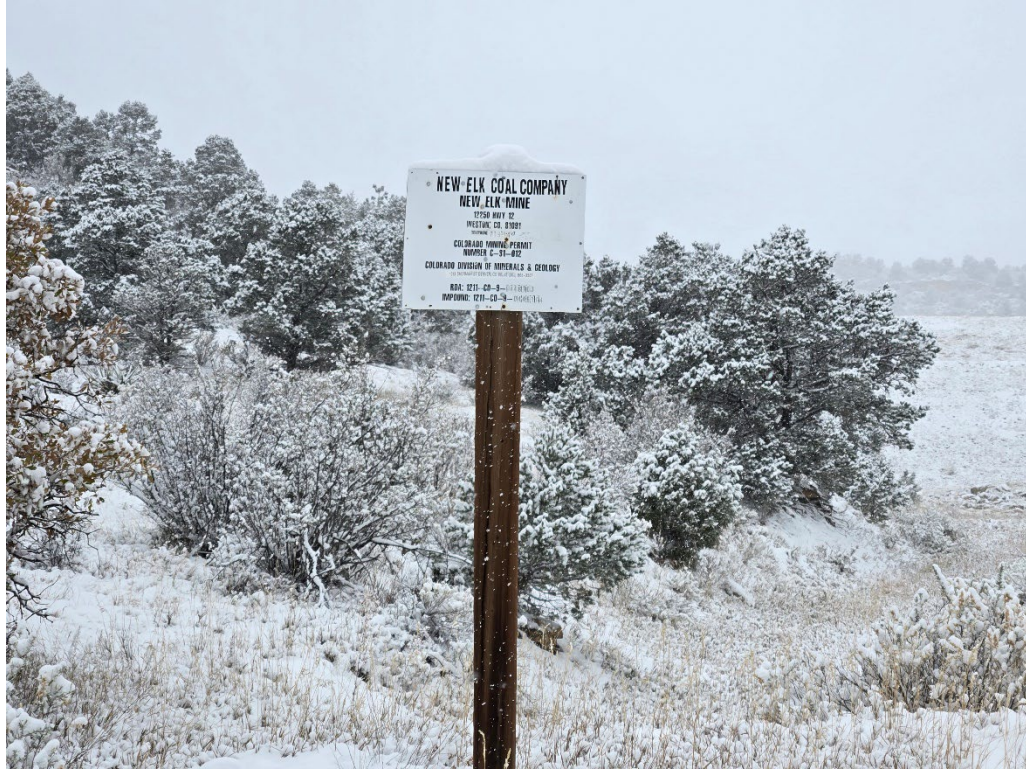
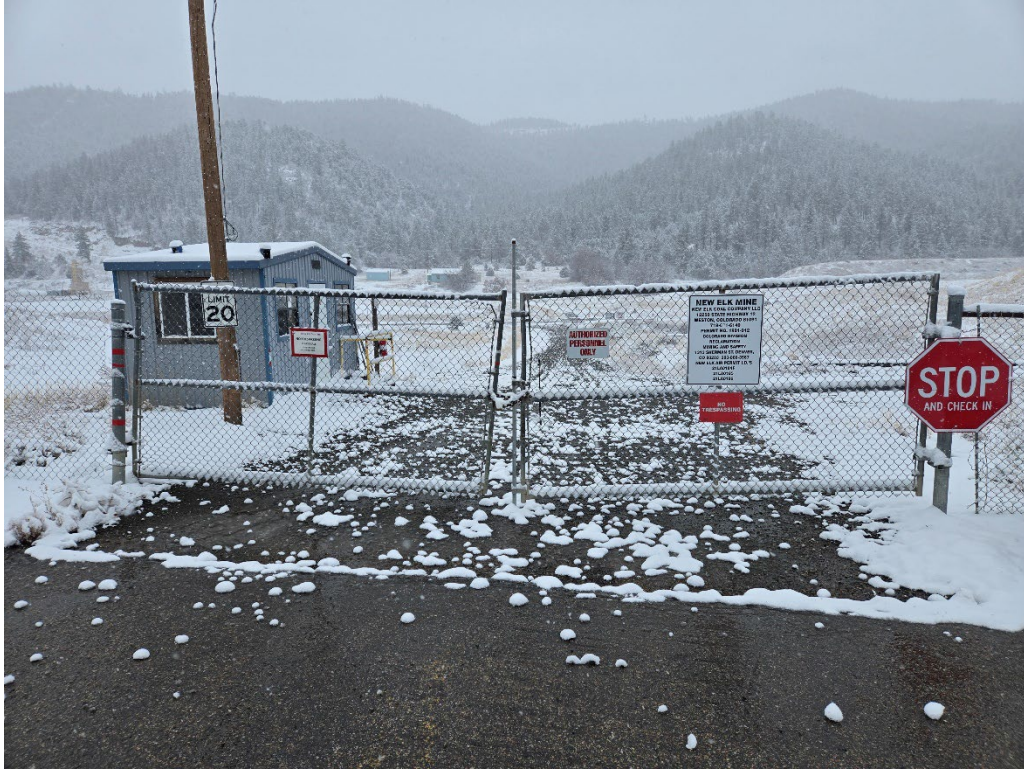
- Mine signs were posted in compliance with Rule 4.02 (Photos 17-18). A new contact number has also been provided and posted on the entrance gate to comply with the public access requirements of Rule 5.02.4.

*Photo 17: Mine sign posted near the access entrance for the southside of Pond 08.*

*Photo 18: The Division was able to access the site with the gate code provided to the inspector.*
