November 2024 Lorencito Canyon Mine C-1996-084 Inspection Report

PERMIT INFORMATION

INSPECTION INFORMATION

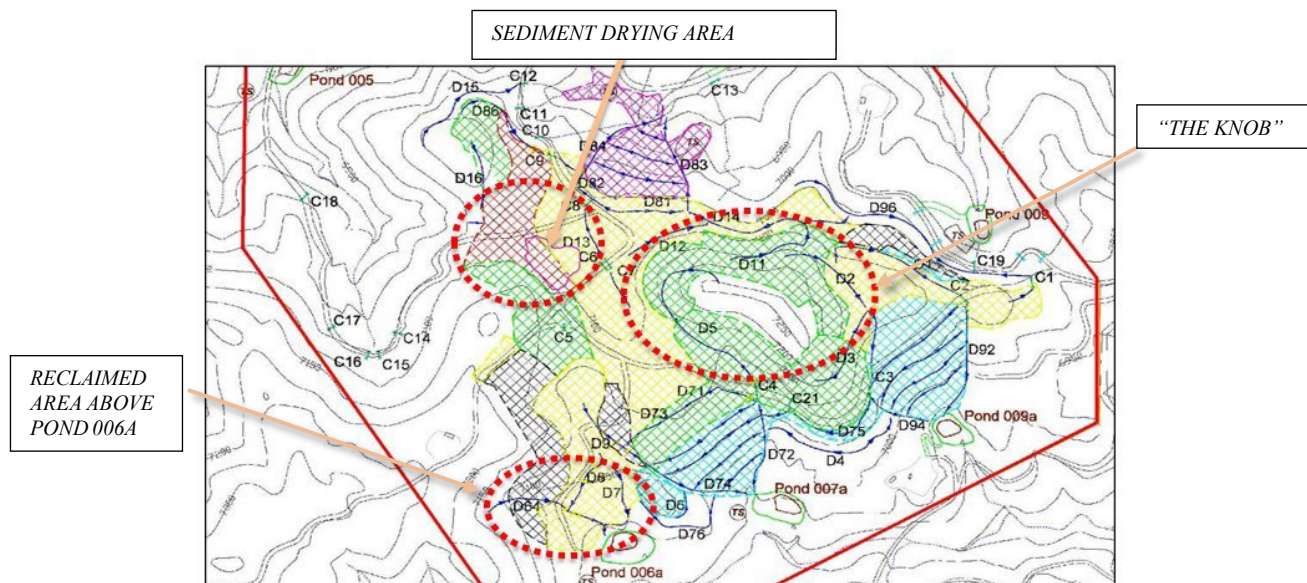
4. The following items pertain to ongoing erosional issues in the areas shown in Figure 1, that pursuant to Rule 4.14.6 need to be addressed. A Technical Revision will be required to expand on the current Rill and Gully plan in the PAP. **The Operator shall submit the technical revision, obtain approval, repair the erosion, and stabilize the slopes pursuant to the approved plan by December 31, 2024.**

FIGURE 1. AREAS WHERE RILLS, GULLIES AND SPARSE VEGETATION HAS BEEN FOUND TO BE A PERSISTENT PROBLEM AT THE SITE ARE WITHIN THE DOTTED CIRCLE AREAS. BACKGROUND IMAGE IS THE 2020 ANNUAL REPORT MAP.

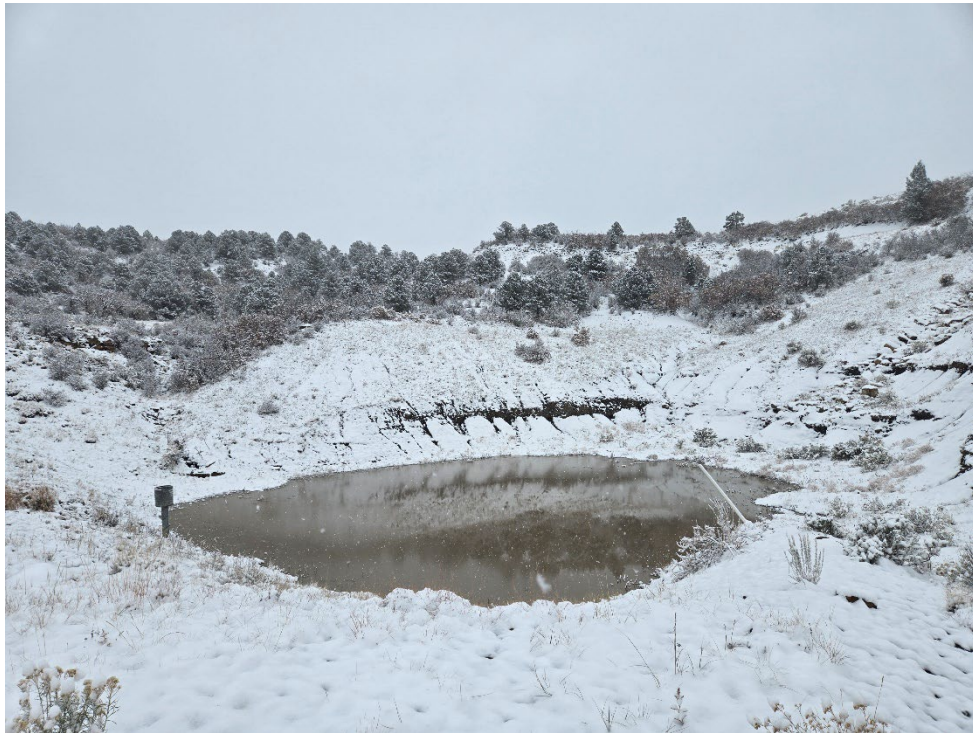
- Pond 009:
 - The pond held some water at the time of the inspection. (Photo 1).
 - The pond embankment appeared to be stable and vegetated. **The rills above the bank do not appear to have worsened, but the Operator shall continue to monitor this area.**
 - The primary and emergency spillways appeared clear and functional.
 - The flume contained some water but was not discharging. Some vegetation has grown over and into the flume (Photo 2). **The Operator shall clear the excess plant material in the flume.**

Photo 1: Pond 009

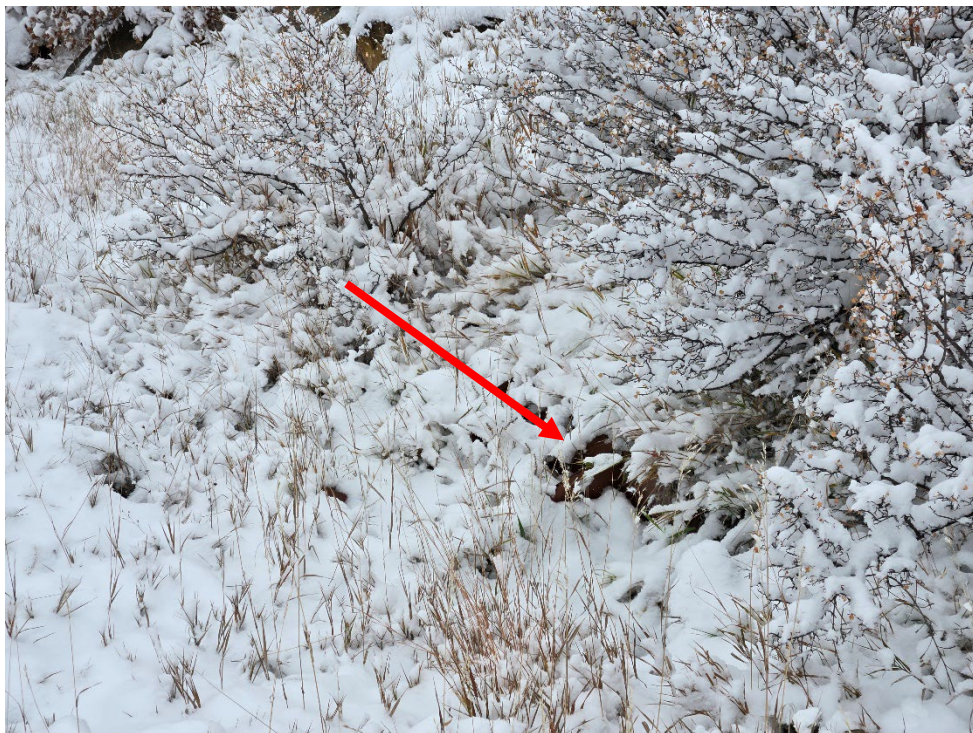
Photo 2: Arrow points to flume at Pond 009.

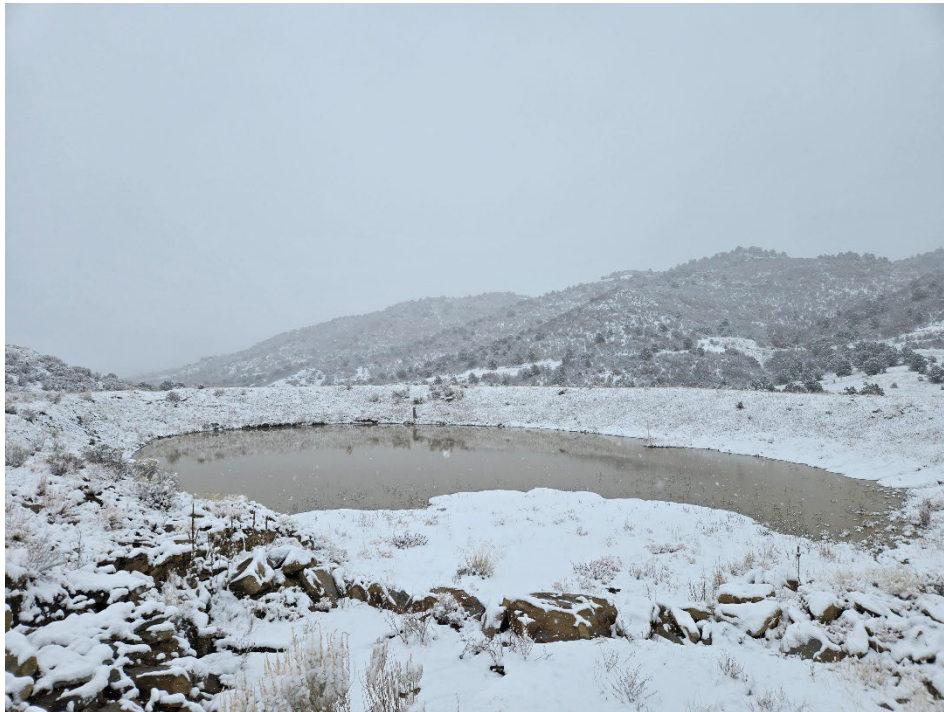
- Pond 006a:
 - Pond 006a contained water (Photo 3) and was not discharging at the time of the inspection.
 - The pond embankment still requires maintenance (see Item # 1 in the outstanding maintenance items list on the first page of this report).
 - The west bank referenced in Item #1 in the outstanding maintenance items list on the first page of this report, currently has a vegetative cover due to volunteer vegetation. This area will likely still need to be re-stabilized, but may need to be re-addressed at a later date once the vegetation has cleared for the season.
 - The primary and emergency spillways appeared to be clear and functional.

Photo 3: Looking southeast at Pond 006a.

1. Erosion rills are forming on the north and west banks of Pond 006a. The erosion on the north bank appears to have been addressed at some point, because rebar is placed above the rills. However, it appears that the prior BMPs are no longer functioning adequately. **Pursuant to Rule 4.05.5(1)(c), the Operator shall address the erosion and repair the north bank.** The erosion on the west bank appears to have been caused by runoff from the road located east of Pond 006a. **Pursuant to Rule 4.05.5(1)(c), the Operator shall address the erosion and repair the west bank.**

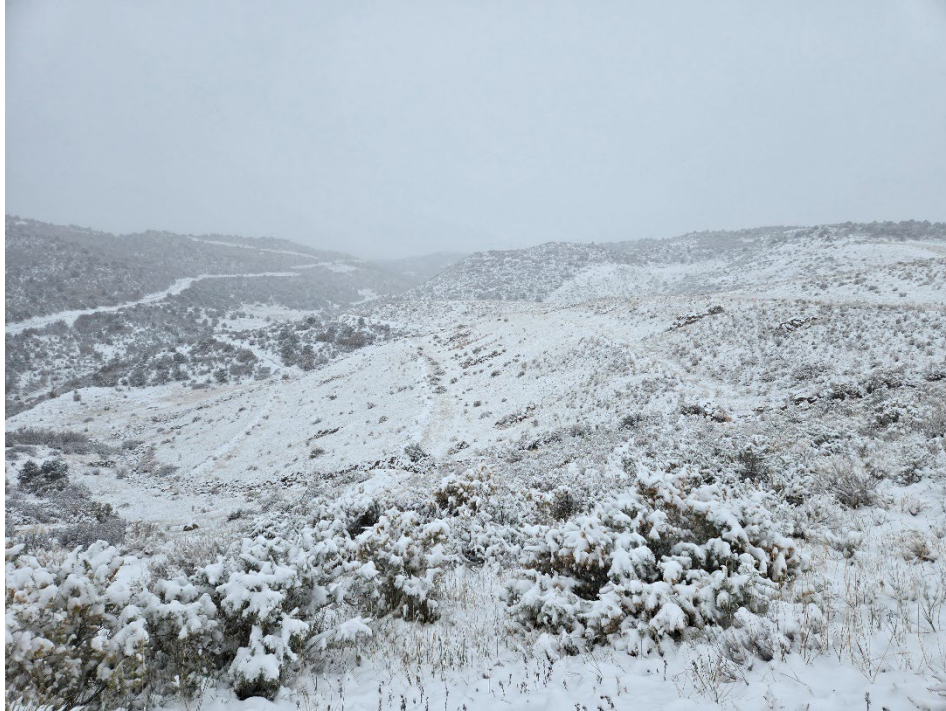
- Fill 007 was observed. Fill 007 was well vegetated and appeared stable (Photo 4).

Photo 4: Looking southwest across Fill 007.

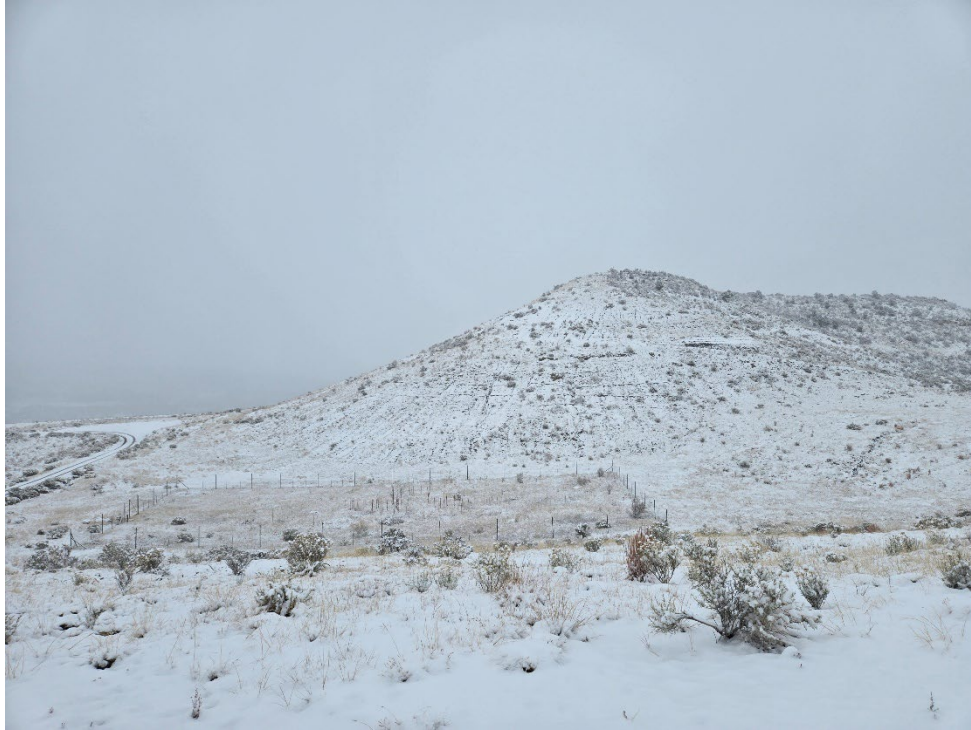
- A previously disturbed area north of Fill 7 and north of the road, referred to as “The Knob”, exhibits erosion on the south and west facing slopes (Photo 5). NECC is required to provide a plan to stabilize this area through a revision following the approval of RN5 (see ongoing maintenance item number 4).

Photo 5: Looking north at the south-facing side of "The Knob".

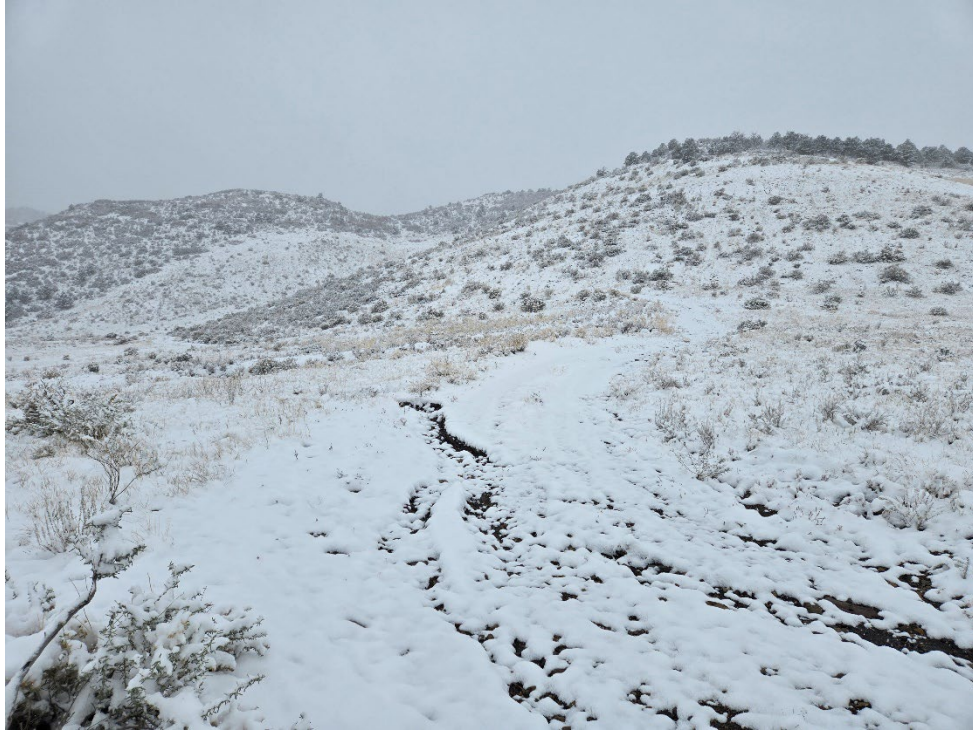
- See ongoing maintenance Item #2 and #3. The road along Pond 006A is washed out in the area between the reclaimed area and Pond 006A, and needs to be repaired.
- Signs of water movement across the road leading down the Pond 006A, above Ditch D9, were observed during the inspection (Photo 6). While the run-off is being contained within its designated location, the sedimentation has contributed to the filling of the check dams within D9, as mentioned in the October 2024 report.

Photo 6: Looking west across the road above D9, leading to Pond 006a.

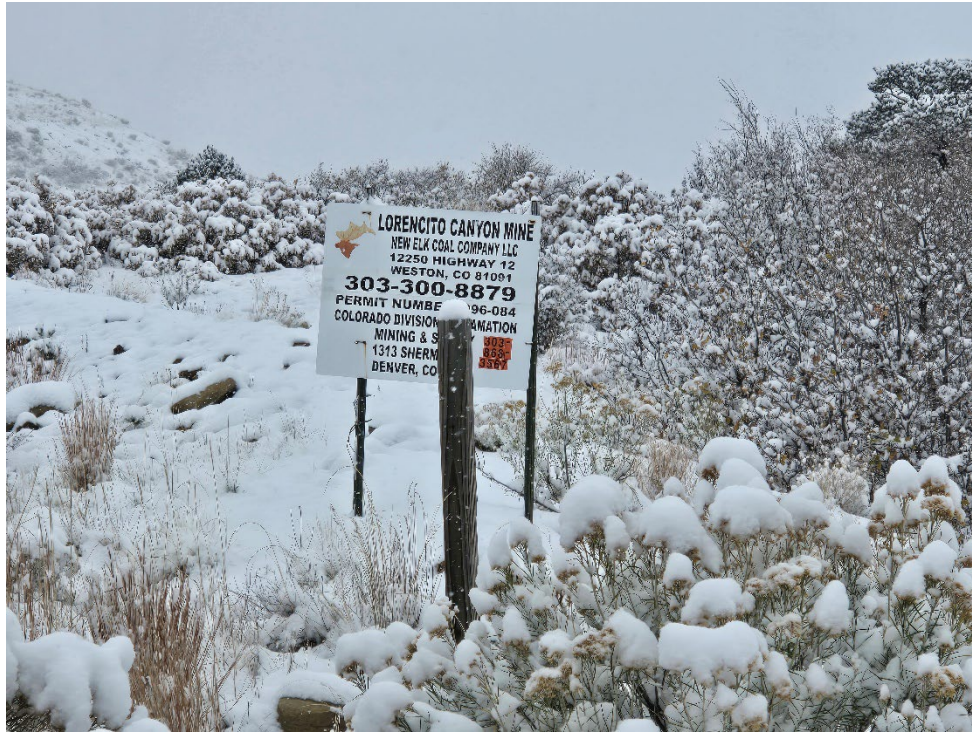
- Mine signs were posted at road entrances and at the entrance to the permit boundary in compliance with Rule 4.02 (Photo 7).

Photo 7: Mine sign
