MINERALS PROGRAM INSPECTION REPORT
PHONE: (303) 866-3567

MINE NAME: South Fruita Gravel Pit	MINE/PROSPECTING ID#: M-1981-243	MINERAL: Sand and gravel	COUNTY: Mesa
INSPECTION TYPE: Surety-Related Inspection	WEATHER: Cloudy	INSP. DATE: November 5, 2024	INSP. TIME: 09:00
OPERATOR: Grand Junction Concrete Pipe Co.	OPERATOR REPRESENTATIVE: Bryan Jorgensen	TYPE OF OPERATION: 112c - Construction Regular Operation	
REASON FOR INSPECTION: Priority	BOND CALCULATION TYPE: Complete Bond	BOND AMOUNT: \$237,724.00	
DATE OF COMPLAINT: NA	POST INSP. CONTACTS: DRMS	JOINT INSP. AGENCY: None	
INSPECTOR(S): Amy Yeldell	INSPECTOR'S SIGNATURE:

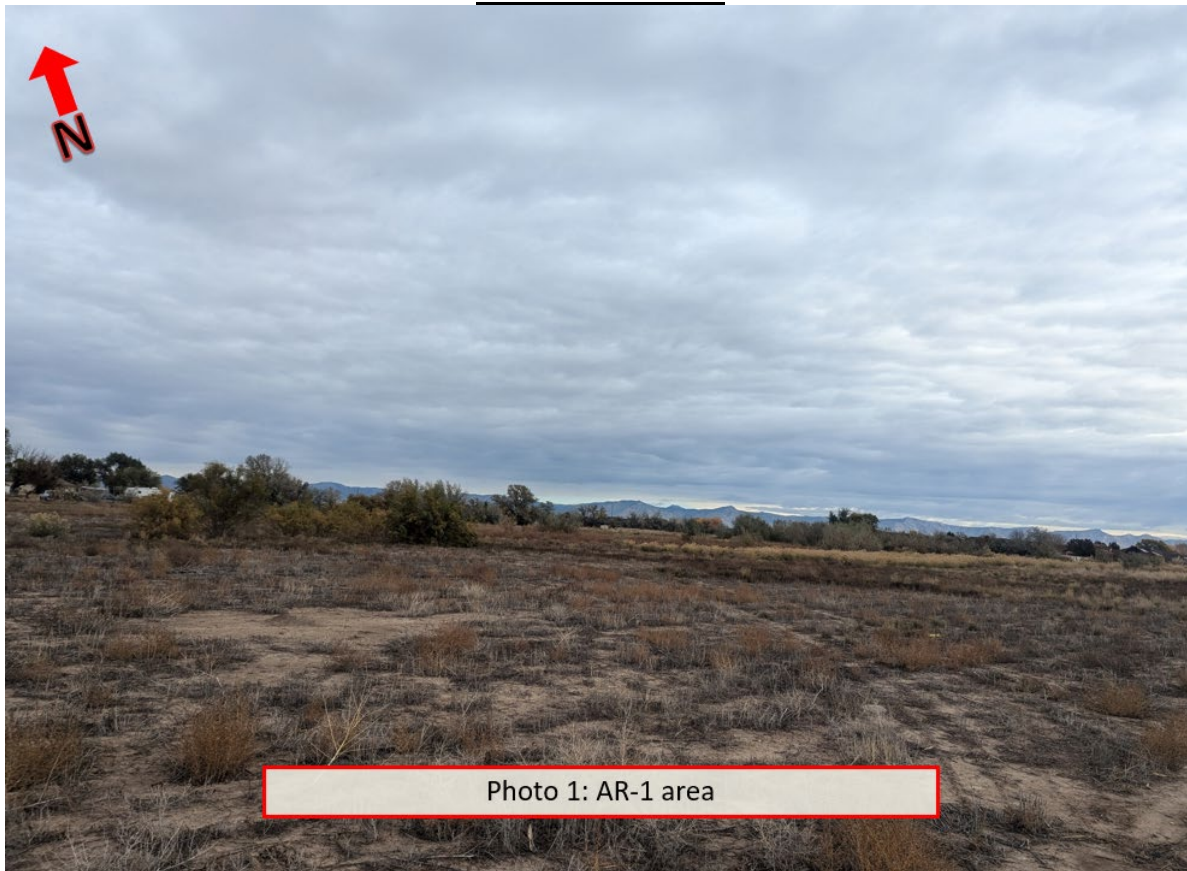
Photo 1: AR-1 area

The northern portion of the Karp parcel which is 8.82 ac has been requested to be released under AR-1. This area is differentiated from the affected lands by a wire fence. This land has not been affected by mining and thus no required reclamation has occurred to date. Vegetation consists of a fallow field with some volunteer of native shrubs. Photos 1-3.

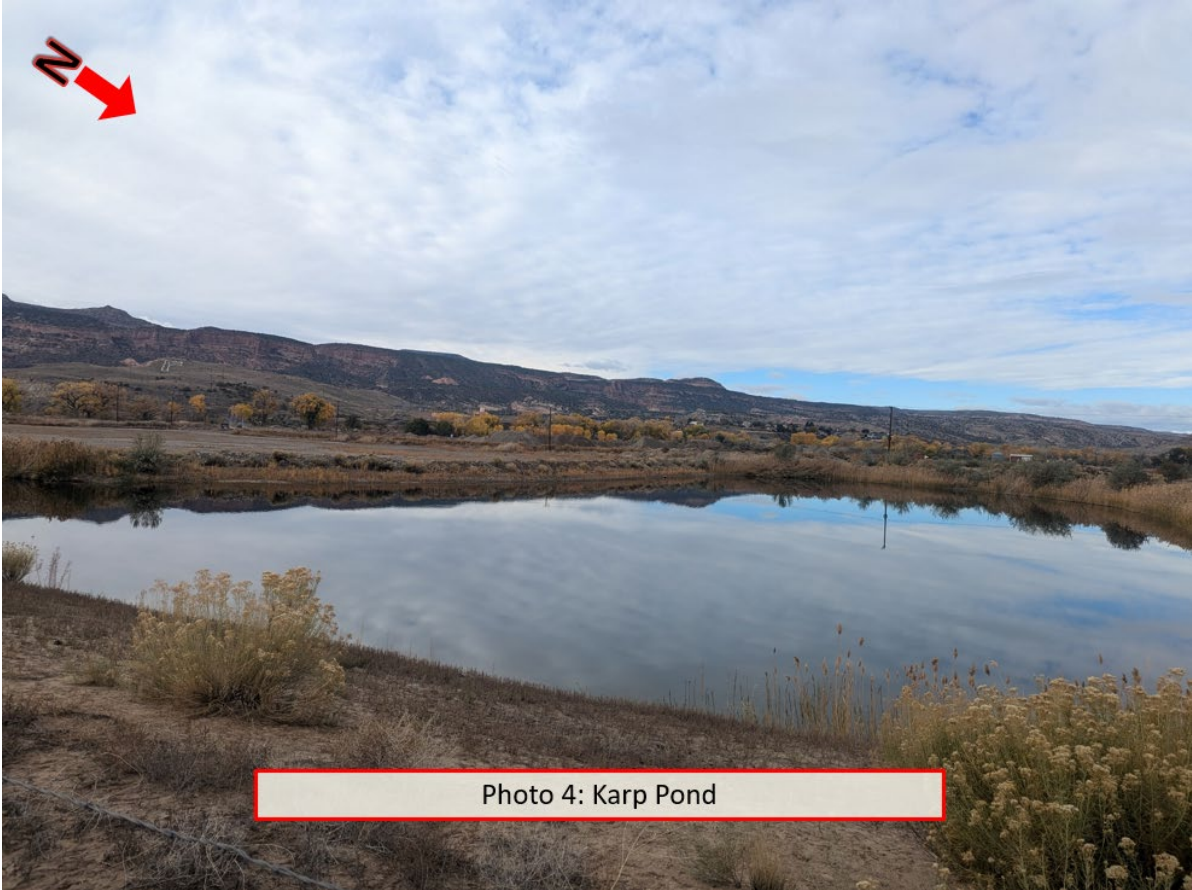
Photo 4: Karp Pond

The slopes along the North and northeast side of the Karp pond appear to be graded to a 3H: 1V or less and are somewhat reclaimed (Photo Four). All highwalls adjacent to the stripped pad that remains along the southwest side are approximately 1H: 1V and will be mined through when mining concludes in this phase. At this time all slopes requiring grading in this phase may be cut/fill graded.

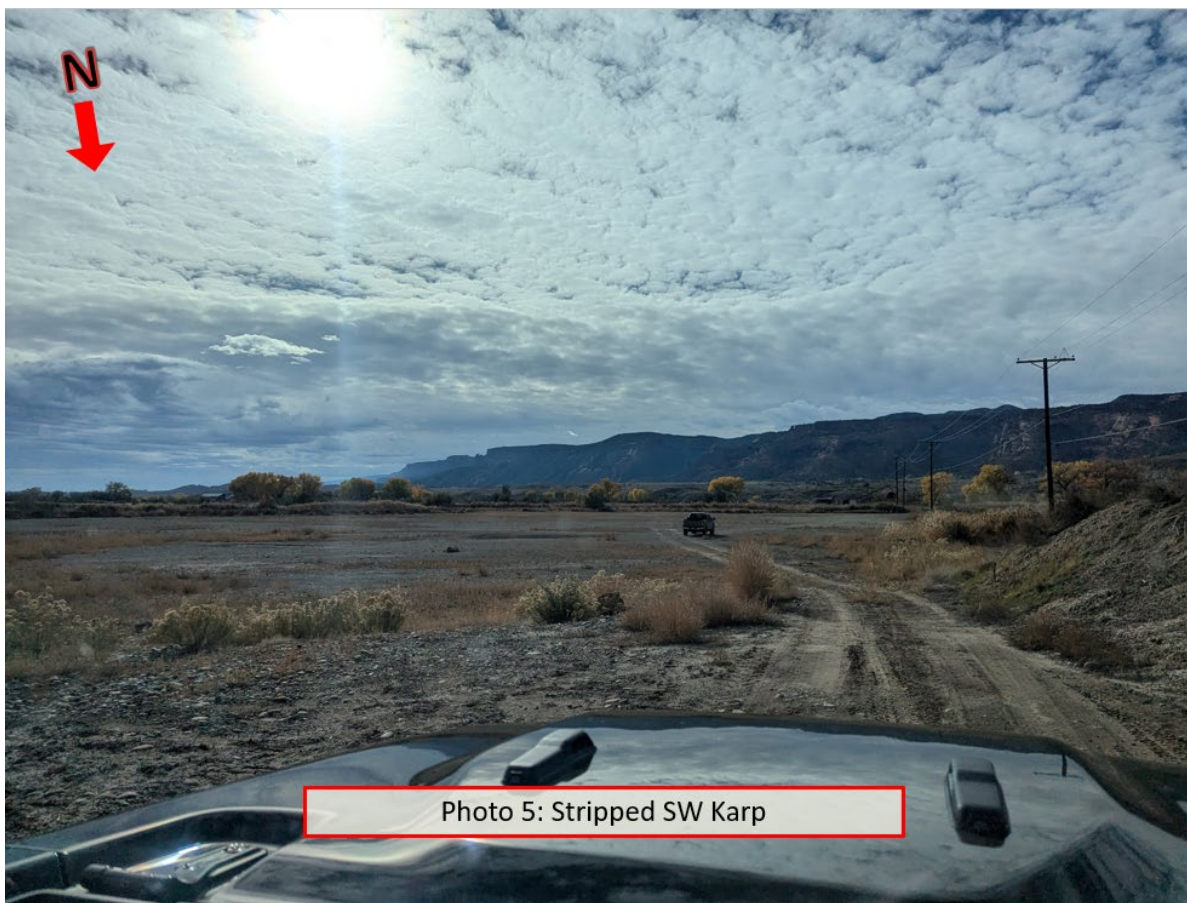
Site conditions of the Karp parcel remain unchanged from the previous inspection. All of the Karp parcel not being requested for release has been stripped (Photo Five). This area is anticipated to be mined within the next two years. Stockpiles are located on the southeast corner of the Karp pond (Photo Six).

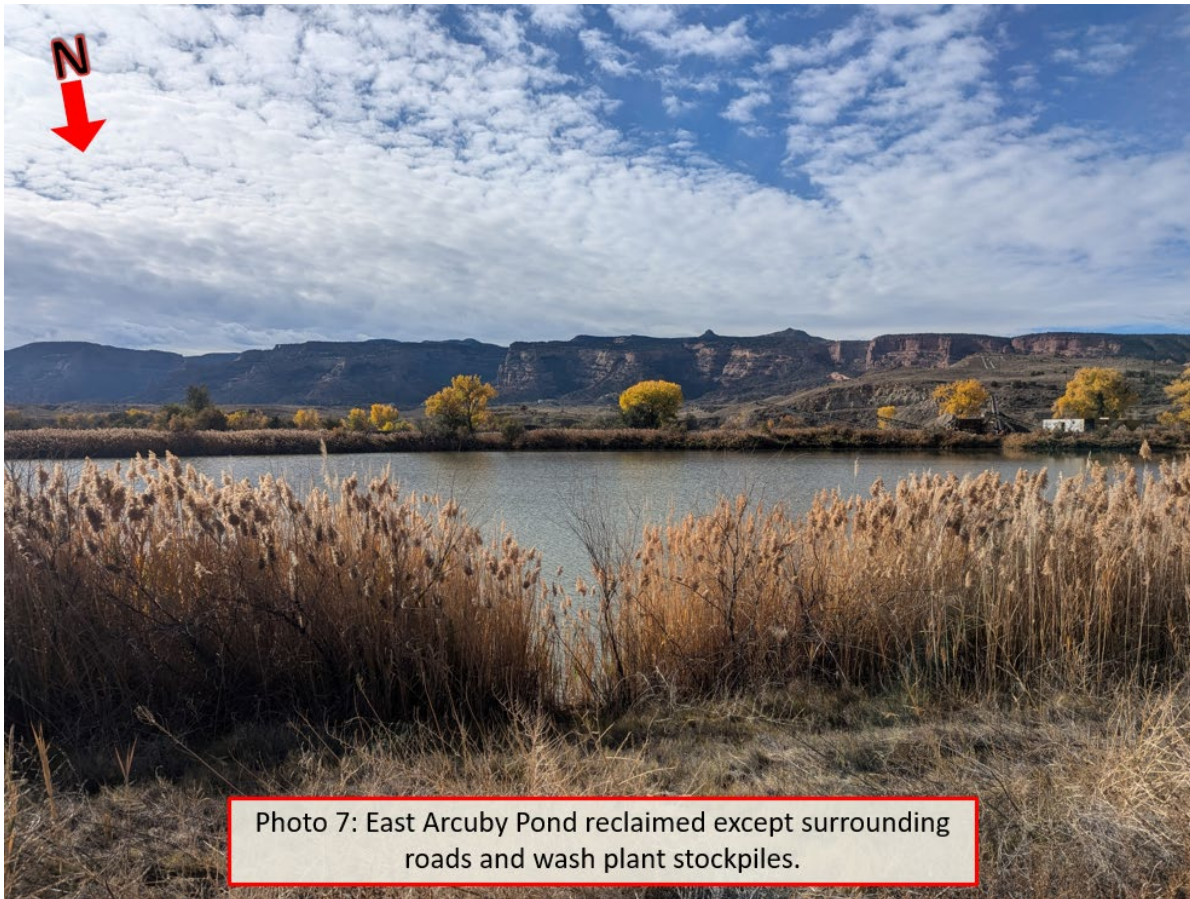
The east Arcuby pond has concluded mining and is being used as the wash pond. All slopes surrounding the existing lake are at a 3H: 1V. Some stockpiles are present along the south side of the lake that would require grading out if not completely removed. Only limited touch-up grading is anticipated for final reclamation. (Photo Seven)

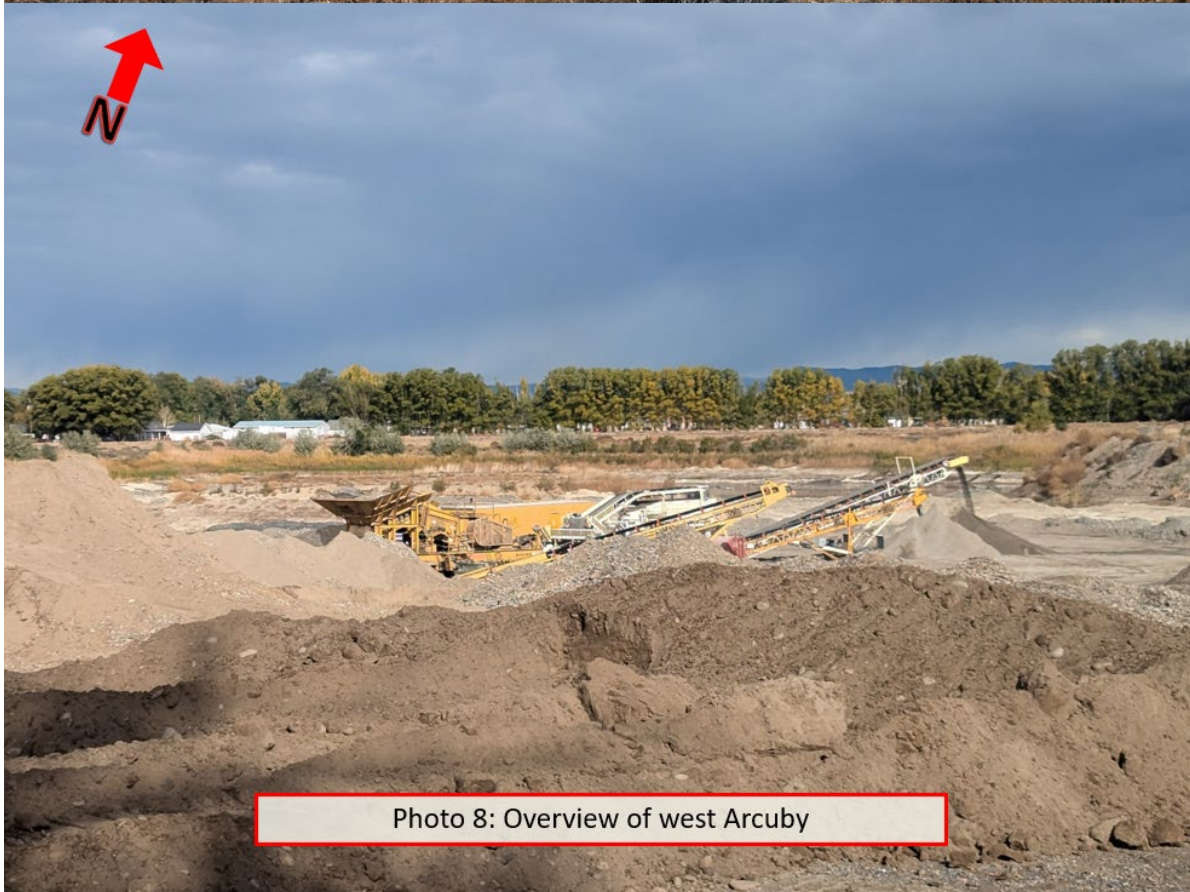
The West Arcuby pond is nearly all mined out. The pit has been excavated to a depth of approximately 25 ft. The northern pit slopes are generally all shaped with only touch up grading and blending. The south and southeast side of the pit has near vertical slopes. Some areas may be cut/fill but a portion of the highwalls do require backfill being transported from areas adjacent to 17 ½ road. It is anticipated that this phase will be completed by early 2025. Photos Eight – Twelve.

The majority of current activity is in the west Arcuby pit where material is being excavated. Photos Eight – Twelve.

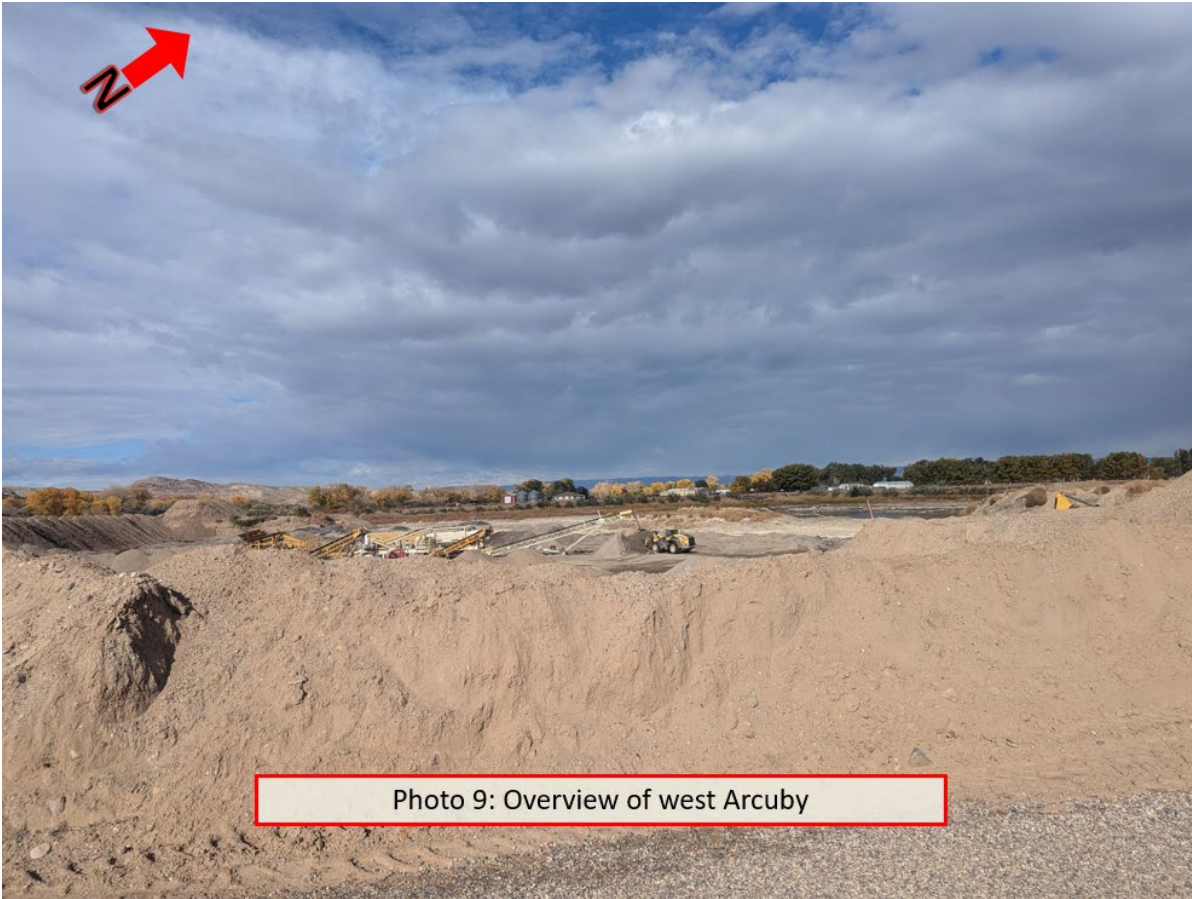
Photo 9: Overview of west Arcuby

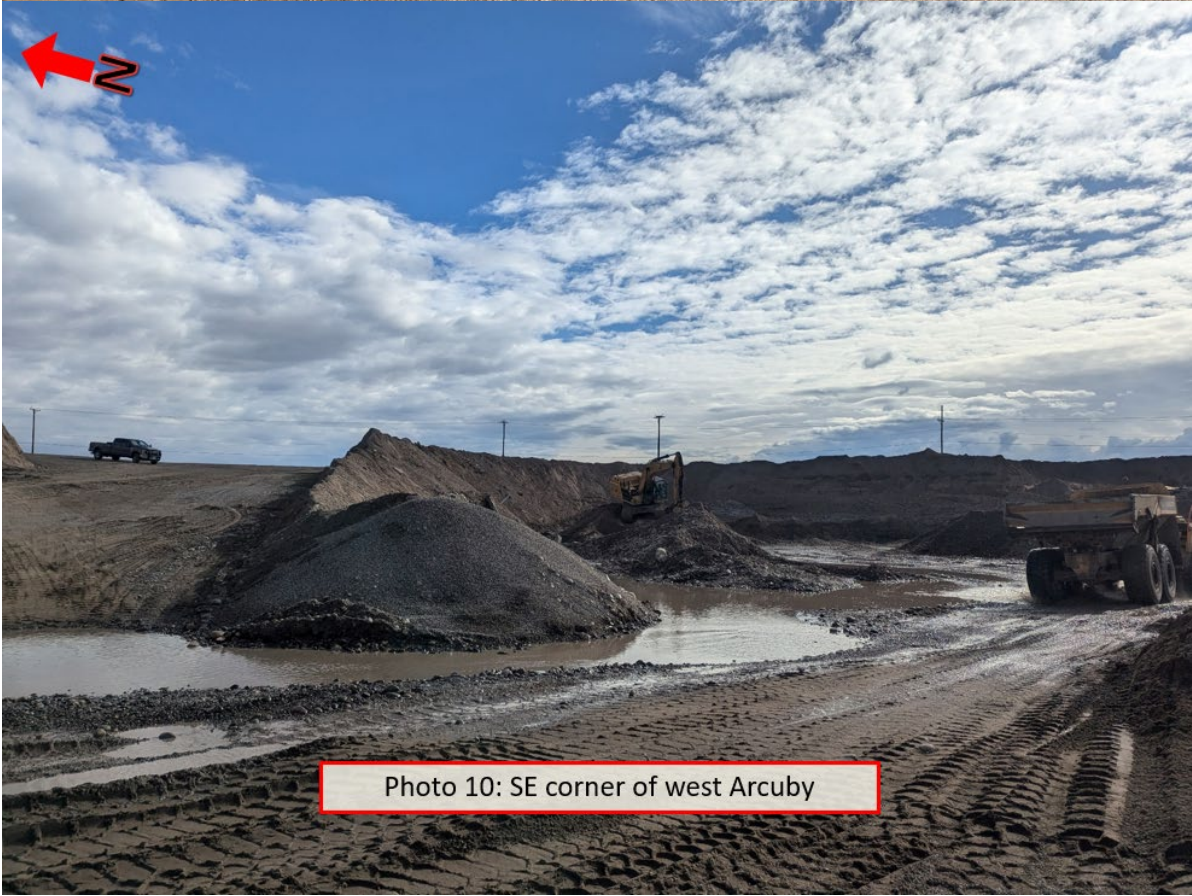
Photo 10: SE corner of west Arcuby

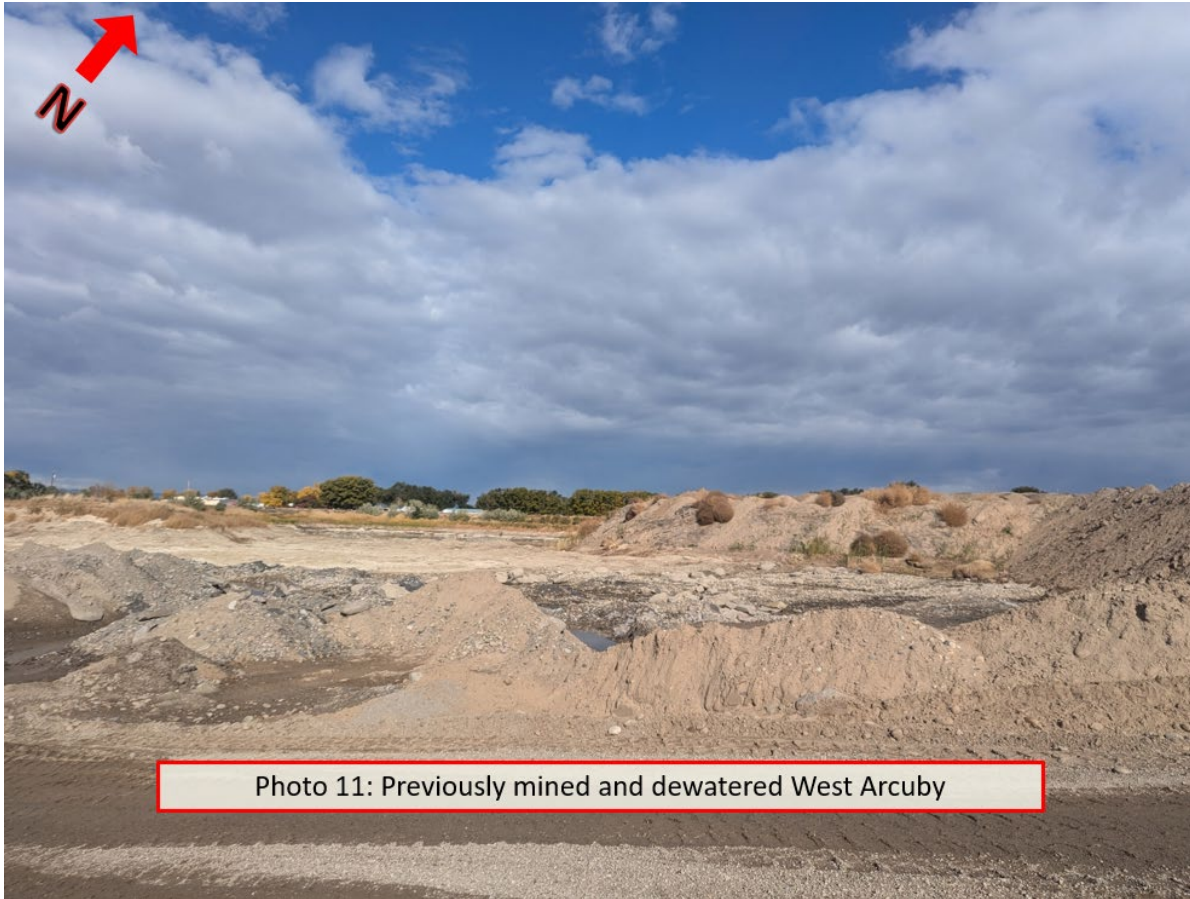
The Arcuby pit on the west side of the road is completely dewatered. Both ponds on the east side of the road are inundated.

Photo 11: Previously mined and dewatered West Arcuby

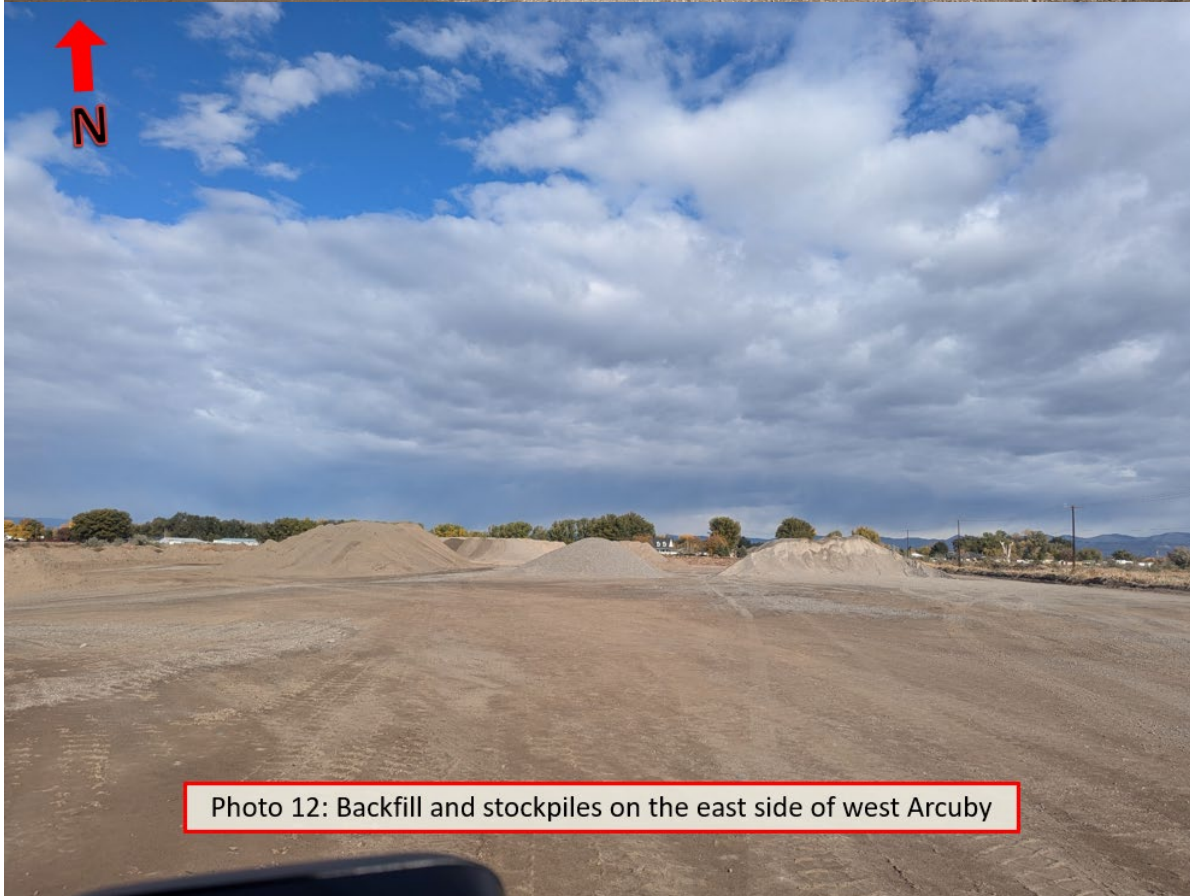
Photo 12: Backfill and stockpiles on the east side of west Arcuby
