Cooley Reservoir-Fulton M-1999-034 AR3 Inspection

MINERALS PROGRAM INSPECTION REPORT
PHONE: (303) 866-3567

MINE NAME: Cooley Reservoir & Fulton Wildlife Area	MINE/PROSPECTING ID#: M-1999-034	MINERAL: Sand and gravel	COUNTY: Adams
INSPECTION TYPE: Surety Release Inspection	WEATHER: Cloudy	INSP. DATE: October 30, 2024	INSP. TIME: 10:00
OPERATOR: Holcim - WCR, Inc.	OPERATOR REPRESENTATIVE: Wyatt Webster	TYPE OF OPERATION: 112c - Construction Regular Operation	
REASON FOR INSPECTION: Surety Release Requested	BOND CALCULATION TYPE: None	BOND AMOUNT: \$1,510,800.00	
DATE OF COMPLAINT: NA	POST INSP. CONTACTS: None	JOINT INSP. AGENCY: None	
INSPECTOR(S): Nikie Gagnon	INSPECTOR'S SIGNATURE:

2022 Thornton Reservoir Slope Assessment

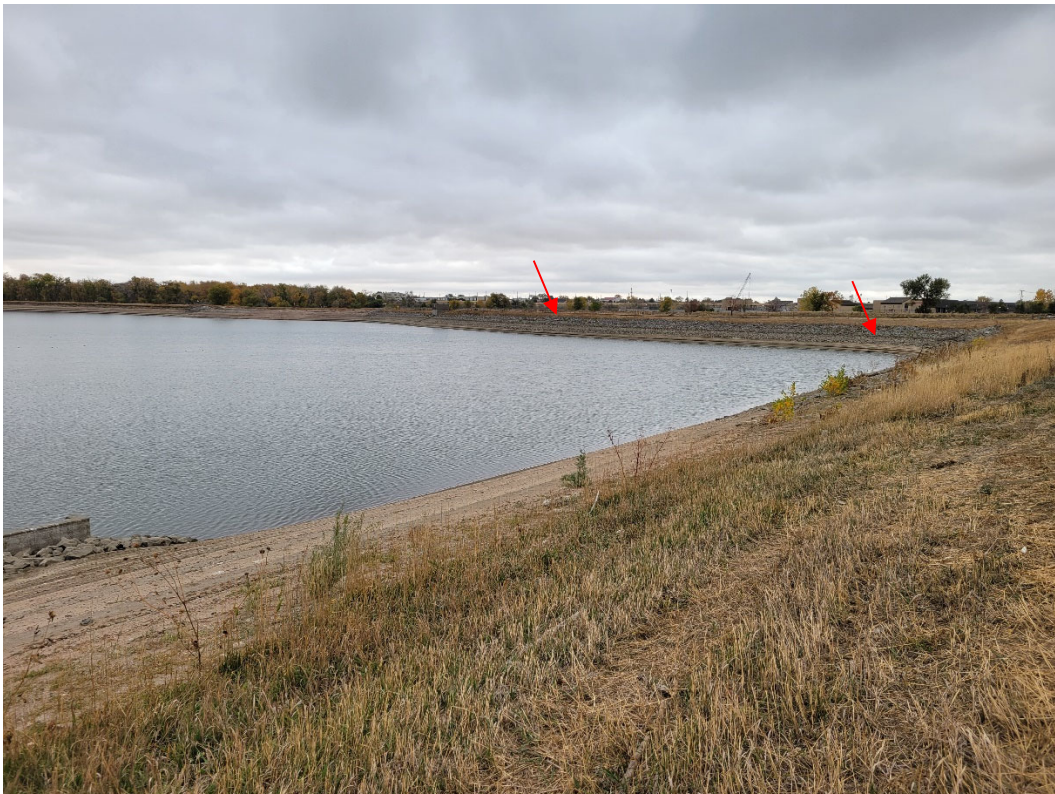
The 2022 report also lists three moderate risk areas on the reservoirs. One of these areas was repaired last in 2023. The Division observed a repaired, armored slope on the south/southwest side of the South Cell (Photo 2).

Photo 2: Looking south along the western shoreline of the South Cell. Arrows indicate where the shoreline was repaired and armored with rip/rap. This area is adequately sloped.

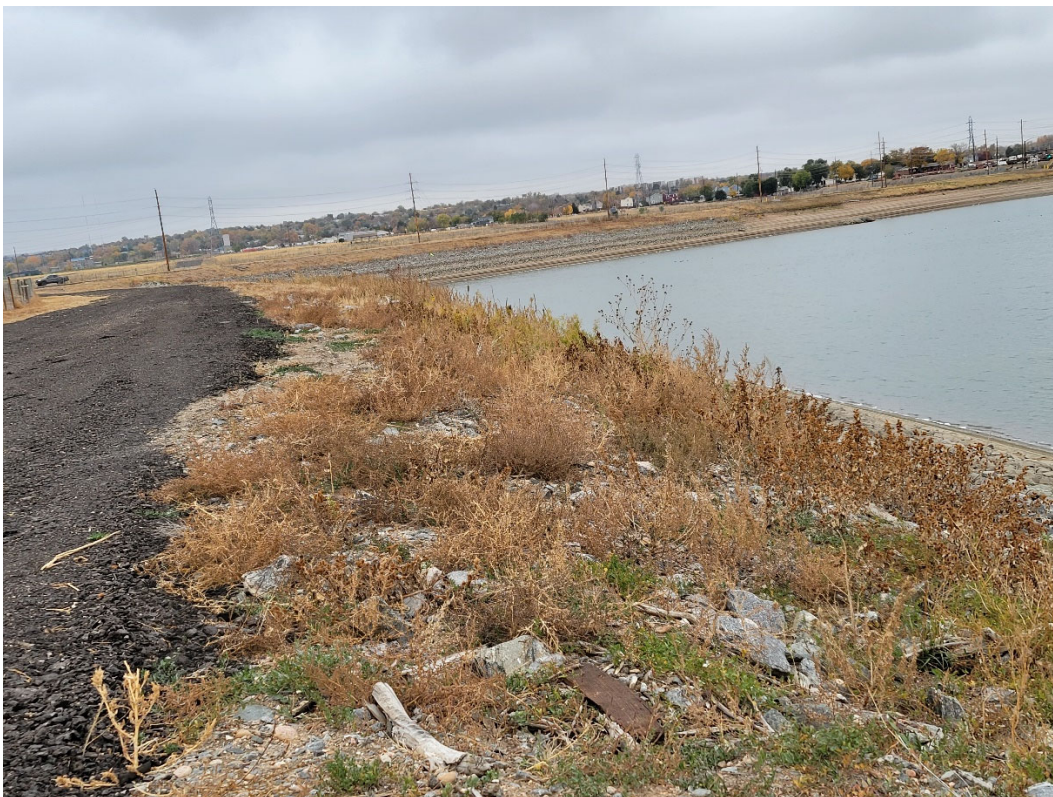
The Division observed the vegetation around the three reservoirs. Near the entrance to the site, on the western shores of the South and Middle Cells, the vegetation is adequate to meet the Rule. However, the Division noted several other areas that need reseeding and weed control, including the southeast shoreline of the South Cell, near the spillway, the South Cell and Middle Cell shorelines that run through the center of the site, and the north shoreline of the North Cell. The Division recommends mowing to control annual weeds and reseeding of the shorelines with the approved seed mix to establish a diverse and long-lasting vegetative cover around the three reservoirs. The operator may consult with the local Conservation Service for recommendations on revegetation and best practices.

Photo 5: Weeds and bare ground observed adjacent to the spillway on the south side of the South Cell.

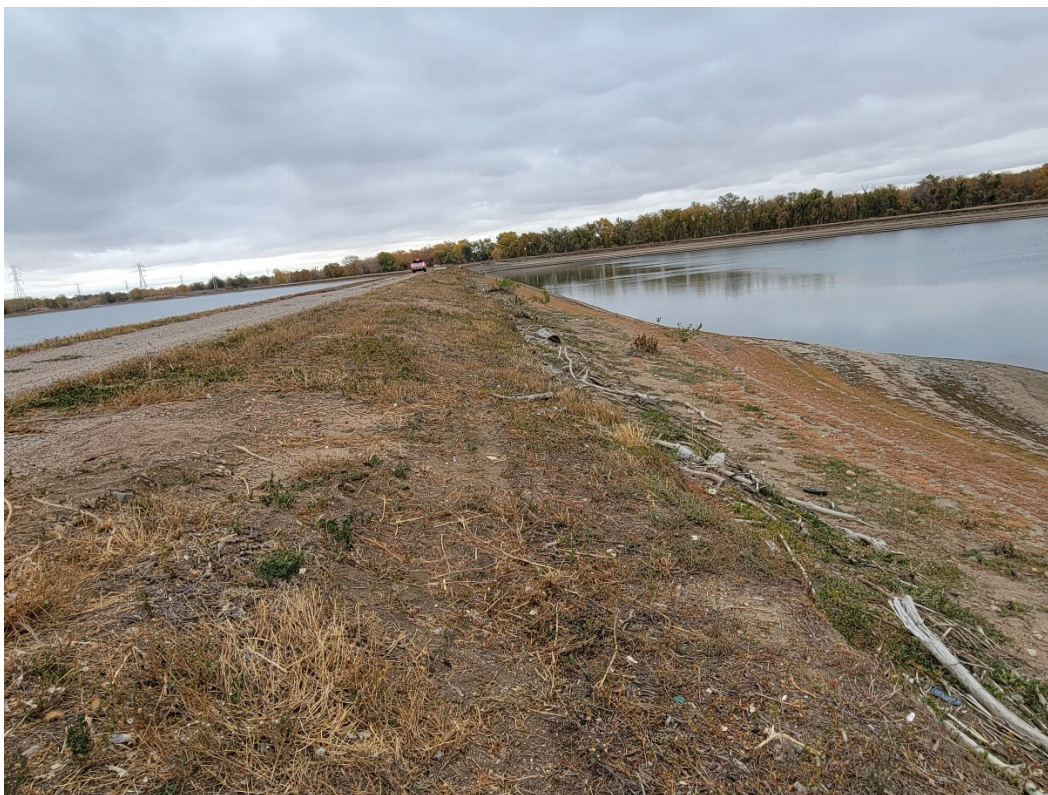
Photo 6: Looking east along the shoreline of the South Cell. Middle cell on the left. Bare ground and weeds noted here.

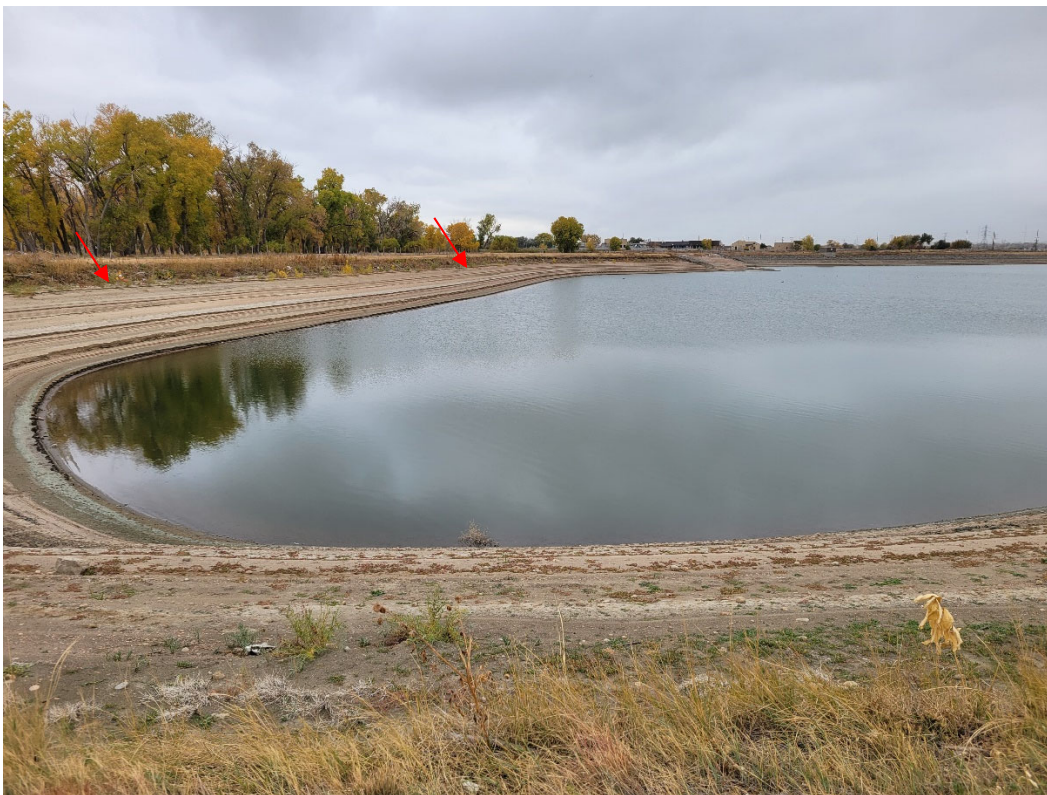
During the inspection, the City of Thornton representatives shared a 2022 Slope Assessment with the Division (enclosed) which evaluated the slope conditions around the three reservoirs and identified areas that need repair. In the 2022 report, approximately 2400 feet on the east side South Cell is rated level 2, which indicates a high risk for damage to slurry wall and/or clay liner, roads, reservoir structures, or 3:1 slope. Additionally, approximately 1,200 feet of the Middle Cell shoreline is also rated level 2/high risk. These high-risk areas are located on the east side of the reservoirs, adjacent to the open space and South Platte River.

Based on observations during the inspection, the Division concurs with the 2022 Slope Assessment. The eastern shorelines of the South Cell (Photo 7) and Middle Cell (Photo 10) show signs of wave cutting and erosion and the slopes are nearly vertical in these areas. Therefore, the reservoirs do not meet the requirements of Rule 3.1.5(7) for a release. The representatives from the City indicated they are in the process of drawing down the South Cell to allow for repair of the eastern shoreline. It is anticipated to take a few years to complete all the recommended slope repairs due to the operation of the facility.

Photo 7: Looking southeast along the eastern boundary of the South Cell. Shoreline erosion observed here. 2022 Assessment rates this area as high risk.

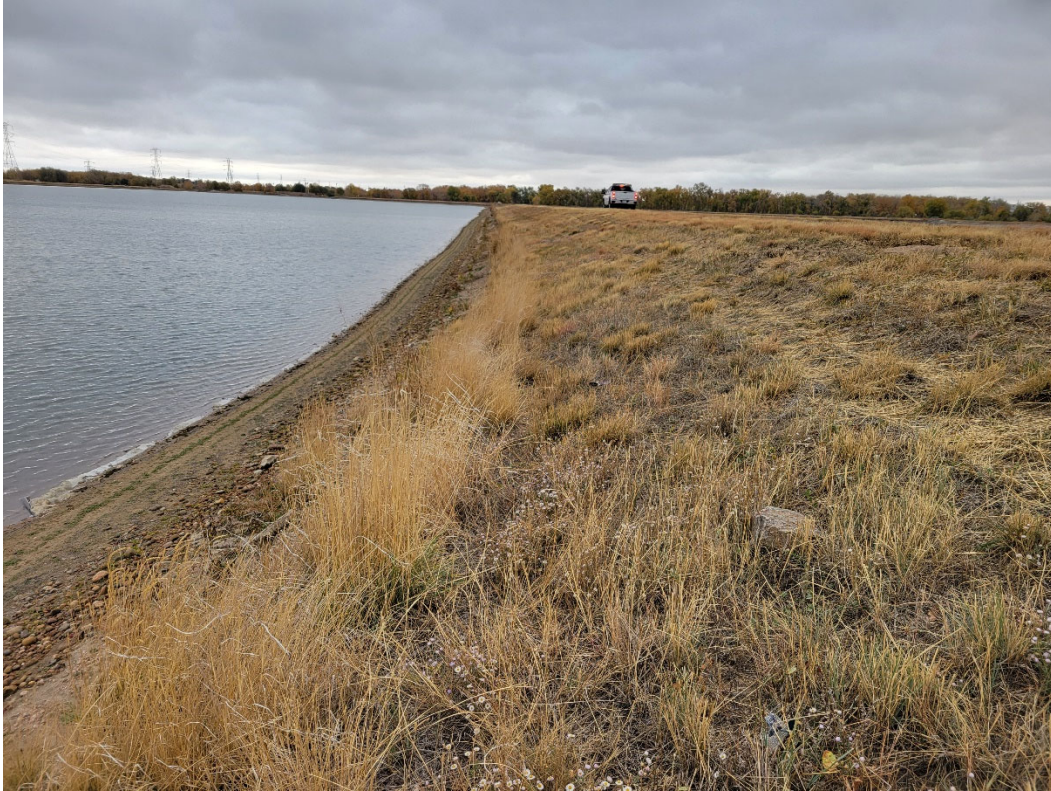
Photo 9: Looking east along the southern shoreline of the Middle Cell. Some moderate shoreline erosion/cutting observed.

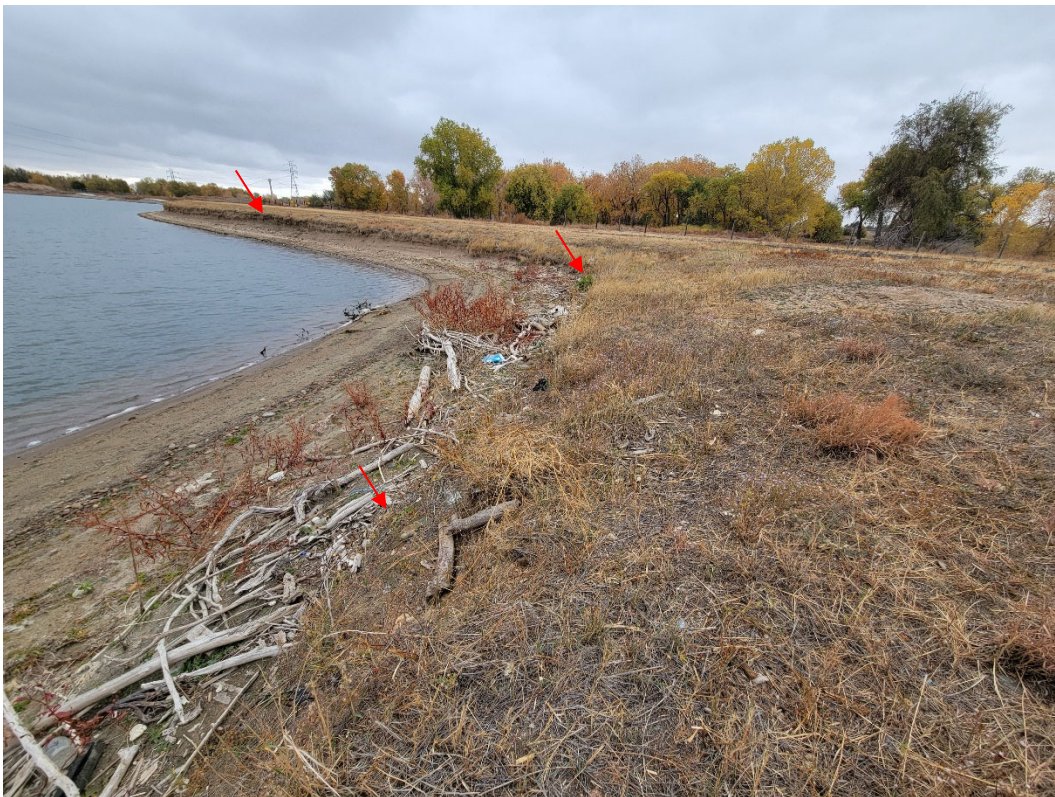
Photo 10: Looking northeast along the eastern shoreline of the Middle Cell. Shoreline erosion observed here. 2022 Assessment rates this area as high risk.

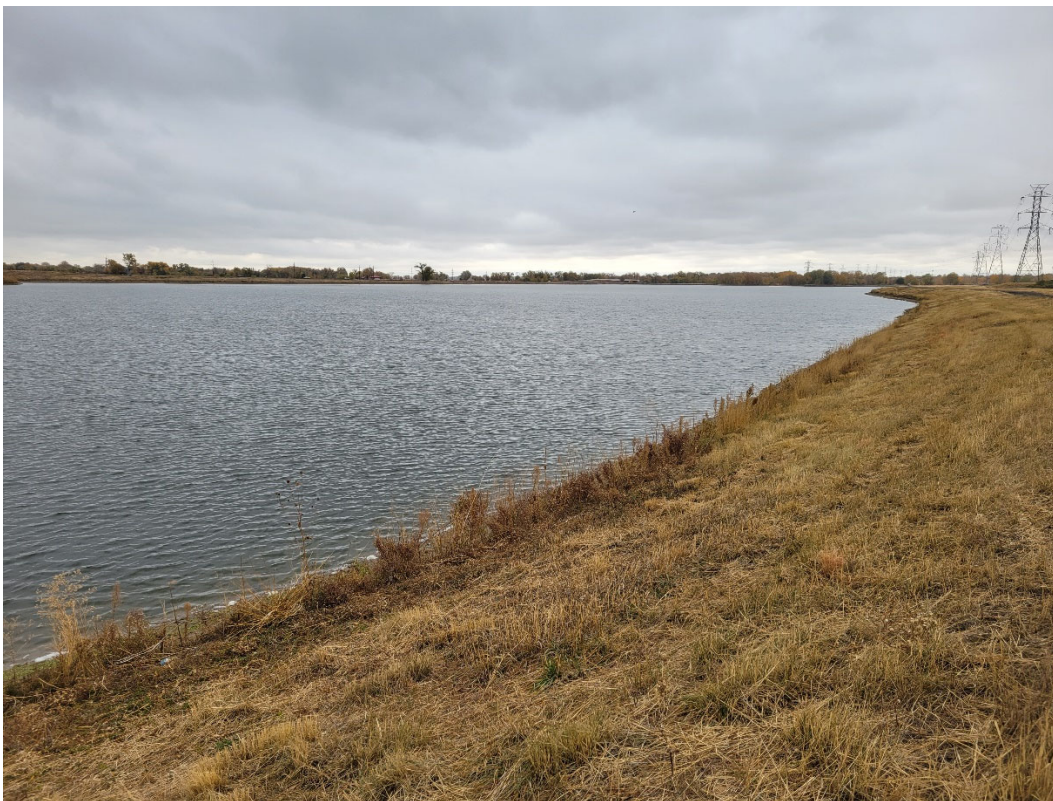
Photo 13: Looking northeast across the North Cell. The shorelines are revegetated and adequately sloped on the south side of the reservoir.

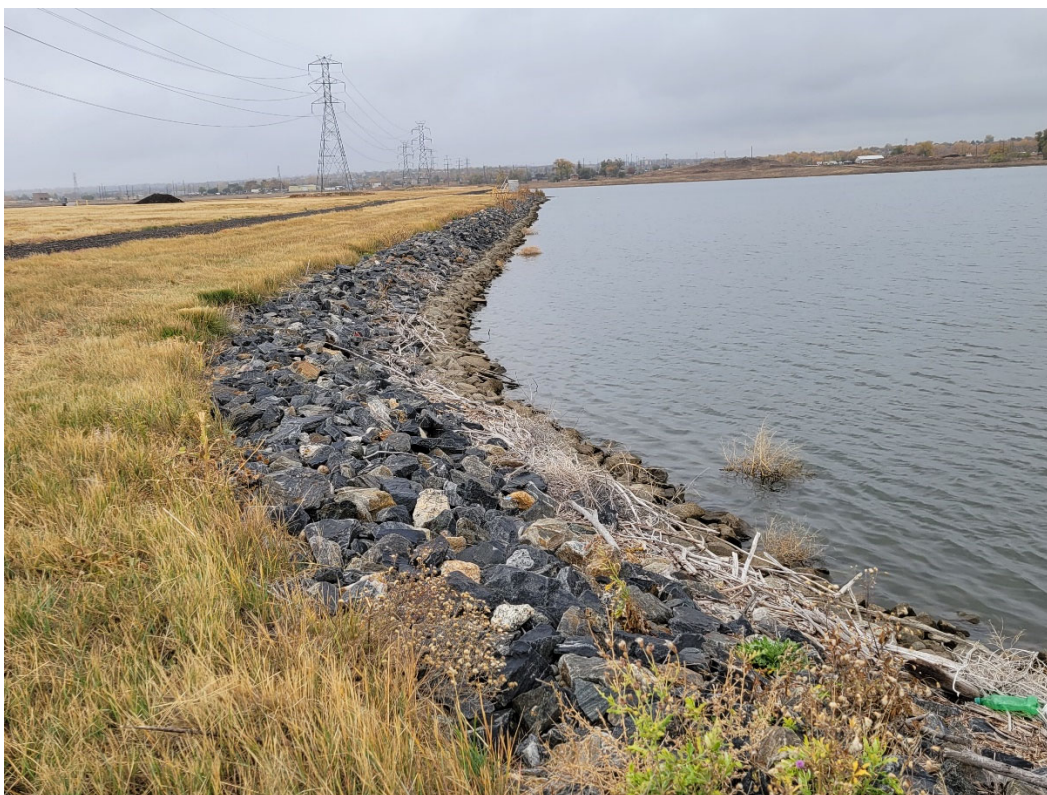
Photo 14: Looking at armored shoreline along the south side of the North Cell. The shorelines are revegetated and adequately sloped here.

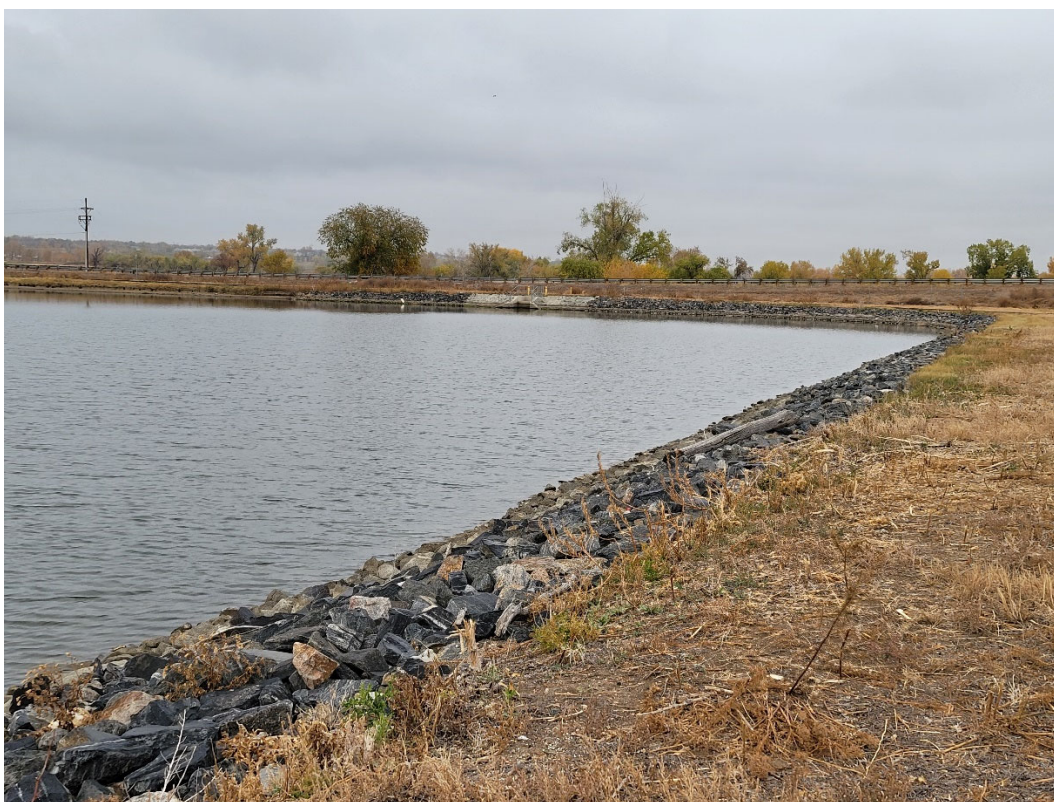
Photo 16: Looking at armored shoreline in the northeast corner of the North Cell. This area is weedy and some bare ground noted here.

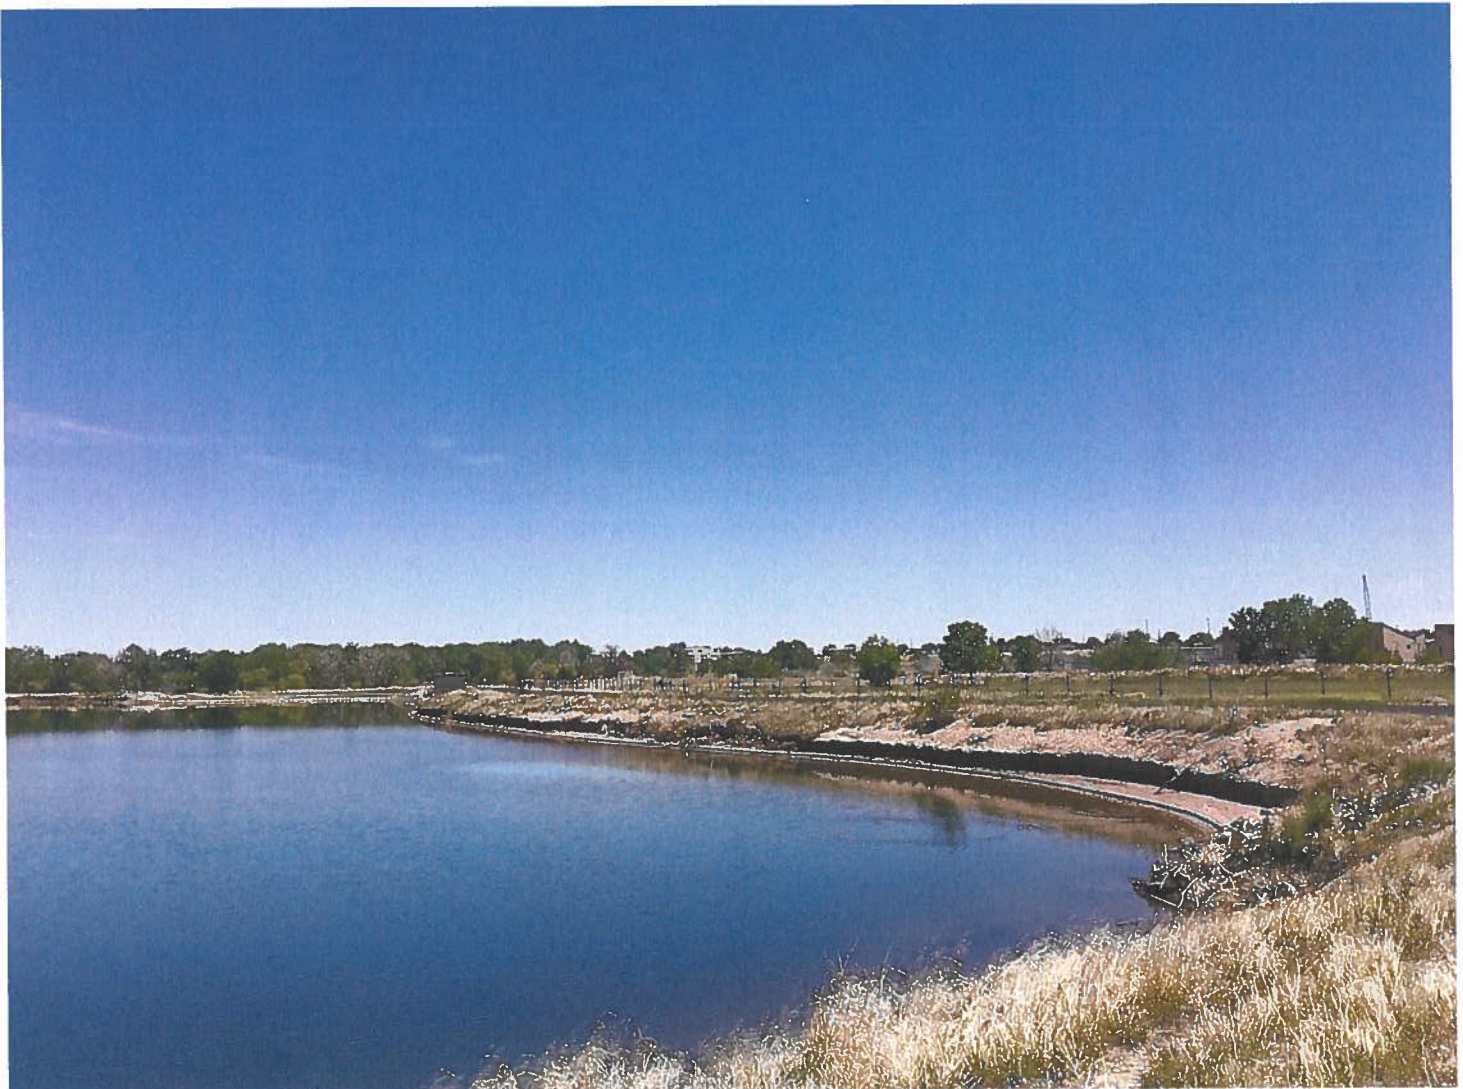
During the 2022 slope assessment, Water Resources staff observed erosion to the eastern and southern slope of South Cooley. Approximately 2,400 linear feet of shoreline was assessed as High Risk. The most noticeable areas are from Southwest to northeast, by the spillway into Middle Cooley's. The reservoir is now taking in additional flows due to common flood stages. The rivers flood risk into the reservoir is more common and effects the shoreline more often than in the past years.

View of southwest corner to spillway severe bank erosion

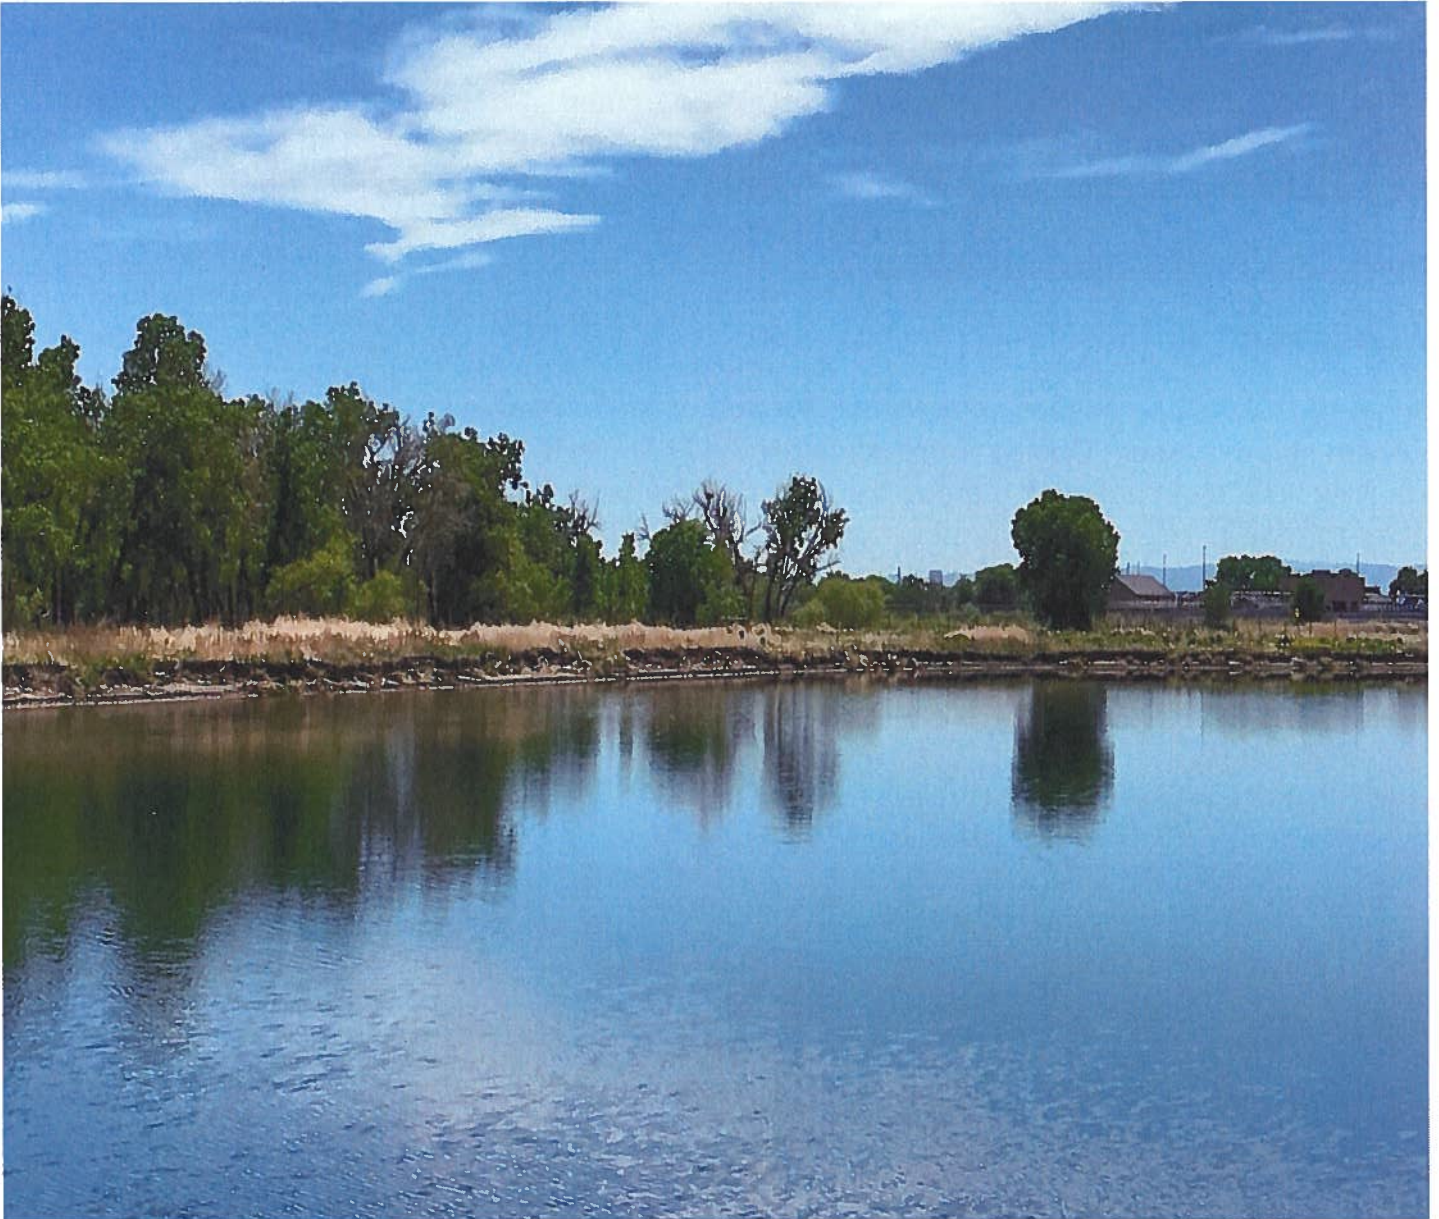
View of southeast section from spillway on the south riverside to our boat ramp northeast corner

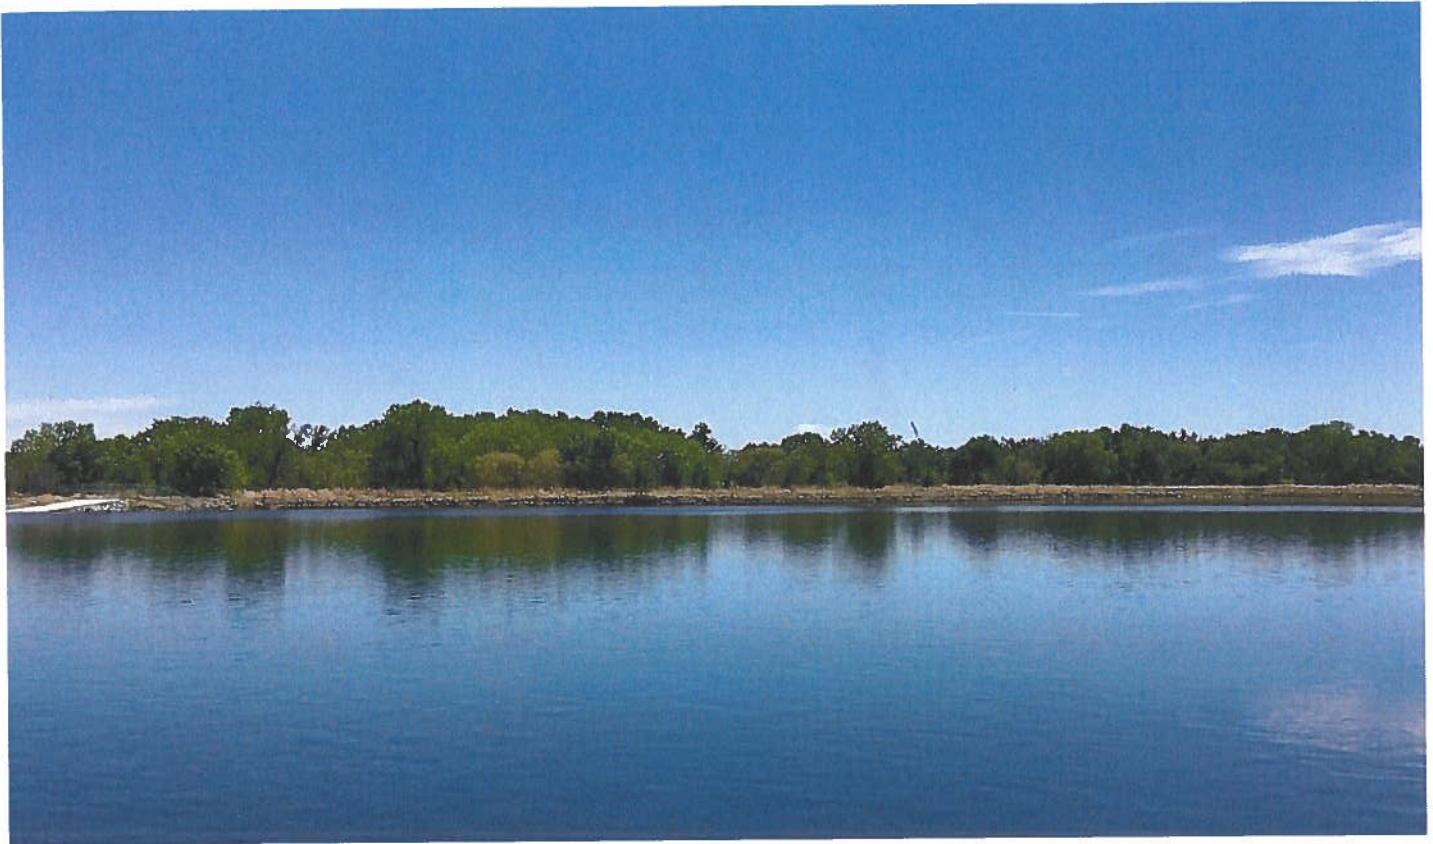
During the 2022 slope assessment, Water Resources staff observed erosion at Middle Cooley along the east section and south shoreline. Most noticeable shoreline erosion is from the spillway on the south, to the exit spillway northeast to river. There is approximately 1,500 linear feet of shoreline was assessed as Moderate Risk and approximately 2,100 linear feet of shoreline was assessed as High Risk. We encounter more flood stages from the river more often now, than is past years.

East side of Middle Cooley from spillway at the south to the exit to the river

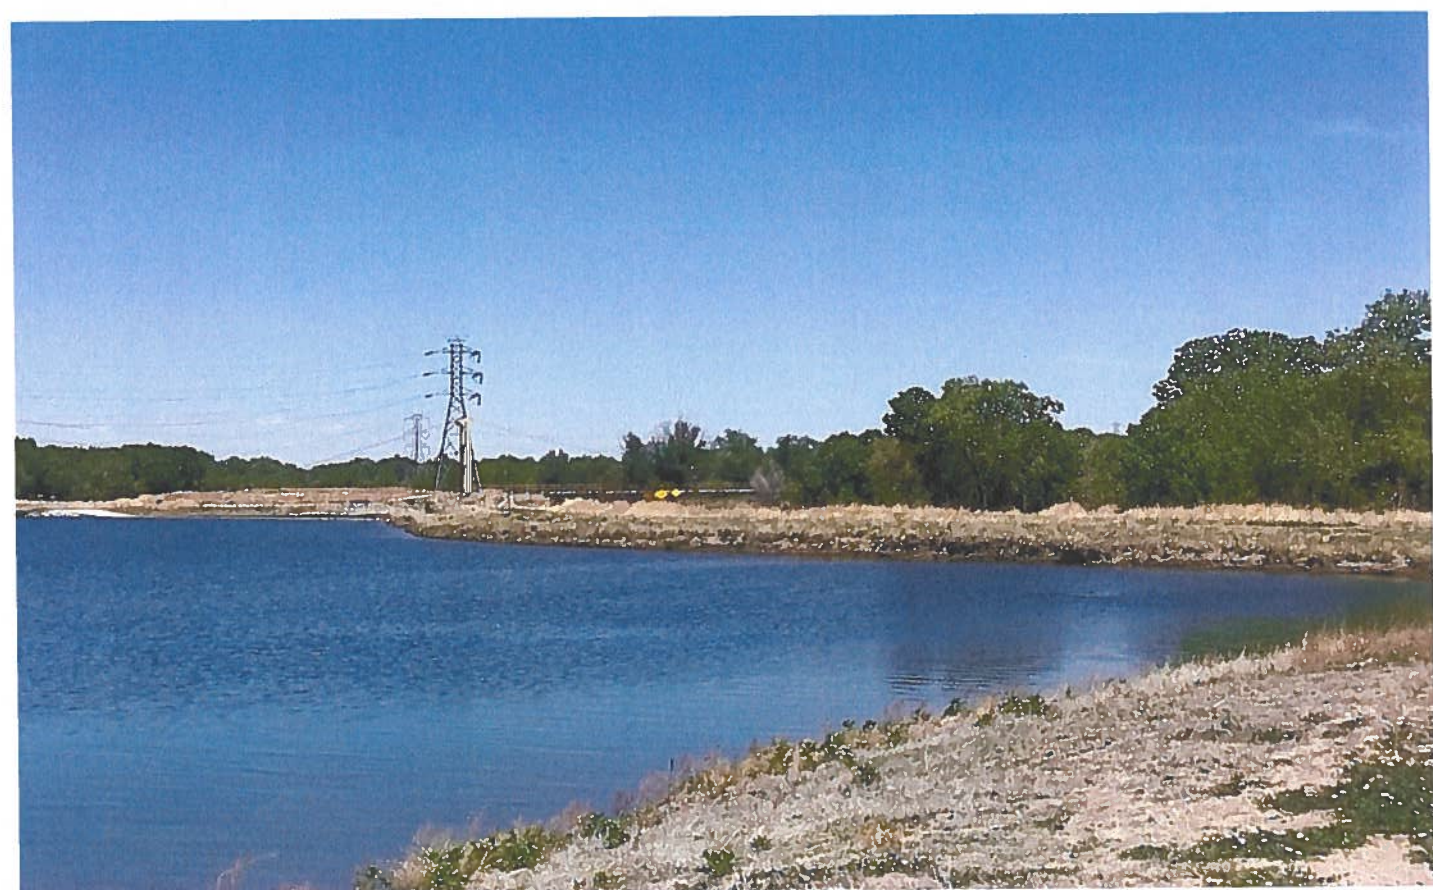
Middle Cooley southeast corner needing rip rap

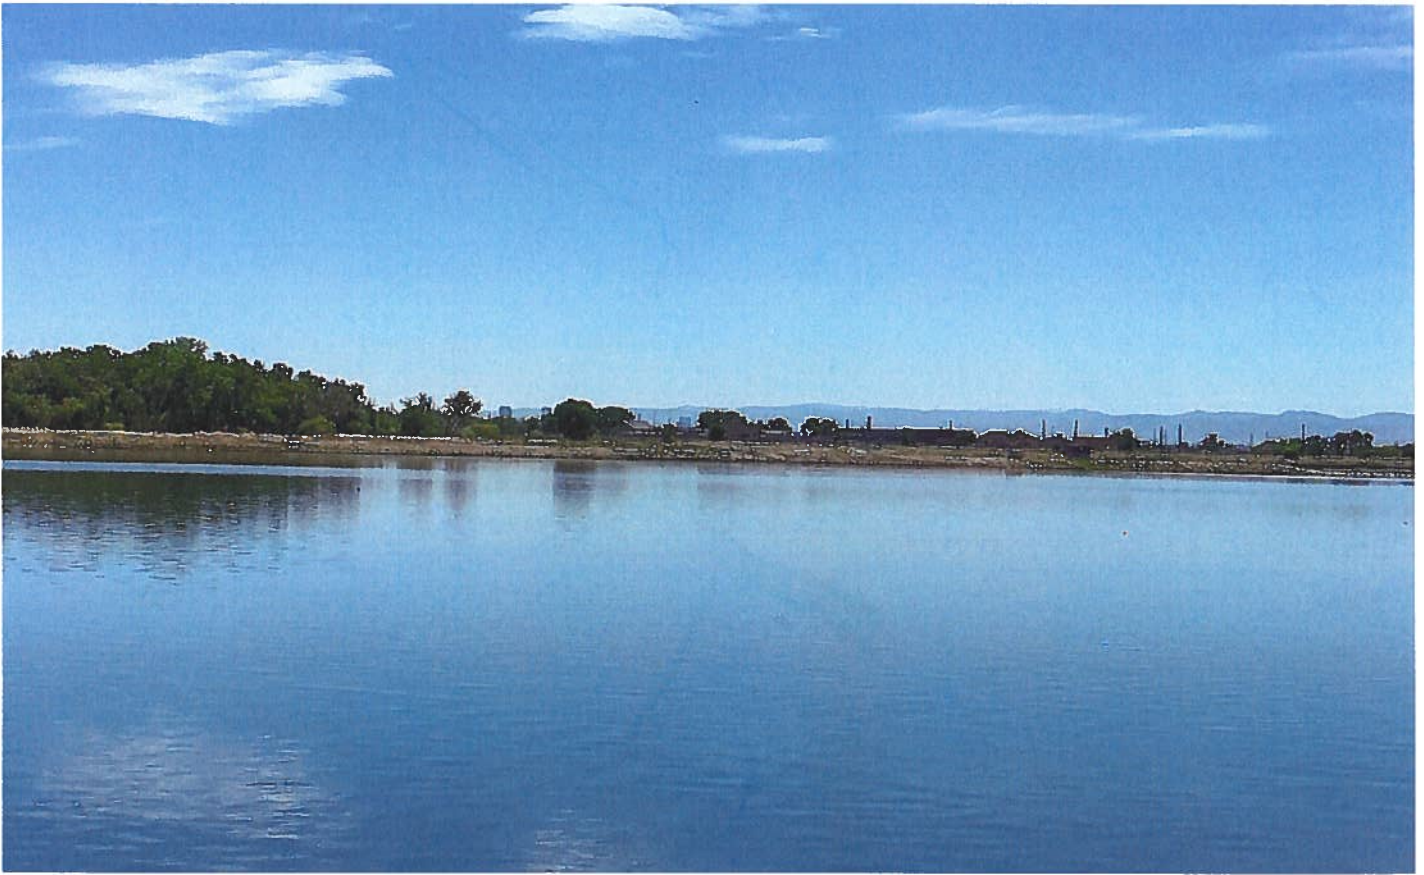
View of south and east shoreline, erosion of banks

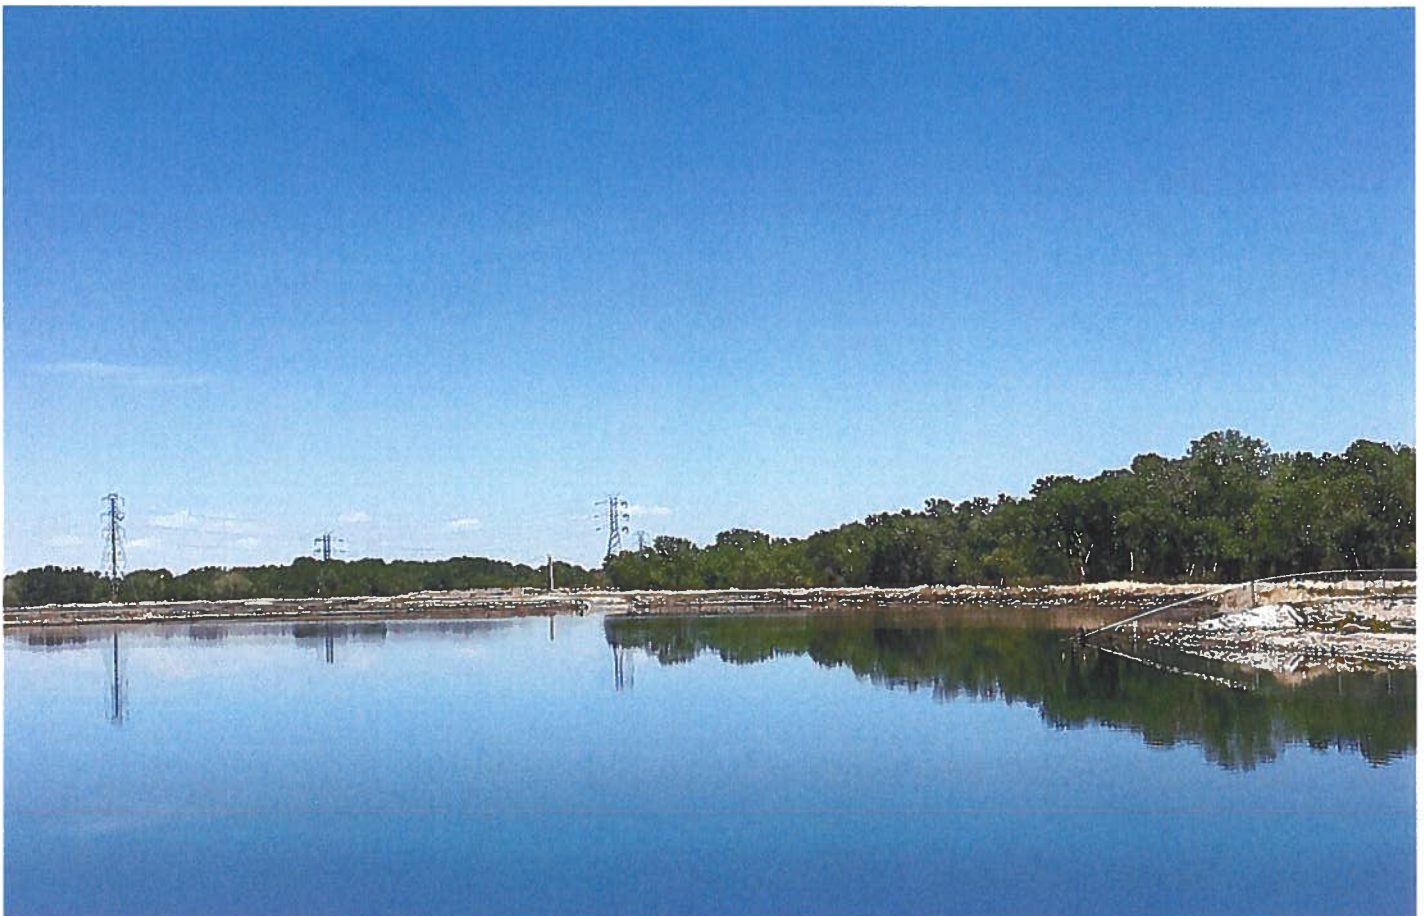
View of spillway section along south end and eastern shoreline, with bank erosion

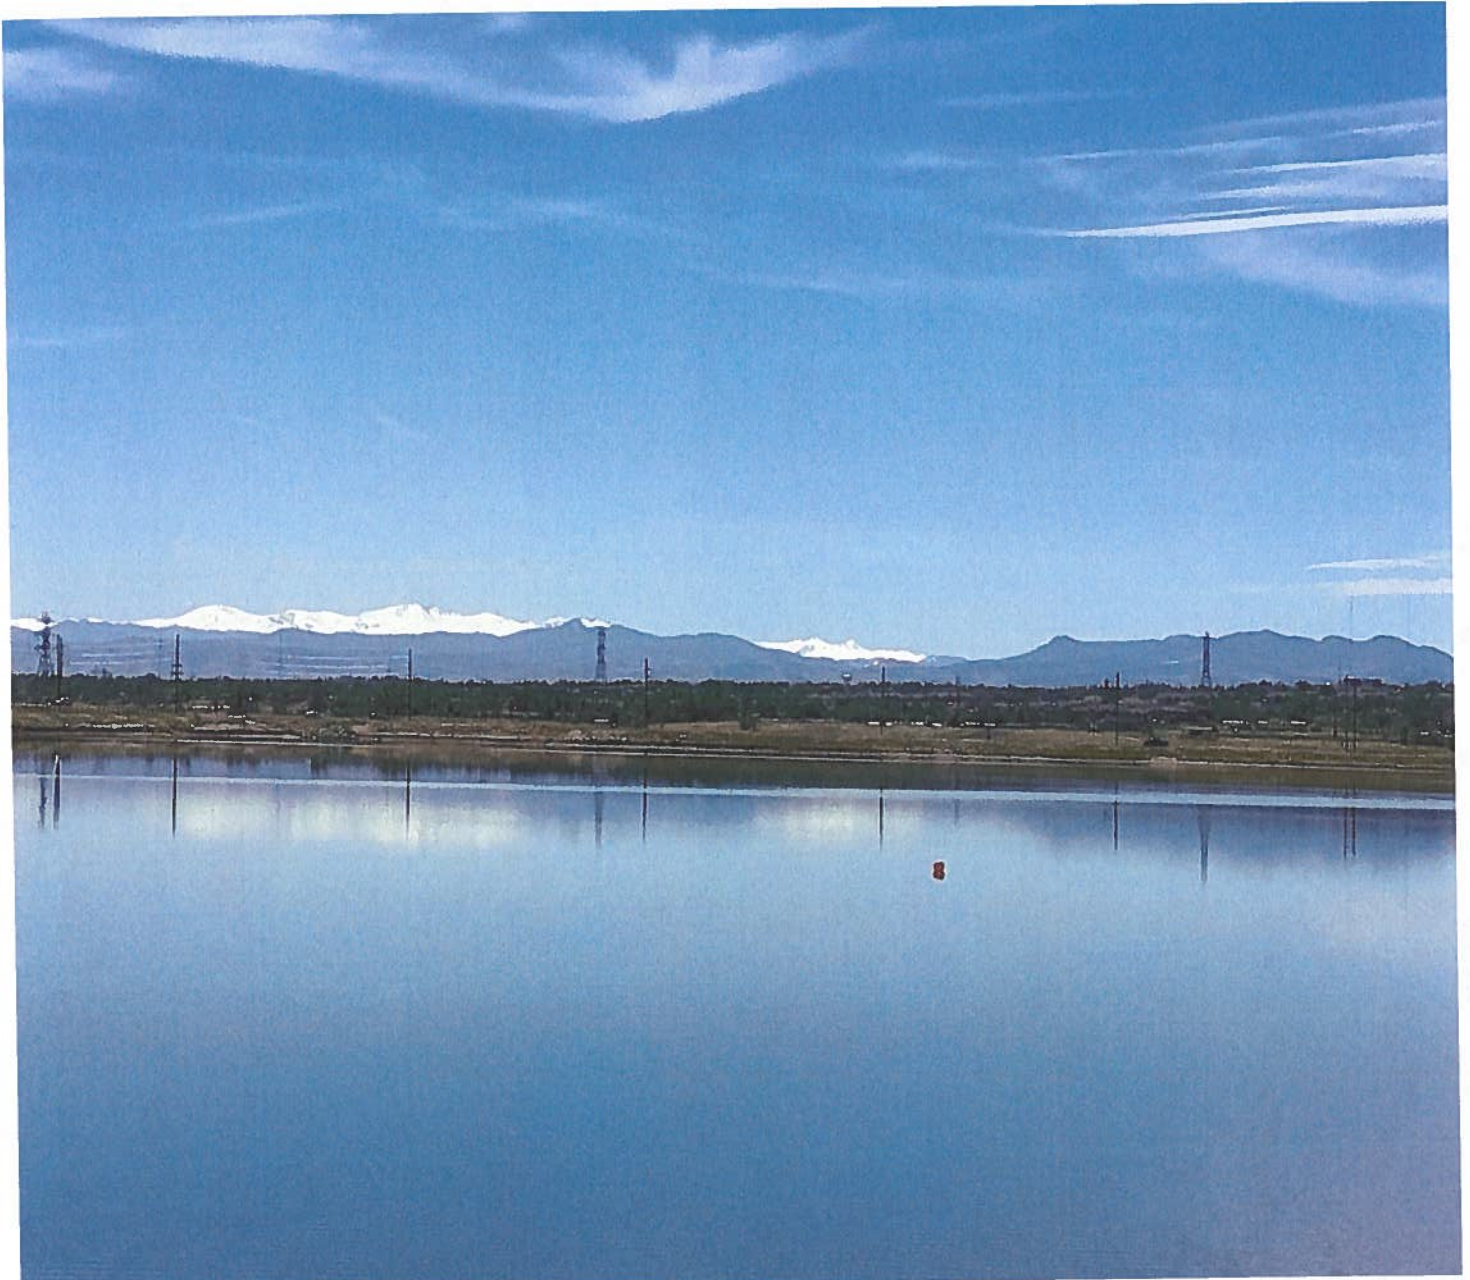
View of west banking, starting to show erosion

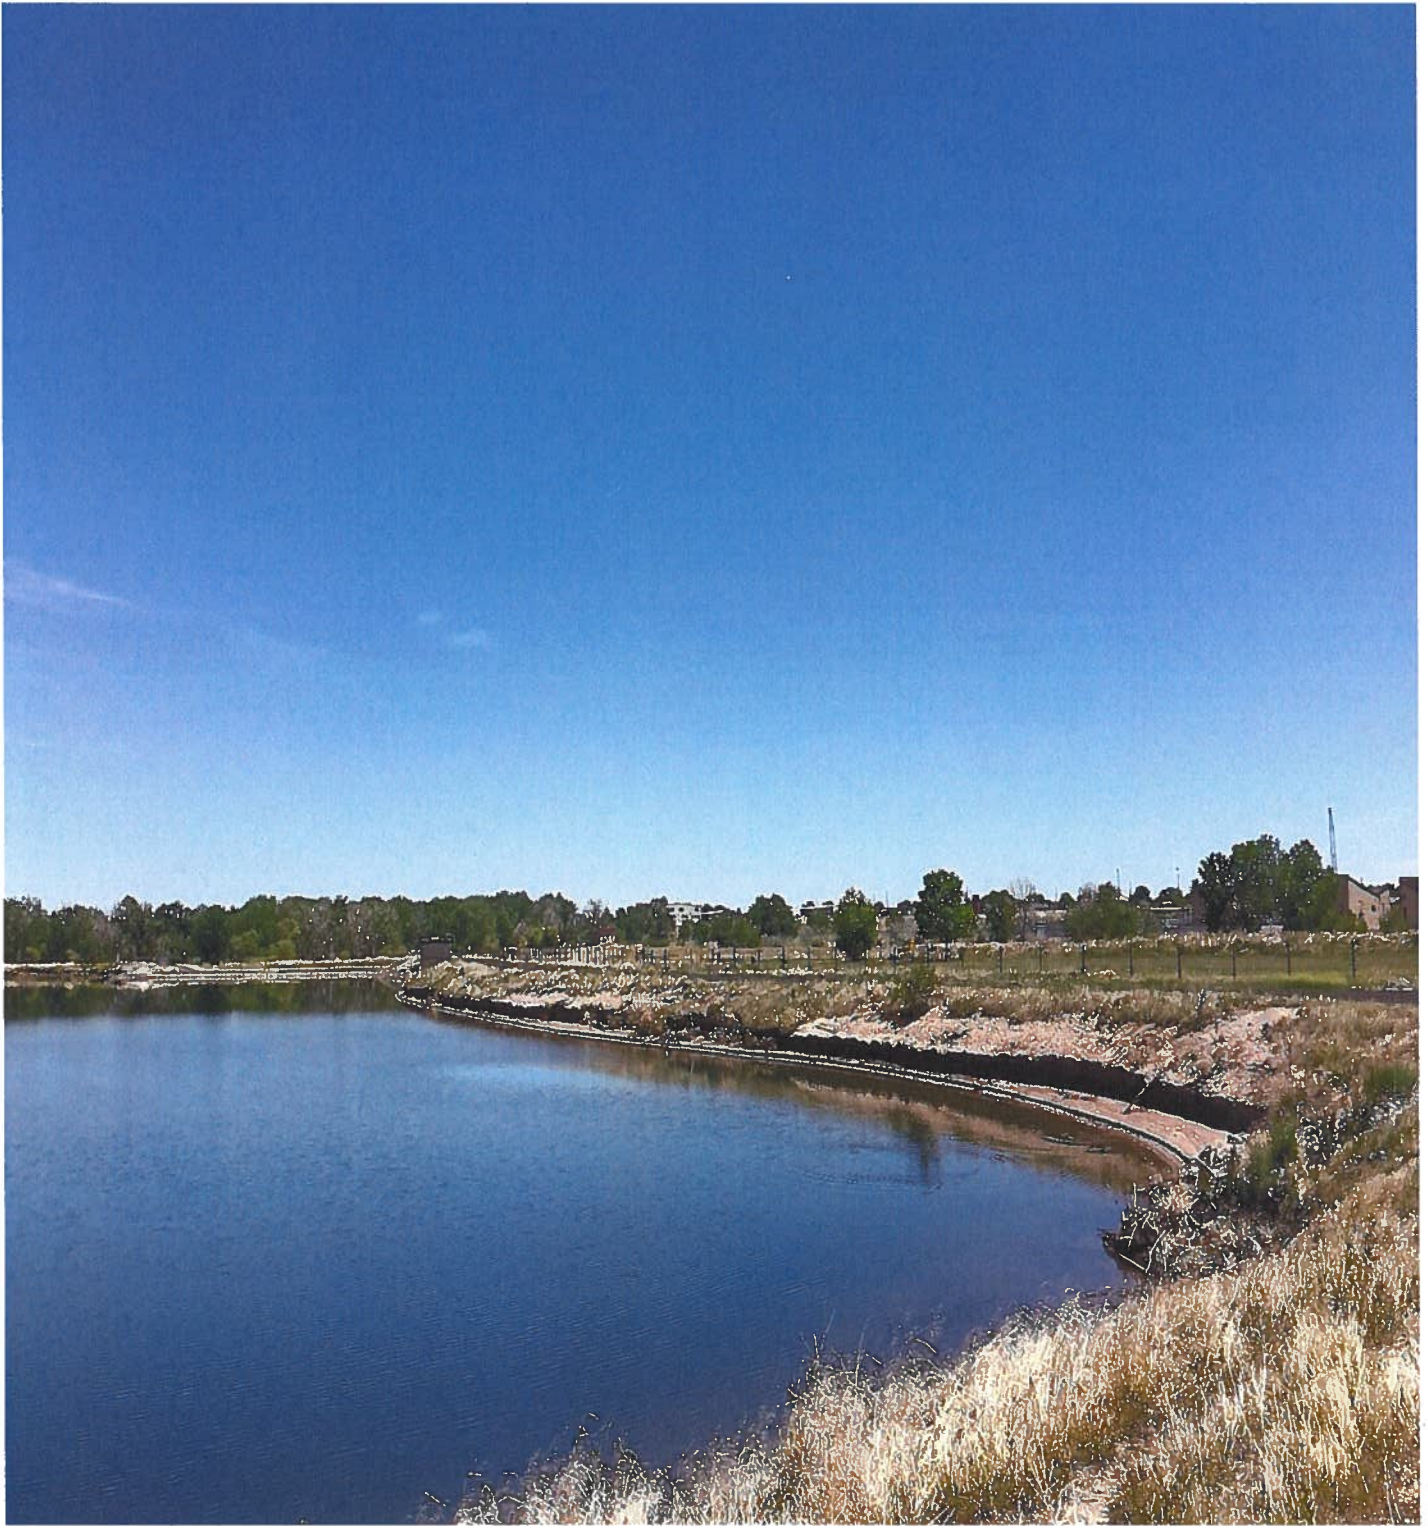
View of south shoreline to spillway with bank erosion
