Cooley Reservoir-Fulton M-1999-034 AR3 Inspection

MINERALS PROGRAM INSPECTION REPORT
PHONE: (303) 866-3567

MINE NAME: Cooley Reservoir & Fulton Wildlife Area	MINE/PROSPECTING ID#: M-1999-034	MINERAL: Sand and gravel	COUNTY: Adams
INSPECTION TYPE: Surety Release Inspection	WEATHER: Cloudy	INSP. DATE: October 30, 2024	INSP. TIME: 10:00
OPERATOR: Holcim - WCR, Inc.	OPERATOR REPRESENTATIVE: Wyatt Webster	TYPE OF OPERATION: 112c - Construction Regular Operation	
REASON FOR INSPECTION: Surety Release Requested	BOND CALCULATION TYPE: None	BOND AMOUNT: \$1,510,800.00	
DATE OF COMPLAINT: NA	POST INSP. CONTACTS: None	JOINT INSP. AGENCY: None	
INSPECTOR(S): Nikie Gagnon	INSPECTOR'S SIGNATURE:

2022 Thornton Reservoir Slope Assessment

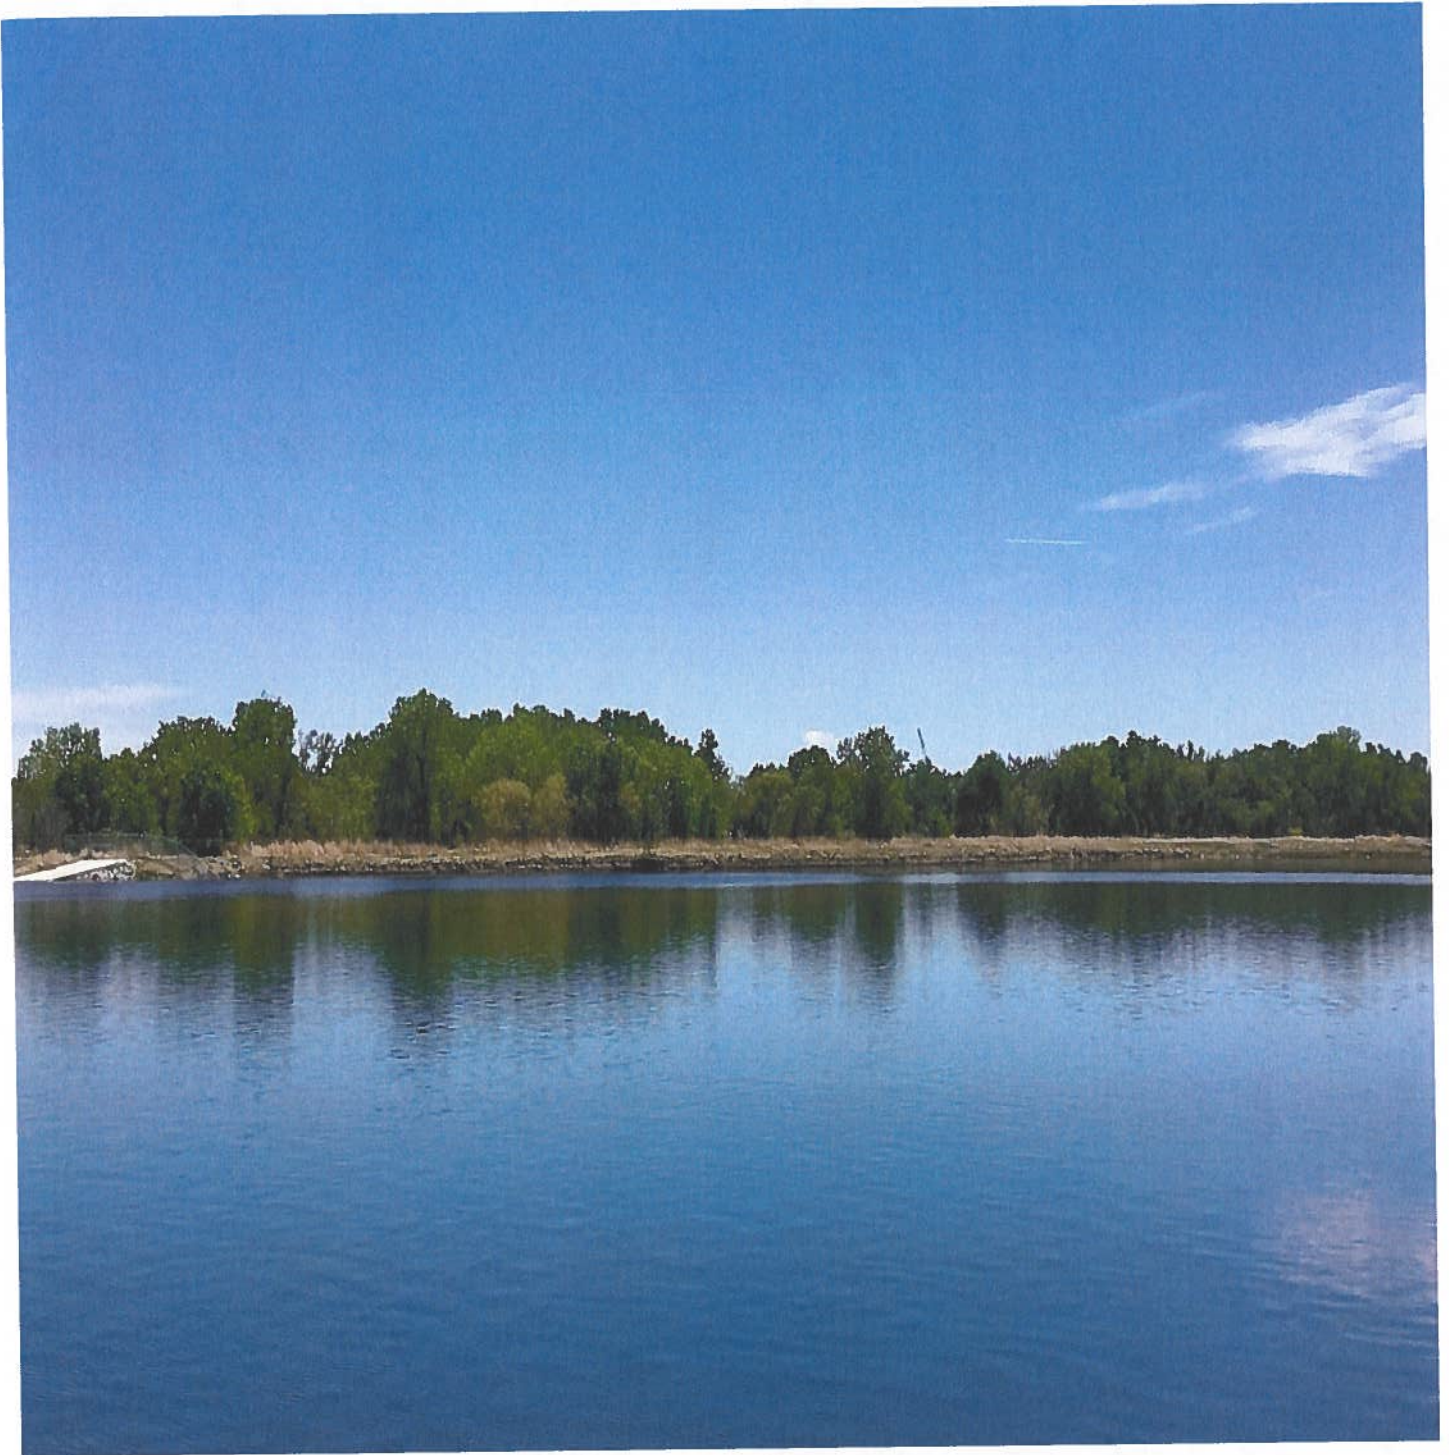
View looking east on Middle Cooley, erosion starting at spillway back to southern shoreline

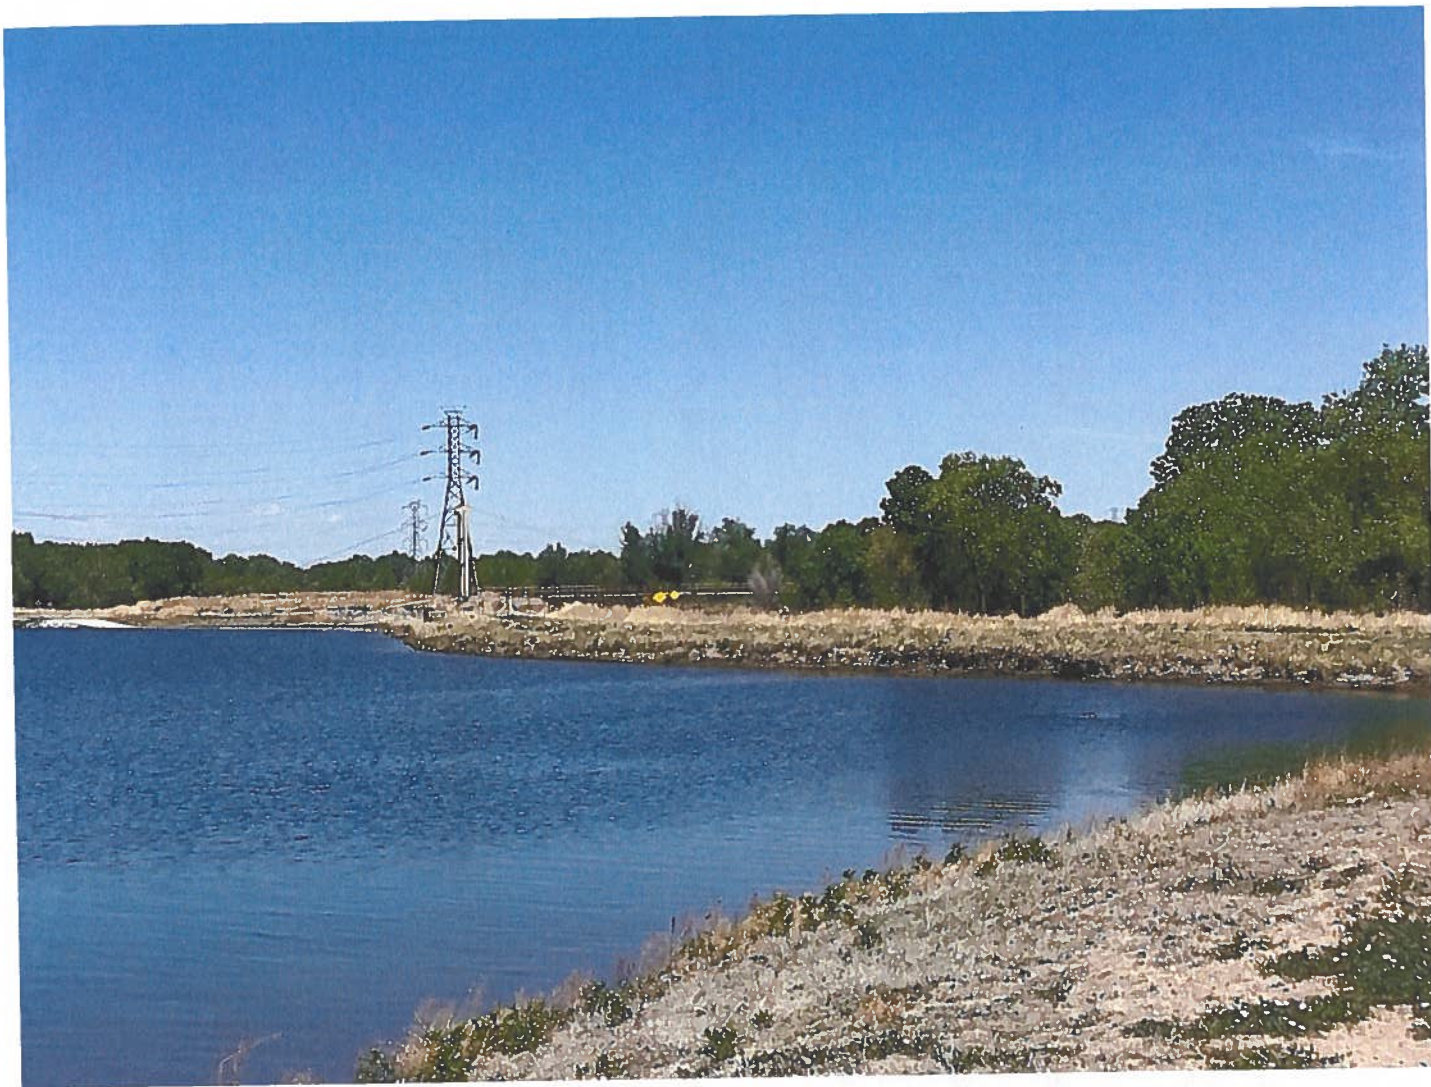
View of east shoreline from south side of Middle Cooley with bank erosion

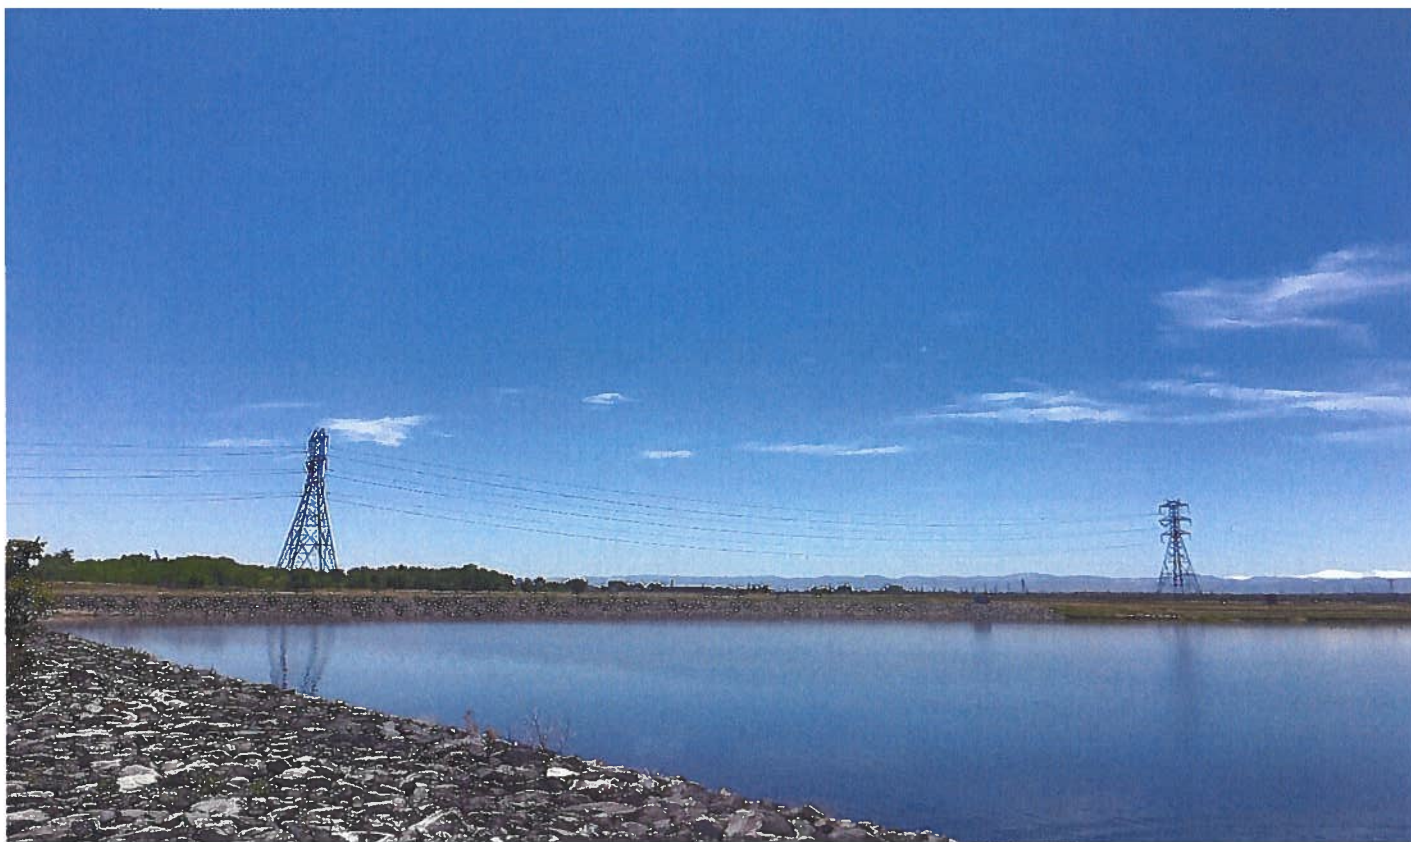
View looking to the south shoreline on North Cooley, some erosion starting at end of rip rap
