**DRMS inspection report for Tri-County Pit**

**MINERALS PROGRAM INSPECTION REPORT**  
**PHONE: (303) 866-3567**

<b>MINE NAME:</b> Tri-County Gravel	<b>MINE/PROSPECTING ID#:</b> M-1977-205	<b>MINERAL:</b> Sand and gravel	<b>COUNTY:</b> Delta
<b>INSPECTION TYPE:</b> Monitoring	<b>WEATHER:</b> Clear	<b>INSP. DATE:</b> October 23, 2024	<b>INSP. TIME:</b> 08:15
<b>OPERATOR:</b> Oldcastle SW Group, Inc. dba United Compas County	<b>OPERATOR REPRESENTATIVE:</b> Jesse Farmer	<b>TYPE OF OPERATION:</b> 112c - Construction Regular Operation

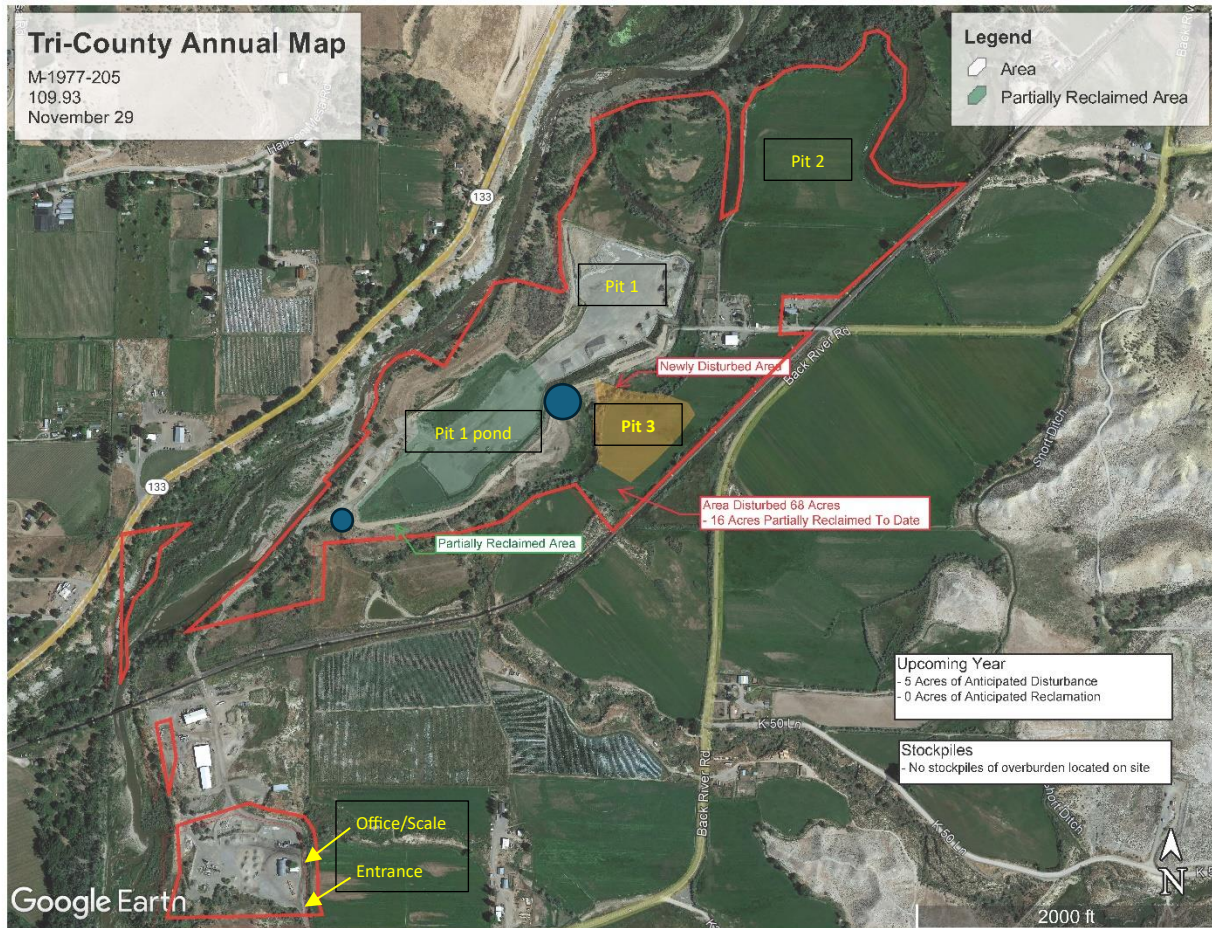
**Figure 1. Tri-County Gravel Pit – 2023 Annual Report Map with Features from DRMS Inspection**

Map C-2 should be updated to better reflect the on-the-ground conditions. For example, the topsoil pile or piles should be shown in the accurate location, and storage of the landowner's equipment should be shown. Features that do not exist (and will not in the future) should be removed from the map. Another reason to update Map C-2, as well as Exhibit D, is the need to illustrate and explain the small ponds that are on the west side of the larger pond.

*Notes: Bold red polygons do not match thin red polygons from Map C-2.*

*Blue circles show locations of topsoil stockpiles.*

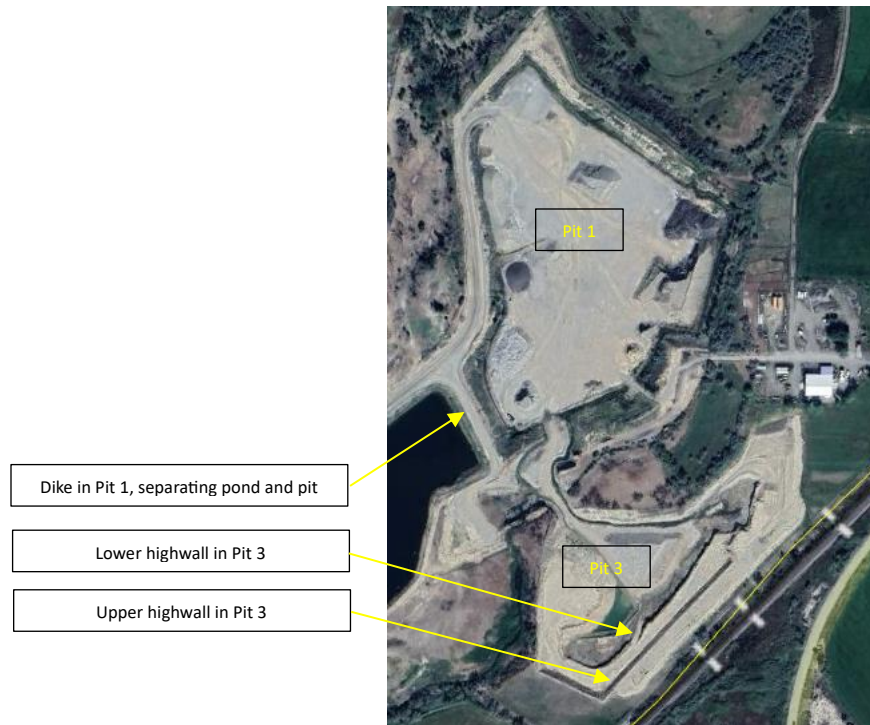
**Figure 2 Tri-County Gravel Pit – Pits 1 and 3**

In Pit 3, a large pile of pit run material was observed. Also, in this pit, two levels of highwall were observed. The upper one is approximately 10 feet high, and the lower one is approximately 15 feet high. There is a road in between them that is approximately 50 feet wide. The highwall is approximately 750 feet long. The locations of these can be seen on Figure 2.

It appears that the operator is not following the Reclamation Plan closely. The plan states that the maximum length of highwall to be reclaimed is 3,000 feet. However, there is approximately 3,000 feet to be reclaimed in Pit 1 (from 2:1 to 3:1), as well as approximately 750 feet of highwall to be reclaimed in Pit 3 (from near vertical to 3:1). A Technical Revision is required to update Exhibit E (as well as any related exhibits such as Exhibit L) for this permit to show the revised plan.

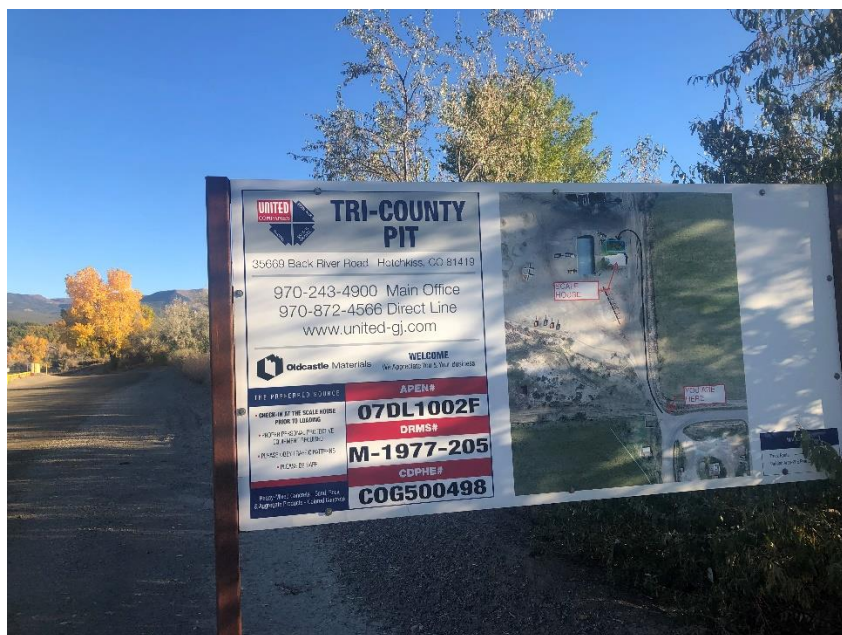
An adequate mine identification sign was clearly visible at the entrance to the site.

### Entrance sign

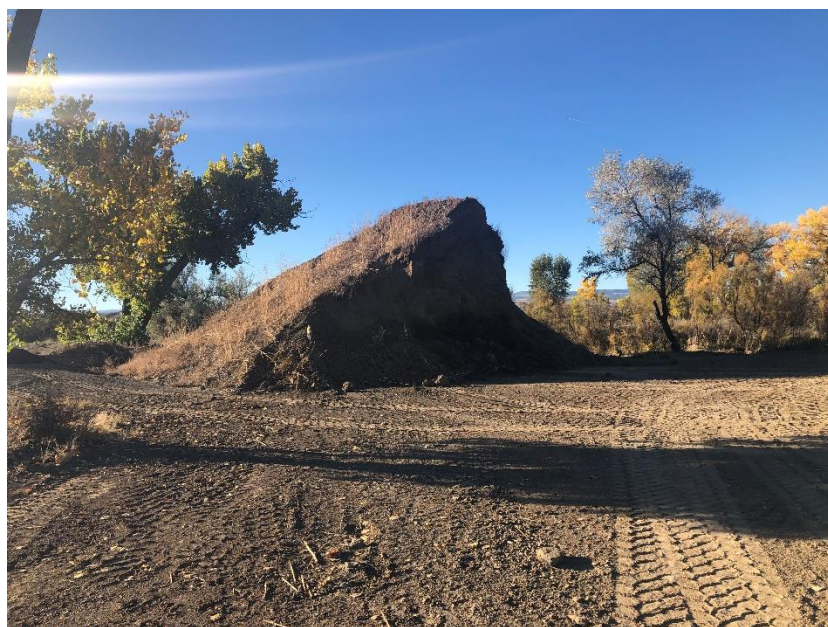
At the south end of the pond, a topsoil pile was in place. It is approximately 40 feet in diameter and 20 feet high. The operator should vegetate the topsoil stockpile to limit wind and rain erosion, thus preserving this soil for reclamation. At least, a berm or other best management practice should be used to limit the loss of this material from rainfall runoff.

**Topsoil pile near south end of pond**

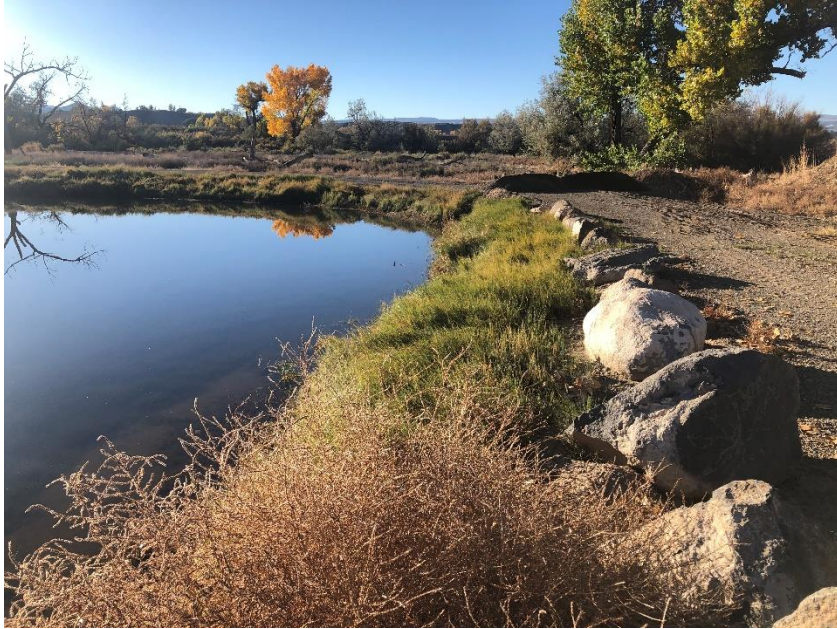
**South end of pond with good vegetation**

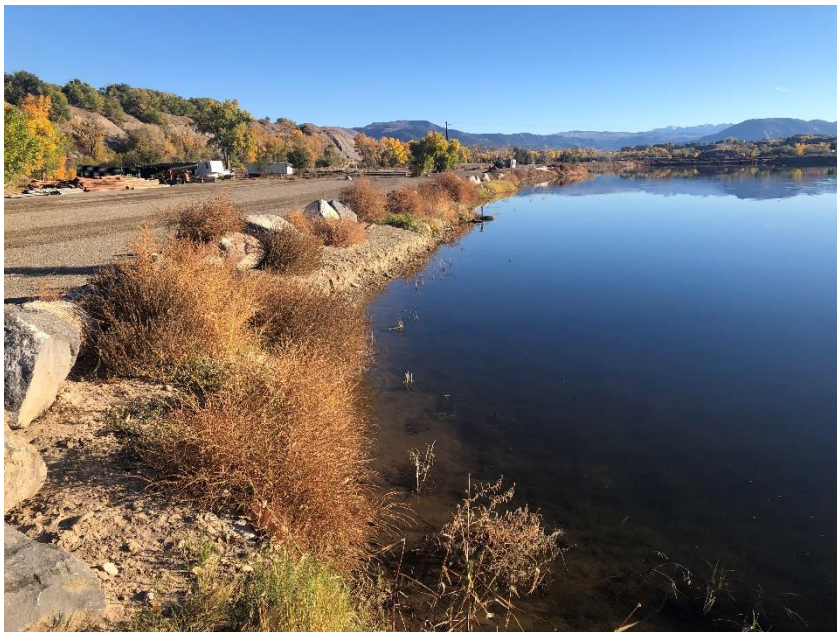
Reclamation of the pond banks has been completed; however, the vegetation growth is poor in some areas. At the north end, a large amount of Russian thistle (an undesirable species) was seen.

**West side of pond with poor vegetation**

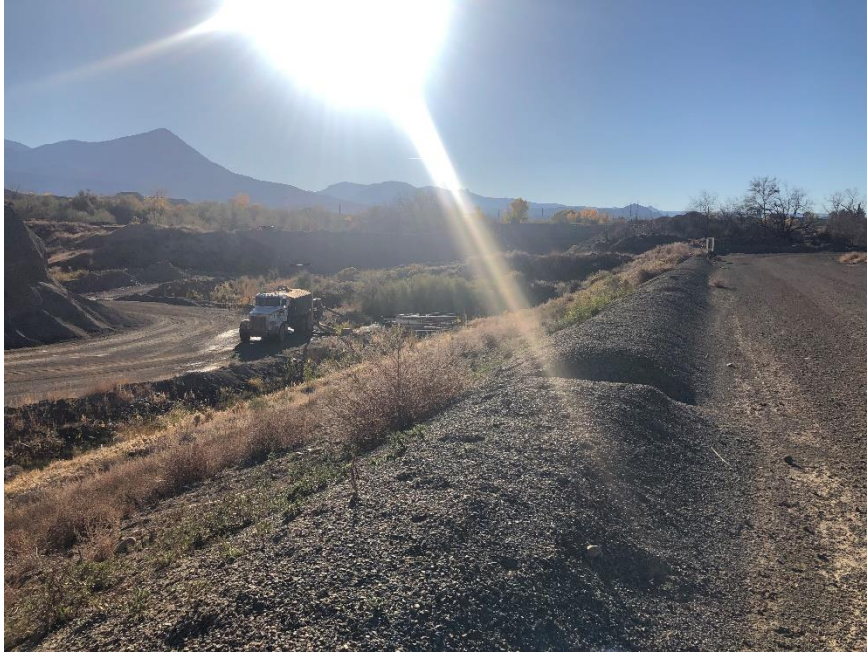
Around the Pit 1 pit area, a drainage ditch leads to a pump for diverting water to the pond. Water was flowing into Pit 1 from Pit 3. A water truck was seen near the pump area, and no fugitive dust issues were observed. The walls around Pit 1 are approximately 20 feet in height. It appears that most of the circumference of the northern portion of Pit 1 still needs to be reclaimed, with the banks graded from 2H:1V to 3H:1V.

**South end of Pit 1 with pump area and water truck**

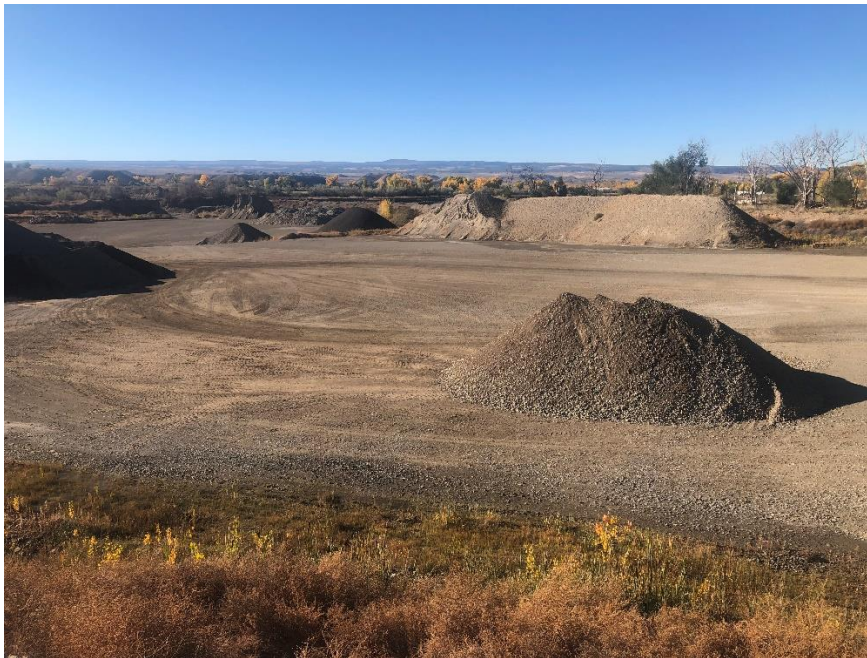
**North end of Pit 1 (looking south)**

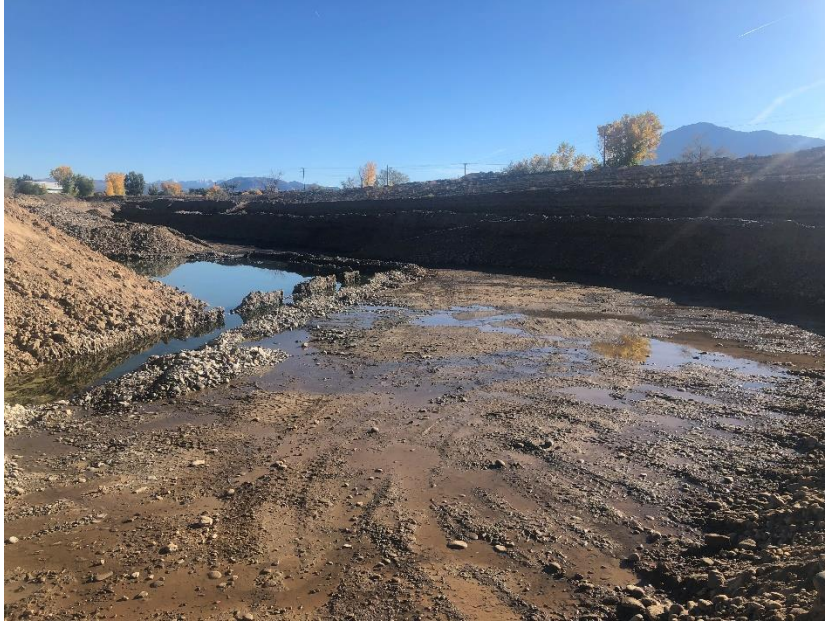
**Pit 3 highwall and floor**

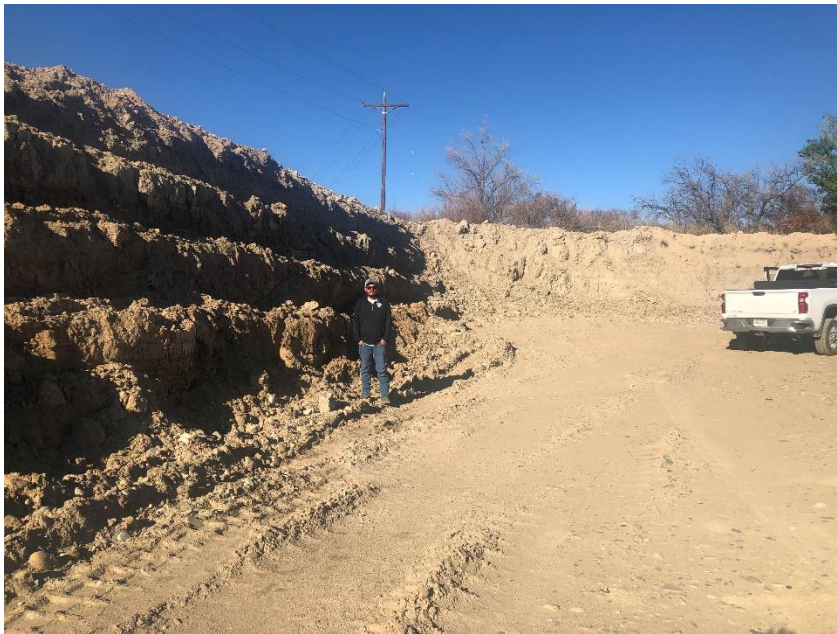
**Upper part of Pit 3 highwall**

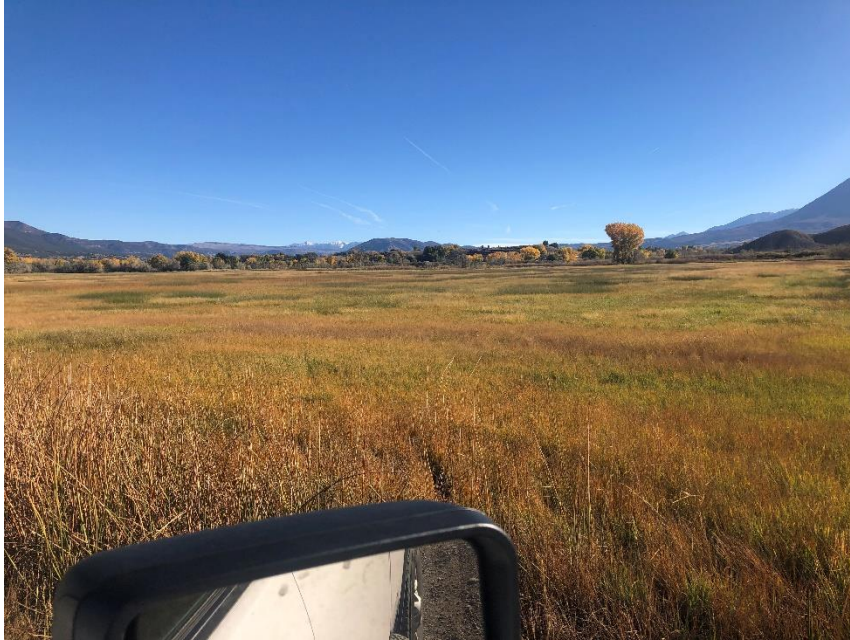
The area north of Pit 1 is undisturbed. The area that is marked as Pit 2 on the C-2 map (Mining Plan) is an agricultural field.

**Pit 2 – currently an agricultural field**

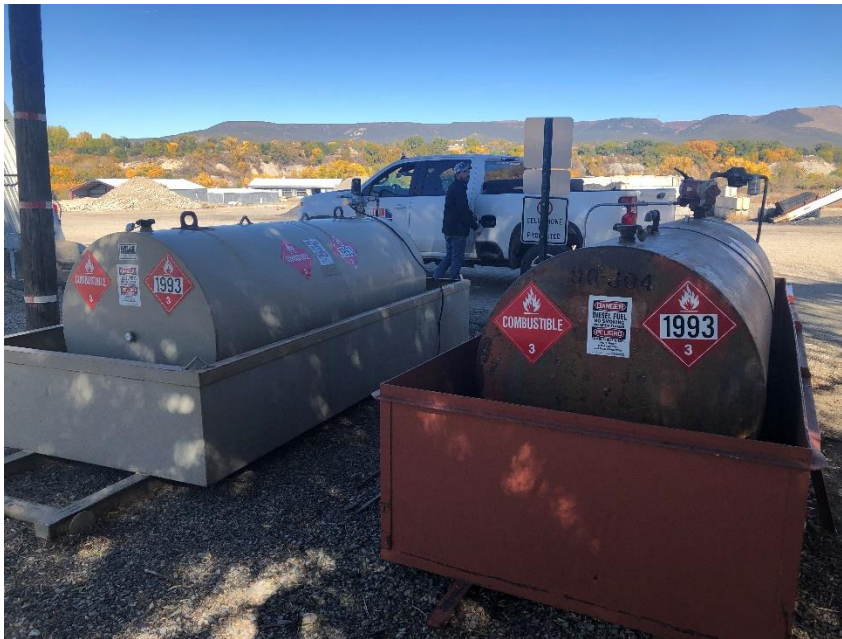
Two diesel tanks were observed near the office. Each appears to be a 1,000 gallon-capacity tank. They were both inside secondary containment structures that look to be adequate to contain any spills.

**Diesel fuel storage near office**

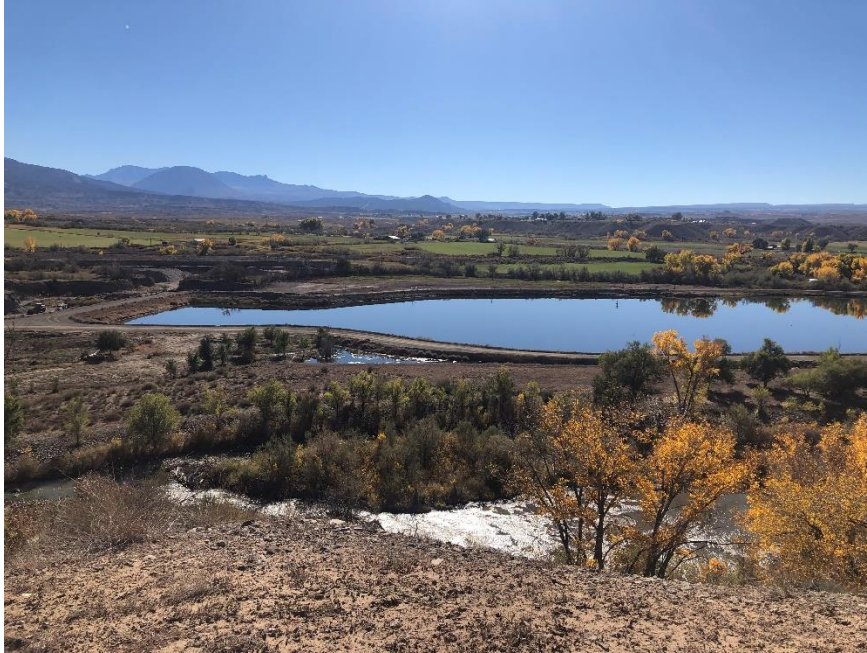
**North end of pond (from hill next to highway)**
