**MINERALS PROGRAM INSPECTION REPORT**  
**PHONE: (303) 866-3567**

<b>MINE NAME:</b> Jolly Pit	<b>MINE/PROSPECTING ID#:</b> M-2012-010	<b>MINERAL:</b> Borrow material for construction	<b>COUNTY:</b> Las Animas
<b>INSPECTION TYPE:</b> Monitoring	<b>WEATHER:</b> Cloudy	<b>INSP. DATE:</b> November 5, 2024	<b>INSP. TIME:</b> 14:00
<b>OPERATOR:</b> Las Animas County	<b>OPERATOR REPRESENTATIVE:</b> Keith Woodring and Joe Avila	<b>TYPE OF OPERATION:</b> 112c - Construction Regular Operation	
<b>REASON FOR INSPECTION:</b> Normal I&E Program	<b>BOND CALCULATION TYPE:</b> None	<b>BOND AMOUNT:</b> \$0.00	
<b>DATE OF COMPLAINT:</b> NA	<b>POST INSP. CONTACTS:</b> None	<b>JOINT INSP. AGENCY:</b> None	
<b>INSPECTOR(S):</b> Amber M. Gibson	<b>INSPECTOR'S SIGNATURE:</b>

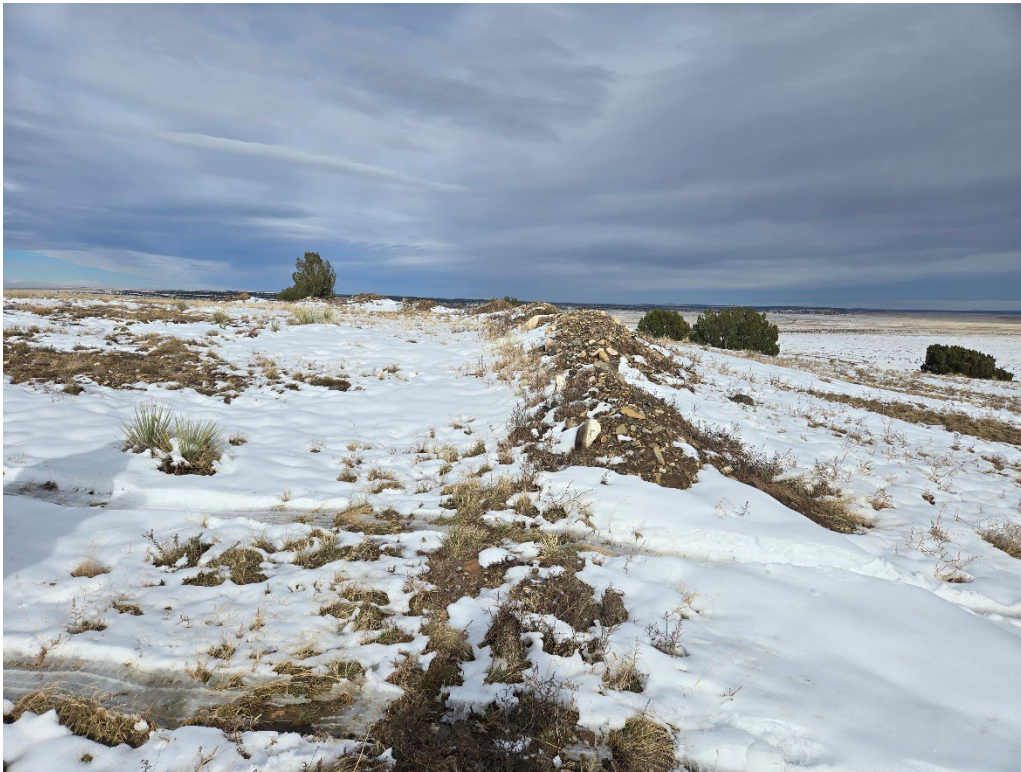
The current pit, and the next areas planned to be excavated, are bordered by stormwater berms to both indicate the disturbance limits within the permit boundary and to prevent run-off and excess sediment from leaving the site (Photo 1; Map 1). The mining plan states that the diversion/disturbance berm will be located approximately 10 feet inside the permit boundary (where existing slopes allow), or further. However, along the north side of the permit boundary, the berm is located on the northern boundary as well as along a portion of the southeast side of the permit boundary (see Map 1). At the time of the inspection, the Division did not observe any standing water nor signs that sediment had left the site.

**Photo 1:** Looking north along the eastern stormwater diversion/disturbance boundary berm.

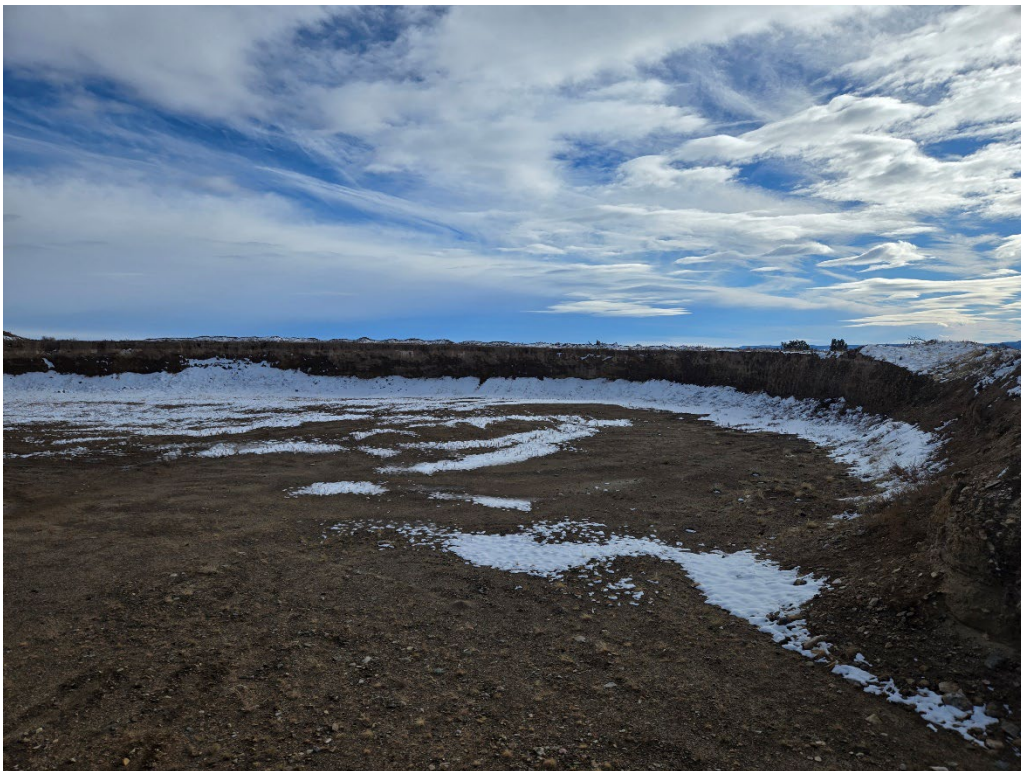
**Photo 2:** Looking south across the pit from the north boundary.

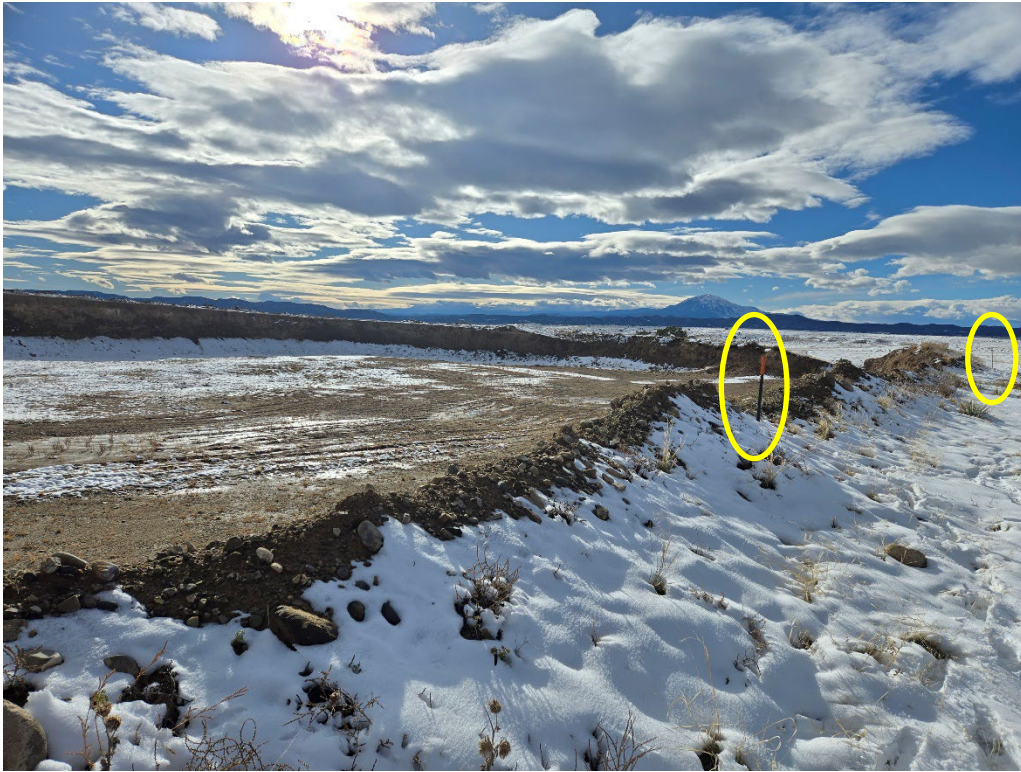
**Photo 3:** Looking west across the pit from the north boundary. The north boundary markers are circled in yellow.

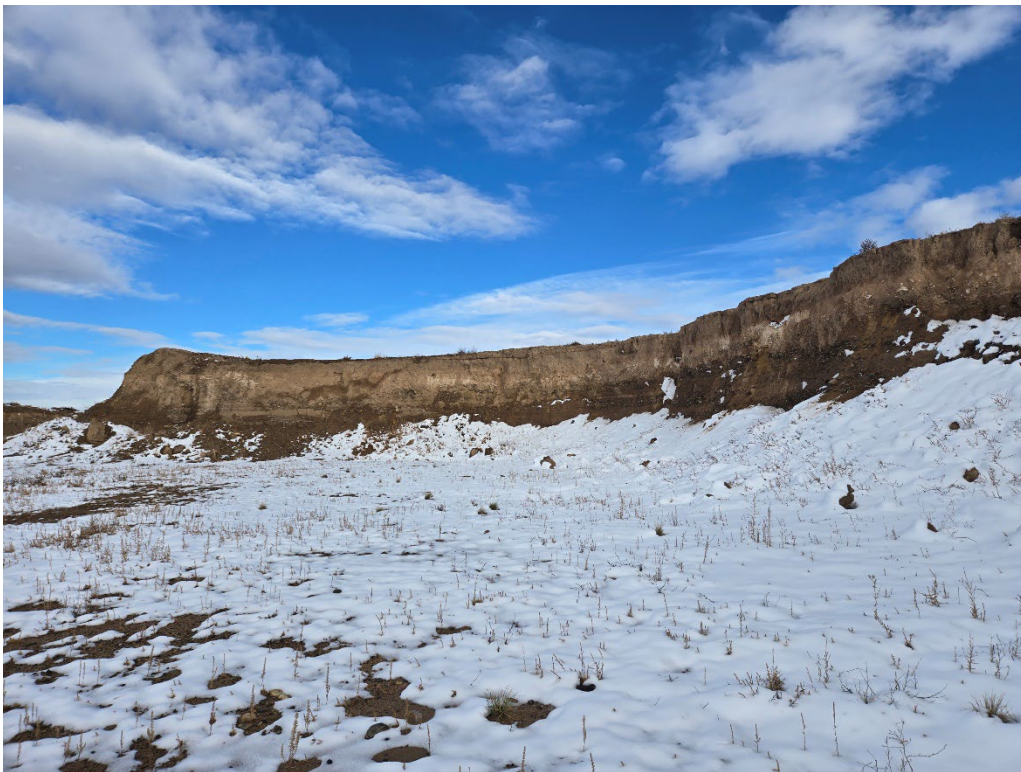
**Photo 4:** Looking east at highwalls from within the pit.

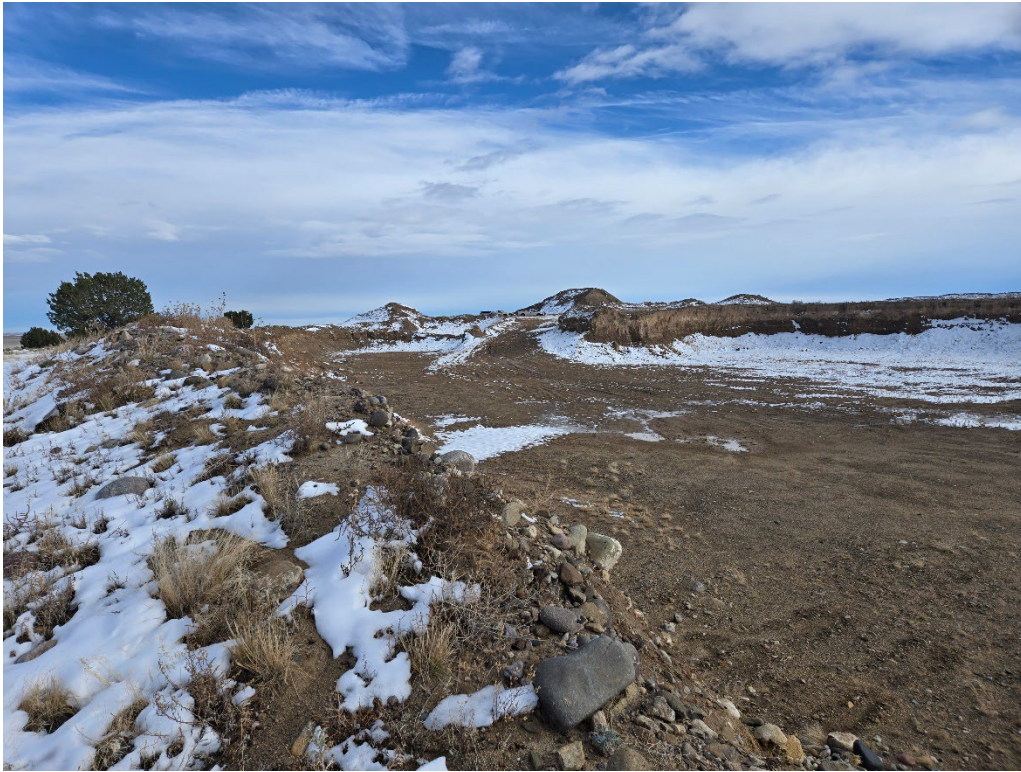
**Photo 5:** Looking east at the internal pit road leading to the processing area.

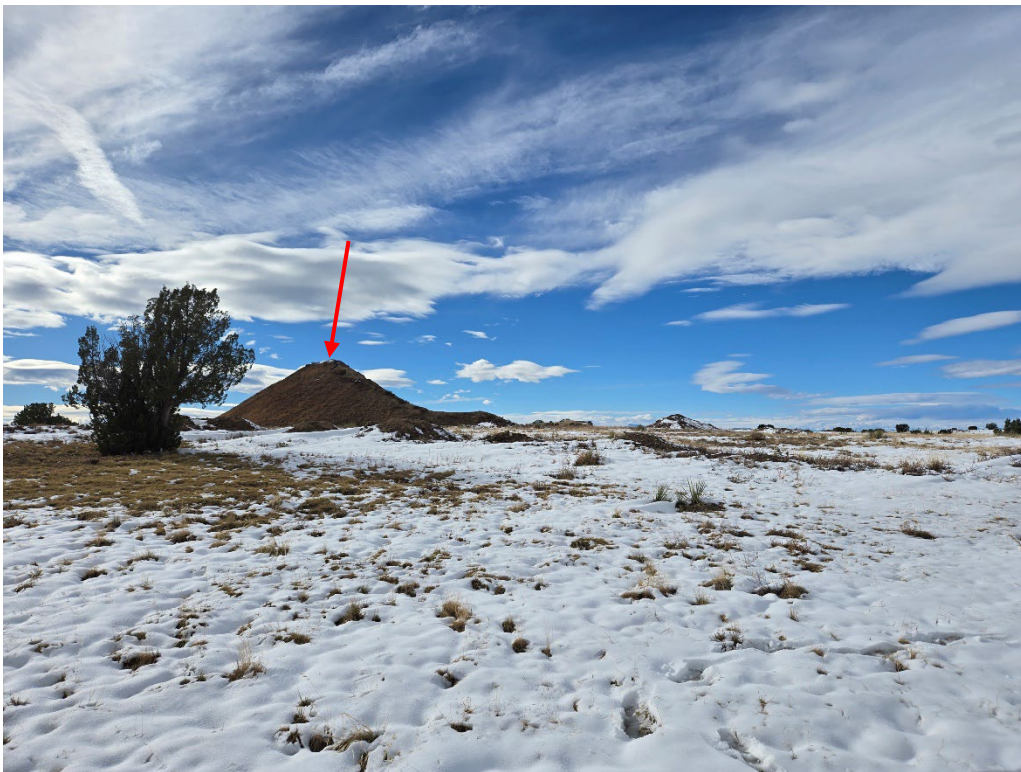
During the inspection, the Operator stated that the last date of active mining at the site was approximately 1.5 years ago and consisted of hauling off material from the product stockpile. Per the mining plan, this operation consists of an open pit, where mining had begun in the northwest corner of the boundary and has since moved south and east. The pit is currently about 1.75 acres, and consists of a level pit floor, approximately 1,087' long by 25' deep highwalls that are at about a 0.5H:1V slope, and an internal road that leads up to the processing area (Photos 2-5). Some overburden material, to be used later during reclamation, is stockpiled above and behind some of the highwalls (Photo 7). There was also a product stockpile located southwest of the pit (Photo 6; Map 1). At the time of the inspection, there was no equipment onsite.

**Photo 6:** Looking west at the processing area and at the processing pile (arrow), from the eastern disturbance boundary.

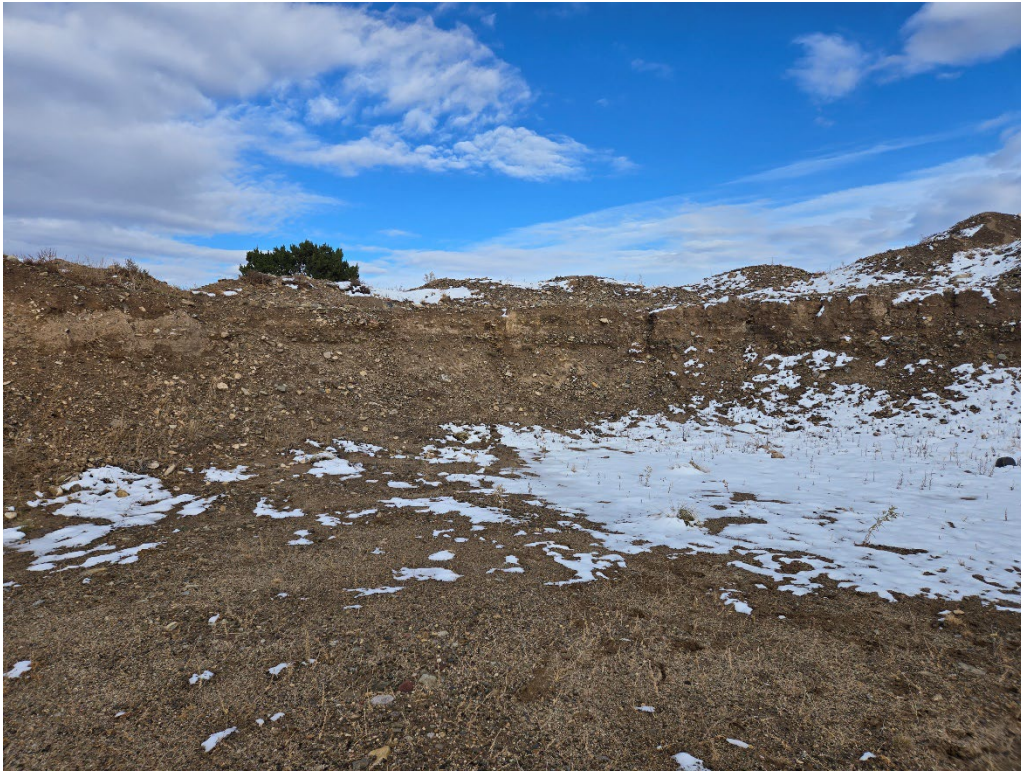
**Photo 7:** Looking at the overburden material stockpiled above and behind the highwalls within the pit area.

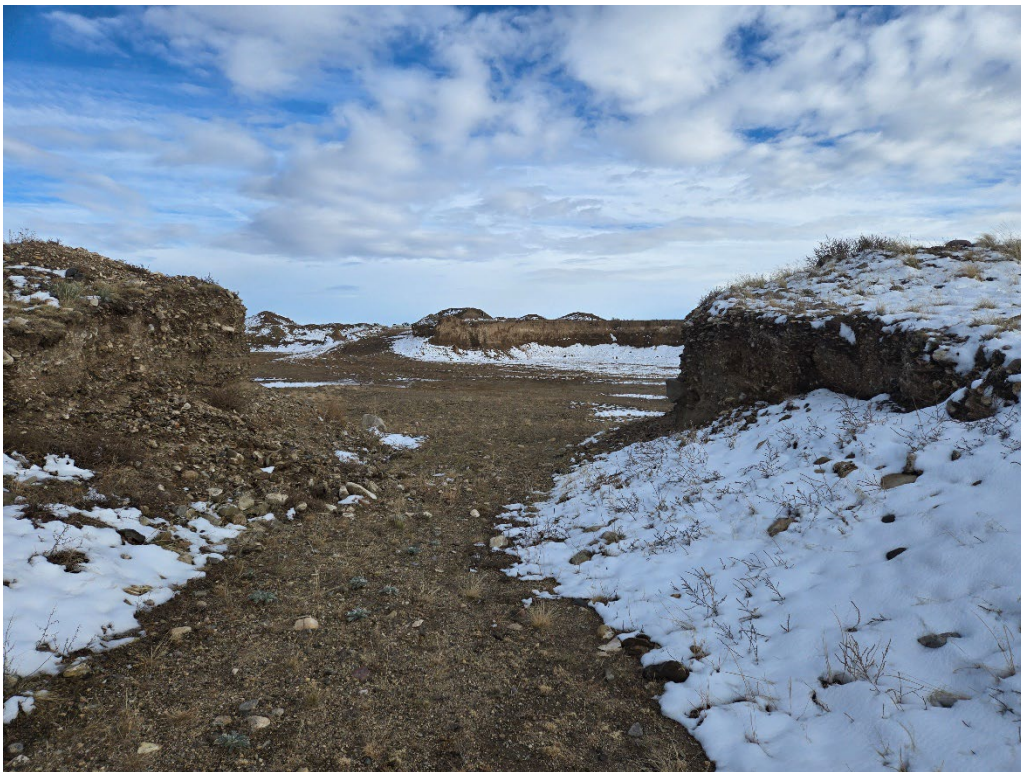
**POSSIBLE VIOLATION:** Land has been affected outside of the approved permit boundary. This is a possible violation at this time pursuant to: 1.) C.R.S. 34-32.5-109(1) for failure to first obtain from the board or office a reclamation permit prior to engaging in a new operation. AND/OR 2.) C.R.S. 34-32.5-116(4)(i) for failure to protect areas outside of the affected land from slides or damages occurring during the mining operation.

The Division estimates the disturbance onsite to be approximately 7.15 acres (see the purple boundary on Map 1). Upon inspection follow-up, the Division discovered that a few roads had been constructed sometime between the time the permit application was submitted in 2012, and 2013. It appears that a section of the road leading into the pit is constructed outside of the permit boundary, as well as a few roads leading into the west side of the permit (Photos 8-9; black polygons on Map 1; Figure 1). **This has been cited as a possible violation**

**above** for off-site damage affecting approximately 0.25 acres near the entrance of the pit, located outside of the approved affected area. The Division will bring this matter before the Mined Land Reclamation Board (MLRB) for a hearing for consideration of a possible violation pursuant to C.R.S. 34-32.5-116(4)(i) for failure to protect areas outside of the approved affected land from slides or damages, and/or for failure to first obtain a reclamation permit prior to engaging in a new operation in accordance with C.R.S. 34-32.5-109(1). The schedule and other details for the MLRB hearing will be provided under a separate document to be sent via certified mail to the Operator.

**Photo 8:** Looking east into the pit from the entrance constructed outside of the permit boundary.

**CORRECTIVE ACTIONS:** This possible violation will require a hearing before the Mined Land Reclamation Board. The schedule and other details for the MLRB hearing will be provided under a separate document to be sent via certified mail to the Operator.

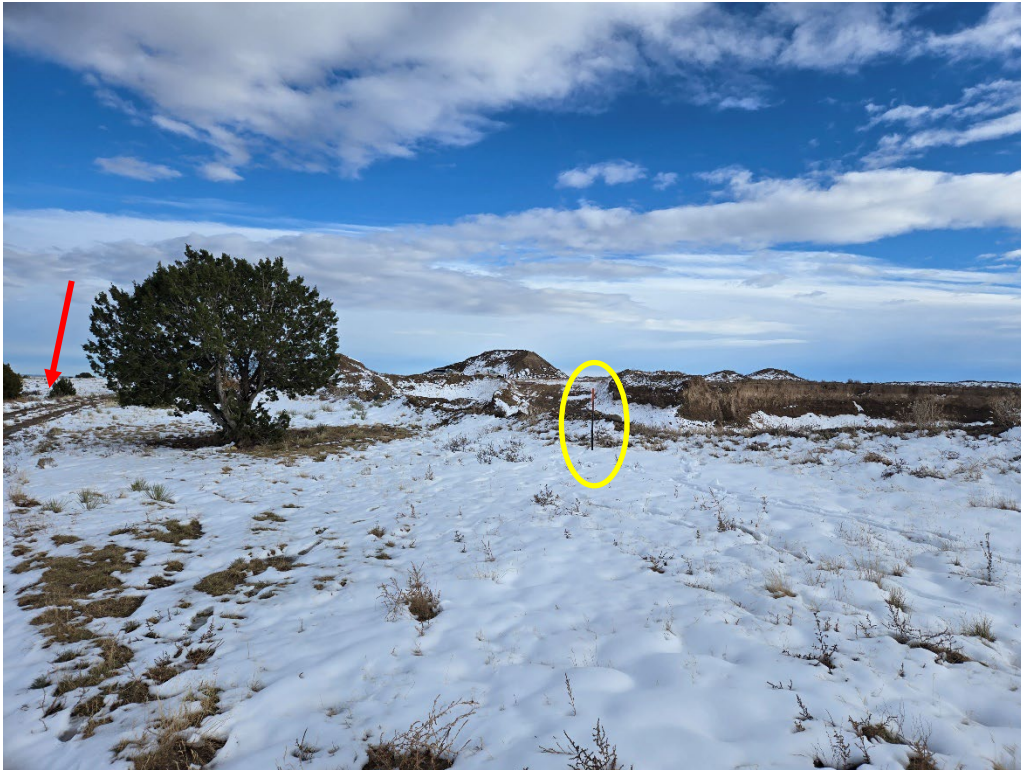
**Photo 9:** Looking southeast at the pit from beyond the permit boundary. The circle indicates the northern permit boundary marker. The arrow points to a road constructed outside of the permit boundary.

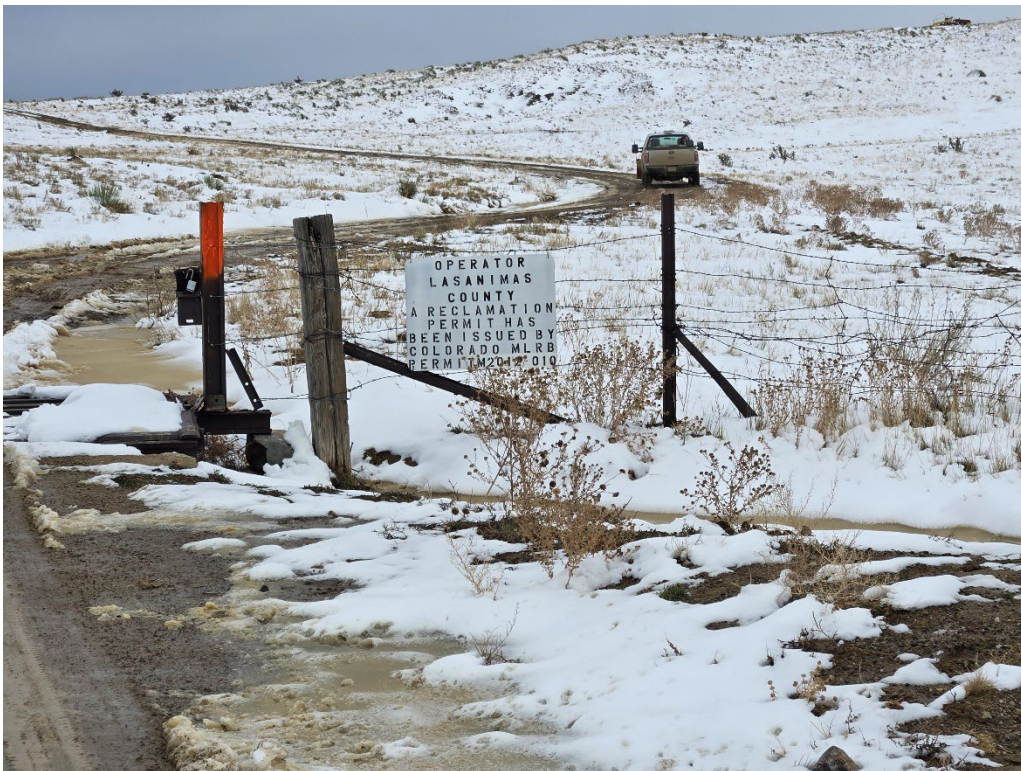
The mine sign was observed and appears to be in compliance with Rule 3.1.12(1). The mine sign is posted approximately 2.9 miles west of the entrance to the pit, near the start of the private road leading east from CR 61 (Photo 10; Map 2).

**Photo 10:** Looking east at the mine sign located approximately 2.9 miles west of the pit boundary (see Map 2).

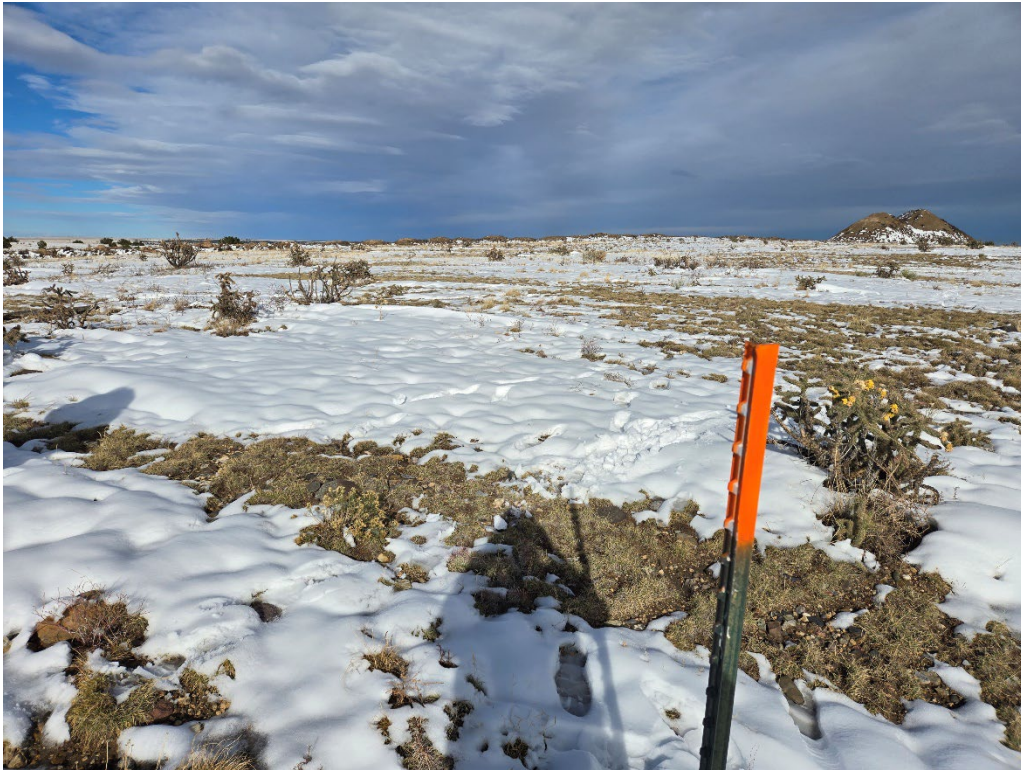
The Division walked around the site with the Operator representatives and collected GPS points for the field markers posted in compliance with Rule 3.1.12(2). The permit boundary is marked with green t-posts with orange tops (Photo 11). The Division georeferenced the permit boundary into the Esri FieldMaps application and determined that the markers appear to closely resemble the placement of the permit boundary. However, in some areas, it appears that the field markers are more conservative than the boundary, and in others, they seem to lie outside of the depicted boundary on the *Permittee's Map C-1 Aerial Photo* (enclosed), which the Division used to georeference the permit boundary. Other than the roads mentioned in the General Compliance with the Mine Plan section above, no additional off-site disturbance was observed. The Division cautions the Operator to ensure that additional disturbance does not go outside of the boundary depicted in the approved application, nor does it exceed the 12.0 acres approved to be affected for this operation.

**Photo 11:** Looking northeast from the west permit boundary at the southern pit boundary.

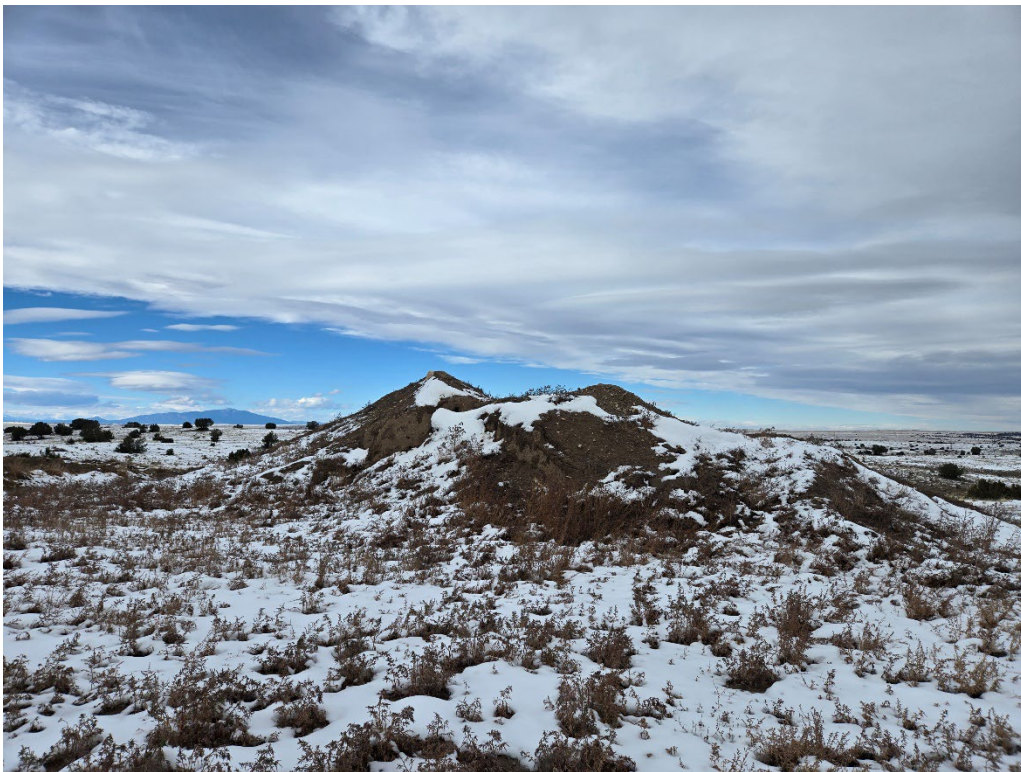
A stockpile of topsoil was observed to the east of the northeastern corner of the pit boundary, approximately where the north topsoil stockpile is indicated on the enclosed Permittee's *Map C-e Mining Plan Map* (Photo 12: Map 1). The topsoil stockpile had some vegetation growing on it and appears stable at this time. The Division reminds the Operator that once placed, per Rule 3.1.9(4), the topsoil stockpile shall not be moved again unless it's being applied to regraded disturbed areas during reclamation, or if it has been approved to be moved through a Technical Revision.

**Photo 12:** Topsoil stockpile.

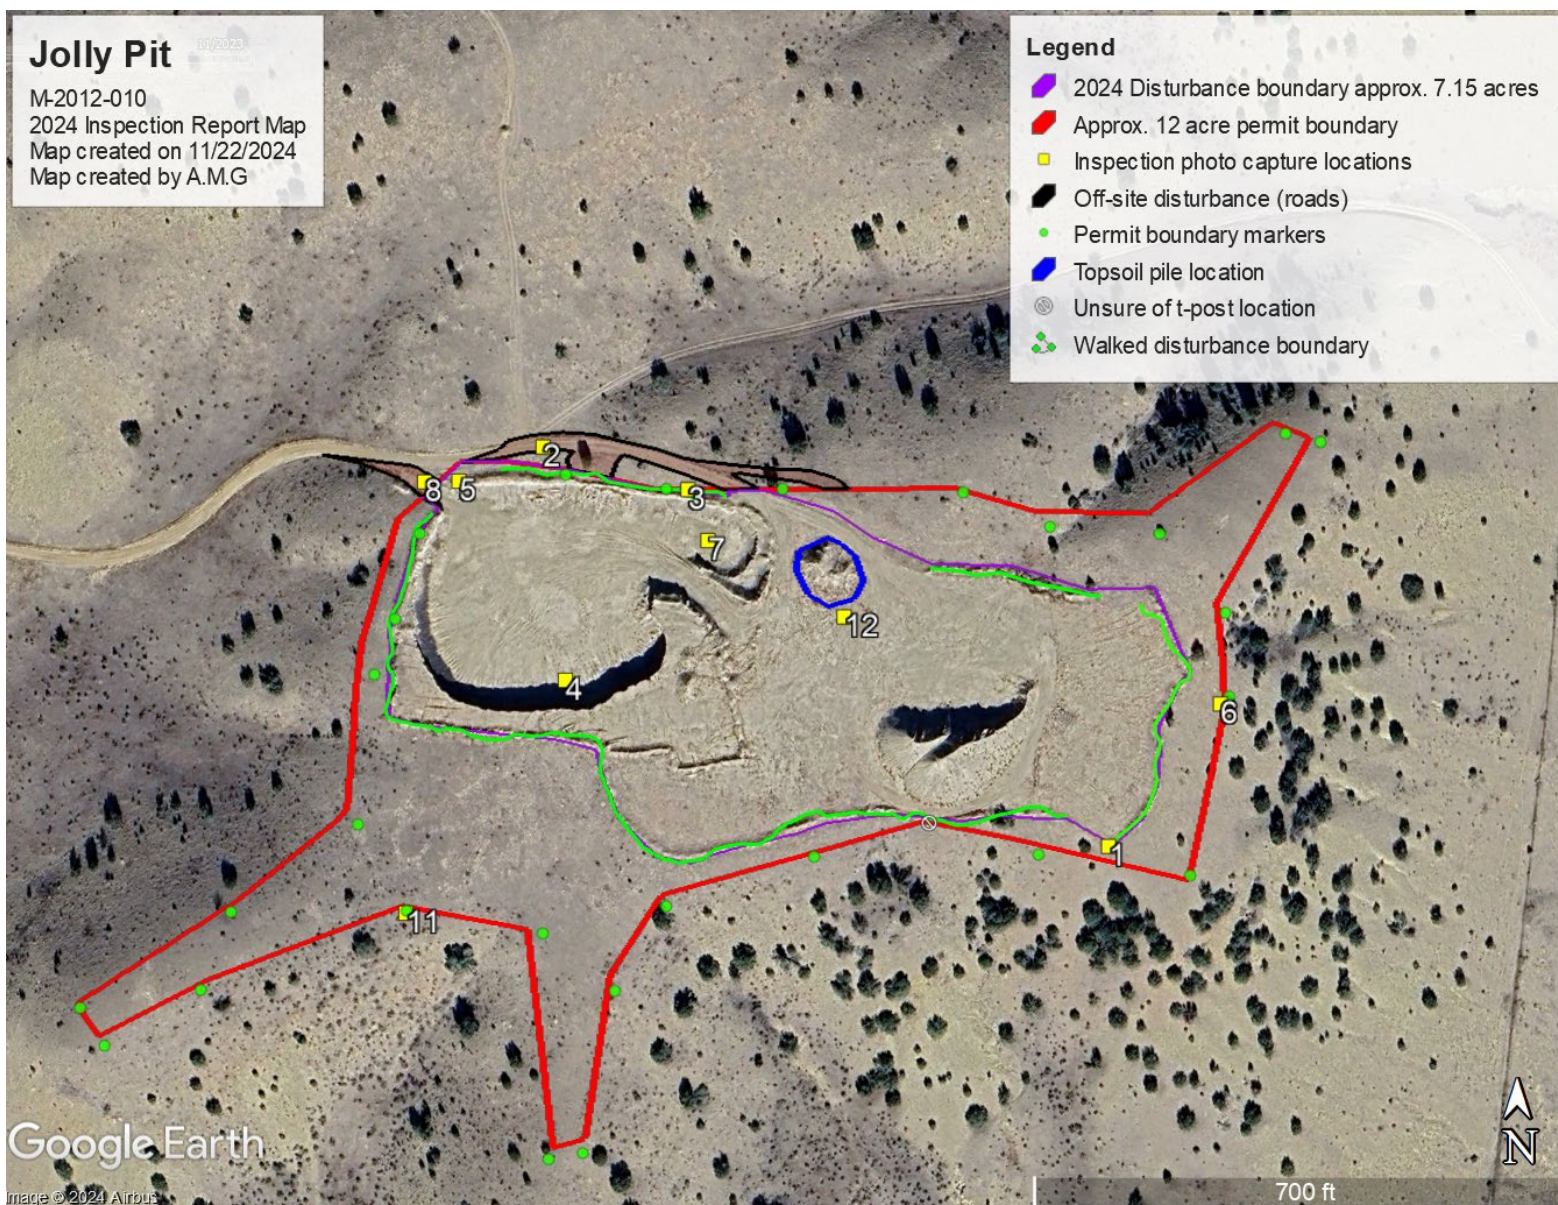
**Map 1:** Inspection map generated in Google Earth Pro, using data collected in the field using Esri FieldMaps, and inspection photo GPS data imported into Esri ArcPro and ArcOnline. The aerial imagery is dated 11/12/2023. The icon shown as a white circle with a slash through it along the southern boundary indicates where there may have been a boundary marker present, but not data was collected at that point. The black outlined polygons located north of the permit boundary indicate areas where roads have been significantly improved and or created in support of the mining operation (see Figure 1 below).

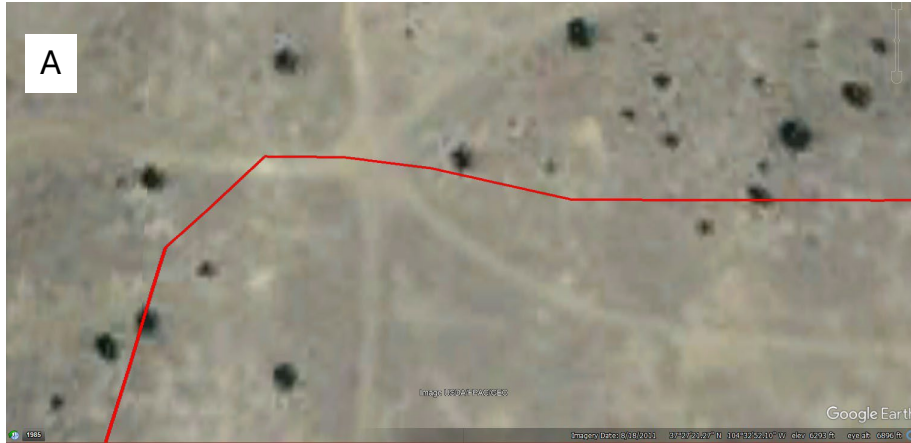
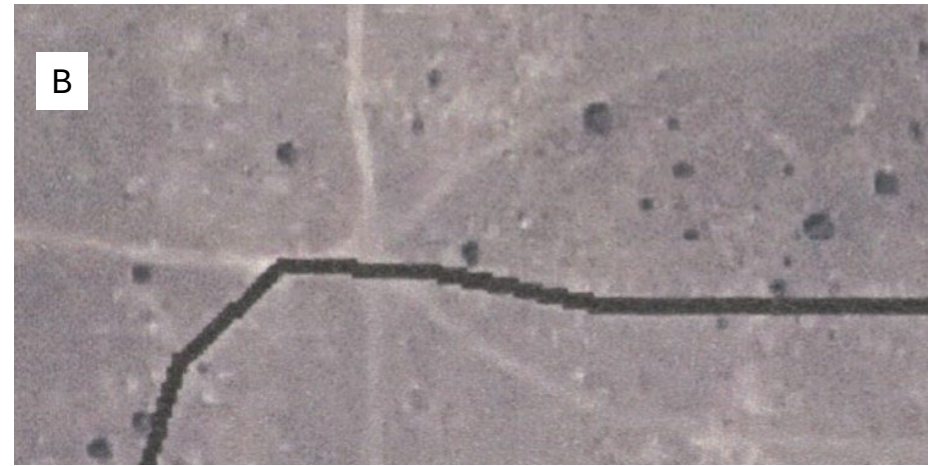
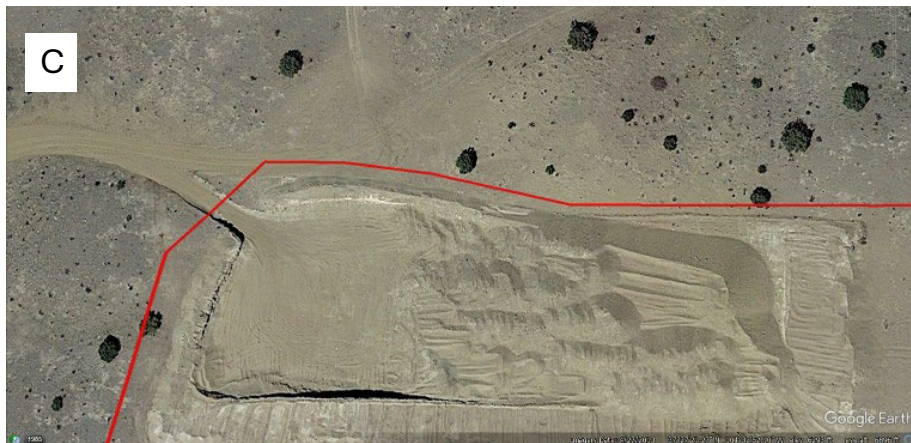
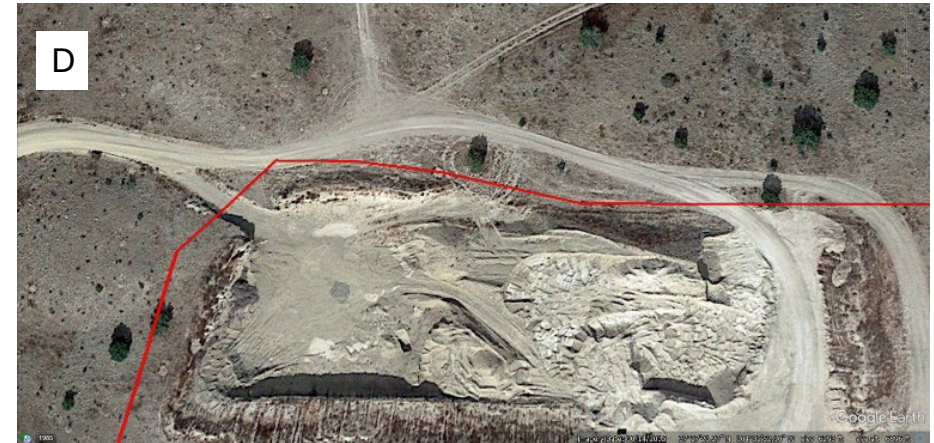
**Figure 1:** Figure showing the formation of roads and paths outside of the approved affected area. A) Google Earth aerial image dated 8/18/2011. B) Road area from the Permittee's Map C-I Aerial Photo where the map is dated 12/8/2011. C) Google Earth aerial image dated 4/27/2013. D) Google Earth aerial image dated 10/14/2015.
