MINERALS PROGRAM INSPECTION REPORT

MINE NAME: Camilletti Milner Pit #2	MINE/PROSPECTING ID#: M-2001-023	MINERAL: Sand and gravel	COUNTY: Routt
INSPECTION TYPE: Surety-Related Inspection	WEATHER: Clear	INSP. DATE: November 20, 2024	INSP. TIME: 08:00
OPERATOR: Precision Excavating, Inc.	OPERATOR REPRESENTATIVE: Tyra Bartuska	TYPE OF OPERATION: 112c - Construction Regular Operation

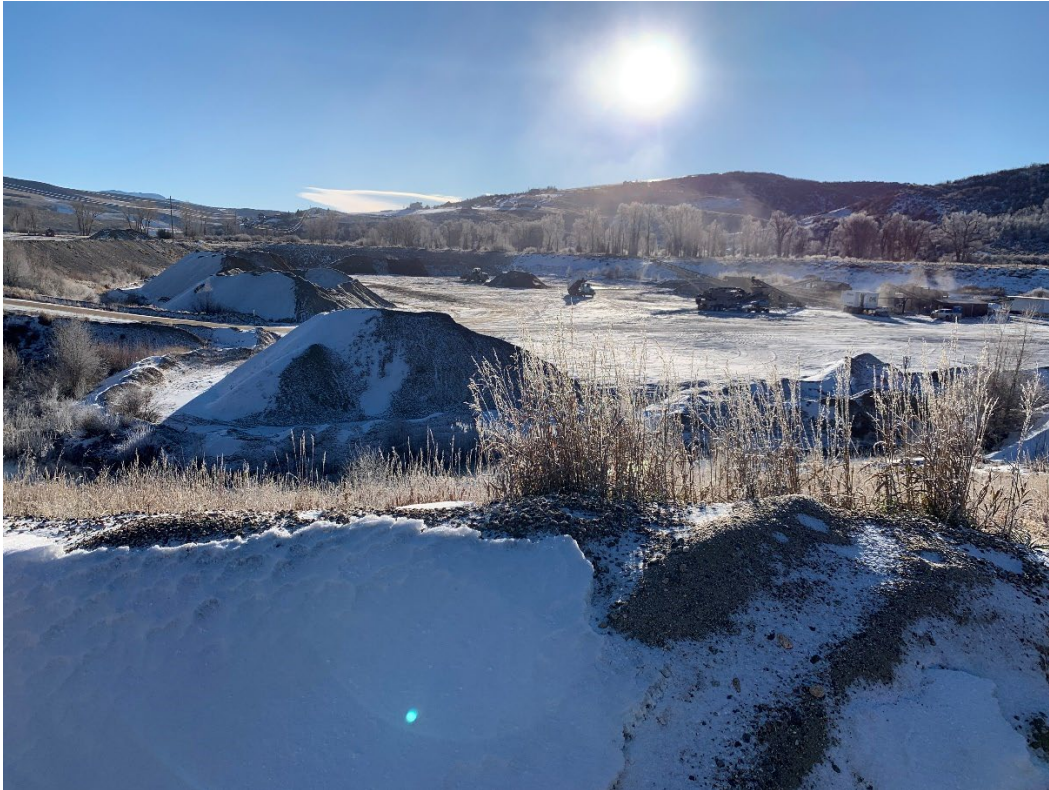
The crushing/ processing equipment are located in the main pit area on the east side of Trout Creek (photo 1). Several product stockpiles are located in this pit area. This area has been mined below the water level and is continually pumped to keep the pit from filling up.

Photo 1- Processing in the main pit area, east of Trout Creek.

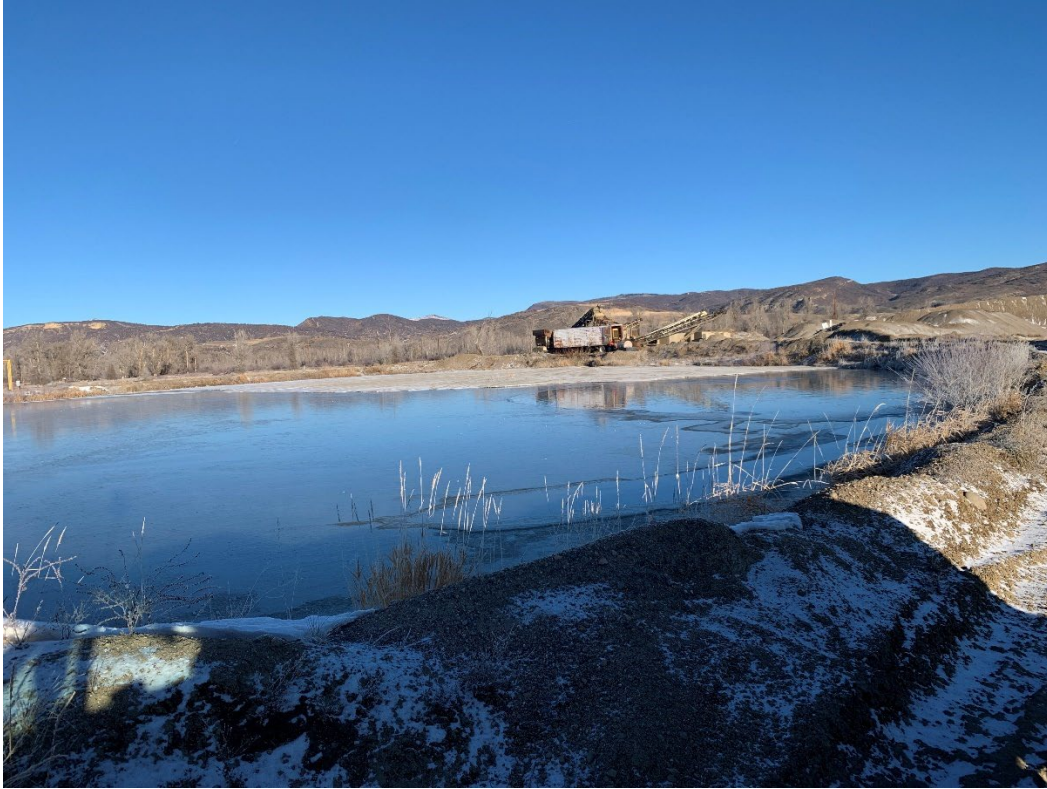
The wash plant is located on the east side of Trout Creek, west of the processing area. Two sediment ponds are adjacent to the wash plant and contained water (photo 2).

Photo 2- Wash plant and sediment pond on east side of Trout Creek.

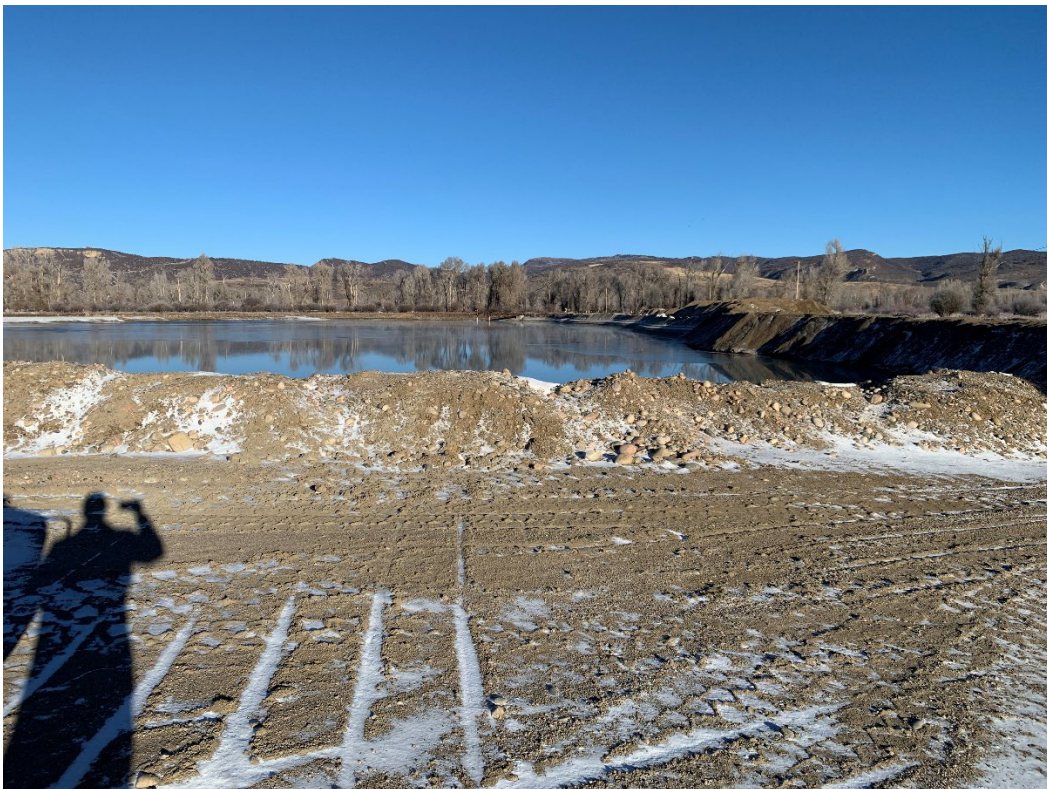
The pit on the west side of Trout Creek is the primary mining area. The pit is mined from north to south and the pit contained water. A perimeter berm is in place around the pit area (photo 3).

Photo 3- Pit area on west side of Trout Creek.

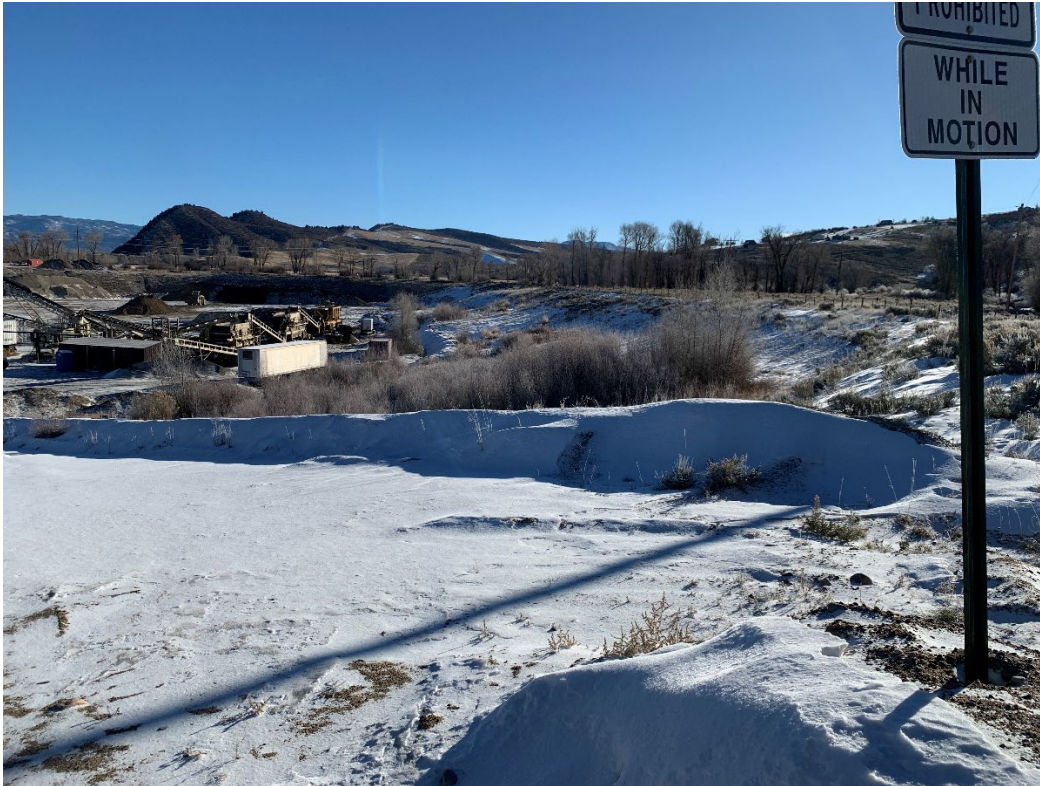
The southern and eastern banks of the main pit on the east side of Trout Creek have been graded to 3h:1v, topsoiled and seeded (photo 4).

Photo 4- Southern and eastern banks of the main pit are vegetated.

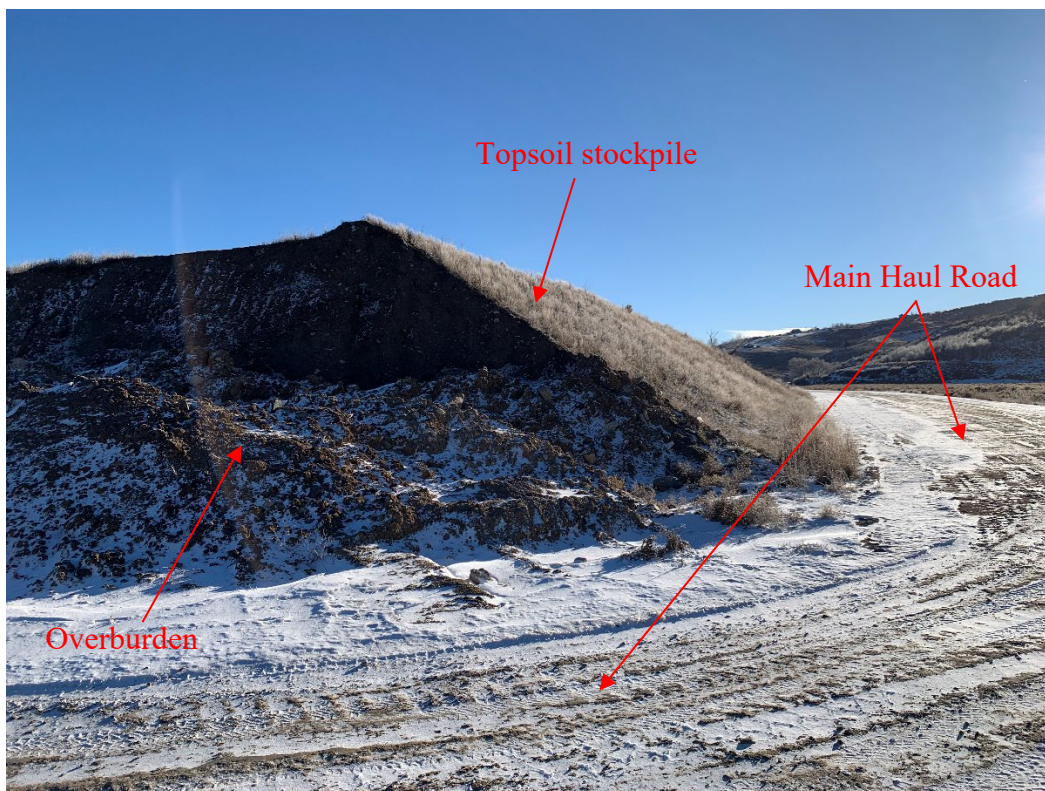
PROBLEM/POSSIBLE VIOLATION: Problem: The topsoil stockpile located in the west mining area, east of the pit area has a large volume of overburden material pushed up against it, mixing the two materials. The topsoil stockpile is also located along the main haul road accessing the west pit area. Plant growth medium stockpiles must be located separate from other stockpiles and out of the way of mine traffic (Rule 6.3.3(b)).

- On the west side of Trout Creek, east of the pit area, the pile is located along the haul road and appears to be well vegetated. The west end of this pile has an overburden stockpile right up against the topsoil stockpile.

The overburden and the topsoil need to be separated to prevent confusion and mixing of the two different materials (photo 5). This has been cited as a possible problem.

Photo 5- Topsoil stockpile and overburden mixed

CORRECTIVE ACTIONS: The operator shall separate the overburden material from the topsoil pile and ensure minimal topsoil loss. The operator shall identify this particular topsoil pile with topsoil signs due to the fact that it has already been mistaken for an overburden pile, and its close proximity to the busy haul road.

The due date for this possible problem will be pushed to April 30, 2025 because 6-8 inches of snow is expected in the next couple of days which may close the mine for the season and will make separating the overburden from the topsoil stockpile challenging.

CORRECTIVE ACTION DUE DATE: 4/30/25
