Lob Lolly Pit M2013066- Inspection Report

MINERALS PROGRAM INSPECTION REPORT
PHONE: (303) 866-3567

MINE NAME: Lob Lolly Pit	MINE/PROSPECTING ID#: M-2013-066	MINERAL: Borrow material for gravel and sand	COUNTY: Archuleta
INSPECTION TYPE: Surety-Related Inspection	WEATHER: Clear	INSP. DATE: October 29, 2024	INSP. TIME: 14:00
OPERATOR: Arboles Sand & Stone, LLC	OPERATOR REPRESENTATIVE: Steve & Joyce Wright	TYPE OF OPERATION: 112c - Construction Regular Operation	
REASON FOR INSPECTION: Surety Related	BOND CALCULATION TYPE: Incomplete	BOND AMOUNT: \$98,585.00	
DATE OF COMPLAINT: NA	POST INSP. CONTACTS: None	JOINT INSP. AGENCY: None	
INSPECTOR(S): Chris Girardi Patrick Lennberg	INSPECTOR'S SIGNATURE:

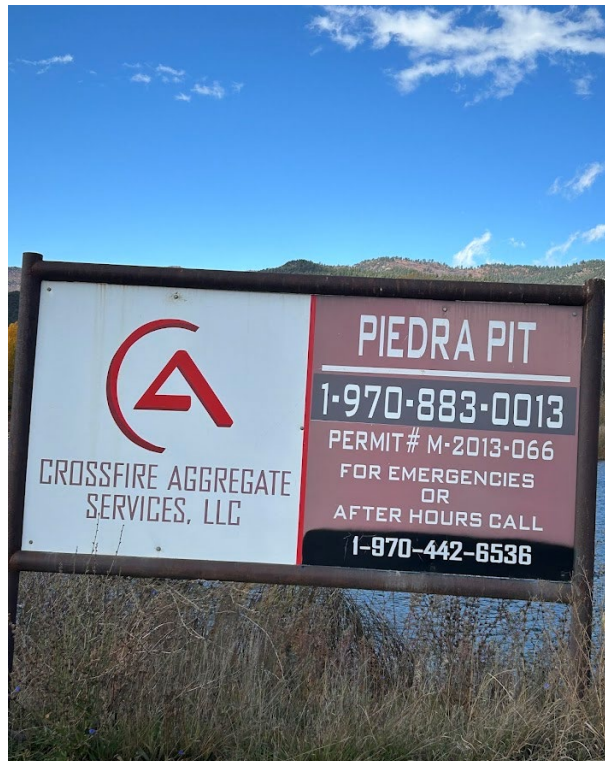
The site is accessed from a gate along on the highway. Th proper mine identification sign (see Photo 1) was observed at the mine entrance in compliance with Rule 3.1.12.

Photo 1: Permit Sign at mine entrance.

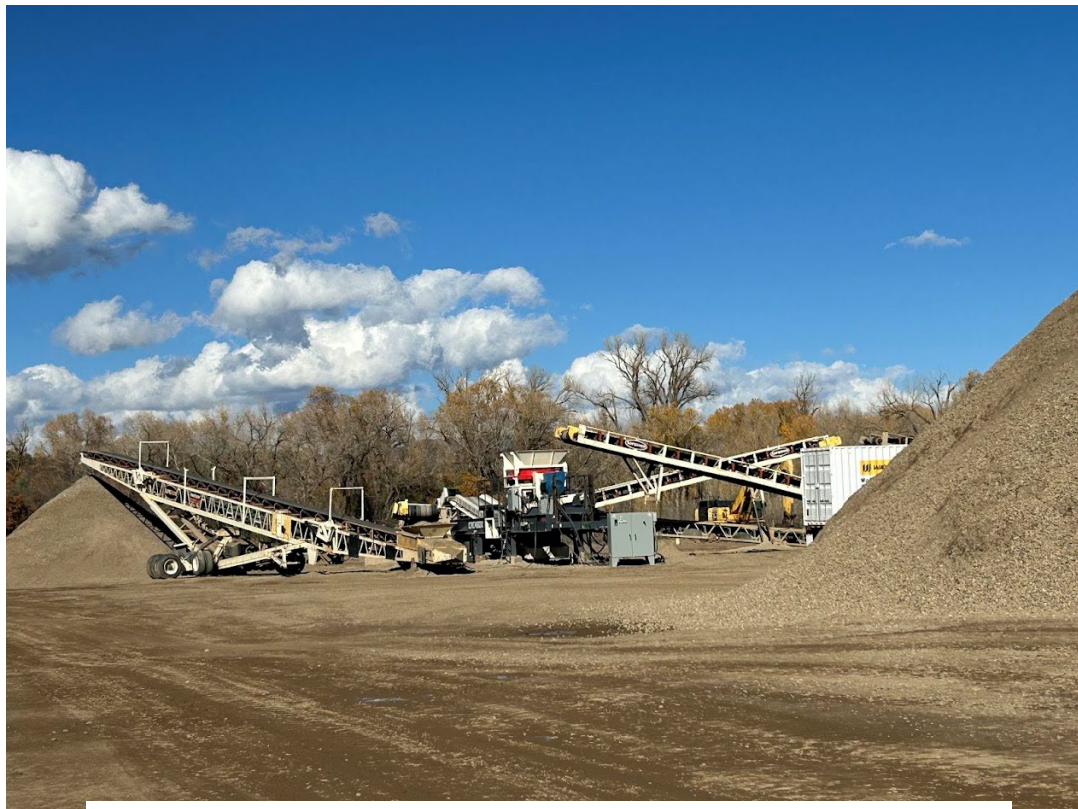
The site consists of two separated areas designated as the North Permit Area and the South Permit Area, with the North Permit Area containing active mining and processing while the South Permit Area is in reclamation. At the time of the inspection, mining was being conducted in the North Permit Area (see Photo 2). The Division observed the screening plant, washing plant, topsoil stockpiles, mining equipment, a laydown area, and haul trucks. The permit area is located along the Piedra River, with the South Permit Area located to the west of the river and the North Permit Area located to the east of the river. The South Permit Area contains the 9.8 acres of requested for release.

Photo 2: Processing area in north portion of permit area.

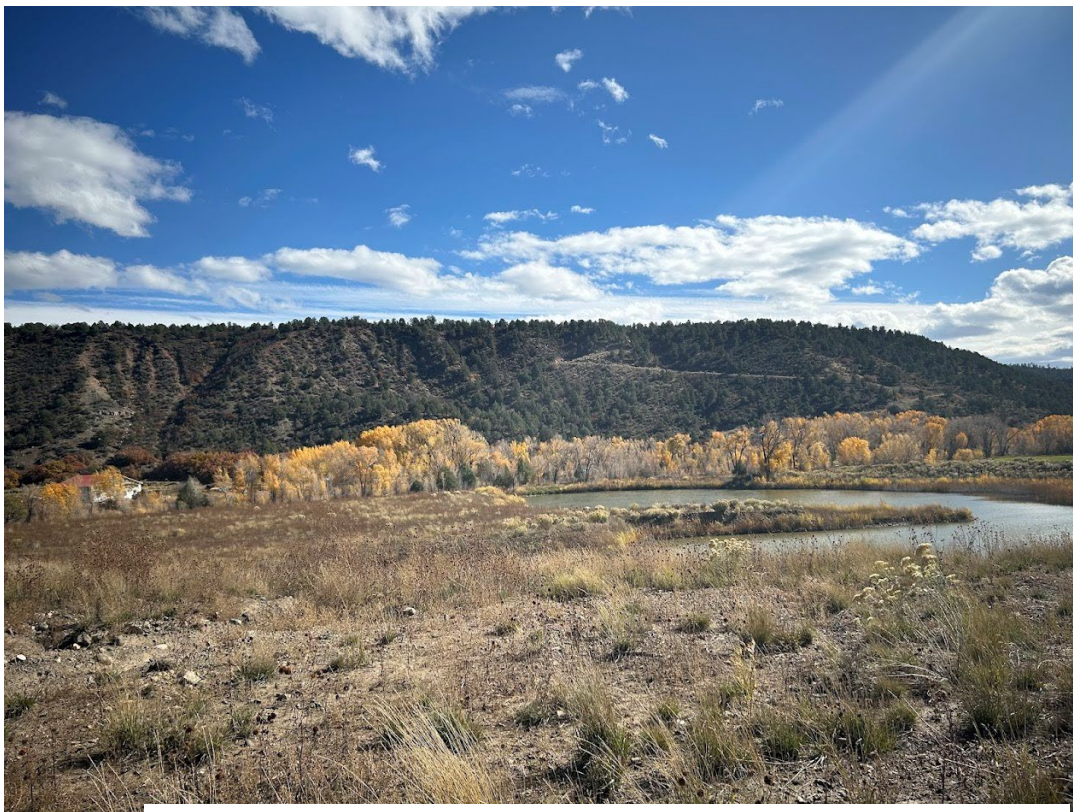
According to the Operator, the release area has been in reclamation since 2012. The area slopes to the southeast towards the pond and exhibits well-established vegetation throughout. Several grasses, Rabbit brush, and sunflowers were observed (see Photos 3-4, 8-10). There were several locations where Common mullein (see Photos 4 and 8) was observed with the release area along the pond shoreline and within the field. Common mullein is listed as a Colorado Noxious Weed List C Species and is not considered a problem at this time due to the limited nature of their presence within the release area. However, the Operator should monitor for weed species and manage them as appropriate. Minor rilling erosion was observed along the natural drainage leading to the pond from the northwest (see Photo 7). The requested release area contains a 1.4 acre undisturbed buffer zone along the eastern edge of the permit area. There was a clear boundary within the release area between the buffer zone and the revegetated area. The buffer zone contained cottonwood tree and willows, while the revegetated area did not (see Photo 11).

Photo 3: Release request area, facing southeast.

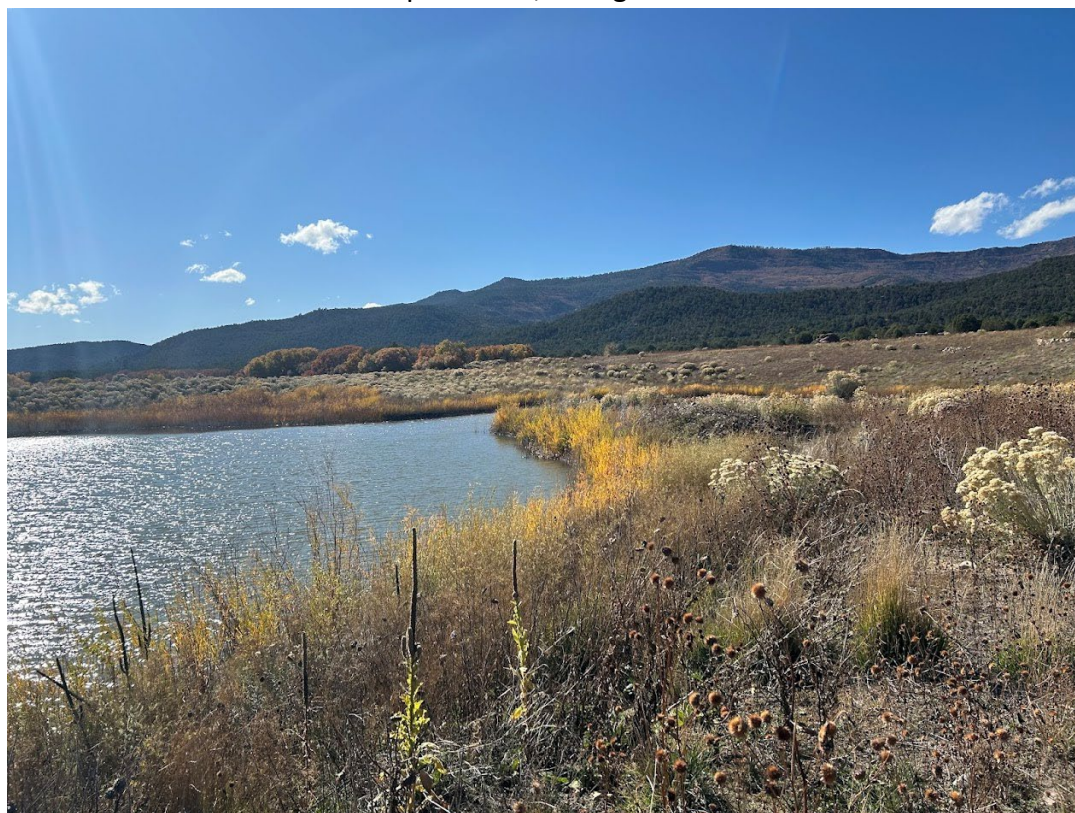
The pond has established vegetation along the side slopes (see Photos 4-6, 8) and mostly contained gentle sides slopes graded to less than a 3H:1V configuration. A small portion of the pond shoreline approximately 75 feet in length exhibited steep slopes exceeding 3H:1V configuration (see Photo 6). This area has well-established vegetation along the slope. The Division noted it would be impractical to grade this portion of the

Photo 4: Vegetation along pond shoreline with gentle slopes, facing west.

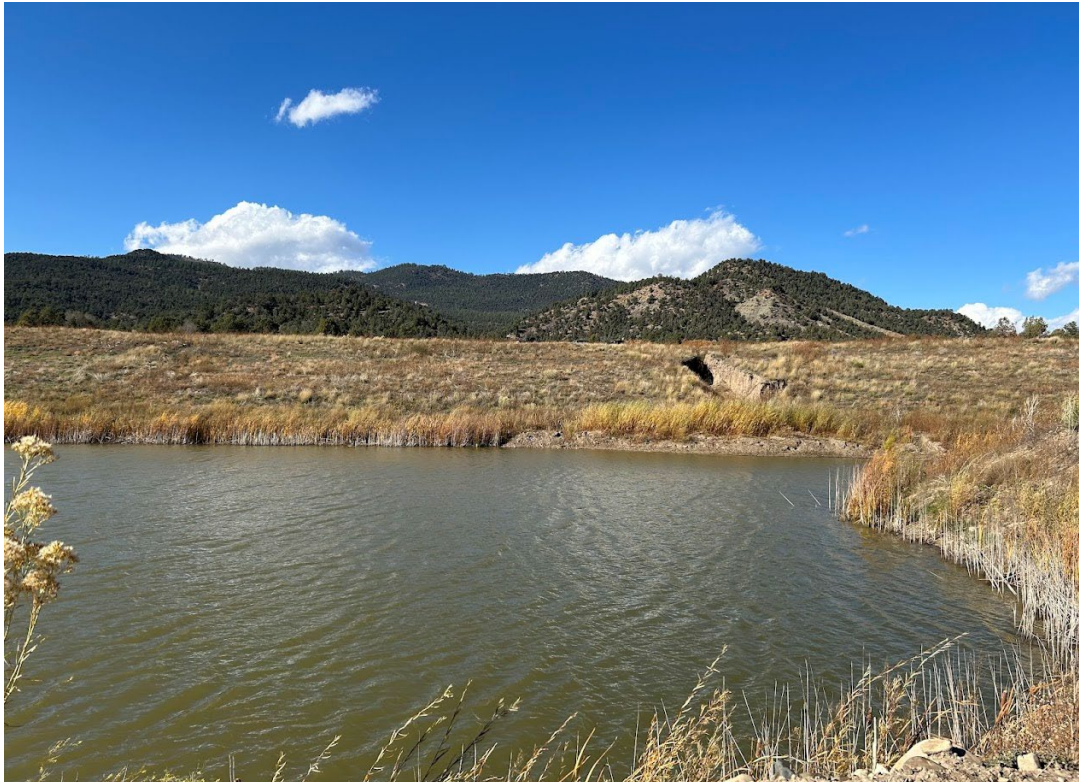
Photo 5: Pond shoreline exhibiting well-established vegetation and gentle slopes.

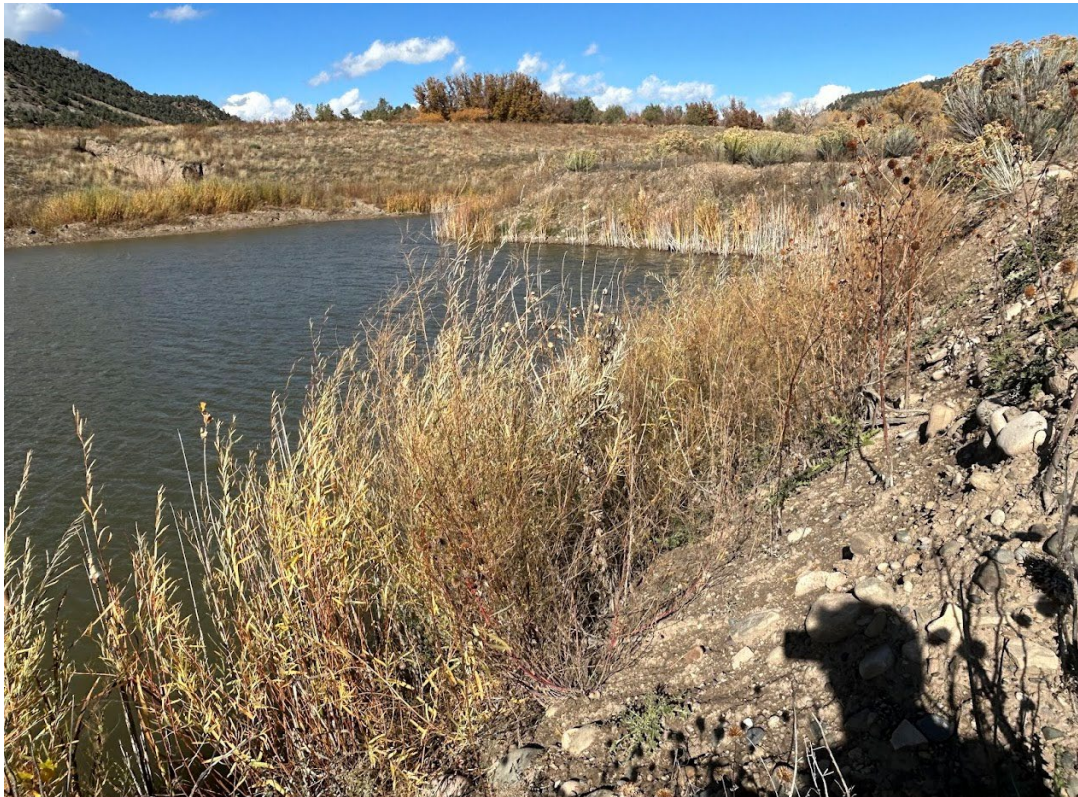
shoreline, as this activity would destroy established vegetation in the area. As a result, this observation as is not considered a problem. Minor rilling erosion was observed along the natural drainage leading to the pond from the northwest (see Photo 7). Overall, the requested release area exhibits excellent, self-sustaining vegetative cover that blends well with the surrounding area.

Photo 6: Pond shoreline exhibiting 2H:1V slopes with well-established vegetation.

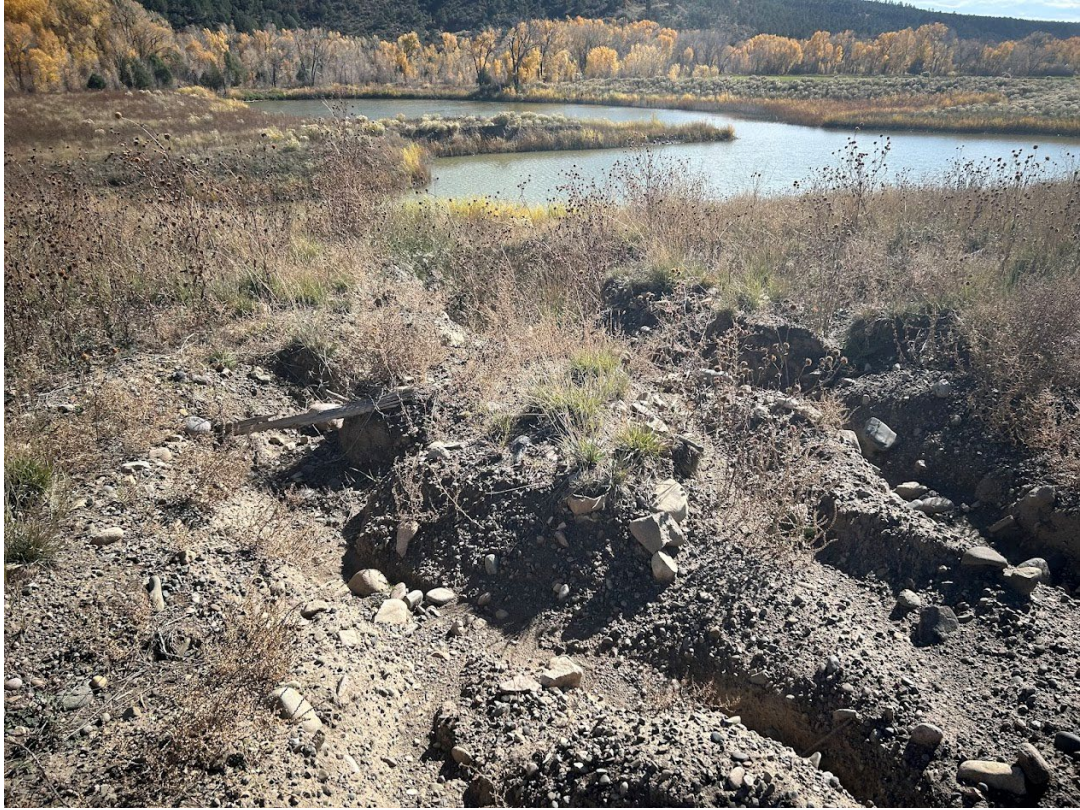
Photo 7: Minor erosional rilling along natural drainage.

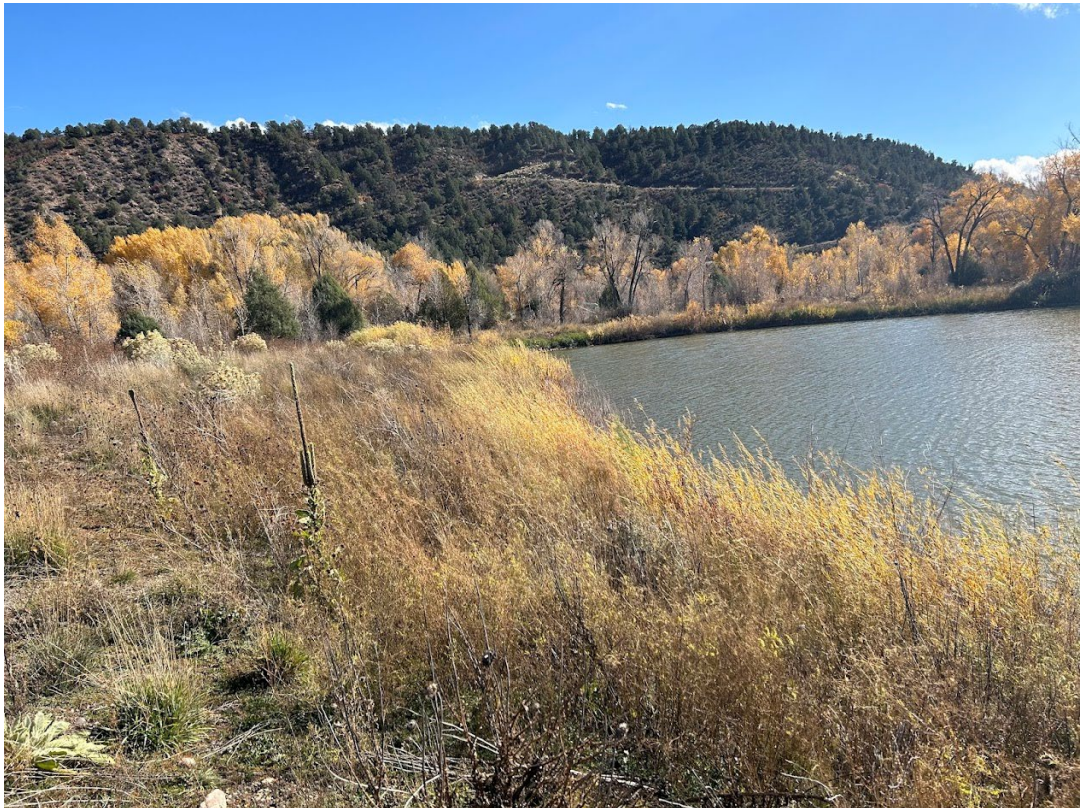
Photo 8: Vegetation along pond shoreline.

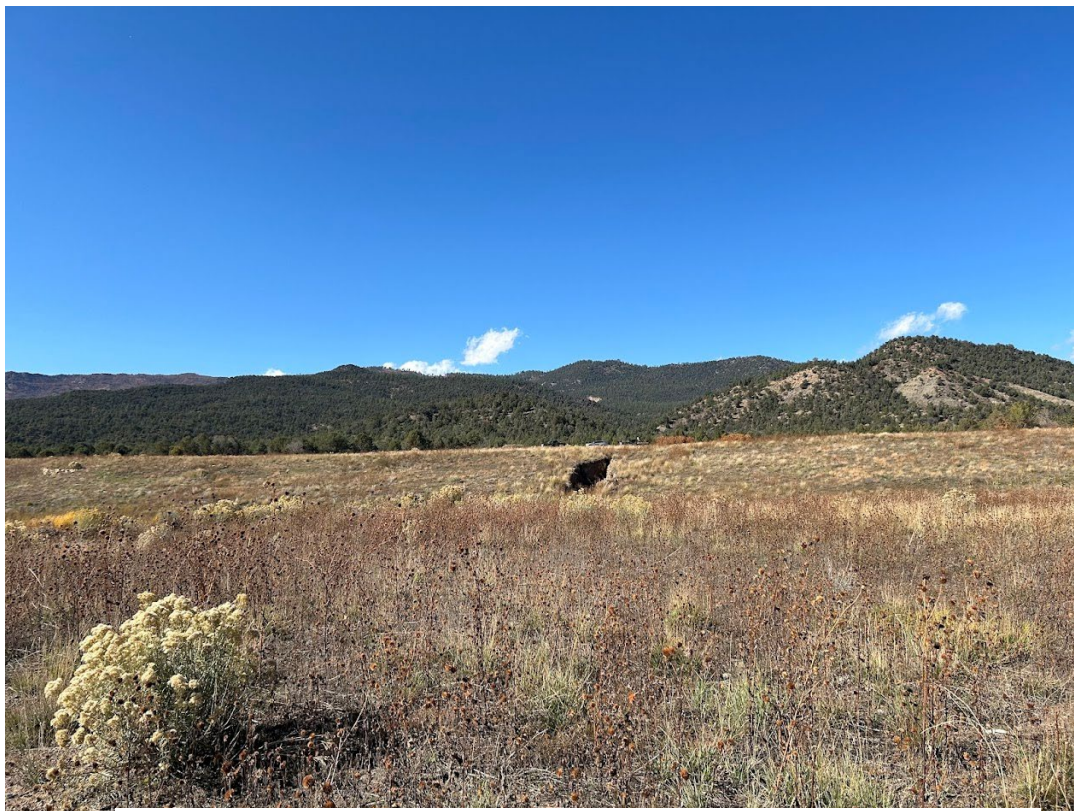
Photo 9: Vegetation within proposed release area.

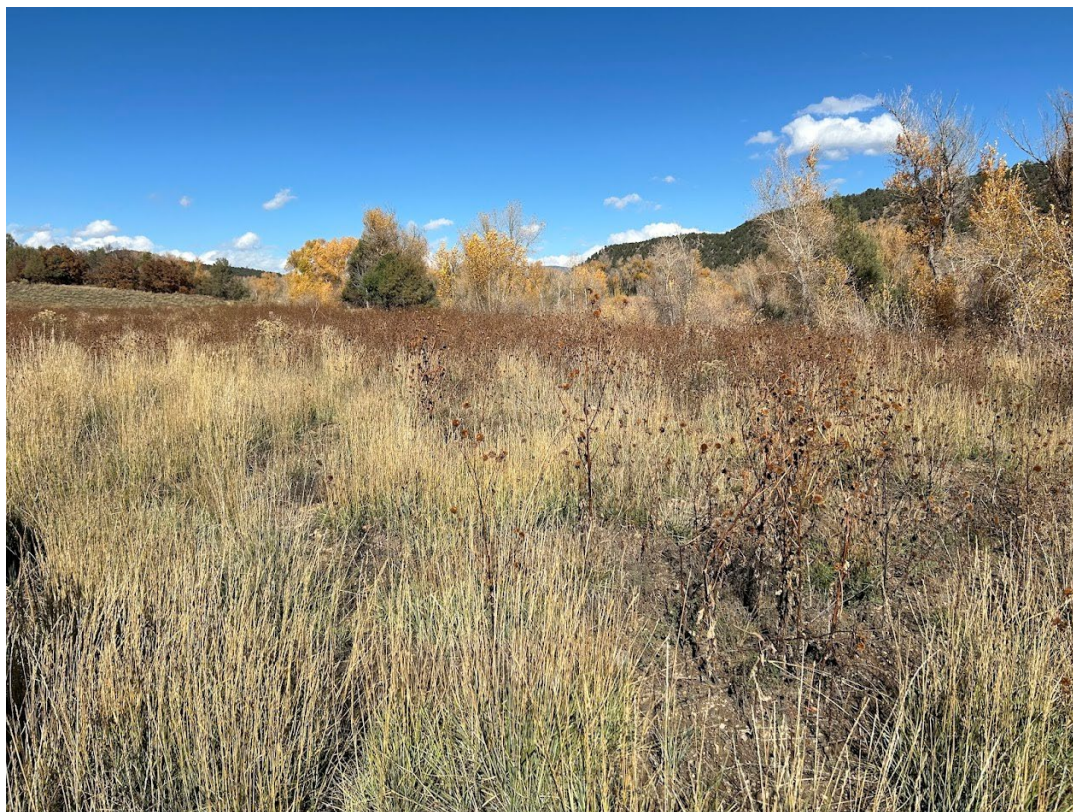
Photo 10: Vegetation within proposed release area.

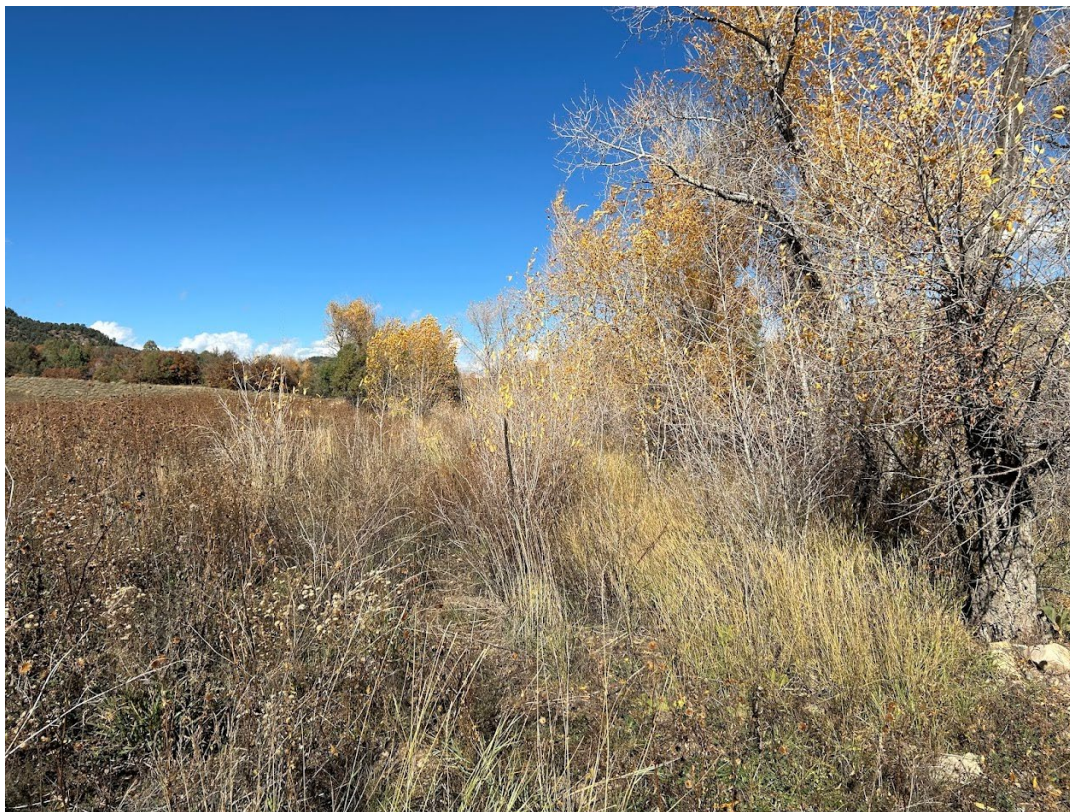
Photo 11: Buffer zone between disturbed area and undisturbed area, facing north.
