## Roadside Mine, C-1981-041, November Partial Inspection Report

<b>Permit Number:</b> C-1981-041 <b>Mine Name:</b> Roadside Portals <b>Operator:</b> Snowcap Coal Company, Inc. <b>Operator Address:</b> MS Tonya Hammond 743 Horizon Court, Suite 334 Grand Junction, CO 81506	<b>County:</b> Mesa <b>Operation Type:</b> Underground <b>Permit Status:</b> Active <b>Ownership:</b> Private
	<b>Operator Representative Present:</b>  Tonya Hammond
<b>Operator Representative Signature:</b> (Field Issuance Only)

<b>Inspection Start Date:</b> November 25, 2024 <b>Inspection Start Time:</b> 09:30 <b>Inspection End Date:</b> November 25, 2024 <b>Inspection End Time:</b> 10:00		<b>Inspection Type:</b> Coal Partial Inspection <b>Inspection Reason:</b> Normal I&E Program <b>Weather:</b> Clear	
<b>Joint Inspection Agency:</b>  None		<b>Joint Inspection Contacts:</b>  None	
<b>Post Inspection Agency:</b>  None		<b>Post Inspection Contacts:</b>  None	
<b>Inspector(s):</b>  Clayton Wein	<b>Inspector's Signature:</b>  <i>Clayton Wein</i>		<b>Signature Date:</b> 11/27/2024

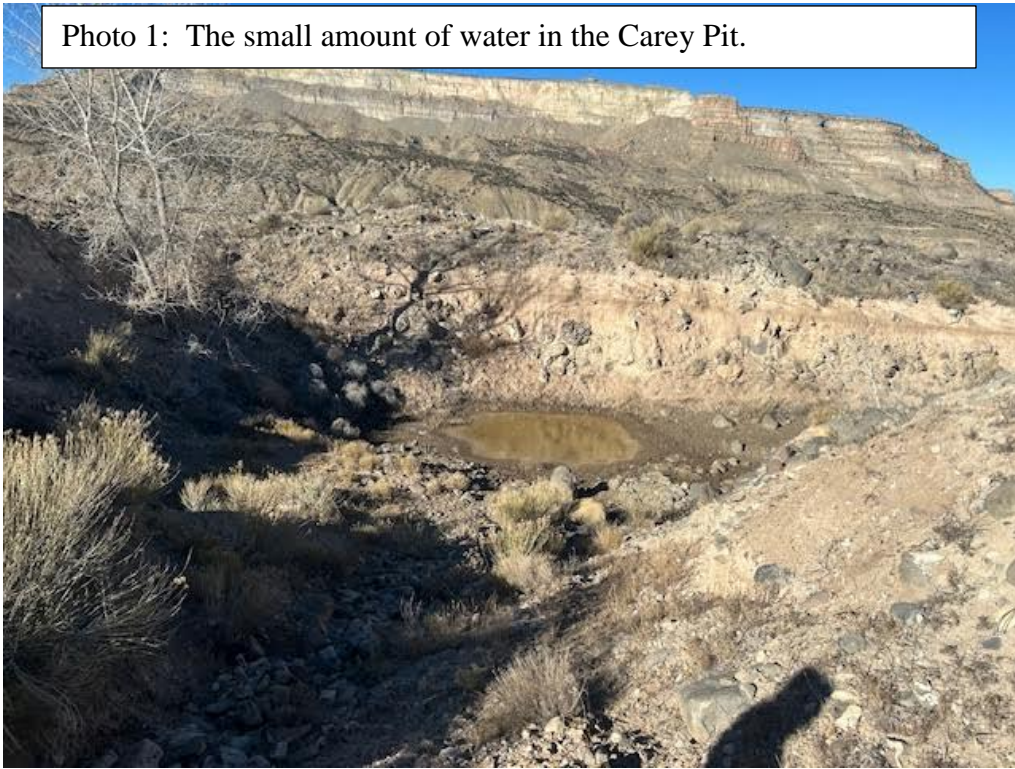
During the inspection, a small amount of water was observed in the bottom of the Carey Pit (Photo 1). The Carey Pit is owned by the landowner and located in the southwestern portion of the permit boundary. The water in the pit was left over from when the landowner cleared out their irrigation pipes for the winter. The water stored in the pit was not impacting any of SCC's remaining reclamation.

Photo 1: The small amount of water in the Carey Pit.

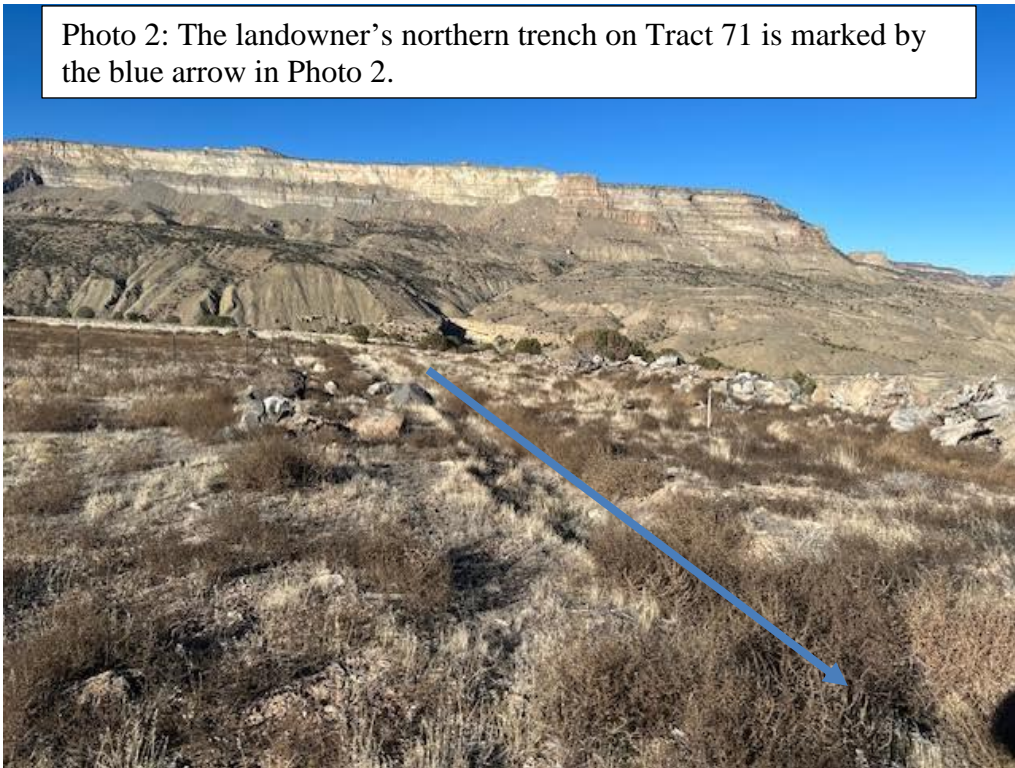
The landowner's trenches on the northern portion of Tract 71, adjacent to the TR-69 Repair Area, were observed to be dry (Photo 2). There were no indications of recent water application to the trenches.

Photo 2: The landowner's northern trench on Tract 71 is marked by the blue arrow in Photo 2.

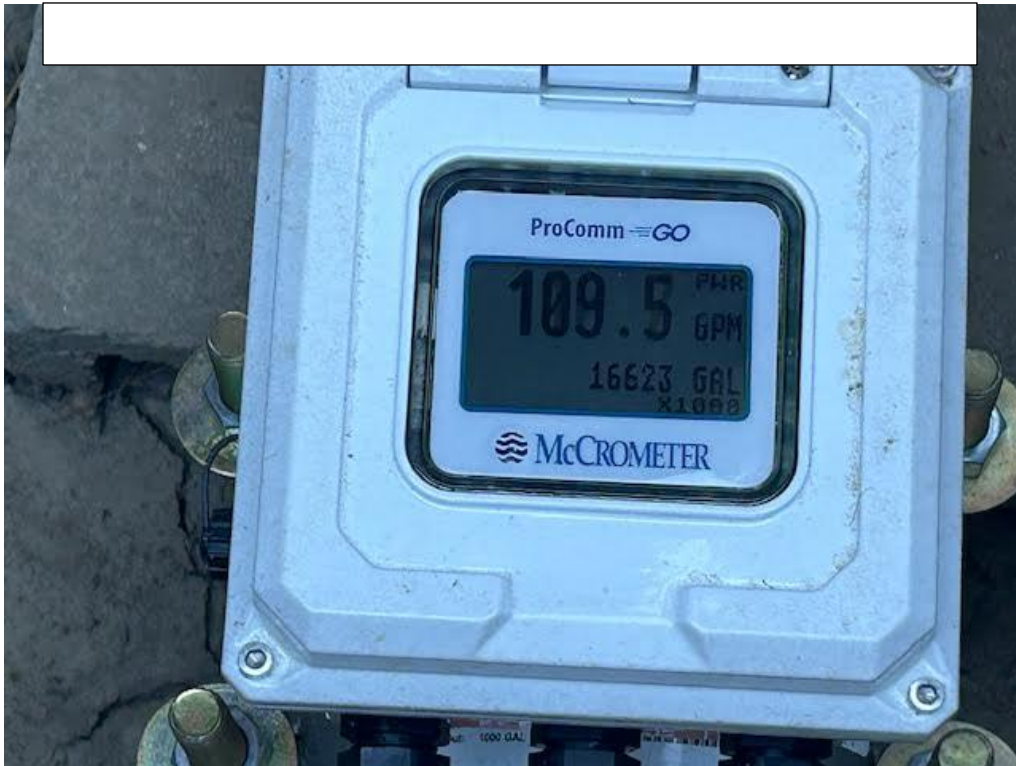
Outfall 016 is located in the northeastern portion of the permit area. During the inspection, Outfall 016 was discharging at a rate of 109.5 gallons per minute (Photo 3). The outfall was unobstructed by debris and functioning as designed.

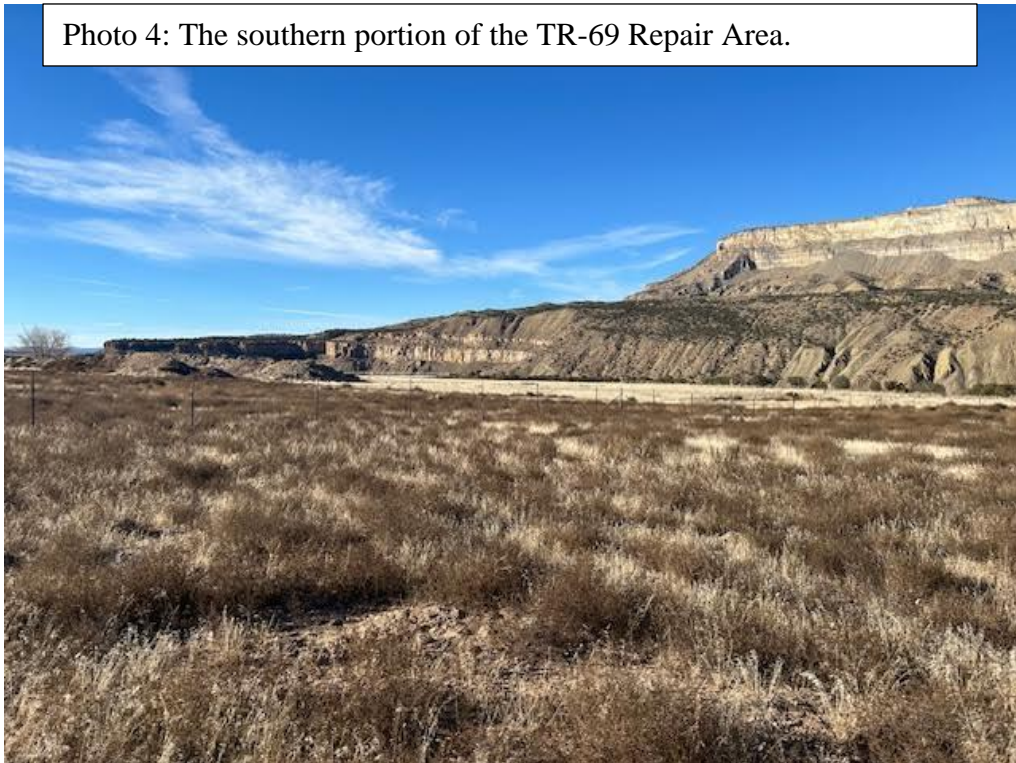
The remaining reclamation parcel at the roadside mine is located in the western portion of the permit area. The parcel is referred to as the TR-69 Repair Area. The reclaimed area is approximately 0.4 acres in size. The parcel was stable with no erosional features observed (Photos 4, 5 and 6). The straw waddles placed on the western end of the reclamation were intact and in good condition. No indications of differential settling were observed. The

Photo 4: The southern portion of the TR-69 Repair Area.

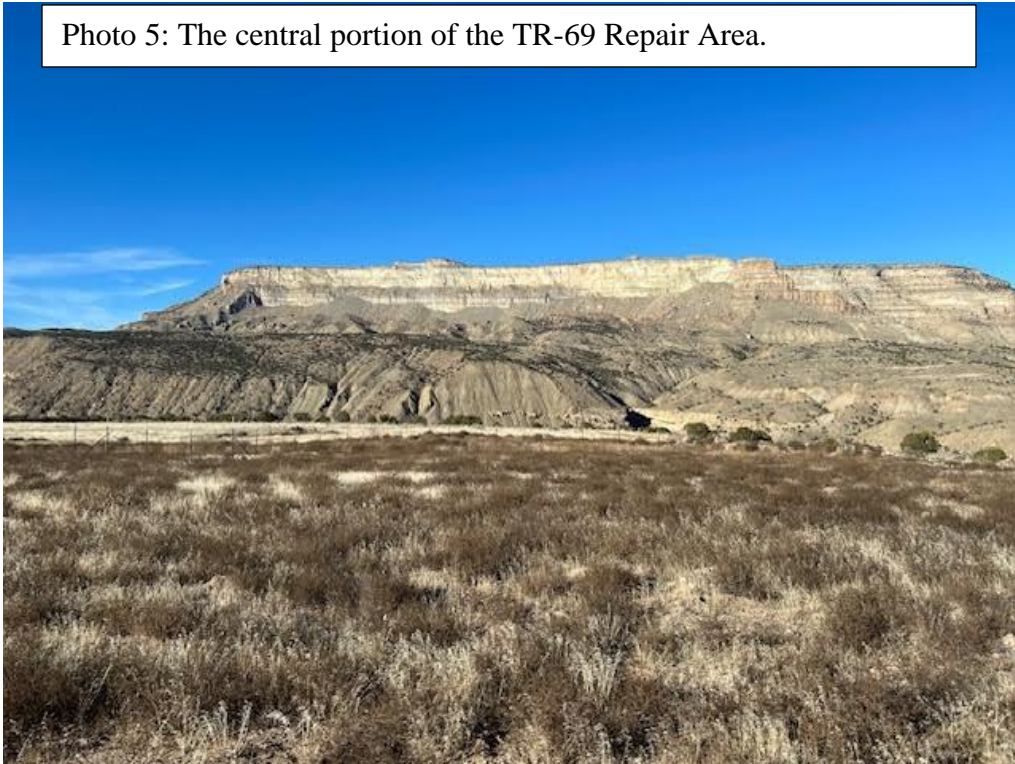
Photo 5: The central portion of the TR-69 Repair Area.

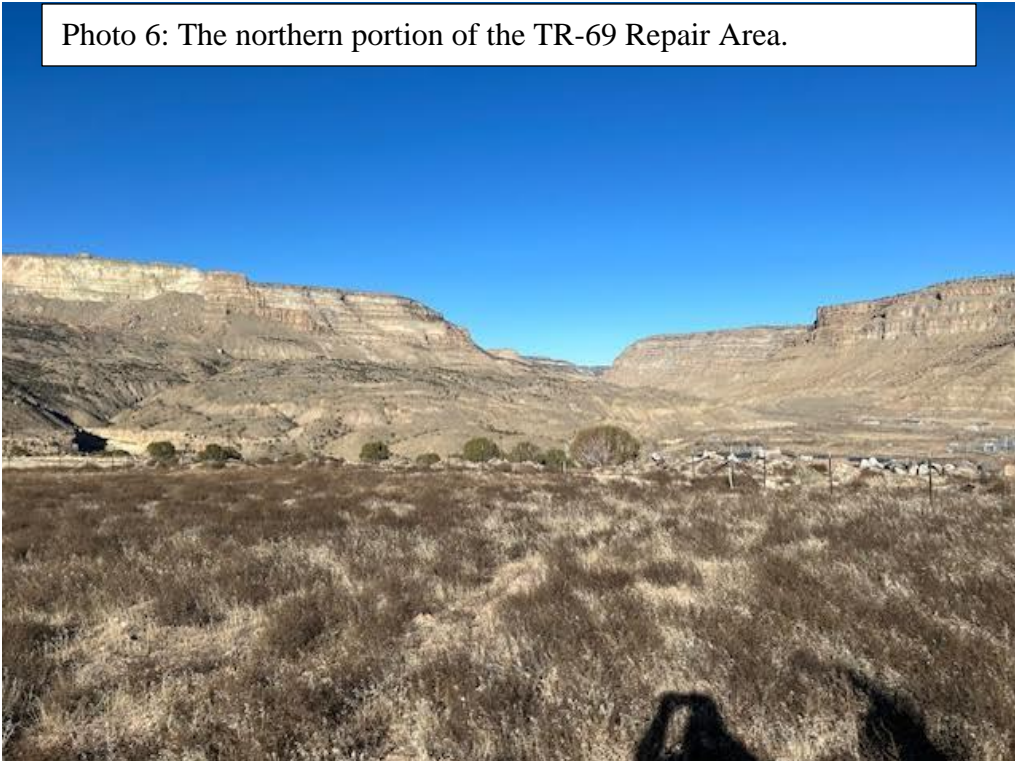
Photo 6: The northern portion of the TR-69 Repair Area.
