MINERALS PROGRAM INSPECTION REPORT
PHONE: (303) 866-3567

MINE NAME: State Line Ranch Pit	MINE/PROSPECTING ID#: M-2000-040	MINERAL: Aggregate	COUNTY: Jackson
INSPECTION TYPE: Monitoring	WEATHER: Windy	INSP. DATE: November 19, 2024	INSP. TIME: 10:30
OPERATOR: Medicine Bow - Routt National Forest USDA Service	OPERATOR REPRESENTATIVE: Nate Davis	TYPE OF OPERATION: 110c - Construction Limited Impact	
REASON FOR INSPECTION: Normal I&E Program	BOND CALCULATION TYPE: None	BOND AMOUNT: \$0.00	
DATE OF COMPLAINT: NA	POST INSP. CONTACTS: None	JOINT INSP. AGENCY: None	
INSPECTOR(S): Brock Bowles	INSPECTOR'S SIGNATURE:

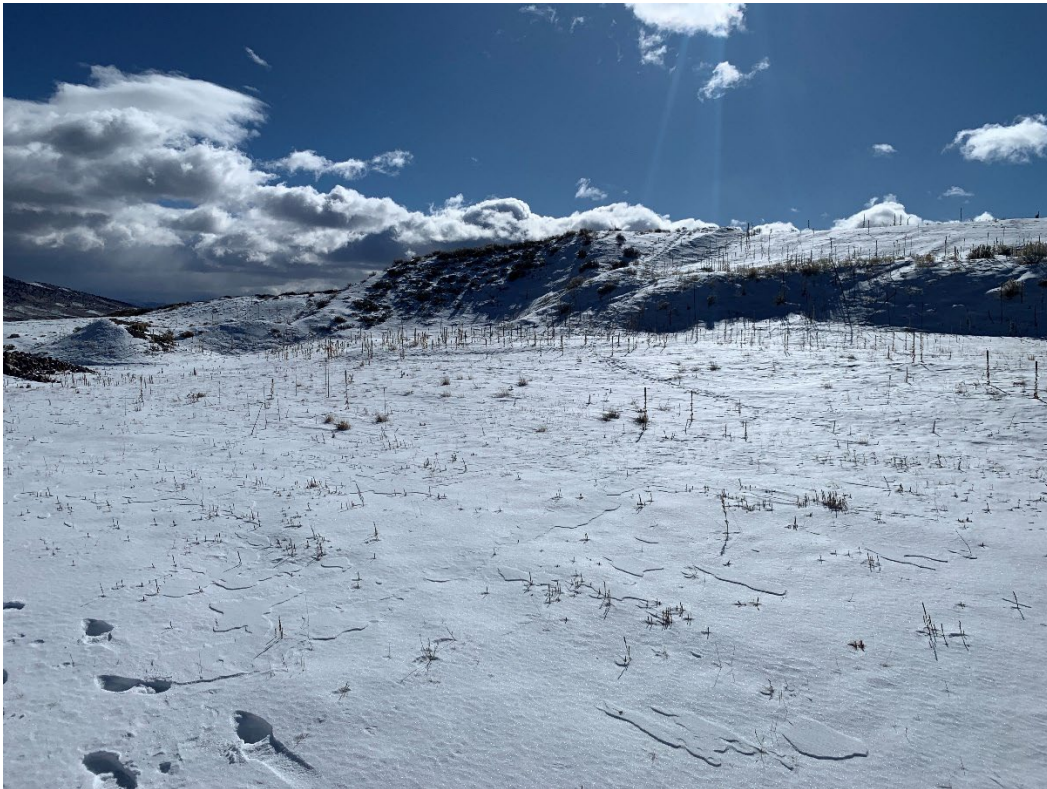
The land around the mine is sloped to the north. The pit highwall is on the south side of the pit and will need to be reshaped to a 3h:1v slope or less (photo 1). Ideally the graded pit will blend in with the surrounding landscape.

Several dead mullein plants were seen on the pit floor area (photos 1 & 2). Mullein is a C-listed Colorado noxious weed. Care should be taken to ensure the plant stalks, and any soil with the potential to have a seed bank are buried beneath the backfill to prevent the spreading of the seeds.

Photo 1- Pit floor and highwall, facing southeast

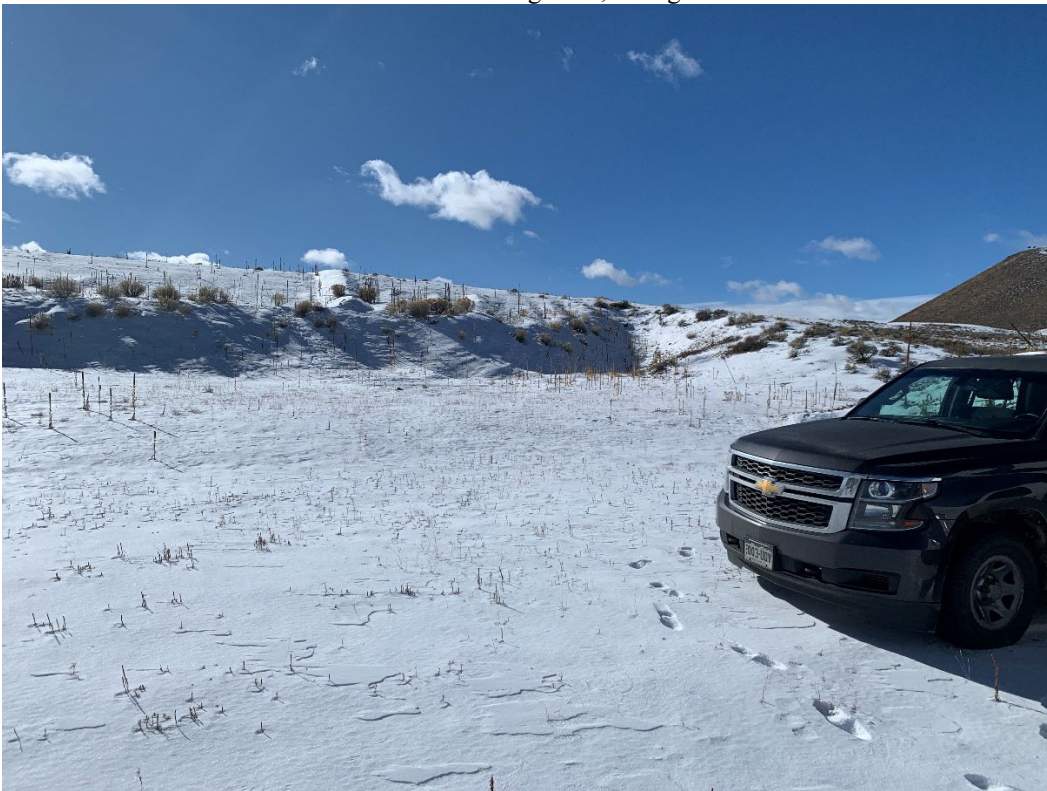
The pit floor is gently sloped to the north and is generally flat. No signs of water impoundment were seen on the site (photo 2).

Photo 2- Southwest corner of pit area. Pit floor currently drains to the north.

The final grading should ensure water is not impounded on the site and directs sheet-water flows to the natural drainages around the site.

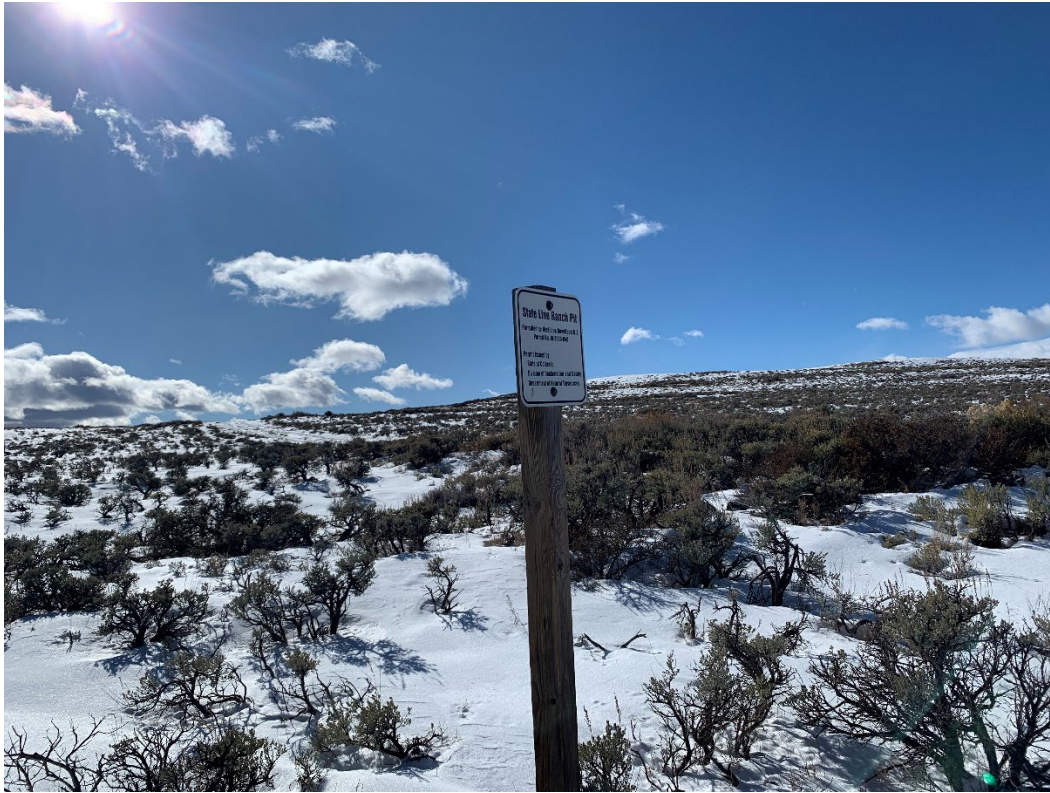
The mine entrance sign was in place along the access road to the pit (photo 3). The sign faces the ranch road which parallels the western permit boundary.

Photo 3- Mine entrance sign facing ranch road on west side of pit area.
