MINERALS PROGRAM INSPECTION REPORT
PHONE: (303) 866-3567

MINE NAME: Henderson Mine	MINE/PROSPECTING ID#: M-1977-342	MINERAL: Molybdenum	COUNTY: Clear Creek, Grand
INSPECTION TYPE: Monitoring	WEATHER: Clear	INSP. DATE: November 7, 2024	INSP. TIME: 11:30
OPERATOR: Climax Molybdenum Company	OPERATOR REPRESENTATIVE: Ron Hickman, Ben Bates	TYPE OF OPERATION: 112d-3 - Designated Mining Operation	
REASON FOR INSPECTION: Normal I&E Program	BOND CALCULATION TYPE:	BOND AMOUNT: \$167,995,252.00	
DATE OF COMPLAINT: NA	POST INSP. CONTACTS: None	JOINT INSP. AGENCY: None	
INSPECTOR(S): Joel Renfro	INSPECTOR'S SIGNATURE:

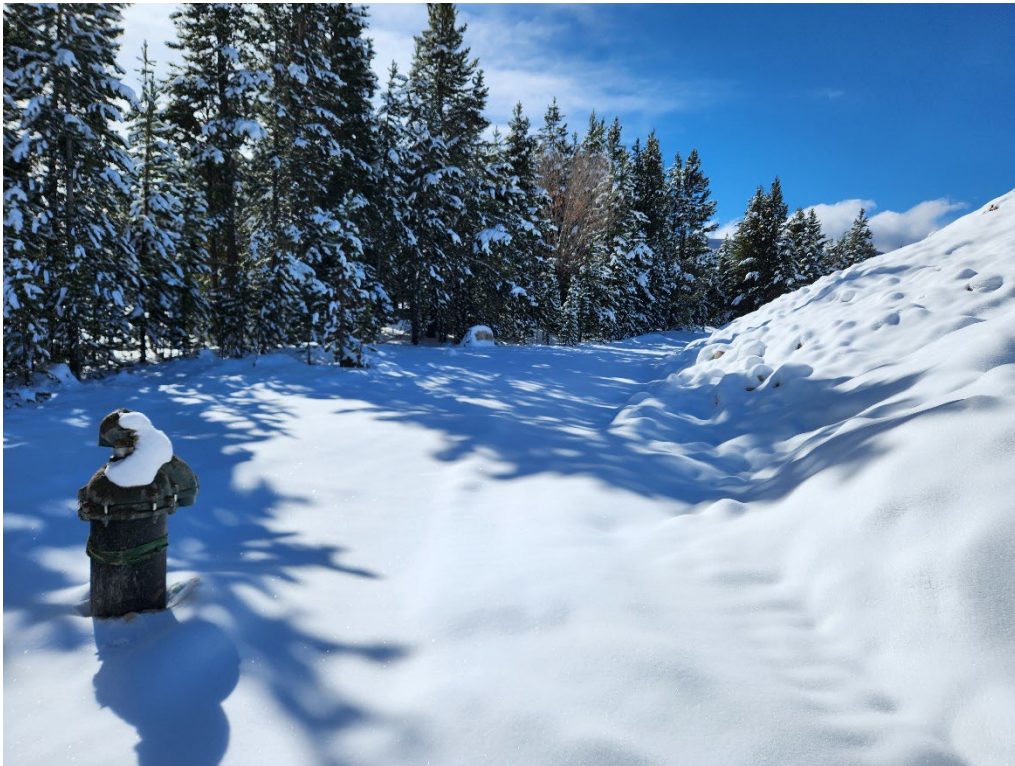
It was noted in the September 25, 2024 inspection report that a drill rig was on-site for the installation of MLEX-6. Both wells have been installed since then. These wells were added in TR-36, which was approved on September 5, 2024, as a part of the Phase IV upgrade to the Ute Park Extraction Wellfield. MLEX-6 has been drilled and installed inside the Ute Park, just east of the MLEX-3, 4, and 5. MLEX-7 has been drilled and installed inside the gravel pit located east of County Road 3. The caps of each well were visible, even through the snow.

Photo 1. Cap of MLEX-7, looking south.

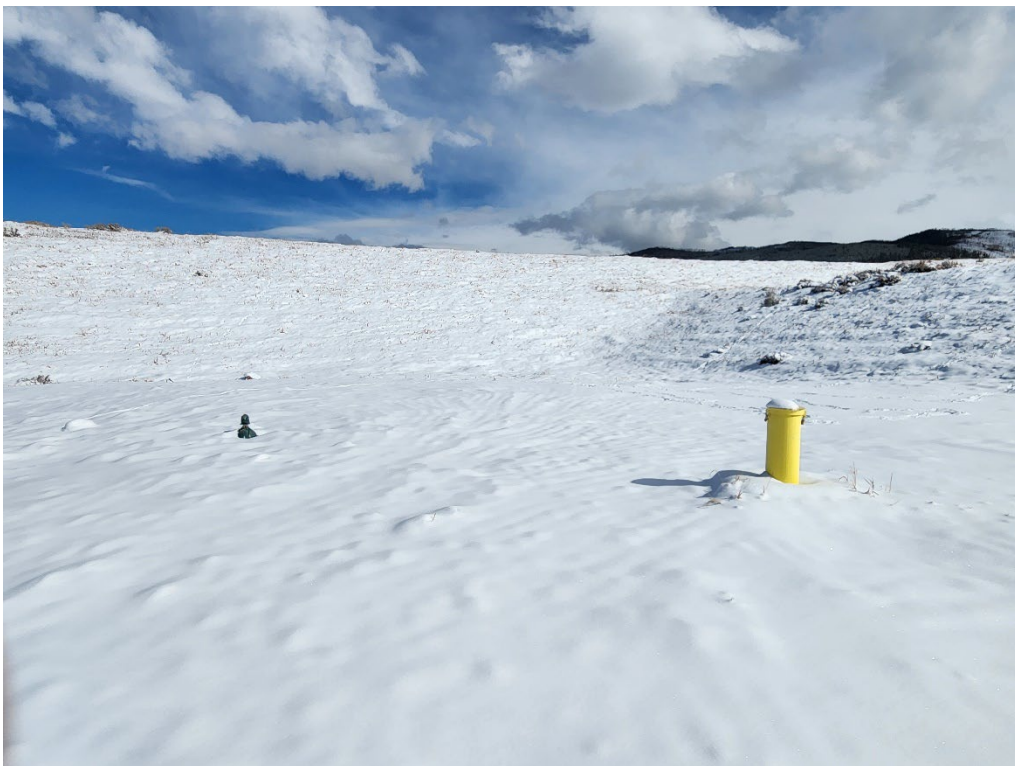
Photo 2. The cap of MLEX-6 to the left, looking east.

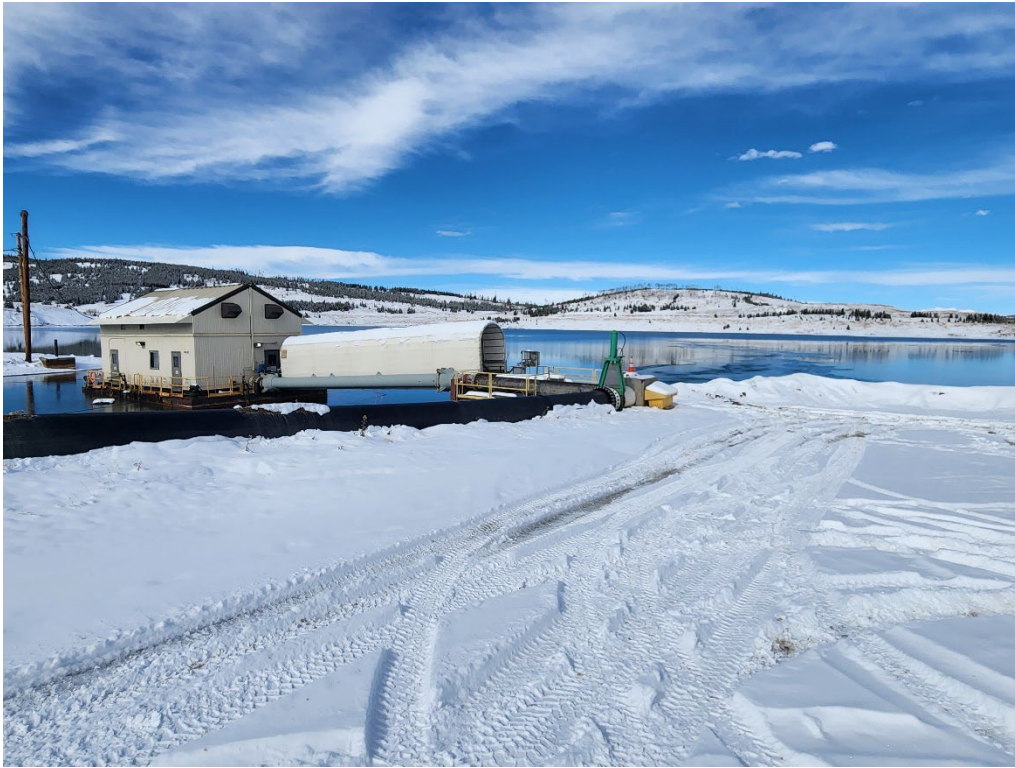
The pipeline was followed from the barge to the East Branch Reservoir. Most of the pipeline is underground, but key support features that are above ground were documented during this inspection. Water is pumped from the barge until it reaches a high point, which is marked above ground with the vacuum vault. After that point, the water moves through the rest of the pipeline using gravity until it's discharged into the East Branch Reservoir. Water is discharged into the reservoir from the south. There are diversions around the reservoir that lead to a pipeline to keep water away from the East Branch, which reduces runoff leading into the reservoir and preserves the tailings dam to reservoir closed loop water system.

Photo 3. Barge, looking northeast.

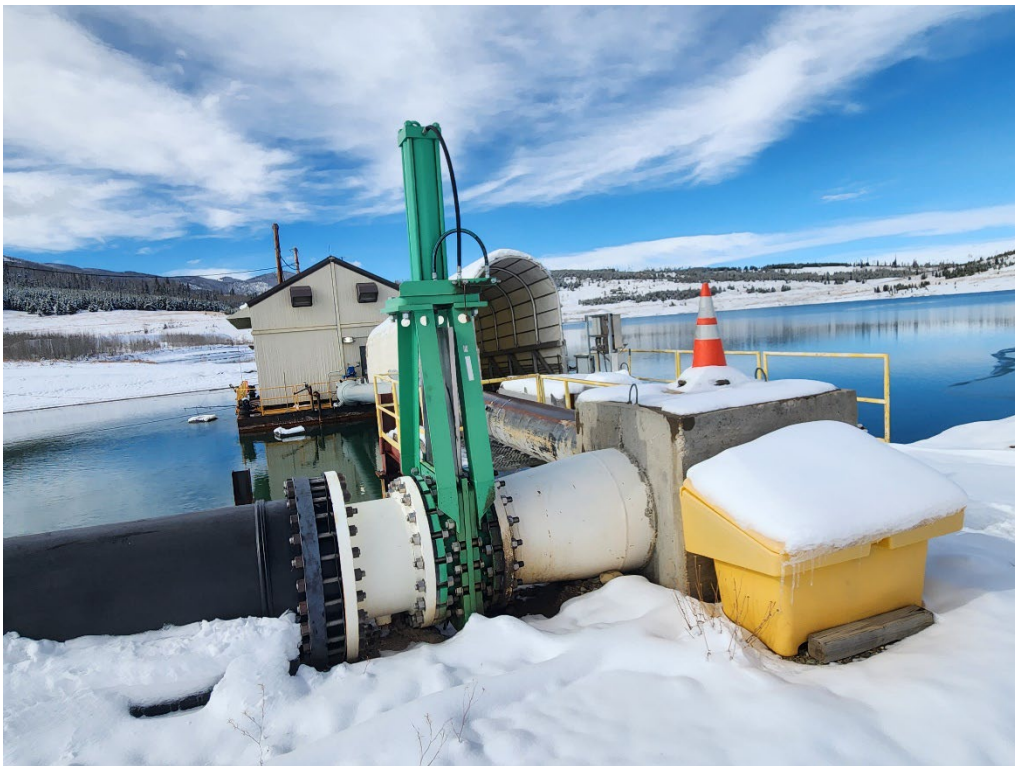
Photo 4. Beginning of the return pipeline from the barge, looking north.

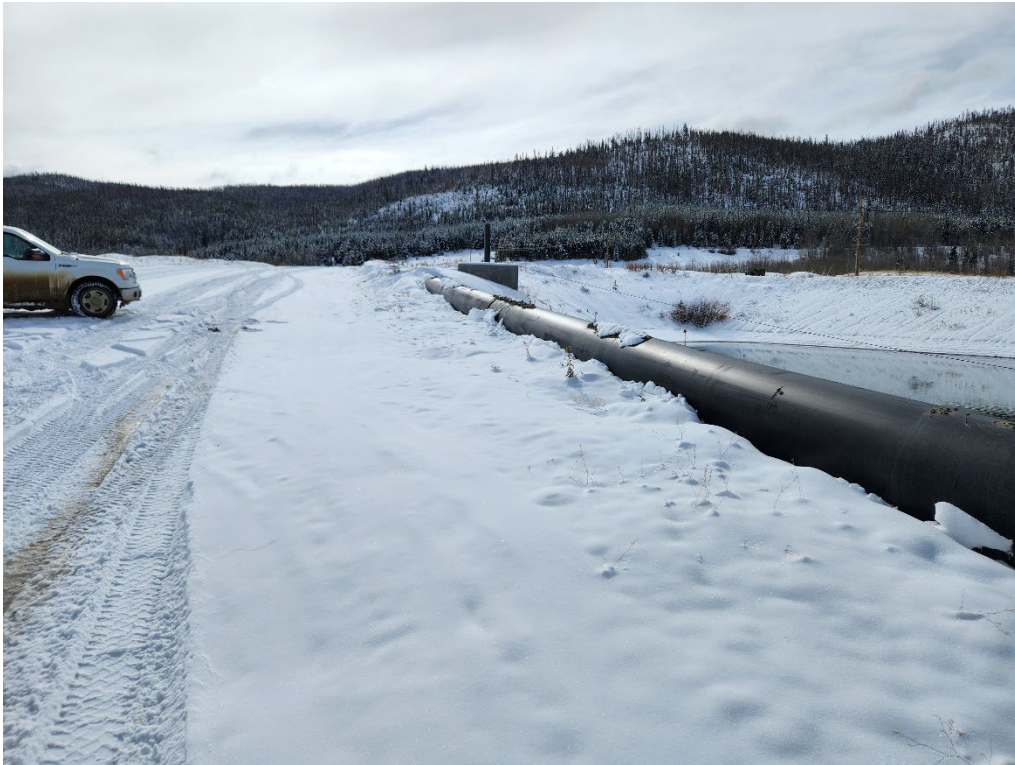
Photo 5. The return pipeline, which is above ground here but moves underground at the end of this image, looking west.

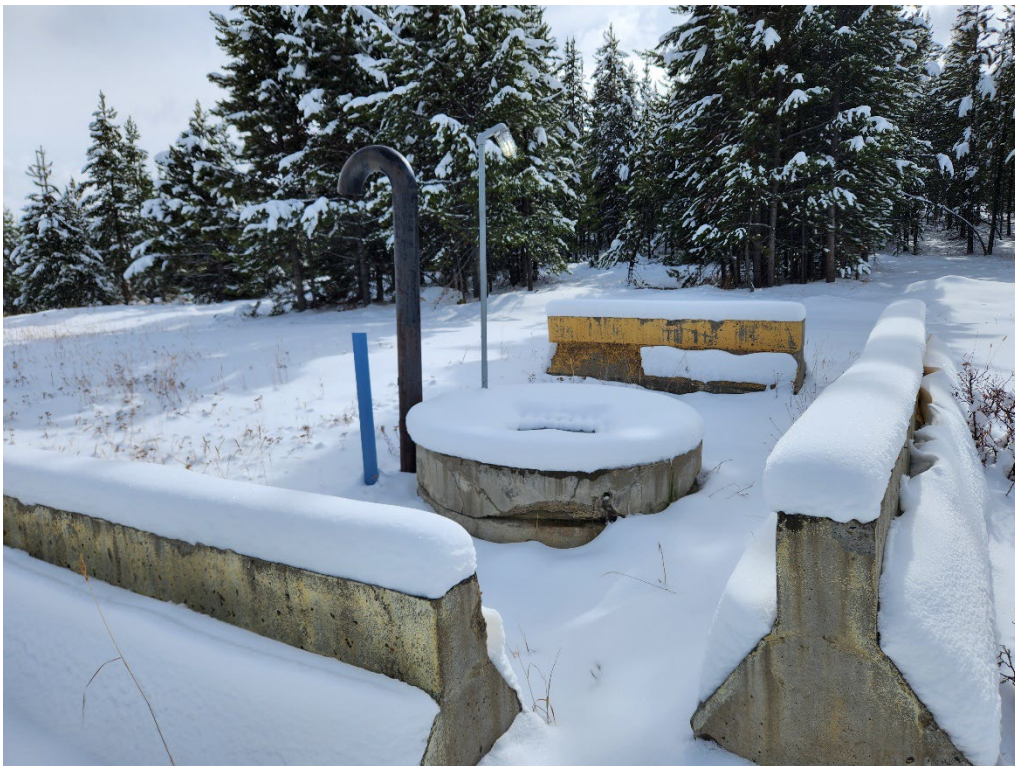
Photo 6. The vacuum vault is located above the peak of the pipeline, looking south.

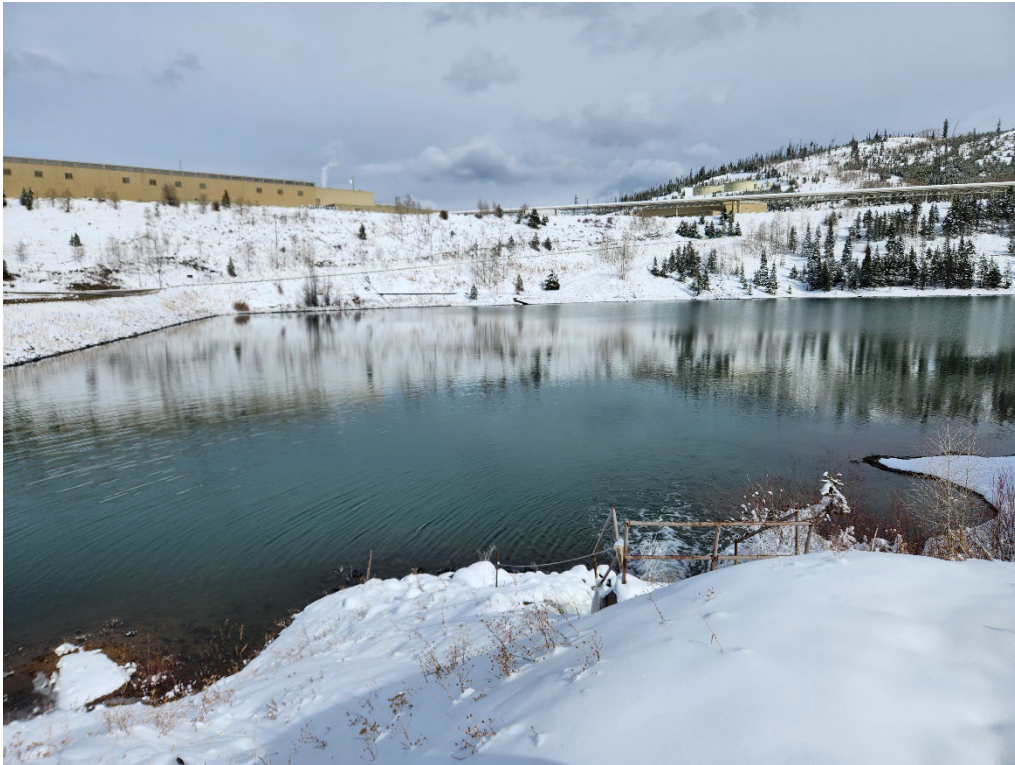
Photo 7. East Branch Reservoir, standing on top of the water discharge point looking east.

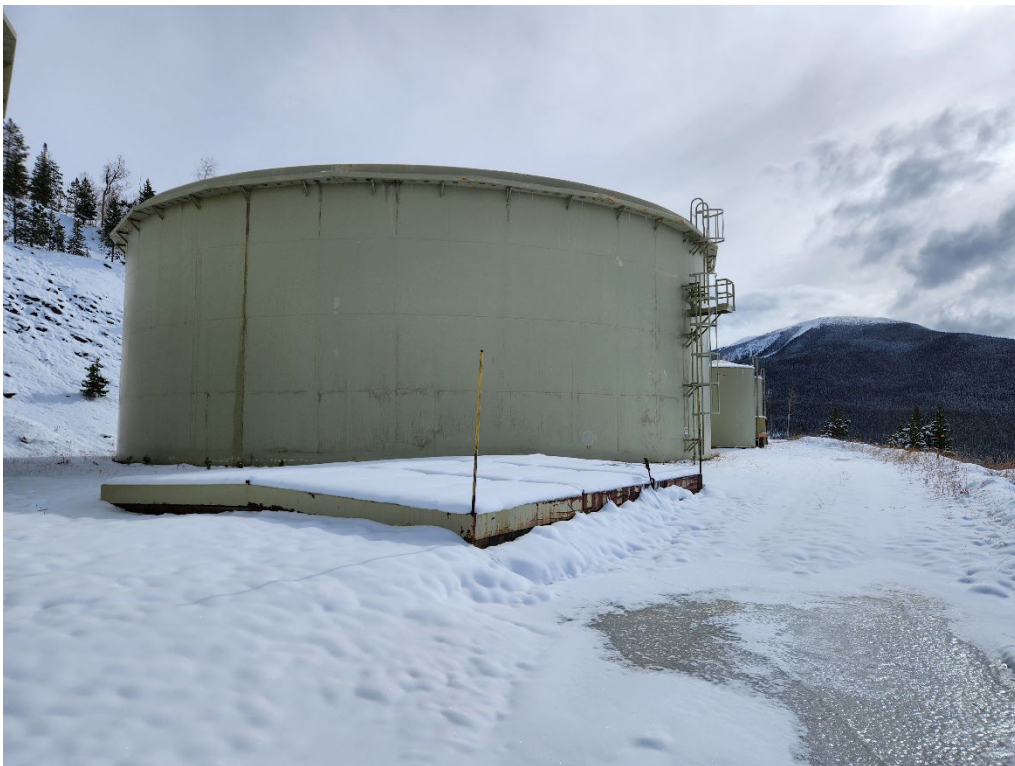
There are two large storage tanks and two smaller ones north of the Mill facilities. The larger tanks store water that is used in the Mill processes and the smaller tanks store water that is used for showers, sinks, etc. These tanks are drained and inspected every few years by Henderson staff to check for any issues such as leaks or tears in the lining.

Photo 8. Water tanks located east of the mill, looking south.

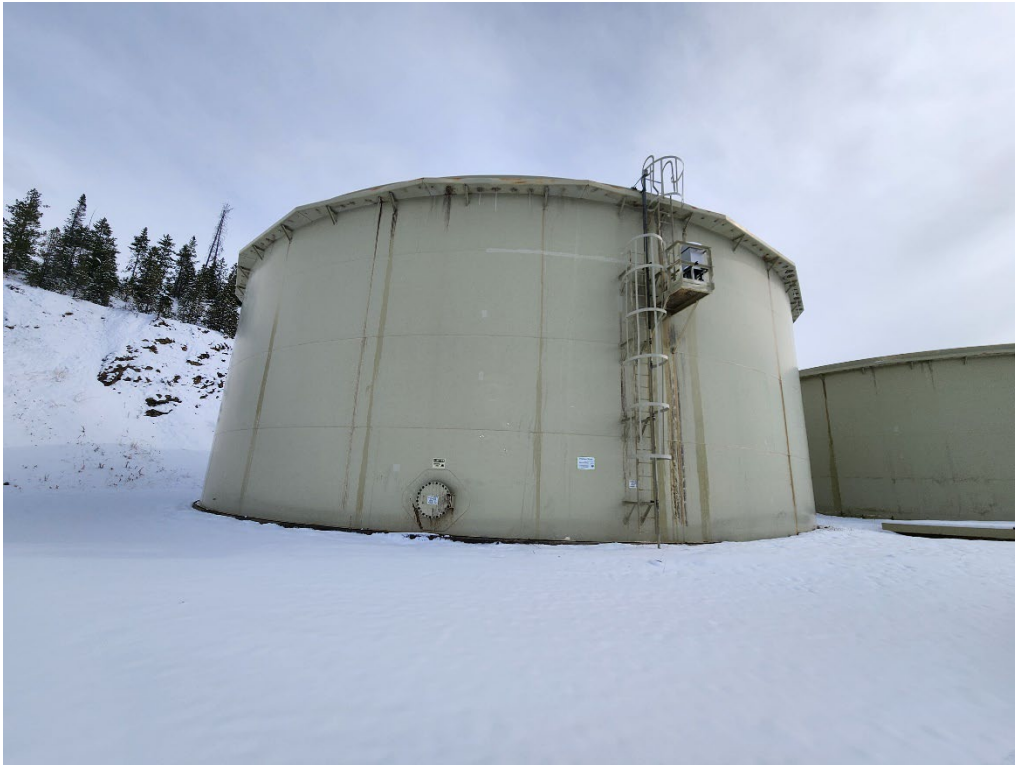
Photo 9. Water tanks located east of the mill, looking east.

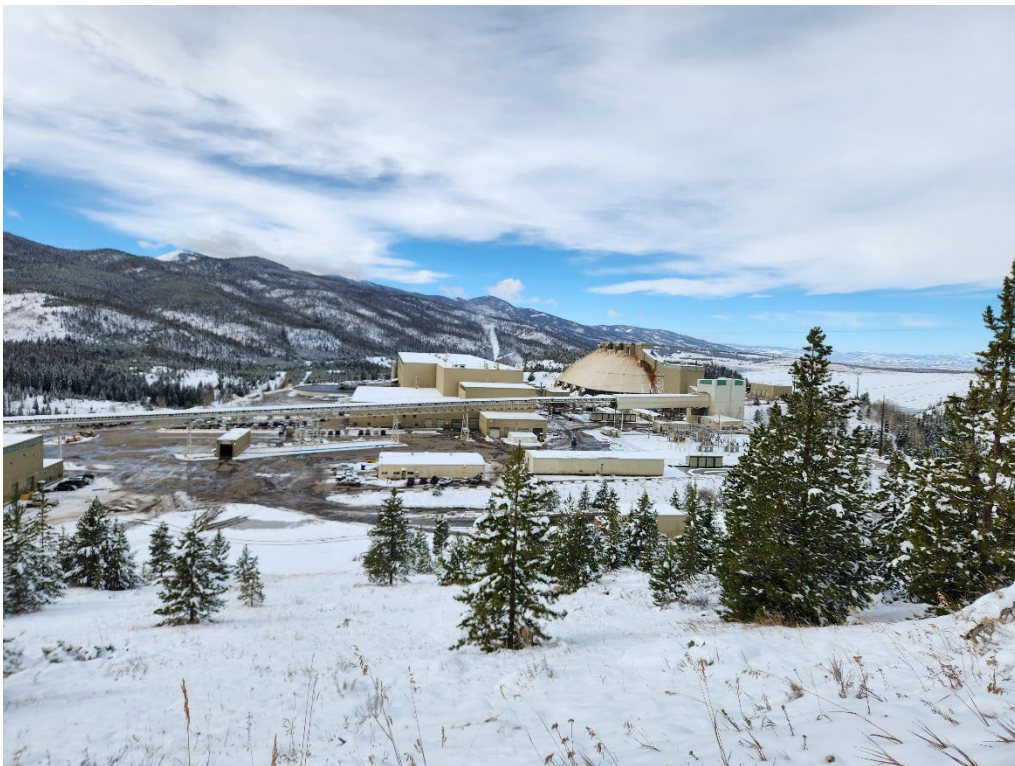
Photo 10. Henderson Mill, looking west.
