MINERALS PROGRAM INSPECTION REPORT
PHONE: (303) 866-3567

MINE NAME: Colony Shale Oil Project	MINE/PROSPECTING ID#: M-1980-047	MINERAL: Oil shale	COUNTY: Garfield
INSPECTION TYPE: Monitoring	WEATHER: Snowing	INSP. DATE: November 18, 2024	INSP. TIME: 09:00
OPERATOR: Caerus Cross Timbers LLC	OPERATOR REPRESENTATIVE: Ed Seymour	TYPE OF OPERATION: 112 - Hard Rock Regular Operation	
REASON FOR INSPECTION: High Priority	BOND CALCULATION TYPE: None	BOND AMOUNT: \$9,500,00.00	
DATE OF COMPLAINT: NA	POST INSP. CONTACTS: None	JOINT INSP. AGENCY: None	
INSPECTOR(S): Amy Yeldell	INSPECTOR'S SIGNATURE:

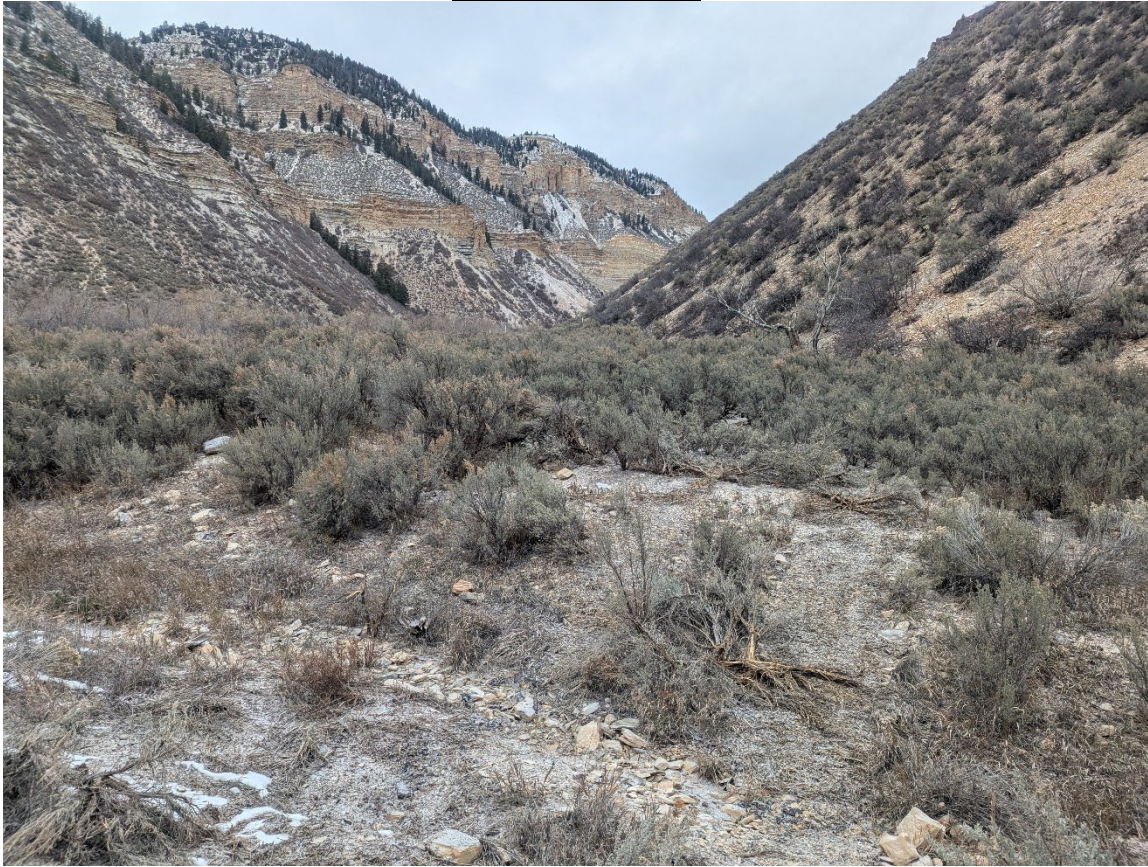
*Area 4 Alternate access road. The road area is self-reclaimed and only identifiable by white PVC posts delineating affected lands. Vegetation consists of mature sage and perennial grasses. The gate and jersey barrier have been removed since the previous inspection. This portion of Area 4 is eligible for release.

Area 4a gate and jersey barriers removed

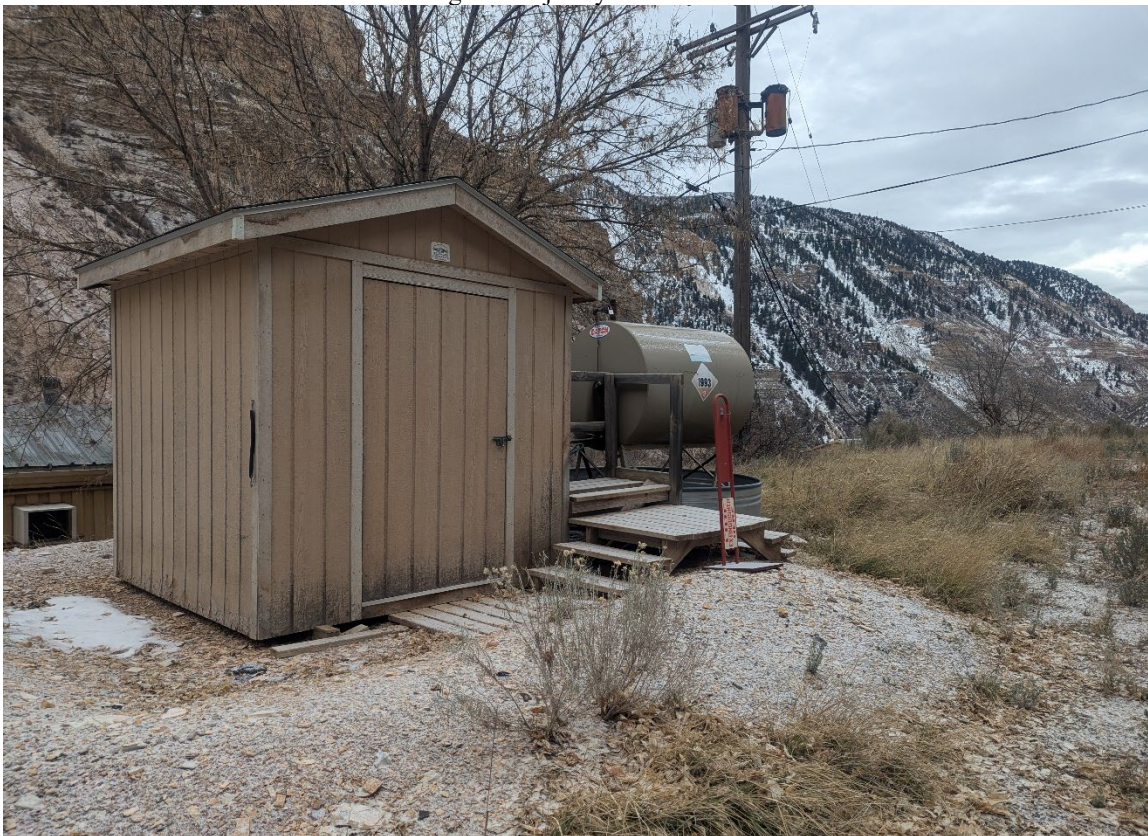
There are also several single electrical poles and wire connecting Area 4 and 5. This power is not tied into the power grid (Excel) and will be removed.

Several pole mounted transformers were observed. These items shall be properly disposed of when removing electrical utilities.

Generator building to stay, transformers on electrical poles to be removed

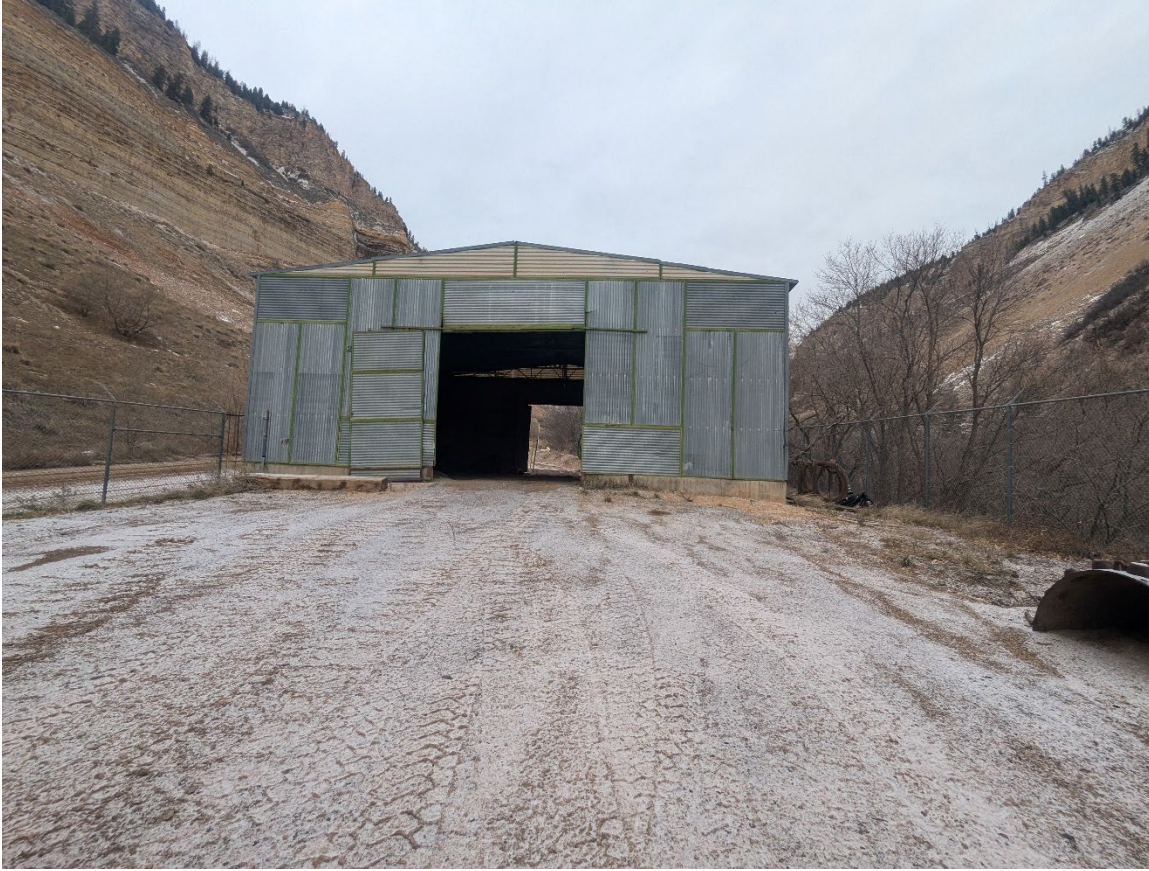
Area 5 Upper Building Area. There are three larger buildings/ shops located in this area. Additionally, there is a smaller yellow generator building and 1000-gallon propane tank. All three of the buildings are currently in use to store road maintenance equipment. Under TR-18 these features are proposed to remain. Only the overhead electrical utility will be removed.

Area 5 buildings remain for road maintenance

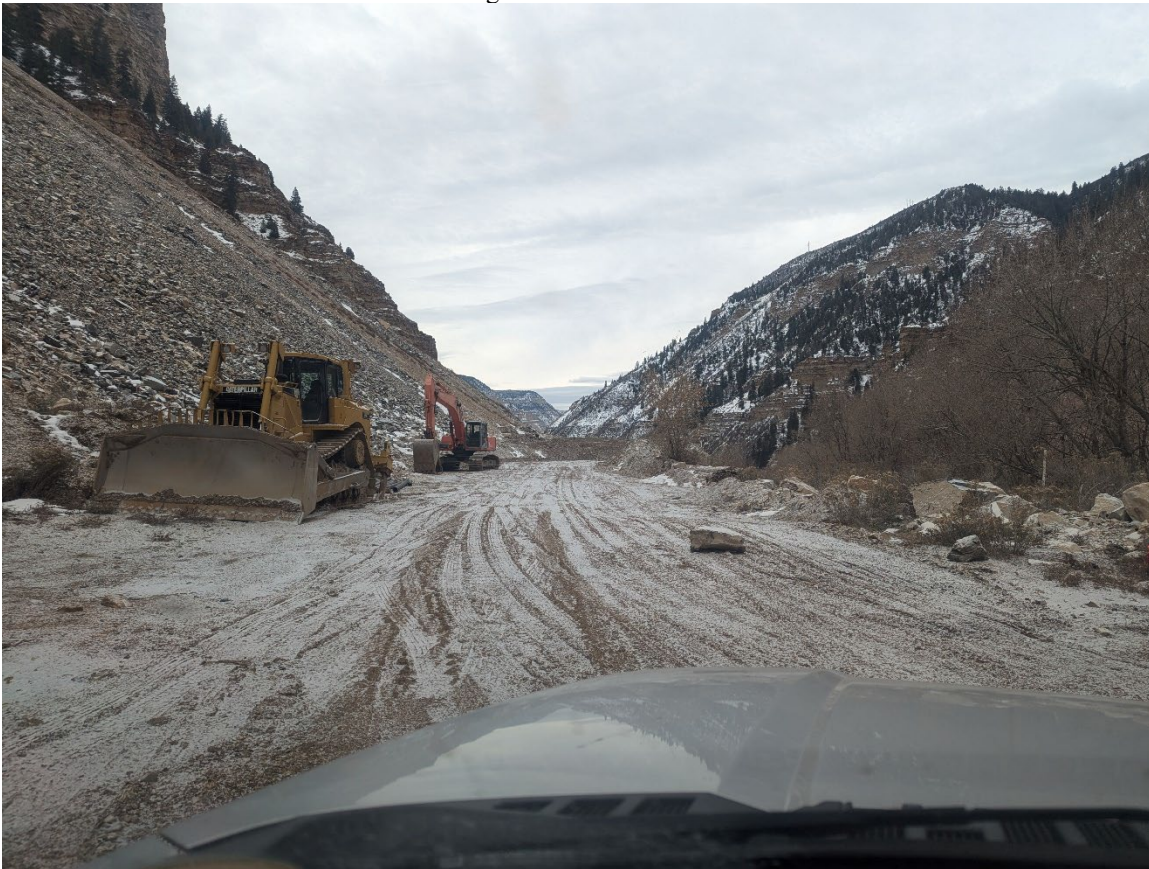
Area 5 Pullout. The norther portion of area 5 is a pull out just before the mine bench. The large white empty tank has been removed. Equipment was located on site and Initial civil work and contouring has begun.

Civil work has begun on Upper 5

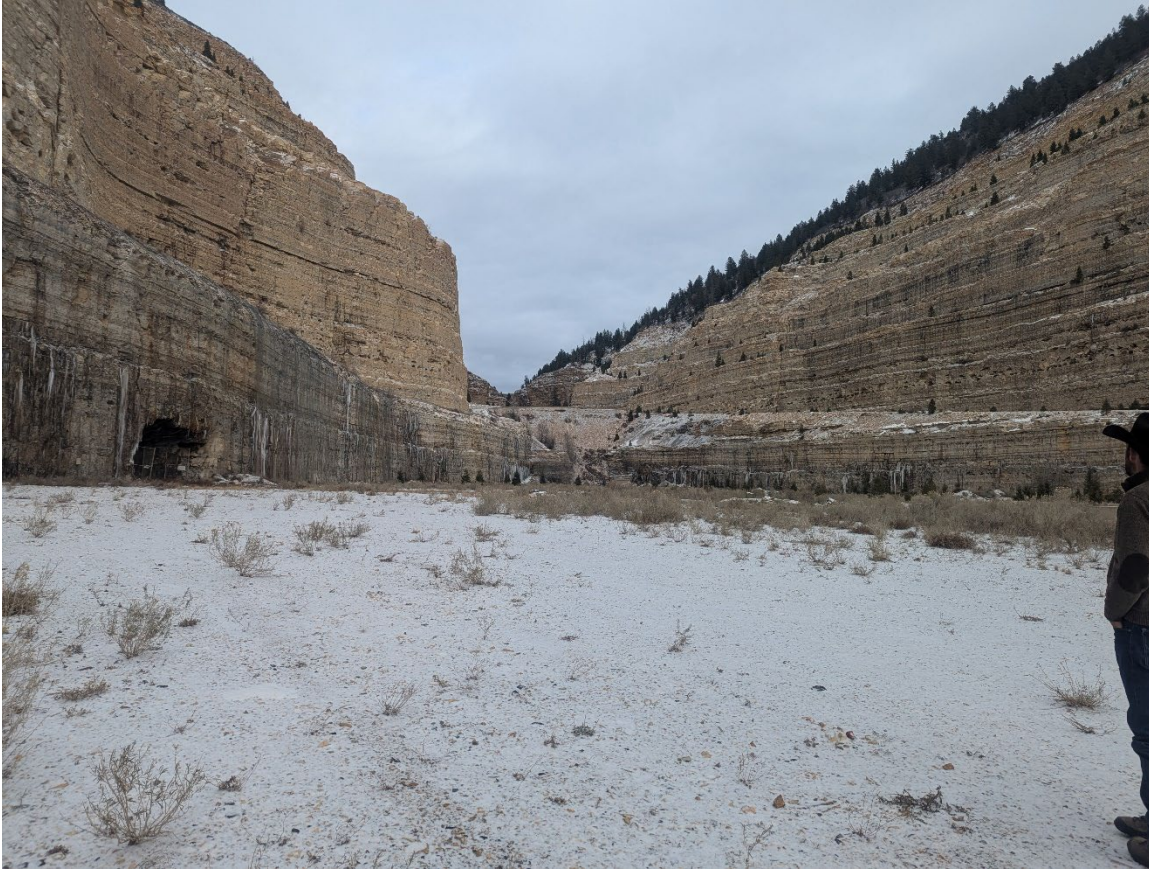
6B Upper - Mine Bench. Removal of the 6ft steel culvert is impractical and the mine bench and road will likely remain. Ensure that sufficient documentation is provided to support the proposed post-mining land configuration of the mine bench and pipped creek. This includes but is not limited to NDE testing of the steel pipe to assuage concerns of potential collapsing and subsidence. Closure methods have been proposed and were selected from the IMP Bid Spec Book for the portal closures and ventilation shaft.

Upper 6 no changes to mine bench to date.

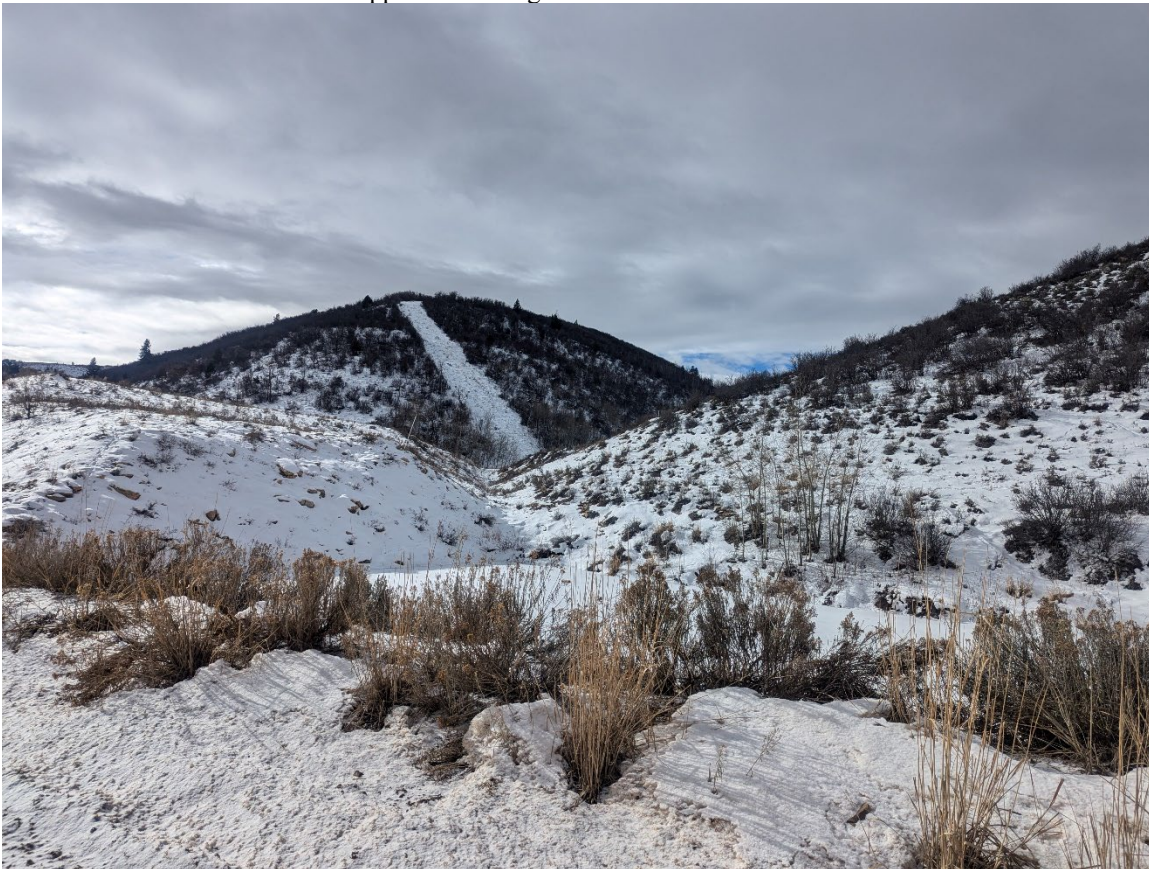
Area 10B. This area is largely self-reclaimed and mostly comprised of perennial grasses. The slope, though steeper than a 3H:1V are stable and well established. Some minor grading will be required where area 15B intersects 10B. There is also an abandoned well (pipe) in the rip-rap spillway area.

Contouring and blending necessary on 10B to 15B

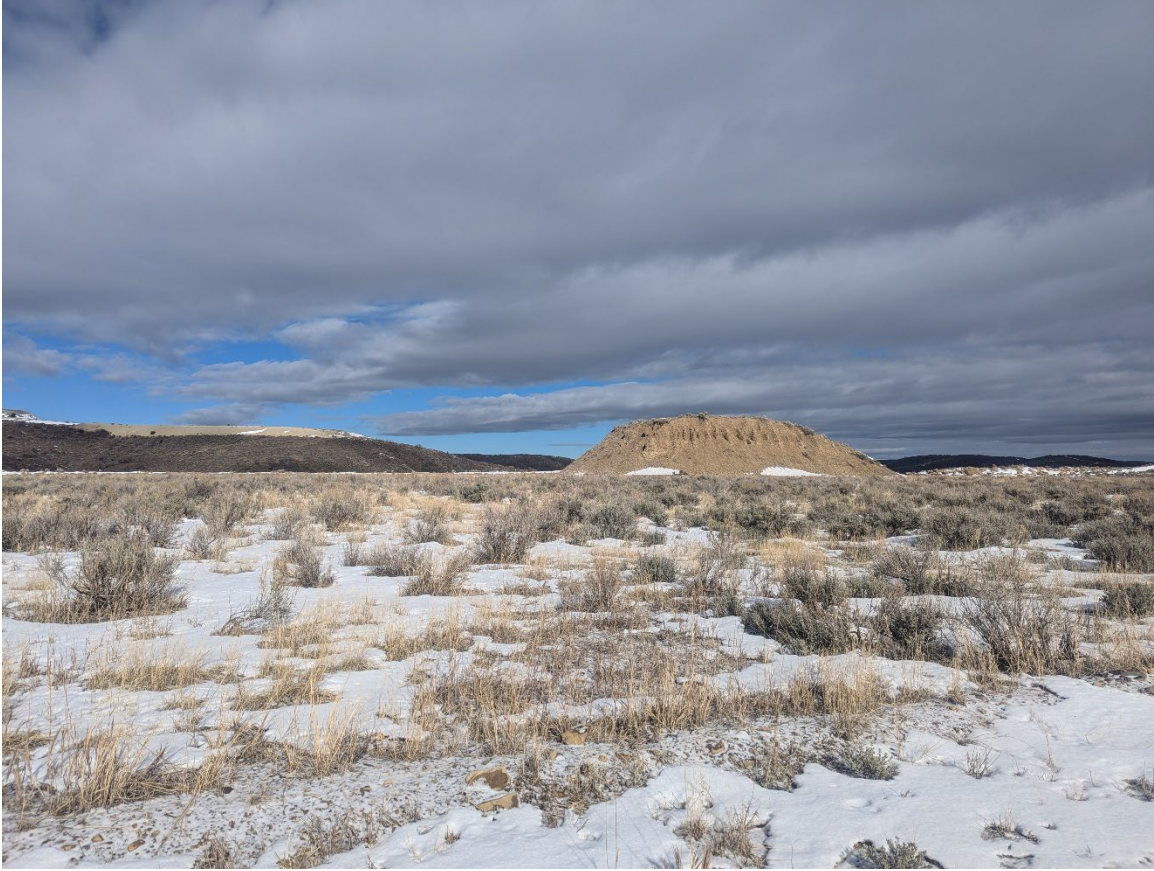
Area 18D, E and F North Valley Fill. There is an upper and lower haul road associated with this area that will need to be reclaimed. The majority of the northwest side of this area is cut/fill general dozing. The northeast edge of disturbance will likely need to be pulled back. Areas 18E and F have lots of random highwalls and pits that will need general shaping. There is one large overburden pile located within this pad. A foundation is also located on the west side below the back haul road. The entire pad area will need to be decompacted and topsoiled prior to revegetation.

Area 18-Load carry stockpile for blending to avoid damaging existing vegetation.
