Inspection Report, Colowyo, C-1981-019

PERMIT INFORMATION

INSPECTION INFORMATION

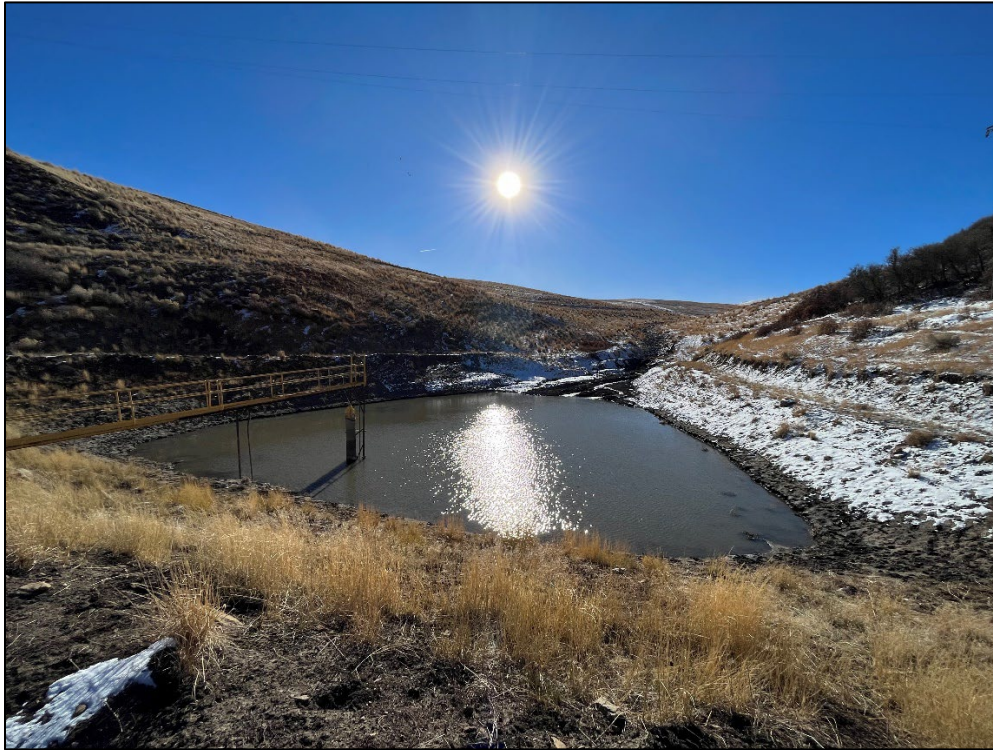
Photo 1: View south of East Taylor Pond.

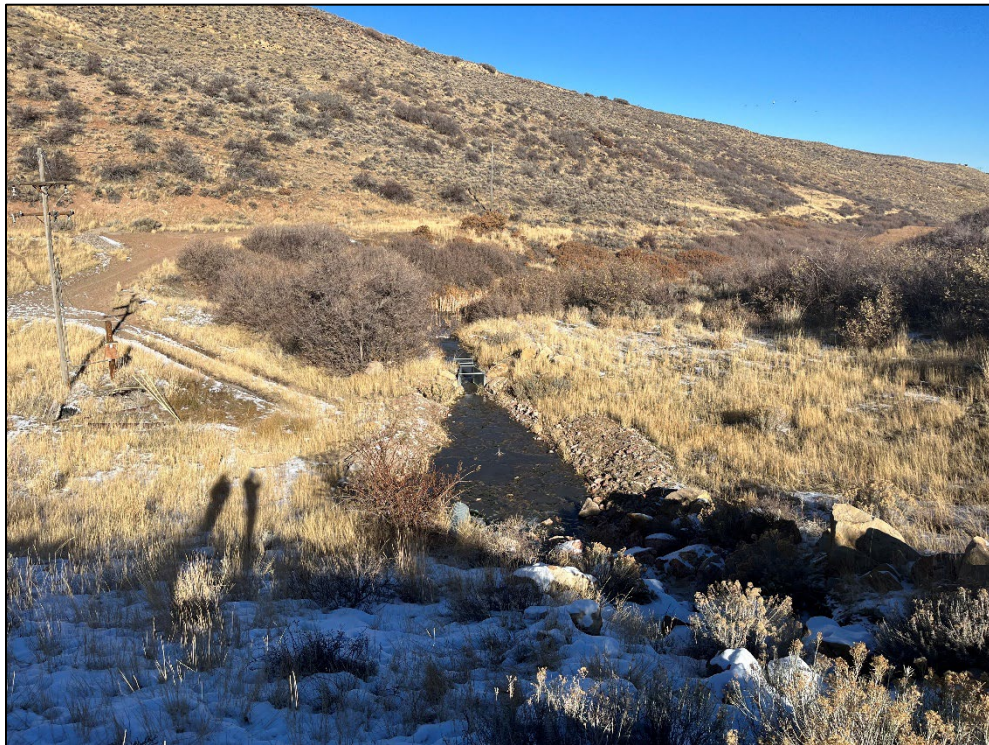
Photo 2: View north of the discharge flume at East Taylor Pond.

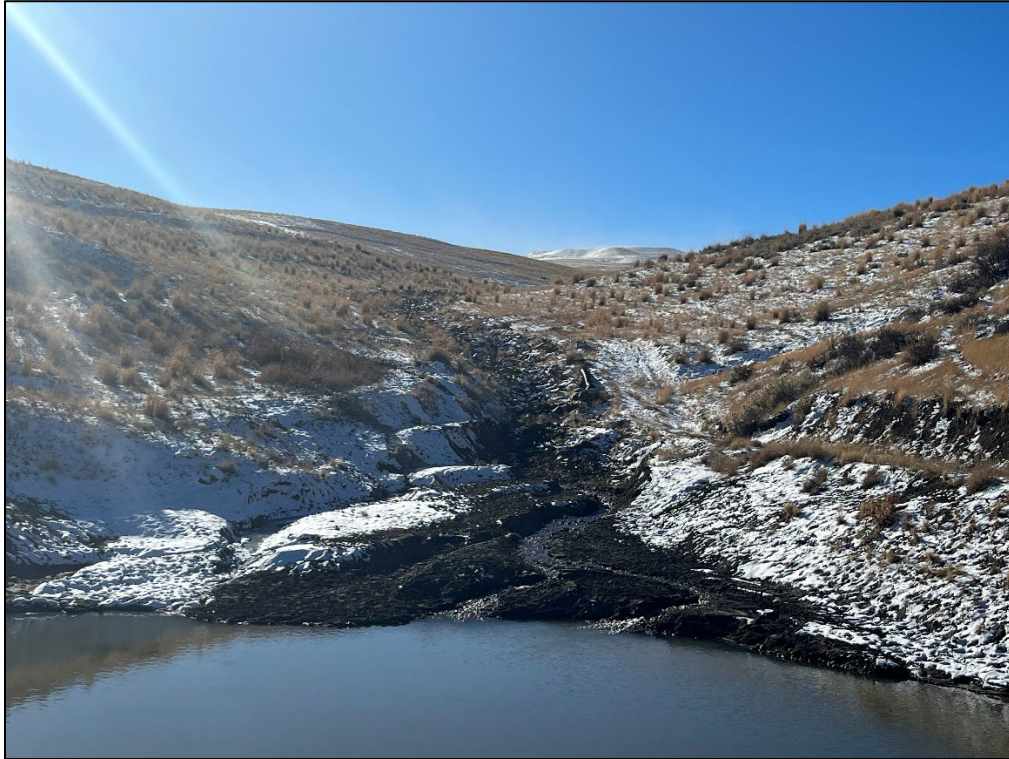
Photo 3: View of the seep area at the East Taylor Pond.

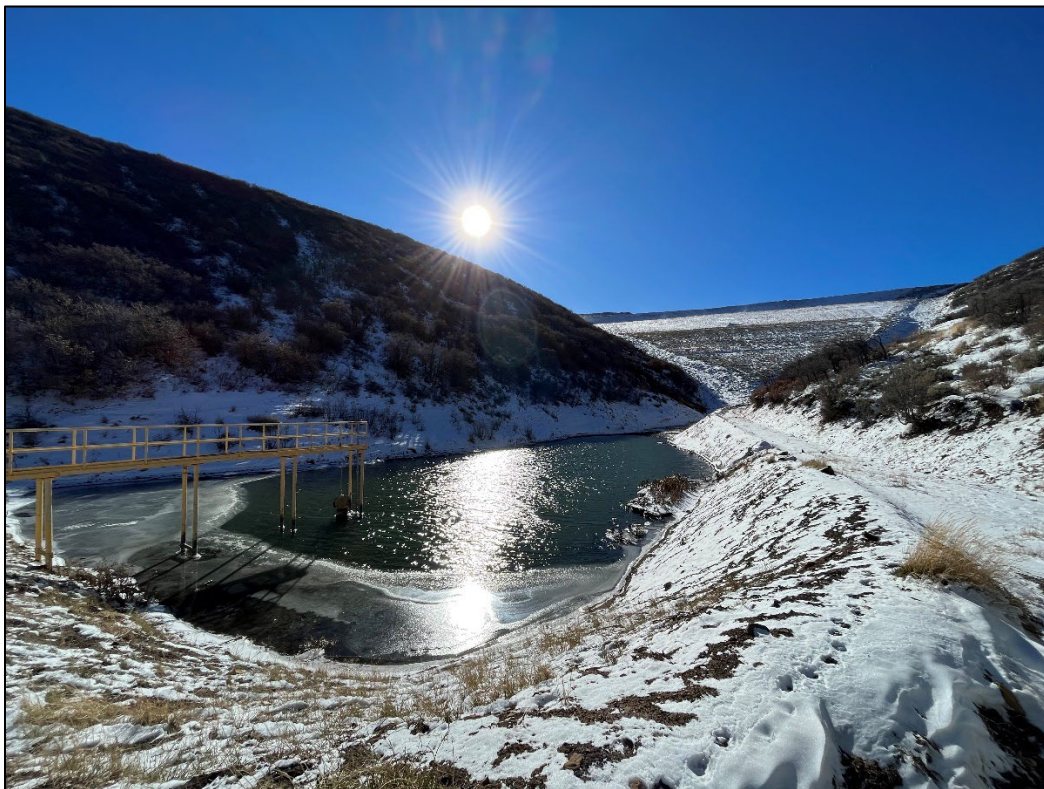
The West Taylor Valley Fill area (Photo 5) was inspected from below at the West Taylor Pond (Photo 4). No erosional issues were noted. The pond was partially frozen, but still appeared to be discharging slightly. The face of the valley fill is well covered with vegetation, made up of sagebrush and native grasses.

Photo 4: View south of West Taylor Pond.

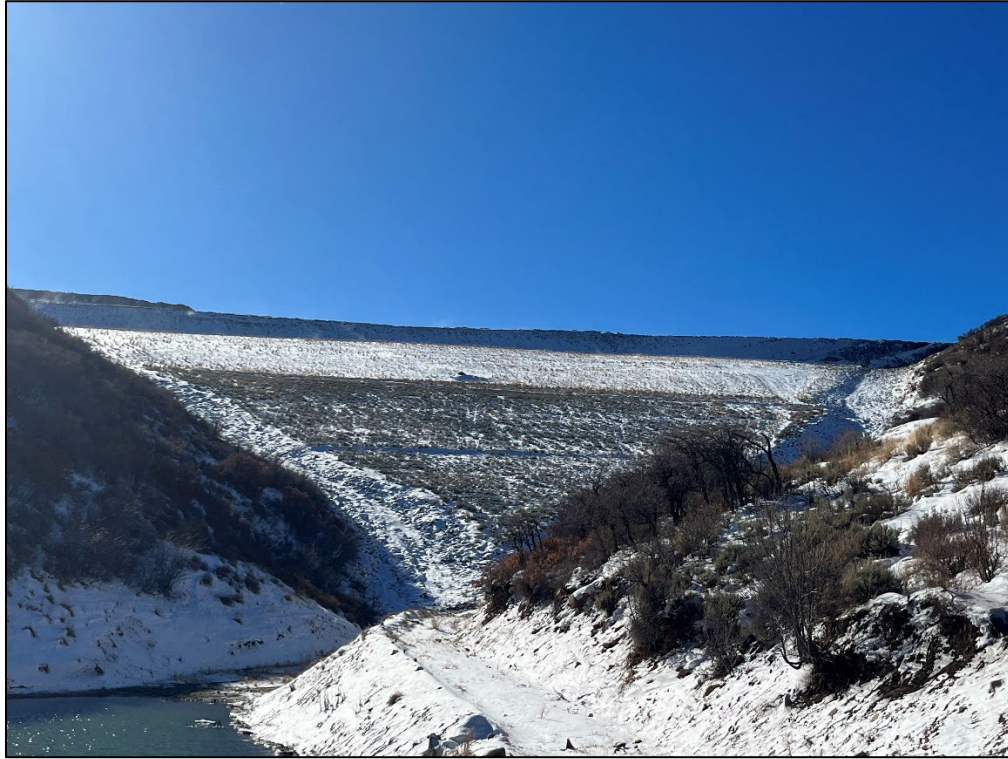
West Taylor Pond (Photo 5) was inspected this month as part of the observance of the West Taylor Valley Fill. West Taylor Pond was holding water but was partially frozen over. Water was heard trickling down the discharge pipe. Embankments were stable. Inlets and outlets remained free of obstruction. The West Pit stock ponds were observed from above and looked to be stable. East Taylor Pond (Photos 1 – 3) was inspected and found to be holding water, which is mostly contributed to by the spoil spring flowing into the pond. Embankments on both ponds were stable and no overall issues were noted.

Photo 5: View south of the West Taylor Valley Fill.

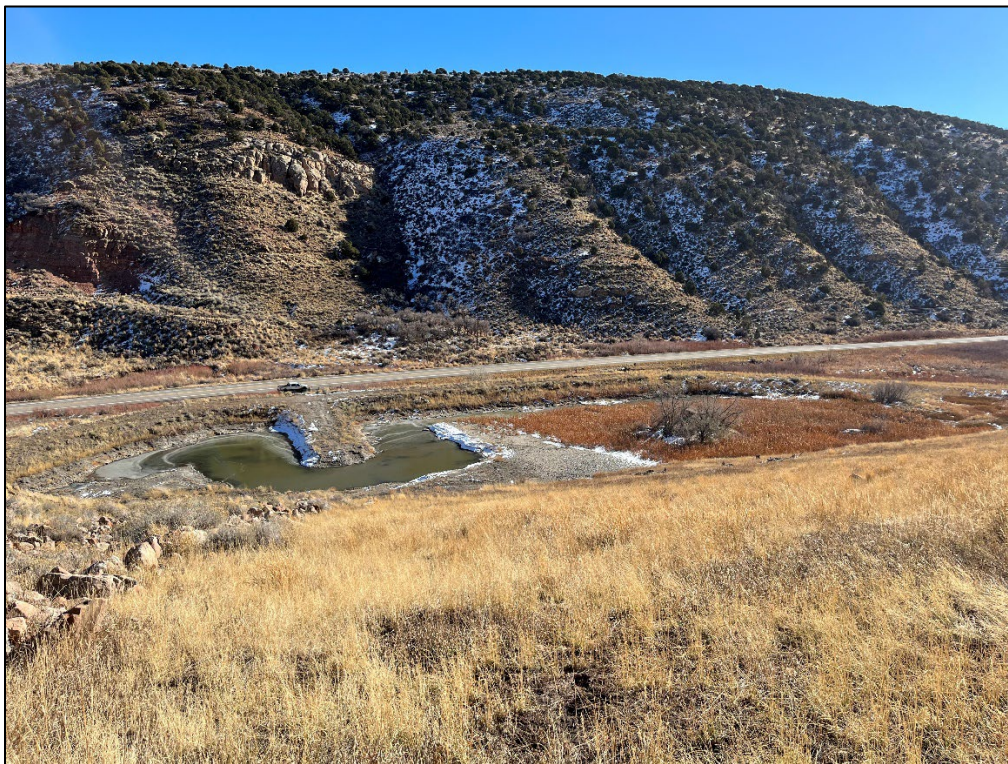
The Streeter Pond and Prospect Pond, accessible via Hwy 13, were inspected. Streeter (Photo 6) and Prospect (Photo 7) Ponds held water at the time of inspection. All embankments were stable and vegetated. No issues were noted.

Photo 6: View east of Streeter Pond from atop the Streeter Fill.

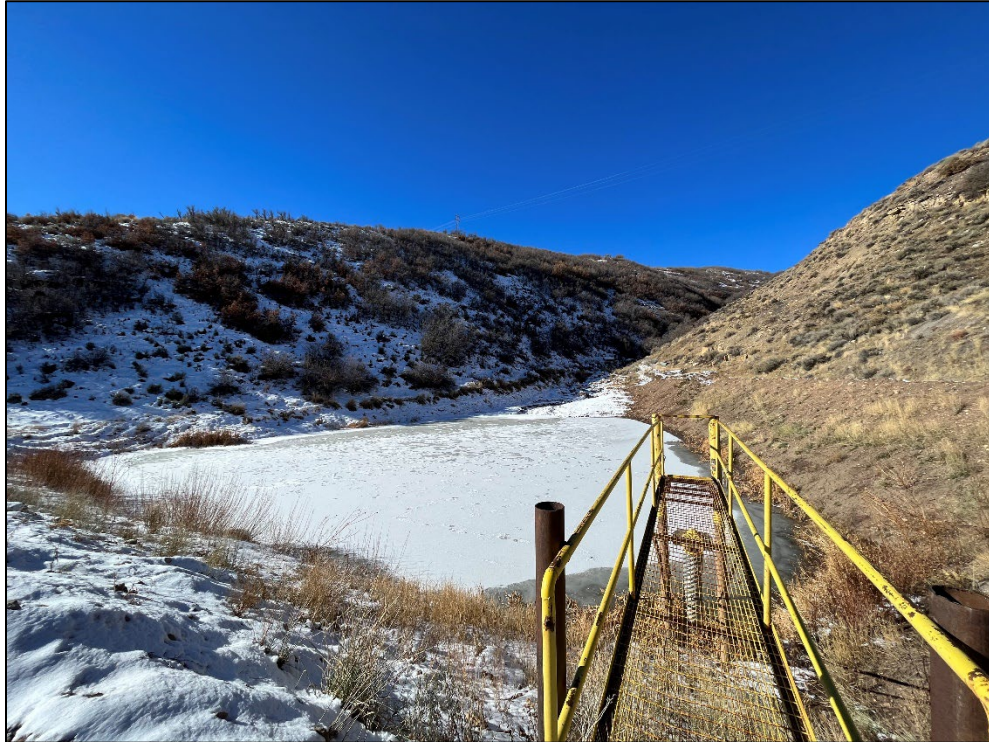
Photo 7: View of Prospect Pond.

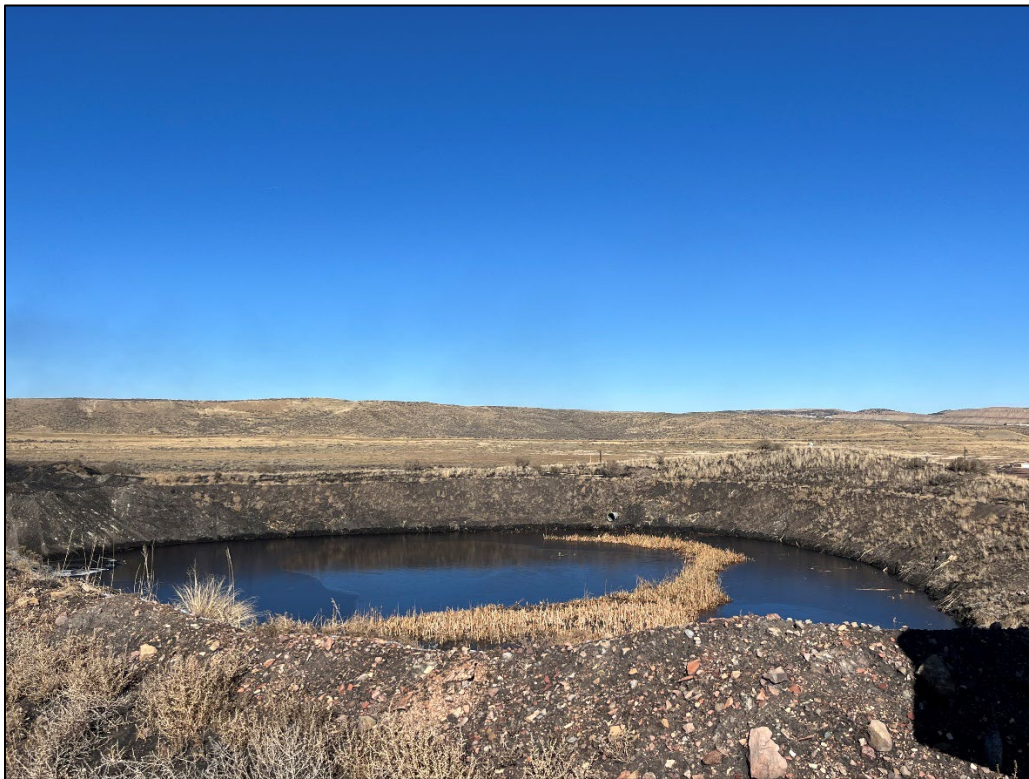
The following ponds in the Loadout Area were inspected this month: Gossard Pond (Photo 8) and Stoker Siding Pond. The Rail Loop Pond was inaccessible due to restricted access from a train being loaded at the site (Photo 9). No problems or erosional concerns were noted. All inspected ponds were noted to be holding water.

Photo 8: View of Gossard Pond, recently cleaned.

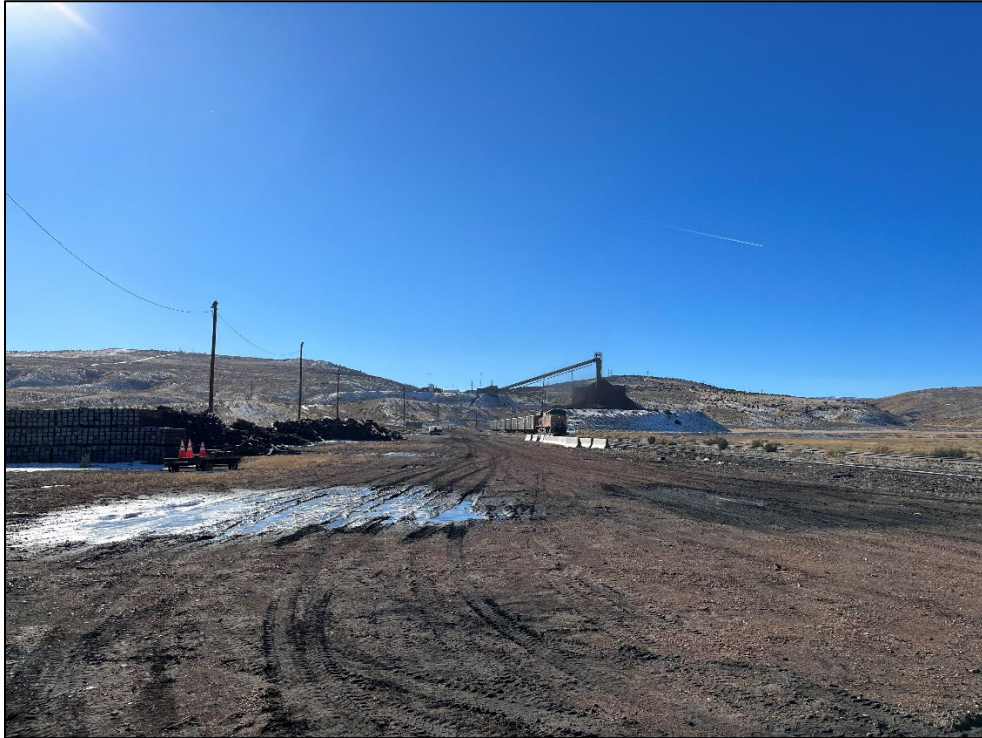
Highwall mining operations were observed to be active in Collom Pit. Truck teams were observed to be hauling both mined material and spoil material. A dragline was observed in the south end of Collom Pit but was not moving spoil material at the time of inspection. A train of ~50 cars was working its way through the rail loop area just south of CR 51 (Photo 9).

Photo 9: View southwest of the Rail Loop area, a train of ~50 cars was loading up at the time of inspection.

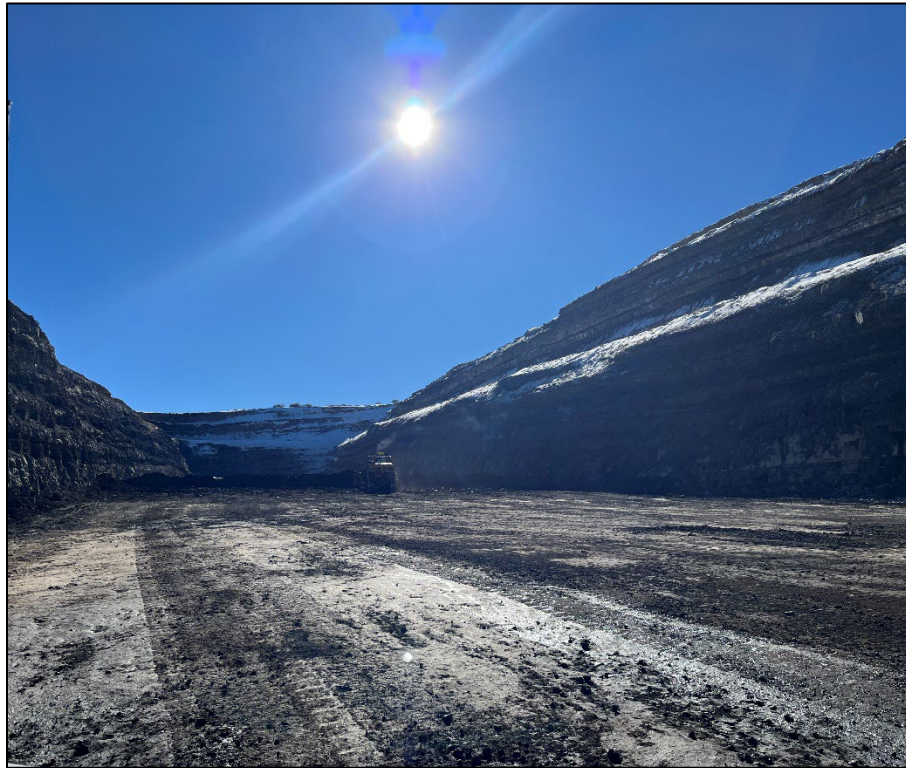
Backfill operations were observed in the eastern cut area in Collom Pit (Photo 10).

Photo 10: Backfill operations continue in the eastern side of Collom Pit mining.

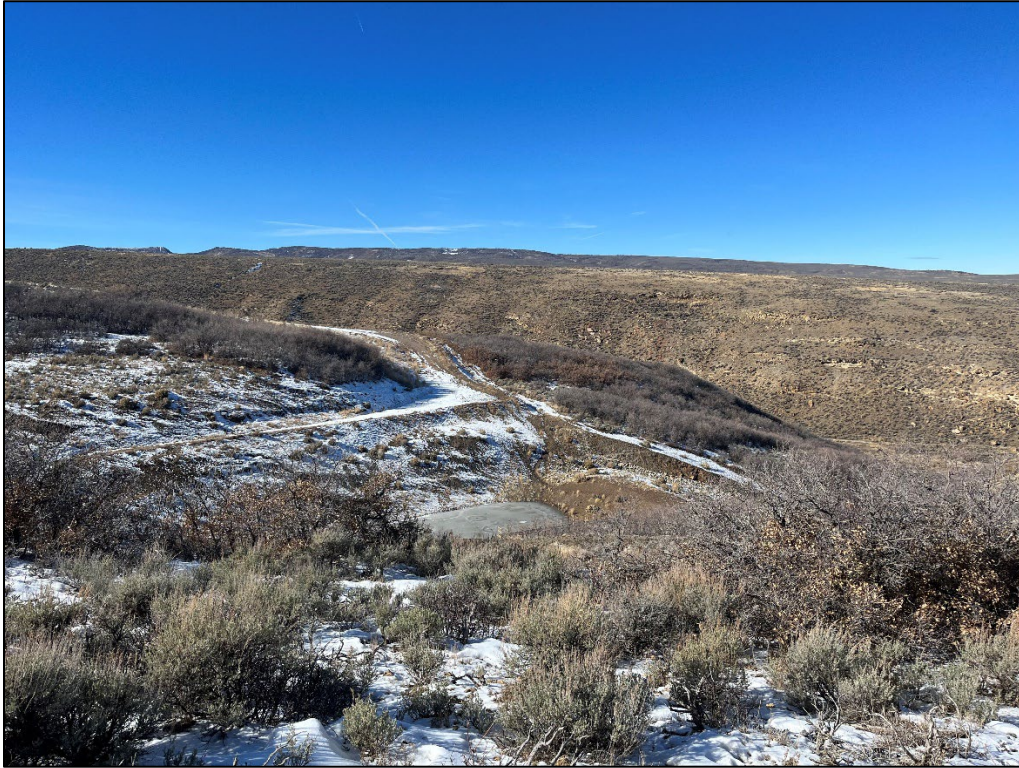
The following Ponds in the Collom Pit area were inspected this month: Section 36 Pond (Photo 13), Middle Pond (Photos 13 and 15), Section 25 Pond (Photo 14), and Section 26 Pond (Photo 11). Sidehill Pond and Section 26 Pond were inaccessible from the usual access road due to ongoing cable laying operations in Collom Pit (Photo 22) which blocked the path to the road. Section 26 Pond was able to be partially inspected from above. No outstanding problems were noted at any of the ponds. All ponds were holding water.

The small slump areas on the east and southwest sides of Section 26 Pond continue to be monitored for signs of movement, but overall remain stable. This southwest slump is likely due to a natural seep. Colowyo should continue to monitor this area closely for exaggerated signs of movement or degradation.

Photo 11: View west of Section 26 Pond from atop the ridge to the east of the pond.

- Monitor the slump area at Section 26 Pond
- Monitor the small erosional feature in D4, repairs will be necessary if conditions worsen

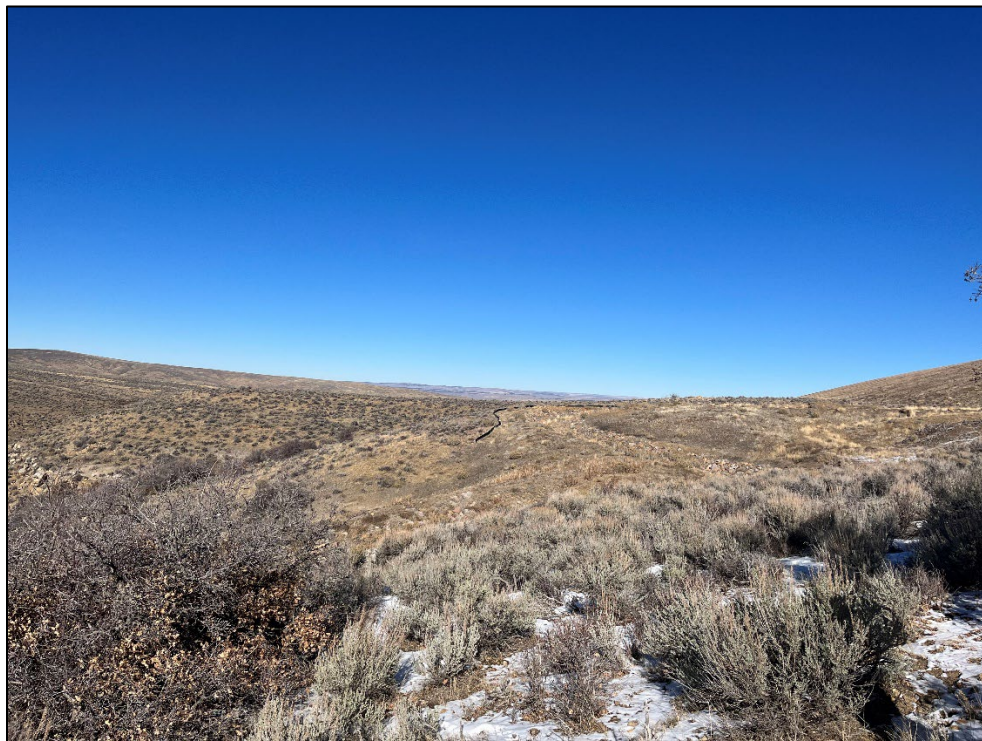
The following ditches in the Collom Pit area were inspected this month: D-1 (Photo 12), D-2 (Photo 12), and D-3 (Photo 14). These ditches were observed from vantage points near Collom Pit Ponds and were walked where accessible. All channels appeared to be stable and functioning properly with no signs of major erosion or undercutting.

Topsoil piles across the site contained appropriate markers. Topsoil Pile 26A, behind Section 26 Pond, has been seeded in preparation for the winter season (Photo 12). The ERTEC 'S-Fence' is still located around the base of topsoil pile 26A. The sump which collects runoff from topsoil pile 26A was observed to be holding a small amount of water.

Photo 12: View north of the western end of Topsoil Pile 26A, the intersection of ditches D1 and D2 are visible.

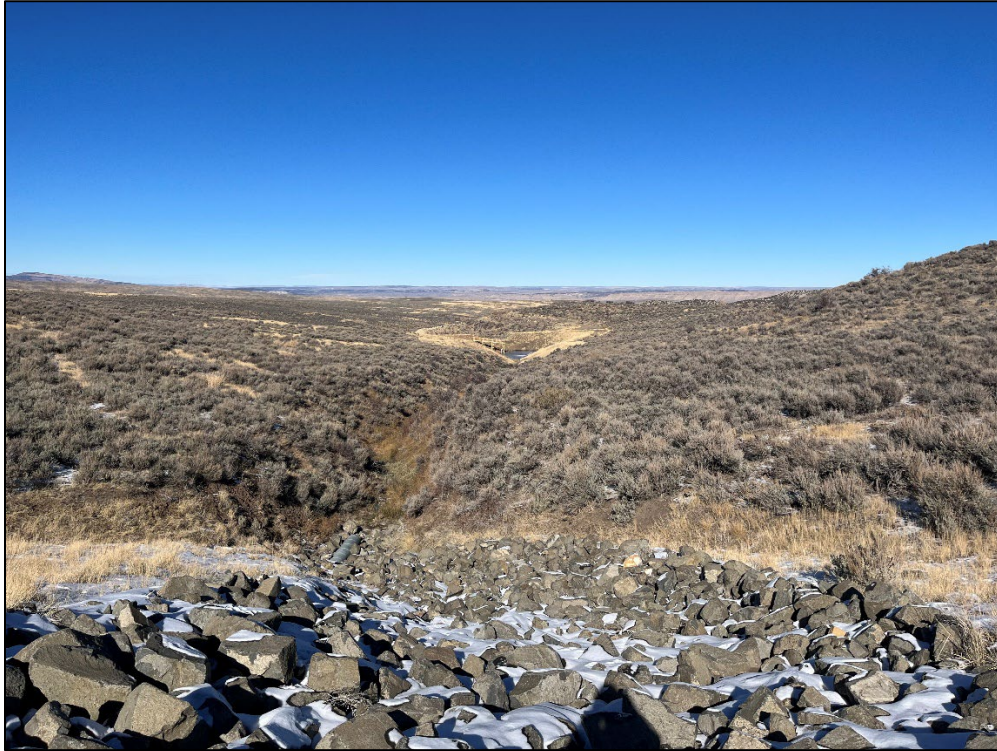
Photo 13: View north towards Middle Pond from Section 36 Pond, Section 36 Pond pipe is visible.

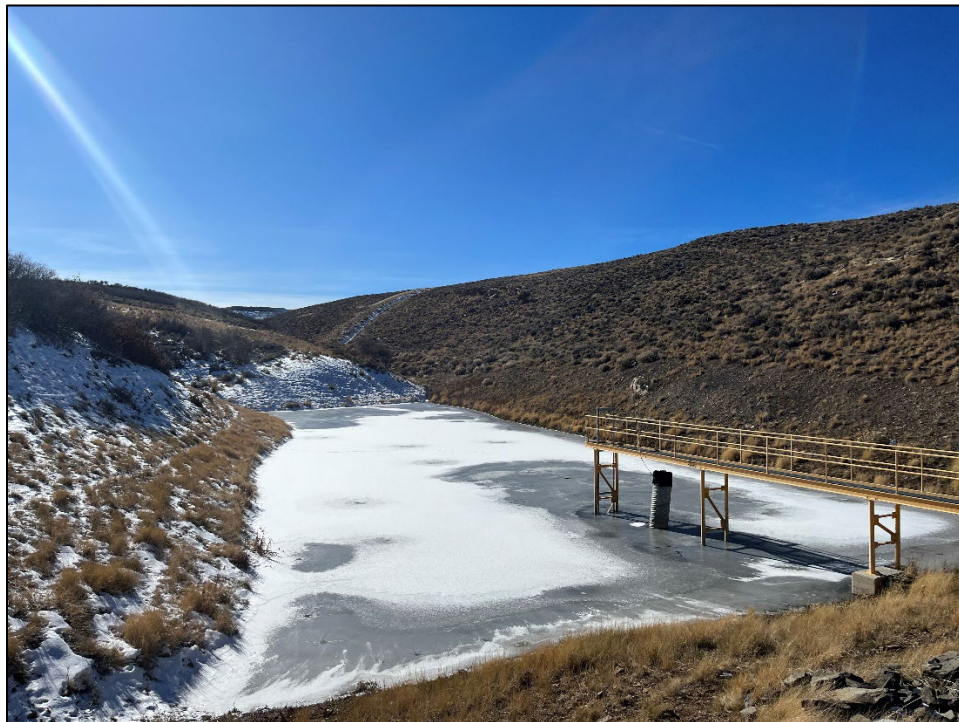
Photo 14: Section 25 Pond in Collom Pit, Ditch D3 is visible in the background.

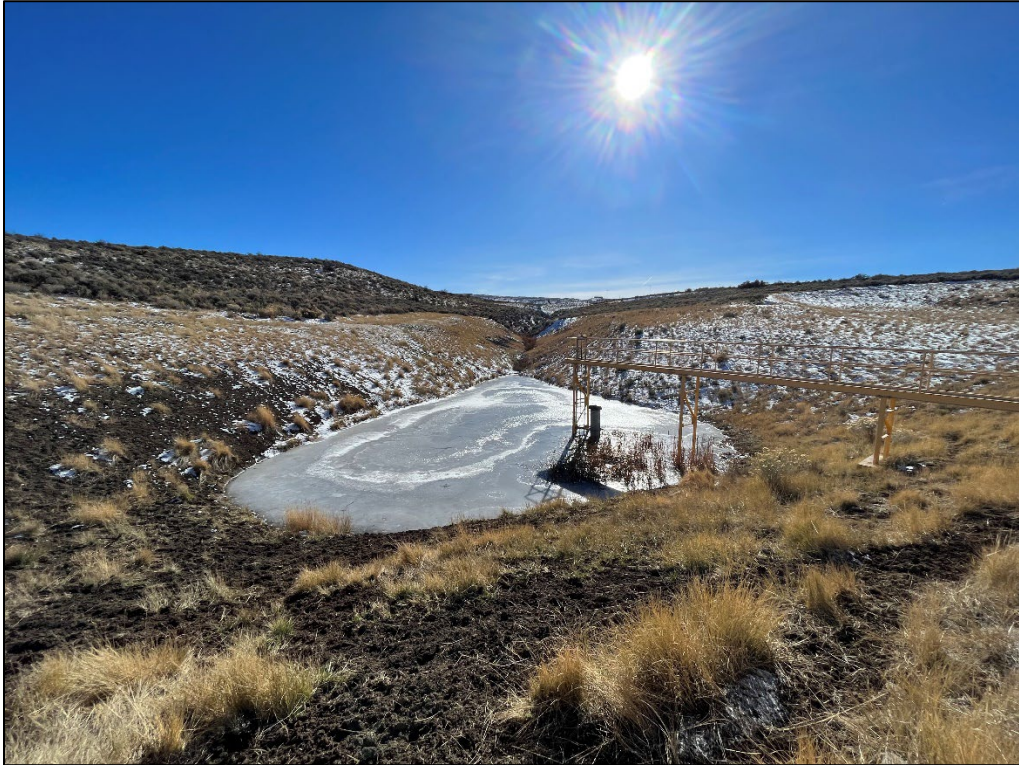
Photo 15: Middle Pond in Collom Pit.

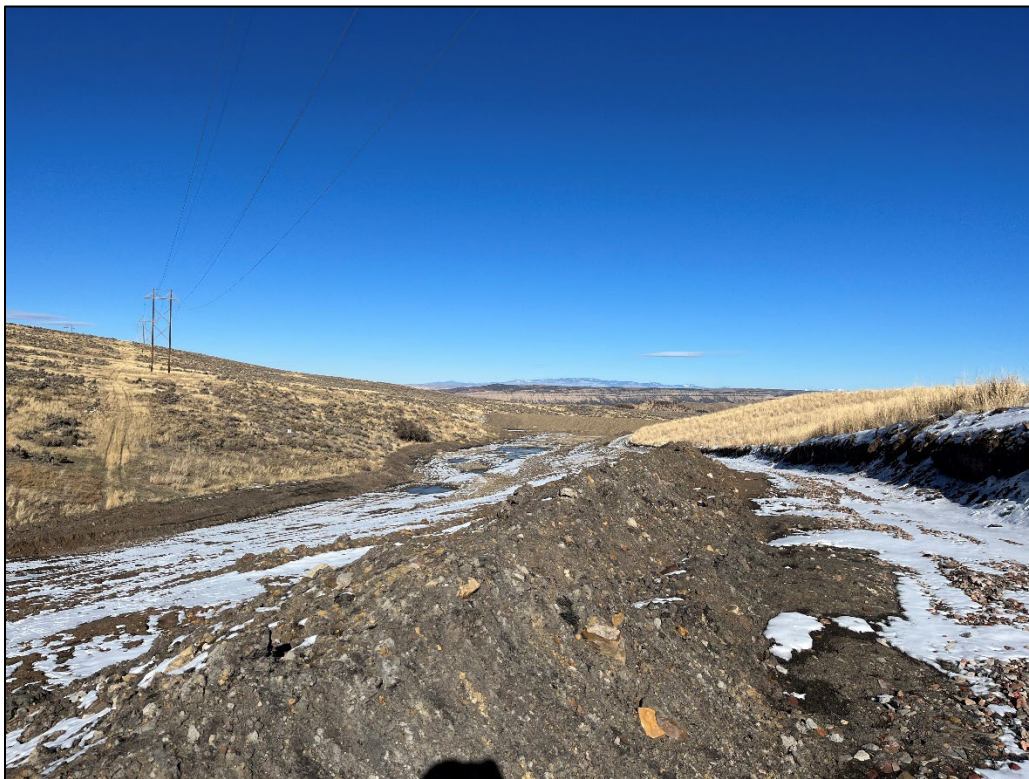
Upper and Lower Section 3 Ponds in the East Pit have been completed (Photos 17 and 16, respectively). The approved access road around these ponds remains in place. As-built design materials were reviewed by the Division under the submission of Technical Revision 164 (TR-164) and were approved on November 1, 2024. These sediment ponds function in series, with the Lower Section 3 Pond being a non-discharging structure.

Photo 16: View east of the Lower Section 3 Pond.

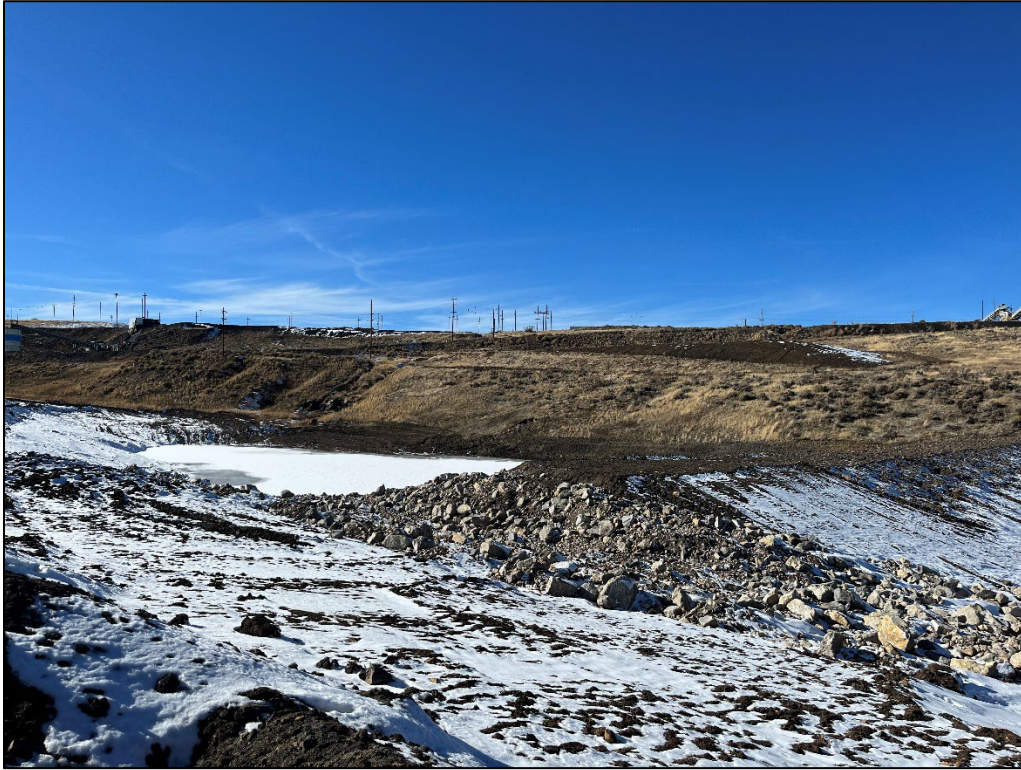
Photo 17: View northwest of the Upper Section 3 Pond.

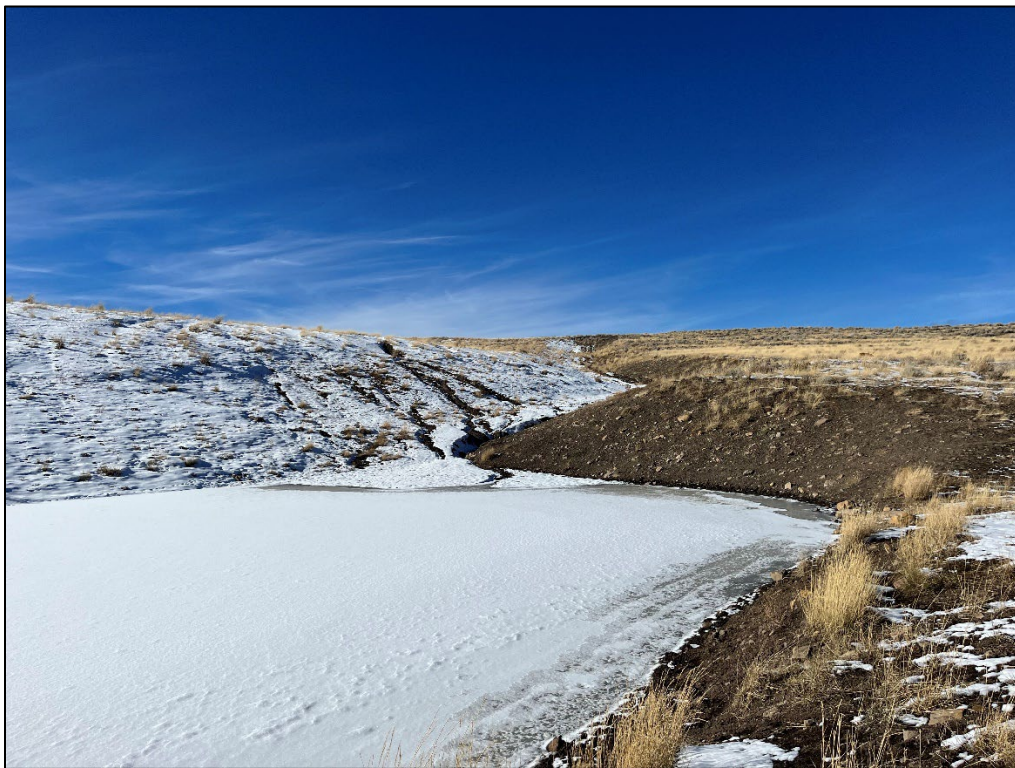
Prospect Ditch was mostly dry, but PD1 and PD2 were holding a small amount of water, mostly frozen over. No issues or signs of erosion were noted. Final East Pit Ditch was inspected on foot and from vantage points. The ditch was mostly dry, and no signs of erosion or obstruction were observed. Gabion boxes are in place along Final East Pit Ditch and remain in place. EP1, EP2 and EP3 were all holding a small amount of water. Reach 2 and Reach 1 of Final East Pit Ditch were observed from EP1 and EP3 and appeared to be stable.

Photo 18: View of PD2.

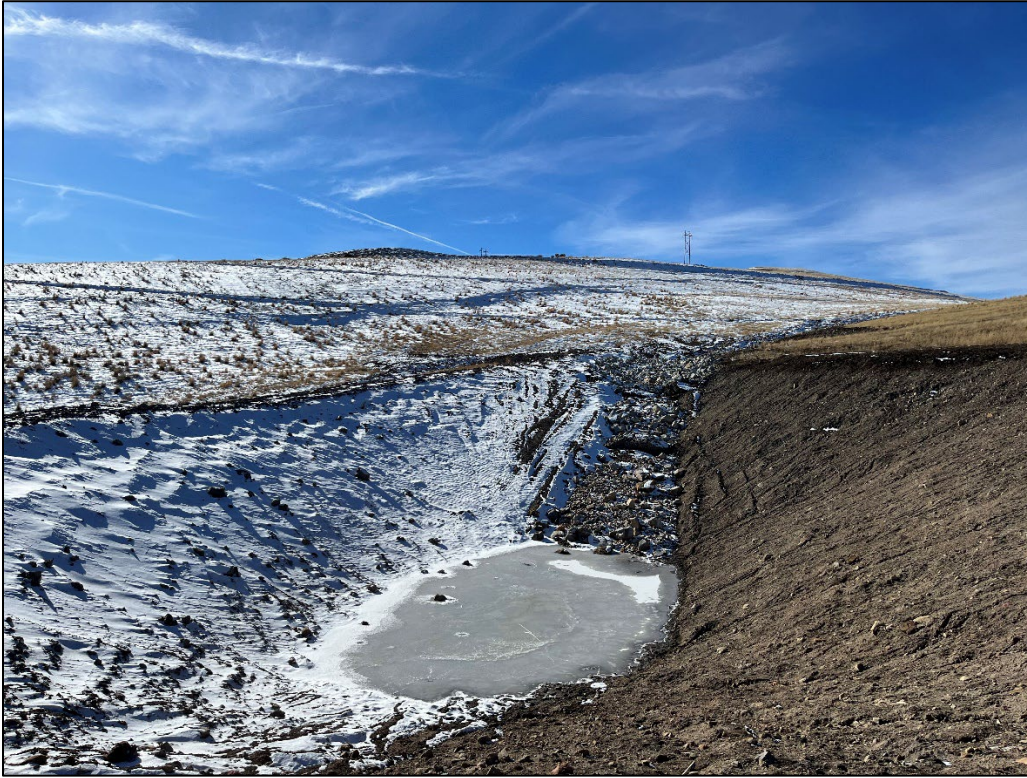
Photo 19: View of PD1.

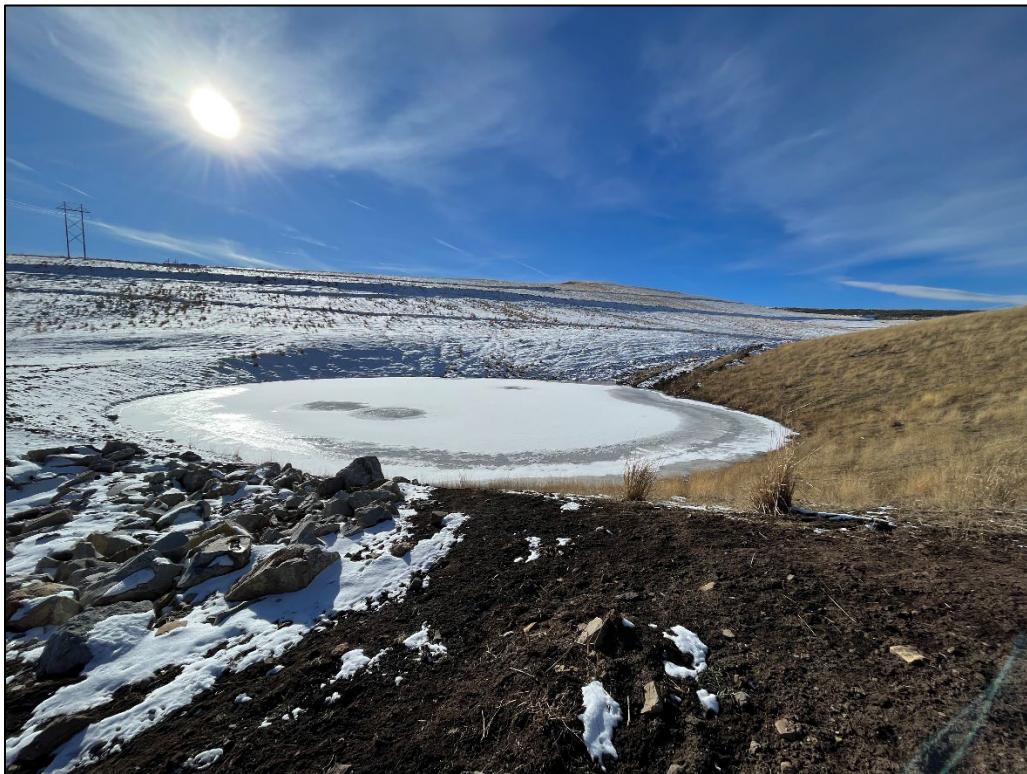
Photo 20: View west of EP2.

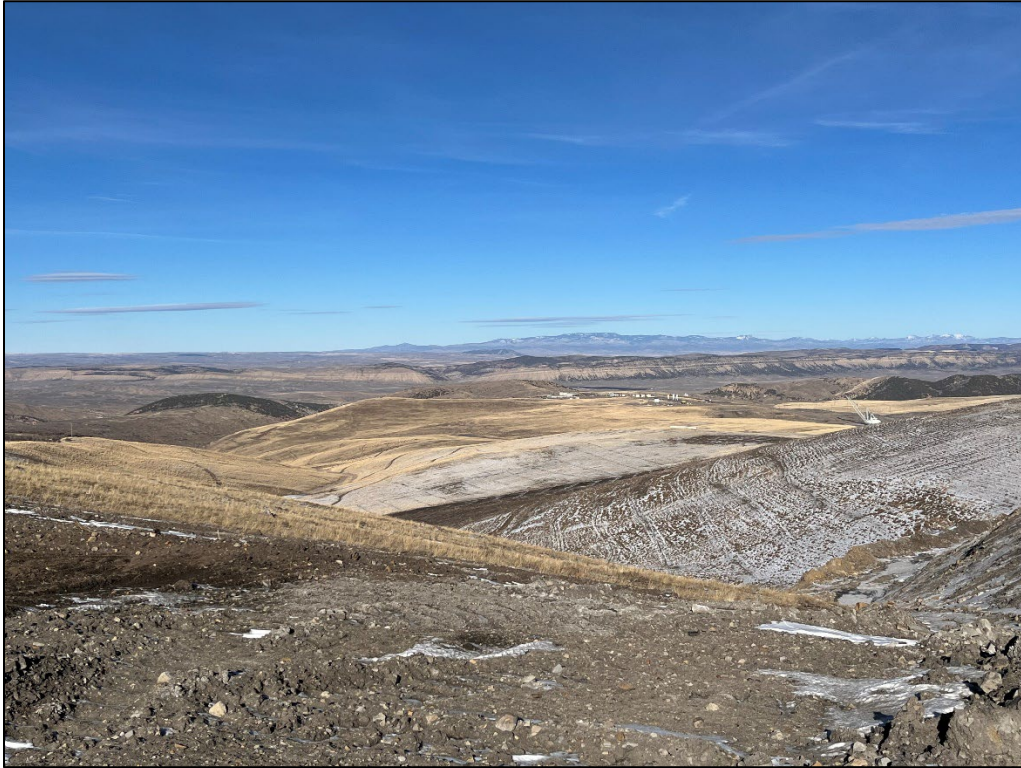
West Pit reclamation was observed from atop the spoil pile south of West Pit (Photo 21). West Pit is near completion in terms of backfill operations. The newly topsoiled area at the southern end of West pit was seeded during the fall season. Other areas of the West Pit, to the north, have been both backfilled and

reclaimed. Vegetation in this area is established, but some areas do not yet appear at full coverage. Taylor Ditch and other drainage channels in West Pit appeared to be stable.

Photo 21: View north of the West Pit reclamation.

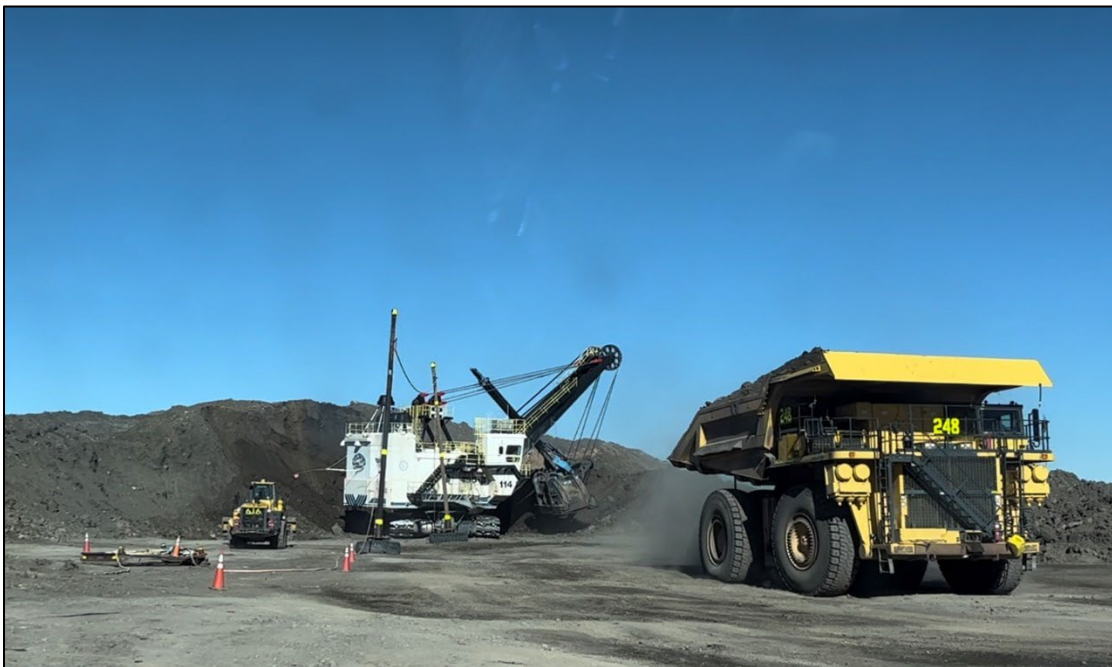
Construction of the Collom Temporary Spoil Pile continues as mining in Collom Pit progresses. A shovel was being used to fill haul trucks (Photo 22). The spoil stockpile area in Collom Pit is encompassed by a berm to ensure spoil is contained within the approved disturbance boundary of the pile.

Photo 22: A shovel was observed to be filling haul trucks with spoil material in Collom Pit.
