# MINERALS PROGRAM INSPECTION REPORT PHONE: (303) 866-3567

MINE NAME:		MINE/PROSPECTING ID#:	MINERAL:	COUNTY:	
Yocam Borrow Pit		M-2018-020	Borrow material for o	Morgan	
INSPECTION TYPE:		INSPECTOR(S):	INSP. DATE:	INSP. TIME:	
Monitoring		Brock Bowles	July 6, 2022	09:30	
OPERATOR:		<b>OPERATOR REPRESENTATIVE:</b>	TYPE OF OPERATION:		
Castle Rock Construction Company of Colora		Travis Bell	111 - Construction by Goverment Agency		
<b>REASON FOR INSPECTION:</b>		BOND CALCULATION TYPE:	BOND AMOUNT:		
Normal I&E Program		None	\$42,500.00		
DATE OF COMPLAINT:		POST INSP. CONTACTS:	JOINT INSP. AGENCY:		
NA		None	None		
WEATHER:	INSPECTOR'S SIGNATURE:		SIGNATURE DATE:		
Cloudy	Br	al Sauls	August 22, 2022

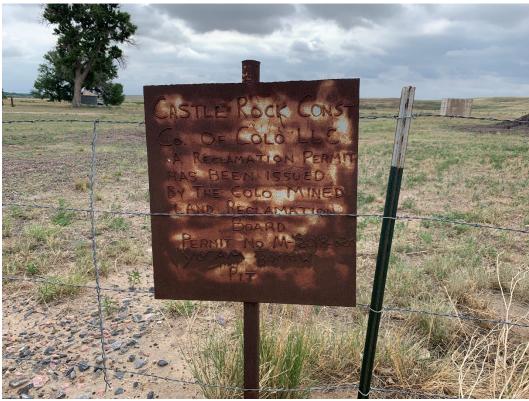
The permit entrance sign was in place (photo 1) and the permit boundary was marked with an electric fence. The fence was open upon arrival.

Photo 1 – Mine entrance sign facing CR 144

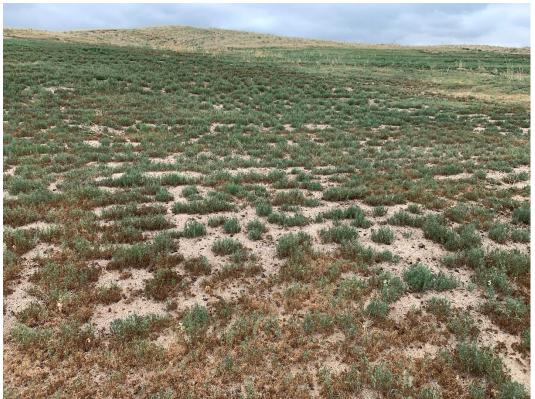
The vegetation in the reclaimed areas mostly consisted of kochia and Russian thistle (photo 2). Both of these species are non-desirable annuals but are also not on the Colorado Dept. of Agriculture noxious weed list. Very few native/desirable grasses were seen. A few Rocky Mountain bee plants (*Cleome serrulata*) were also seen. The annual species seem to have become more dominate than the desirable vegetation, compared to previous years.

The usual plant succession pattern is that perennial species outcompete the annual species and become the dominate life form within a few years after planting. This does not appear to be the case at this time. DRMS recommends that CRCC contact the local NRCS, CSU Extension Office or a private consulting firm for assistance in creating a new reclamation plan.

Photo 2 - Vegetation mostly kochia and Russian thistle
