Division of Reclamation,
Mining and Safety

MINERALS PROGRAM INSPECTION REPORT

MINE NAME: Meadow Hollow Quarry	MINE/PROSPECTING ID#: M-2009-006	MINERAL: Sandstone (silica, st quartzite)	COUNTY: Larimer
INSPECTION TYPE: Monitoring	WEATHER: Windy	INSP. DATE: October 24, 2024	INSP. TIME: 13:00
OPERATOR: Colorado Quarry I, LLC	OPERATOR REPRESENTATIVE: John Holiday	TYPE OF OPERATION: 110c - Construction Limited Impact

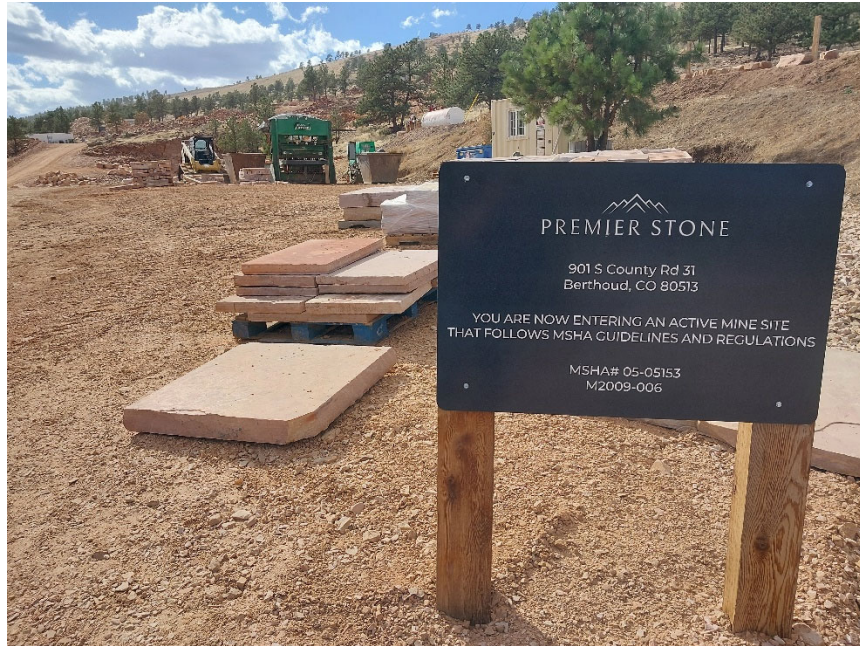
PROBLEM #1: The mine identification sign was posted at the entrance of the mine site, but did not have full and accurate information. This is a problem for failure to post a mine identification sign as required by Section 3.1.12(1) of the rule.

The mine sign was posted near the entrance of the permitted area in accordance with Rule 3.1.12(1), see Photo #1. However, the sign does not meet all the requirements outlined in the rule; the name of the Operator, the name of the operation, and a statement that a reclamation permit for the operation has been issued by the Colorado Mined Land Reclamation Board are not provided. See the problem #1 above for information about the corrective action required to address this problem. Permit boundary markers appeared to be in place at the time of the inspection, in accordance with Rule 3.1.12(2), see Photo #2. However, not all the boundary markers were verified during the inspection.

Photo #1: Mine sign at/near entrance of the permit area. The name of the Operator, the operation name, and a statement that a reclamation permit issued by the Colorado Mined Land Reclamation Board are not given. See problem #1 above for information about the corrective action required.

CORRECTIVE ACTIONS: The Operator shall, at the entrance of the mine site, post a sign which shall be clearly visible from the access road, with a minimum size equaling one hundred and eighty-seven (187) square inches, such as eleven (11) inches in height and seventeen (17) inches in width, with appropriate font size, with the following: the name of the Operator, the name of the operation, a statement that a reclamation permit for the operation has been issued by the Colorado Mined Land Reclamation Board; and the permit number. The operator shall submit photo documentation that a proper sign has been posted by the corrective action date.

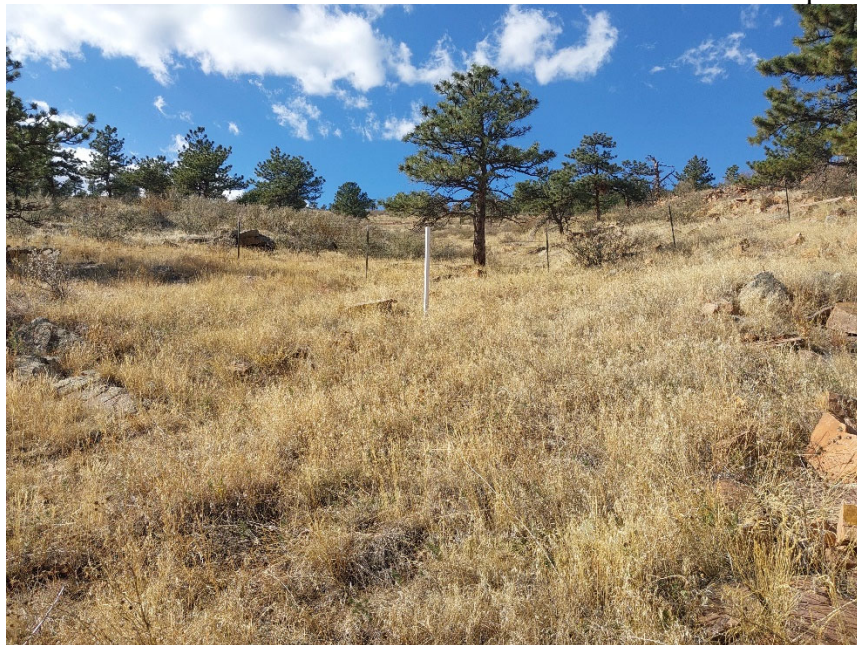
Photo #2: Permit boundary marker viewed on the west end of the permit area.

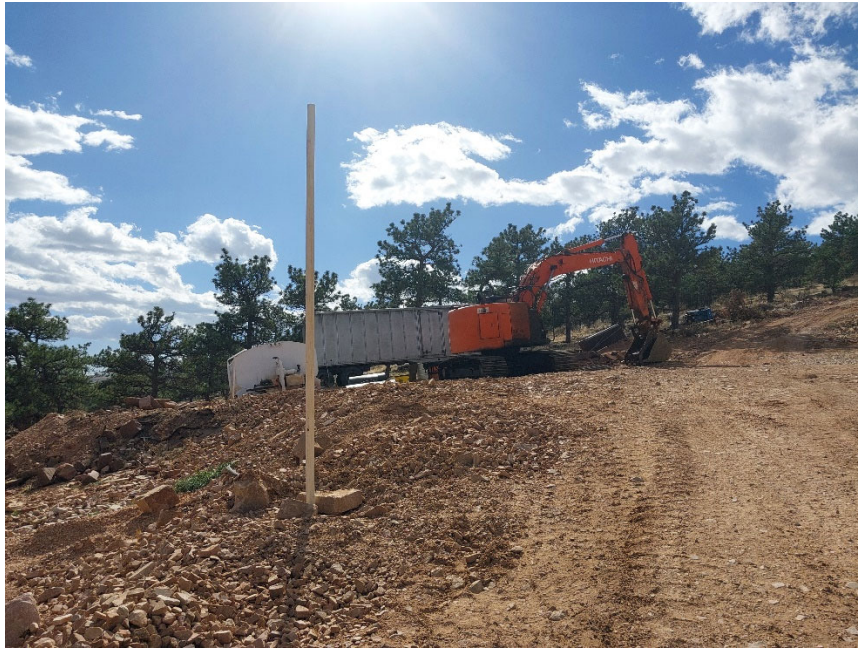
Photo #3: One of the excavators and storage unit viewed on the permit area. Looking west-southwest from the southeast area of the permit.

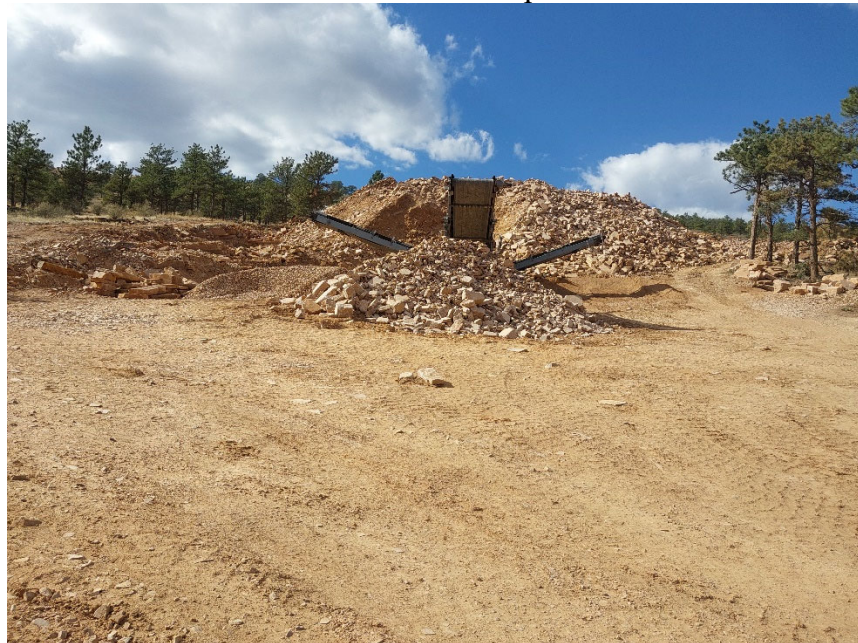
Photo #4: Rock crusher/processor viewed on the permit area. Looking west-northwest from the southeast area of the permit.

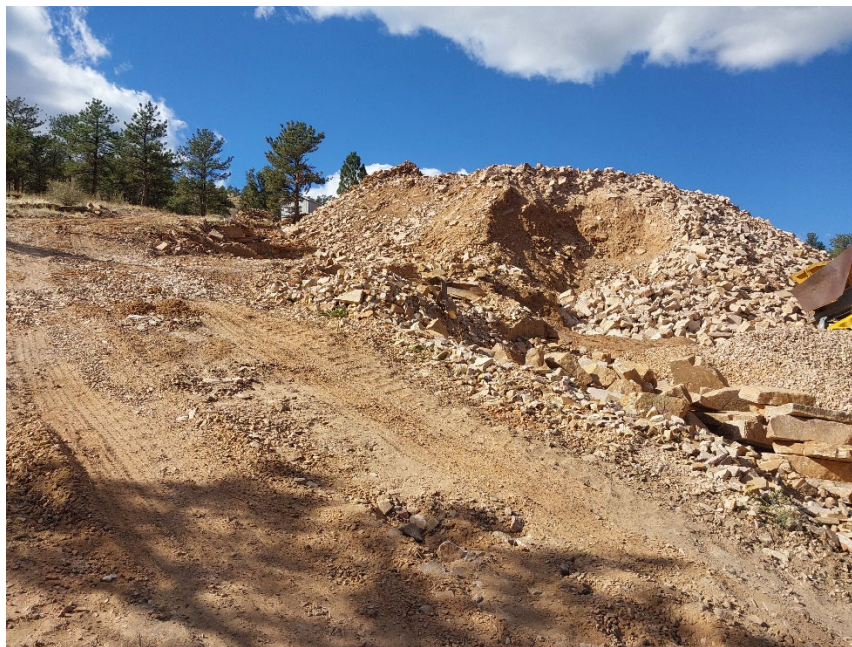
Photo #5: Perimeter road in the southwest portion of the permit area; looking northwest.

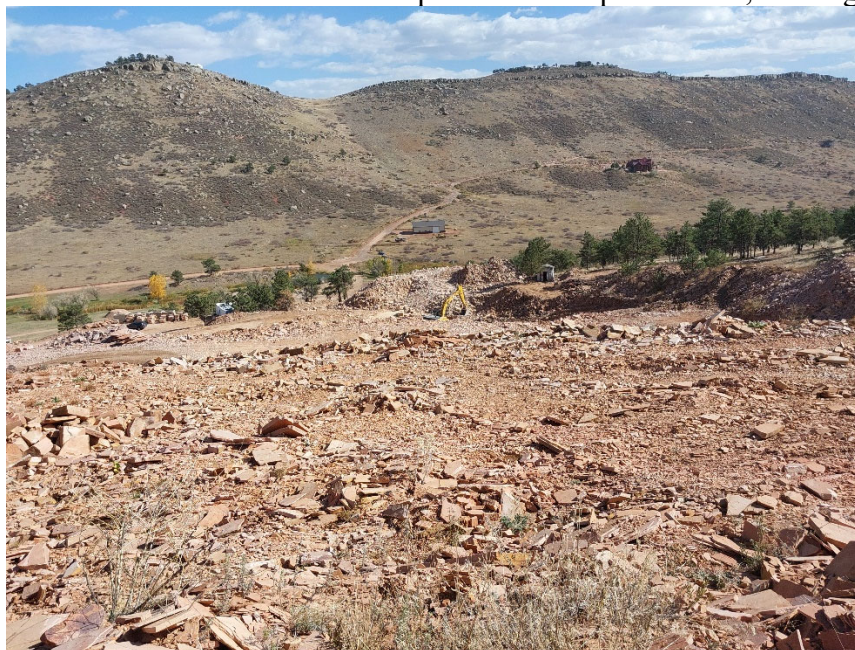
Photo #6: View of the disturbed area from the west portion of the permit area. The active quarry area is seen in the center of the photo.

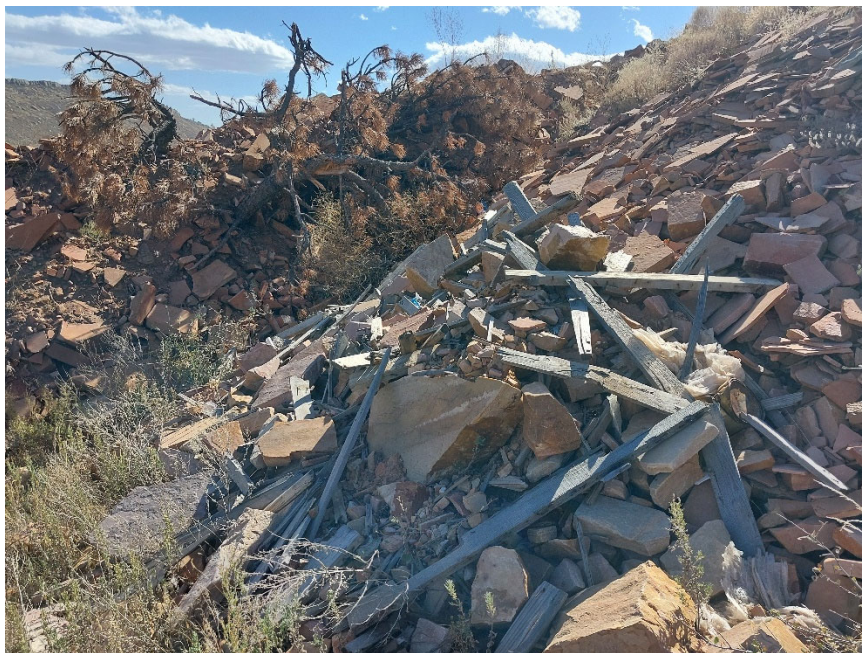
Discarded pallets, both wooden and plastic, were observed to be a part of stockpiles located on the northeast

Photo #7: Discarded lumber observed in the berms surrounding the quarry and disturbed area.

side of the disturbed area; see Photos #7 and #8. It is recommended that the Operator properly discard of used pallets and other waste materials and keep the permit area clean and free of trash/debris.

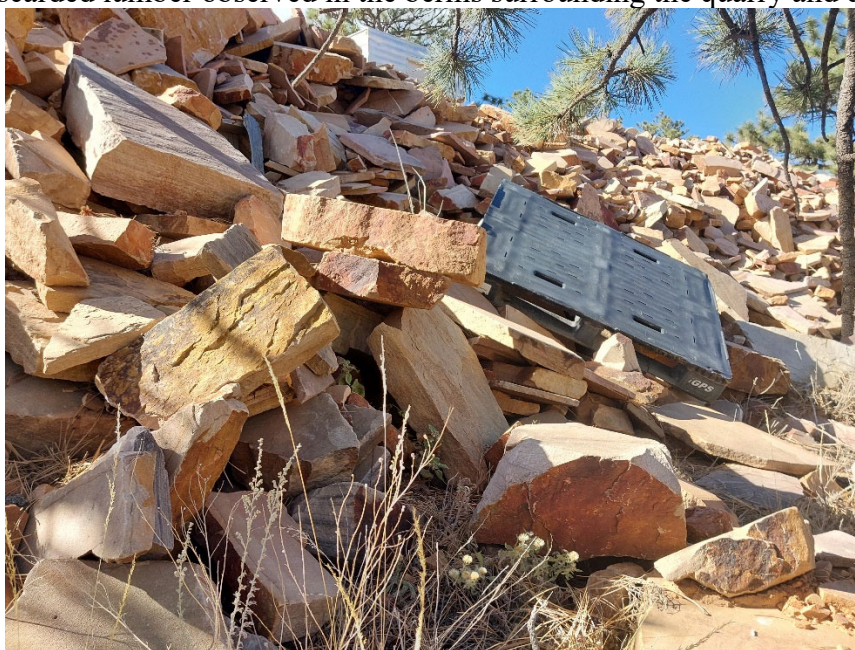
Photo #8: Discarded plastic pallet observed in the berm surrounding the disturbed area.

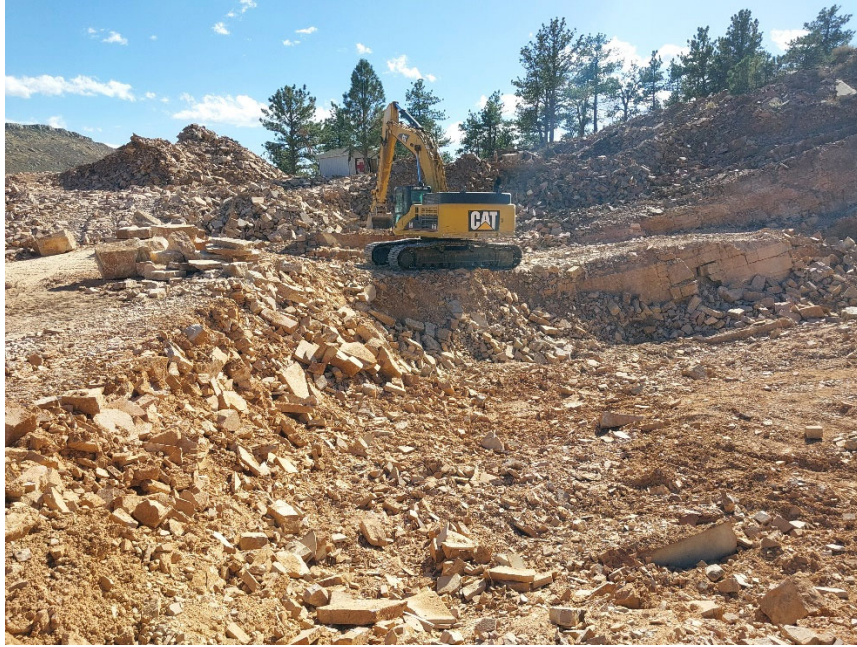
Photo #9: One of the excavators viewed within the permitted area, located in the quarry area; looking south.

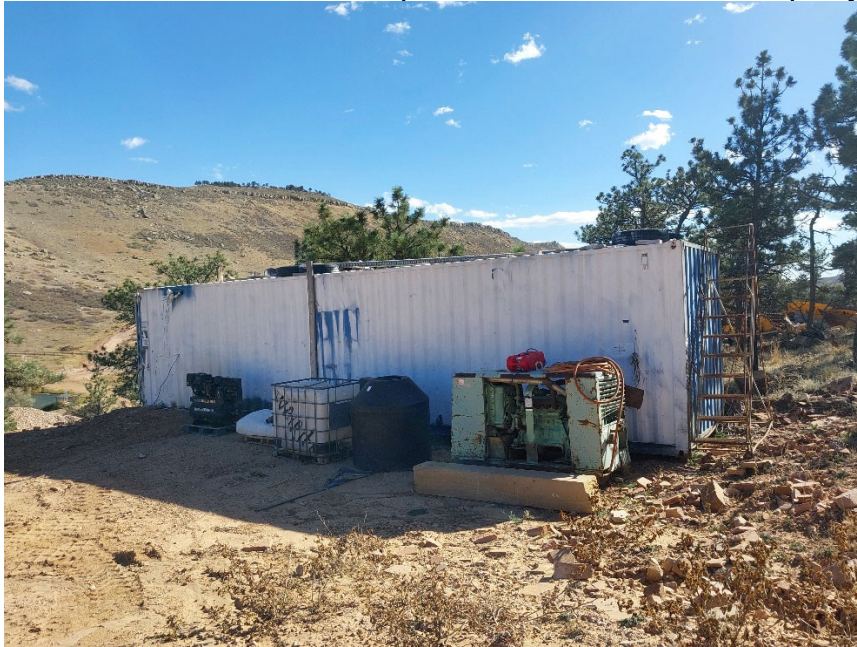
Photo #10: Storage container, generator, pump, and additional other supplies observed within the permitted area.

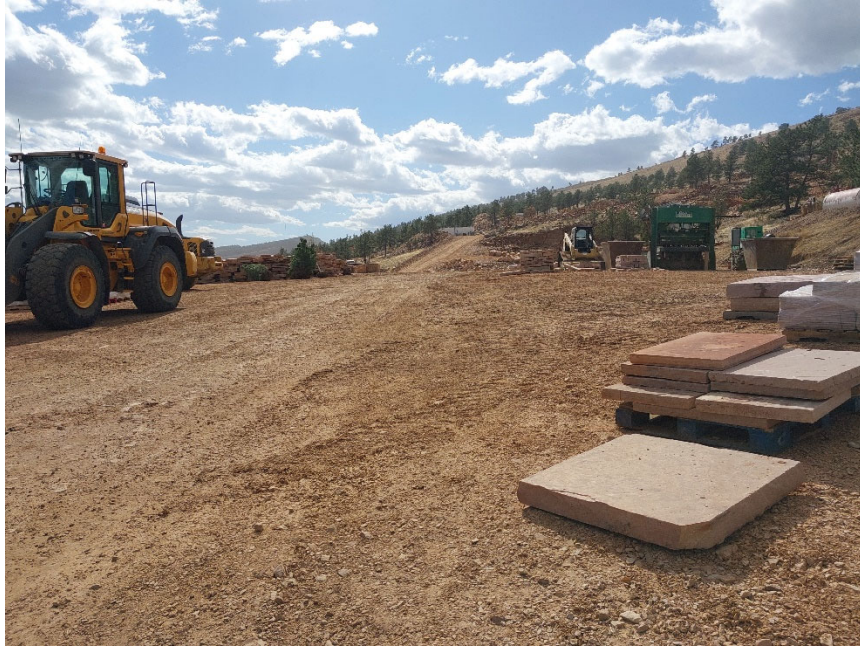
PROBLEM #3/POSSIBLE VIOLATION: Land has been affected outside of the approved permit boundary. This is a possible violation at this time pursuant to: 1.) C.R.S. 34-32.5-109(1) for failure to first obtain from the board or office a reclamation permit prior to engaging in a new operation. AND/OR 2.) C.R.S. 34-32.5-116(4)(i) for failure to protect areas outside of the affected land from slides or damages occurring during the mining operation.

In the inspection report for the DRMS inspection that was conducted on January 16, 2020, it states that the pre-law quarry pit located just to the north of the permitted area was being used by the landowner for non-mining related storage. During my inspection, it appeared that the pre-law quarry floor had been cleared and was being used to store palletized product, stockpiles of material, and various mine-related equipment. It was also observed that the areas along both sides of the road from the location of the mine sign (see the map/satellite image) to the quarry, were being used to store mine-related material and various equipment, including a scale; see Photos #11, #12, and #13. Per Rule 1.1(3), which defines "affected land", the current use of the pre-law quarry pit floor and the land along the road are considered affected land and need to be included in the permitted area. See problem #3/possible violation cited above for more details about the required corrective action. Note the Division will need to conduct an additional site inspection to better assess the extent of the affected lands outside of the approved permit boundary.

Photo #11: Area just to the south of the mine sign, north of the permit boundary and the pre-law quarry; looking to the south. Area appears to be affected lands; material is stockpiled and palletized, and there is various equipment associated with mining stored.

CORRECTIVE ACTIONS: The Division will conduct another physical inspection by the given due date, pending weather. At that time, more GPS data will be gathered to better assess the extent of the affected lands outside of the approved permit boundary.

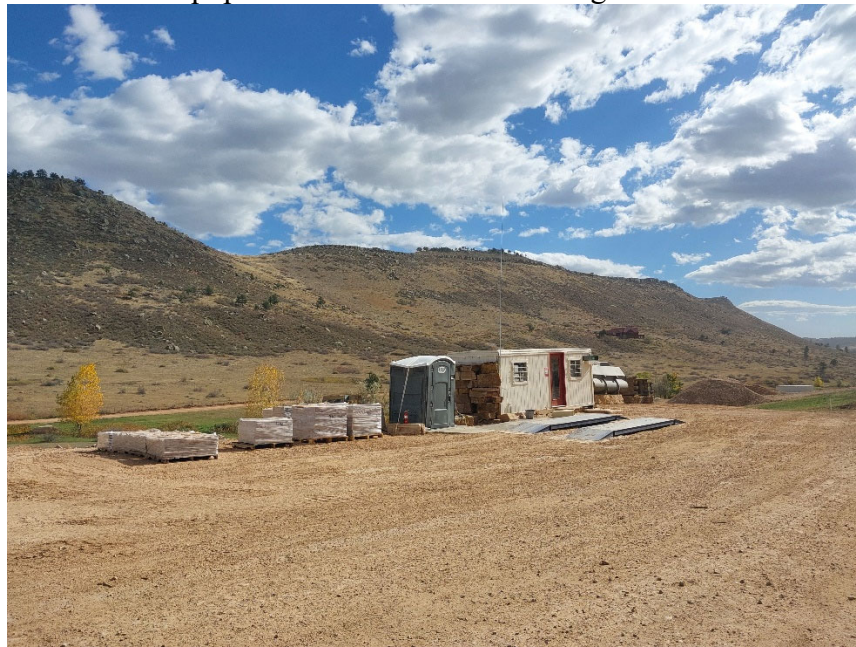
Photo #12: Scale, a structure, and more palletized material observed along the access road, to the north and outside of the permit area.

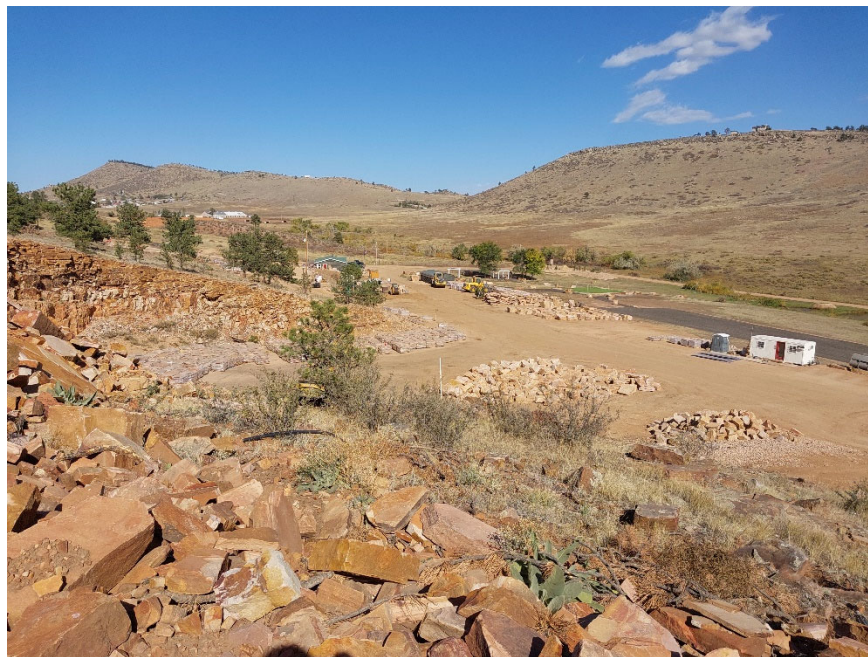
Photo #13: Area to the north of the permit area and south of the permit sign, the scale can be seen in the lower right side of the photo. The pre-law quarry area appears to be used for storage of material, palletized material, and equipment. The land in this photo is not located within the permitted area.
