## Hayden Gulch inspection

Miranda and Mike,  
Attached is the Hayden Gulch, C-1992-081, inspection report for November 2024.  
Brock

<b>Permit Number:</b> C-1992-081 <b>Mine Name:</b> Hayden Gulch Loadout <b>Operator:</b> Hayden Gulch Terminal, LLC <b>Operator Address:</b> Ms. Miranda Kawcak 29515 Routt County Road 27 Oak Creek, CO 80467	<b>County:</b> Routt <b>Operation Type:</b> Loadout <b>Permit Status:</b> Active <b>Ownership:</b> Private
	<b>Operator Representative Present:</b>  N/a
<b>Operator Representative Signature: (Field Issuance Only)</b>

<b>Inspection Start Date:</b> November 20, 2024 <b>Inspection Start Time:</b> 09:30 <b>Inspection End Date:</b> November 20, 2024 <b>Inspection End Time:</b> 10:15		<b>Inspection Type:</b> Coal Partial Inspection <b>Inspection Reason:</b> Normal I&E Program <b>Weather:</b> Clear	
<b>Joint Inspection Agency:</b>  None		<b>Joint Inspection Contacts:</b>  	
<b>Post Inspection Agency:</b>  None		<b>Post Inspection Contacts:</b>  	
<b>Inspector(s):</b>  Brock Bowles	<b>Inspector's Signature:</b>

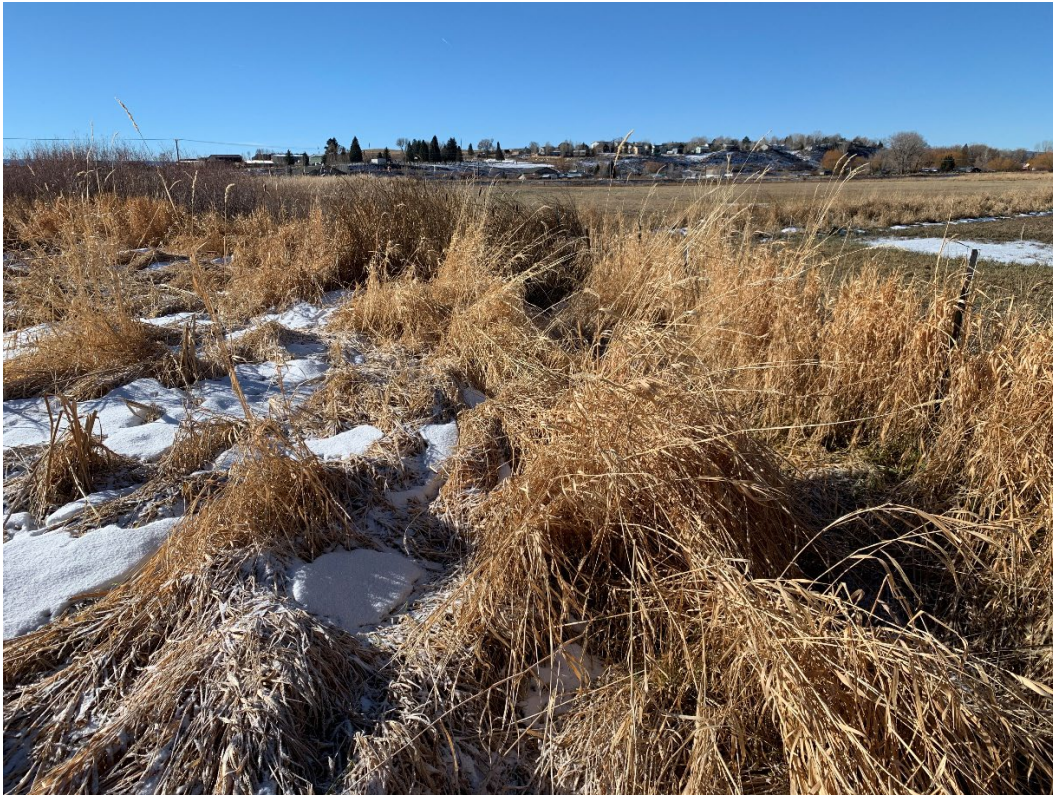
Photo 1 – Outfall 004A

The area near Outfall 004A was densely covered with grasses (photo 1). Some of the grass has been pushed down by snow. The ground surface was not seen in this area due to the density of the grasses.

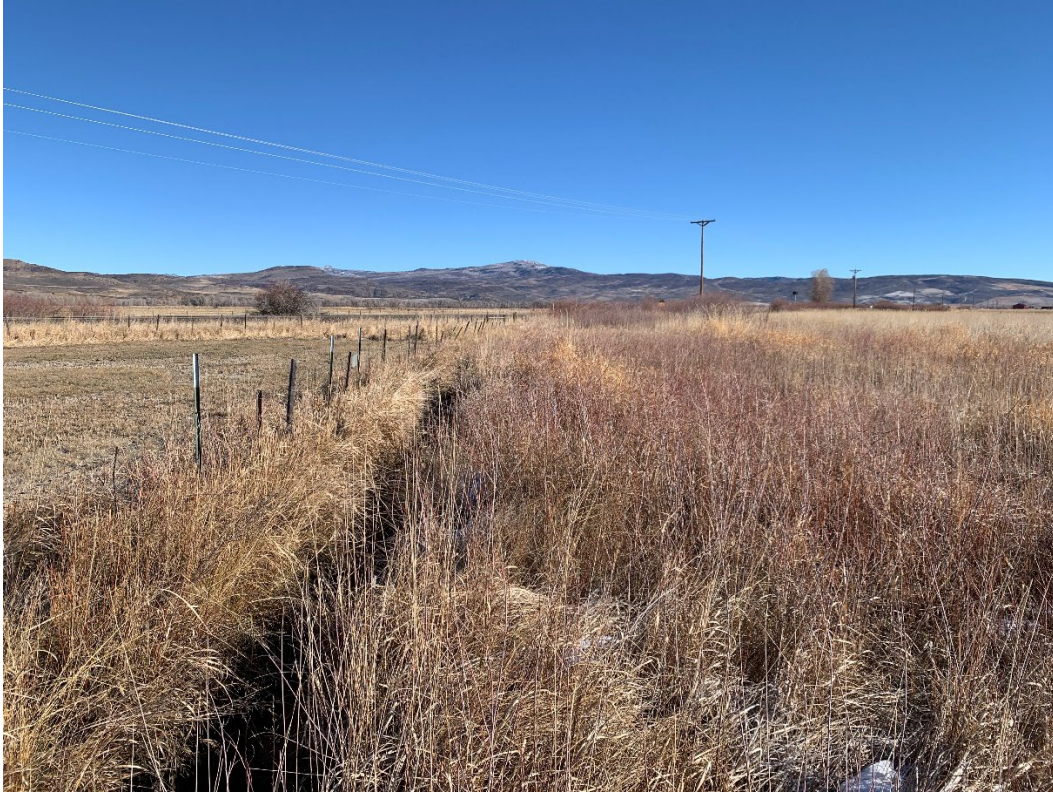
Photo 2 – Outfall 005A

The area near Outfall 005A (photo 2) had a dense stand of grass with some young willow shoots emerging. The ground cover in this area is estimated at 90% due to the dense stand of grasses.

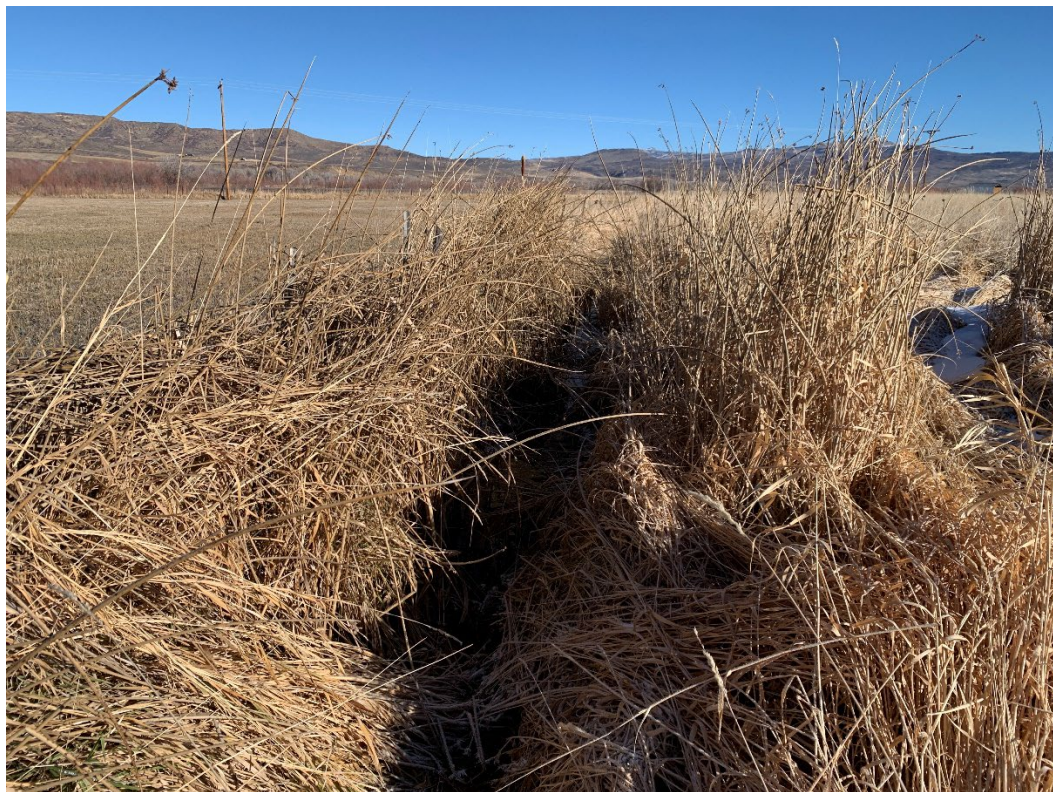
The drainage ditch along the western side of the permit boundary contained water and was lined with a dense stand of grasses (photo 3). The water was frozen in the ditch.

Photo 3 – Ditch along wester permit boundary.

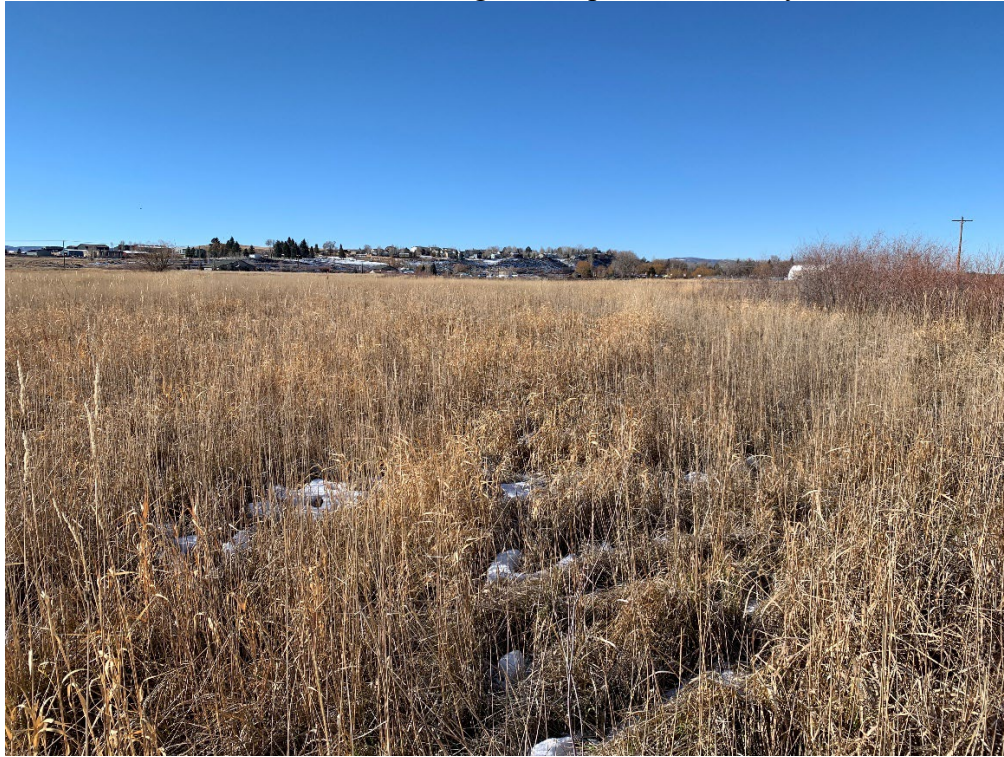
The area between Hwy 40 and the mainline railroad (photo 4) was well vegetated with a dense stand of grasses. Some of the species noted were Reed canary grass, wheatgrasses, meadow brome and orchard grass. A species of carex was noted along the drainage ditch paralleling the western permit boundary.

Photo 4 – Reclamation, facing southwest from mainline railroad track.

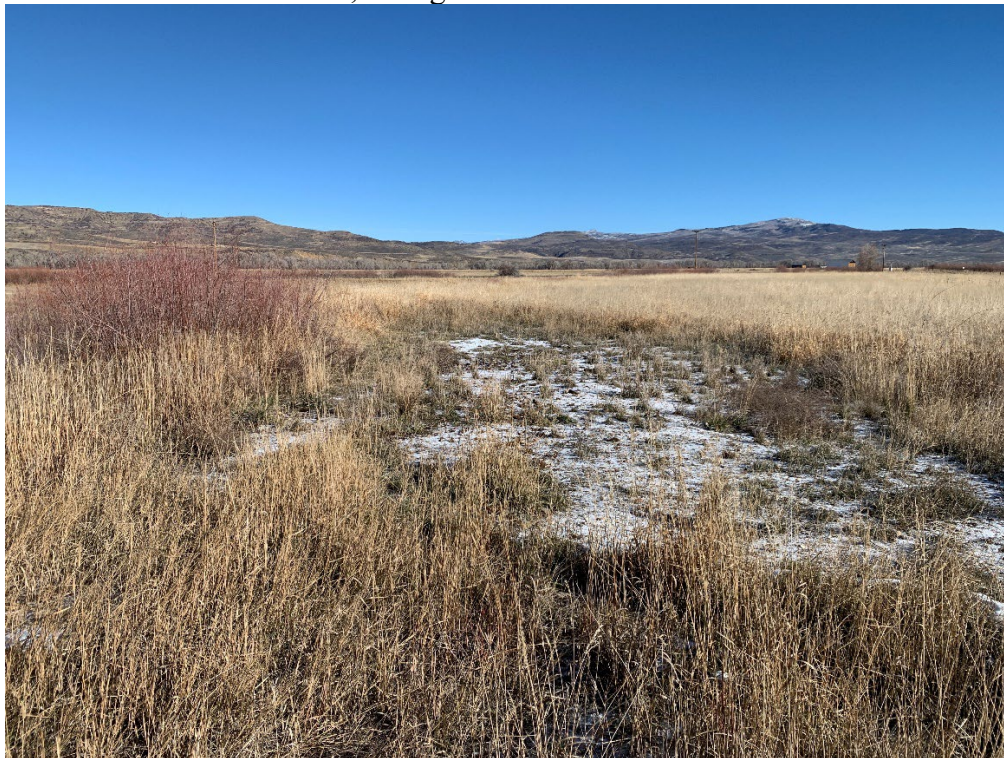
There was a spot (300-400 sq. ft.) in the reclamation where the vegetation was thinner than the surrounding areas (photo 5). The soil in this area contained some larger rocks (1 - 2-inch diameter) which may contribute to the

slower plant establishment. Several houndstongue plants were seen in this area and will have to be treated in the spring.

Photo 5 – Area with thinner vegetation and some houndstongue plants.
