Foidel Inspection report

Miranda and Mike,
Attached is the Foidel Creek, C-1982-056, inspection report for November 2024.
Brock

Permit Number: C-1982-056 Mine Name: Foidel Creek Mine Operator: Twentymile Coal, LLC Operator Address: Ms. Miranda Kawcak 29515 Routt County Road No. 27 Oak Creek, CO 80467	County: Routt Operation Type: Underground Permit Status: Active Ownership: Private
	Operator Representative Present: Michael Howard
Operator Representative Signature: (Field Issuance Only)

Inspection Start Date: November 19, 2024 Inspection Start Time: 10:30 Inspection End Date: November 20, 2024 Inspection End Time: 15:00		Inspection Type: Coal Complete Inspection Inspection Reason: Normal I&E Program Weather: Clear	
Joint Inspection Agency: None		Joint Inspection Contacts: 	
Post Inspection Agency: None		Post Inspection Contacts: 	
Inspector(s): Brock Bowles	Inspector's Signature:

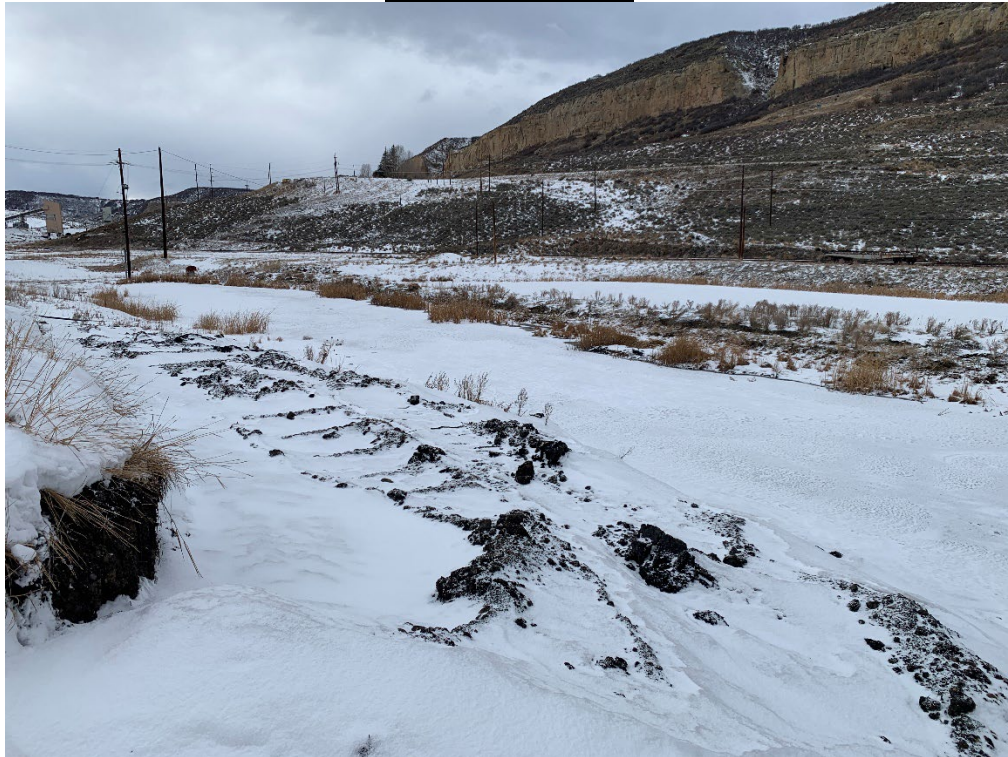
Pond E contained water (photo 1). The pond was mostly snow covered and frozen.

Photo 1 – Pond E

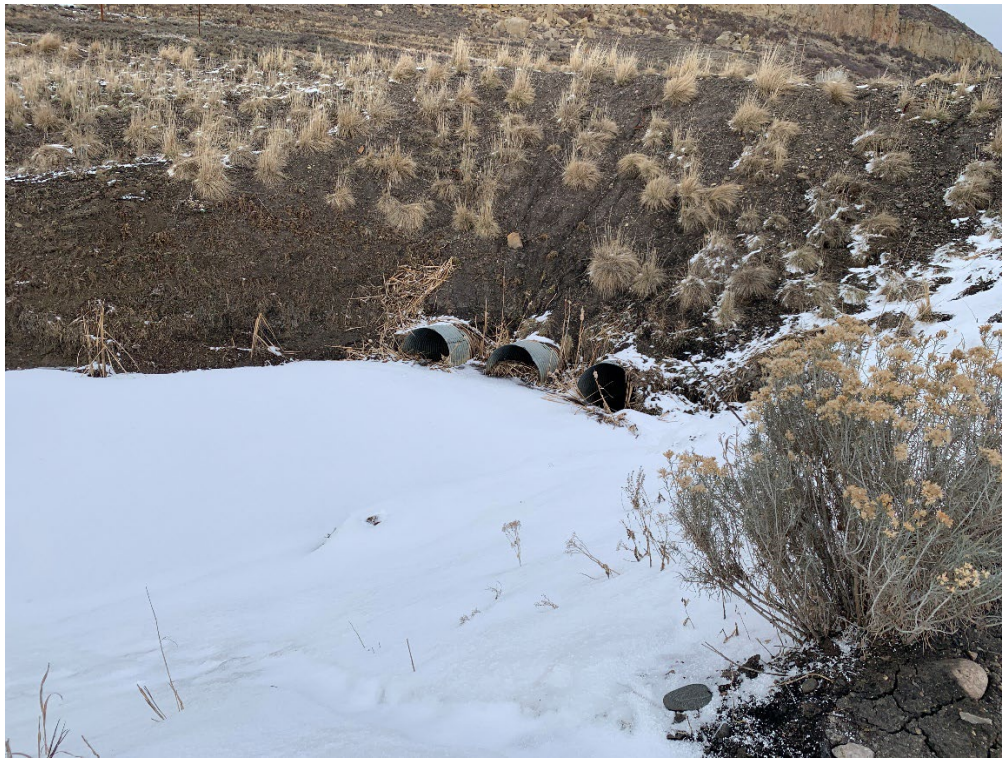
The beaver dam that was clogging the 3 culverts in Foidel Creek by Pond B had been removed (photo 2). The water from the flow of the creek was now freezing in front of the culverts.

Photo 2 – Foidel Creek culverts by Ponds B

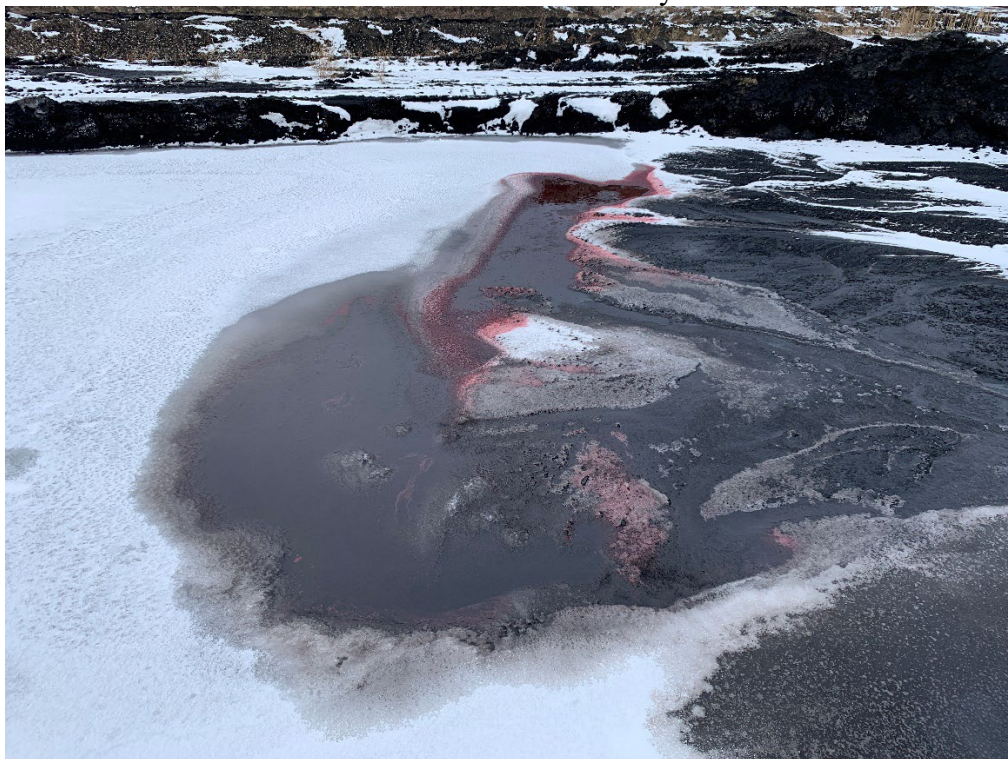
The sump above Ponds B had a lot of sediment removed. A patch of red snow was noted in the Pond B sump (photo 3). The red snow was only located on the inlet side of the sump and not near the outlet (photo 4). It was determined by the operator that the fluid causing the red snow was anti-freeze used on the belt system in winter. The red snow was removed from the sump by the end of the inspection (photo 5).

Photo 3 – Anti-freeze in sump above Ponds B

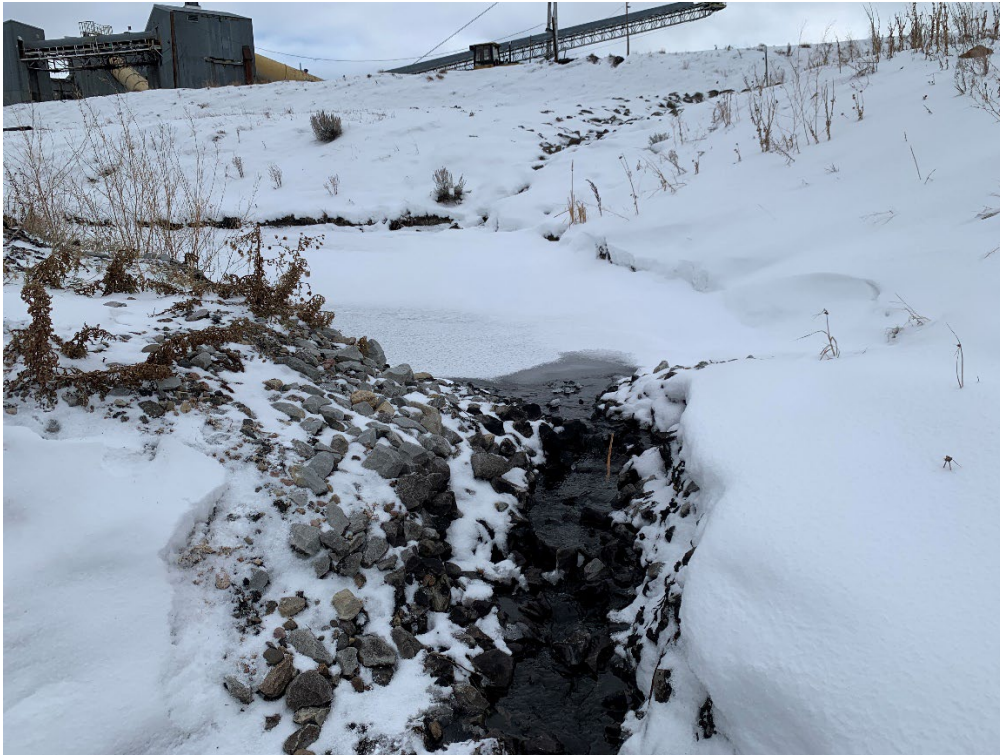
Photo 4- Sump outlet above Ponds B

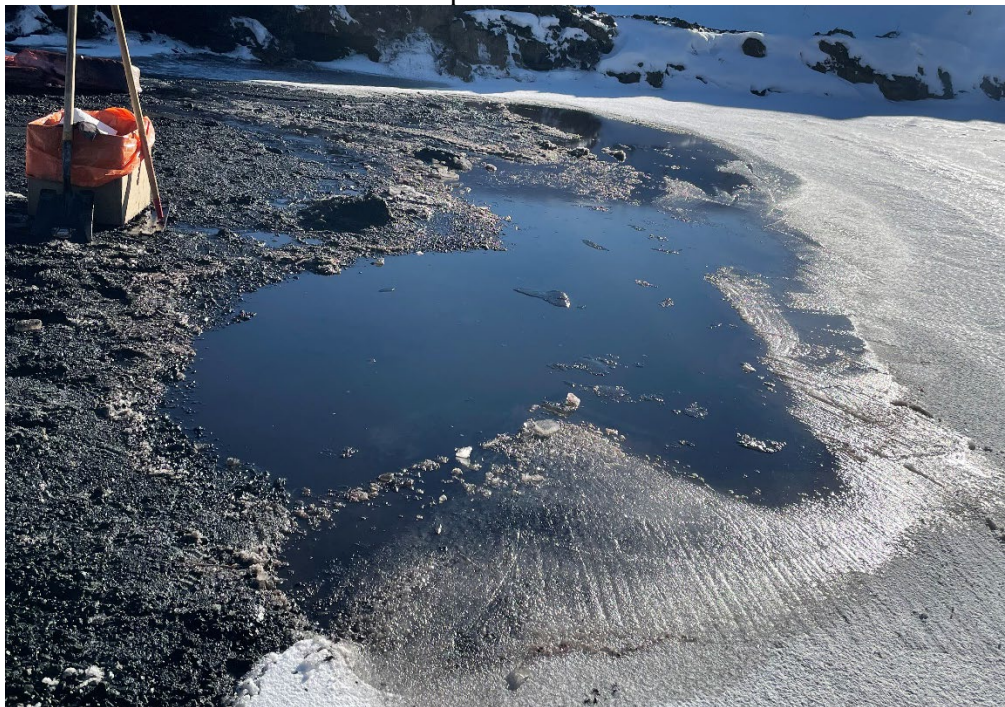
Photo 5 – Anti-freeze removed from sump above Ponds B

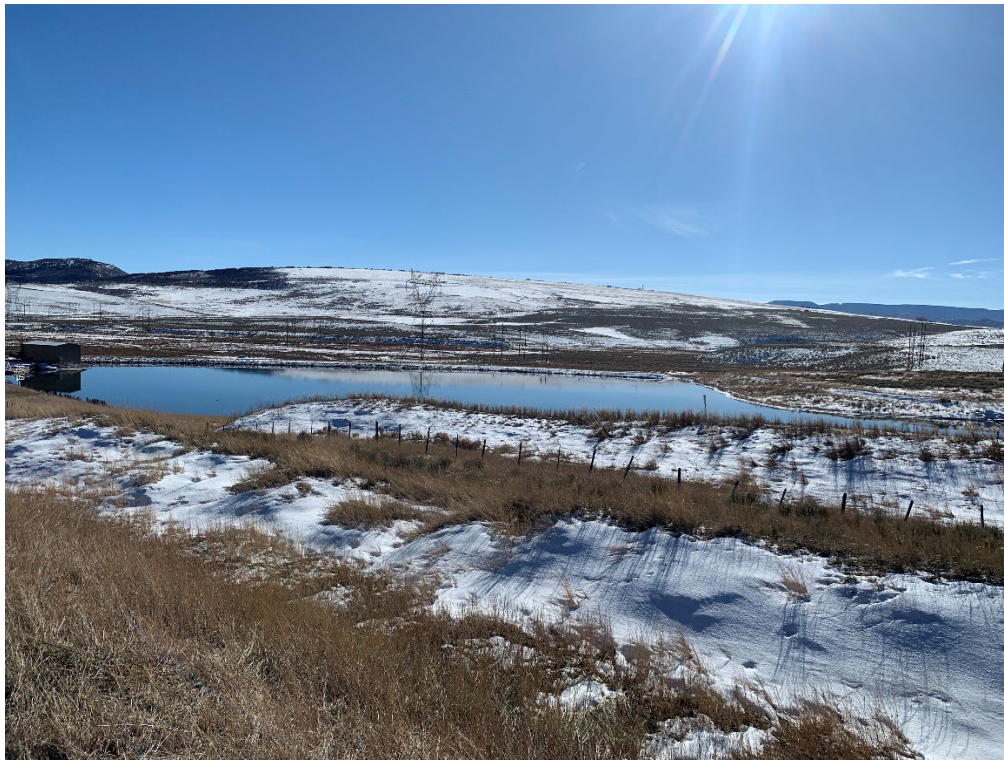
The 6 main north pond contained water and was not frozen (photo 6).

Photo 6 – 6 Main North Pond

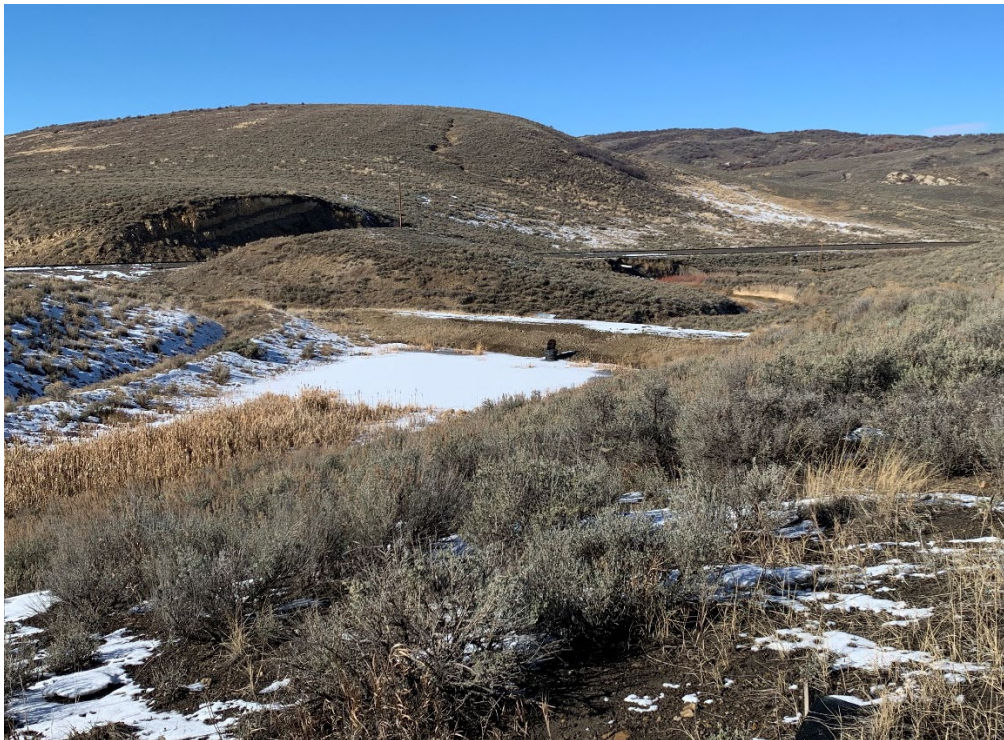
The discharge flume at the Tipple Pond had been replaced (photo 7). The soil was too wet and slippery to walk to

Photo 7 – Tipple Pond flume replaced

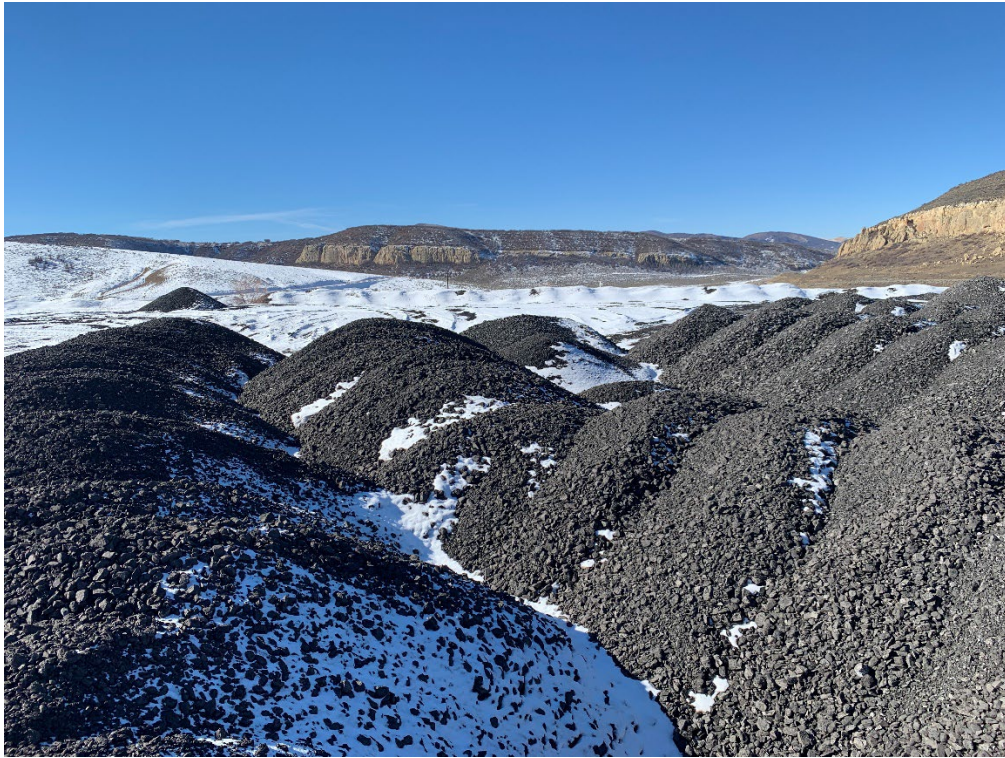
Coal waste piles were stacked on the coal refuse pile (photo 8). The piles were on the north side of the pile. The overall top slope of the refuse was sloped to the south to allow for drainage.

Photo 8 – Stacked coal waste on refuse disposal area

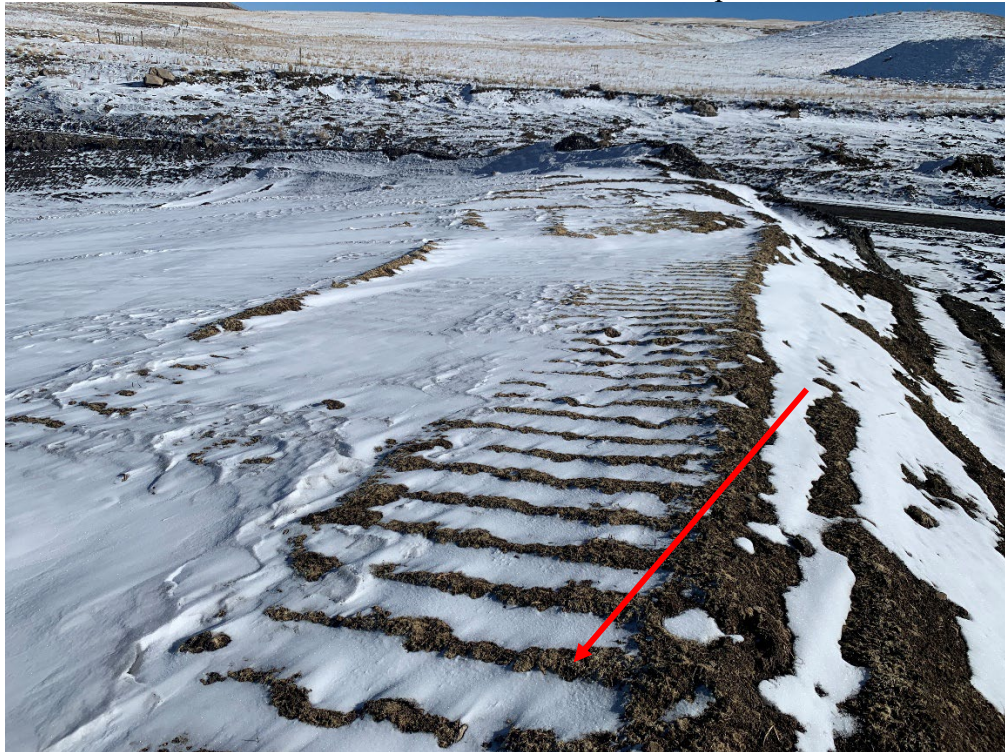
The next lift face of the refuse disposal pile being reclaimed has been hydro seeded. The spray mulch could be seen around some melting snow (photo 9).

Photo 9 – Hydro seeding mulch seen in tractor tracks
