MINERALS PROGRAM INSPECTION REPORT
PHONE: (303) 866-3567

MINE NAME: Clayton Sand and Gravel	MINE/PROSPECTING ID#: M-1999-022	MINERAL: Sand and gravel	COUNTY: Saguache
INSPECTION TYPE: Surety Release Inspection	WEATHER: Clear	INSP. DATE: November 19, 2024	INSP. TIME: 12:30
OPERATOR: Eddie Clayton	OPERATOR REPRESENTATIVE: Rod Clayton	TYPE OF OPERATION: 110c - Construction Limited Impact	
REASON FOR INSPECTION: Surety Release Requested	BOND CALCULATION TYPE:	BOND AMOUNT: \$0.00	
DATE OF COMPLAINT: NA	POST INSP. CONTACTS: None	JOINT INSP. AGENCY: None	
INSPECTOR(S): Todd Jesse	INSPECTOR'S SIGNATURE:

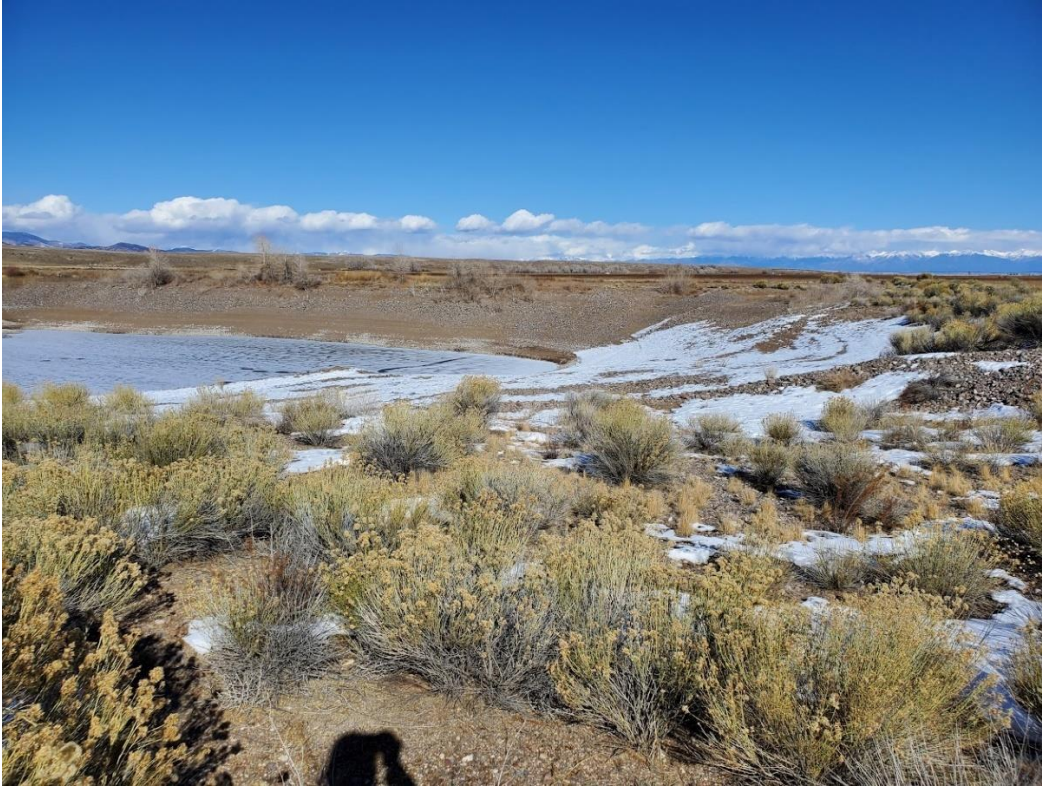
The portion of the permit area that was disturbed was mined at reclamation grade. The slopes of the pond appear stable. There are no signs of slumping or other forms of erosion.

Photo 1 – View to the northeast of sloping on the recharge pond.

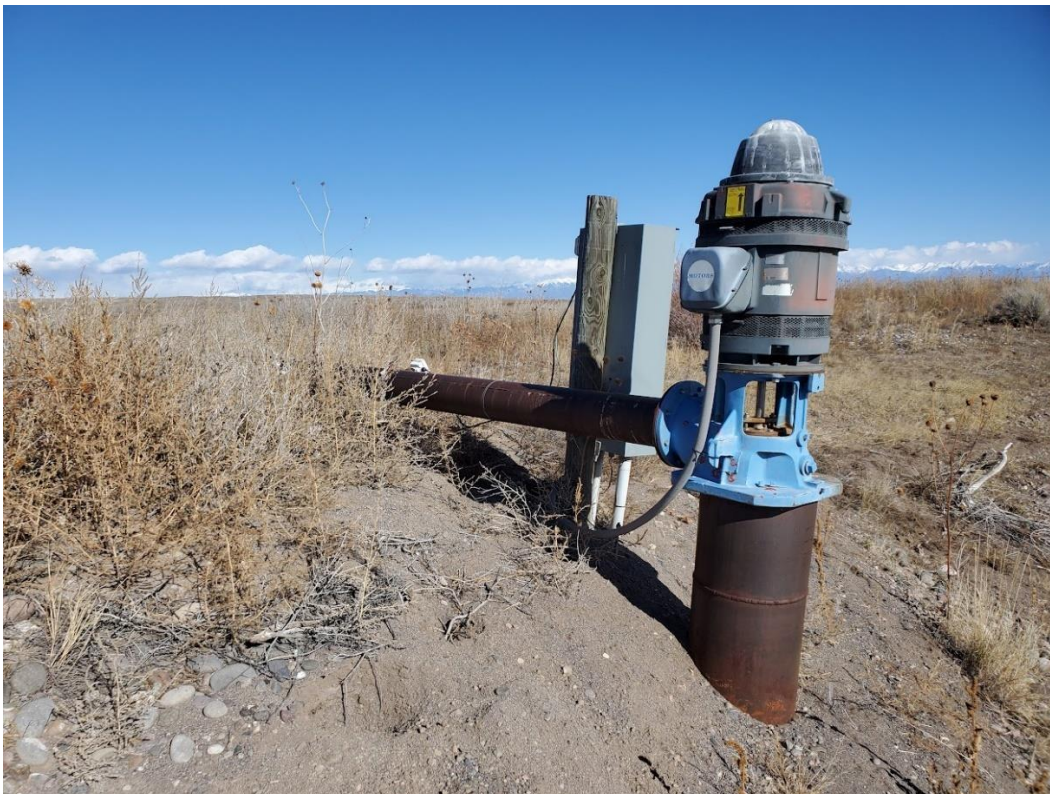
There was a small amount of recharge water and meteoric water present at the bottom of the recharge pond. An irrigation ditch connects to the west side of the recharge pond and irrigation equipment runs from the northern bank of the pond. There is no evidence observed of exposed groundwater. No hydrocarbons were observed on the site.

Photo 2 – View to the north of irrigation infrastructure attached to the recharge pond.

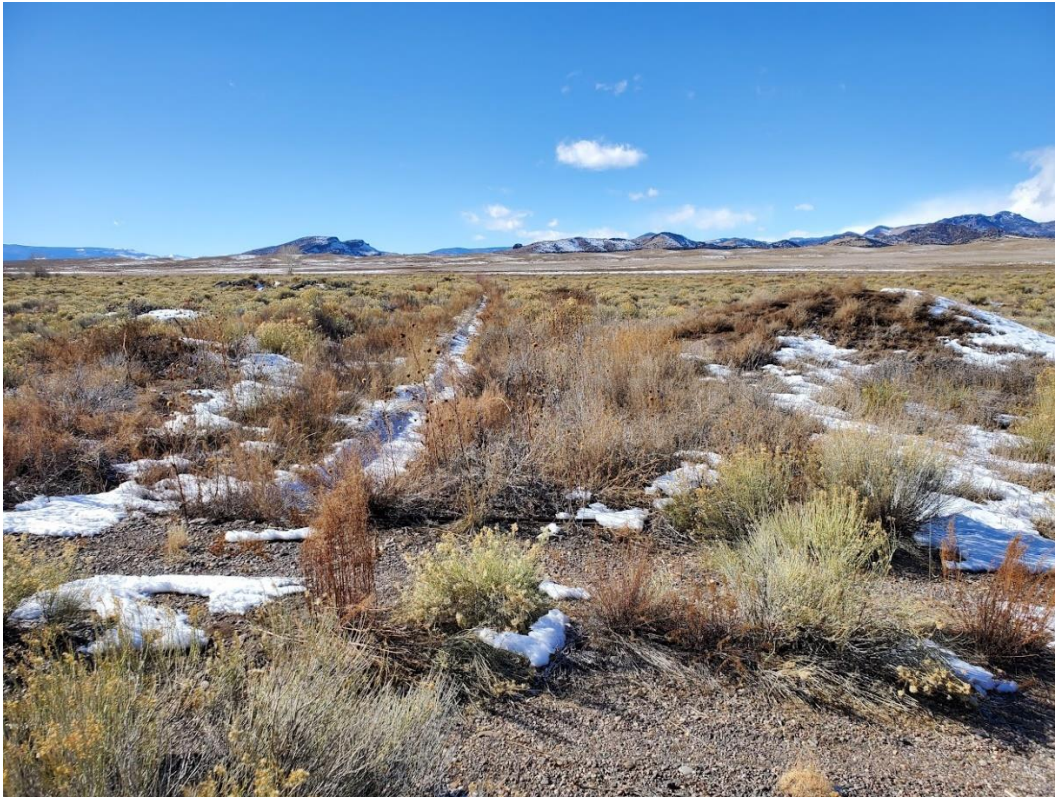
Photo 3 – View to the west of irrigation ditch attached to the recharge pond. Ditch is currently snow covered.

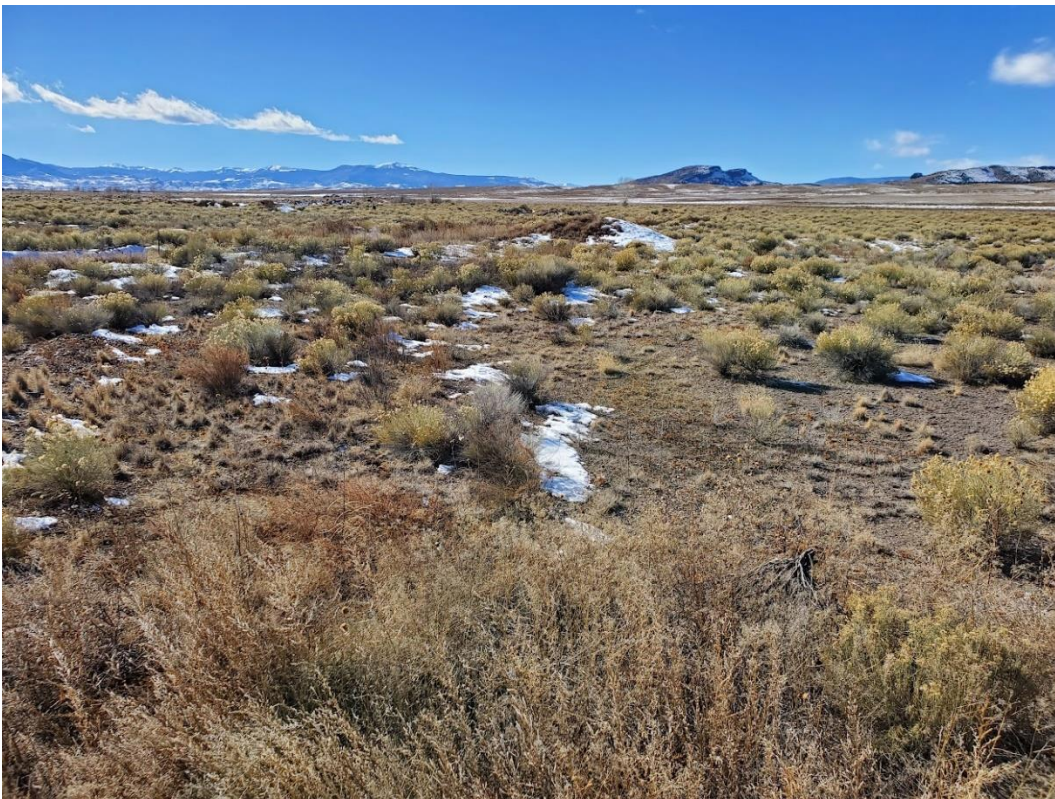
The majority of the permit area remains undisturbed. The mine plan calls for the permit area to be mined in phases. The first phase of the plan was completed and now serves as a recharge pond. The other phases of the plan were not completed and remain undisturbed.

Photo 4 – View to the southwest of undisturbed portion of the permit boundary.

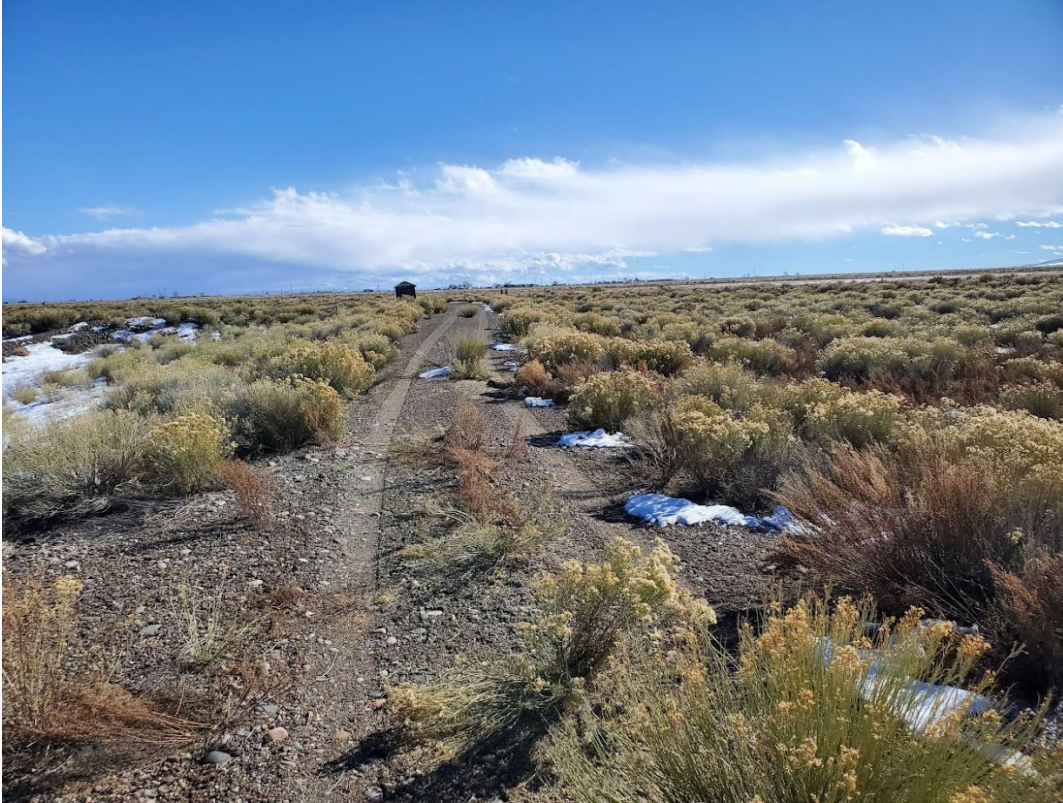
There is one road accessing the permit area. The main haul road that accessed the pit will remain so that the operator can maintain the recharge pit. The road is in good condition with no signs of erosion.

Photo 5 – View to the south of access road to recharge pit.

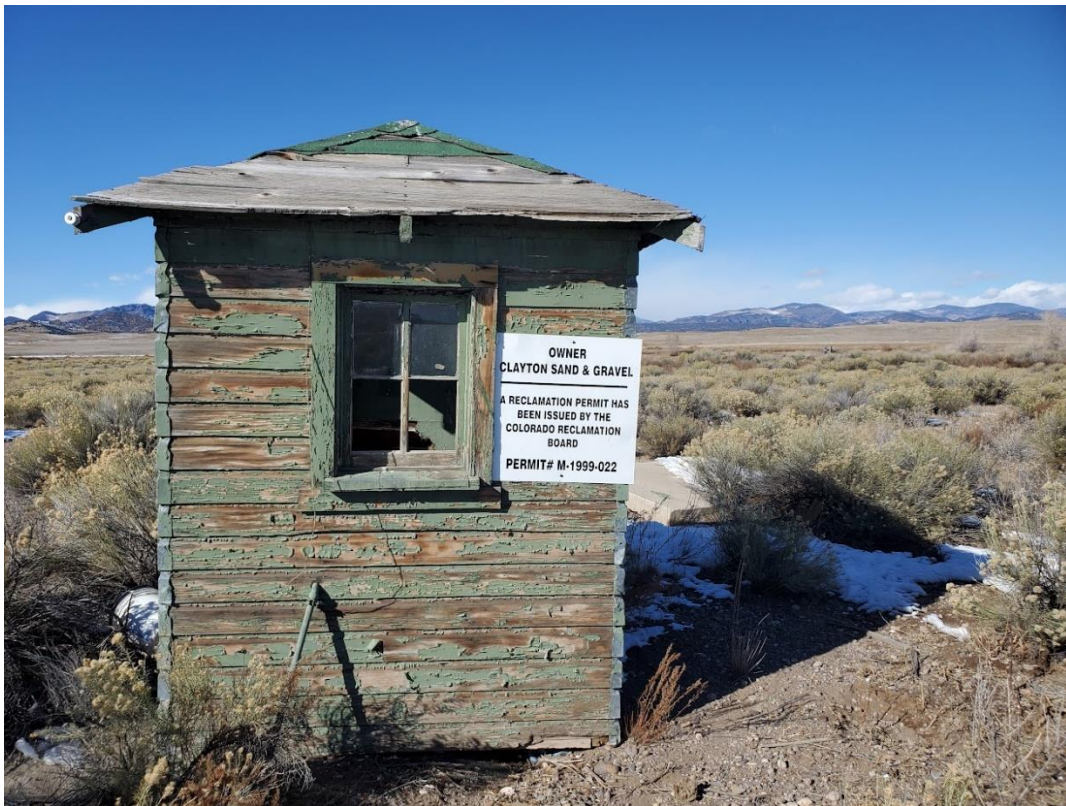
The mine identification sign and the affected area boundary markers are in place and in compliance with Rule 3.1.12. The identification sign is located at the entrance to the permit boundary. The affected area is marked with earthen berms that are easily identifiable.

Photo 6 – View to the northwest of sign at entrance to the site.
