### MINERALS PROGRAM INSPECTION REPORT

<b>MINE NAME:</b> Yocam Borrow Pit	<b>MINE/PROSPECTING ID#:</b> M-2018-020	<b>MINERAL:</b> Borrow material for construction	<b>COUNTY:</b> Morgan
<b>INSPECTION TYPE:</b> Monitoring	<b>WEATHER:</b> Clear	<b>INSP. DATE:</b> November 14, 2024	<b>INSP. TIME:</b> 13:00
<b>OPERATOR:</b> Castle Rock Construction Company LLC	<b>OPERATOR REPRESENTATIVE:</b> None	<b>TYPE OF OPERATION:</b> 111 - Construction by Government Agency	
<b>REASON FOR INSPECTION:</b> Normal I&E Program	<b>BOND CALCULATION TYPE:</b> None	<b>BOND AMOUNT:</b> \$42,500.00	
<b>DATE OF COMPLAINT:</b> NA	<b>POST INSP. CONTACTS:</b> None	<b>JOINT INSP. AGENCY:</b> None	
<b>INSPECTOR(S):</b> Patrick Lennberg	<b>INSPECTOR'S SIGNATURE:</b>

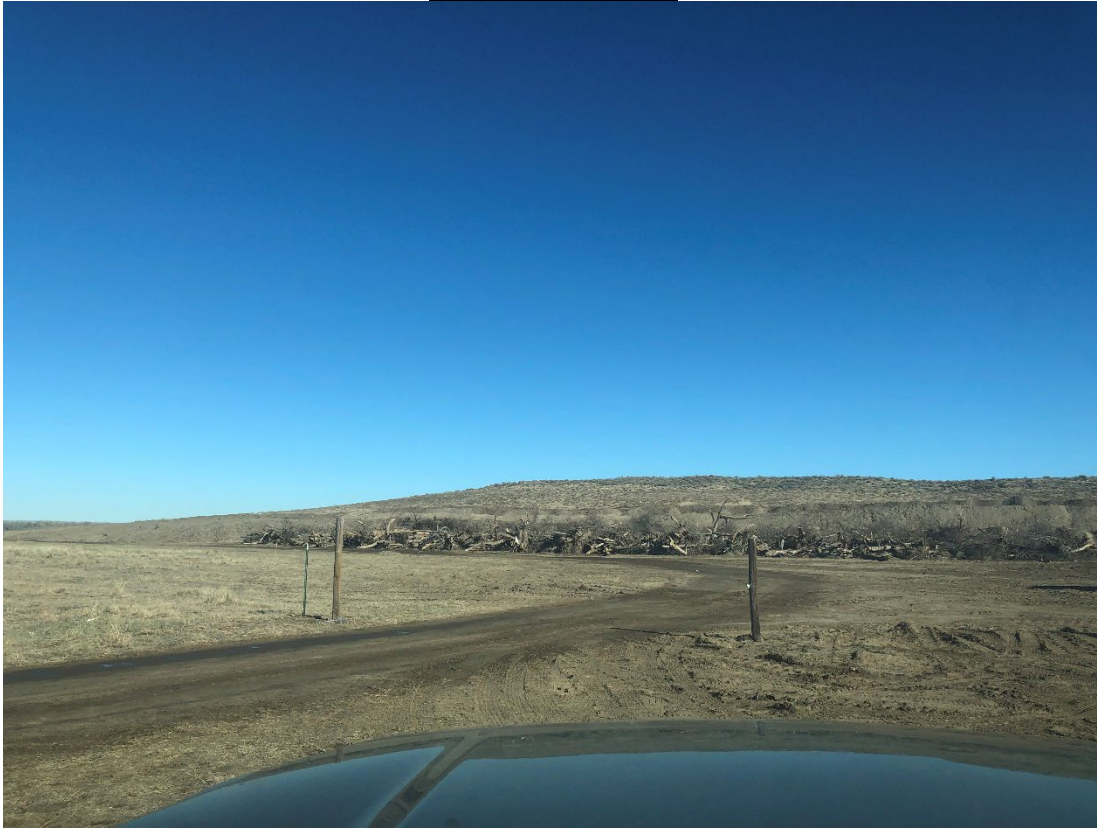
**Photo 1:** Large woody debris being stockpiled at the site, north end of the site

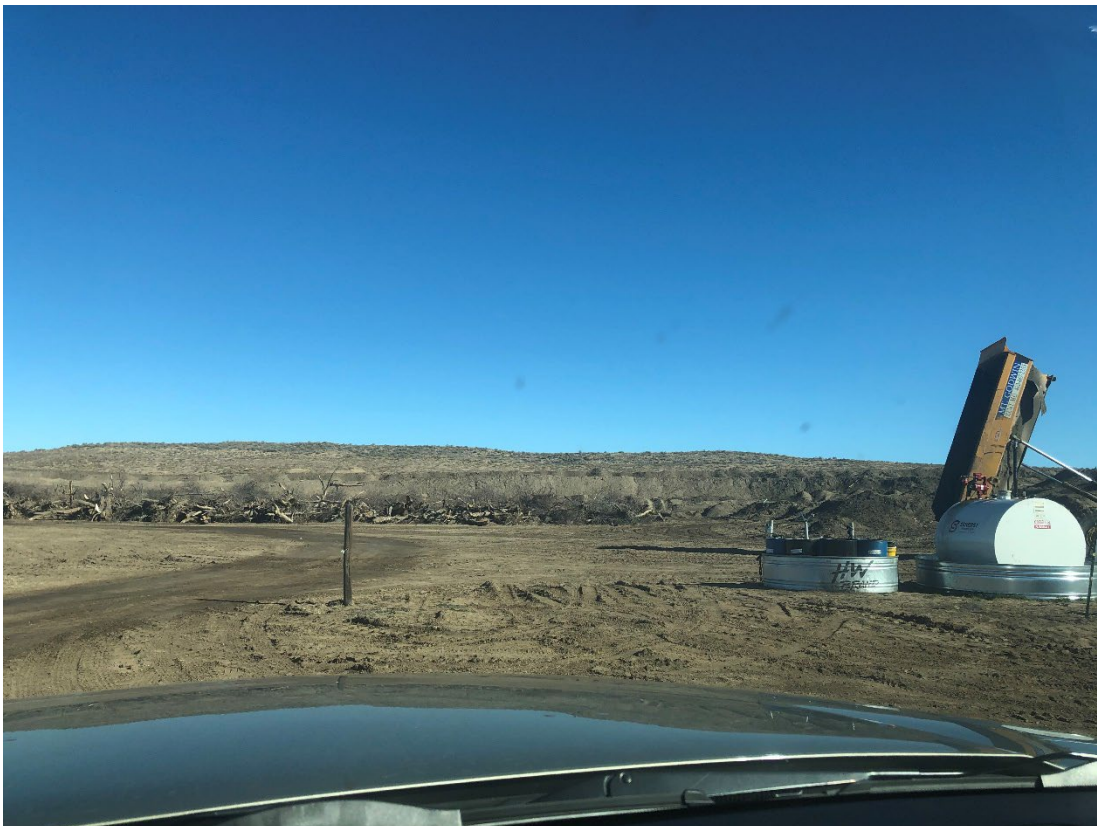
**Photo 2:** Large woody debris and soil being stockpiled at the site, central portion of the site

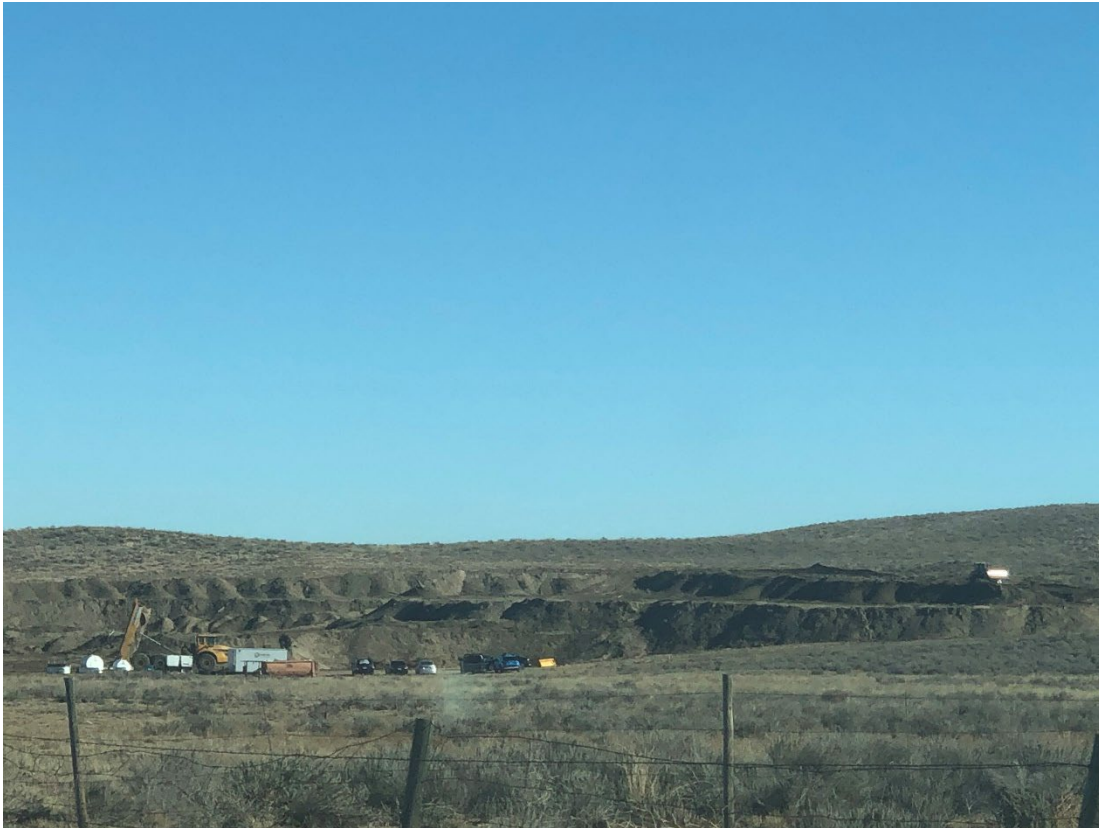
**Photo 3:** Dozer grading out soil material imported by dump trucks, southern portion of the site

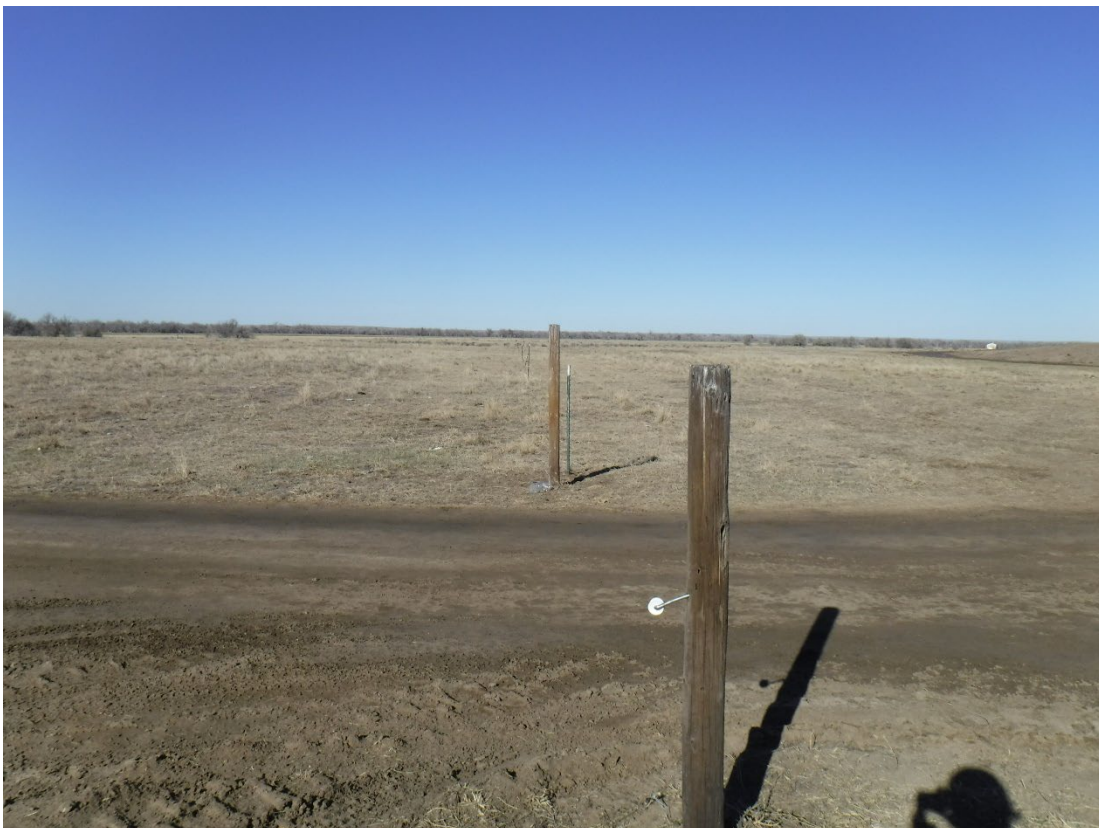
**PROBLEM:** The affected area boundary markers are missing or incorrectly placed. This is a problem for failure to maintain boundary markers around the affected area as required by Section 3.1.12(2) of the rule.

**Photo 4:** Possible permit boundary markers

**CORRECTIVE ACTIONS:** The operator shall conduct a survey and replace the boundary markers in the correct location(s). The operator shall provide proof to the Division that this has been done by the corrective action date.

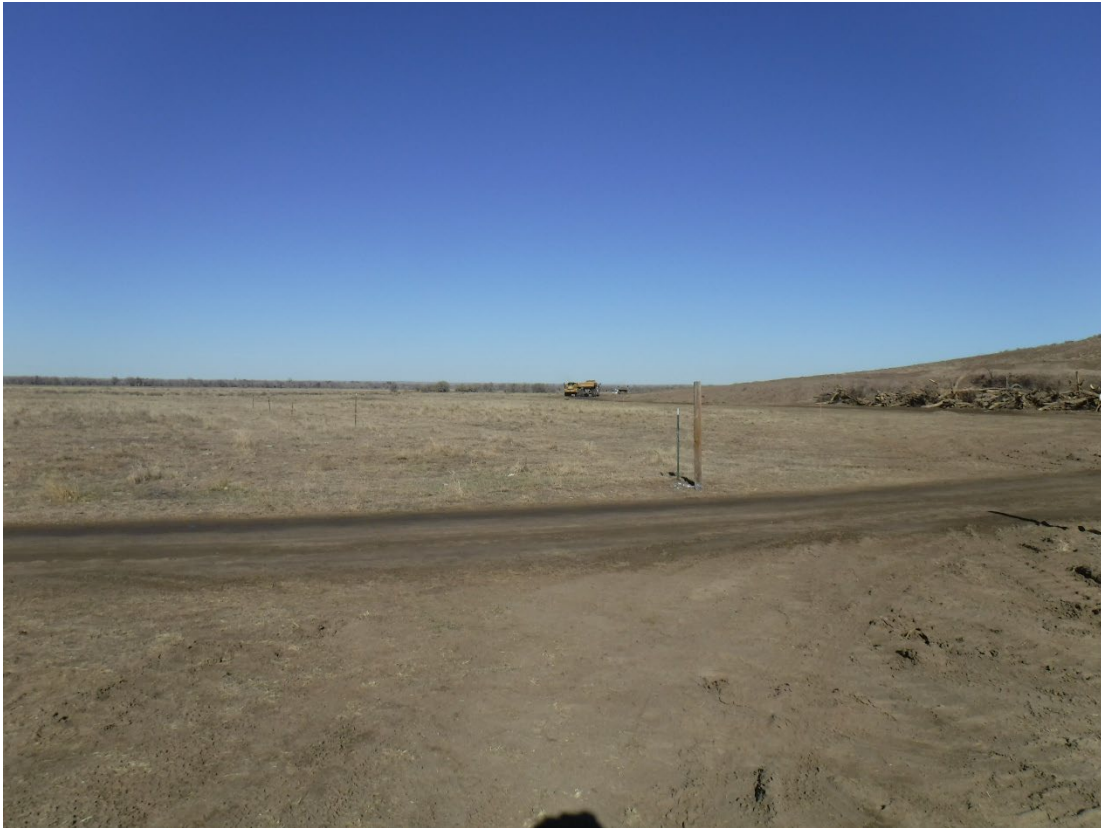
**Photo 5:** Haul trucks transporting material

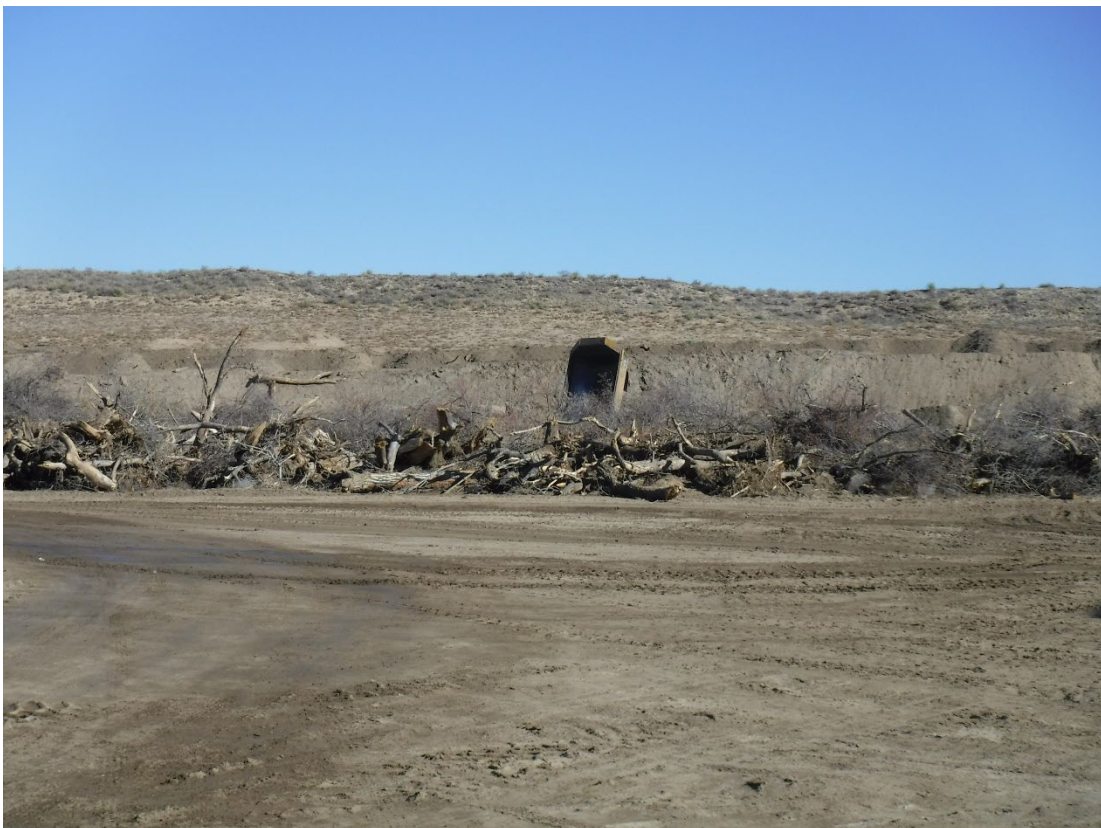
**Photo 6:** Haul truck dumping large woody debris
