MINERALS PROGRAM INSPECTION REPORT
PHONE: (303) 866-3567

MINE NAME: Cash & Who Do Mines	MINE/PROSPECTING ID#: M-1983-141	MINERAL: Gold and silver	COUNTY: Boulder
INSPECTION TYPE: Monitoring	WEATHER: Clear	INSP. DATE: October 8, 2024	INSP. TIME: 11:00
OPERATOR: Colorado Milling Company, LLC	OPERATOR REPRESENTATIVE: Mark Steen	TYPE OF OPERATION: 110(2) - Hard Rock Limited Impact	
REASON FOR INSPECTION: Normal I&E Program	BOND CALCULATION TYPE: Complete Bond	BOND AMOUNT: \$216,200.00	
DATE OF COMPLAINT: NA	POST INSP. CONTACTS: None	JOINT INSP. AGENCY: None	
INSPECTOR(S): Patrick Lennberg	INSPECTOR'S SIGNATURE:

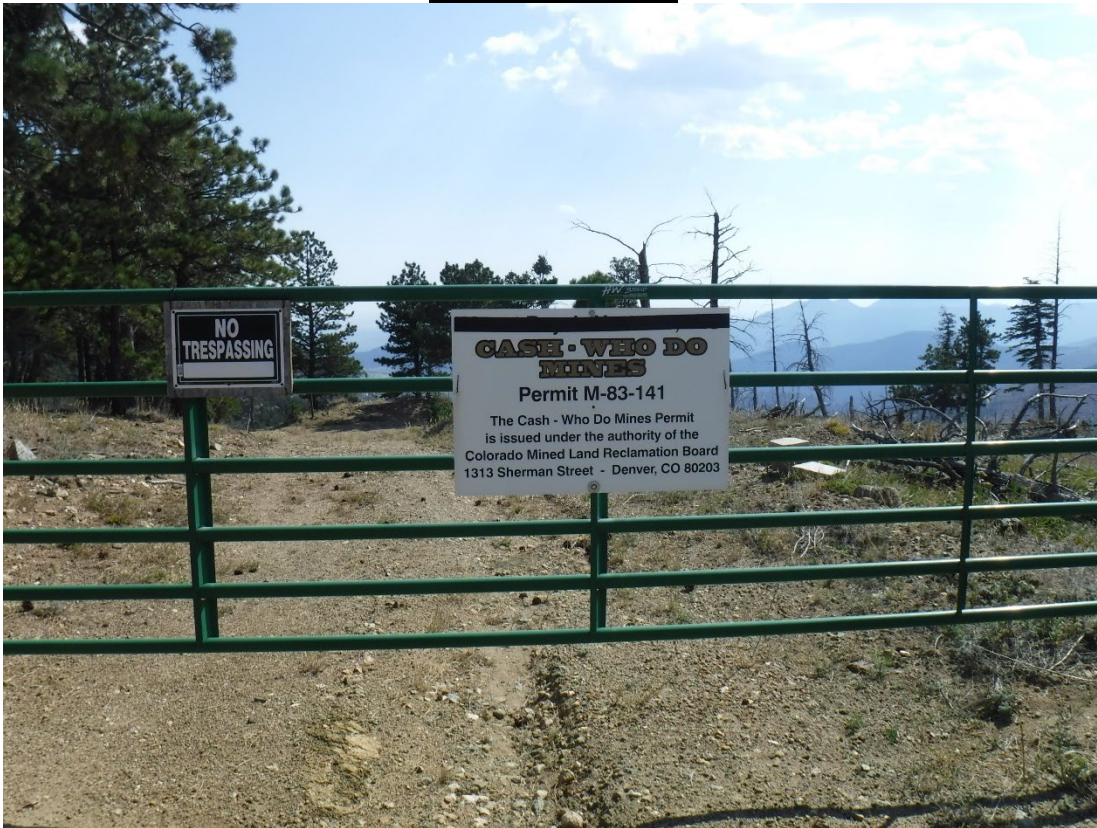
The site is located approximately 10 miles northwest of Boulder, Colorado. The site can be accessed from the south from Gold Run Road, or from the north by passing through the Operator's other permitted mine site, Gold Hill Mill (Permit No. M-1994-117). The approved post-mining land use for the site is forestry. The affected land consists of several patented mining claims owned by Colorado Milling Company and some unpatented claims managed by the BLM. A mine sign was posted at the primary mine entrance as required by Rule 3.1.12. The weather was clear and mild.

Photo 1: Mine sign at primary mine entrance

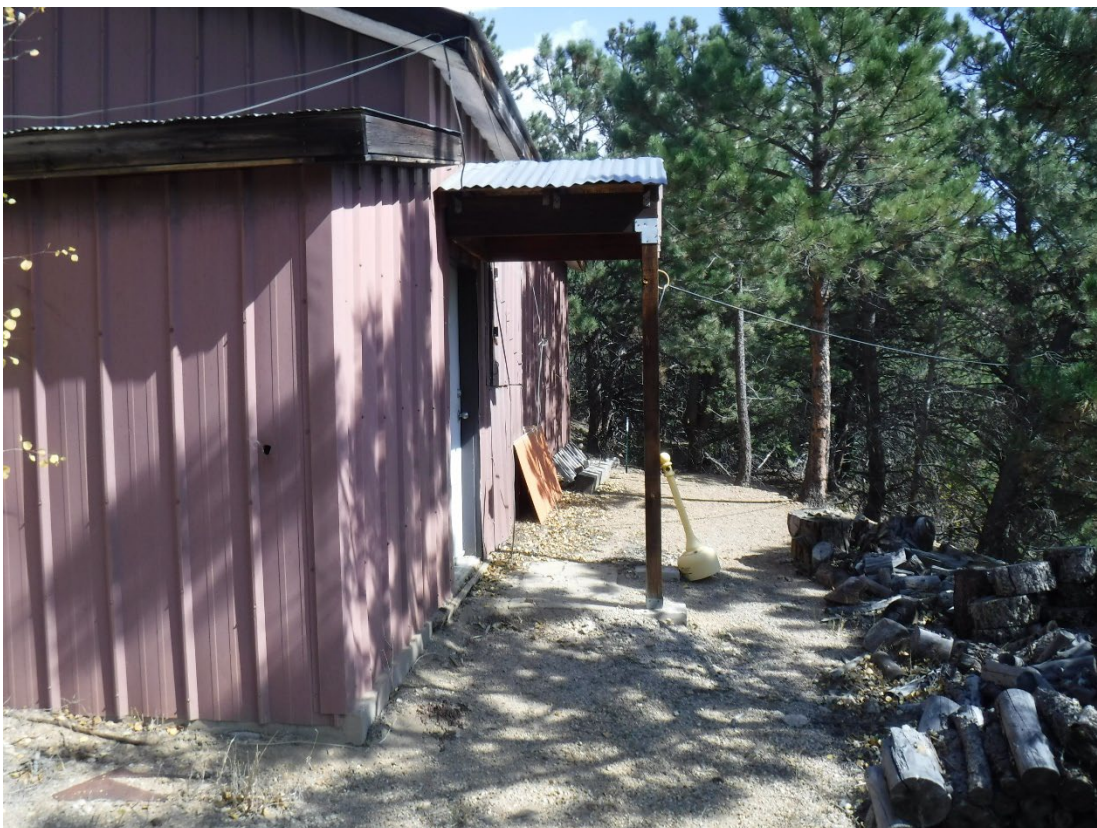
Photo 2: Office Building next to Hoist House

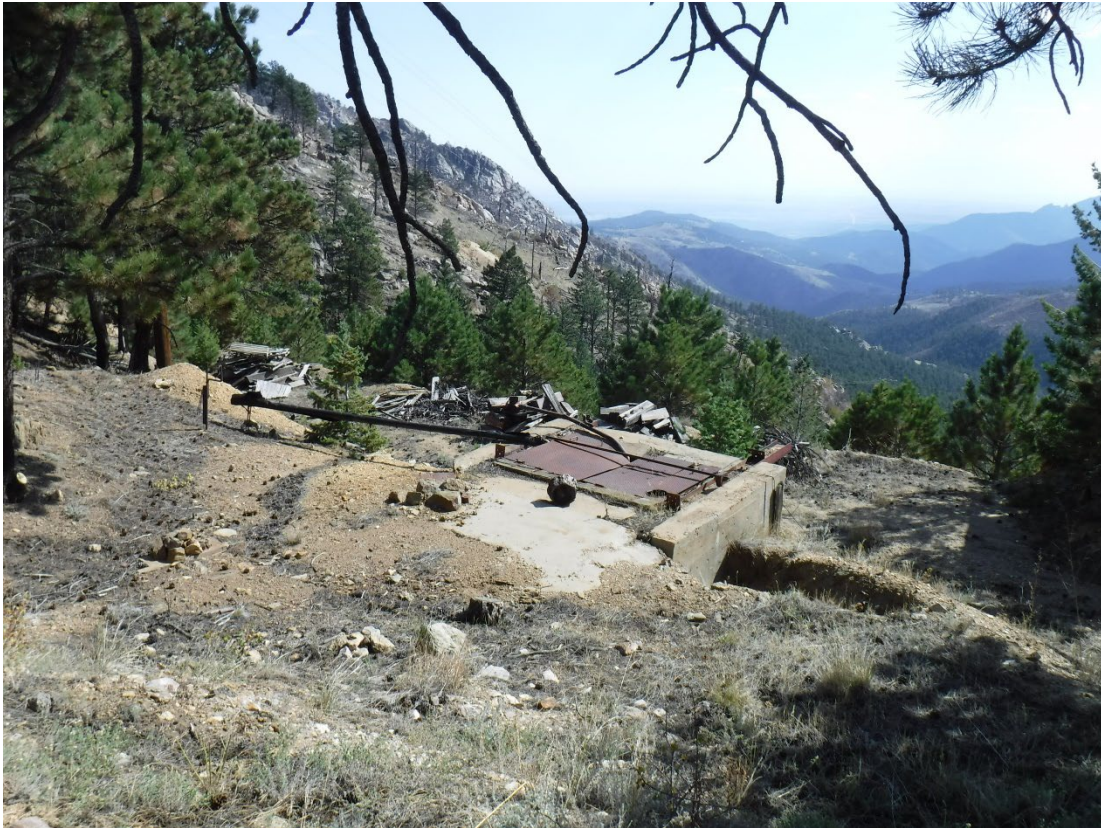
Photo 3: Cash Shaft

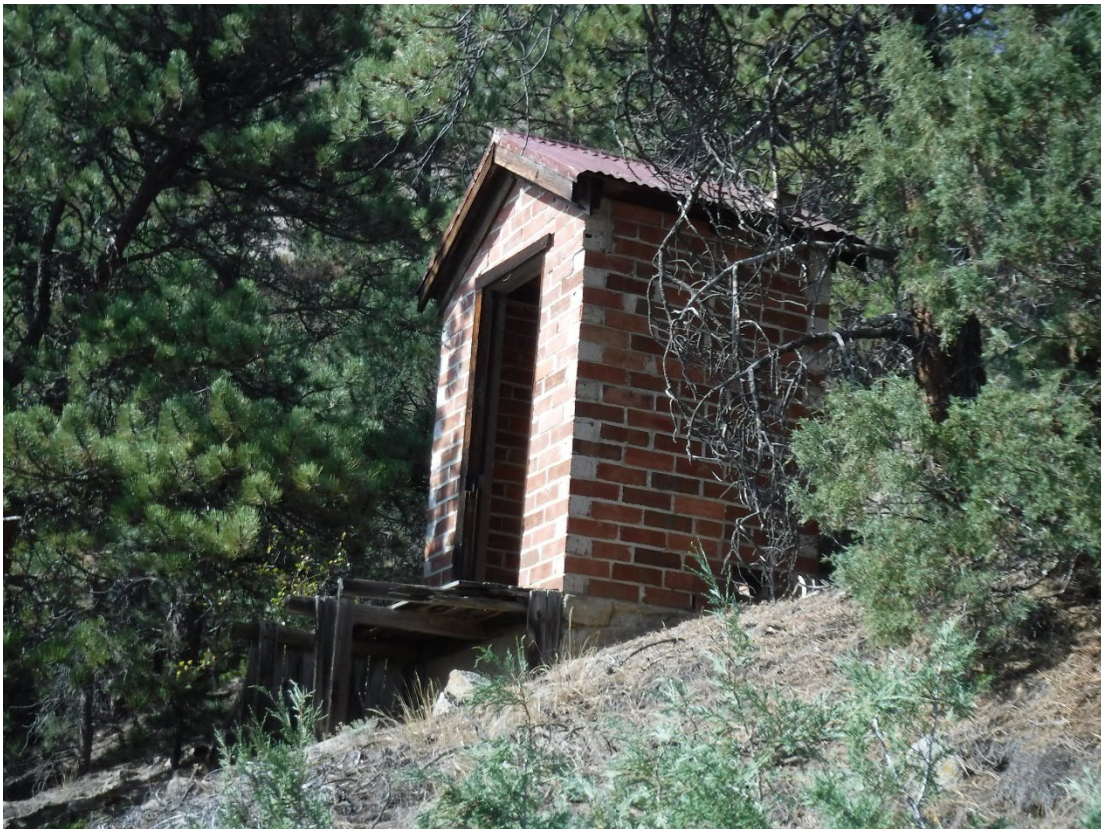
Photo 4: Old privy on hillside

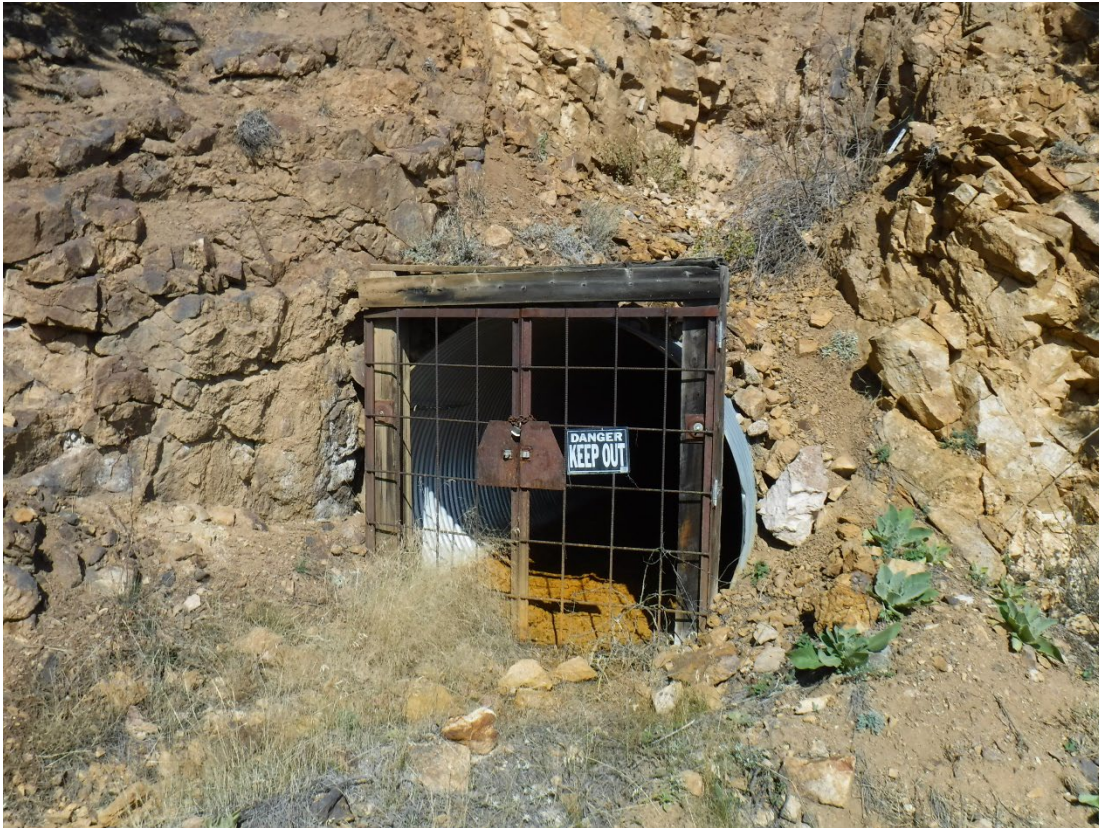
The Division inspected the Who Do Mine Area located on the other side of Cash Gulch, west of the Cash Mine Area. This area includes a mine portal (referred to as the Donald R. Adit in the mining plan), the Who Do shaft and headframe, a mine dump area, a collapsed building (possibly the remnant Hoist House mentioned in the mining plan), and a small brick building (possibly the remnant Powder Magazine mentioned in the mining plan). The adit in this area is typically referred to in the permit file and inspection reports as the Who Do Mine or the Who Do Portal. The Division did not observe any water present in the mine portal and the sediment at the portal entry was dry and desiccated. The ground surface of the small sump located directly in front of the portal had some orange staining, indicating the sump does impound mine discharge as intended.

Photo 5: Who Do portal

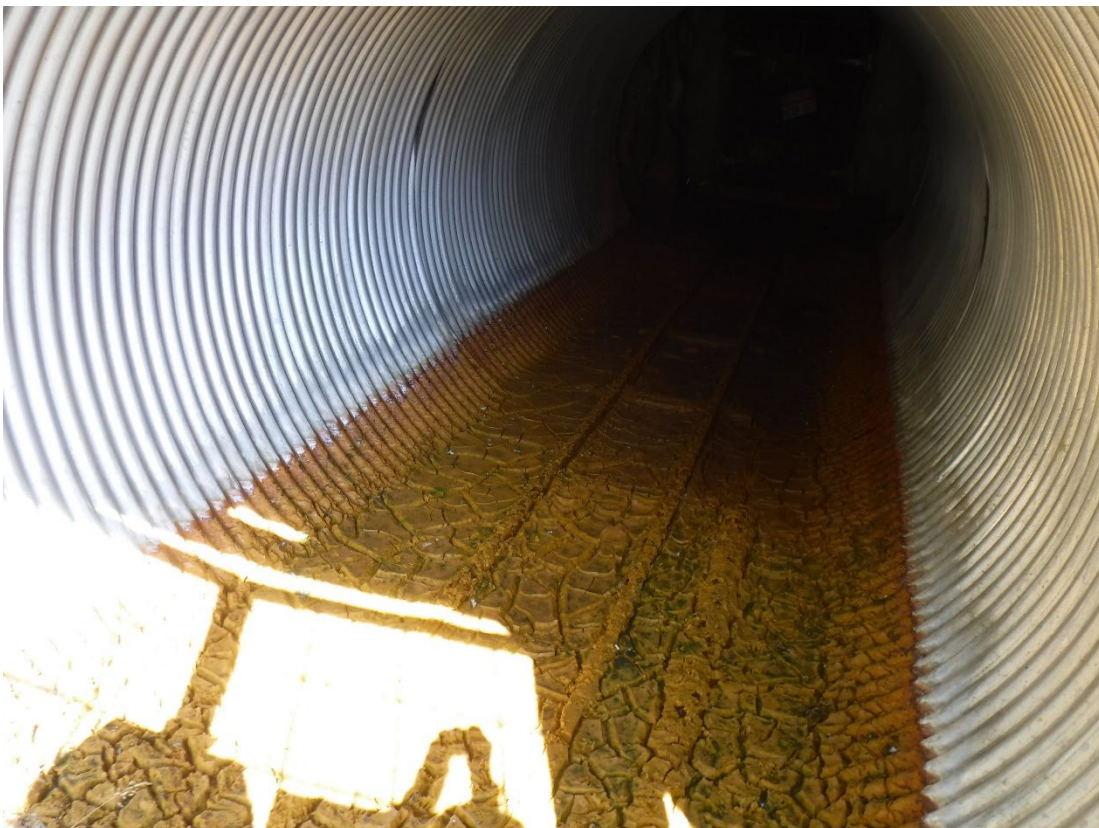
Photo 6: Sediment in Who Do portal

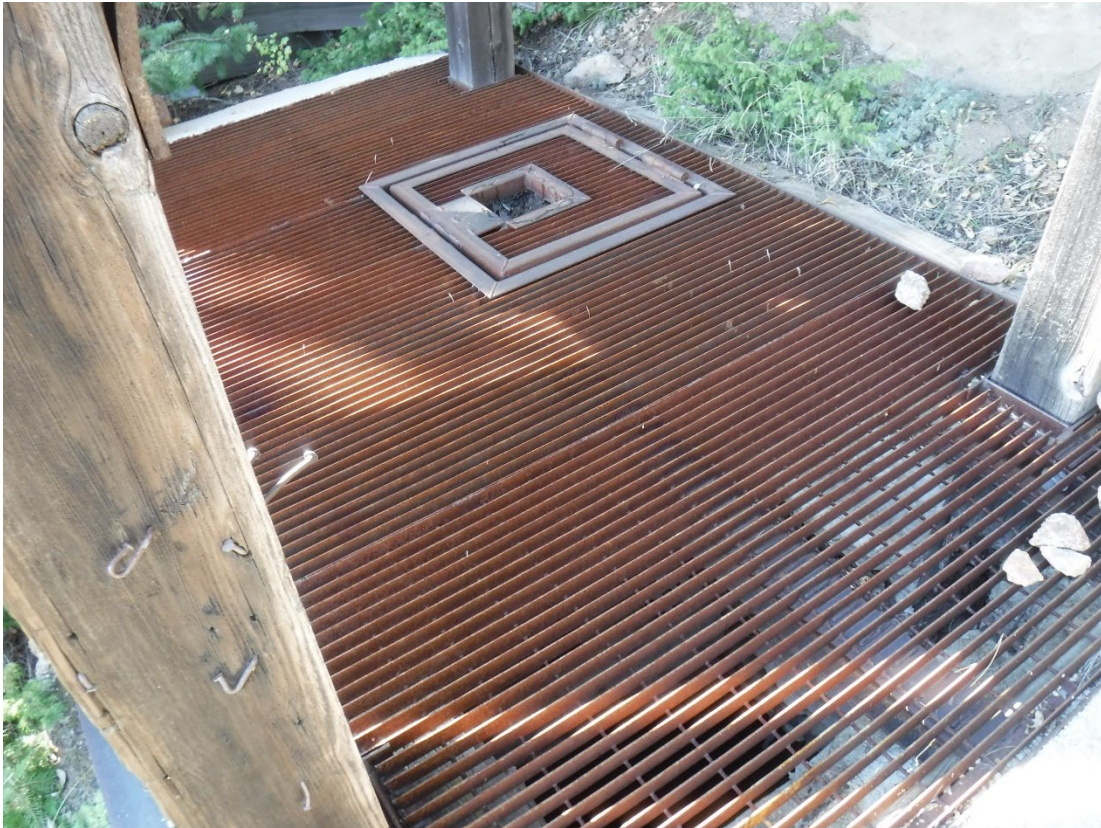
Photo 7: Who Do shaft below the headframe

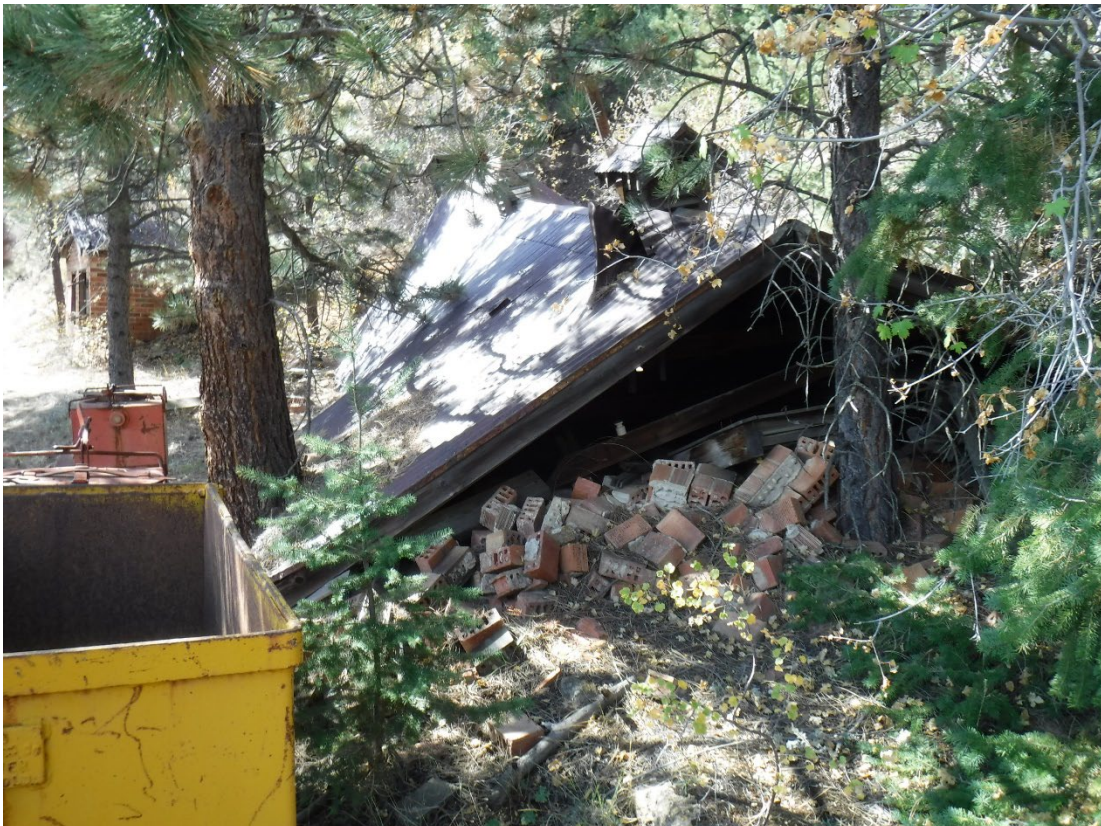
Photo 8: Collapsed building, maintenance building, adjacent to Who Do shaft

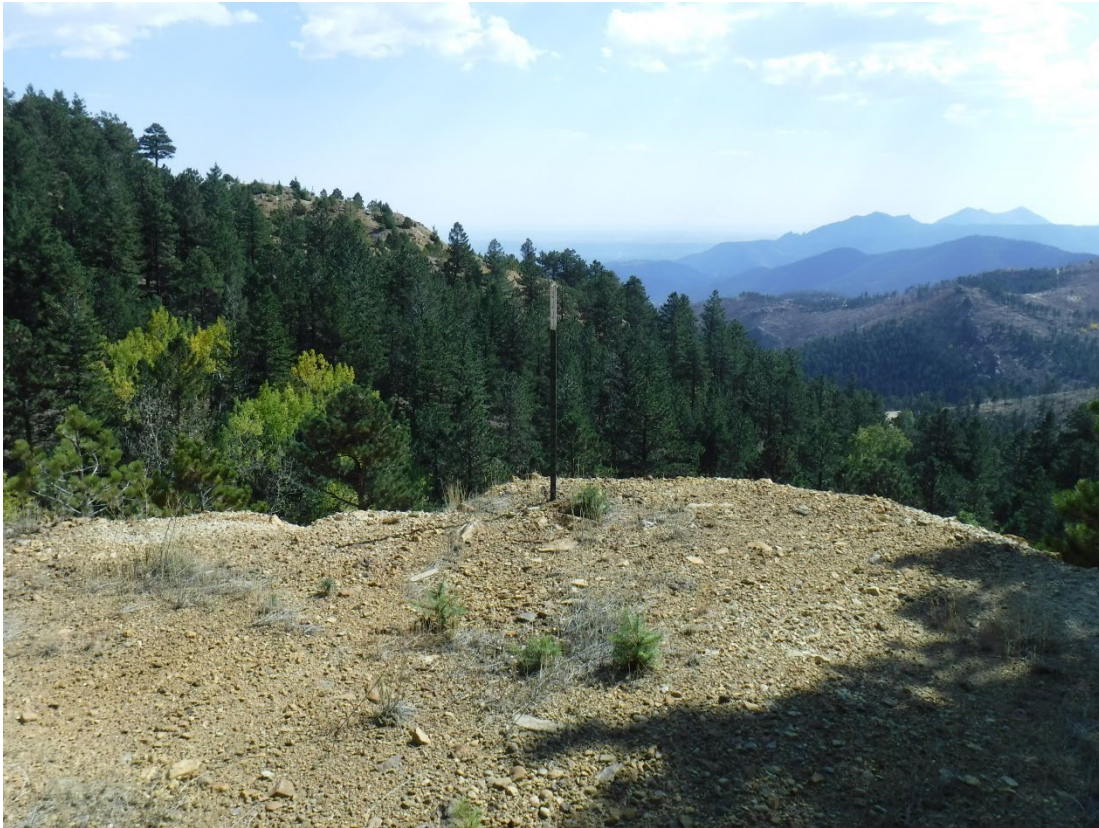
Photo 9: Typical permit boundary marker

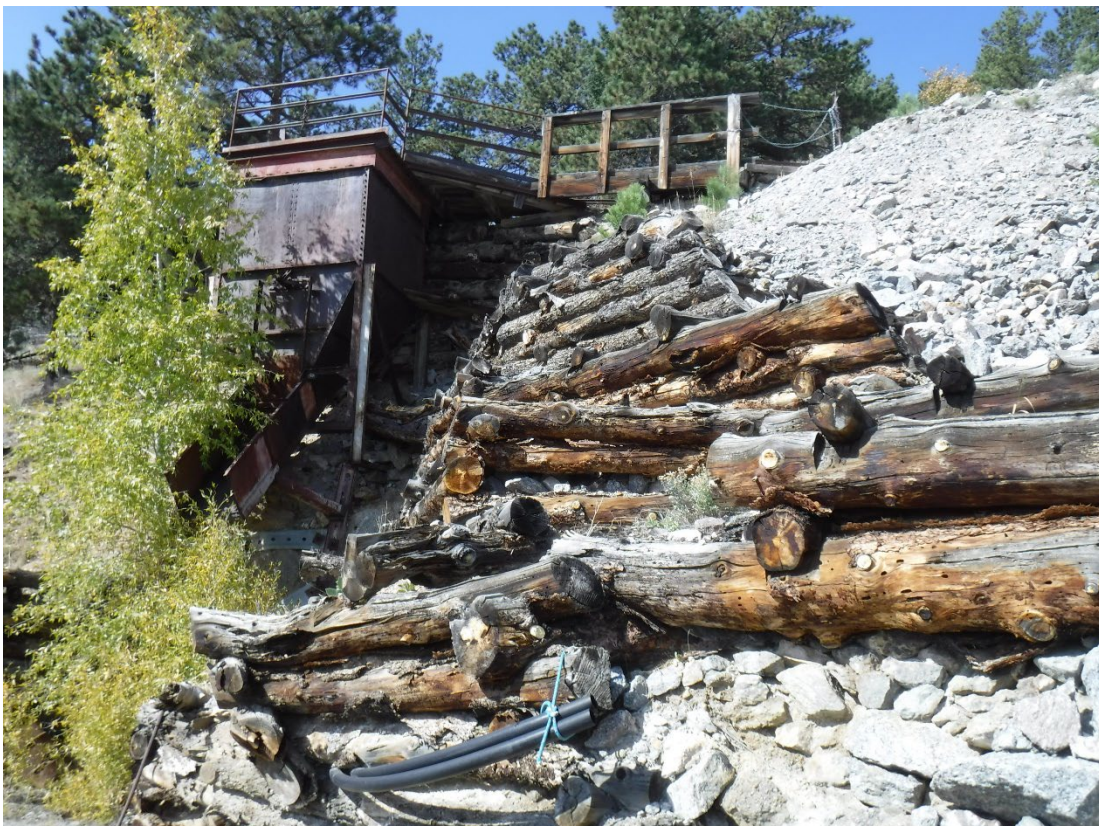
Photo 10: Mount Royale loadout area

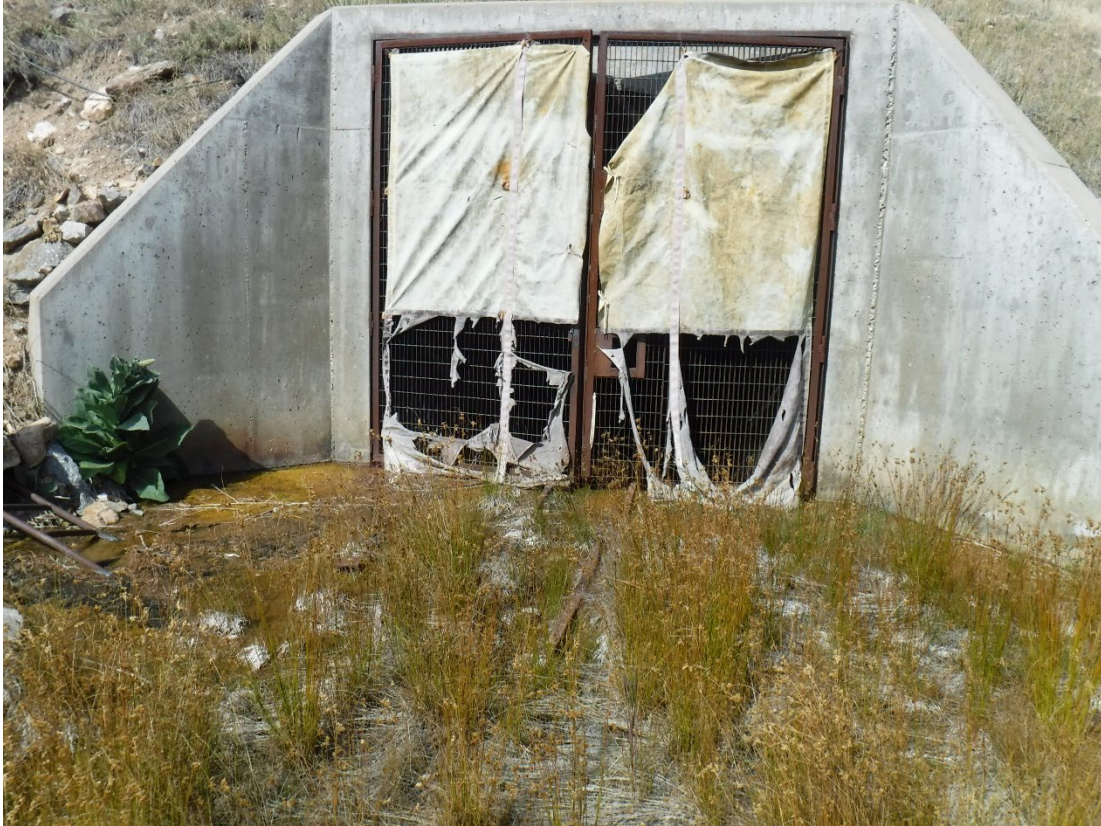
The Division inspected the Mount Royale Adit Area, which is located downgradient from the other two areas. This area includes the main ore bin/loadout, waste rock dump areas, the Mount Royale No. 1 Adit, and a small sediment pond located below the mine portal (on top of the waste rock pile). The adit was discharging some water at the time of the inspection. The water was leaving an orange stain on the ground surface, consistent with an iron oxide precipitate. The mine water reports to the sediment pond. The sediment pond was partially full of water and no water was observed to be discharging from the pond. The Water Quality Control Division of the Colorado Department of Public Health and Environment has determined that a discharge permit is not required for this operation. Additional information regarding the need for a discharge permit can be obtained in the permit file.

Photo 11: Mount Royale Adit No. 1

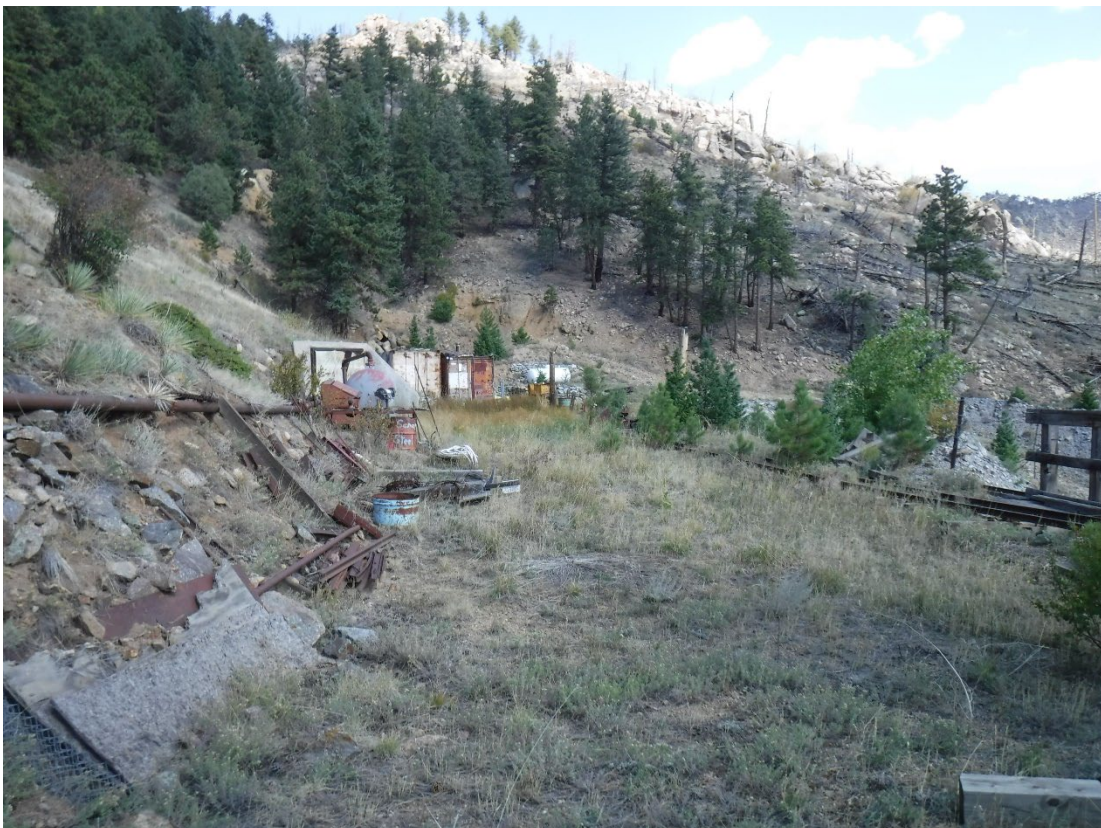
Photo 12: Looking east across Mount Royale Adit No. 1 area

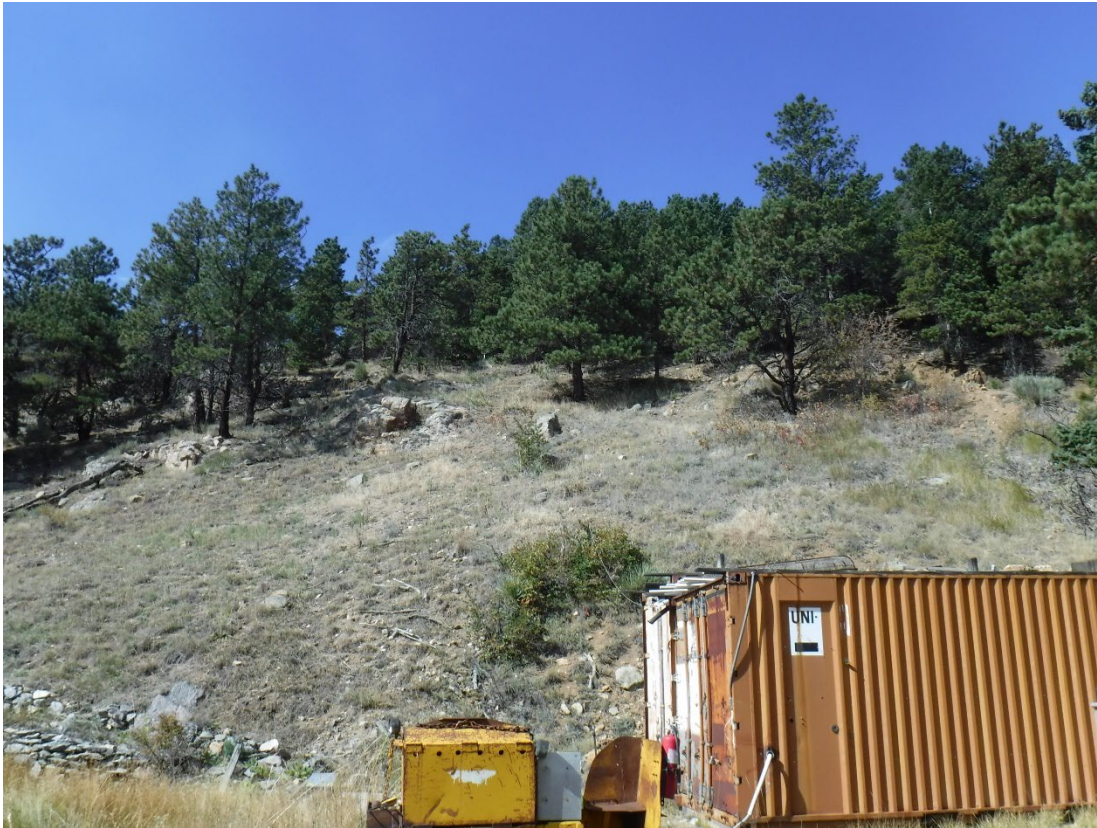
Photo 13: Looking uphill from Mount Royale Adit No. 1 area towards Cash Mine area

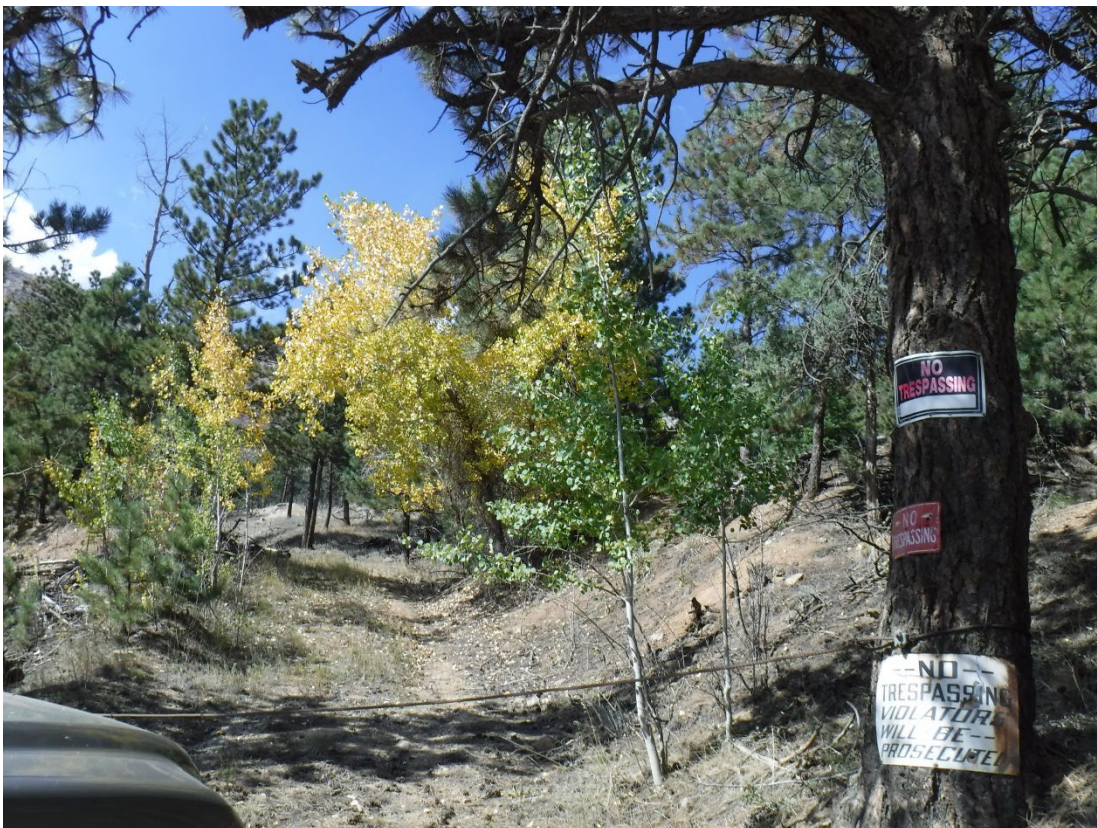
Photo 14: Mine entrance area from Gold Run
