December 9, 2024

#### Re: M-1977-573 – West Pueblo Pit - Arkansas River Bank Erosion Repair Project

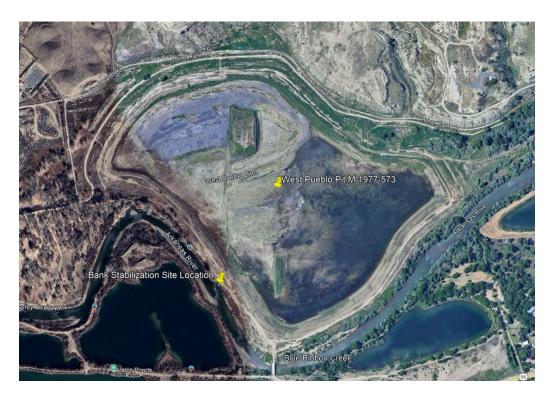
The Arkansas River at the West Pueblo Pit is eroding a section of the bank near the West Pueblo Pit just west of the city of Pueblo, Colorado (Figure 1).

Figure 1. Overview of West Pueblo Pit, Showing Location of Bank Erosion.

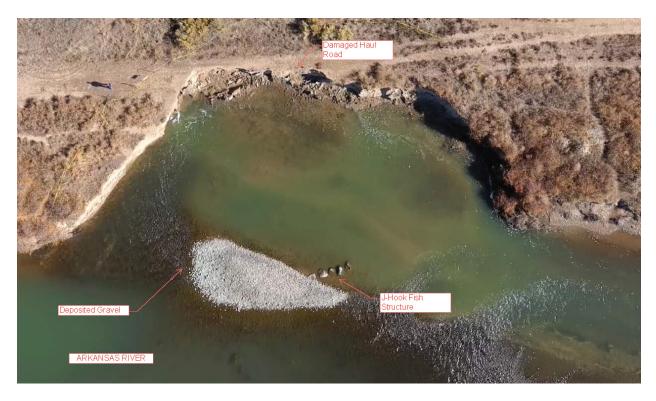
The erosion is believed to be caused by the deposition of gravel and rocks at the location of a rock J-Hook fish habitat structure present in the river near the bank. The rock structure has forced these materials to settle upstream of the rocks, forming a large rock and gravel bar that particularly at lower flows, is high enough to force a portion of the river's flow to turn as though it was flowing over a broad-crested weir laterally into the bank line. The soils at this location did not have any armoring or protection from highly erosive hydraulic factors such as the increased shear stress resulting from the higher velocities to prevent this erosion. Additionally, the native soils themselves are highly erodible and appear to be mostly composed of fine-grained sands and silts that are cohesionless and have no ability to resist when a shearing force is applied to

them. Any native vegetation that was originally present was easily destabilized when the underlying soils started to erode away from the roots of that vegetation; soils, when they become saturated, lose strength that they need to resist loads that are applied to them. When the soils become saturated and lose strength, the mass of the upper soils becomes unsupportable and the entire bank collapses vertically down into the river; this is easily observable at this location. Figure 2 below shows an overview of the scour hole and shows the cause of the erosion and the damage that has been sustained on AGRA's property as a result.

# Figure 2. Overview of The Scour Hole at West Pueblo Pit, Showing Cause of Erosion and Damaged Areas.

As stated above, AGRA and CPW are working jointly on a design to stabilize and repair this site. At this time, the planned work includes placing roughly 5,000 cubic yards (CY) of fill to restore the mass of soil and the bank line that has been lost to erosion. This volume has been estimated using recent topographic surveys of the site. The gravels in the riverbed that are re-directing flow laterally into the bank will be removed and under U.S. Army Corps of Engineers (USACE) guidelines, will be re-used as subgrade fills in the hole. Finished slopes are not known at this

time, but from survey, the undamaged banks upstream and downstream from the damaged area have slopes of about 1.25:1. The finished grades of this project will seek to match those areas in a way that also accommodates the flow the river. Slope protection measures are undetermined at this time, but may include alternatives including riprap, buried soil riprap, or koir wrap soil lifts. The rock structures will not be removed and as such, long-term coordination with CPW will be necessary to ensure that the river does not re-deposit bed materials in such a way that this problem will only occur again in the future.

A revegetation plan that makes use of native grasses, willows, and cottonwoods will be used to stabilize the finished surface of the slope. Topsoil from existing stockpiles within the pit will be used as a final lift of soil above the subgrade to help with establishment of the planting and seeding on the project.

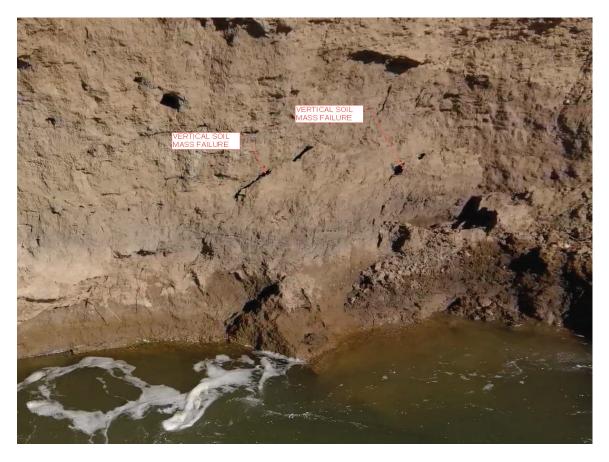
Figure 3 below shows an example of the vertical bank caving that is occurring due to saturated soils.

Figure 3. A Close-Up View of the Damaged Bank, Showing Where The Bank Is Failing Vertically.
