MINERALS PROGRAM INSPECTION REPORT
PHONE: (303) 866-3567

MINE NAME: Shook Gravel Pit 1	MINE/PROSPECTING ID#: M-2001-012	MINERAL: Gravel	COUNTY: Washington
INSPECTION TYPE: Monitoring	WEATHER: Cloudy	INSP. DATE: December 6, 2024	INSP. TIME: 11:30
OPERATOR: Washington County	OPERATOR REPRESENTATIVE:	TYPE OF OPERATION: 112c - Construction Regular Operation	
REASON FOR INSPECTION: Normal I&E Program	BOND CALCULATION TYPE:	BOND AMOUNT: \$0.00	
DATE OF COMPLAINT: NA	POST INSP. CONTACTS: None	JOINT INSP. AGENCY: None	
INSPECTOR(S): Ben Hammar Zach Trujillo	INSPECTOR'S SIGNATURE:

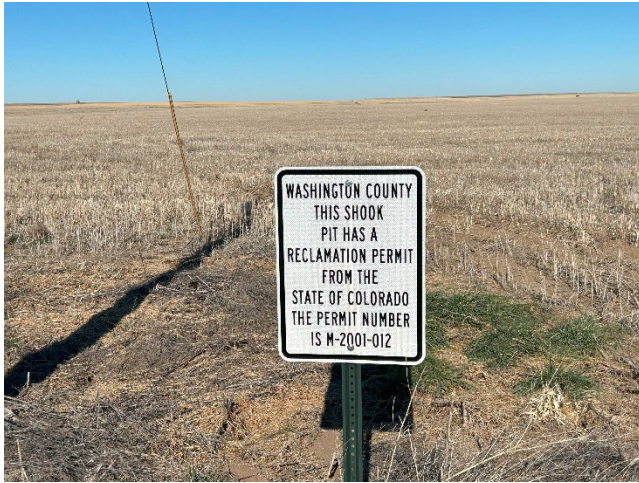
The permit sign was clearly posted at the entrance of the active pit and all signs and markers denoting the active boundary were in good condition. No issues were found during this inspection.

Photo 1: Posted mine sign.

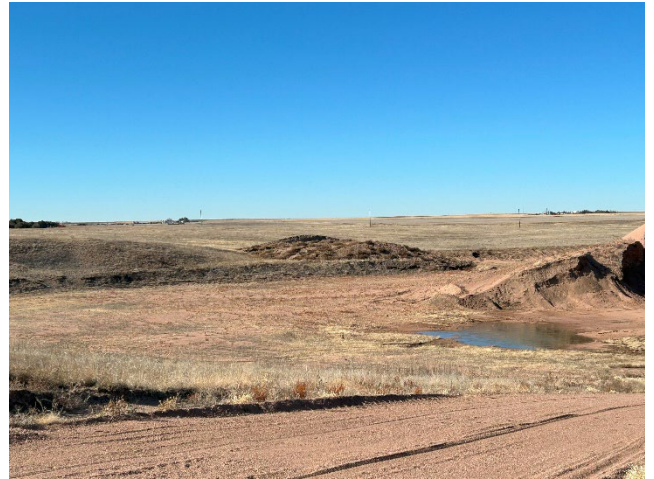
No significant signs of erosion were found during this inspection, with only a handful of shallow rills being present around the active pit wall likely from recent local precipitation. Similarly, a small section of standing water was located in the pit floor during the time of this inspection, but is likely caused by recent rainfall in the area.

Seeded topsoil piles were located along the western edge of the active pit floor. They appeared to be well-seeded and stable at the time of this inspection, and no sign of erosion were observed.

Photo 2: Seeded topsoil piles and collected water from storm event.

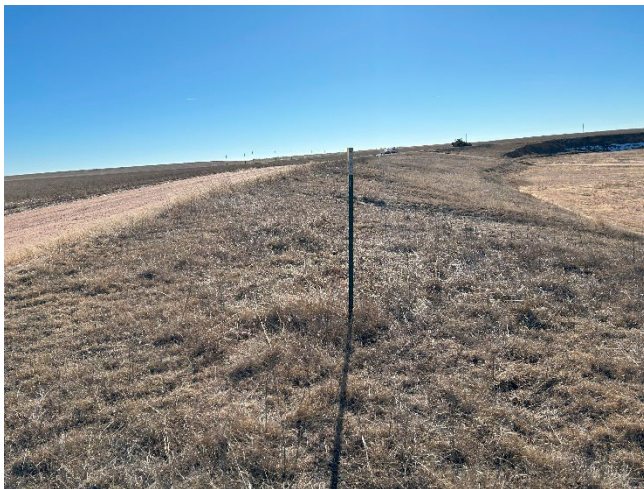
Photo 3: Boundary marker and sloped hillside.

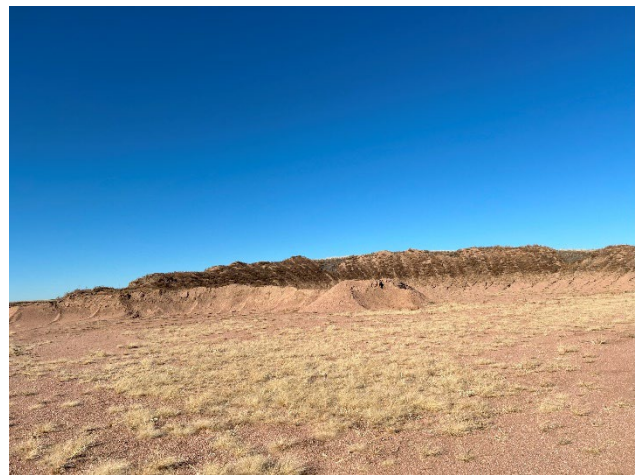
Photo 4: Active mining and product stockpiles.

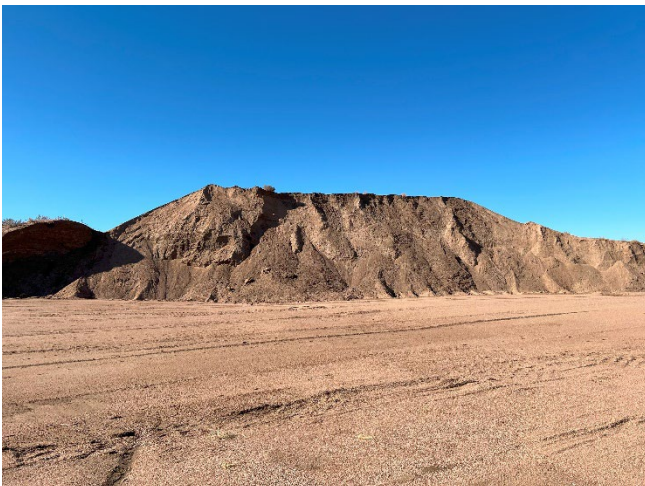
Photo 5: Large product stockpile.
