December 11, 2024  
Project No.: 19125

Holcim  
1687 Cole Boulevard, Suite 300  
Golden, CO 80401

Regarding: Daniels Sand Pit 2, Permit No. M-1973-007-SG  
Slope Stability Monthly Monitoring Report

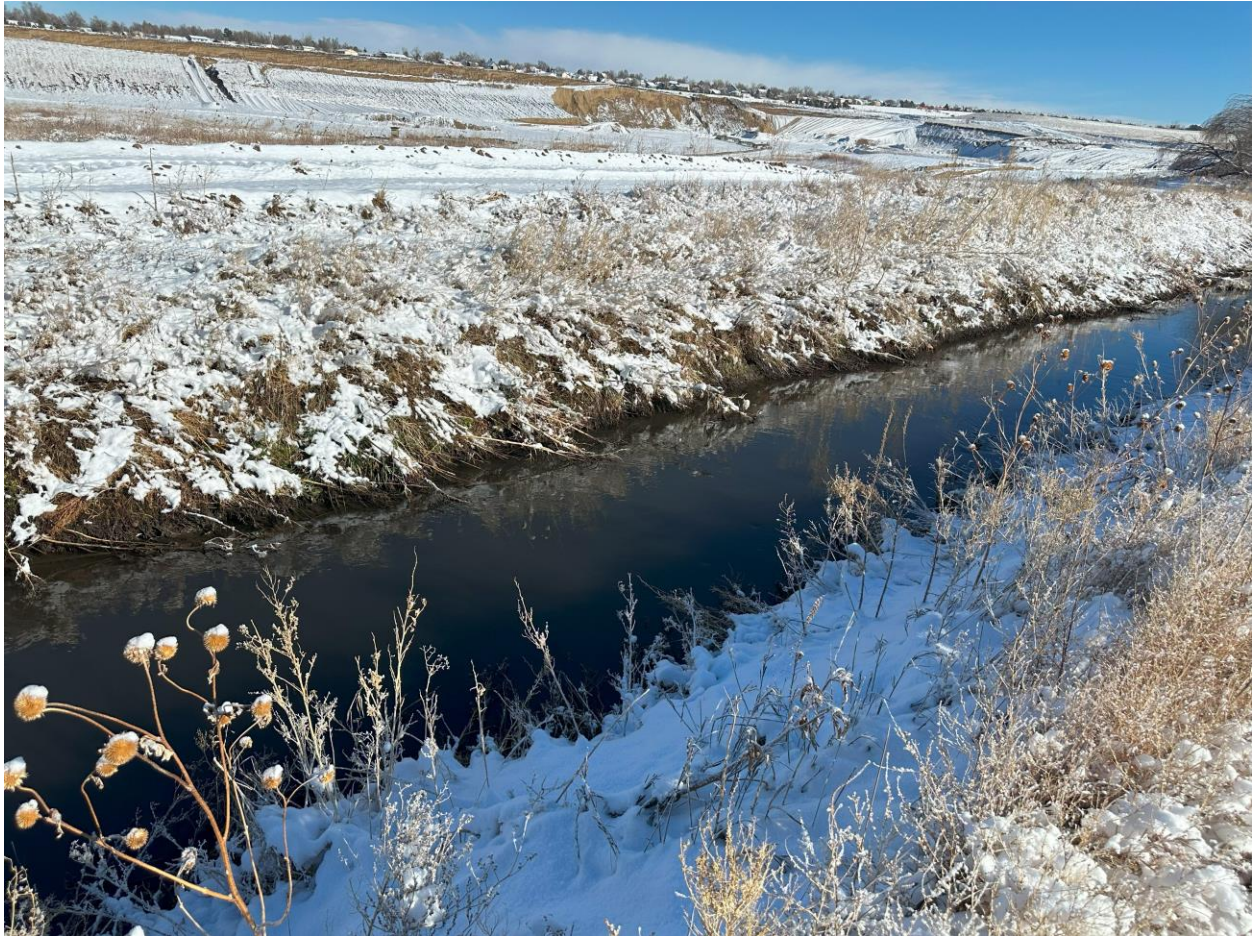
Photo 1. Water flowing in ditch

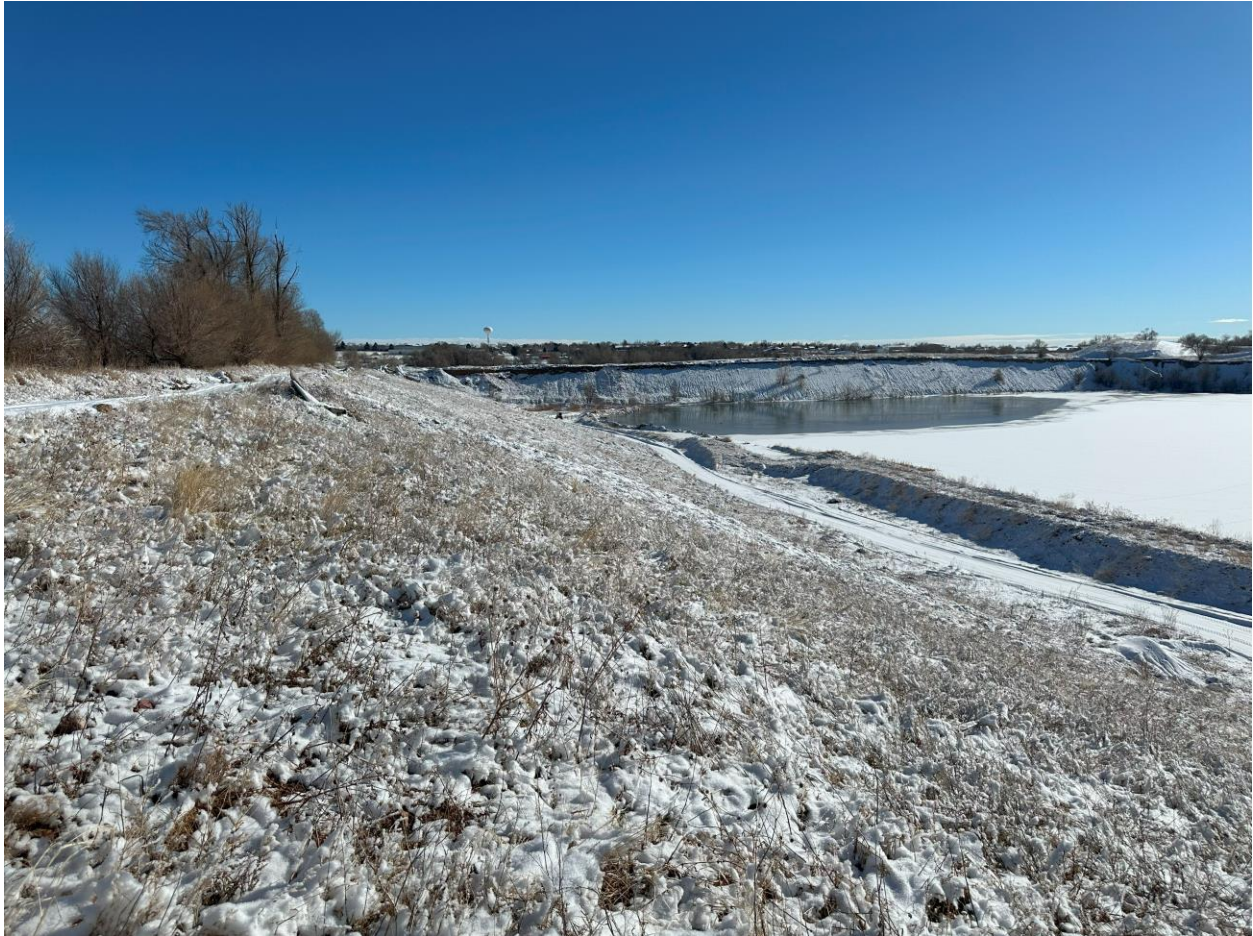
Photo 2. Buttress slope with ditch access road

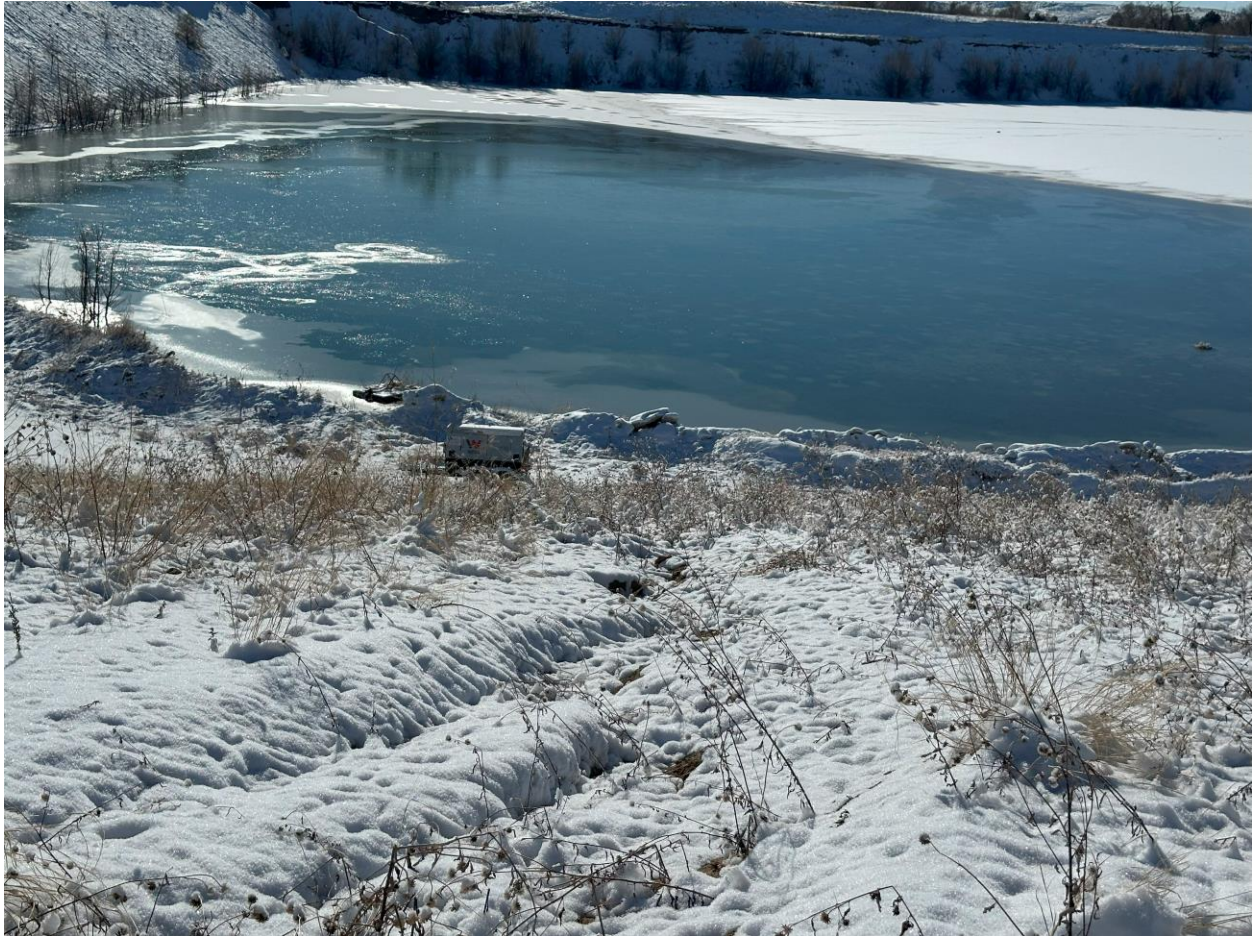
Photo 3. Erosion gully in eastern portion of buttress

- 1) A few erosion gullies exist within the embankment slope. We recommend those areas be reconstructed ASAP and that the areas be seeded per the reclamation plan.
- 2) Weather: 20°, partly sunny, slight wind, snow- and ice-covered ground
- 3) Visual observation of the Fountain Mutual Ditch and ditch road:
  - a) No tension cracks.
  - b) Vegetation growing on banks of ditch.
  - c) Flowing water.
  - d) Ditch access road not level/flat in a few areas.
- 4) Visual observations of the Buttress Slope
  - a) The buttress slope varies from 3H:1V to 4H:1V. Some portions of the slope should be regraded.
  - b) Majority of the buttress is covered in natural vegetation/weeds.
  - c) Few locations show visible evidence of surface water runoff and expanding erosion gullies throughout the buttress.
  - d) Several broken trees exist on the slope/buttress crest near the ditch access road.

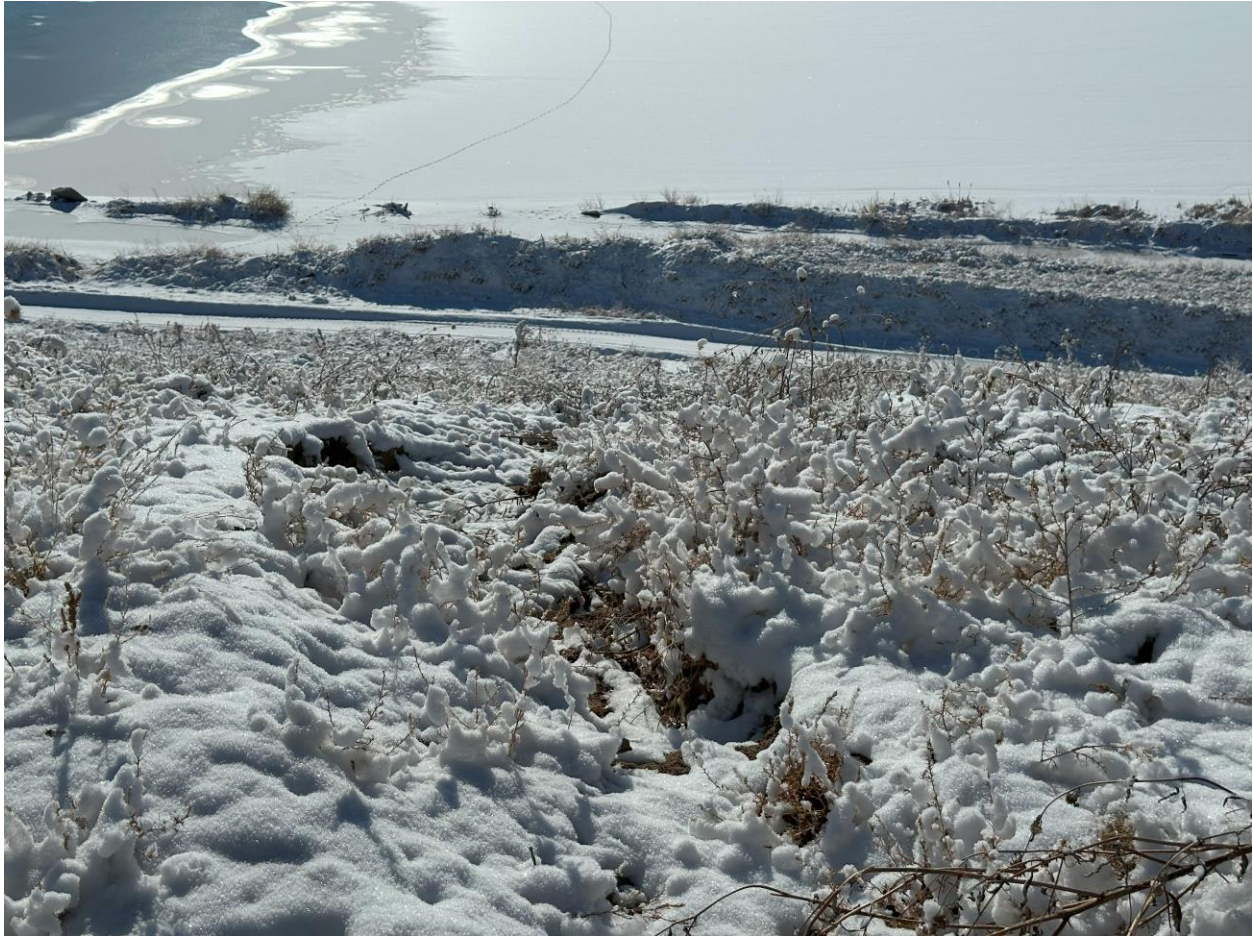
Photo 4. Erosion gullies in central area of buttress

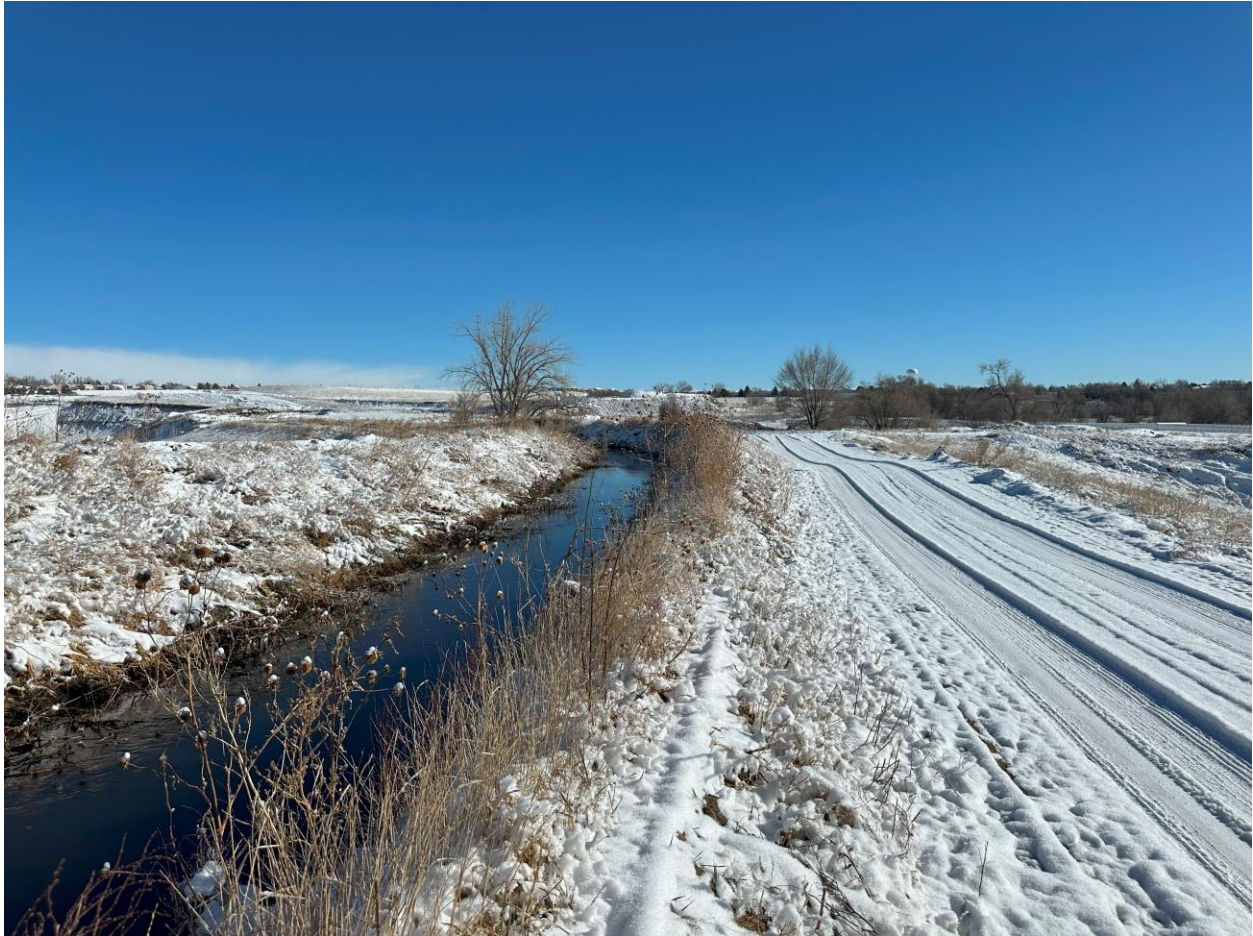
Photo 5. Ditch and access road looking east

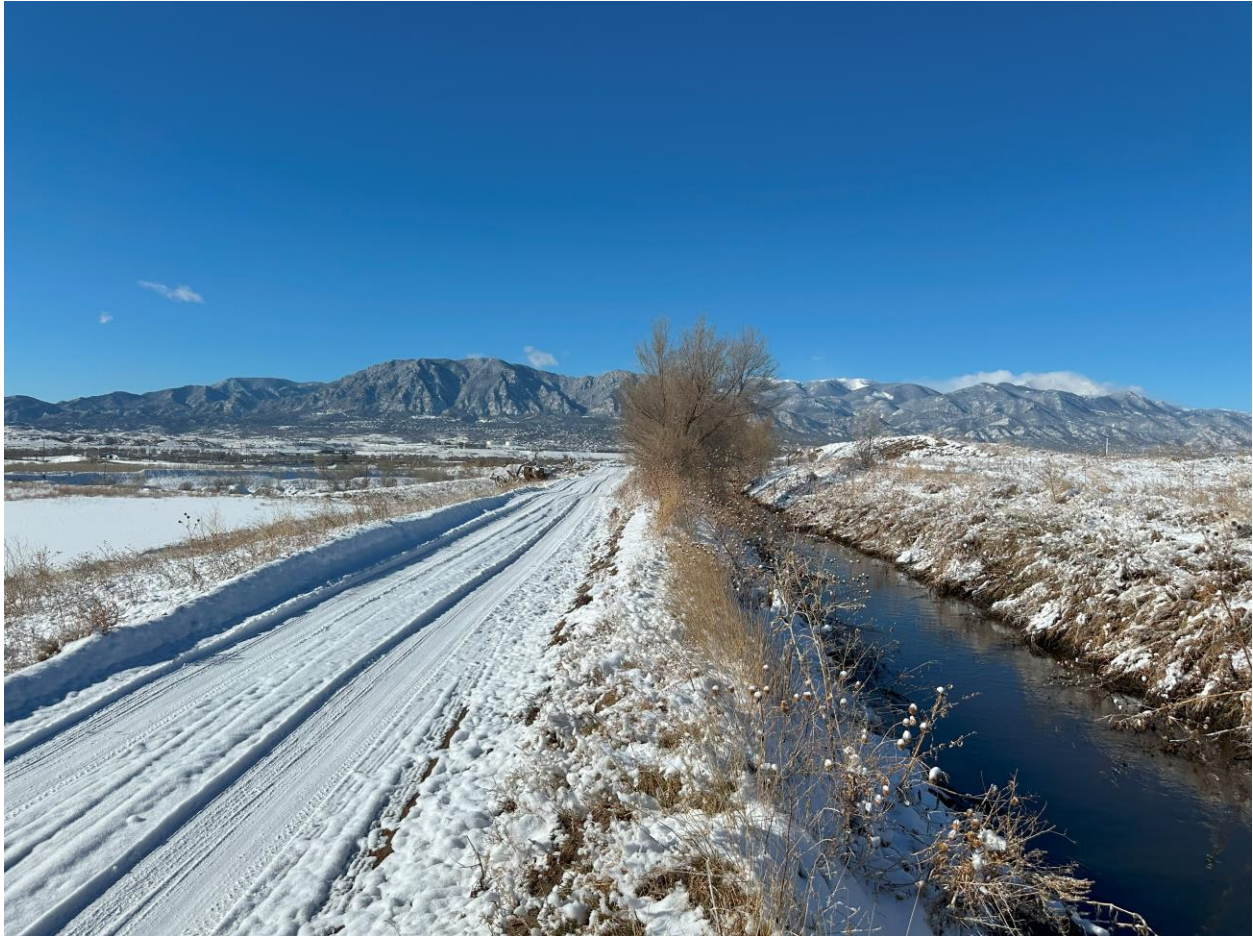
Photo 6. Ditch and access road looking west

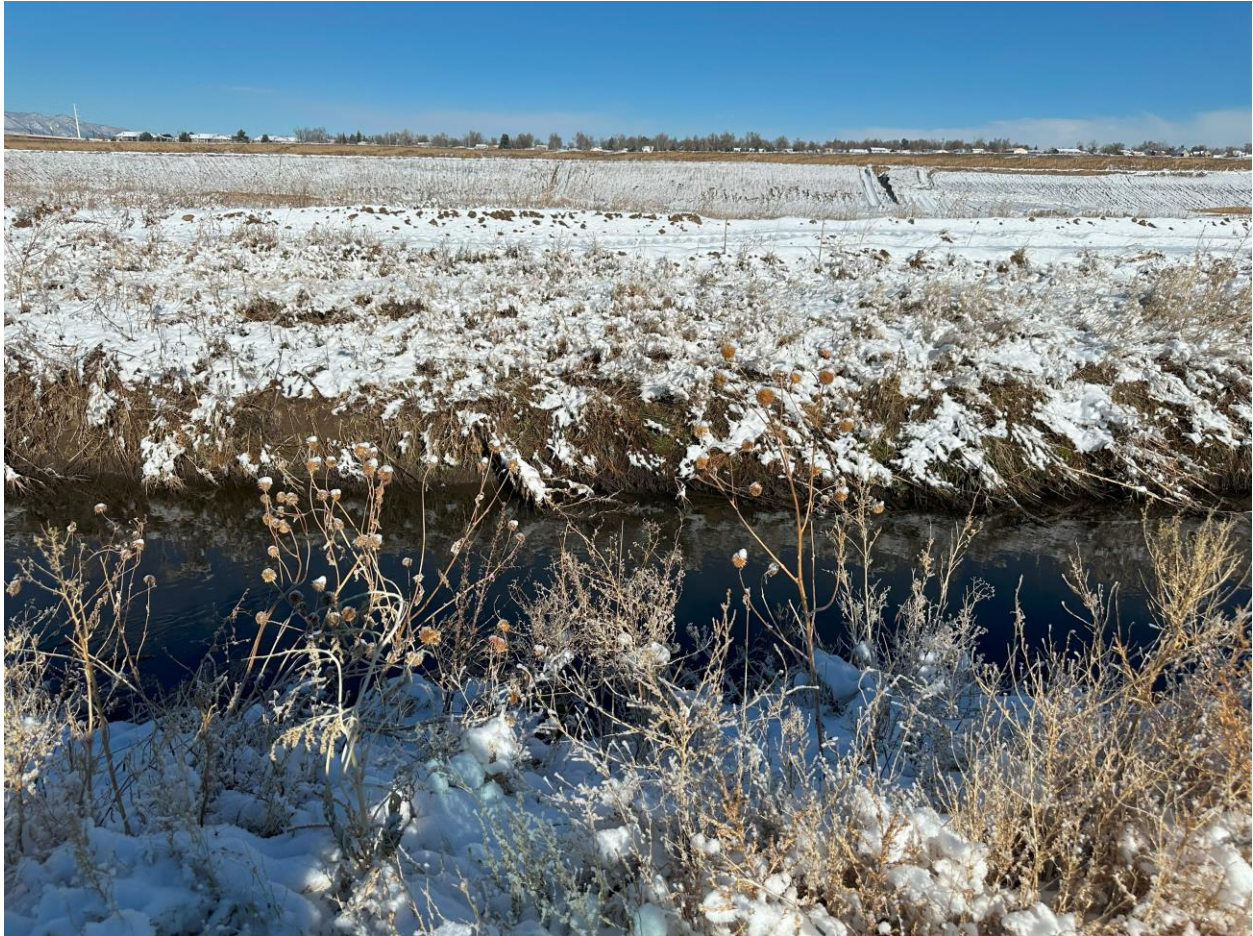
Photo 7. Ditch looking north
