Re: Tucson South Inspection Report and Cost Estimate

MINERALS PROGRAM INSPECTION REPORT

MINE NAME: Tucson South Resource	MINE/PROSPECTING ID#: M-2004-044	MINERAL: Sand and gravel	COUNTY: Adams
INSPECTION TYPE: Monitoring	WEATHER: Clear	INSP. DATE: October 30, 2024	INSP. TIME: 08:30
OPERATOR: Holcim - WCR, Inc.	OPERATOR REPRESENTATIVE: Wyatt Webster	TYPE OF OPERATION: 112c - Construction Regular Operation	
REASON FOR INSPECTION: Normal I&E Program	BOND CALCULATION TYPE: Complete Bond	BOND AMOUNT: \$834,000.00	
DATE OF COMPLAINT: NA	POST INSP. CONTACTS: None	JOINT INSP. AGENCY: None	
INSPECTOR(S): Nikie Gagnon	INSPECTOR'S SIGNATURE:

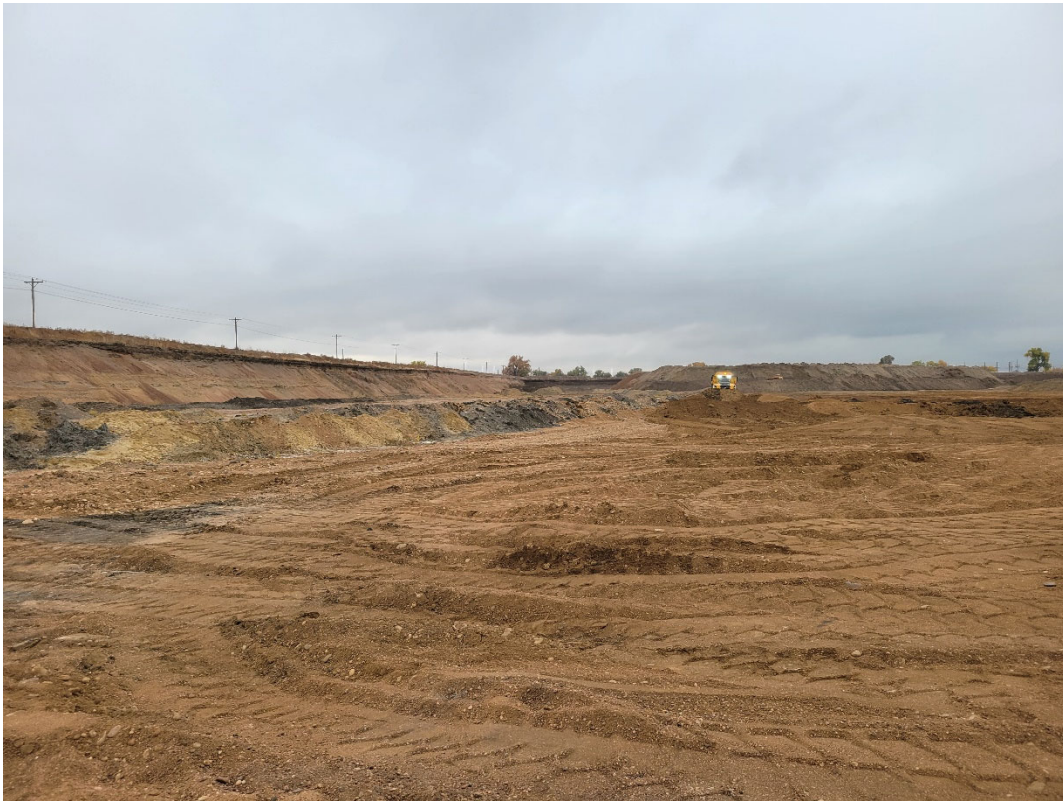
Photo 1: Looking south from the entrance at the mined slopes along the eastern boundary of the west mining area.

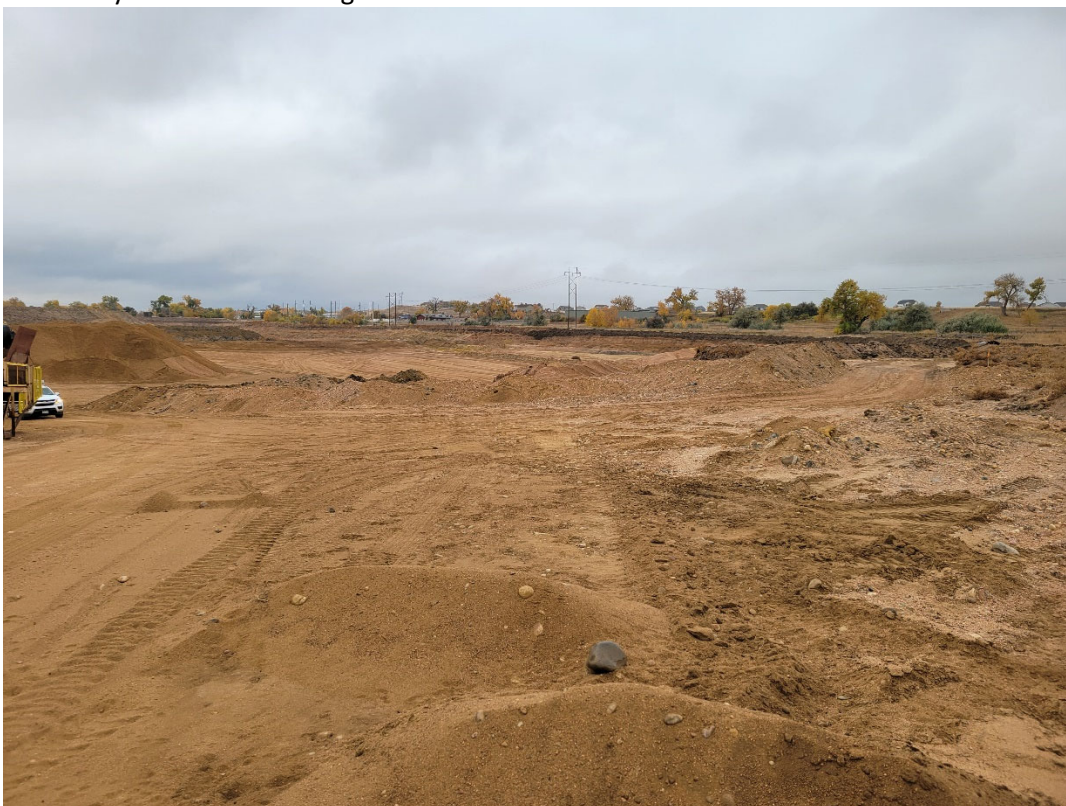
Photo 2: Looking across the west mining area from the north end near the conveyor.

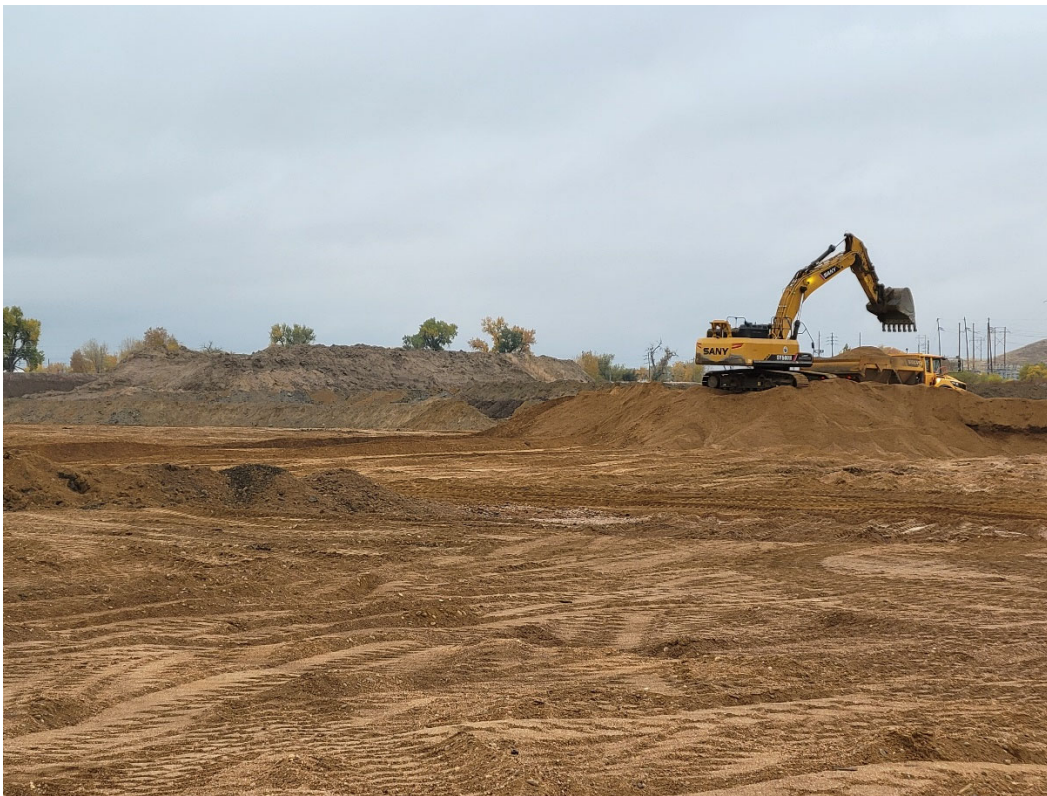
Photo 3: Excavator observed loading a haul truck in the west mining area.

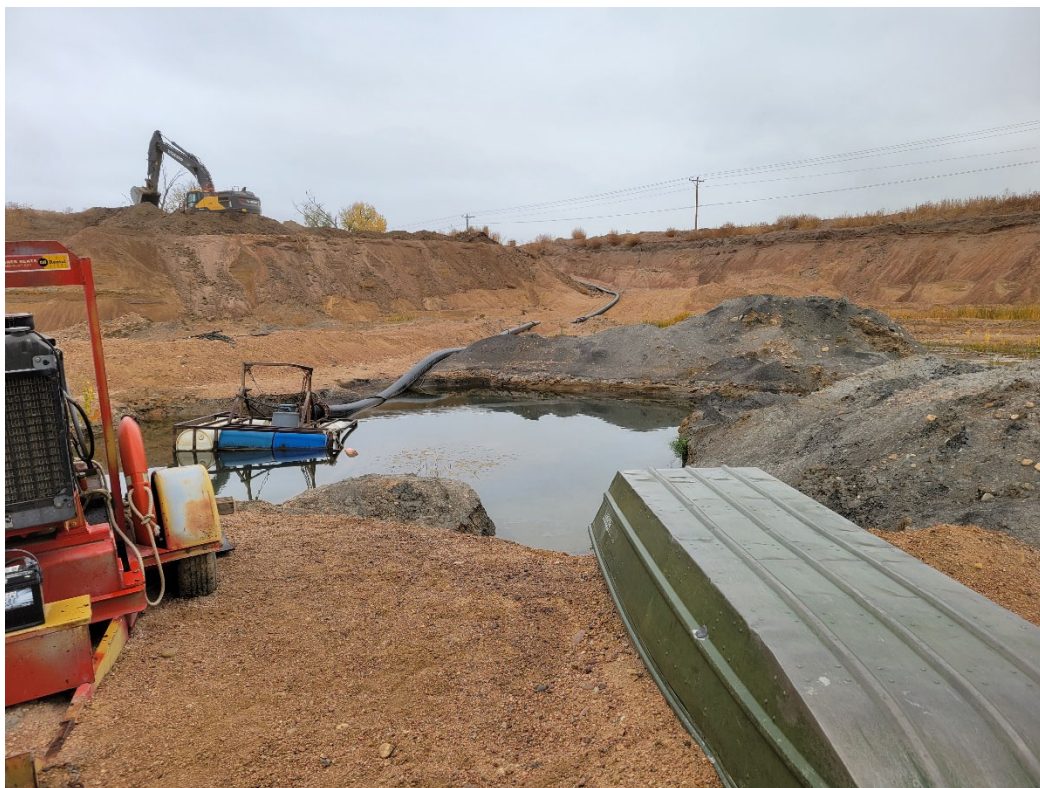
When encountered, groundwater in the west mining area is pumped to a settling pond located in the northeast corner of the east mining area. The ponds discharge to the South Platte River. During this inspection, except for a small amount of water in dewatering trenches along the east side of the active mining area, the west mining area was dry. A small pool of water was observed near the sump in the west mining area. The pump was not operating. The Division observed the settling pond in the east mining area. No water was observed in the pond or discharging to the river. Holcim has an approved Substitute Water Supply Plan (WDID 0202565) which allows for an exposed surface area of up to 3.0 acres. Depletions covered include evaporation, aggregate production, slurry wall construction, landscape irrigation and dust control.

Photo 4: Groundwater sump in the northeast corner of the west mining area. Pump not operating.

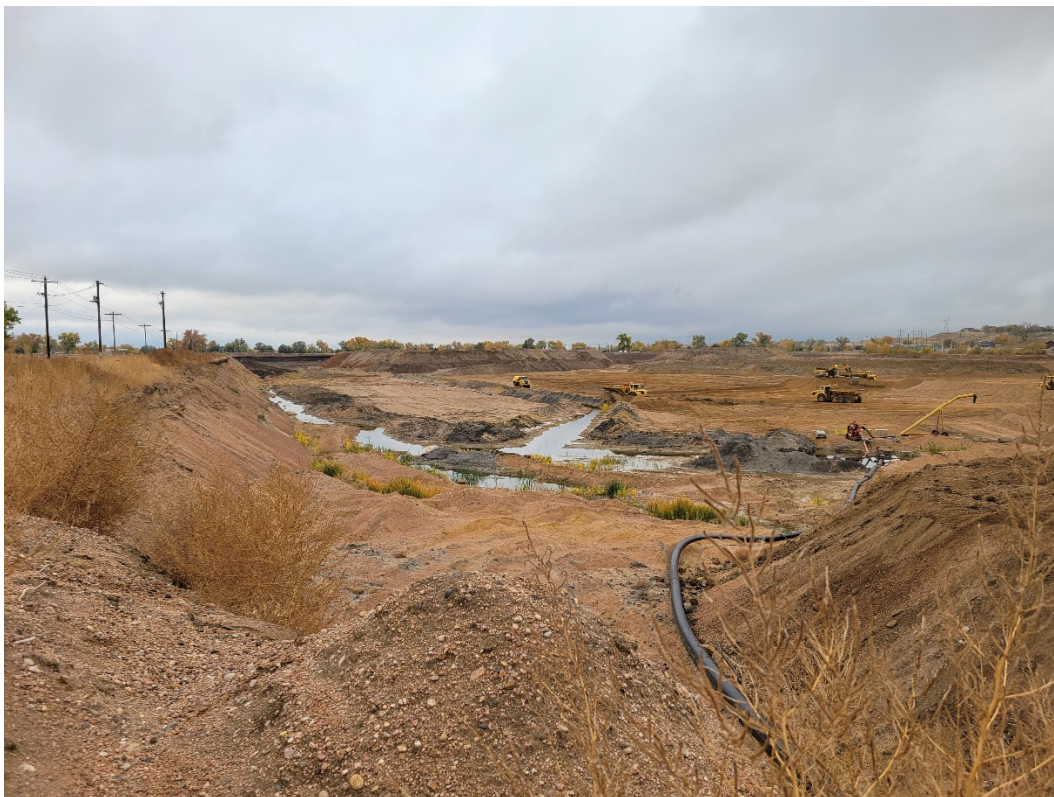
Photo 5: Groundwater trenches moving water to the sump area in the northeast corner of the west mining area.

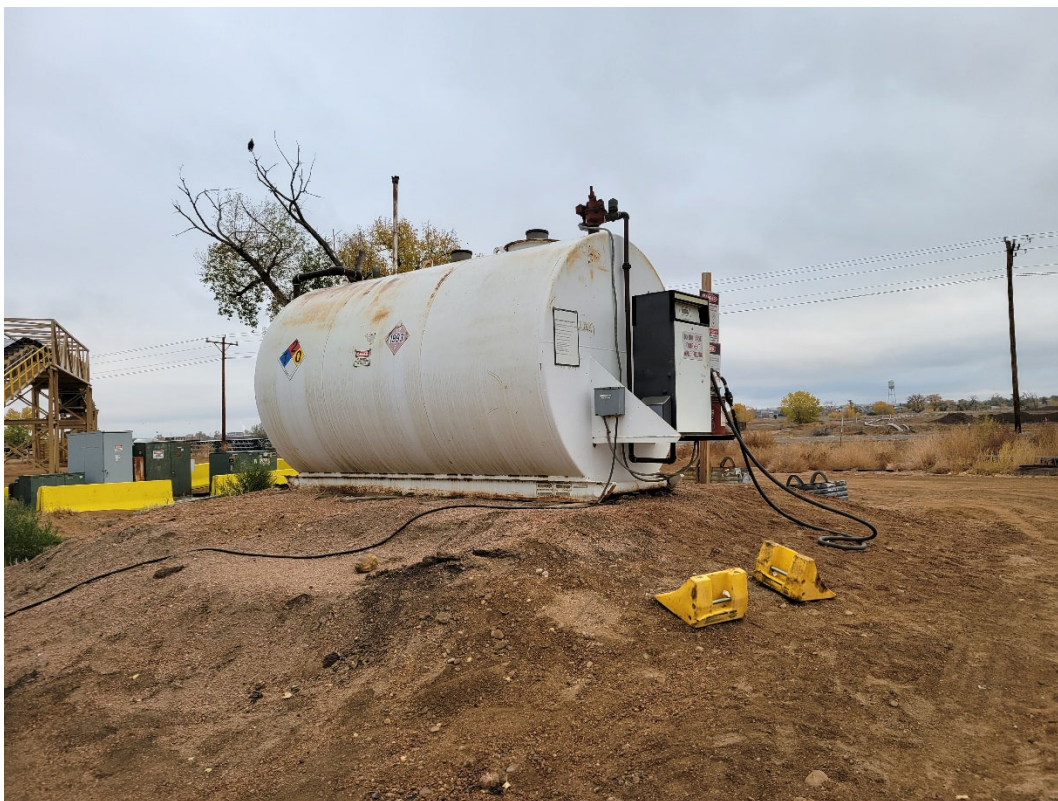
Photo 6: Double walled fuel tank adjacent to the office in the west mining area.

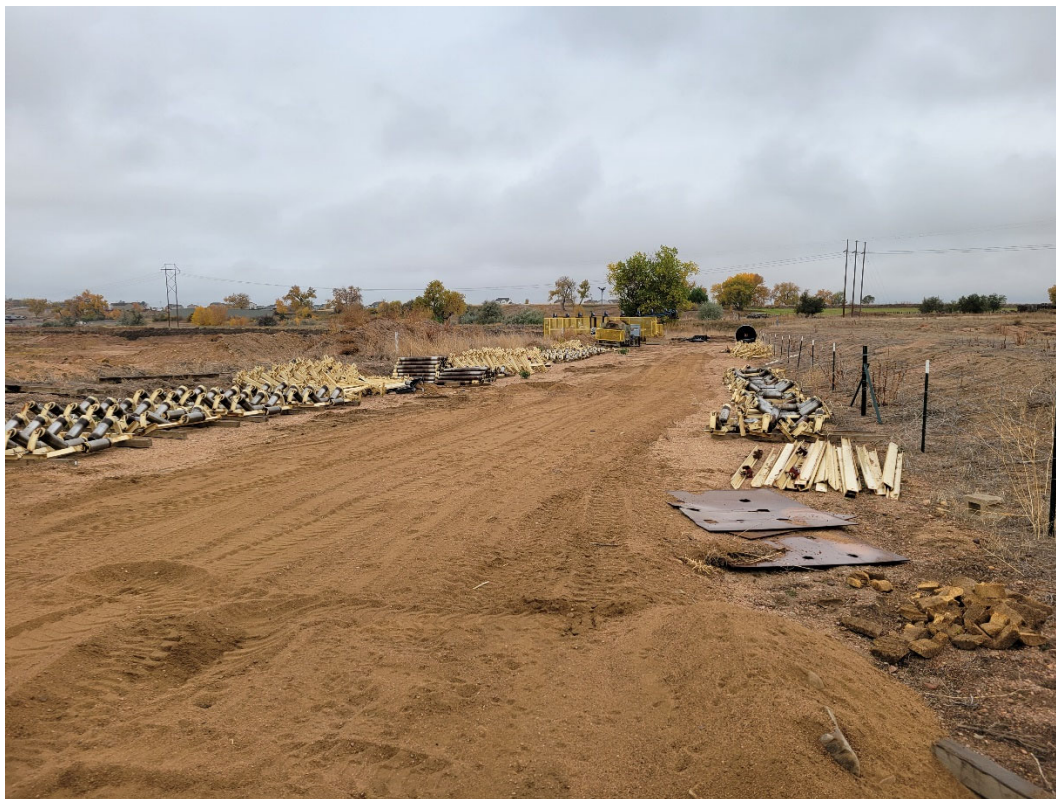
Photo 7: Equipment storage area in the west mining area, near the office.

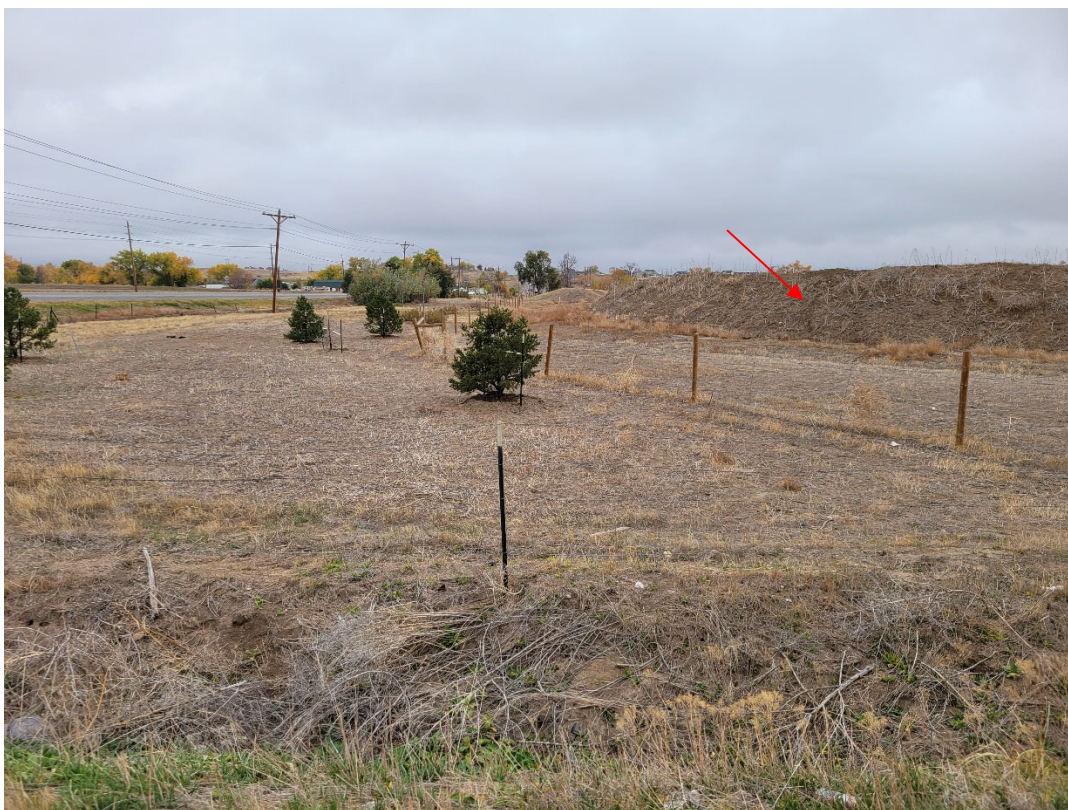
Screening berms are well vegetated and line the south end of the east and west mining areas, along Highway 7. Trees have been planted in front of the topsoil berms for aesthetics and visual mitigation along Highway 7.

Photo 8: Southeast corner of the west mining area. Screening berm placed around the mining area noted by arrow, and trees planted by operator.

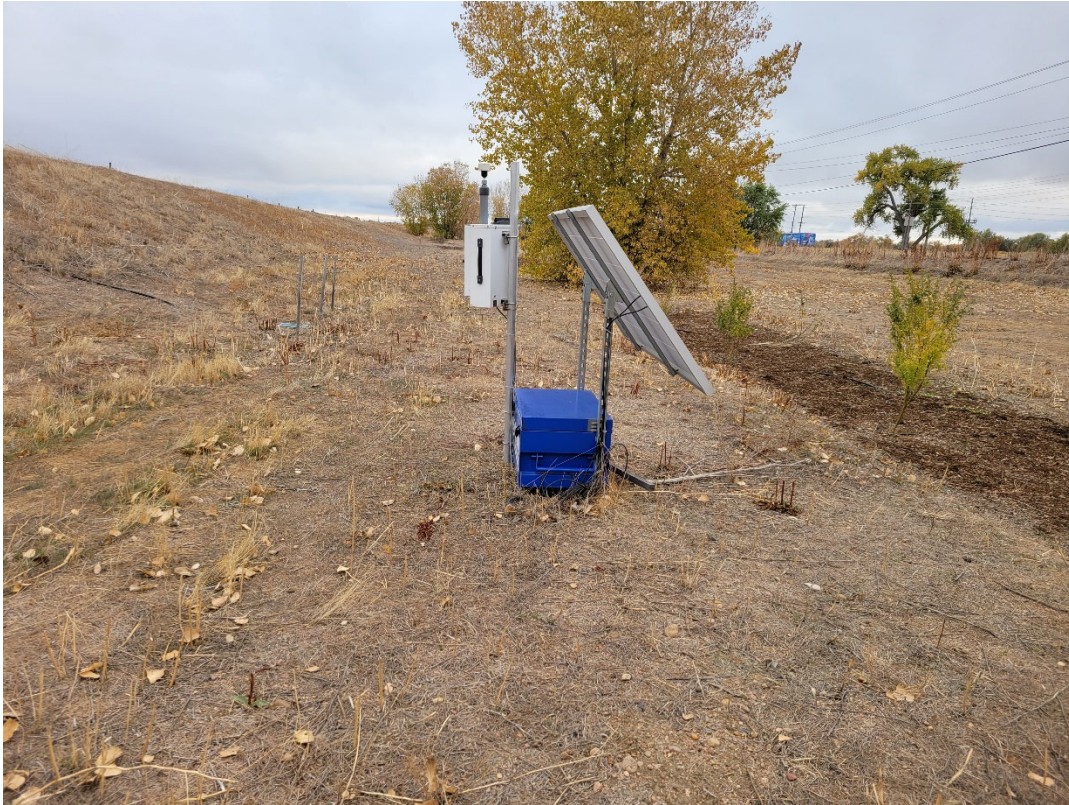
The operator continues to monitor air quality to ensure to compliance with the Adams County Conditional Use Permit. During the inspection, the Division observed a wind sensor in the southwest corner of the west mining area. The winds were calm, and dust was not observed blowing around the site.

Photo 9: Air quality monitor in the southwest corner of the permit area.

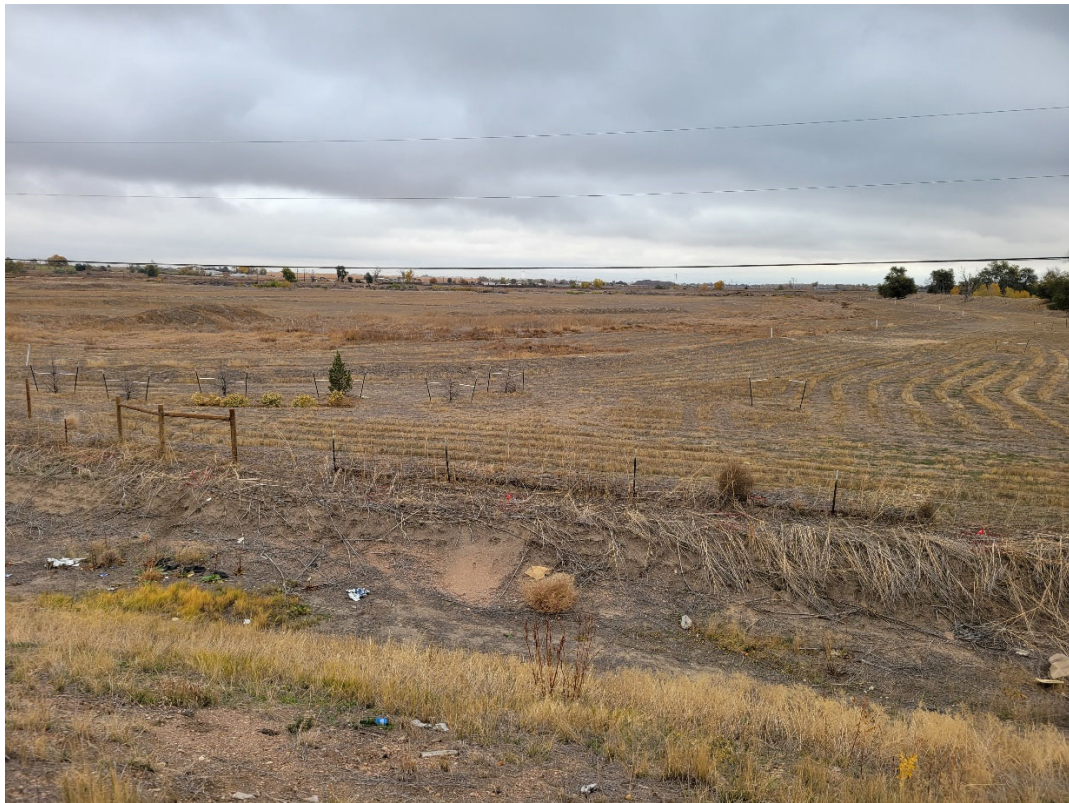
Photo 10: Looking north across the east permit area from Highway 7.

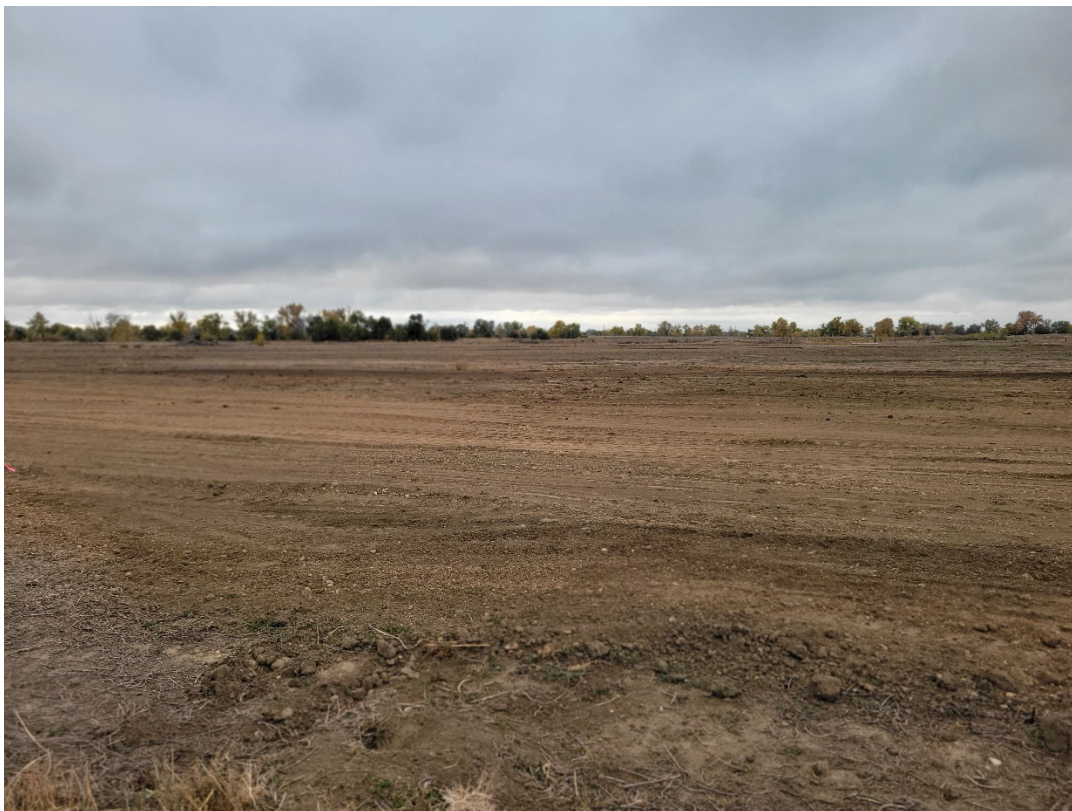
The east mining area was observed during this inspection. In preparation for mining, the operator started clearing vegetation and removed trees on the east side in 2023, outside the raptor nesting season. During the inspection, the Division observed an eagle roosting in a tree near the office and another flying around the east mining area.

Photo 11: Looking south across the east permit area where vegetation clearing is occurring, and trees were removed in 2023.

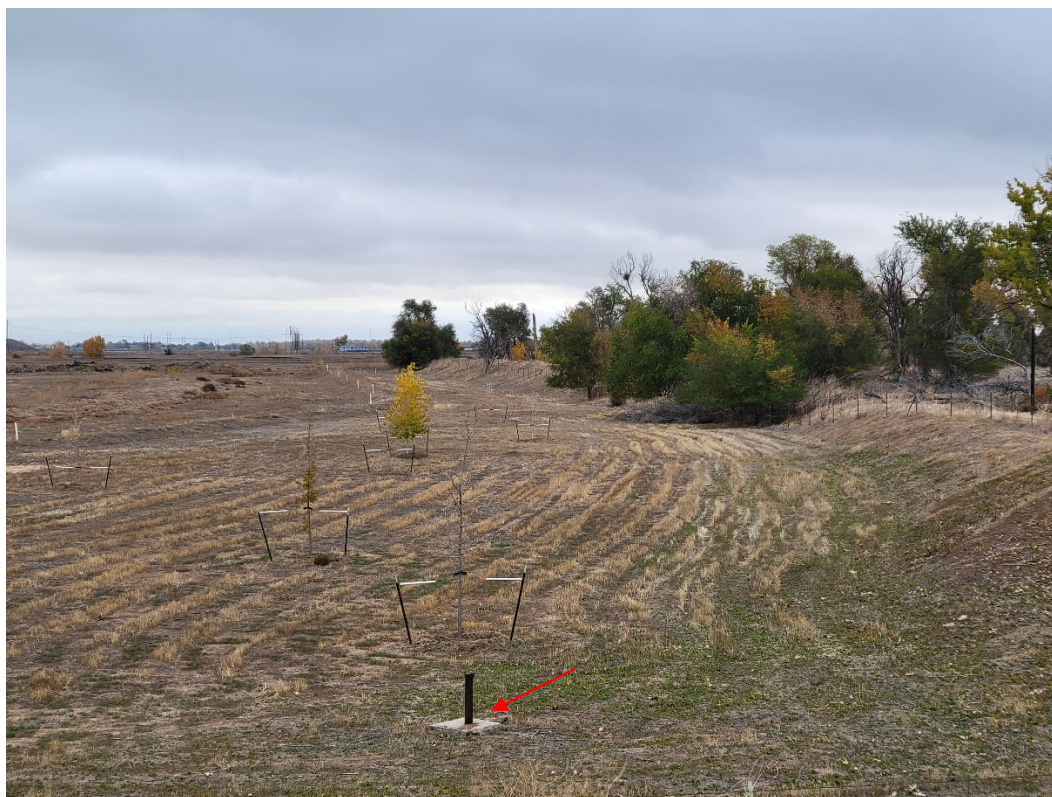
Photo 12: Looking at monitoring well 8 in the southeast corner of the permit area.

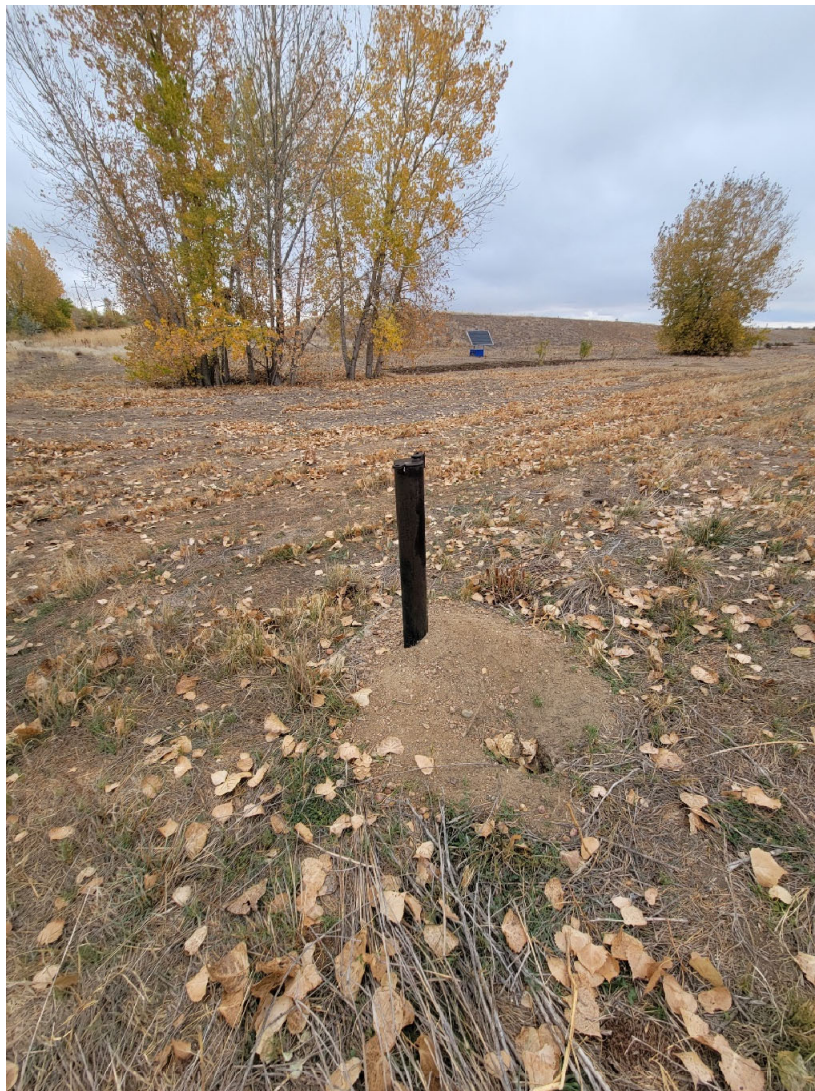
Photo 13: Groundwater monitoring well #17 in the southwest corner of the west permit area.

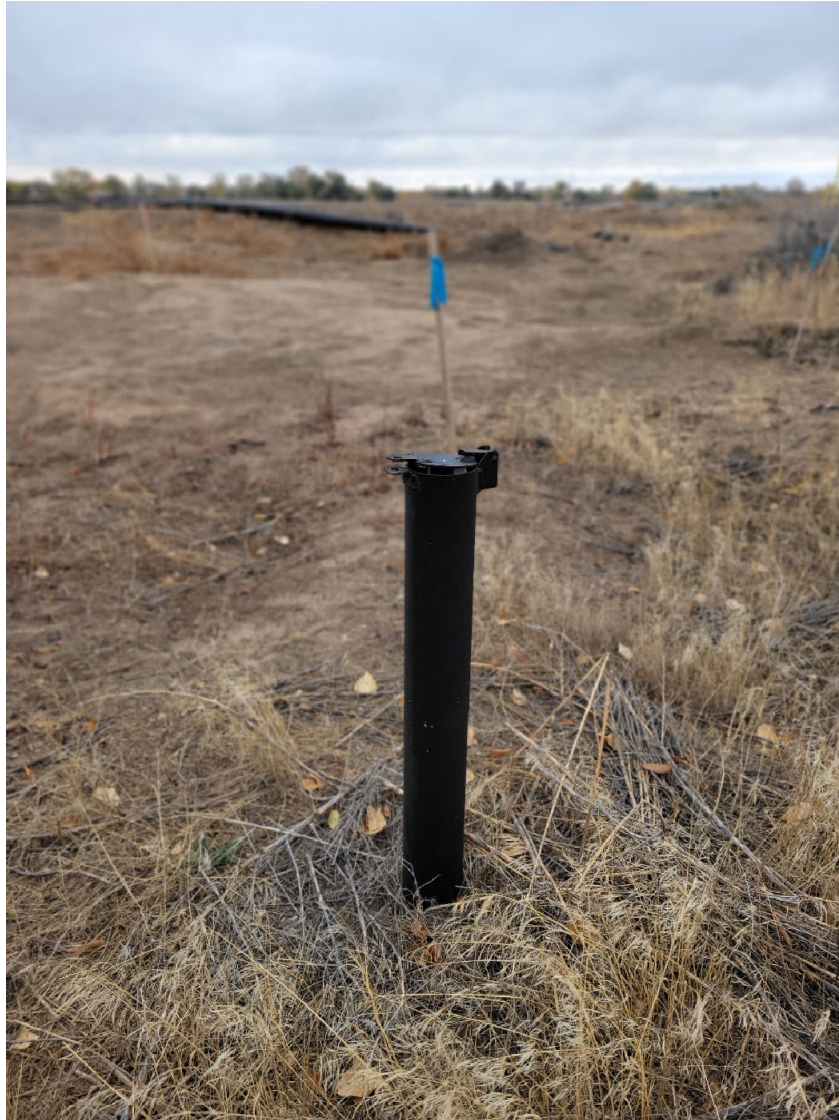
Photo 14: Groundwater monitoring well #9 in the east mining area.

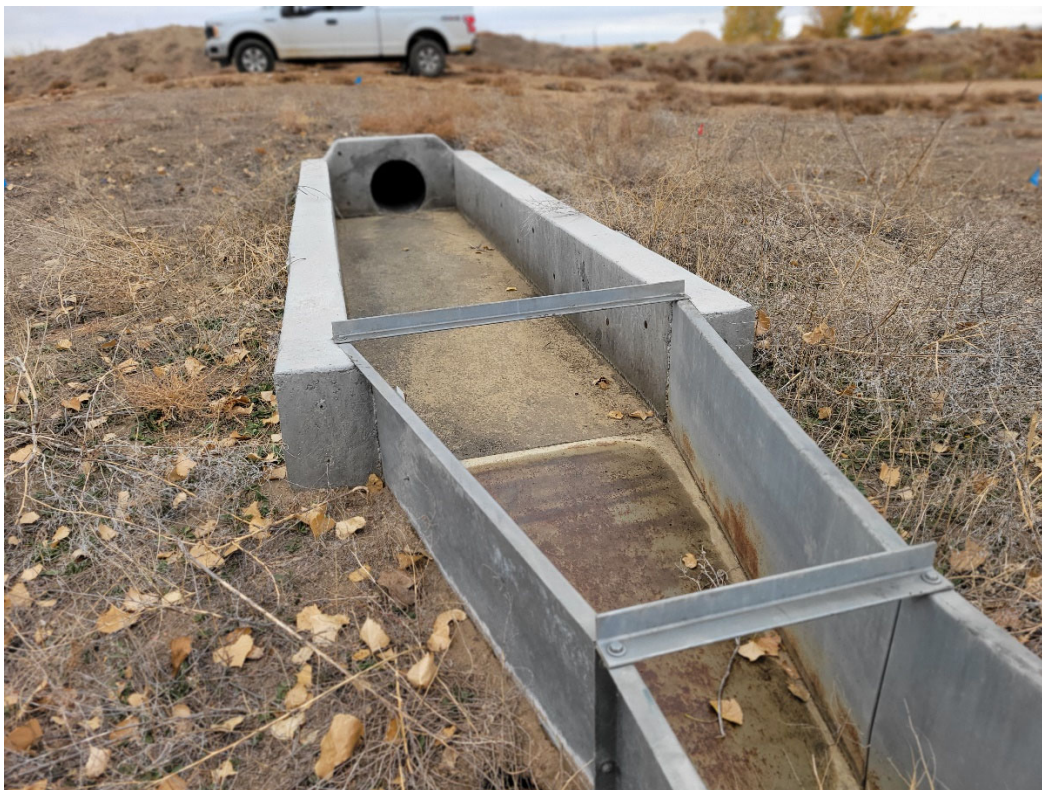
Photo 15: Discharge structure to the South Platte on the east side of the permit area.

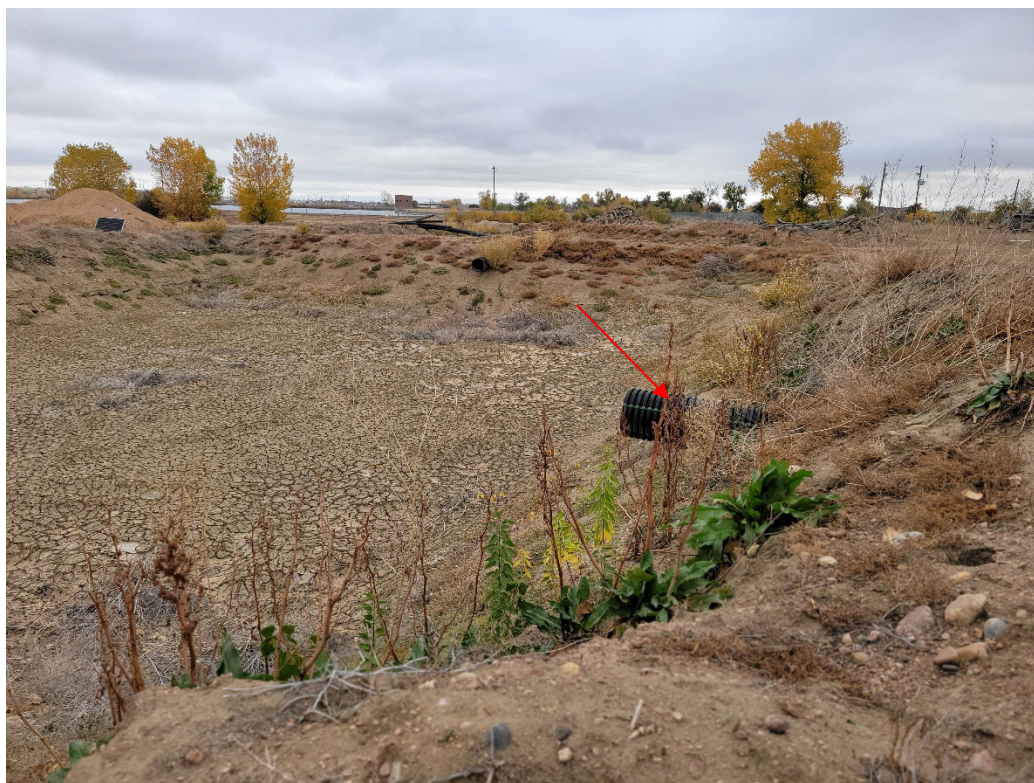
Photo 16: Settling pond east side of the permit area. Discharge pipeline indicated by arrow.
