**King Coal Mine, C-1981-035, December Complete Inspection Report**

**PERMIT INFORMATION**

**INSPECTION INFORMATION**

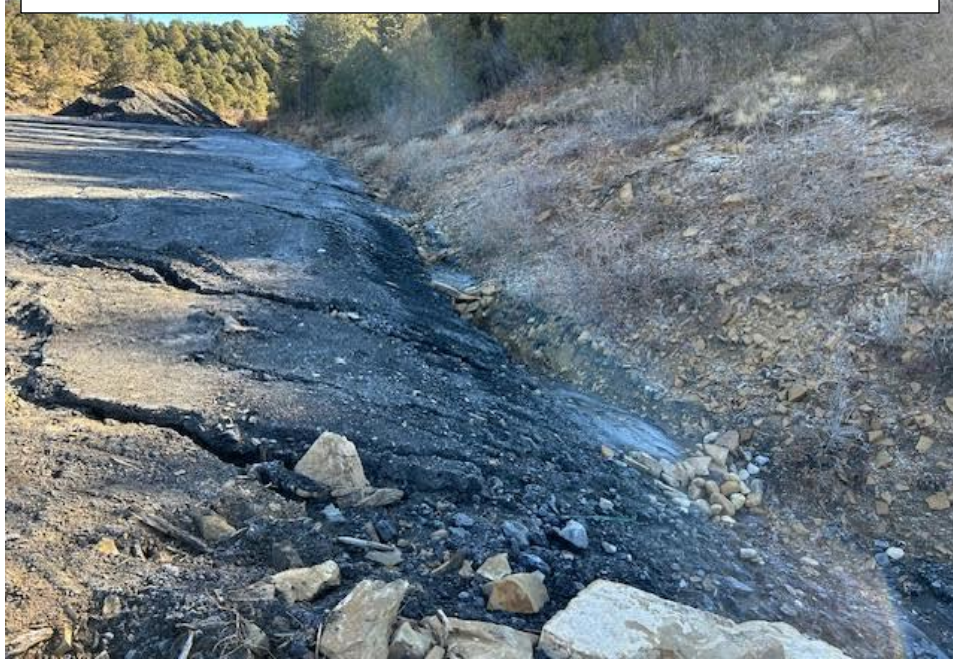
Reach 10 extends from the west side of the Upper Refuse Disposal Area (URDA, Photo 1)), down the west side of the haul road (Photo 2), and continues down the west side of the Lower Refuse Disposal Area (LRDA, Photo 3)). The upper portion of Reach 10 was stable with no blockages. The channel was armored and had small check dams in place to dissipate water velocity during runoff. The Middle portion of the channel located on top of the LRDA was well defined and stable. There were no blockages or erosional features observed. The lower portion of Reach

Photo 1: The upper portion of Rach 10 on top of the URDA.

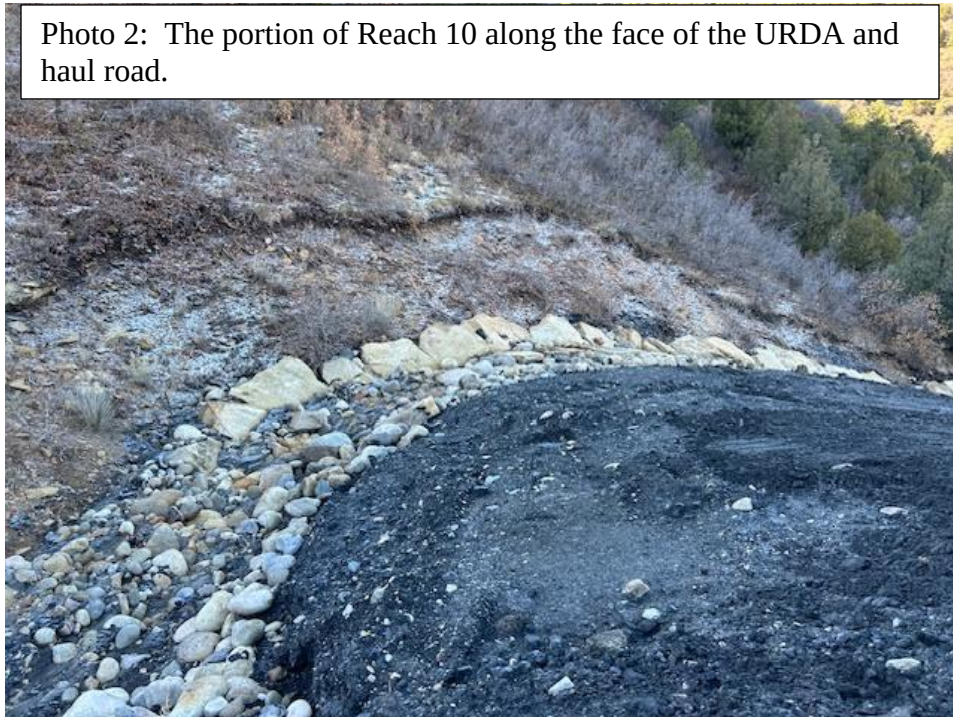
Photo 2: The portion of Reach 10 along the face of the URDA and haul road.

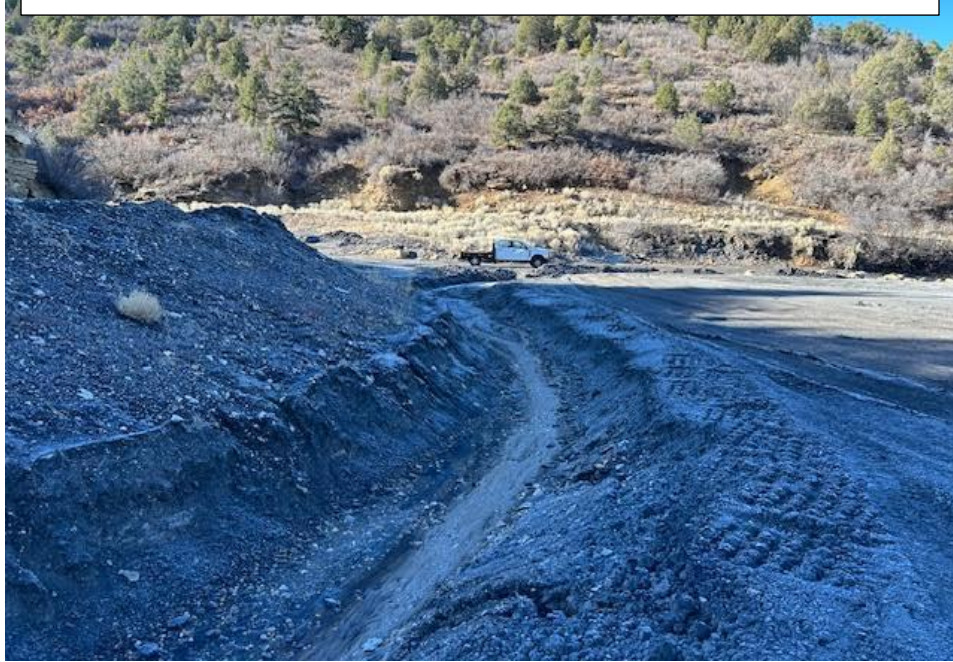
10 extending down the west side of the LRDA, adjacent to the haul road, was in good condition. The channel was clear and stable. The rock checks were intact and no erosional features were observed.

Photo 3: The portion of Reach 10 on top of the LRDA.

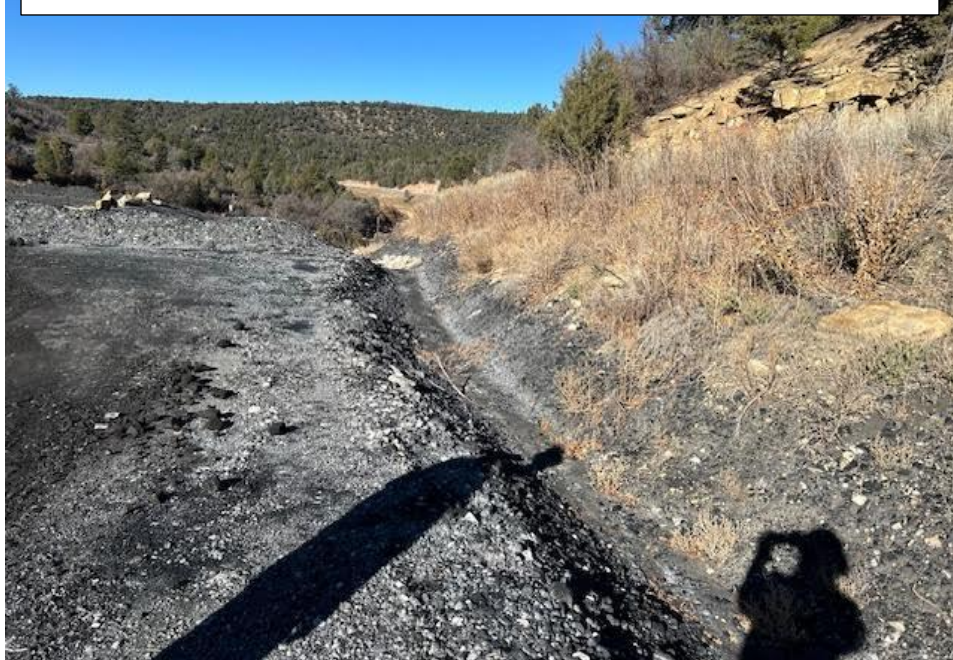
Reach 13 extends down the eastern side of the haul road, continues on the east side of the top of the LRDA (Photo 4), and then extends down the eastern side of the face of the LRDA (Photo 5). Reach 13 was dry during the inspection. There were no erosional features or blockages observed. The lower portion of the channel was armored and in good condition. The bottom of the channel ties into a drain leading to the west pond. The drain was unobstructed.

Photo 4: The portion of Reach 13 on top of the URDA.

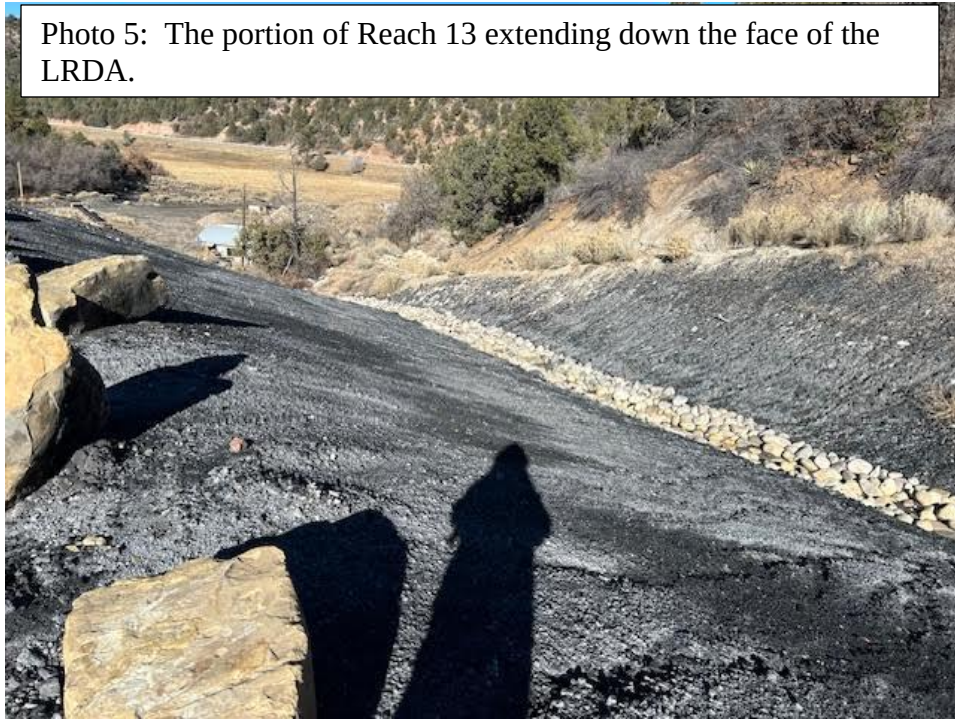
Photo 5: The portion of Reach 13 extending down the face of the LRDA.

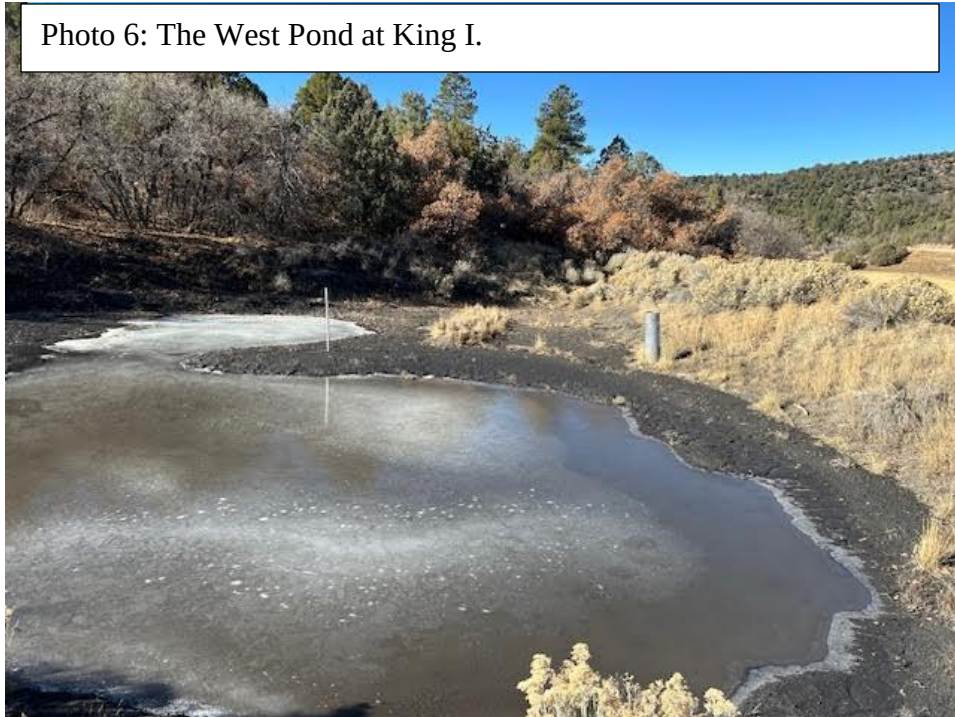
The west pond was holding a small amount of frozen water in it during the inspection (Photo 6). The level of water in the pond was below the primary outlet. No discharge was occurring. The outlet was clear of blockages. The embankment was stable with vegetative cover. There were no erosional concerns identified.

Photo 6: The West Pond at King I.

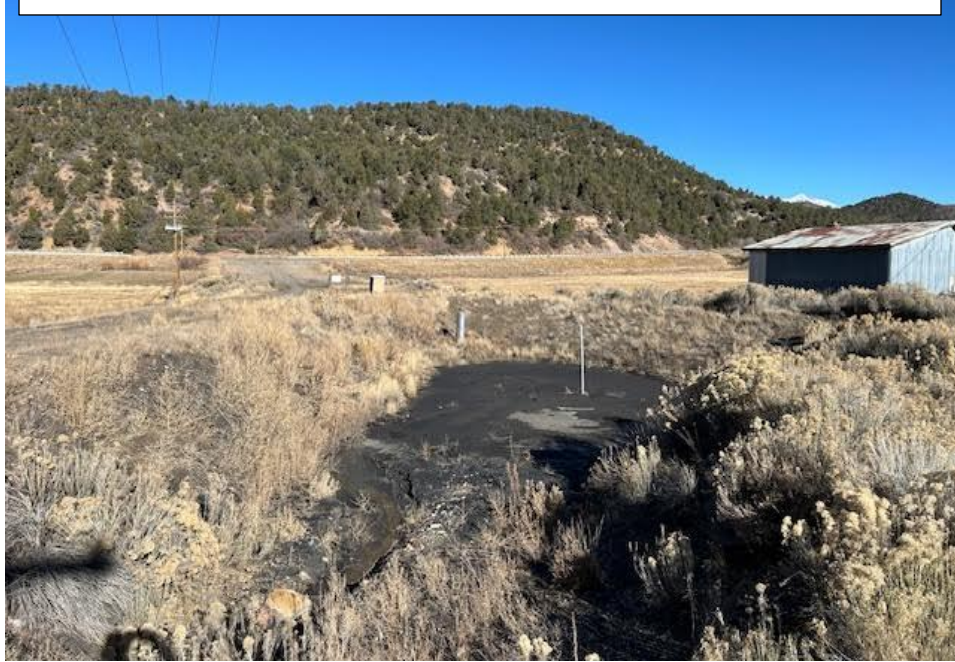
The east pond was muddy and not holding any water (Photo 7). There was no discharge from the outlet. The outlet was clear of debris. The pond's embankment was vegetated and stable. No erosional features were observed.

Photo 7: The East Pond at King I.

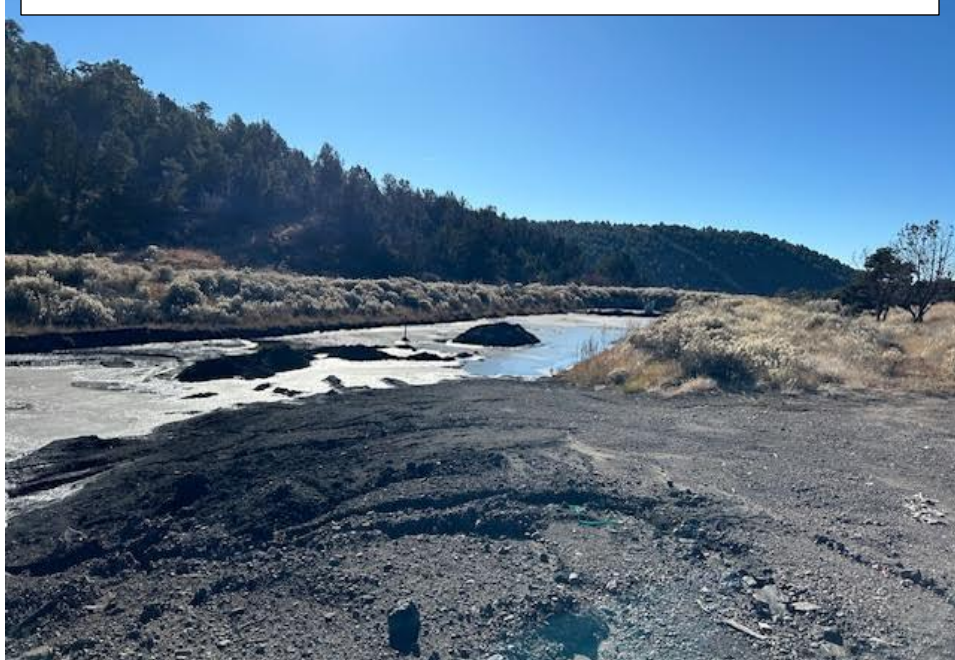
The sediment pond for the King II facilities is located on the south side of the facilities area. The pond was holding a small amount of frozen water in it. The level of water in the pond was below the primary outlet (Photo 8). The outlet was observed to be clear of debris. More sediment had been removed from the pond since the previous inspections. The sediment from the pond is removed when conditions allow equipment access. The culvert inlets to the pond were unobstructed. The embankments were stable with vegetative cover. No indications of erosional features were observed.

Photo 8: The sediment pond at King II.

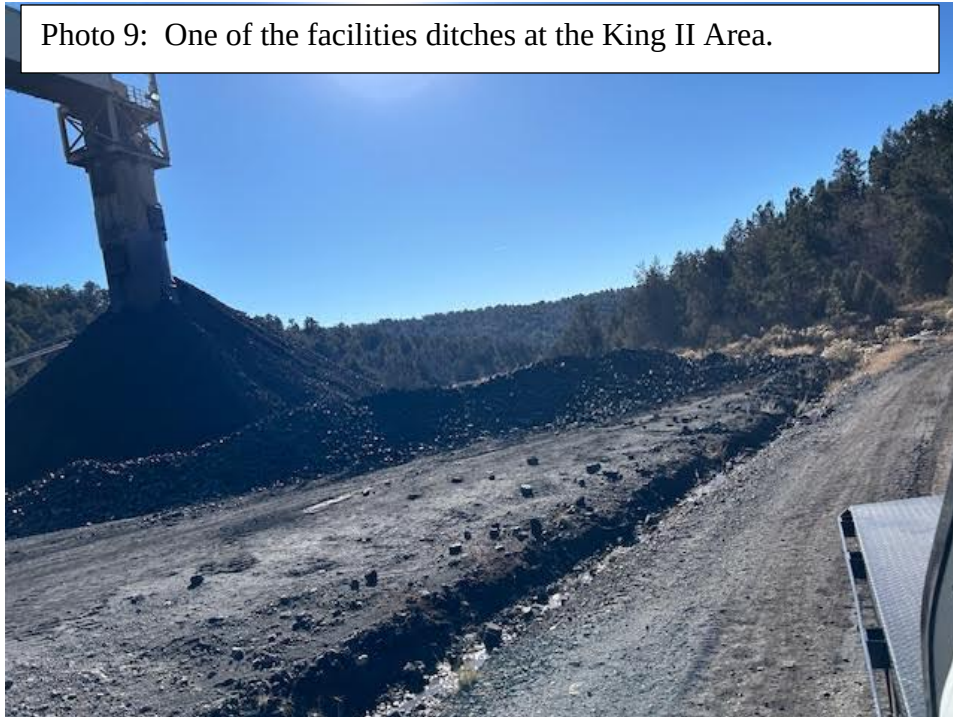
Ditches throughout the facilities area were well maintained and clear of blockages (Photo 9). Small amounts of water were observed flowing throughout the ditches to the sediment pond. Culverts associated with the ditches were unobstructed and functioning as designed. The ditch located on the north side of the shop has a screen in front of a culvert to keep the culvert from plugging (Photo 10). The screen was mostly plugged up with debris. The culvert was clear of blockages though. Water was able to pass through the screen and then through the culvert. The Division recommended to the operator that the ditch be cleaned. On December 11, 2024, the Division received photos of the completed maintenance item. The ditch was clear of debris and functioning. The maintenance item is resolved.

Photo 9: One of the facilities ditches at the King II Area.

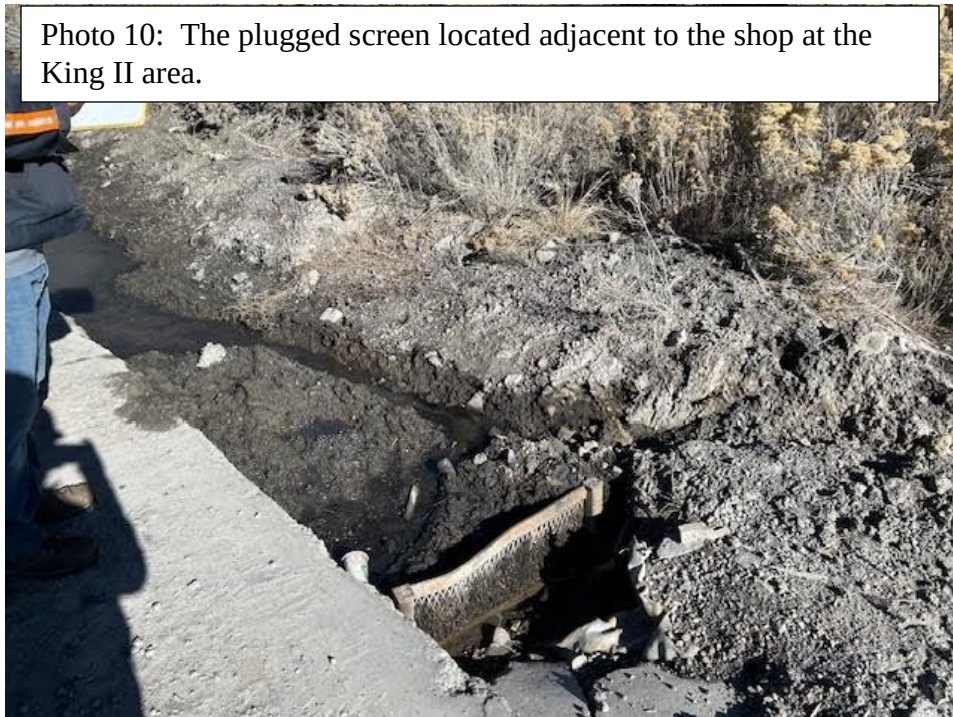
Photo 10: The plugged screen located adjacent to the shop at the King II area.

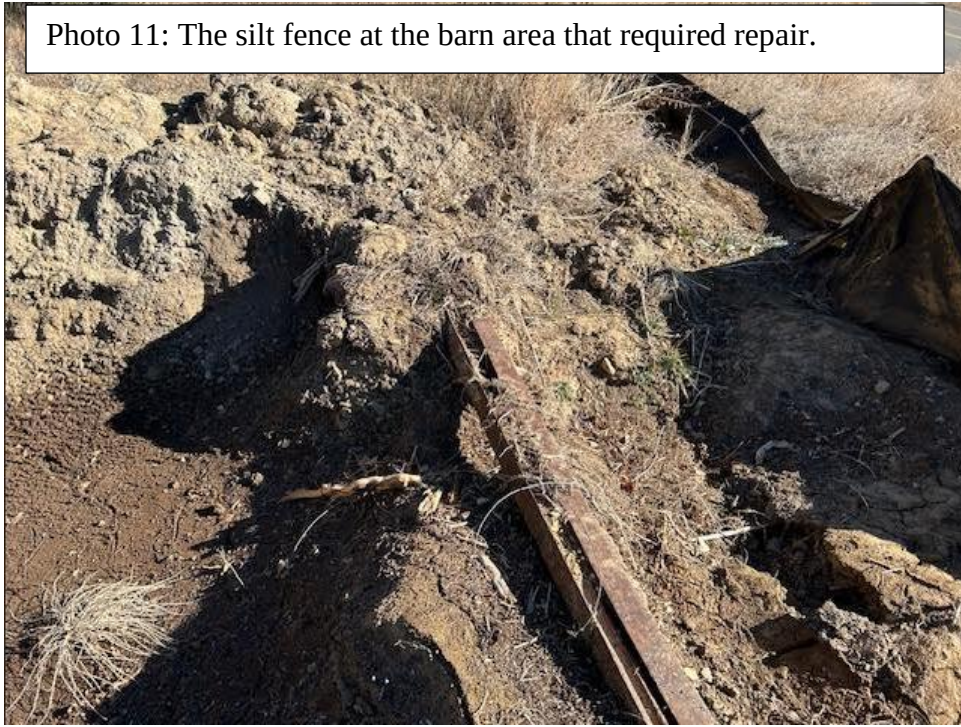
The barn area is located in between the King I and King II areas. The pad for the barn area was stable with no erosional features. The drainage channel was clear of debris and in good condition. The operator installed a partly buried beam at the end of the ditch to dissipate the velocity of flow prior to discharging through the silt fence. The silt fence had a short section that rolled up on itself (Photo 11). The Division recommended maintenance on the silt fence. On December 11, 2024, the Division received photos of the completed maintenance item. The silt fence had been propped back up. The maintenance item is resolved.

Photo 11: The silt fence at the barn area that required repair.

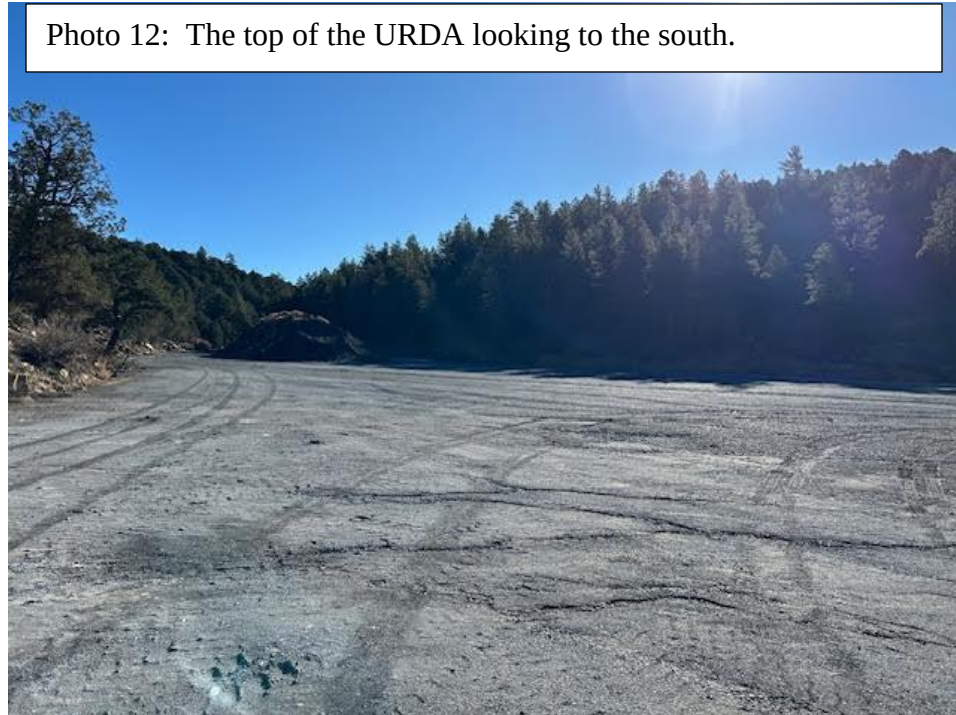
The URDA was stable. The face of the pile had minor rills extending from the top to the bottom. The rills are common and do not affect the stability of the pile. If the rills increase in size the operator will patch the rills and resurface the face of the pile. The top of the pile slopes gently to the northwest to direct any runoff to reach 10 (Photo 12). The top of the pile was in good condition and there was no evidence of runoff flowing to any other portions of the pile. There was a stockpile of coal near the southern end of the pile waiting to be spread and compacted.

Photo 12: The top of the URDA looking to the south.

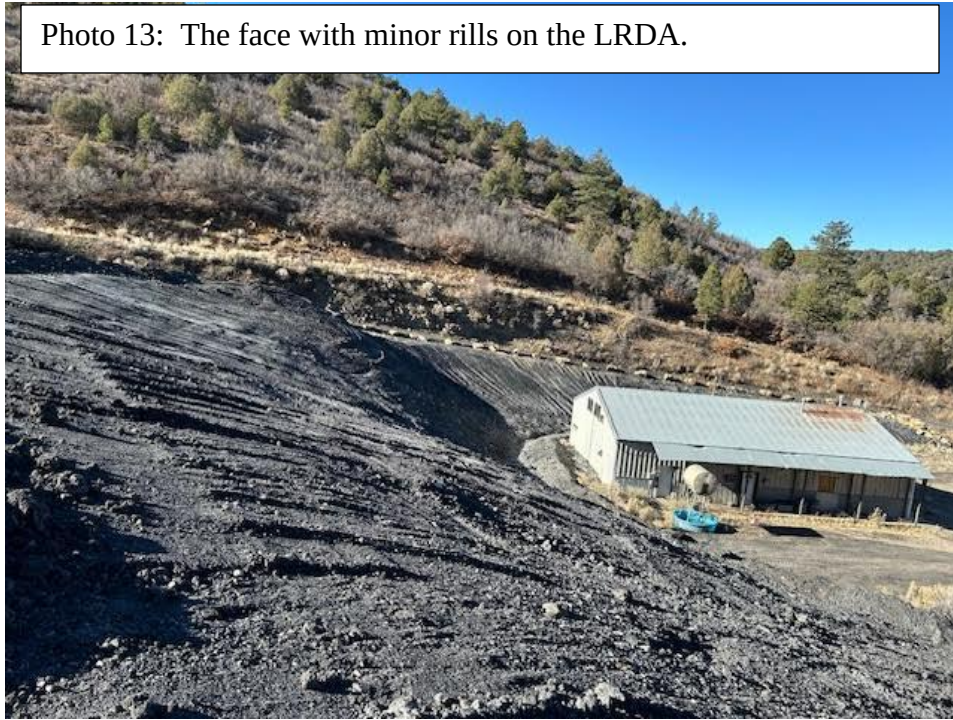
The LRDA was stable with no erosional concerns. The top of the pile sloped gently to promote runoff to the associated ditches. Reach 13 is located on the eastern side of the pile. The ditch was clear of debris and stable. There was a stockpile of coal refuse located on the top of the LRDA. The stockpile was contained to the top of the LRDA. The face of the LRDA was stable with minor rills (Photo 13). The rills were not large enough to affect the stability of the LRDA. If the rills increase in size, the operator will resurface the face of the LRDA. No indications of sloughs or slides were observed.

Photo 13: The face with minor rills on the LRDA.

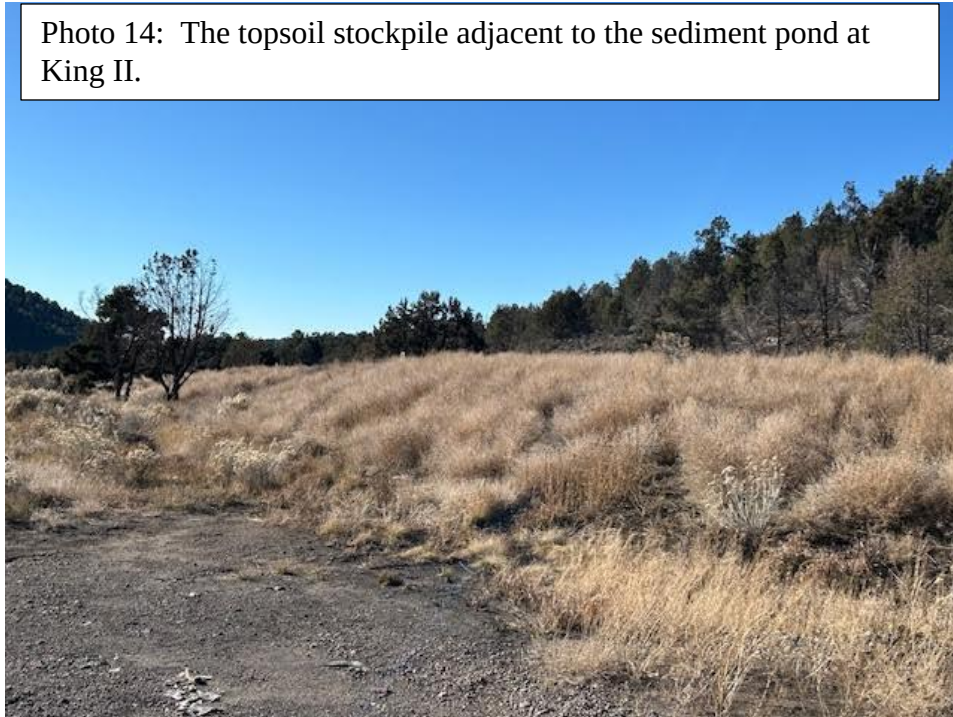
Two topsoil piles are located at the King II area. One is to the south and east of the sediment pond and the other is north of the air jig. The pile located adjacent to the sediment pond was stable with no erosional features (Photo 14). The pile was covered with vegetation. There was no loss of topsoil resources observed. The second pile was also vegetated and stable (Photo 15). There were no erosional concerns identified.

Photo 14: The topsoil stockpile adjacent to the sediment pond at King II.

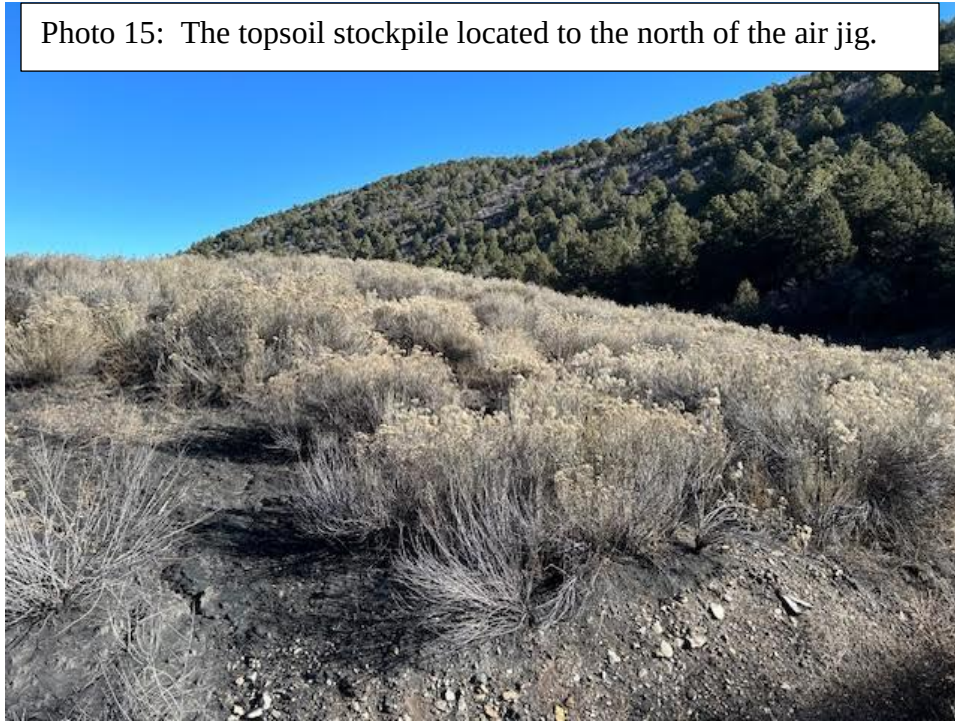
Photo 15: The topsoil stockpile located to the north of the air jig.
