LTS Performance Horses LLC- Inspection Report

MINERALS PROGRAM INSPECTION REPORT
PHONE: (303) 866-3567

MINE NAME: LTS Performance Horses LLC	MINE/PROSPECTING ID#: File No. M-2024-052	MINERAL: NA	COUNTY: Weld
INSPECTION TYPE: Possible Illegal(Unpermitted Operation)	WEATHER: Clear	INSP. DATE: November 20, 2024	INSP. TIME: 09:00am
OPERATOR: LTS Performance Horses LLC	OPERATOR REPRESENTATIVE: Dakota Rathbun	TYPE OF OPERATION: NA	
REASON FOR INSPECTION: Citizen Complaint	BOND CALCULATION TYPE: NA	BOND AMOUNT: NA	
DATE OF COMPLAINT: NA	POST INSP. CONTACTS: NA	JOINT INSP. AGENCY: None	
INSPECTOR(S): Chris Girardi Jared Ebert	INSPECTOR'S SIGNATURE:

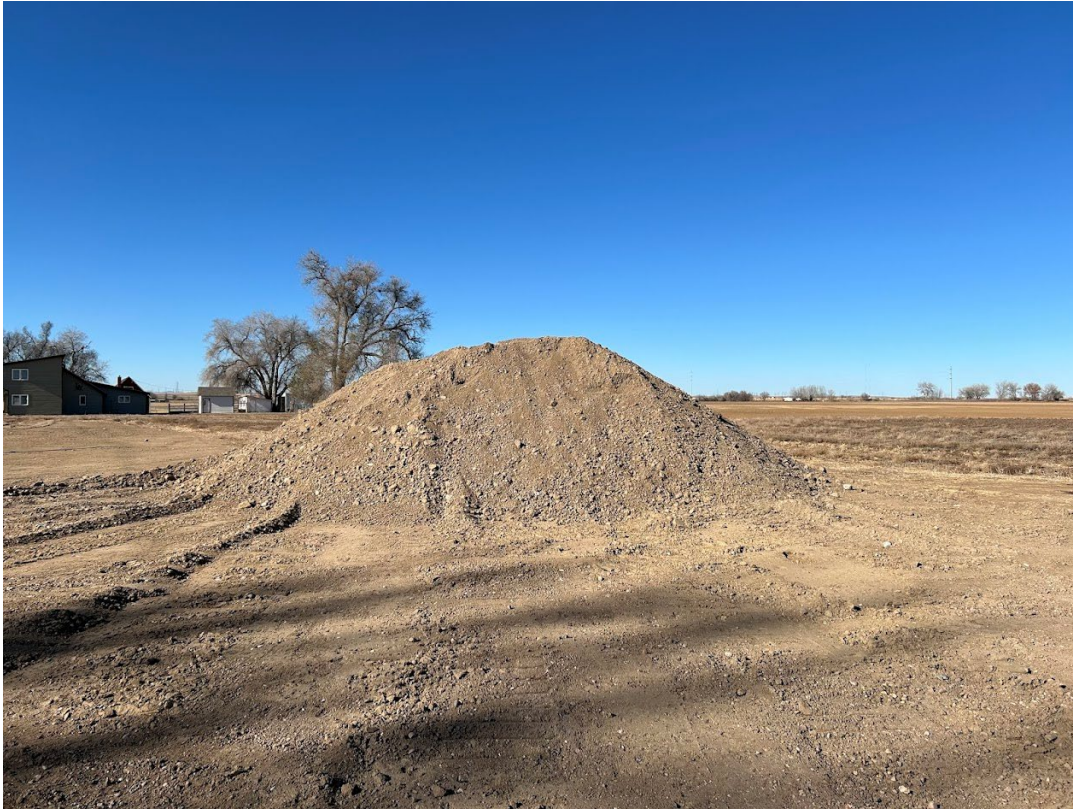
The surrounding land use is agricultural, residential, and industrial. The subject property is located to the northwest of the intersection of County Road 84 and County Road 31. An oil and gas tank battery is located nearby. Mr. Rathbun was not present during the inspection but gave the Division permission to conduct the inspection of the property. Two small stockpiles of soil or borrow material were observed adjacent to the north of County Road 84 (see Photos 1-2). Two large, vegetated stockpiles of what appeared to be topsoil were present (see Photos 4-5). To the north was a field that showed evidence of tilling (see Photos 6-9). Tillage equipment (see Photo 7) was observed in the field as well. A dirt access road ran parallel to County Road 31 and the tilled field and showed evidence of vehicular traffic. On the northern side of the field, a large stockpile of soil/borrow material approximately fifteen (15) feet in height was observed along with a wheel loader and dozer combo equipment (see Photo 9). The access road leads to this stockpiled material. It appears recent excavation into the stockpile has occurred and it seems this material may have been transported to the south

side of the property and stockpiled near the entrance to the site (Photo 1-2)

Photo 1: Dirt stockpile near County Road 84, facing west.

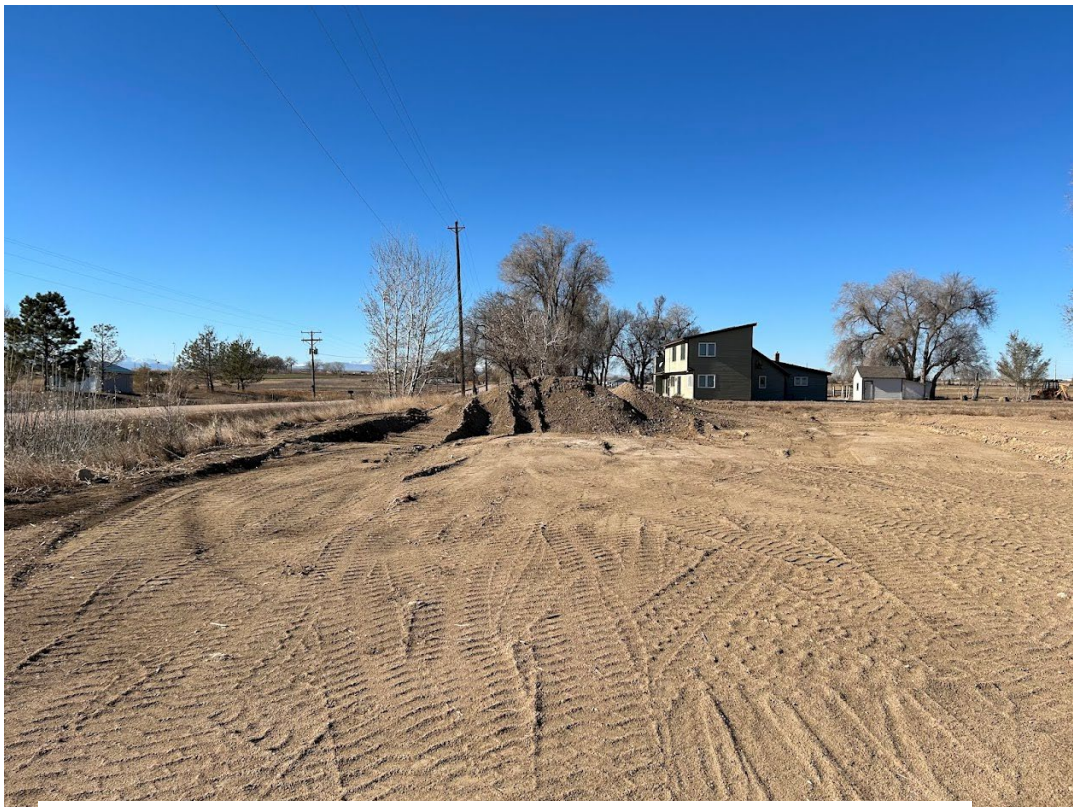
Photo 2: Second dirt stockpile near County Road 84, facing west.

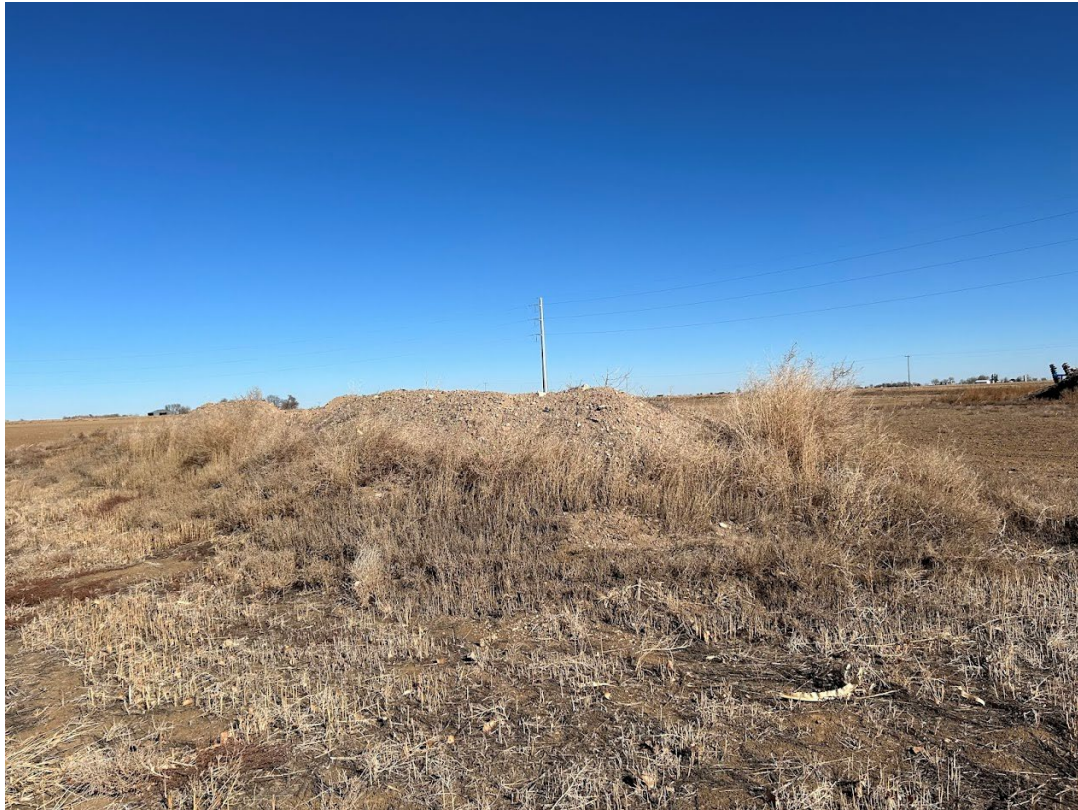
Photo 3: Stockpile near in field, facing northeast.

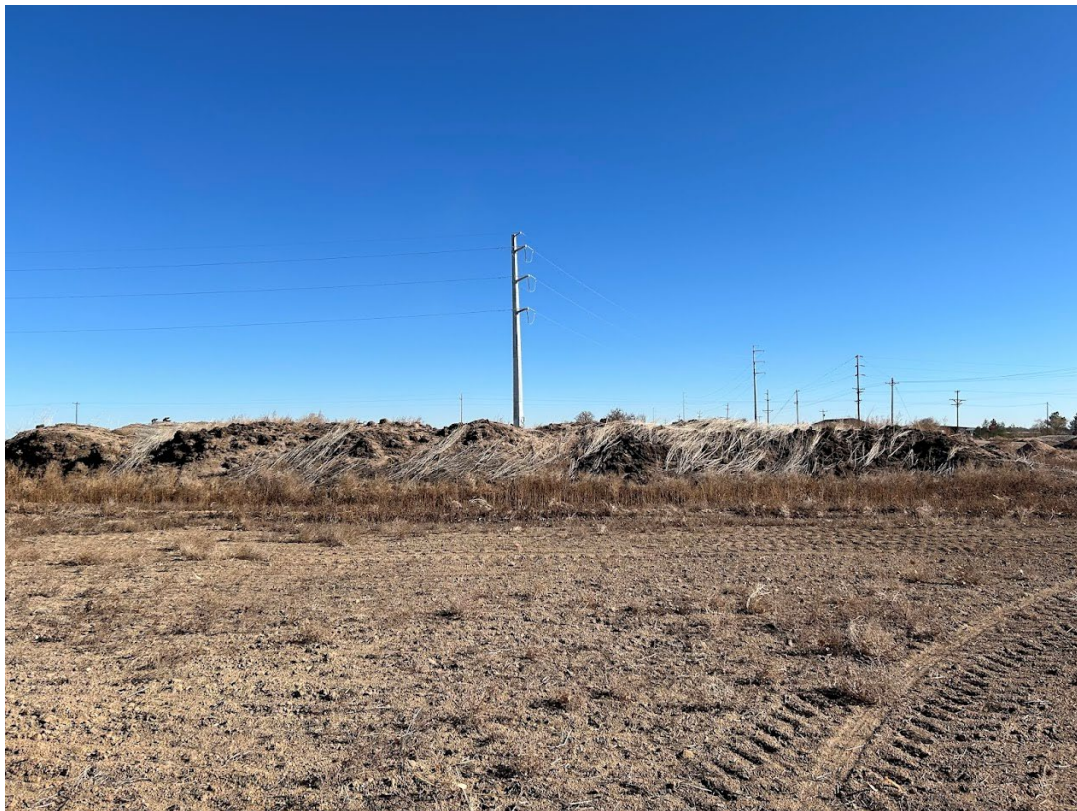
Photo 4: Topsoil stockpile near in field, facing east.

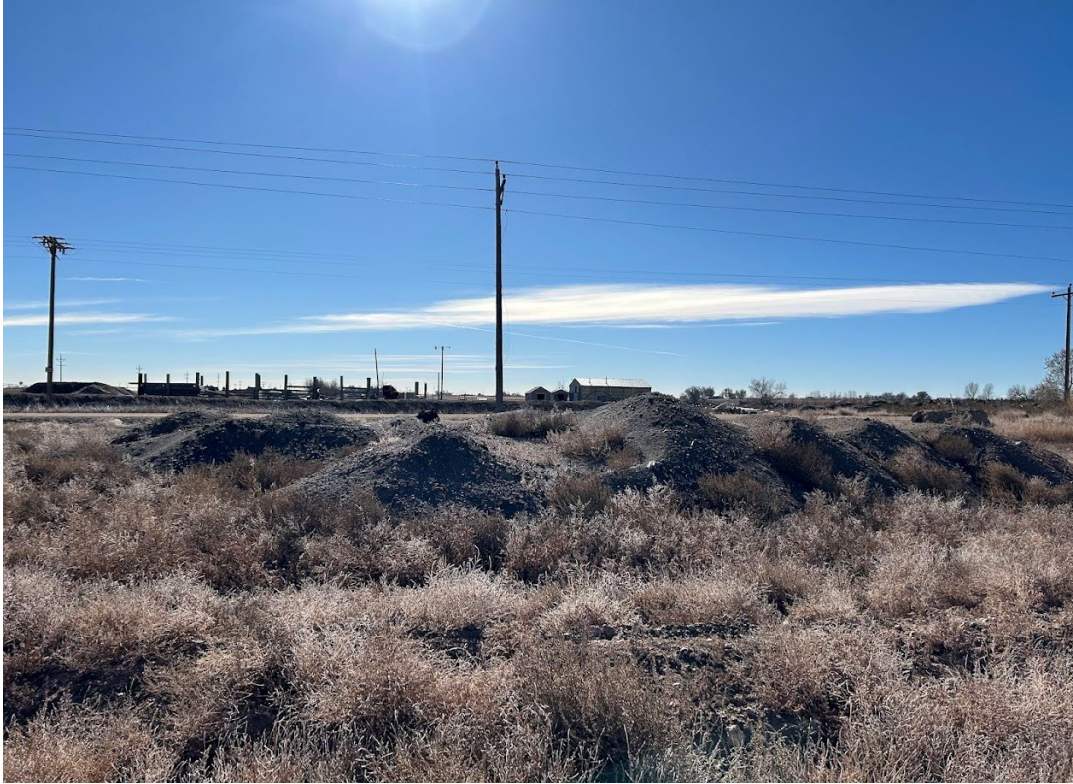
Photo 5: Stockpile near intersection of County Road 84 and County Road 31, facing east.

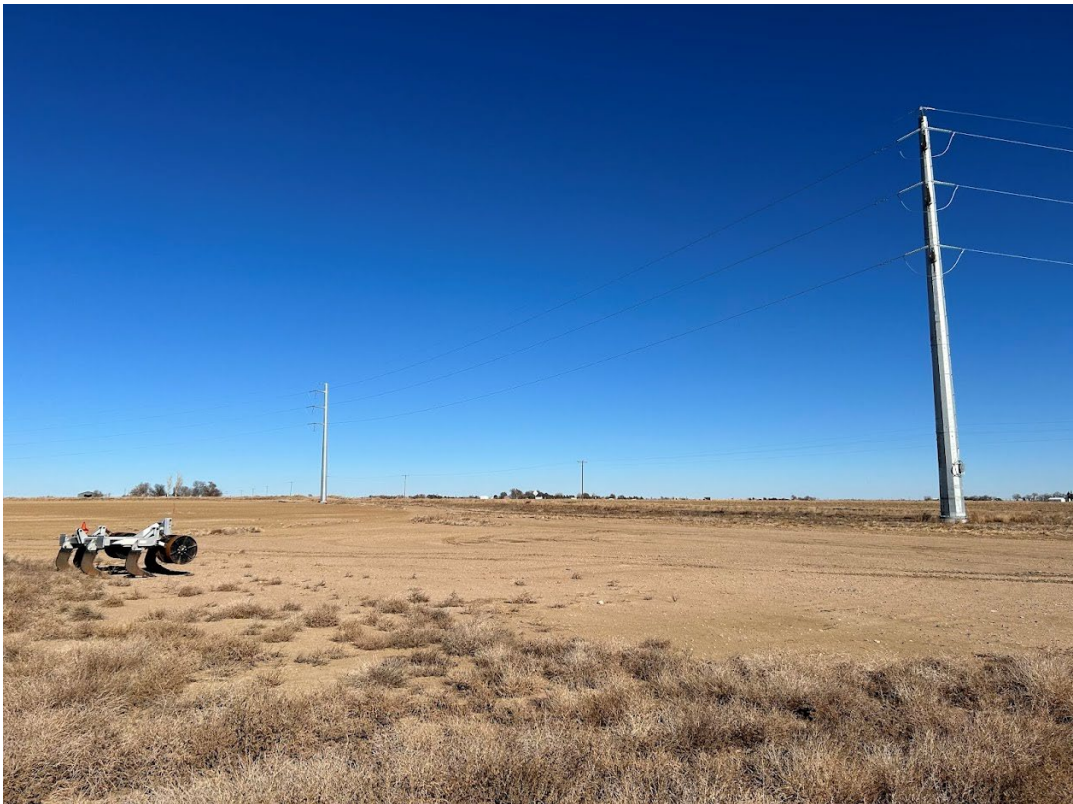
Photo 6: Power lines along County Road 31, facing north.

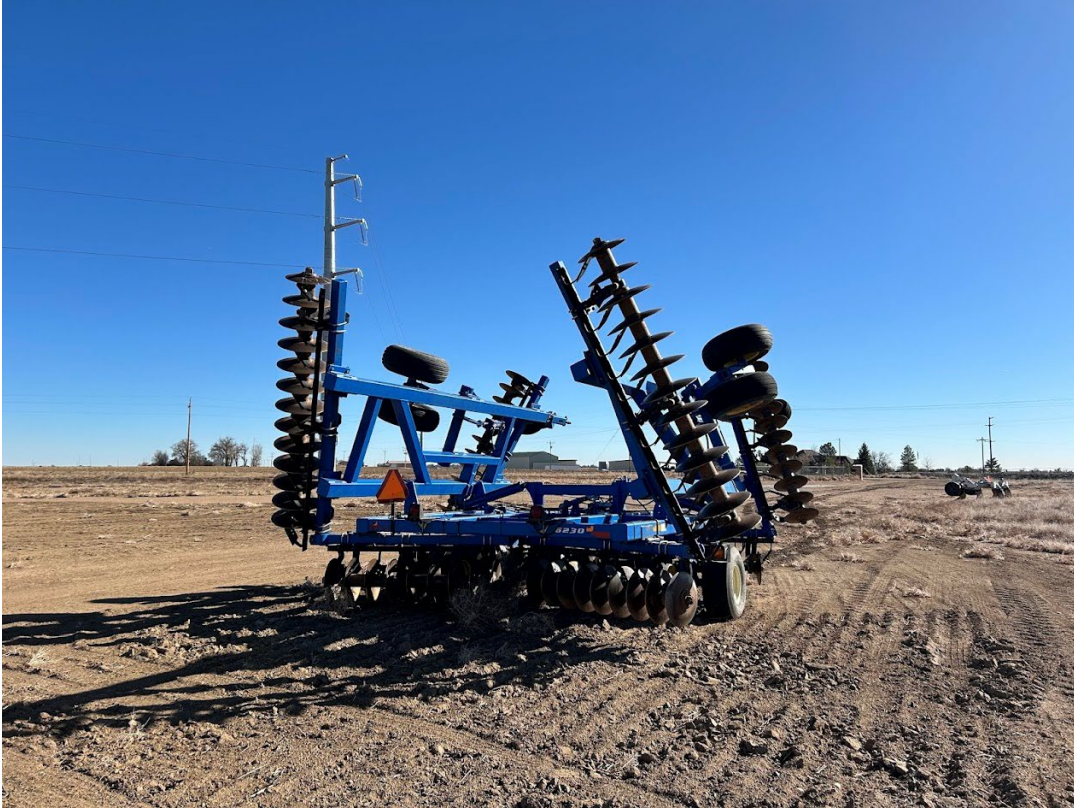
Photo 7: Tilling equipment in field.

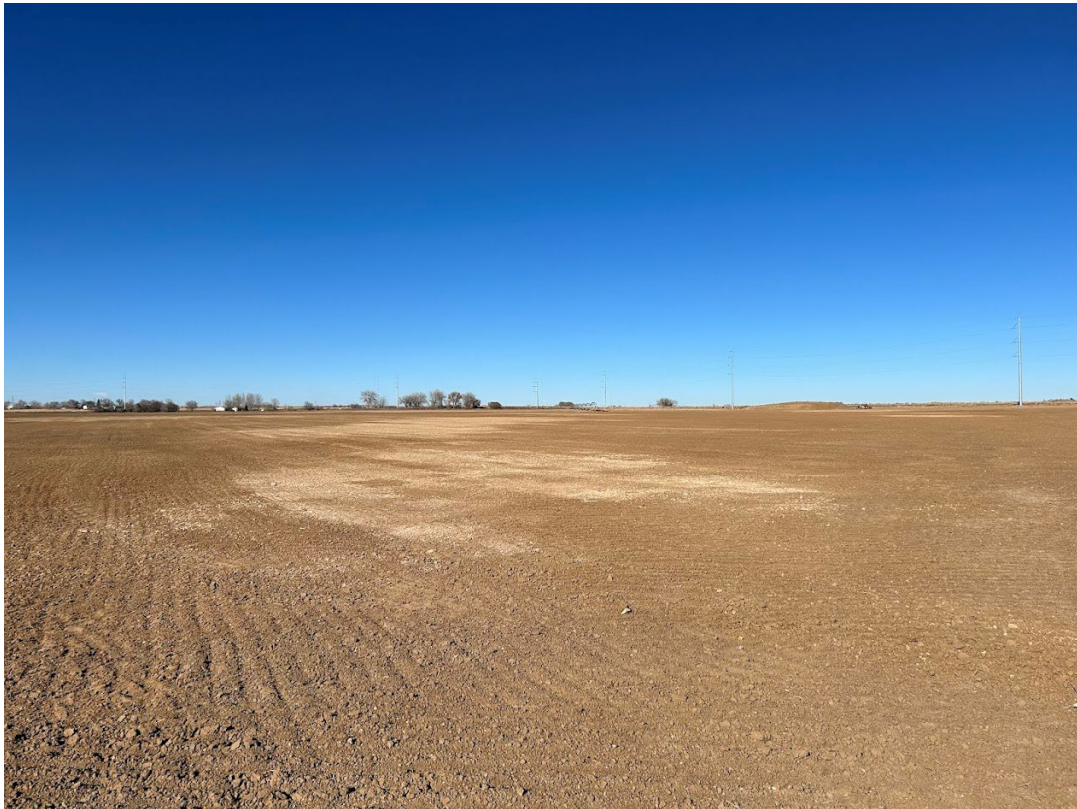
Photo 8: Tilled field, facing west.

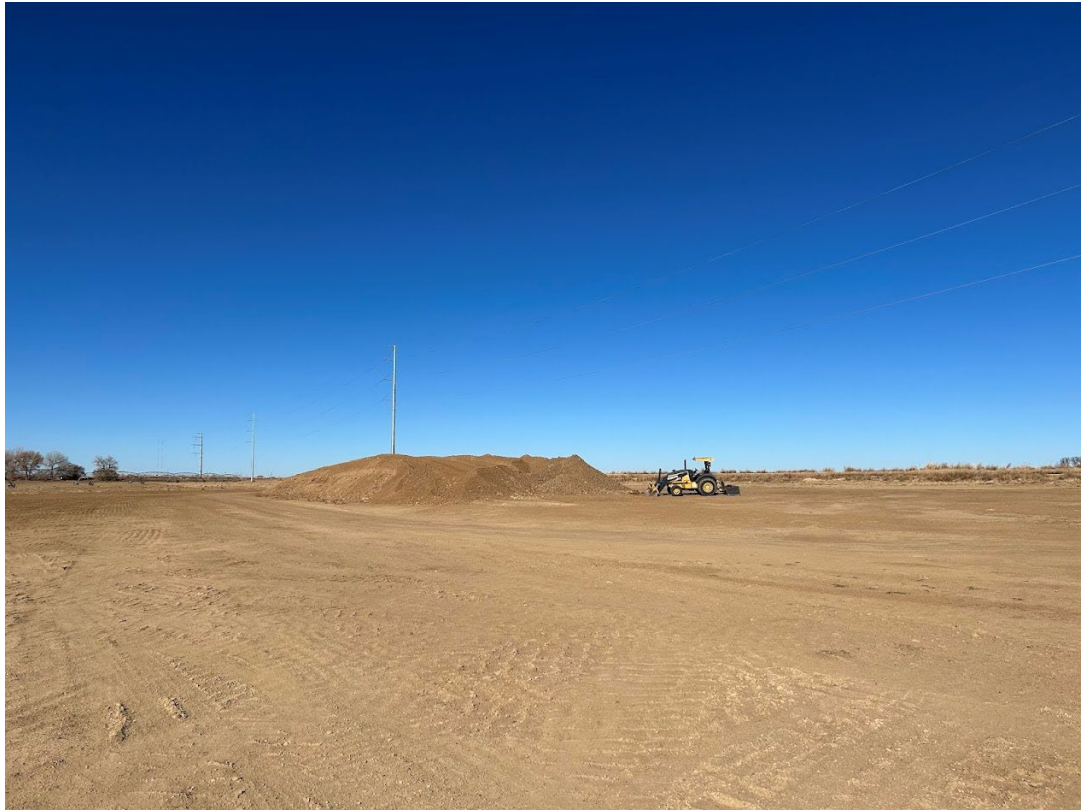
Photo 9: Large stockpile in the northern portion of the tilled field, facing northwest.
