## New Horizon 2 Mine, C-1981-008, December Complete Inspection Report

**PERMIT INFORMATION**

**INSPECTION INFORMATION**

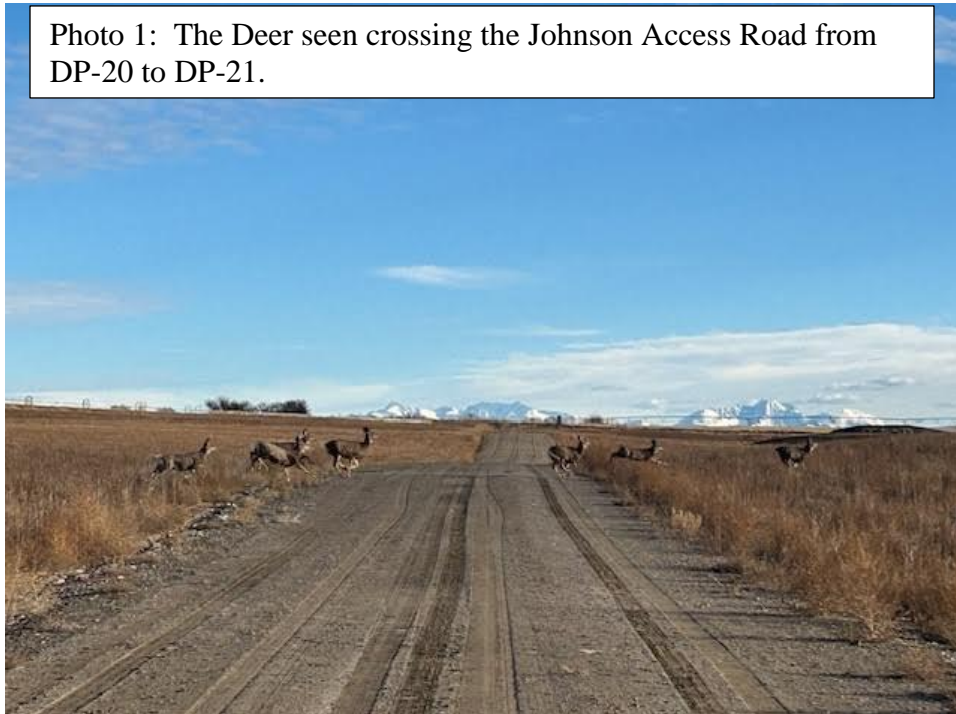
During the inspection a group of deer was seen on Dryland Pastures DP-20 and DP-21 (Photo 1). There were approximately 10 to 12 deer in the group. Several other sets of deer tracks were seen throughout the inspection of the mine site.

Photo 1: The Deer seen crossing the Johnson Access Road from DP-20 to DP-21.

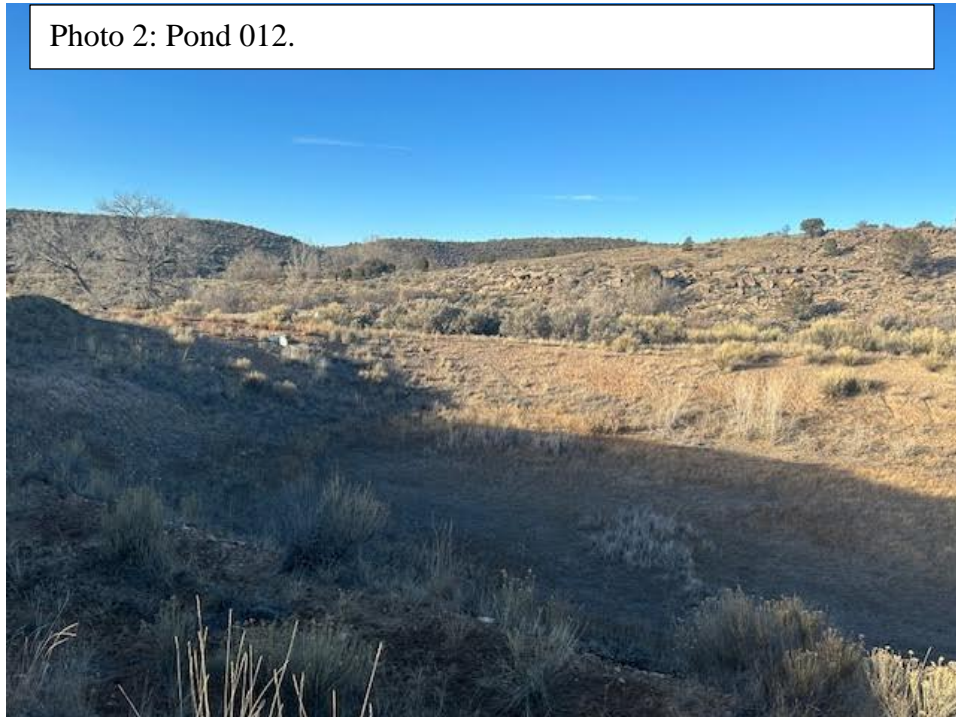
Photo 2: Pond 012.

Pond 12 is located north of Dryland Pasture DP-12. The pond was dry during the inspection (Photo 2). The pond's embankment was stable with vegetative cover. The discharge outlet was clear of debris. There were no indications of erosional features observed.

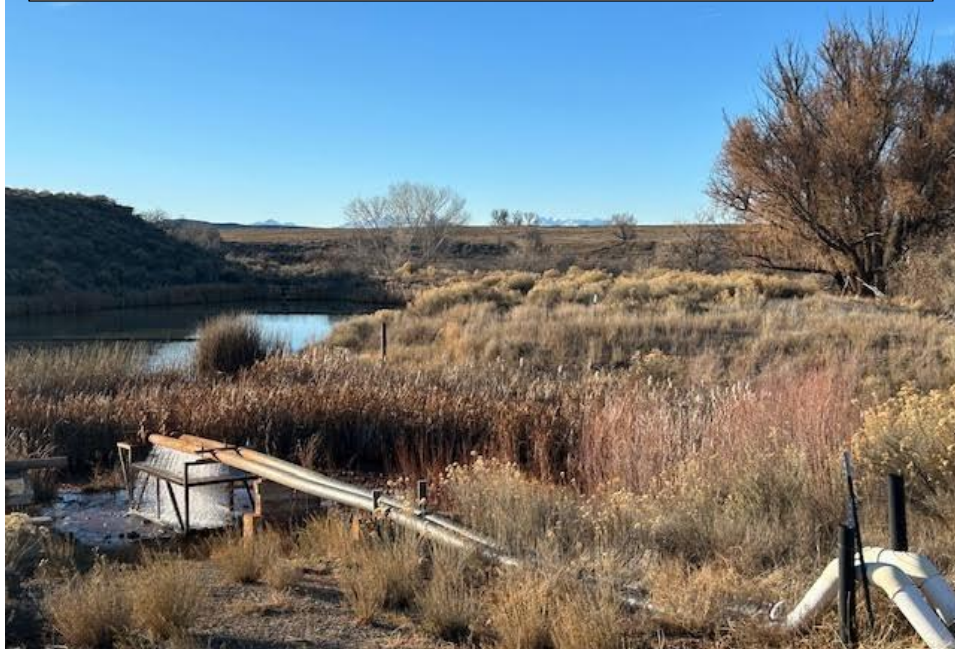
Photo 3: Pond 013.

Pond 013 is located north of Dryland Pasture DP-21. Pond 013 was impounding water during the inspection (Photo 3). The water was at the level of the discharge outlet. There were no blockages on the outlet observed. The embankment was vegetated and stable. No erosional features were identified.

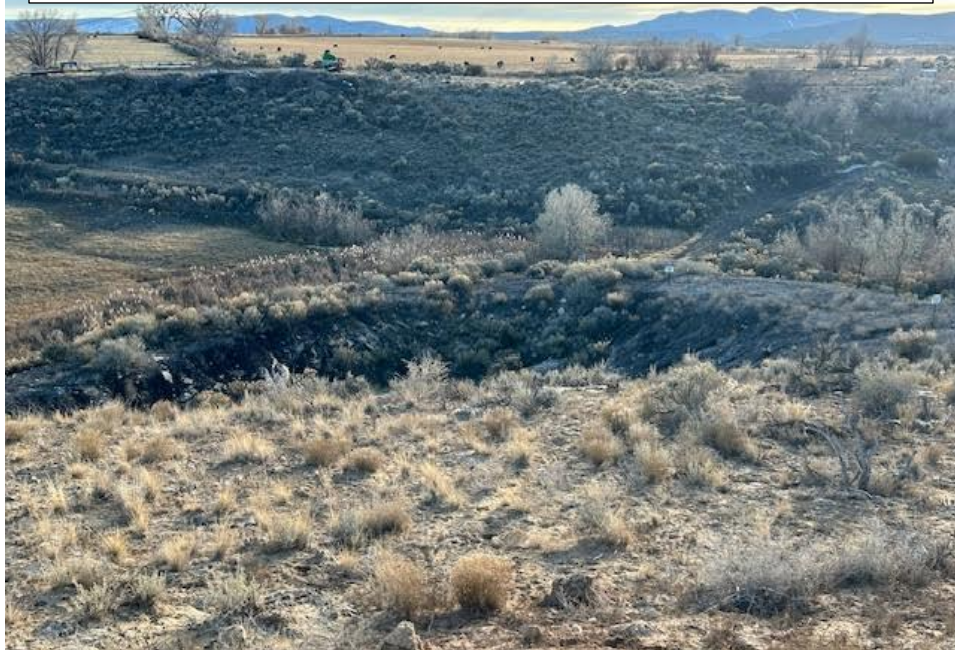
Photo 4: Pond 015.

Pond 015 is located to the south of the southwestern corner of DP-21. Pond 015 was dry (Photo 4). There were no blockages observed in the pond's outlet. The embankment for the pond was stable with vegetation. There were no new erosional features identified. Minor rills on the interior of the pond's embankment have been noted in previous Division inspections. The rills had not enlarged in size.

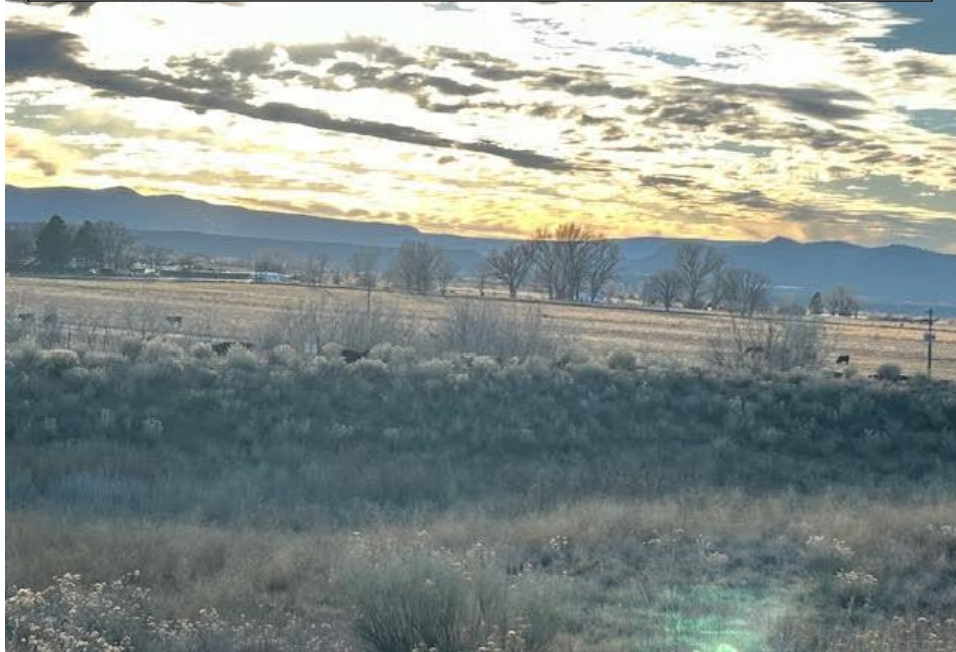
Photo 5: Pond 018.

Pond 018 is located to the south of the mine office and facilities pad. Pond 018 was also dry during the inspection (Photo 5). The outlet for the pond was observed to be clear of debris. The embankment had no indications of erosion or instability. The embankment was well vegetated.

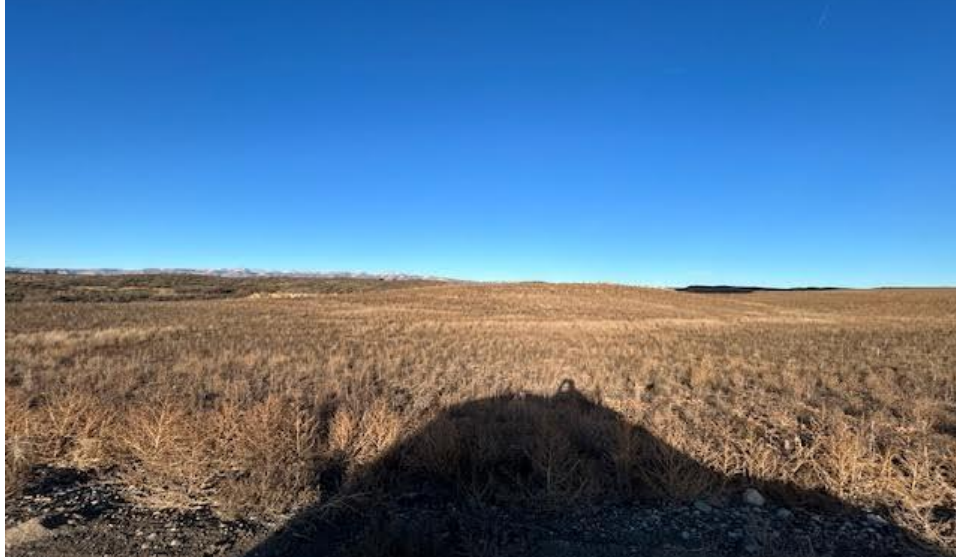
Photo 6: Dryland Pasture DP-20.

A total of 9 Dryland Pasture parcels (DP-10, DP-11, DP-13, DP-14, DP-15, DP-18, DP-20 (Photo 6) and DP-21 (Photo 7) are located in Section 36. DP-10, DP-11, DP-12, DP-13, DP-14 and DP-15 were stable with vegetative cover. There were no observed signs of erosion or differential settling. DP-18, DP-20 and DP-21 were reclaimed and seeded in 2023. All three of the reclaimed parcels were stable and had vegetative cover. There were no sections observed with differential settling or erosion.

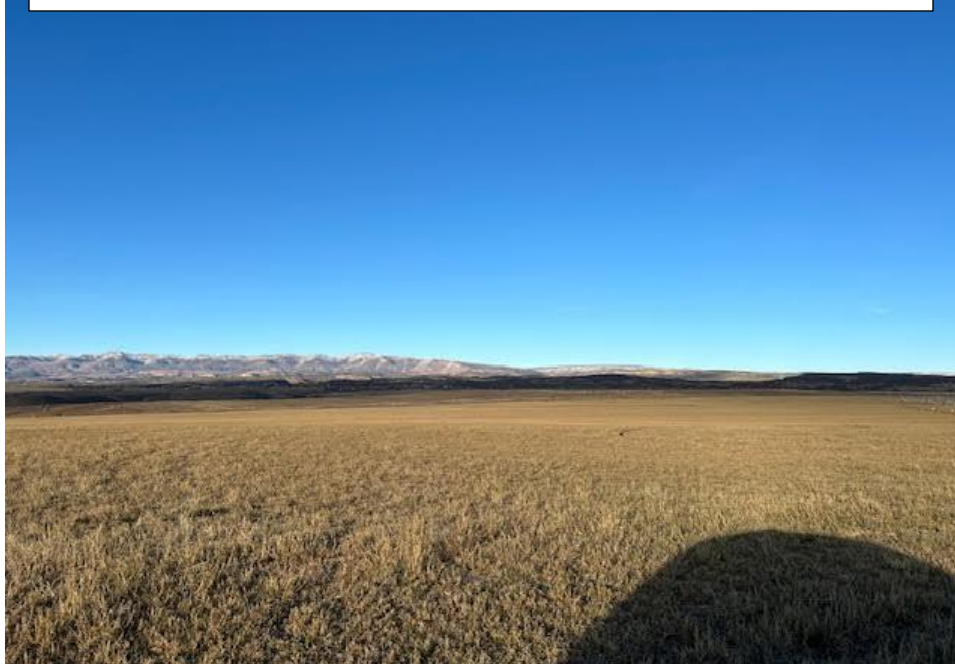
Photo 8: Irrigated Cropland IC-1.

One parcel of Irrigated Cropland (IC-1) is located in the northeast portion of Section 1. The field was vegetation during the inspection (Photo 8). No indications of differential settling observed. There were no erosional concerns identified.

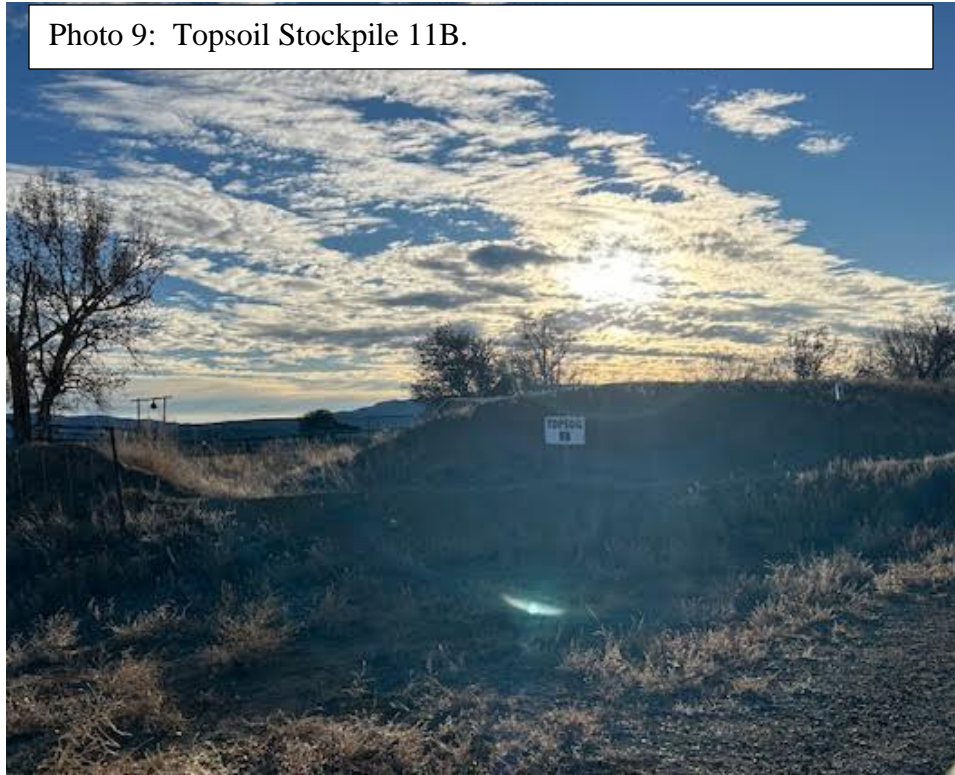
Photo 9: Topsoil Stockpile 11B.

Another 2 Topsoil Piles, 11A and 11B (Photo 9), are located in the southern part of the permit boundary south of IC-1. The piles were observed to be stable with no erosional features. Both piles were covered with vegetation. There was no indication of the loss of topsoil resource.
