MINERALS PROGRAM INSPECTION REPORT
PHONE: (303) 866-3567

MINE NAME: Pikeview Quarry	MINE/PROSPECTING ID#: M-1977-211	MINERAL: Limestone (general), granite gneiss and do	COUNTY: El Paso
INSPECTION TYPE: Monitoring	WEATHER: Clear	INSP. DATE: December 16, 2024	INSP. TIME: 10:00
OPERATOR: Riverbend Industries Inc.	OPERATOR REPRESENTATIVE: Jerry Schnabel	TYPE OF OPERATION: 112c - Construction Regular Operation	
REASON FOR INSPECTION: Normal I&E Program	BOND CALCULATION TYPE: None	BOND AMOUNT: \$6,805,607.00	
DATE OF COMPLAINT: NA	POST INSP. CONTACTS: None	JOINT INSP. AGENCY: None	
INSPECTOR(S): Hunter Ridley	INSPECTOR'S SIGNATURE:

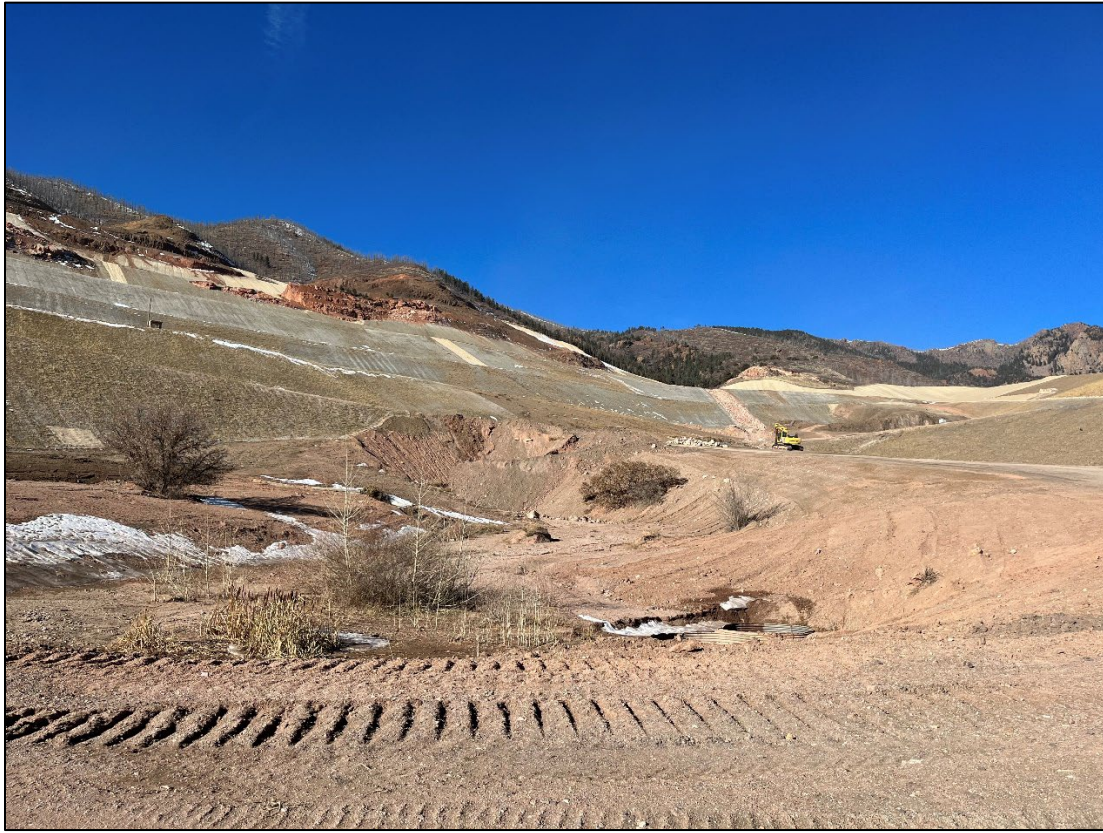
The large culvert area at the eastern end of the site continues to allow water to flow through the buttress slope underdrain as designed. This water was observed to be flowing consistently and is now connected with a small creek at the edge of the permit and flowing into the adjacent open space. The western slope in this culvert area still requires some grading and lay back efforts to reduce the slope grade (Photo 1).

Photo 1: Culvert area just west of the main office.

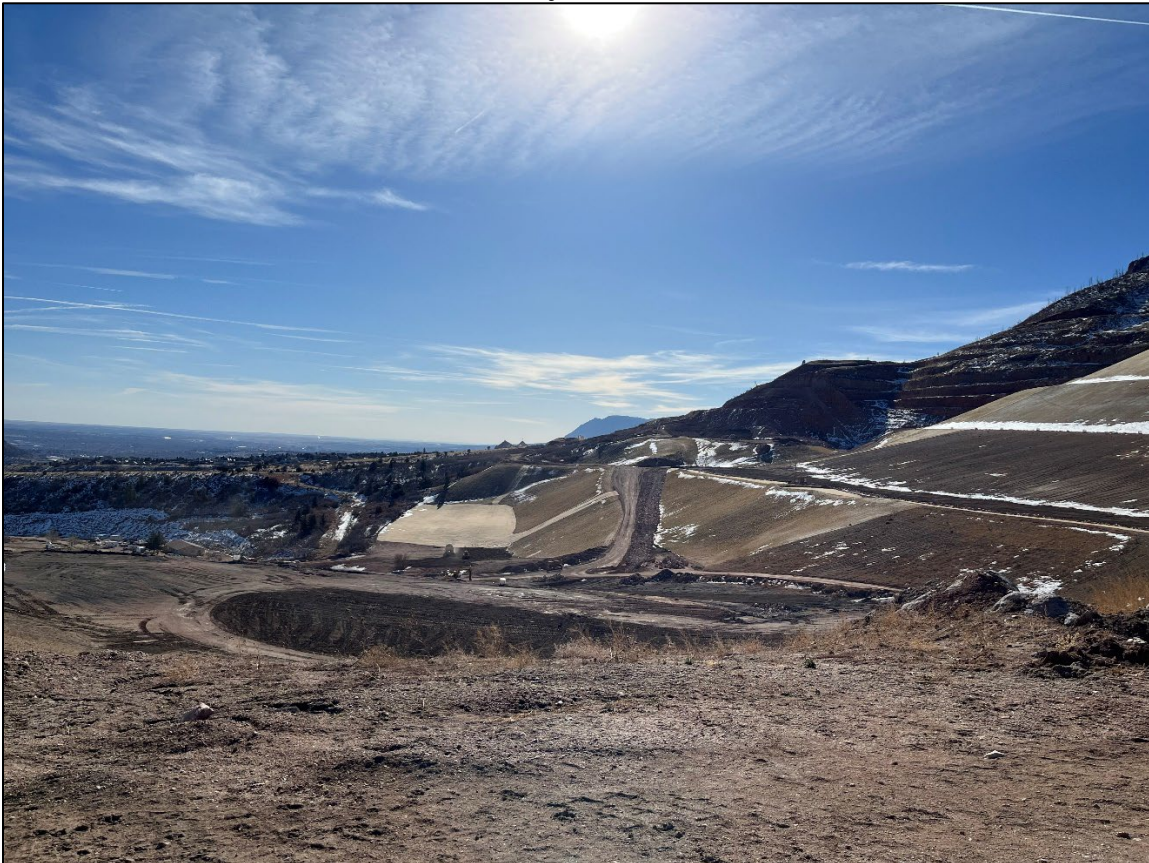
Revegetation & Topsoil: The Division has retained all bonding tasks associated with revegetation at the site. Areas which remain on site to be topsoiled and seeded include the south quarry area and the lower culvert area (Photo 2). Depending on how much excess matting material is available, these areas may receive matting instead of the usual seeding method.

Photo 2: View south from the northern portion of the permit boundary.

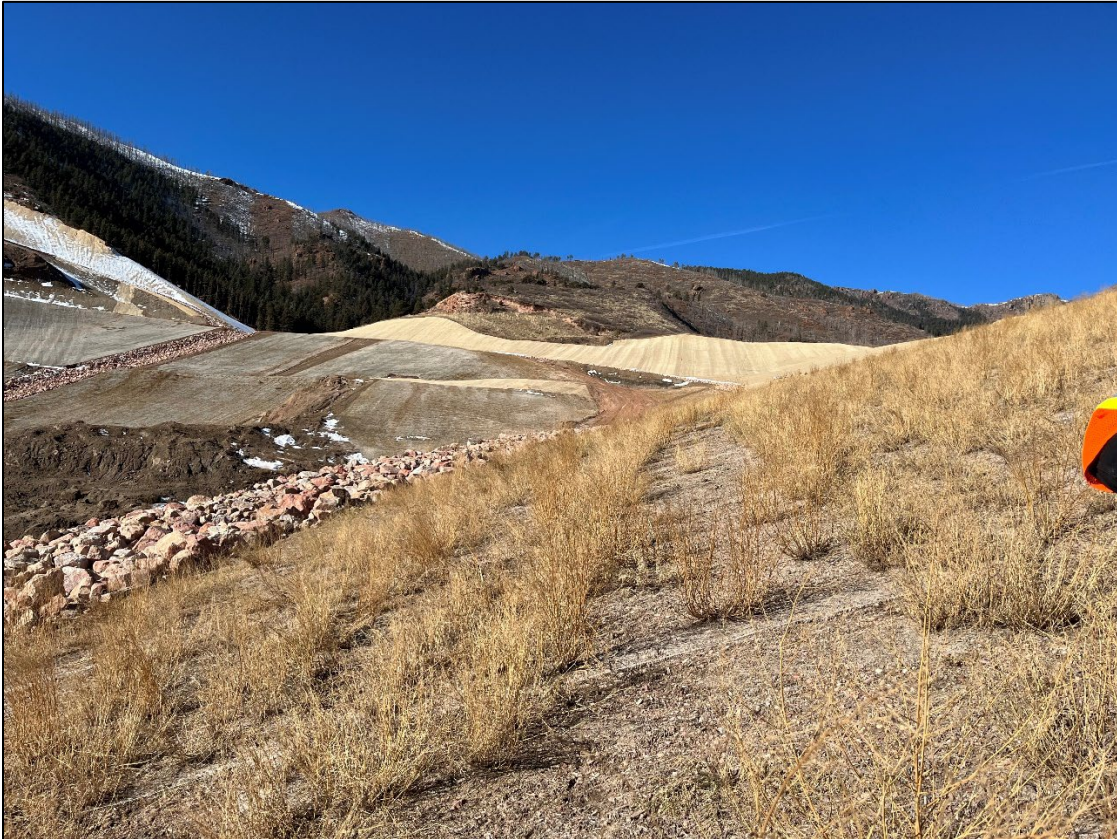
Photo 3: View northwest of the partially revegetated City property. Clumps of trees and shrubs have been planted on this hillside, but grasses are struggling to grow.

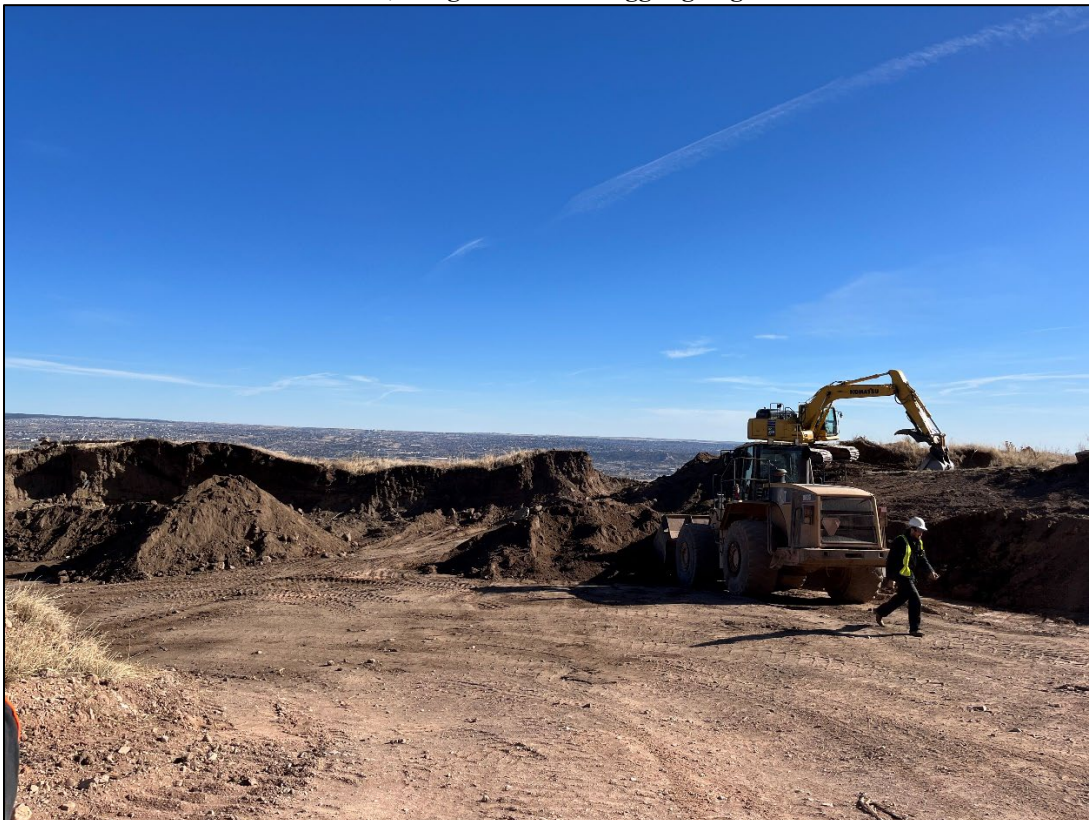
Roads: The site continues its work in obliterating all roads on Forest Service property, as requested by the Forest Service (Photos 4 and 5). The Forest Service has requested that the final 'design' of the obliterated road be comprised of the rough, pocketed piles of material seen in Photo 5. Topsoil from nearby is currently being used to facilitate this road obliteration. Each portion of the road is being approved by the Forest Service as Pikeview works on obliteration down the slope. A grading task remains in place with the Division to cover these costs and to cover the cost of rebuilding and re-

Photo 4: Topsoil stockpiles are being excavated and utilized for road obliteration on USFS land.

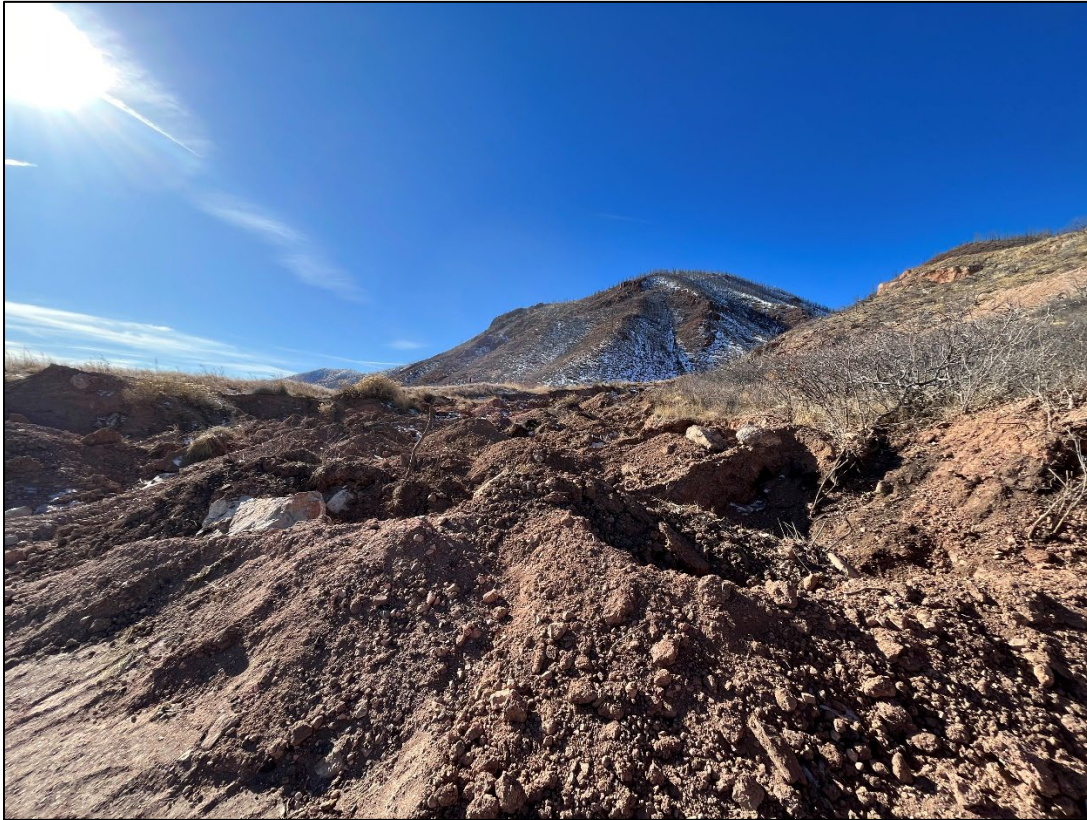
Photo 5: The USFS has approved the rough, pocketed 'design' of the road for the purposes of obliteration.
