Bowie #1 inspection report

PERMIT INFORMATION

Permit Number: C-1981-038 Mine Name: Bowie No. 1 Mine Operator: Bowie Resources, LLC Operator Address: Mr. Basil R Bear P.O. Box 1488 Paonia, CO 81428	County: Delta Operation Type: Underground Permit Status: Active Ownership: Private
	Operator Representative Present: None
Operator Representative Signature: (Field Issuance Only)

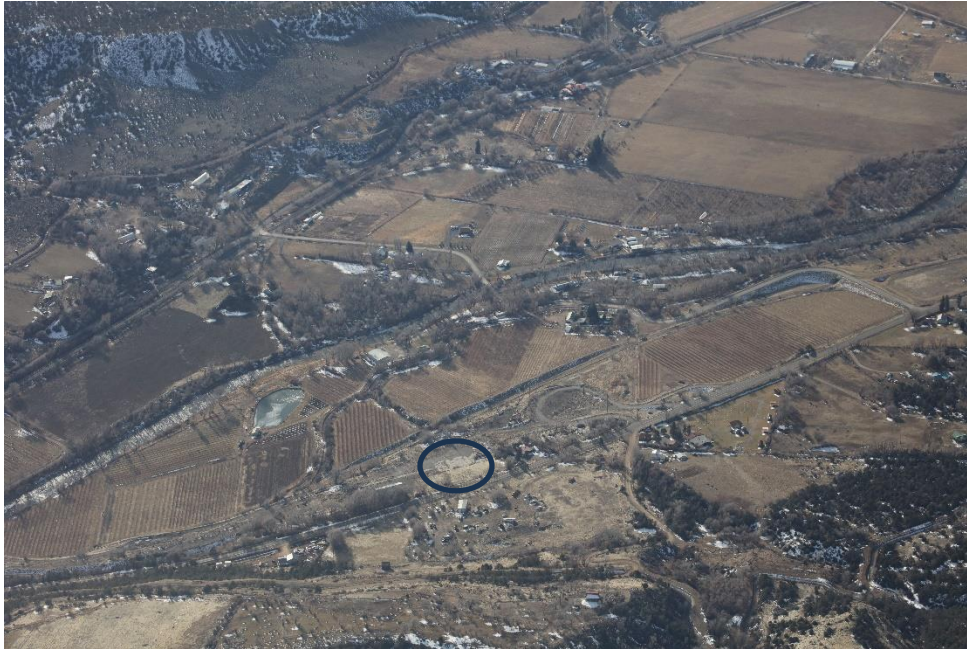
No erosion was seen at the loadout, including the steep slope between the loadout and the orchard below. The trestle across the river appears stable. No problems were seen with the railroad tracks southeast of the loadout, as viewed in aerial photographs.

Area around loadout, with silo foundations circled

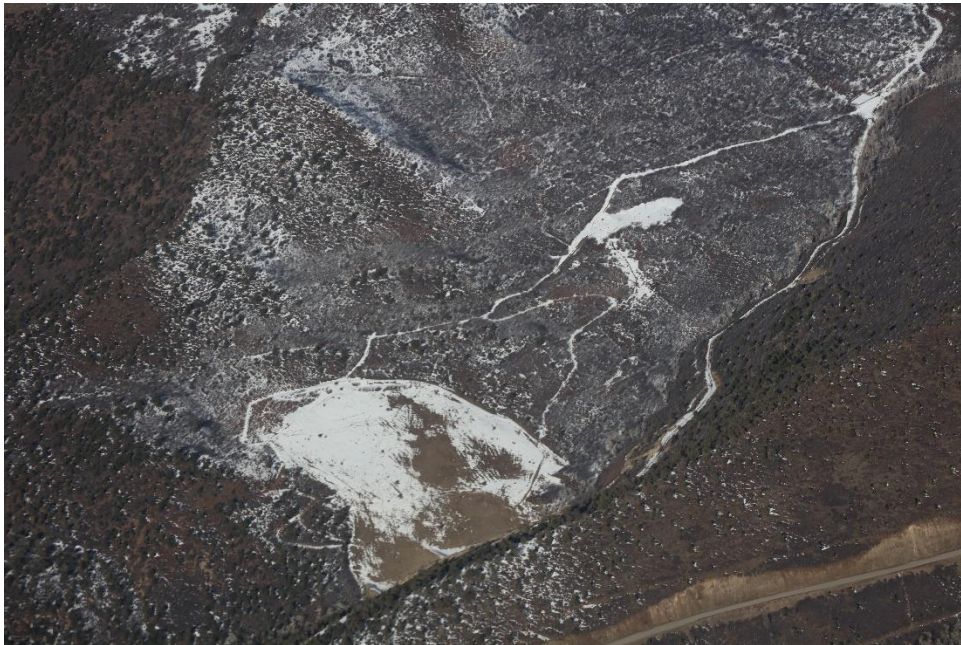
The ponds at the West Mine were observed in aerial photographs. They contained a small amount of snow. No problems were seen with these ponds.

No problems were identified with the reclamation in the area of Ponds 1, 2, 3, and 4 at the East Mine. No problems were identified with the road to the ponds at the West Mine or the pad for the West Mine Fan, which is north of the primary West Mine area.

West Mine and pad for the West Mine Fan

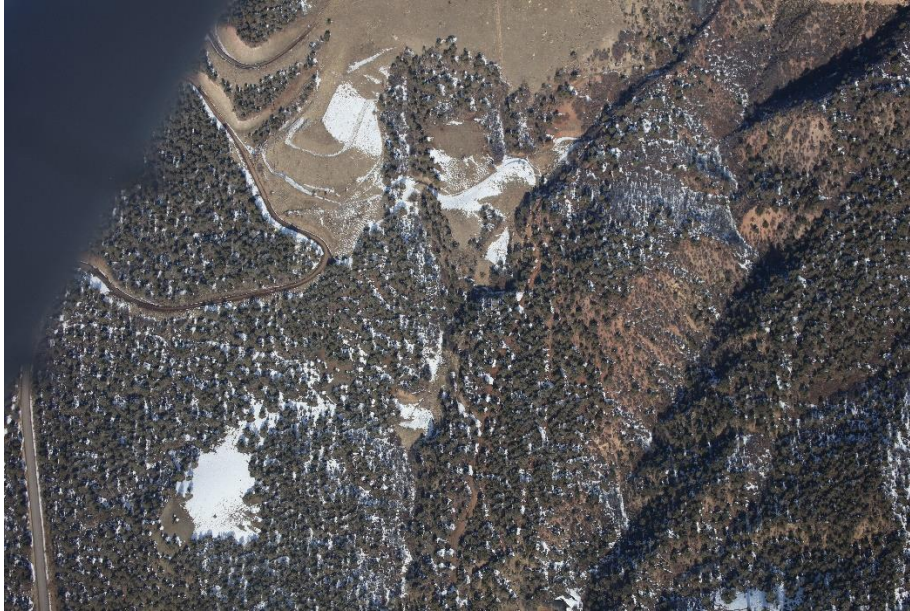
East Mine drainage with reclaimed Ponds 1 - 4

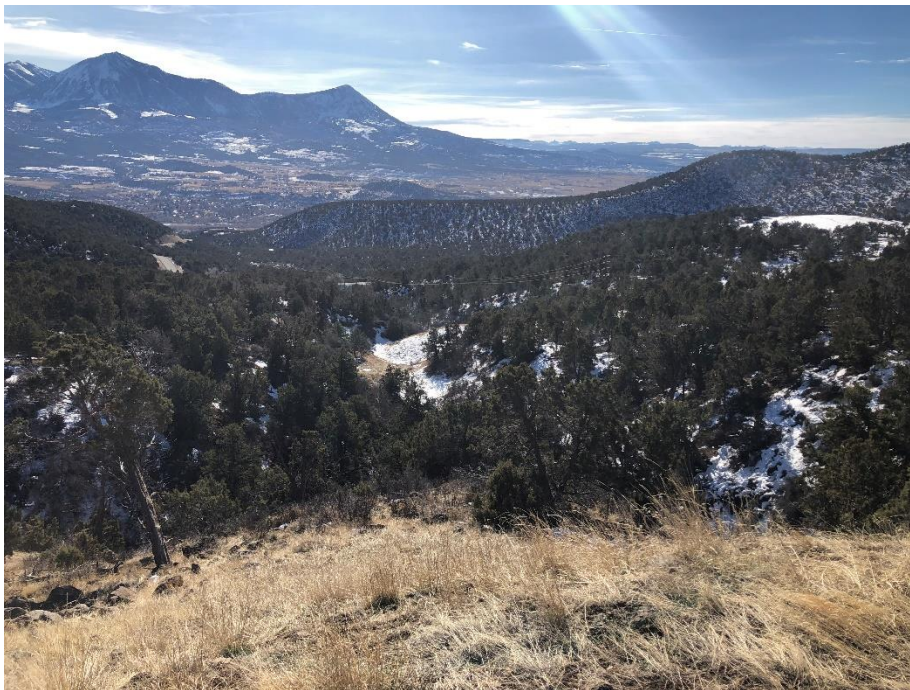
East Mine drainage looking down at reclaimed Ponds 3 and 4 (from the Old Waste Disposal Area)
