Bowie #2 inspection report

PERMIT INFORMATION

Permit Number: C-1996-083	County: Delta		
Mine Name: Bowie No. 2 Mine	Operation Type: Underground		
Operator: Bowie Resources, LLC	Permit Status: Active		
Operator Address:	Ownership: Private		
Mr. Basil Bear	•		
P.O. Box 1488	Operator Representative Present:		
Paonia, CO 81428			
	Basil Bear, Tamme Bishop		
	-		
Operator Representative Signature: (Field Issuance Only)

INSPECTION INFORMATION

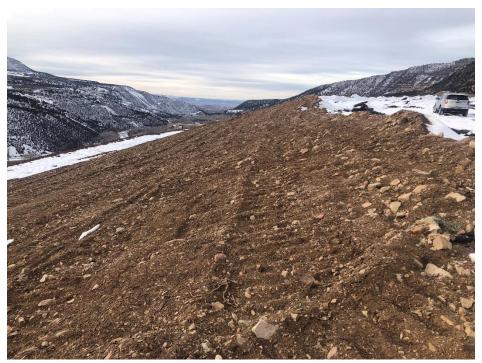
Reclaimed slope on Gob Pile #2

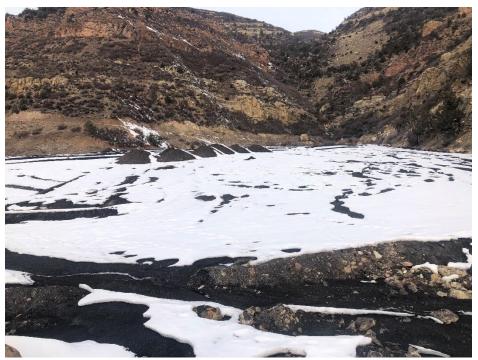
Gob Piles 1, 2, 3, and 4 appeared stable, and no significant erosion was observed. On the flat, un-reclaimed portion of Gob Pile #2, piles of material were seen. These are soil from pond cleaning and do not present a major problem. No low spots to collect water were seen on this pile, and the small ditches appear to be functioning.

Upper portion of Gob Pile #2, with piles that need to be spread

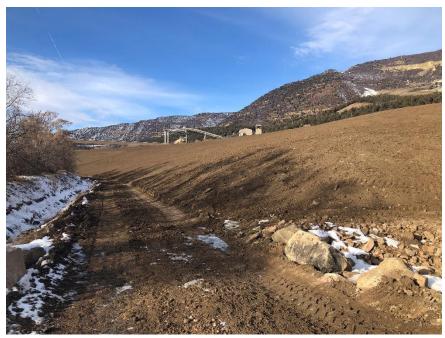
Southeast corner of Gob Pile #3

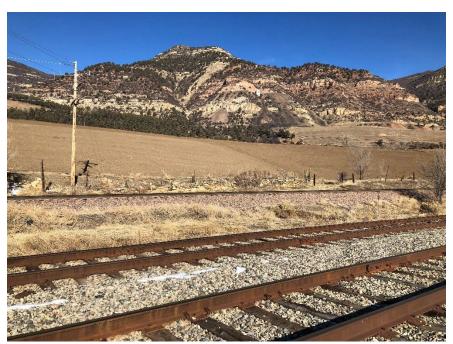
South side of Gob Pile #3

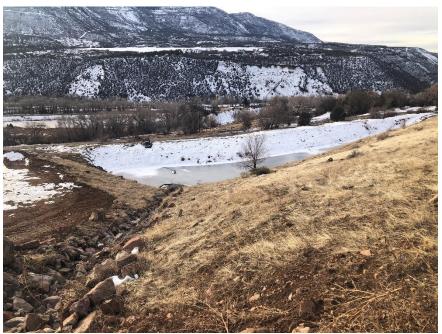
Pond F

Six sediment ponds were inspected: B, C, D, F, J, and K. None of the ponds was close to discharging, but most of them contained snow and/or ice. The bottom of Pond J is obscured by cattails, and no water (liquid or solid) was seen. No significant problems were identified with embankments, spillways, inlet channels, or other features of the ponds.

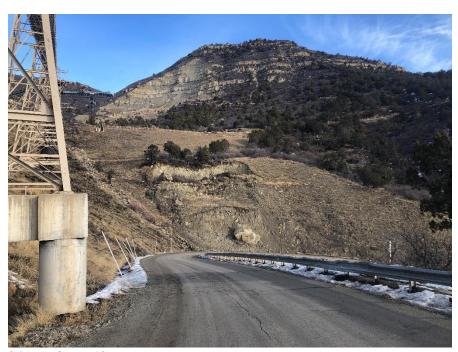
The road to the portals was in adequate condition. The slopes adjacent to this road are generally stable, except for the slide at Curve 10 (see Slides and Other Damage section).

At the slide above Curve Number 10, the slope appeared to be the same as in November, and the ditch appeared to be functioning.

Slide at Curve 10

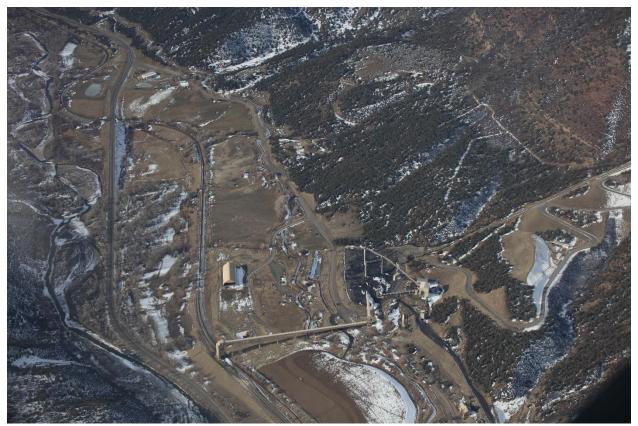
The North Fork of the Gunnison River was observed in the aerial photographs. There appeared to be no signs of pollutant loading from the mine site.

North Fork of Gunnison River on left and Gob Pile #3 in center foreground

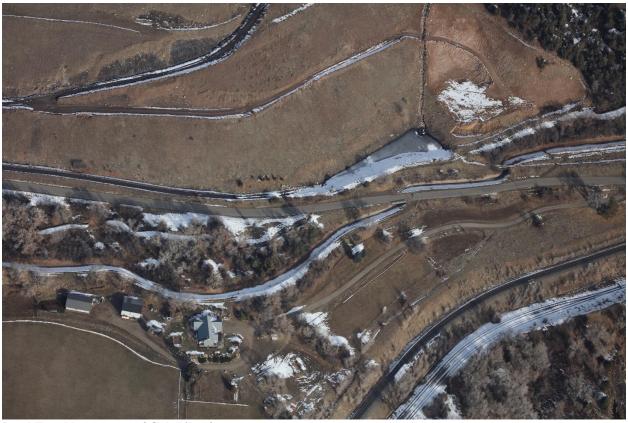
The ditch from Gob Pile #2 to Pond F appeared stable. A portion of this ditch must be completed after the soil pile has been used and the footprint reclaimed.

Pond F and lower part of Gob Pile #2
