McClane Canyon Mine, C-1980-004, December Complete Inspection Report

PERMIT INFORMATION

Permit Number: C-1980-004 Mine Name: McClane Canyon Mine Operator: ARC McClane Canyon, LLC Operator Address: Joe Brinton 652 Peony Dr Grand Junction, CO 81507	County: Garfield Operation Type: Underground Permit Status: Temporary Cessation Ownership: Private
	Operator Representative Present: Chuck Selingo
Operator Representative Signature: (Field Issuance Only)

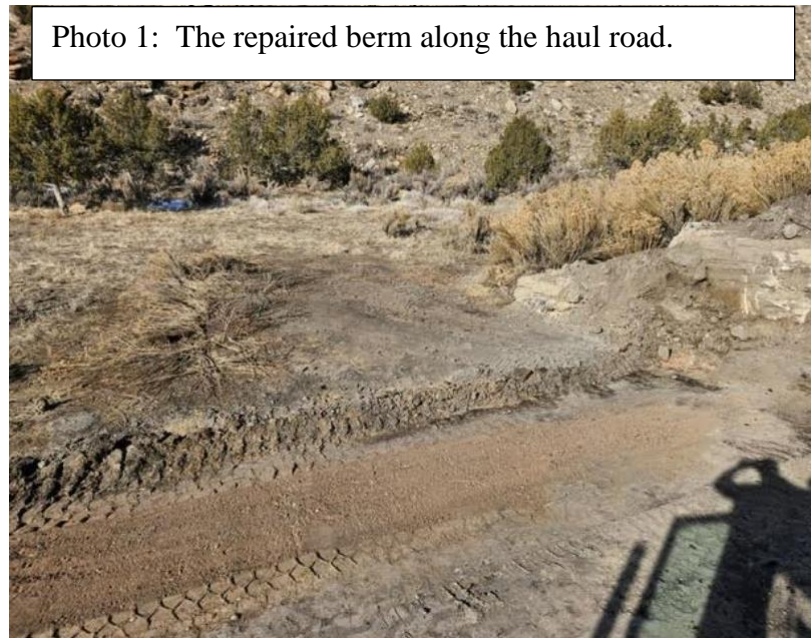
The portion of the haul road ditch west of Sump Q needed to be repaired. The ditch's berm had flattened out. On December 16, 2024, the operator submitted to the Division photo showing the repair of the ditch's berm (Photo 1). The Division considers the maintenance item to be satisfied.

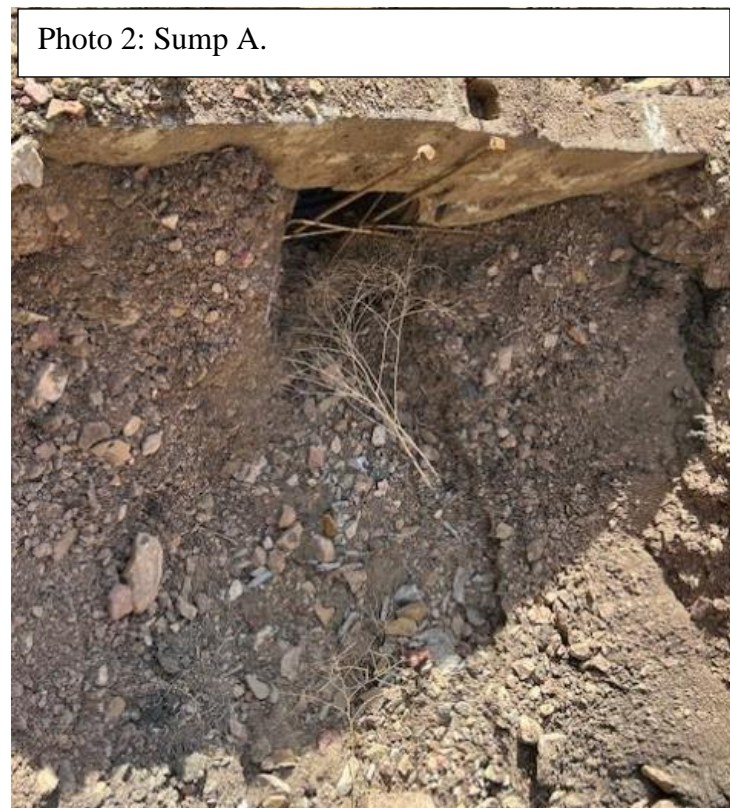
directed to Upper McClane Creek. Sump A is located on the northwestern side of the portals facilities area. The sump was observed to be dry and stable. The outlet for the sump was clear of debris (Photo 2). No indications of erosion were noted. Sump B is located on the northeastern side of the portals facilities area. Sump B was also dry. The trash rack covering the discharge outlet was clear of blockages. Snow was observed on the sump's embankment (Photo 3). There were no erosional features were observed. Sump D is located on the eastern portion of the portals facilities area. The sump was holding a small amount of snow in it during the inspection (Photo 4). The sump was stable with no erosional features. The outlet was clear of blockages. Sump E is located on the southeast side of the portals facilities area. The sump was covered with snow and appeared stable (Photo 5). The inlet to the discharge culvert was clear of debris and no erosional concerns were identified.

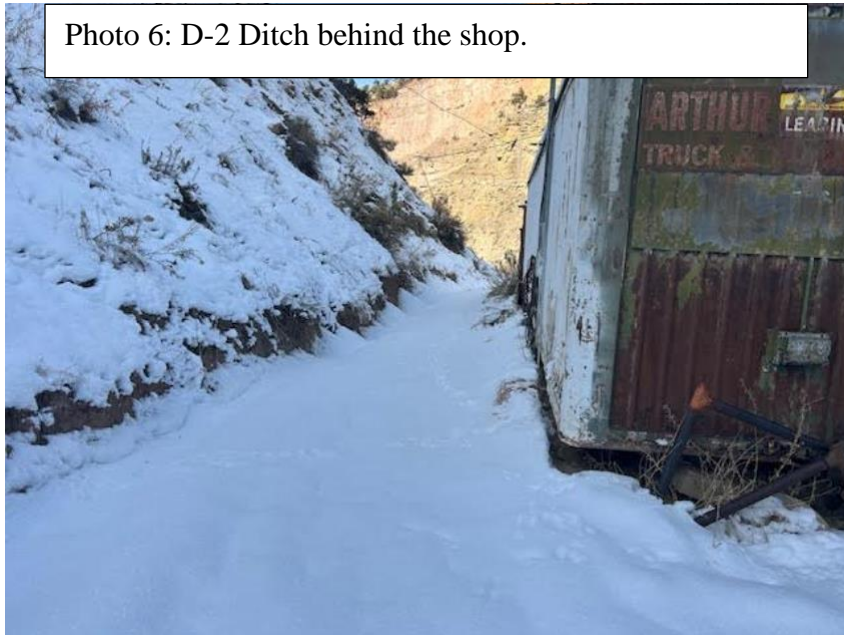
Photo 6: D-2 Ditch behind the shop.

The ditches D-2 and D-3 are located within the portals facilities area. The ditches help transport runoff from the upper bench to the sumps below the portals bench. The D-2 Ditch extends on the south side of the portals facilities area and goes behind the shop and connects to the D-3 Ditch. The ditch was covered in snow during the inspection (Photo 6). Mr. Silengo stated that he was waiting for the ditch to dry out more before continuing the cleaning process. The remaining work to clean the ditch will be completed as soon as ground conditions allow. An open culvert extends down the hillside connecting the D-2 Ditch to the D-3 Ditch (Photo 7). The culvert was clear of debris and stable. No erosional features were observed. The D-3 Ditch is located along the southwest side of the portals facilities pad. The ditch was covered with snow. No erosional features or indications of instability were identified.

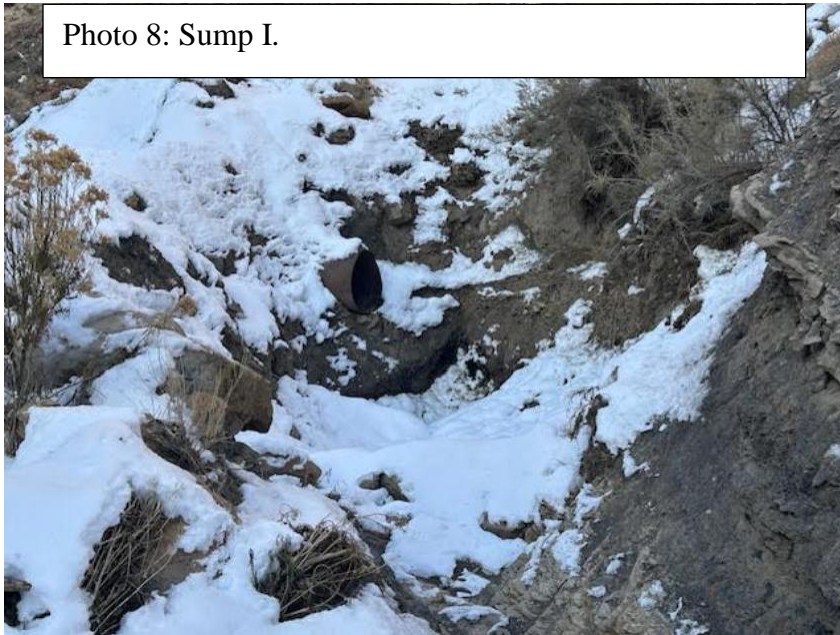
Photo 8: Sump I.

Sump I is located on the north side of the haul road at the western end of the portals facilities area. Sump I was covered with snow during the inspection and appeared stable (Photo 8). The culvert outlet for the sump was unobstructed and there were no erosional features observed.

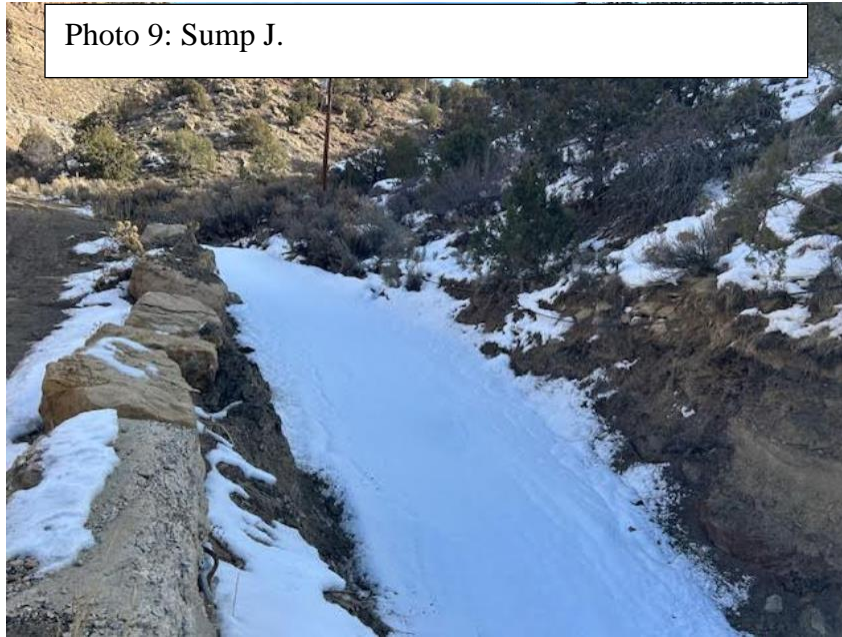
Photo 9: Sump J.

Sump J is located on the south side of the haul road and east of the sediment pond. The Sump was mostly covered in snow (Photo 9). The sump was stable with no erosional concerns. The outlet for the sump is a surface discharge into the D-6 Ditch. The D-6 ditch was stable and unobstructed. The D-6 ditch ends in the sediment pond. The portion of the ditch between Sump J and the sediment pond was clear of debris and partly covered with snow. The remaining portion of the D-6 Ditch along with the D-4 ditch parallel the haul road east to the base of the portals facilities area. Both of the ditches were unobstructed and stable. There were no observed signs of erosional features.

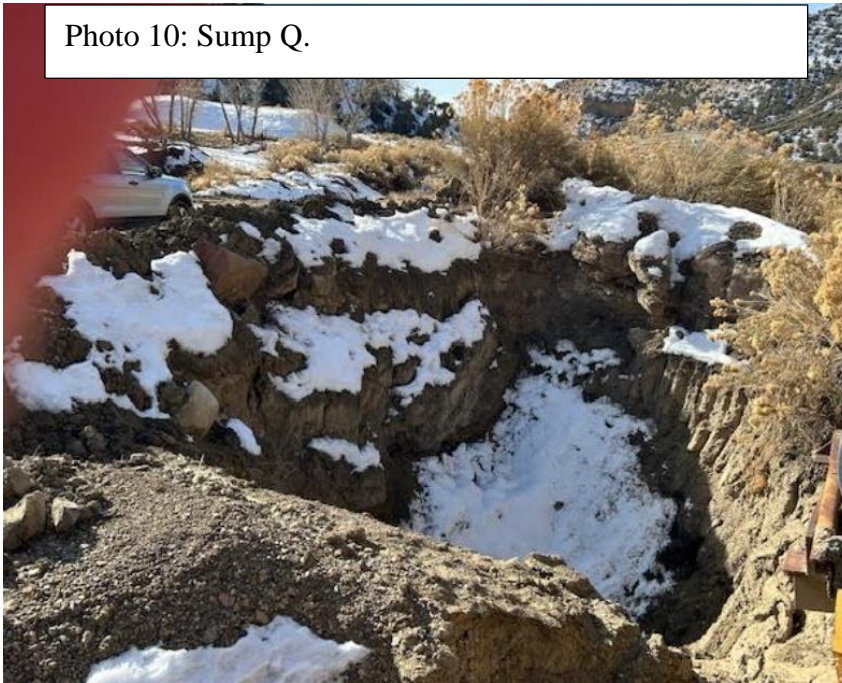
Photo 10: Sump Q.

Sump Q is located on the north side of the haul road, across from the sediment pond. Sump Q partly covered with snow (Photo 10). The culvert outlet for Sump Q was unobstructed. The sump was stable with no erosional features observed.

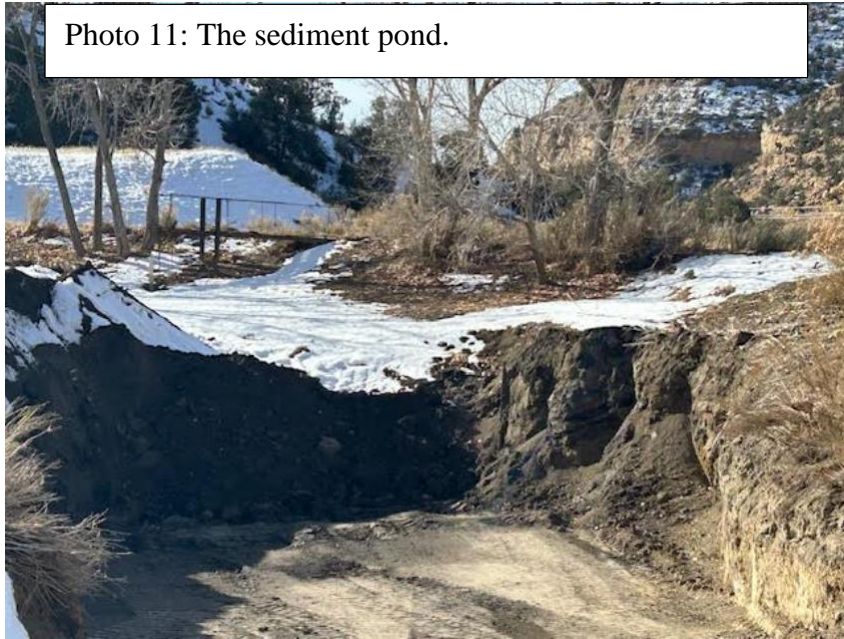
Photo 11: The sediment pond.

The sediment pond is located to the east of Sump Q on the south side of the haul road. The pond was muddy and not holding any water during the inspection. There was no discharge through the primary discharge outlet. Due to recent precipitation events in the late summer and early fall, the sediment level in the pond had reached maximum capacity. The operator's representative has continued cleaning operations on the pond (Photo 11). The operator will use a front end loader to remove as much sediment as possible from the pond as the conditions in the pond

allow. As material is removed, the bottom of the pond becomes muddy and soft. Equipment must wait for the material to dry before more cleaning operations can continue. The operator will continue this method until the sediment pond has been restored to the designed capacity. The primary and emergency spillways were observed to be clear of debris. The pond's embankment was stable with vegetative cover.

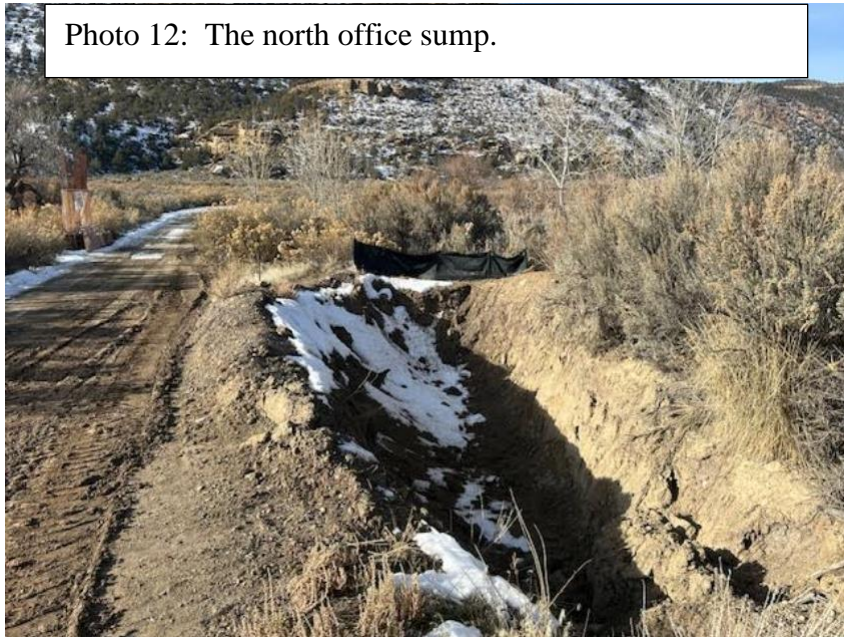
Photo 12: The north office sump.

Two sumps are located on the western side of the mine office pad. One sump is located on the north side of the haul road near the bridge over East Salt Creek. The sump was muddy (Photo 12). The silt fence at the sump's discharge outlet was clean and stable. There were no observed signs of offsite impacts. The second sump is located on the south side of the haul road at the corner of the haul road and the mine office pad. The sump was holding frozen water (Photo 13). The sump was stable. The silt fence at the sump's outlet was in good repair and clean. There were no off-site impacts.

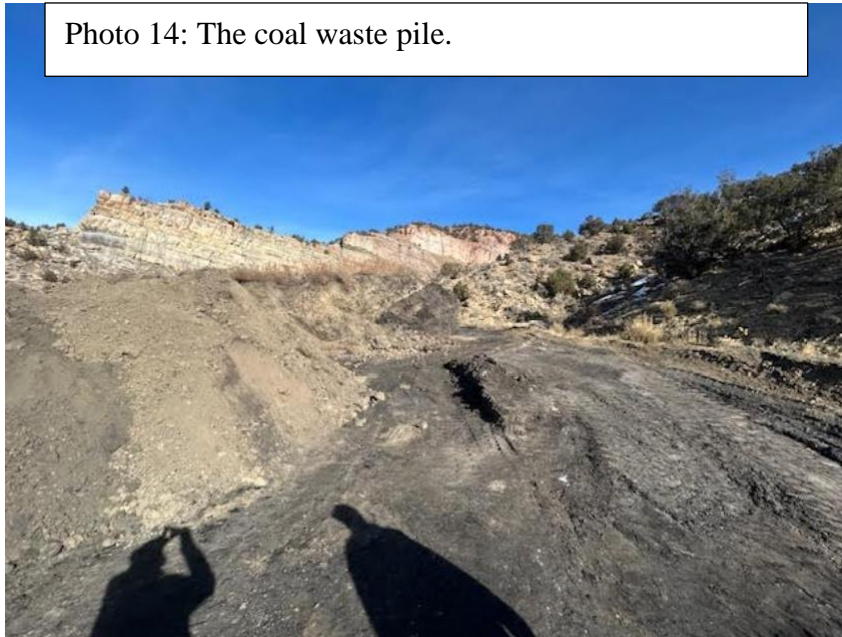
Photo 14: The coal waste pile.

The coal waste pile is located to the east of the sediment pond. The coal waste pile has been used to store material cleaned from the sediment control structures since the site entered temporary cessation. The pile was damp during the inspection. The pile was stable with no erosional features (Photo 14). No off site impacts were observed. The clearwater diversion ditch above the coal waste pile was stable and covered with snow. There were no blockages or erosional concerns noted.

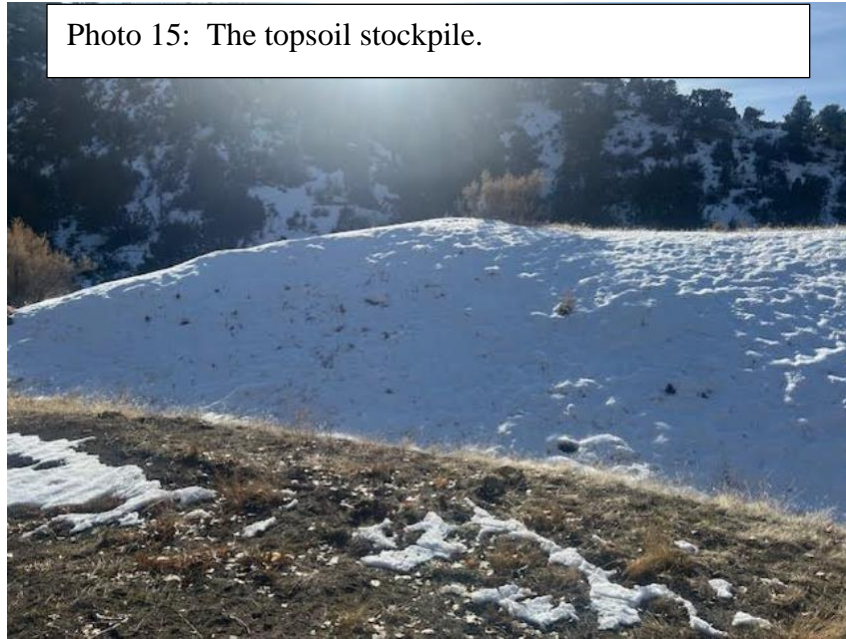
Photo 15: The topsoil stockpile.

The topsoil stockpile is located to the south/southeast of the sediment pond. The stockpile was covered in snow during the inspection (Photo 15). The pile was stable and there were no erosional features. The perimeter ditch was also covered with snow and stable. There was no indication of the loss of topsoil resource.
