**MINERALS PROGRAM INSPECTION REPORT**  
**PHONE: (303) 866-3567**

<b>MINE NAME:</b> Raindance Reservoir #2	<b>MINE/PROSPECTING ID#:</b> M-2021-049	<b>MINERAL:</b> Borrow material for construction and clay (general)	<b>COUNTY:</b> Weld
<b>INSPECTION TYPE:</b> Surety-Related Inspection	<b>WEATHER:</b> Clear	<b>INSP. DATE:</b> December 23, 2024	<b>INSP. TIME:</b> 09:30
<b>OPERATOR:</b> Vima Partners, LLC	<b>OPERATOR REPRESENTATIVE:</b> Cody Wooldridge	<b>TYPE OF OPERATION:</b> 112c - Construction Regular Operation	
<b>REASON FOR INSPECTION:</b> Surety Related	<b>BOND CALCULATION TYPE:</b> Complete Bond	<b>BOND AMOUNT:</b> \$1,191,782.00	
<b>DATE OF COMPLAINT:</b> NA	<b>POST INSP. CONTACTS:</b> None	<b>JOINT INSP. AGENCY:</b> None	
<b>INSPECTOR(S):</b> Patrick Lennberg	<b>INSPECTOR'S SIGNATURE:</b>

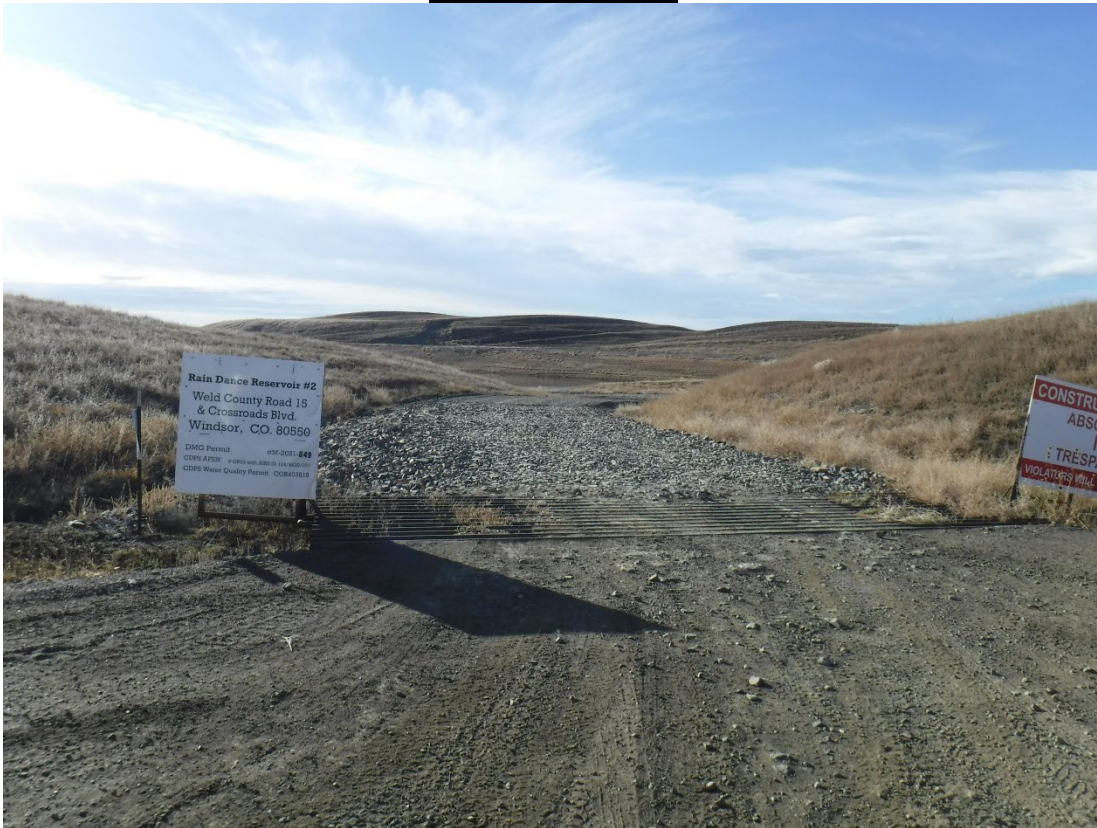
**Photo 1:** Mine sign at the primary mine entrance

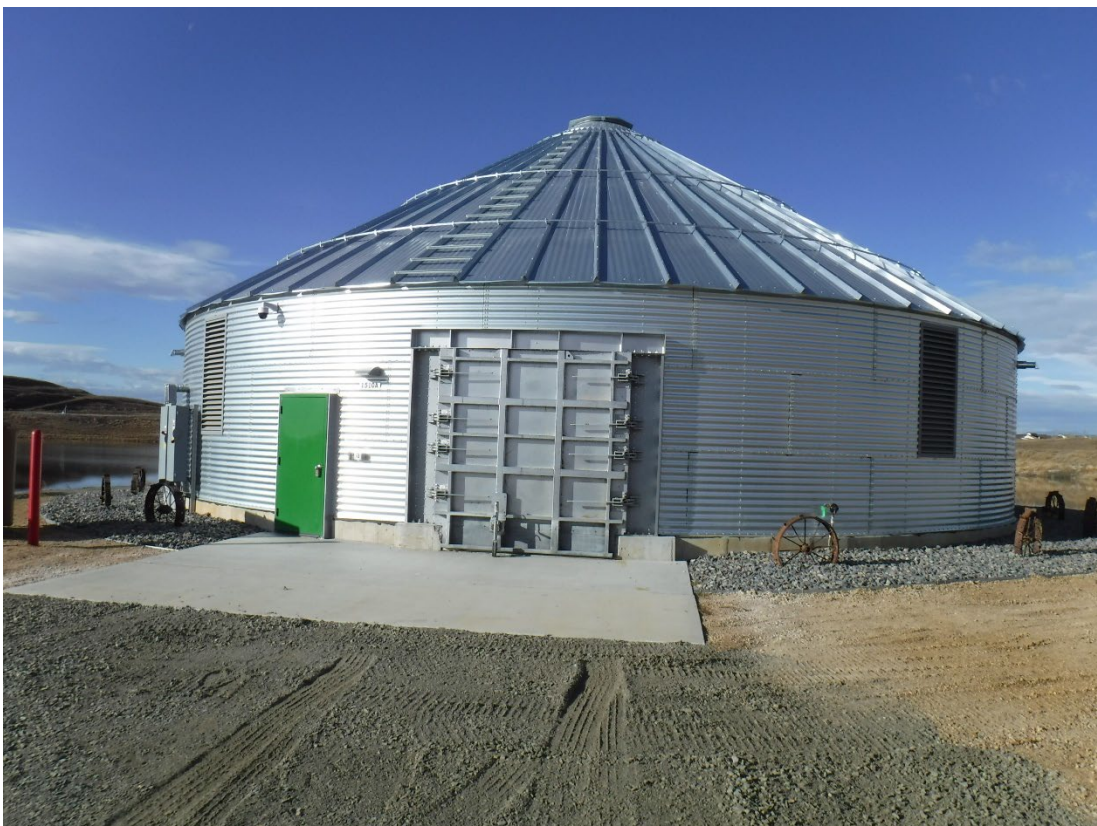
**Photo 2:** Pump house

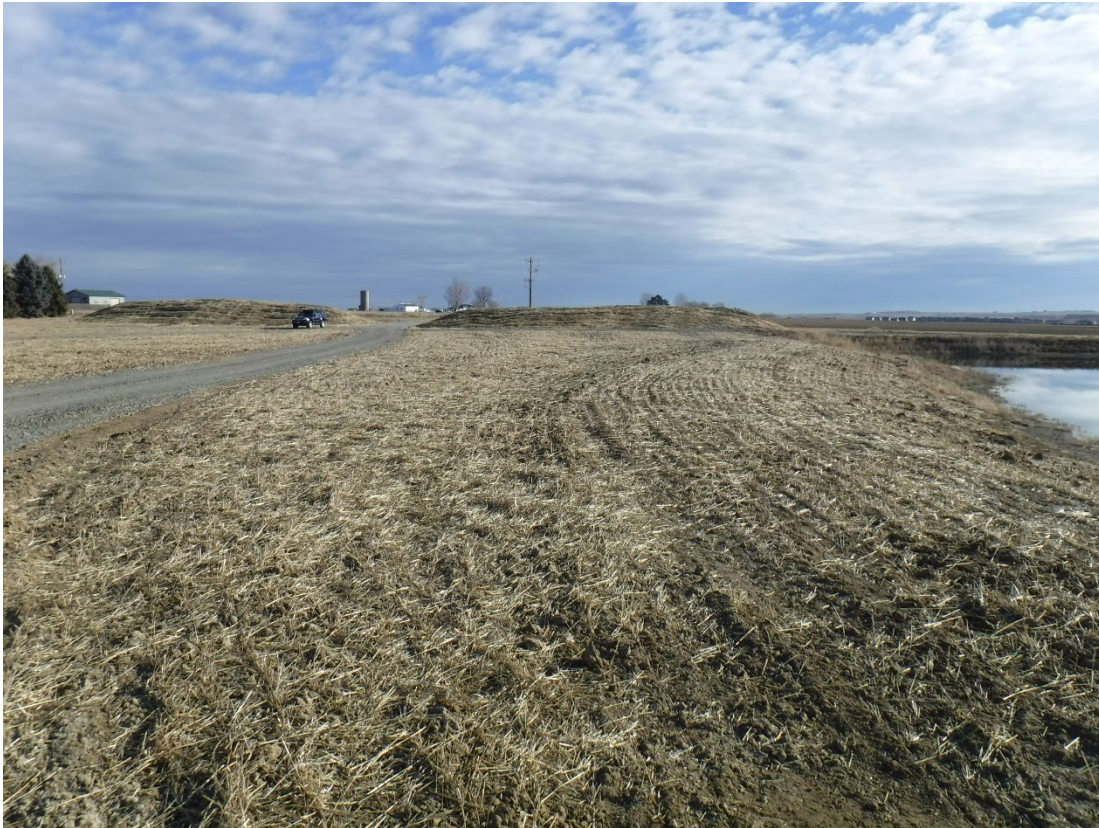
**Photo 3:** Area around the pump house that has been crimped and seeded

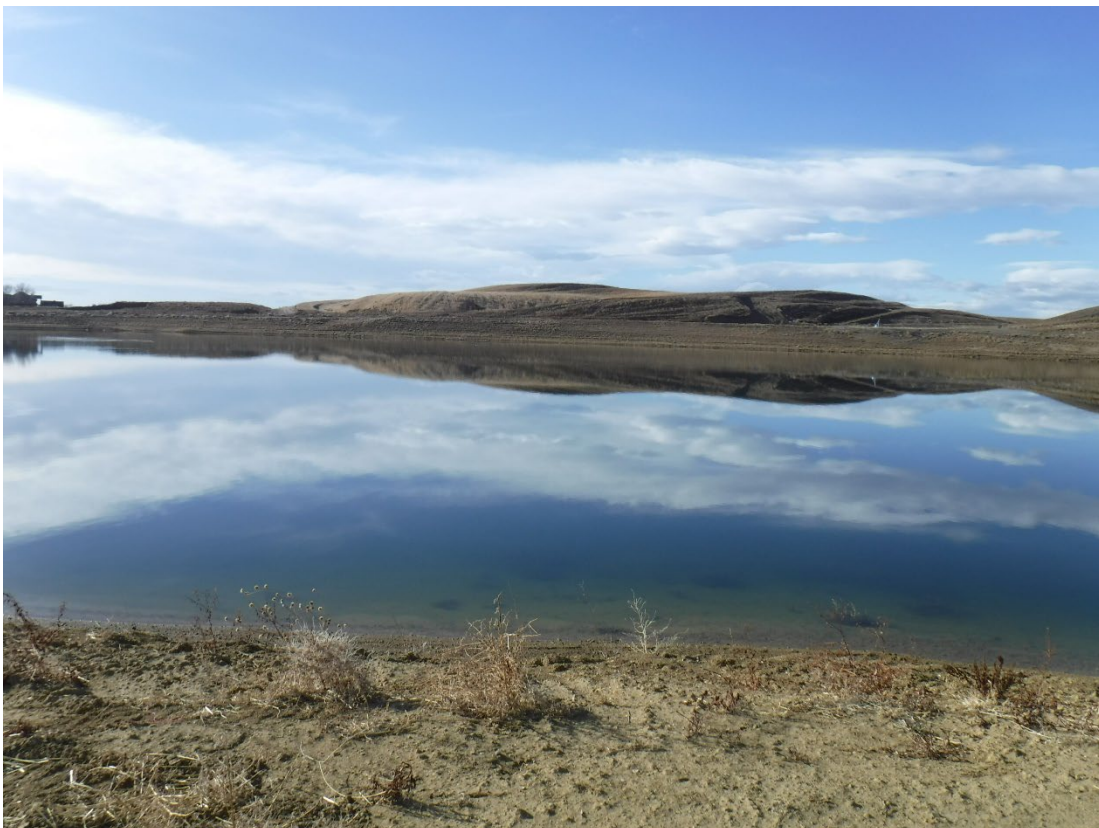
From the topsoil stockpile area to the west and northwest the permit there are various large stockpiles of material. The material a combination of clay material, and overburden material that was removed during construction of the reservoir. The stockpiled materials encompass around 49-50 acres of area. The area between the reservoir road to the stockpile area has been graded and seeded. Interspersed with the stockpiles is land that is being placed back into cultivation.

**Photo 4:** Looking across the reservoir at the remaining stockpiles of material that will be removed from the site

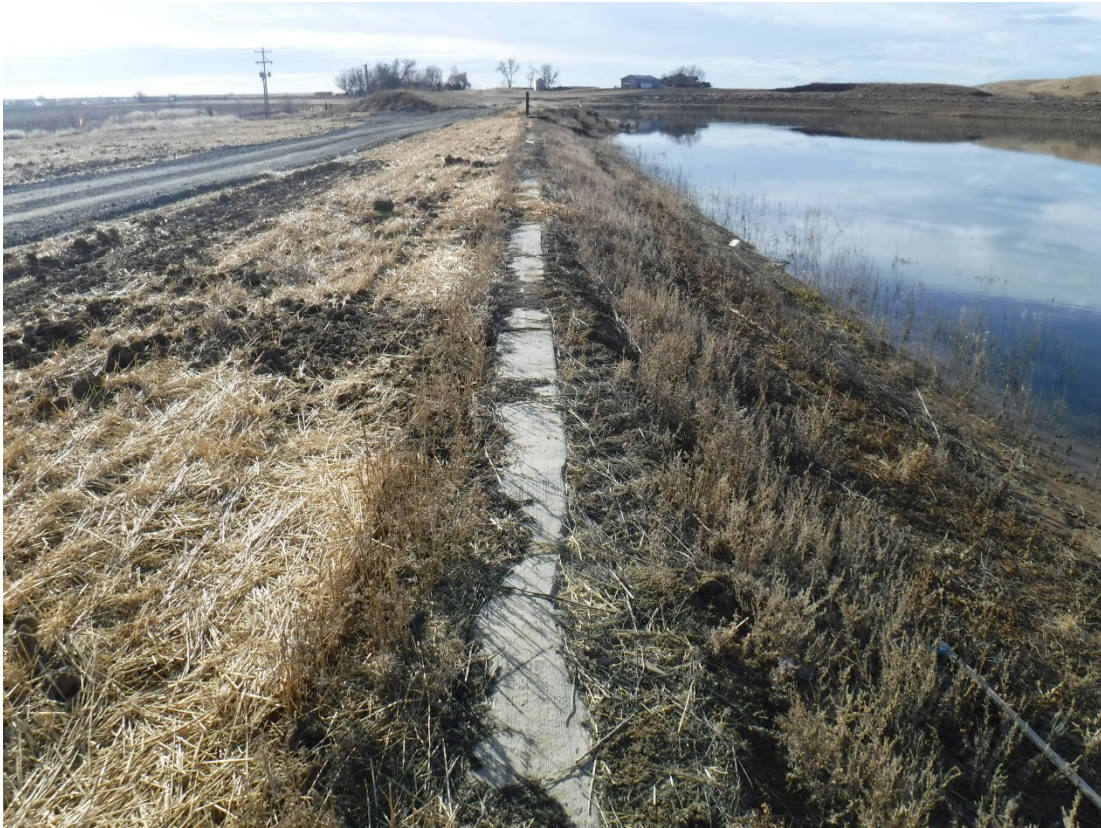
**Photo 5:** Cutoff wall marking the emergency spillway for the reservoir

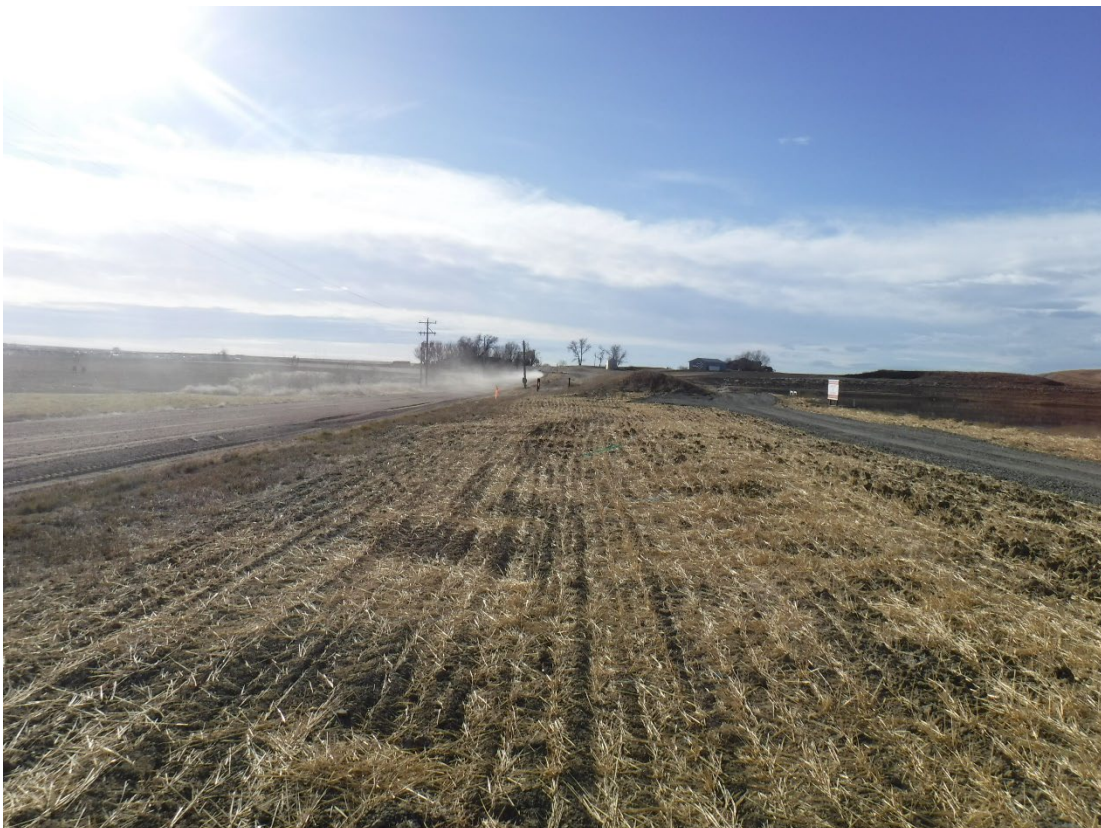
**Photo 6:** Reclaimed areas along eastern side of permit boundary

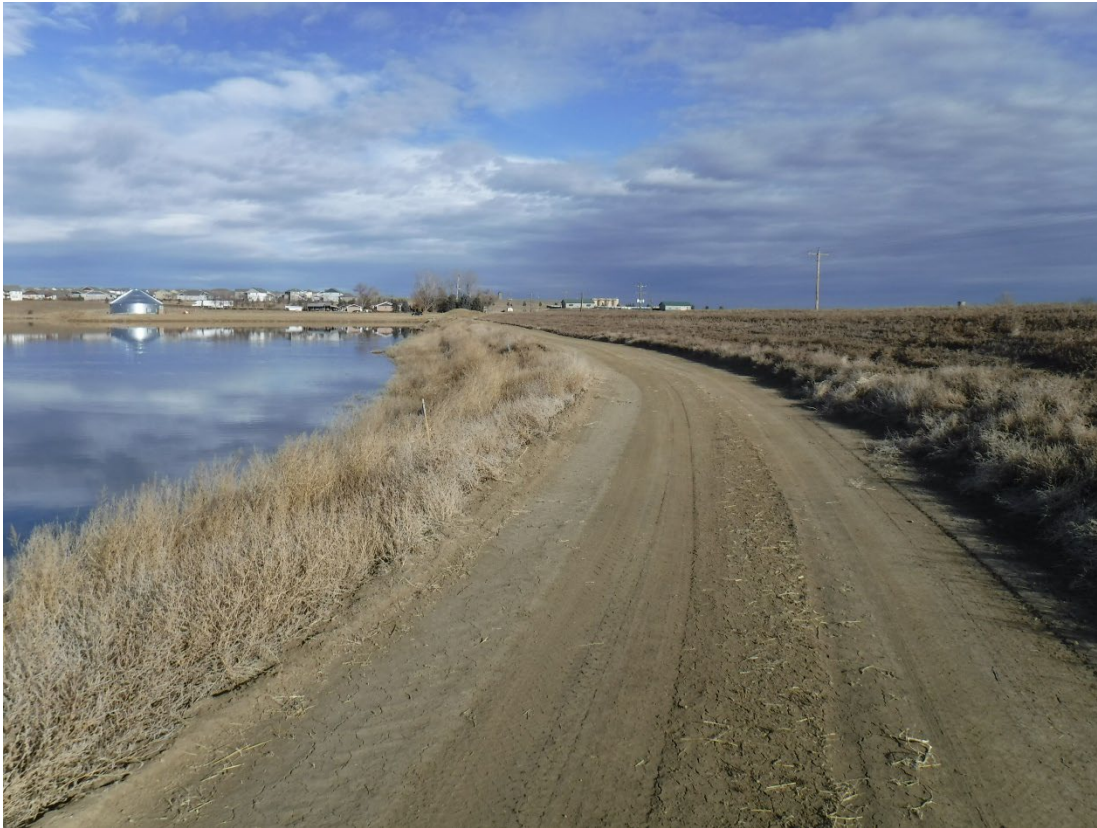
**Photo 7:** Typical roadway conditions around the reservoir

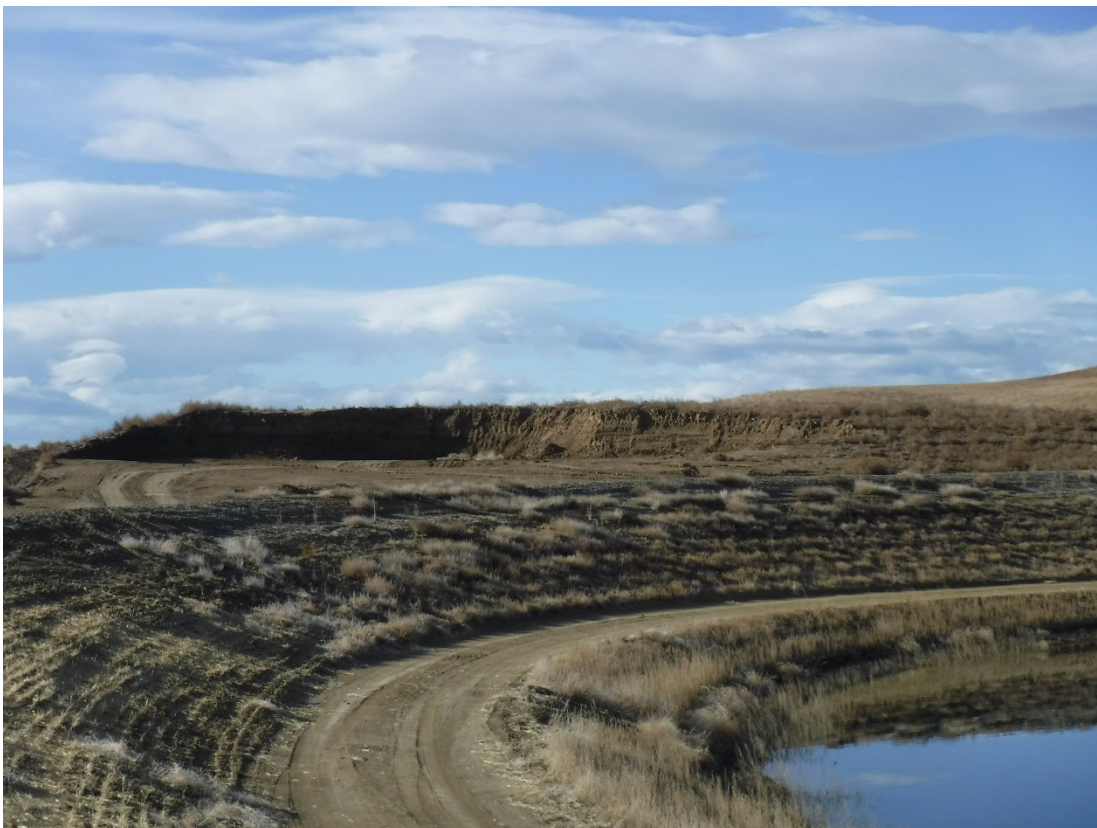
**Photo 8:** Topsoil stockpile adjacent to the reservoir

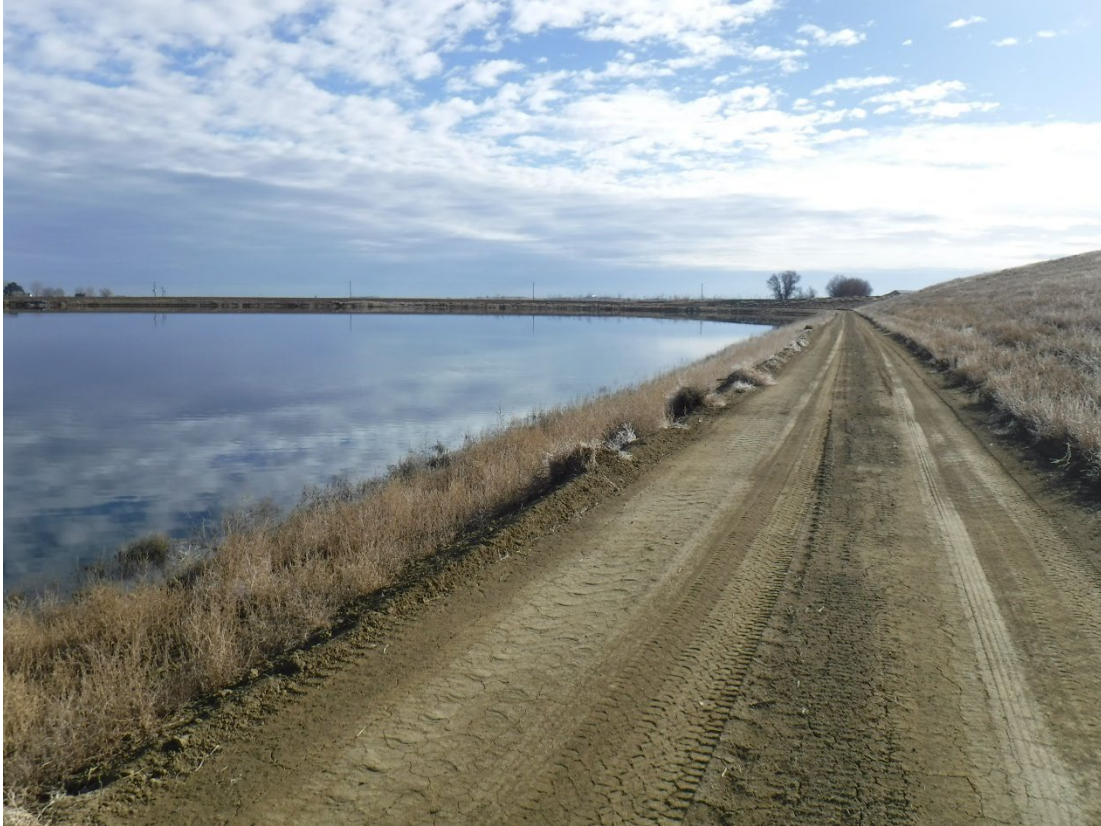
**Photo 9:** Looking south along the reservoir road on the west side

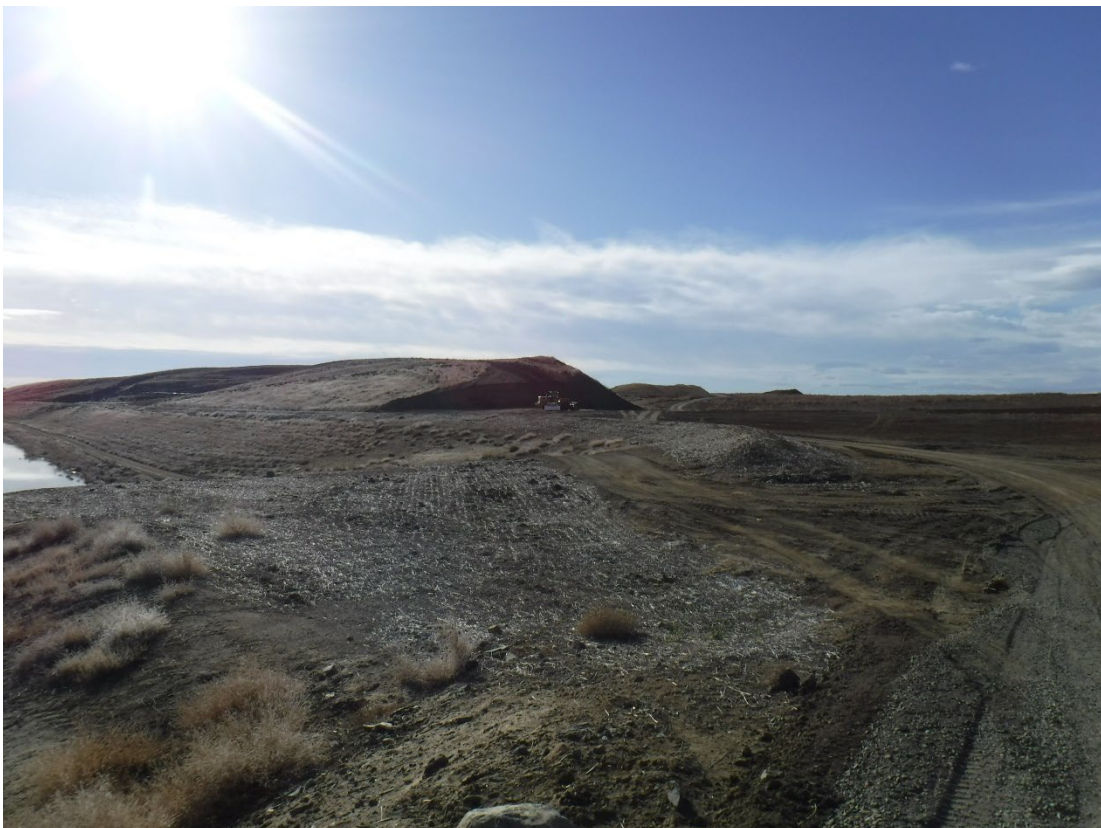
**Photo 10:** Looking south from the north side of the permit area at the remaining stockpiles

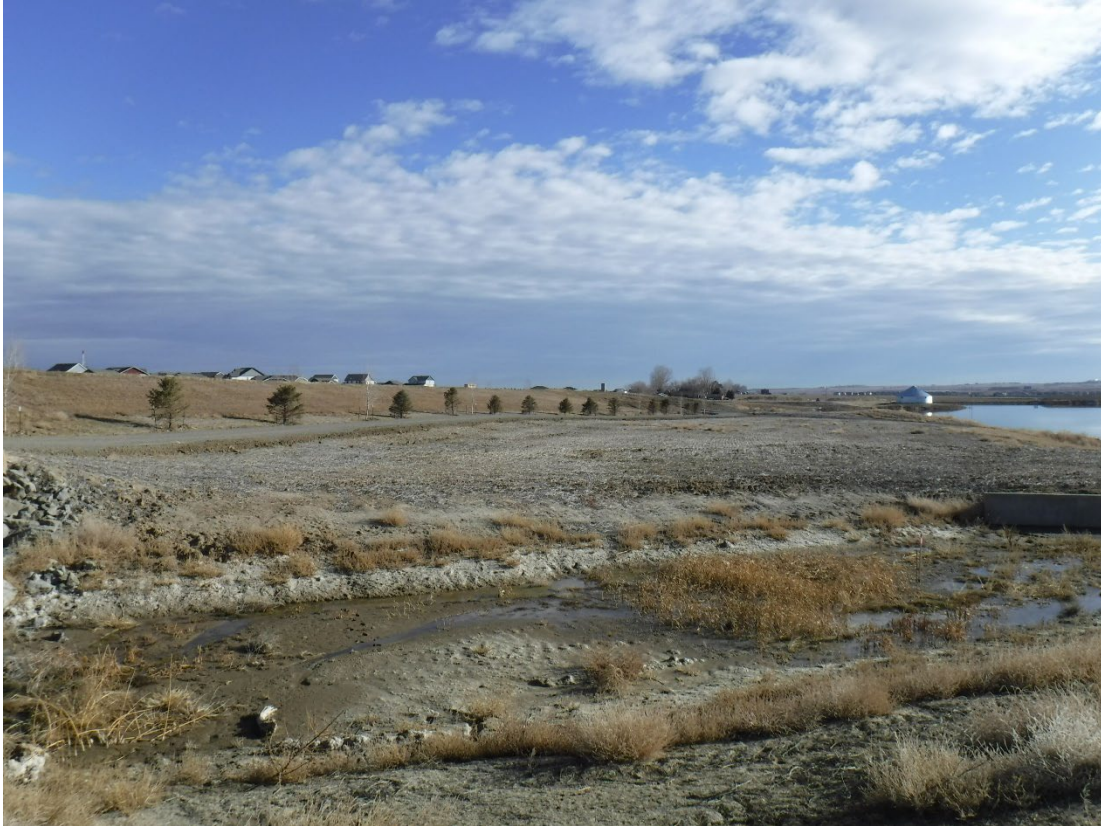
**Photo 11:** Looking east across the northern berm area of the permit boundary

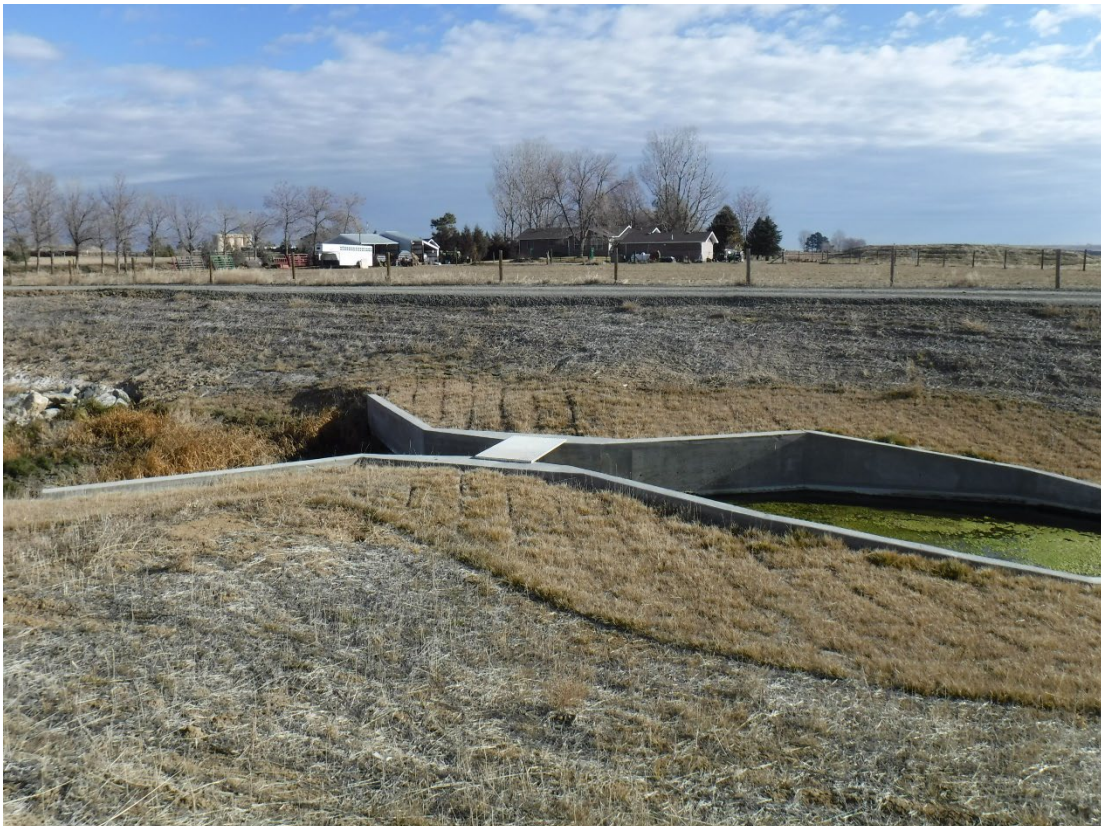
The Parshall flume that enters the reservoir in the northeastern portion of the permit boundary has been completed and has vegetation establishing around it. The berms along the northern portion of the permit area, adjacent to Crossroads Blvd, have been seeded and have trees planted on them. While it was difficult to determine the plants that were growing, they appeared to be establishing well. The Operator has installed irrigation lines along the berms to help with vegetation establishment and individual driplines to the trees. In the area of the pump station, metal cylindrical building, the ground appeared to have been recently planted and crimped and mulched. Along the reservoir edge the rock riprap had been installed and the permitter access road was well established. On the other side of the reservoir road, along the eastern permit boundary, the ground has been crimped and mulched along with seed planting. Towards the southeast corner of the permit there is an access road that leads to the topsoil stockpile that is being sold to market. The topsoil stockpile area is approximately 2.6 acres.

**Photo 12:** Parshall flume adjacent to pump house
