New Elk Inspection Report, December 2024 (Complete)

Attached for your records is a copy of the Division's inspection report for the complete inspection conducted for the New Elk Mine (C-1981-012) on December 17-18, 2024.

Permit Number: C-1981-012 Mine Name: New Elk Mine Operator: New Elk Coal Company, LLC Operator Address: Mr. John Terry 12250 Highway 12 Weston, CO 81091	County: Las Animas Operation Type: Underground Permit Status: Active Ownership: Private
	Operator Representative Present: None
Operator Representative Signature: (Field Issuance Only)

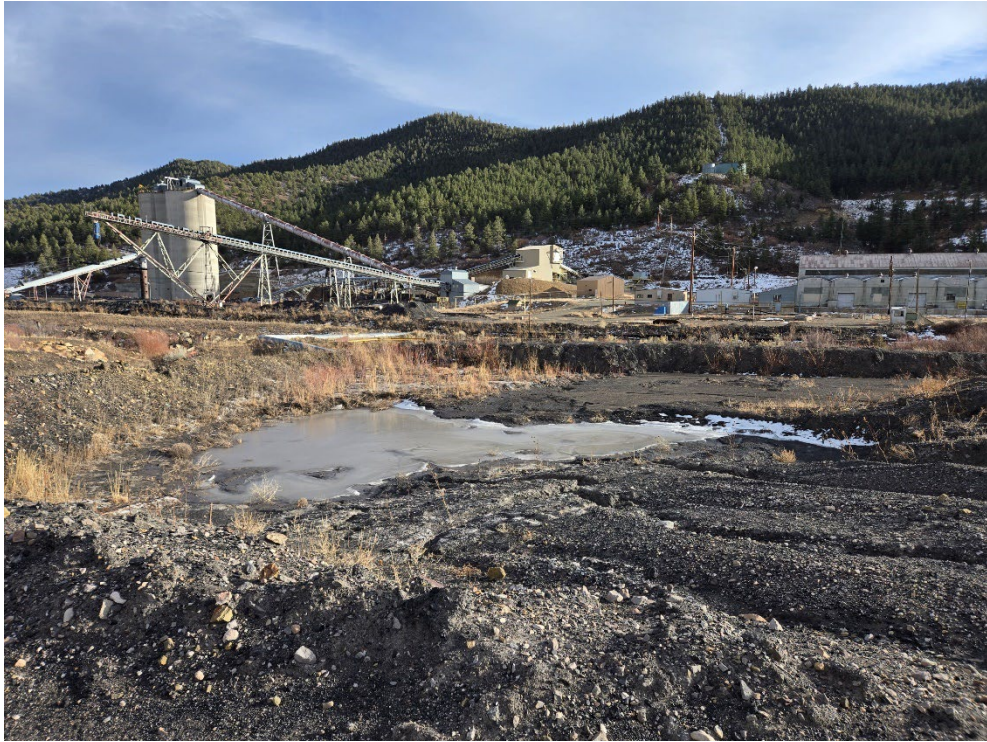
- The sediment basin at the east end of DWDA #2 held water at the time of the inspection (Photo 1). The berm around the basin appeared to be stable. The check dams along the north side of the sediment basin have filled with sediment (Photo 2). **The Operator shall clean the check dams of sediment and ensure that the sediment control structures are functioning appropriately.**
- Culvert C13 was free of obstructions. However, the vegetation in-front of C13 should be cleared before next spring.
- No signs of erosion were observed along the slopes of DWDA #1. The slopes appear to be well vegetated and stable (Photo 3).

Photo 1: Sediment containment basin, SE corner of DWDA #2.

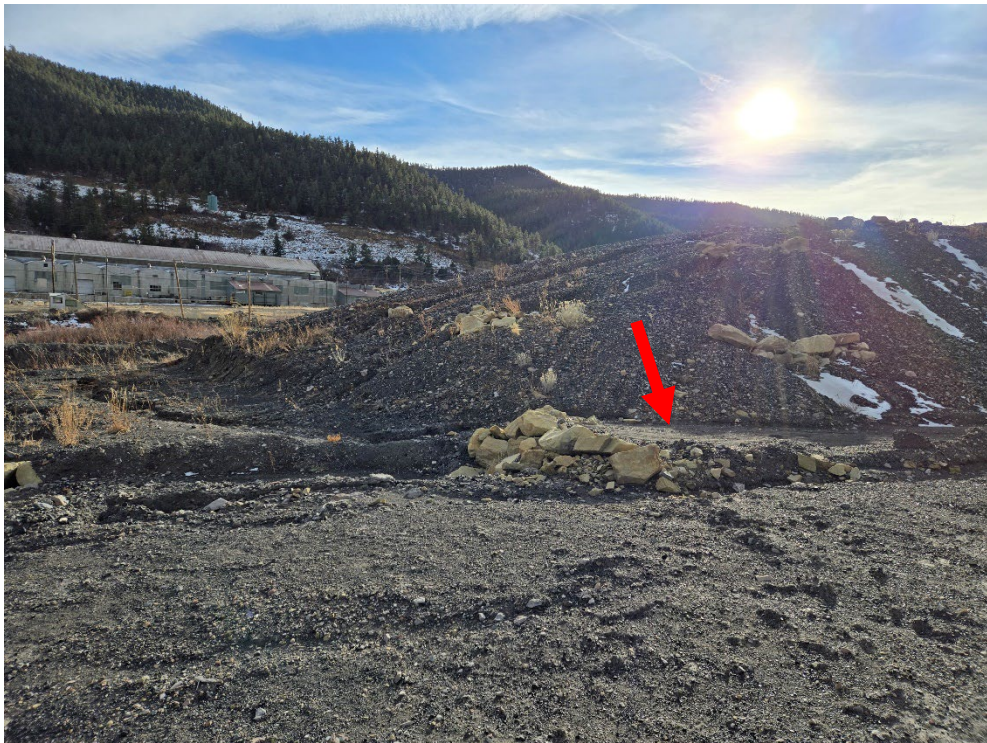
Photo 2: Check dam full of sediment on NE side of DWDA #2 pile.

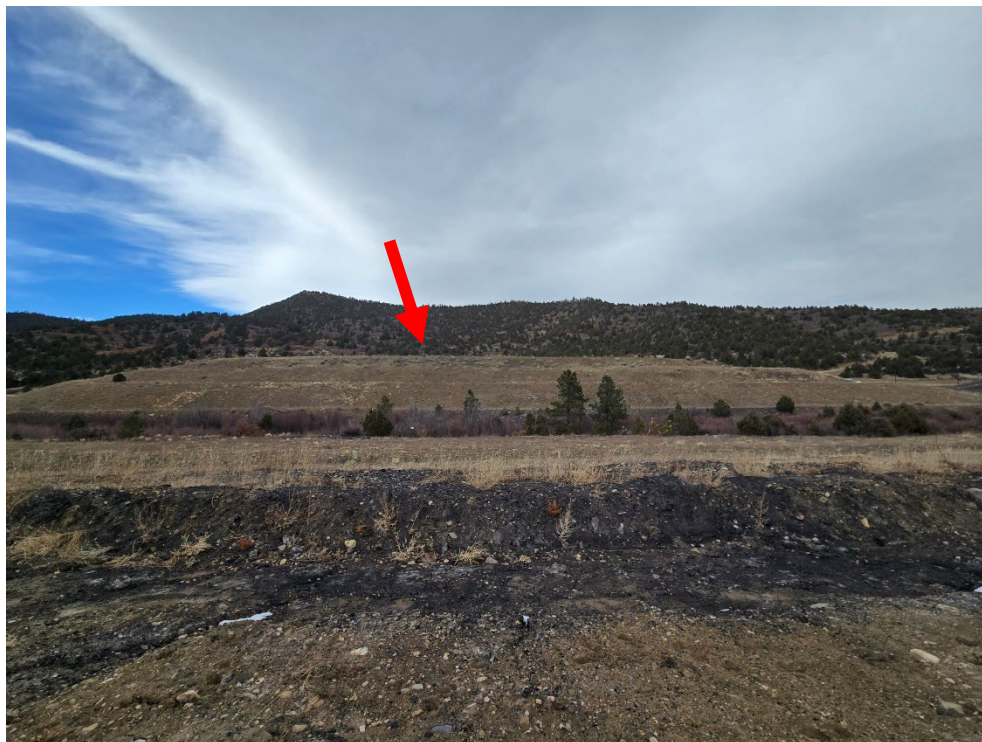
Photo 3: Looking north at south side of DWDA #2 from subsoil storage area.

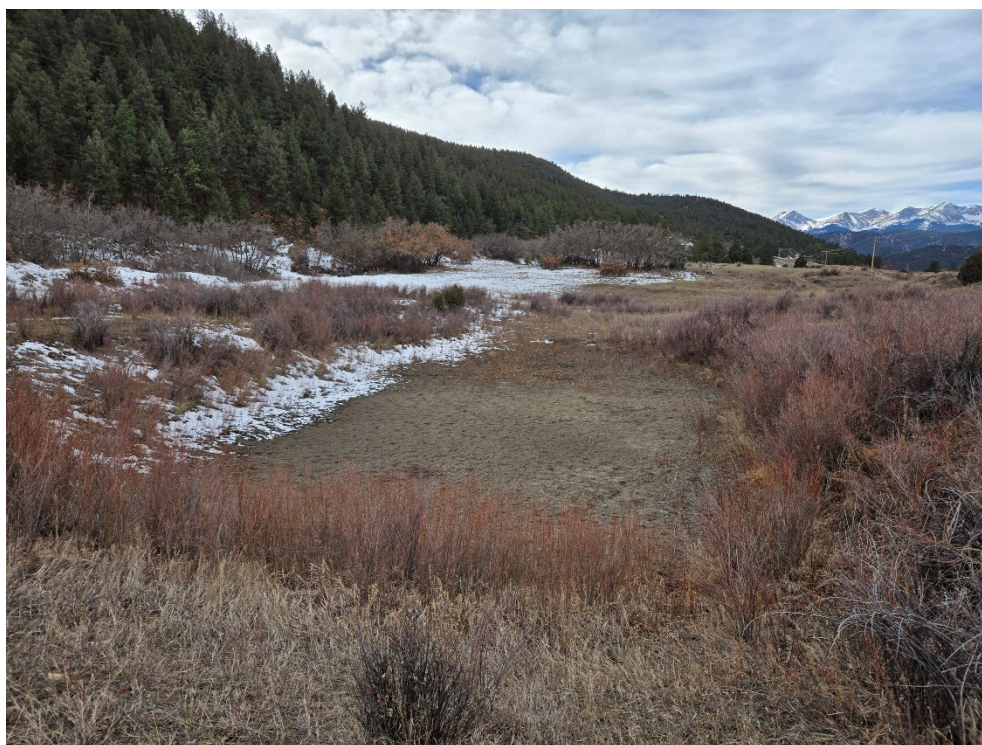
- Containment area #1 was dry (Photo 4). No signs of erosion were observed.
- Containment area #2 was dry (Photo 5). No signs of erosion were observed.
- Containment area #3 was dry (Photo 6) No signs of erosion were observed.

Photo 4: Containment Area no. 1.

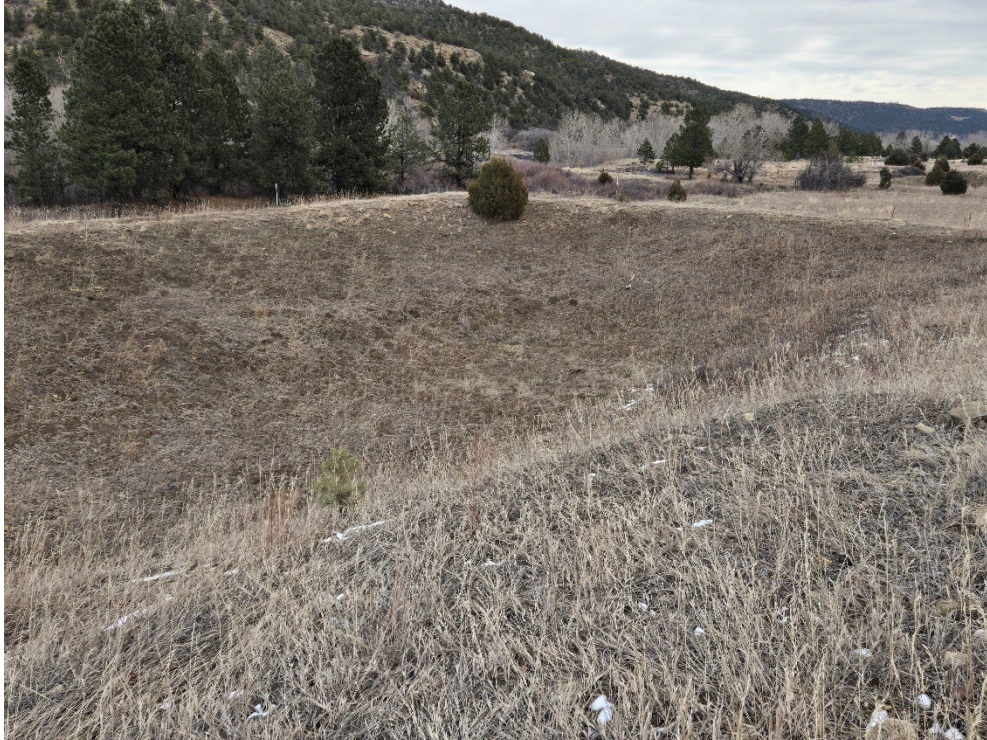
Photo 5: Containment Area no. 2.

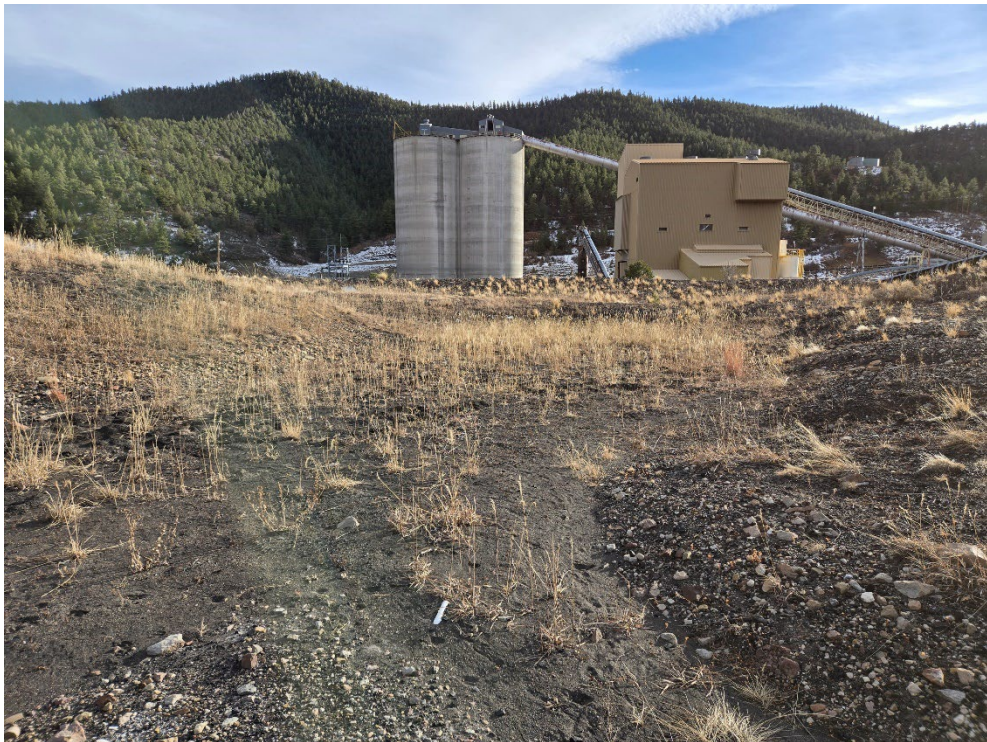
Photo 6: Containment Area no. 3.

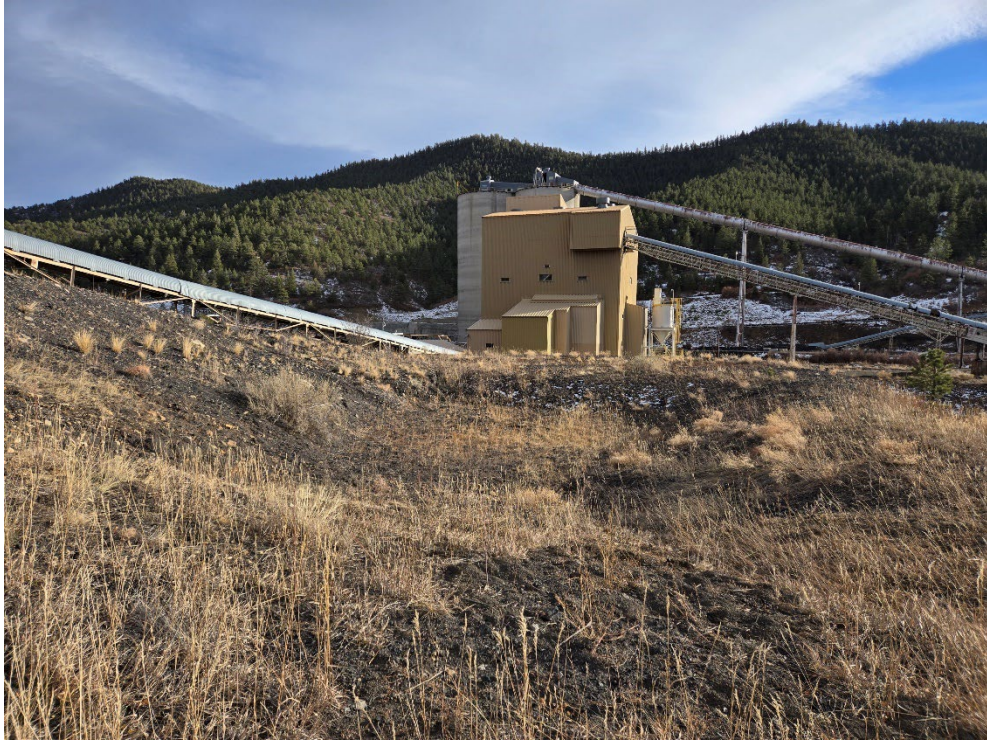
- Containment area #4 was dry (Photo 7). No signs of erosion were observed.
- Containment area #5 contained some frozen water and was below capacity (Photo 8).

Photo 7: Containment Area no. 4.

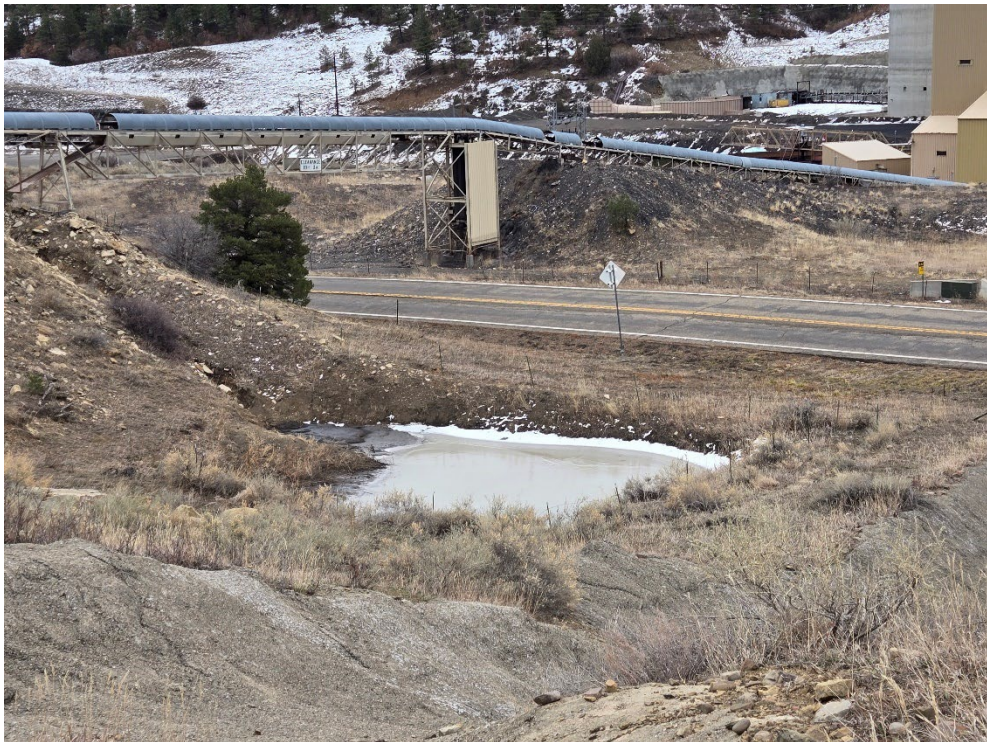
Photo 8: Containment Area no. 5.

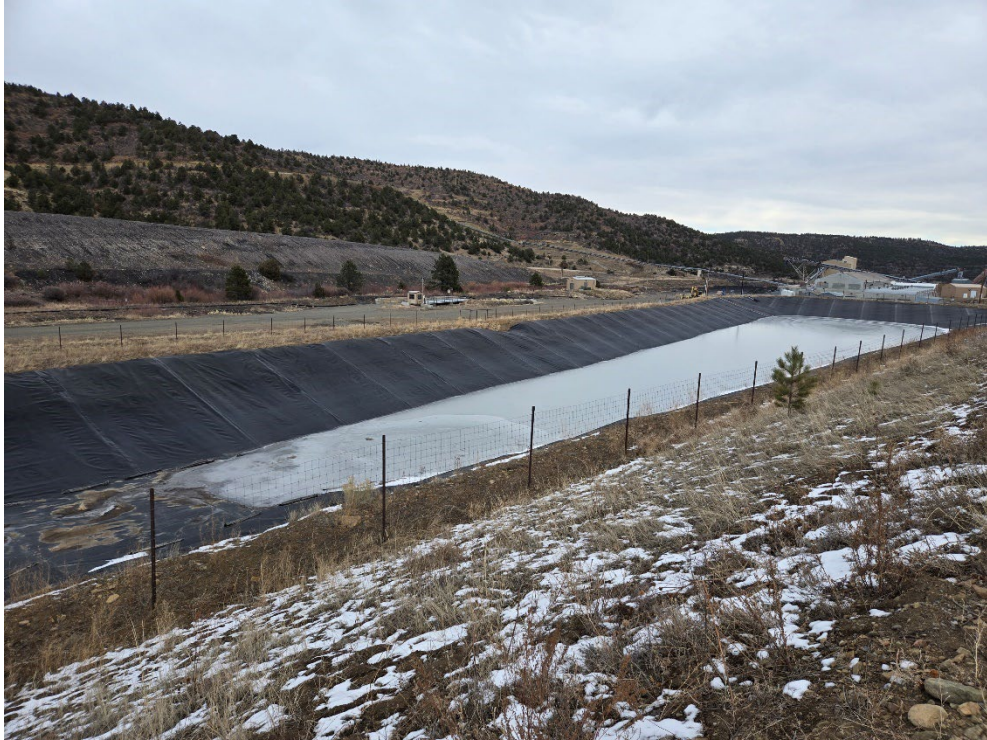
- Stream buffer zone signs were observed throughout the site.
- Pond 001A held some frozen water at the time of the inspection and was not discharging (Photo 9). No tears were observed in the lining at the time of the inspection (Photo 10).

Photo 9: Looking northeast at Pond 001a.

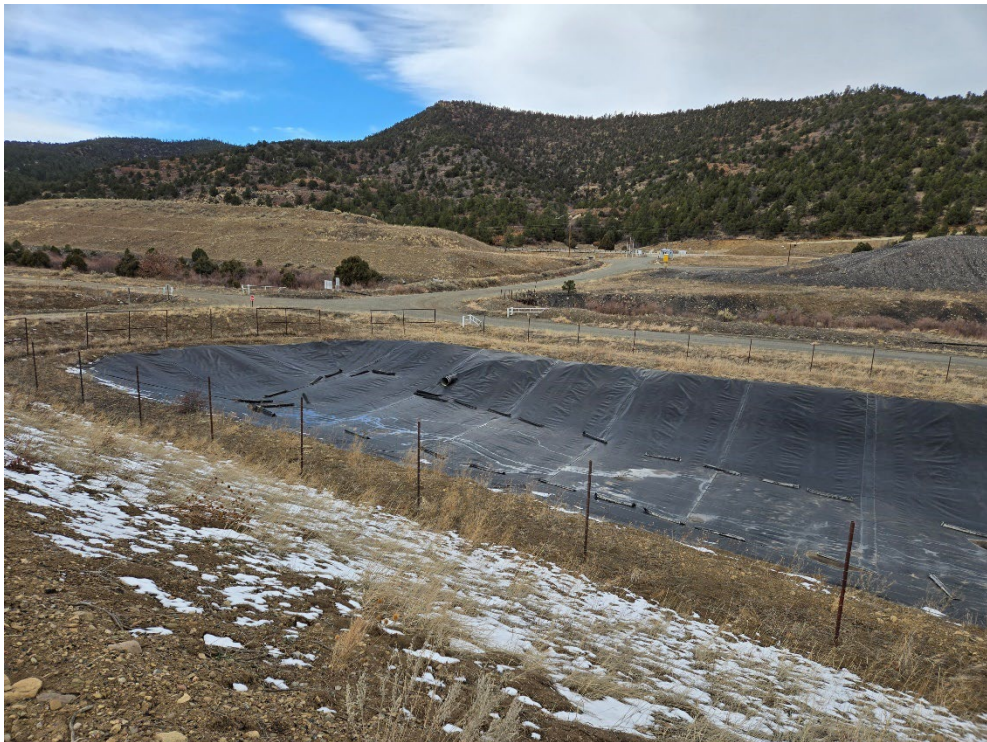
Photo 10: Looking northwest at Pond 001a.

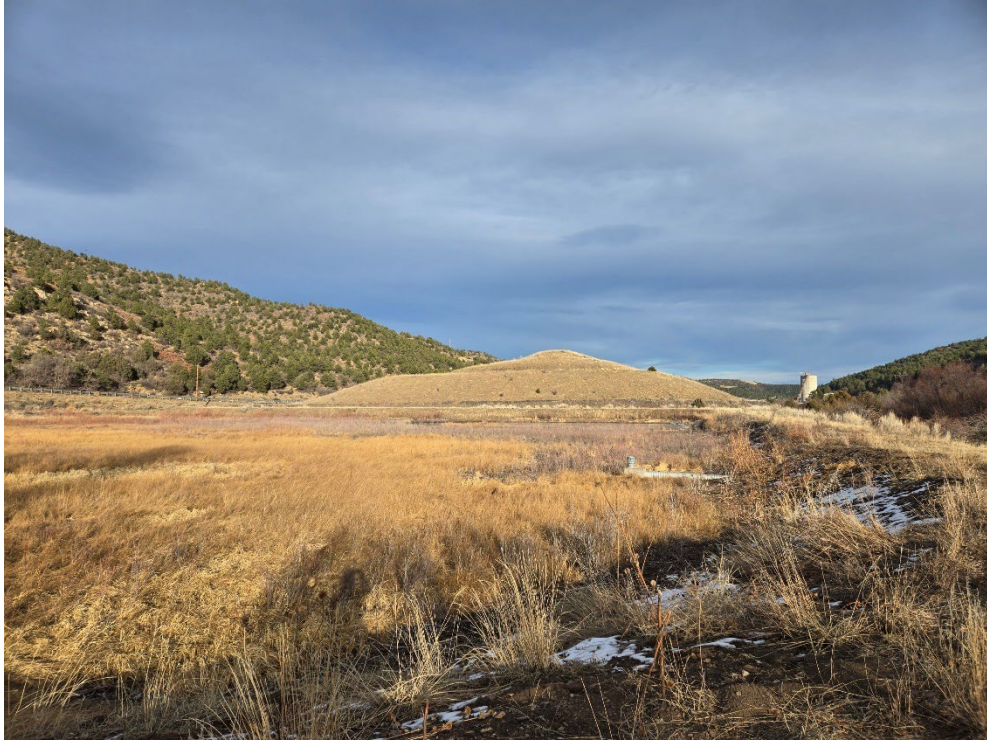
- Pond 004A contained a small amount of water located within the southeast corner (Photo 11). The inspector walked along the south and east banks. No signs of seepage or stability concerns were observed during the inspection.

Photo 11: Looking east at Pond 004a.

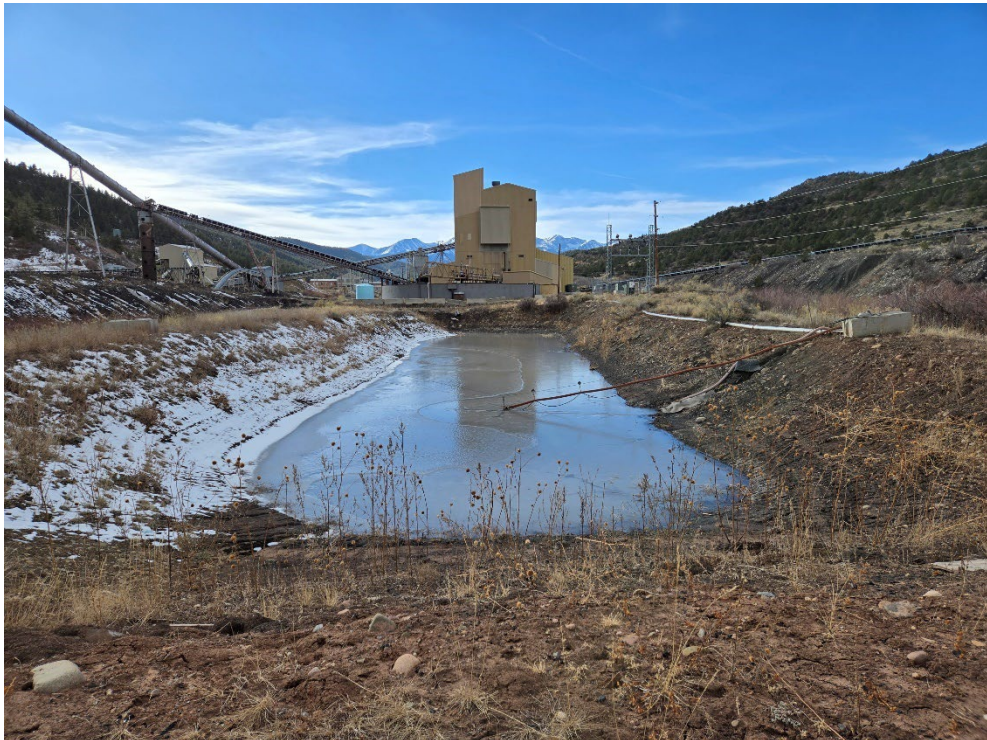
- Pond 006A contained some frozen water at the time of the inspection (Photo 12). The banks of the pond appeared to be stable.
- Pond 007A contained some frozen water at the time of the inspection. The water level was up to the lower portions of the primary spillway (Photo 13), but the pond was not discharging. The emergency spillway was free of obstructions and the embankment appeared to be stable.

Photo 12: Looking west at Pond 006a.

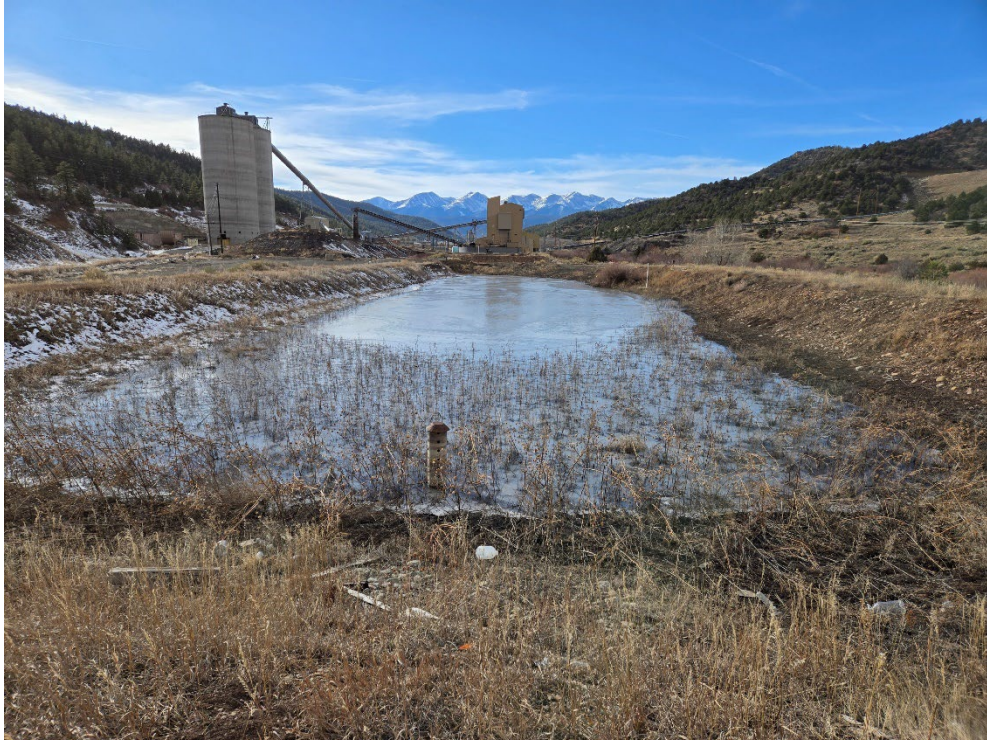
Photo 13: Looking west at Pond 007a.

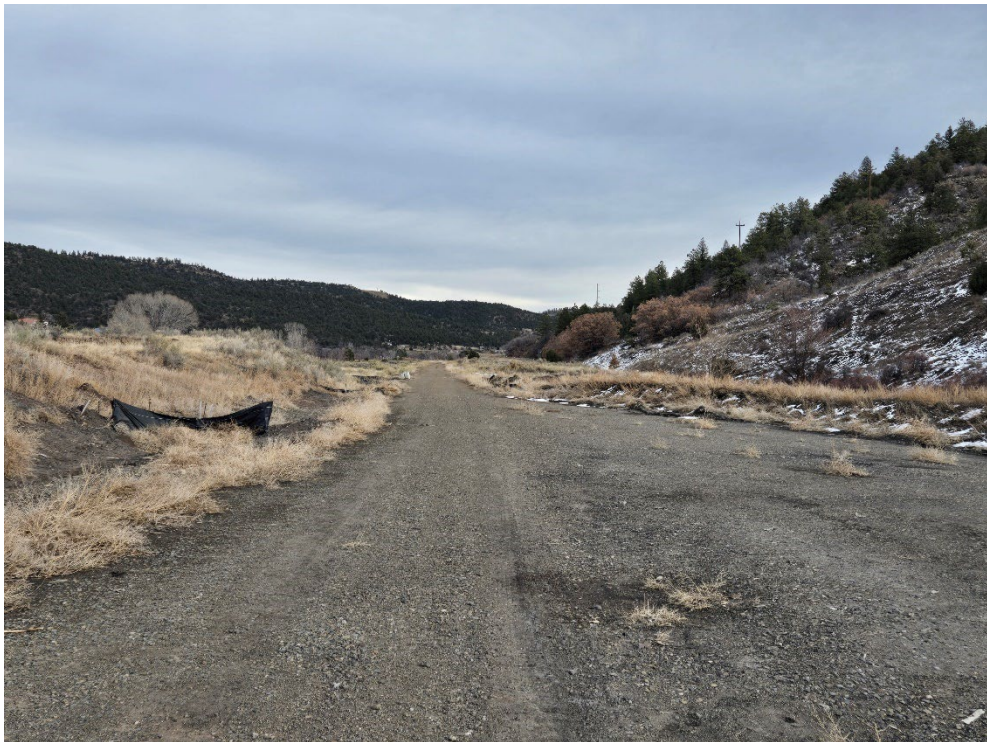
- The silt fences along the road leading to Pond 007A, within the S.A.E., are full of tumbleweeds and are damaged (Photo 14). **The Operator shall clear the silt fences of vegetation/debris and repair and/or replace the fences.**

Photo 14: Looking east at the silt fences on the north and south sides of the road leading to Pond 007a, within the S.A.E.

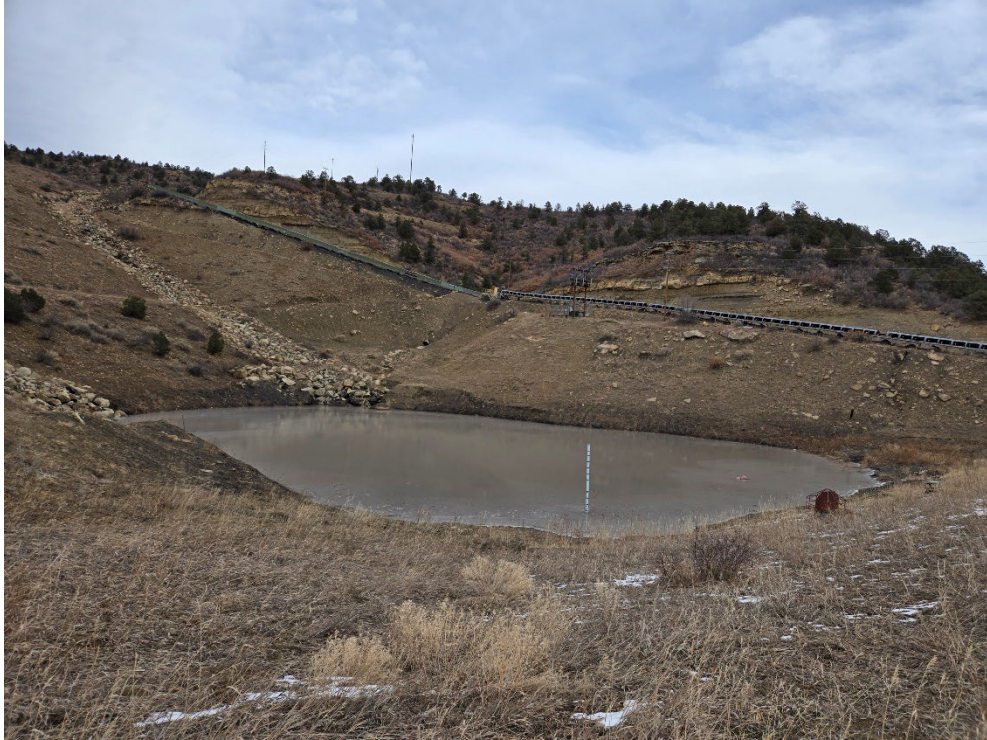
- Pond 08 contained some frozen water at the time of the inspection and was below its capacity (Photo 15). The spillways appeared clear, and the banks were stable. Pond 08 was not discharging.

Photo 15: Pond 08.

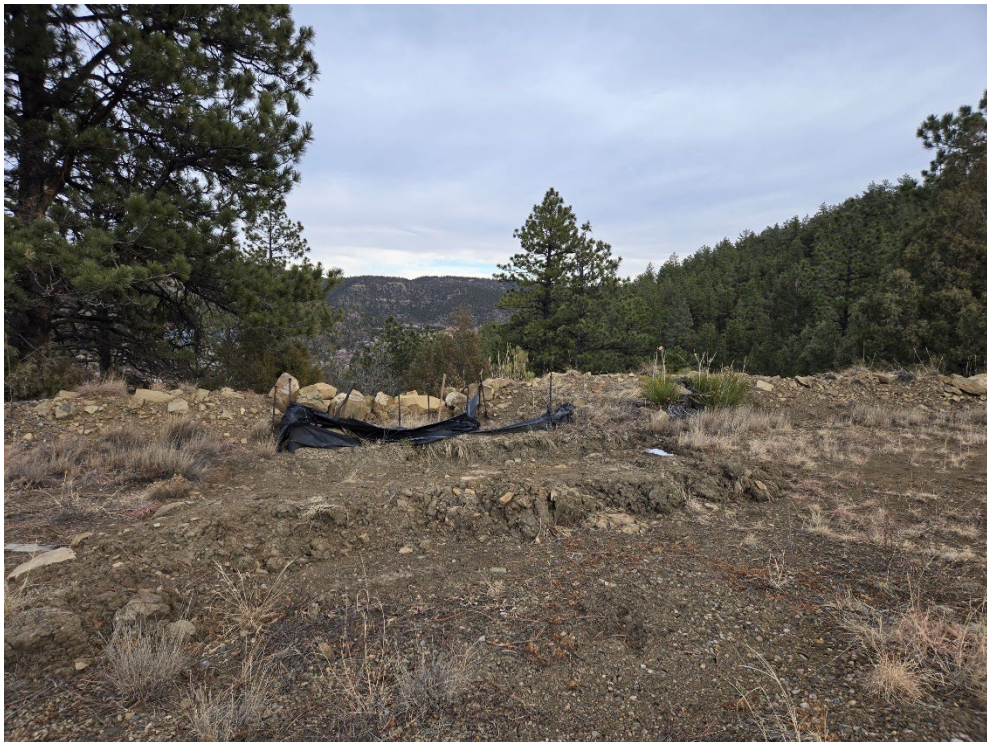
- The S.A.Es along the southern portion of the permit, along Ditch D18, appeared stable. However, **the silt fence on the eastern border of the S.A.E. on the top of the hill still needs to be repaired** (Photo 16).

Photo 16: Silt fence along the east side of the S.A.E on the southside of the permit, east of the water tanks.

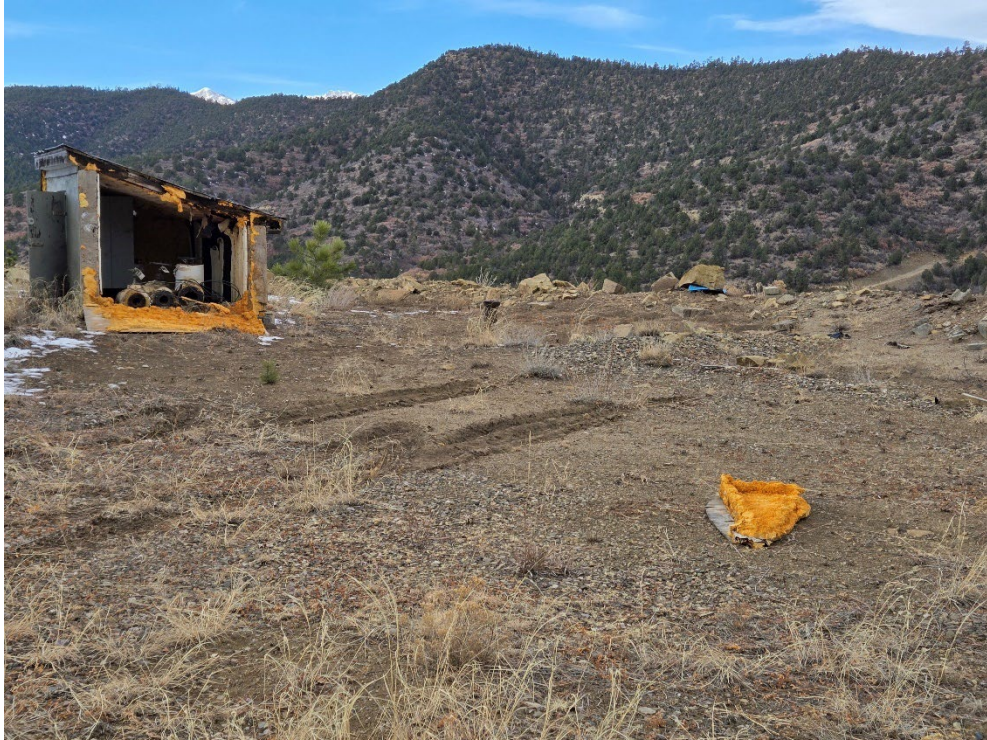
- The water pump/valve cover structure near the water tanks on the south side of the permit has been damaged (Photo 17). **The Operator shall repair, replace, or remove this structure.**

Photo 17: The damaged water pump/valve cover structure atop the S.A.E on the southside of the permit.

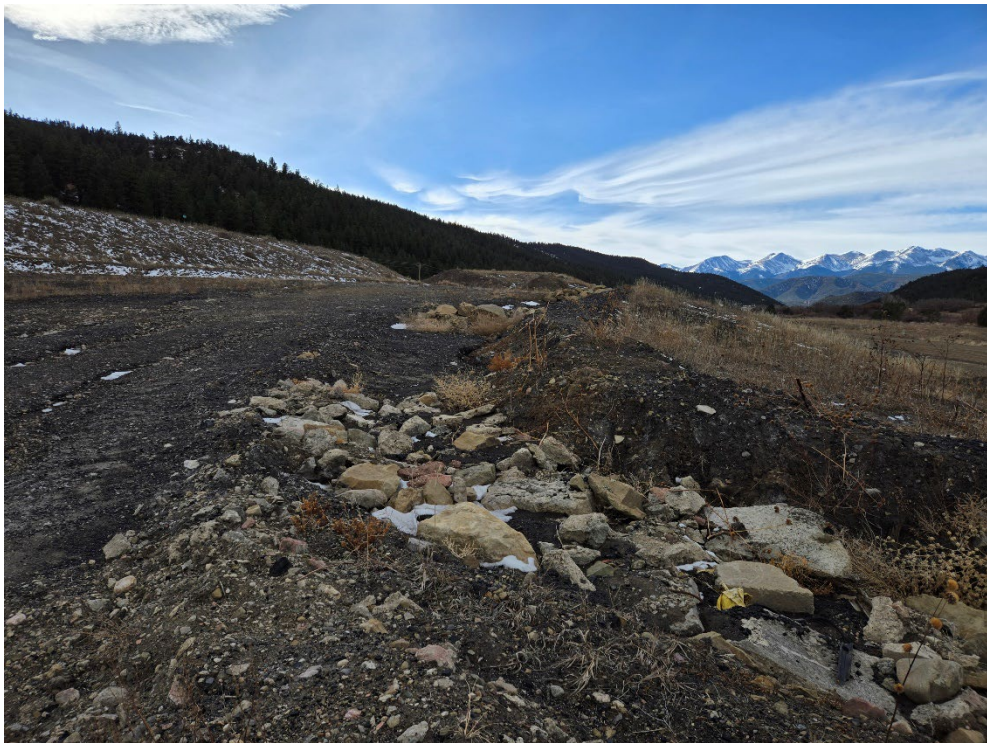
- The check dams located along the north side of the Soil Storage Area have filled with sediment in some areas, and the sides of the check dams have begun to erode (Photo 18). **The Operator shall clean the check dams and stabilize the erosion.**

Photo 18: Looking southwest at the check dams along the northside of the subsoil storage area that have begun to fill with sediment.

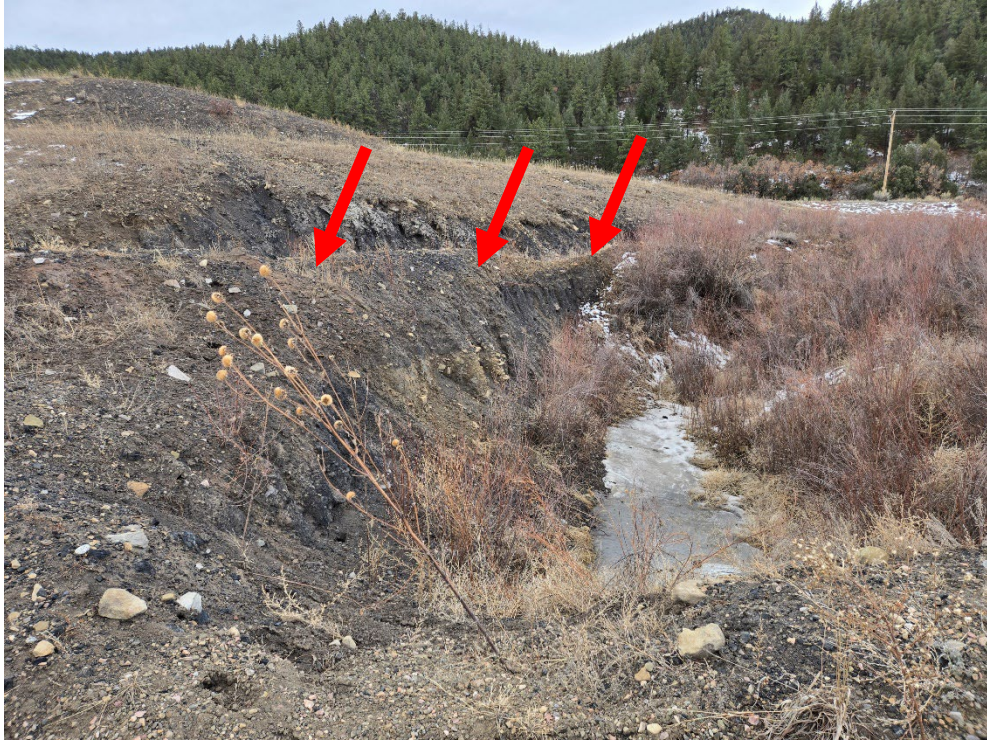
Photo 19: The arrows point to the diversion berm between the clean water and the affected water ditches.

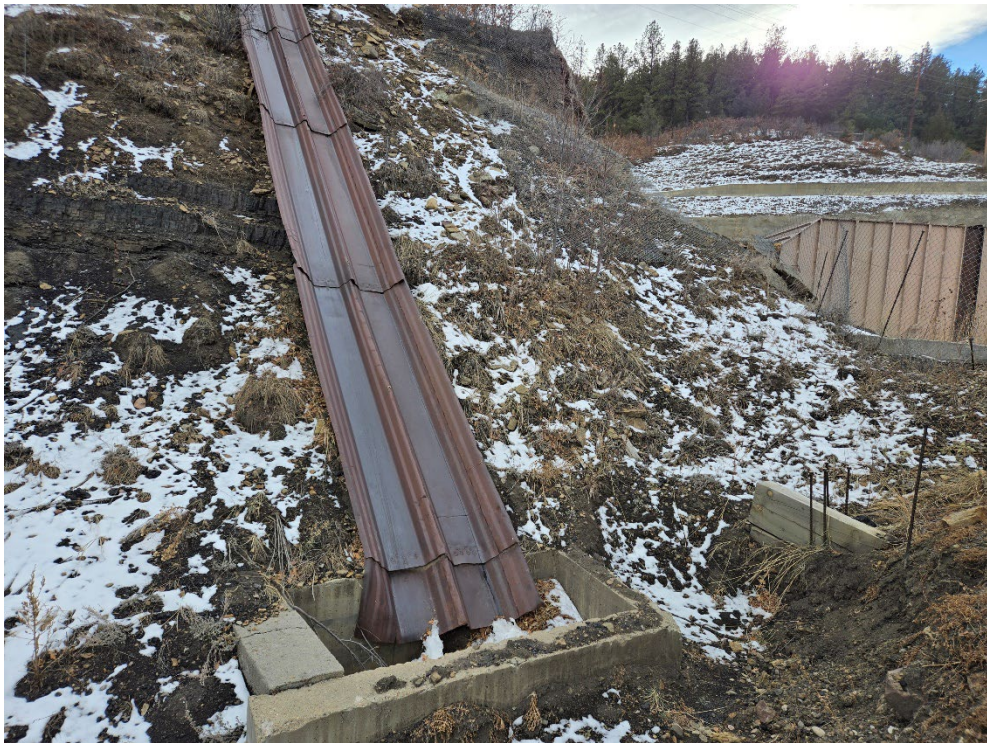
- The berm and concrete box separating the clean water collected from ditch D26 that flows down the flume, from the surrounding run-off generated on site, appears to be well maintained and is functioning appropriately (Photo 20).

Photo 20: Flume and surrounding concrete and earthen berm structures separating the clean water in D26 from the affected water in D24E.

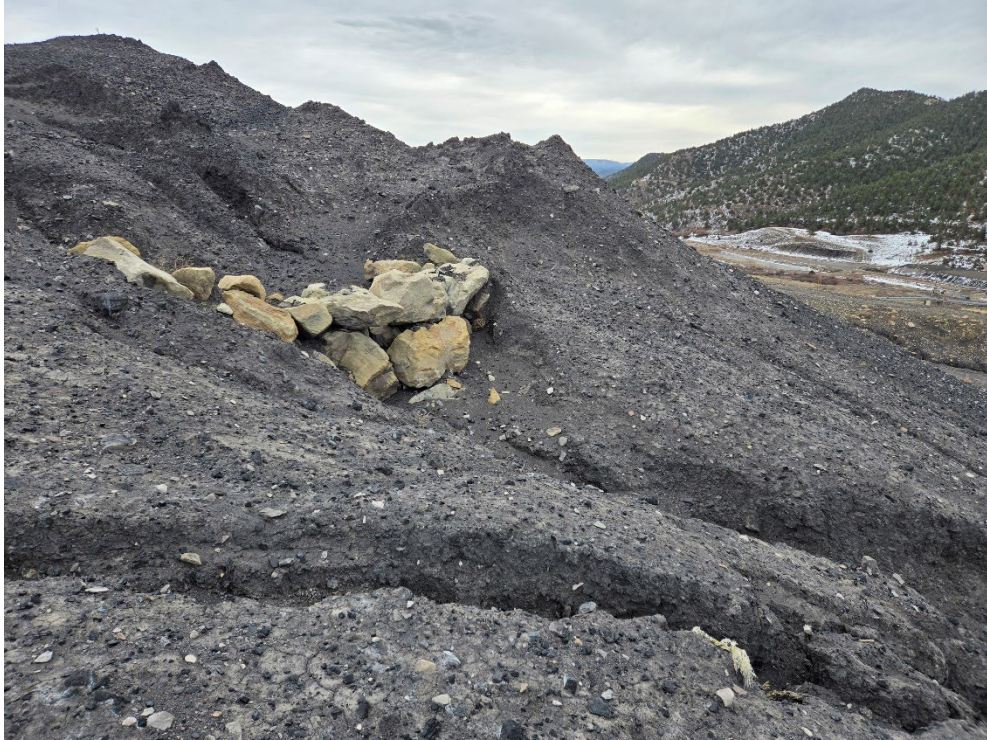
- The northernmost bench, before the leveled area at the top of the RDA, has a small ditch that runs east-west toward the drainages on either side of the RDA. The west side of the bench has a check dam to help slow runoff into the area that leads to culvert C81. The check dam appears functional at the end of the ditch, but erosion has cut around on the slope next to the check dam in some areas, leading to increased sedimentation in the basin leading to C81 (Photo 21). **The Operator shall implement additional erosion control structures along the west slope of the RDA to help reduce erosion on the slope, and stabilize the eroded slopes.**

Photo 21: Looking southeast at the check dam located on the western-most side of the raw coal bench on the RDA.

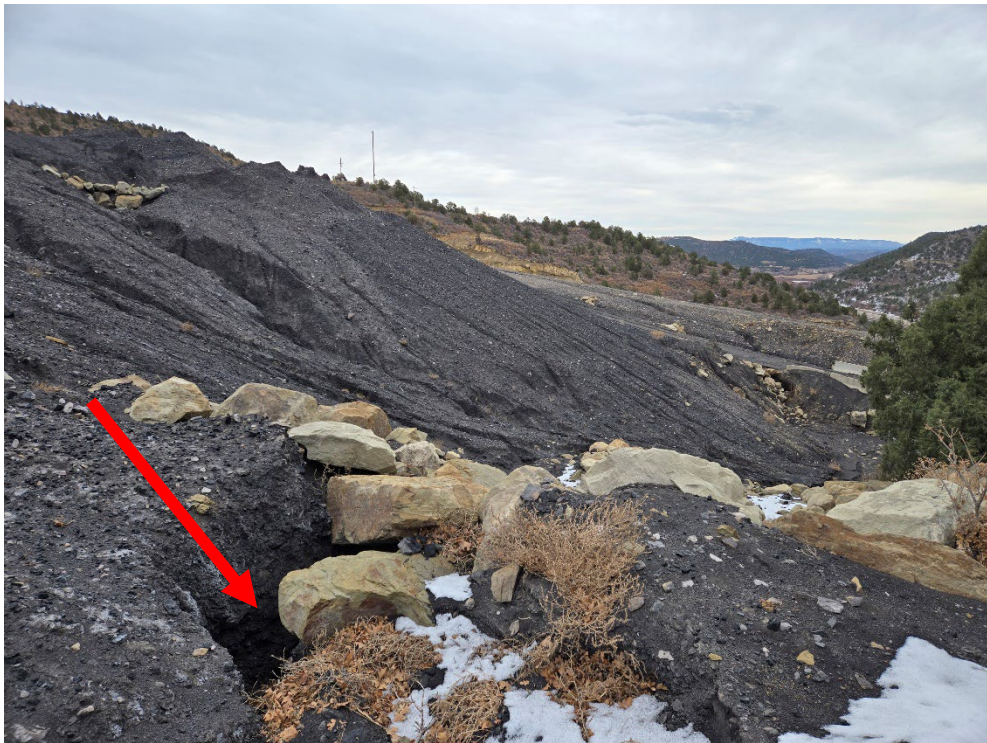
- The unnamed ditch east of D55, running along the west side of the RDA contains a few check dams to control run off and reduce erosion along the RDA. The southernmost check dam is damaged and is no longer functioning appropriately (Photo 22). It appears that water has undercut the check dam and has allowed for excess sediment to accumulate at the end of the ditch. **The Operator shall repair the check dam in the unnamed ditch leading to C81.**

Photo 22: Looking southeast from within the unnamed ditch at the damaged check dam. The arrow points to a hole where water and sediment has run through.

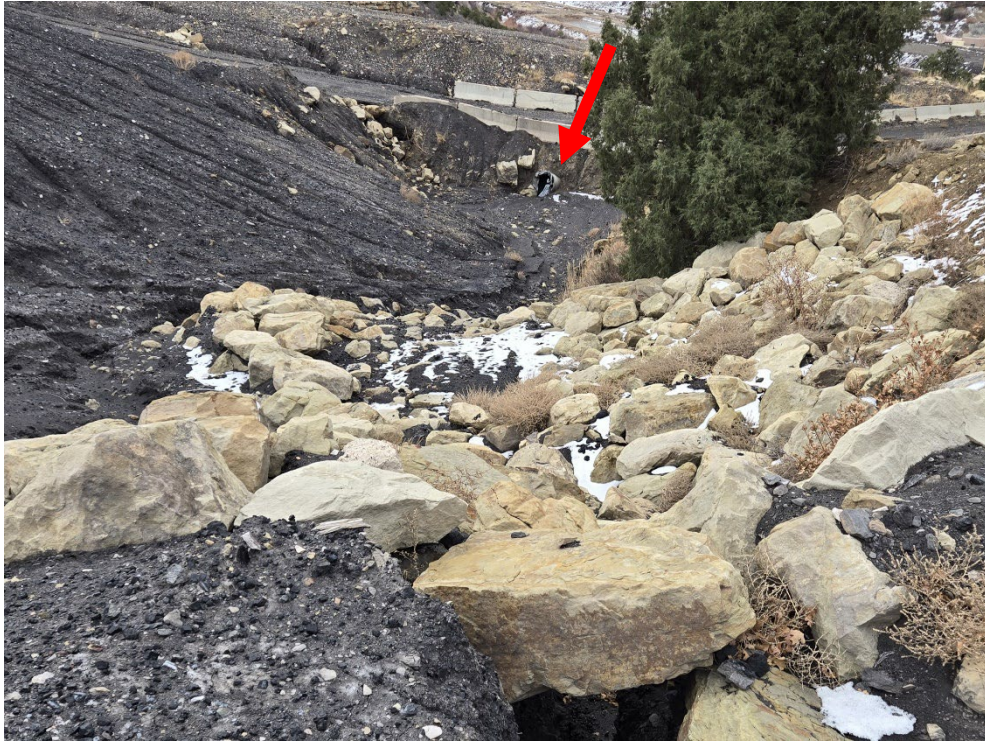
- There is a culvert (C81) at the end of ditch D55 and the unnamed ditch that allows runoff to flow under the road and out to the ditch leading to Pond 08. The inlet side of C81 (located on the north side) appears to be clear of obstructions at this time (Photo 23). **However, the Operator shall remove some of the sediment that has accumulated in the basin to the north of C81 to help minimize the sediment load deposited into Pond 08.**

Photo 23: Arrow points to the inlet side of C81.

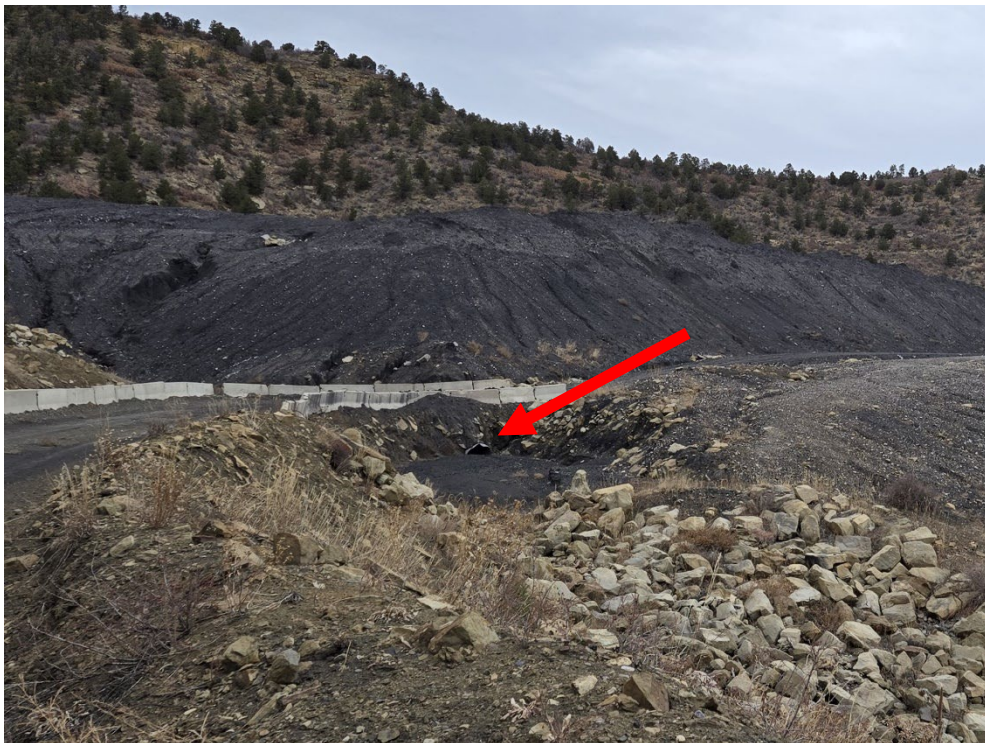
- The outlet side of C81 (located on the south side) has been partially filled with sediment (Photo 24). **The Operator shall clean sediment out of C81 and from the area around the culvert.**

Photo 24: Arrow points to the outlet side of C81.

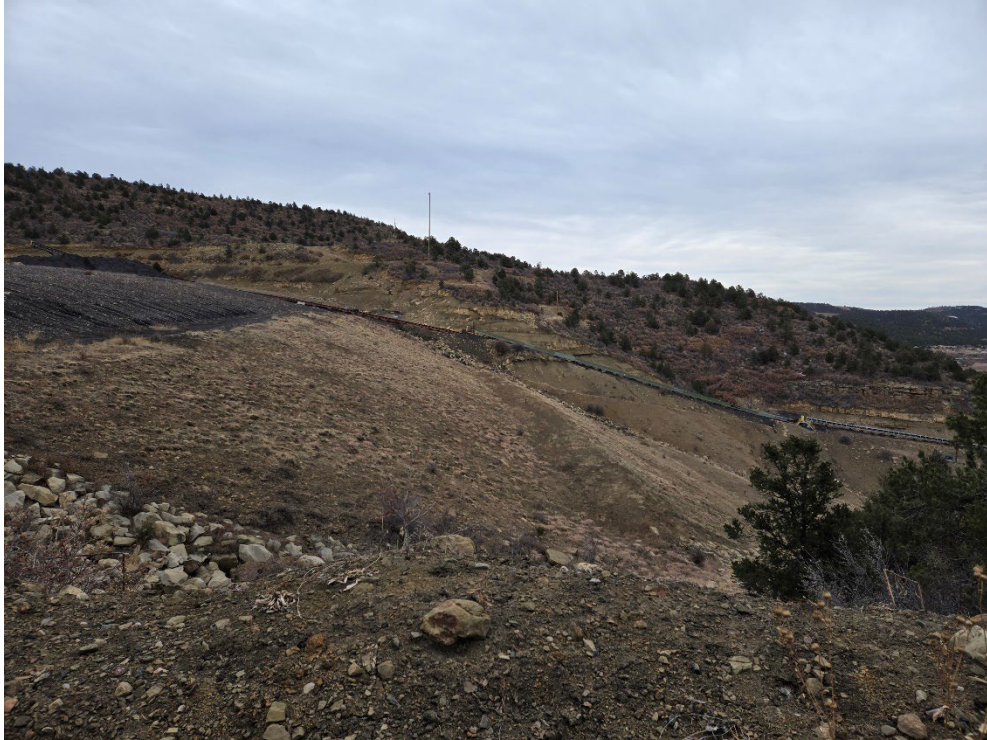
- The reclaimed slopes on the RDA appear to be well vegetated and stable (Photo 25). No signs of erosion on the reclaimed slopes were observed during the inspection.

Photo 25: Looking east across the reclaimed benches on the RDA.

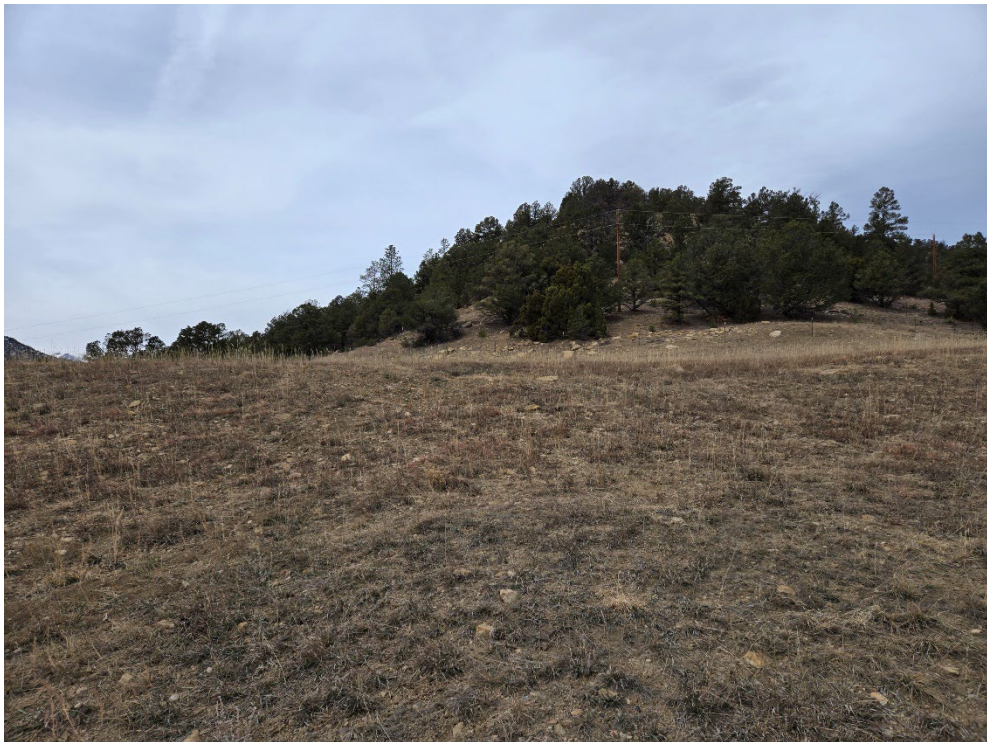
- During the Division's June 2024 inspection, it was noted that a lot more vegetation had established since the Division observed the area in November 2023, however there were still a few bare spots. During the September 2024 inspection, the vegetation cover seemed to be recovering. As of this December 2024 inspection, the vegetation seems to have stabilized (Photo 26), but the Operator may want to assess the area to determine species diversity. **The Operator is advised to monitor this area and consider re-seeding if necessary.**

Photo 26: Looking west across the Golden Eagle ventilation shaft area.

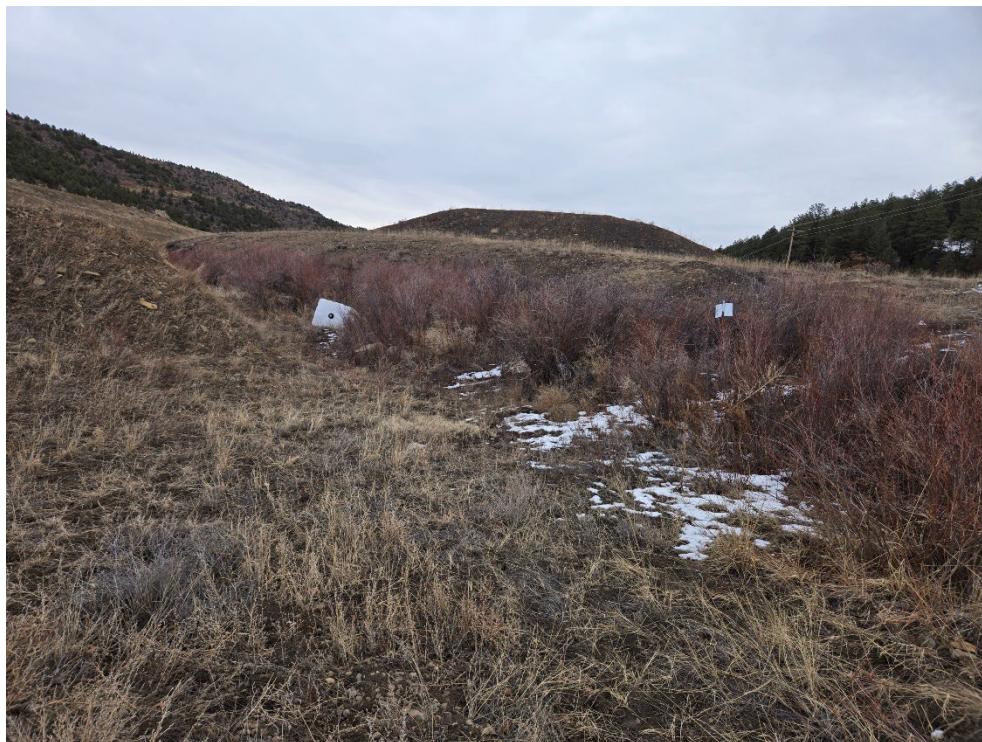
- The berm separating the yard from the Purgatoire River appears to be stable.
- The Portable Explosives and Chemical Storage area was overall stable. However, the Division observed an empty tank in the ditch to the east of the storage area (Photo 27). **The Operator shall remove the tank from the ditch.**

Photo 27: Looking northeast at the empty storage tank within the ditch, east of the chemical storage area.

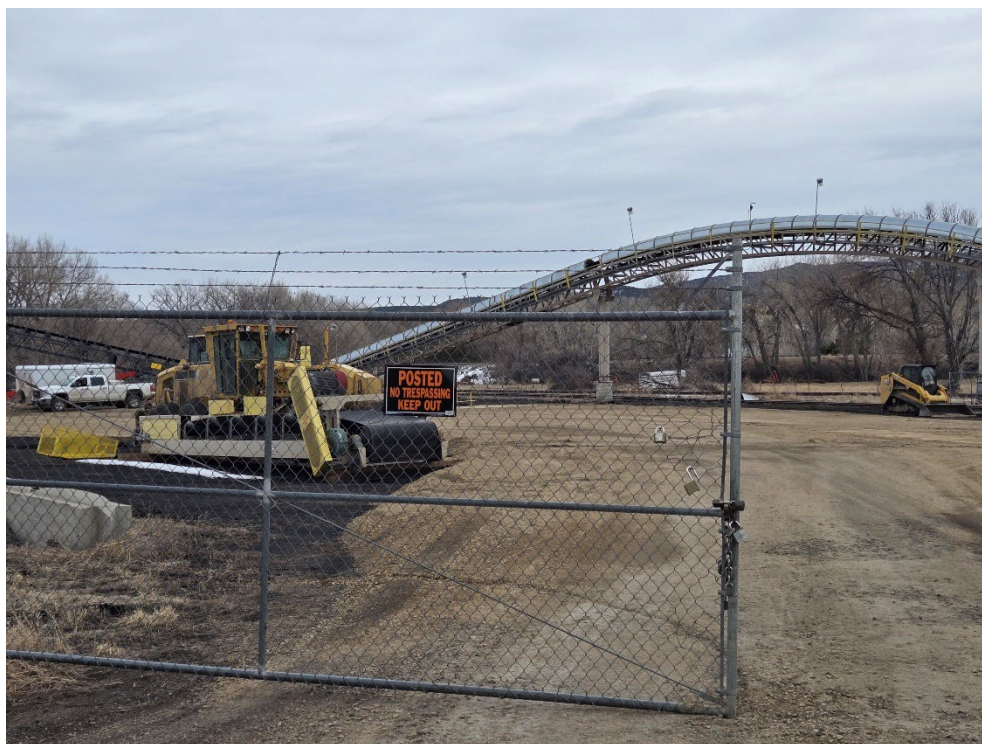
- Mine signs were observed at the main entrance to the New Elk mine site, around the permit boundary, and at the Golden Eagle ventilation shaft area.
- The mine sign is no longer posted at the Jansen Loadout (Photo 28). Therefore, **the Operators shall post a new sign at the Jansen Loadout to comply with the requirements of Rule 4.02.**

Photo 28: Mine sign has been replaced with a no-trespassing-sign at the Jansen Loadout entrance gate.
