New Elk Inspection Report, December 2024 (Complete)

Attached for your records is a copy of the Division's inspection report for the complete inspection conducted for the New Elk Mine (C-1981-012) on December 17-18, 2024.

Permit Number: C-1981-012 Mine Name: New Elk Mine Operator: New Elk Coal Company, LLC Operator Address: Mr. John Terry 12250 Highway 12 Weston, CO 81091	County: Las Animas Operation Type: Underground Permit Status: Active Ownership: Private
	Operator Representative Present: None
Operator Representative Signature: (Field Issuance Only)

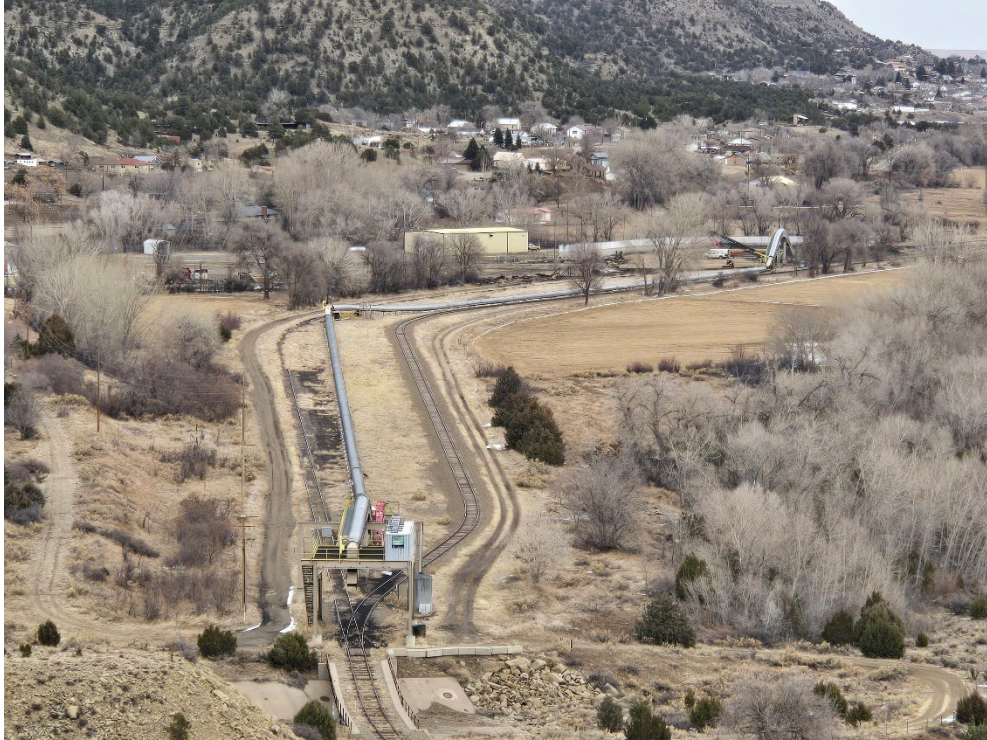
- The facilities at the Jansen Loadout were observed. All equipment on-site appears to be stable at the time of the inspection (Photos 29). A subcontractor for the current tenant was onsite during the inspection and stated that they were working on the conveyor belt system. The Division noted that since the last time the Jansen Loadout was inspected (September 2024), the majority of the mullein observed along the conveyor belt system has been mowed down by the current tenant (Photo 30).

Photo 29: Looking east across the Jansen Loadout area from County Road 18.3, atop the dam, east of Trinidad Lake.

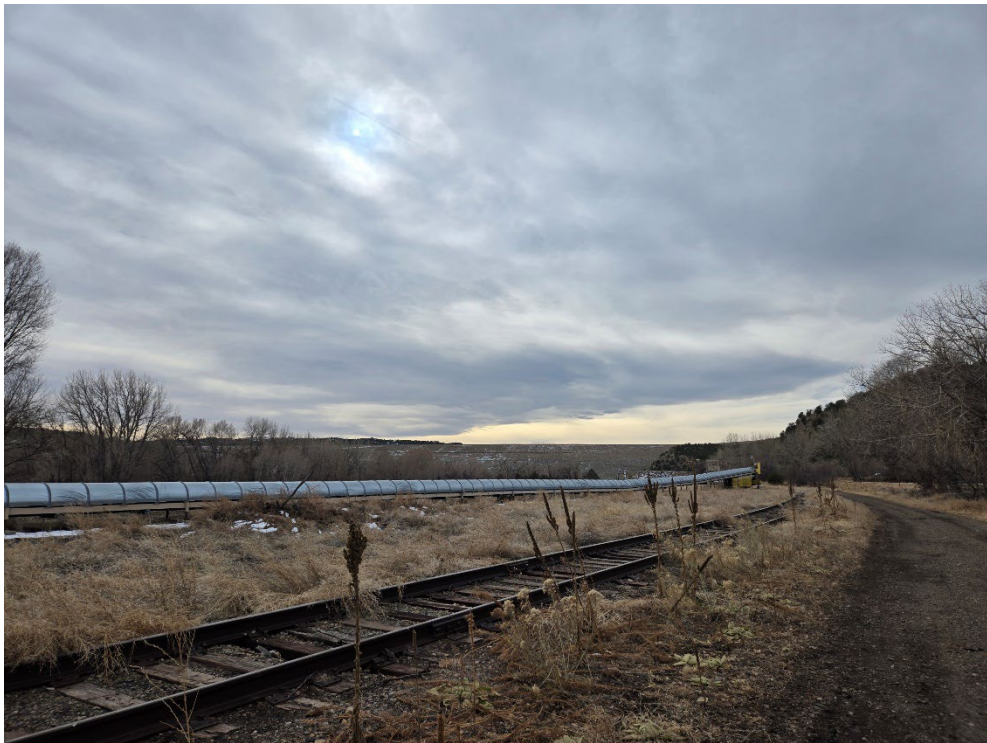
Photo 30: Looking west along the conveyor belt area within the Jansen loadout where a lot of the vegetation has been mowed since the last inspection.

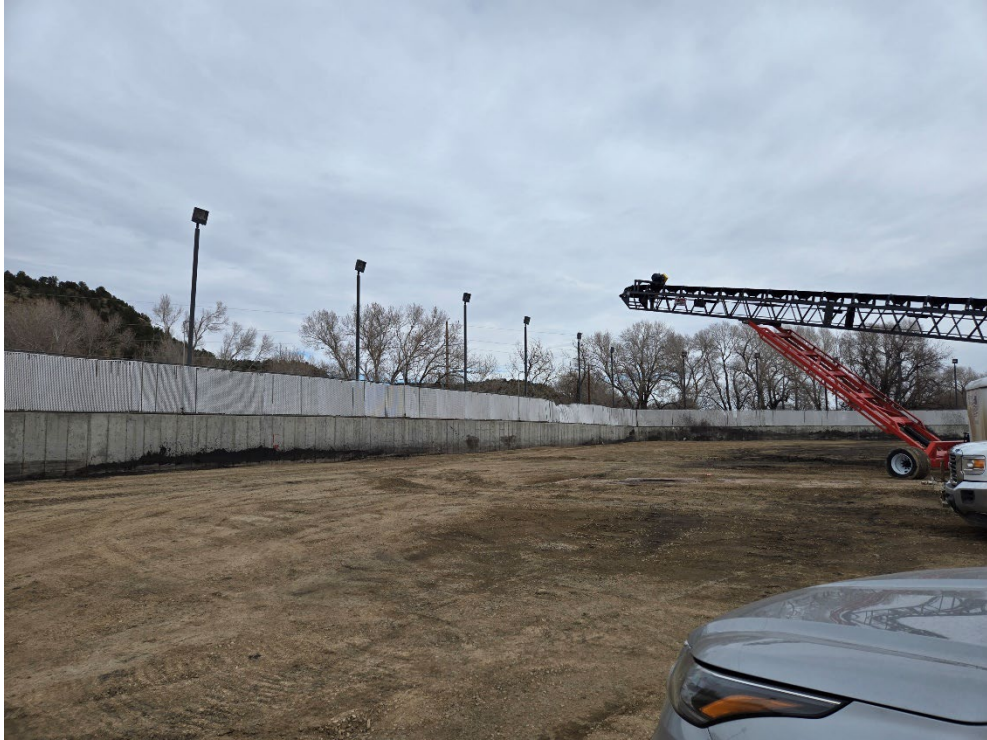
- Much of the coal in the yard area near the entrance has been removed/covered with what looks like soil and/or gravel (Photo 31). On the east side, near the office trailer, the yard still has a coal base (Photo 32).

Photo 31: Looking east at the yard area that has been covered with soil/dirt.

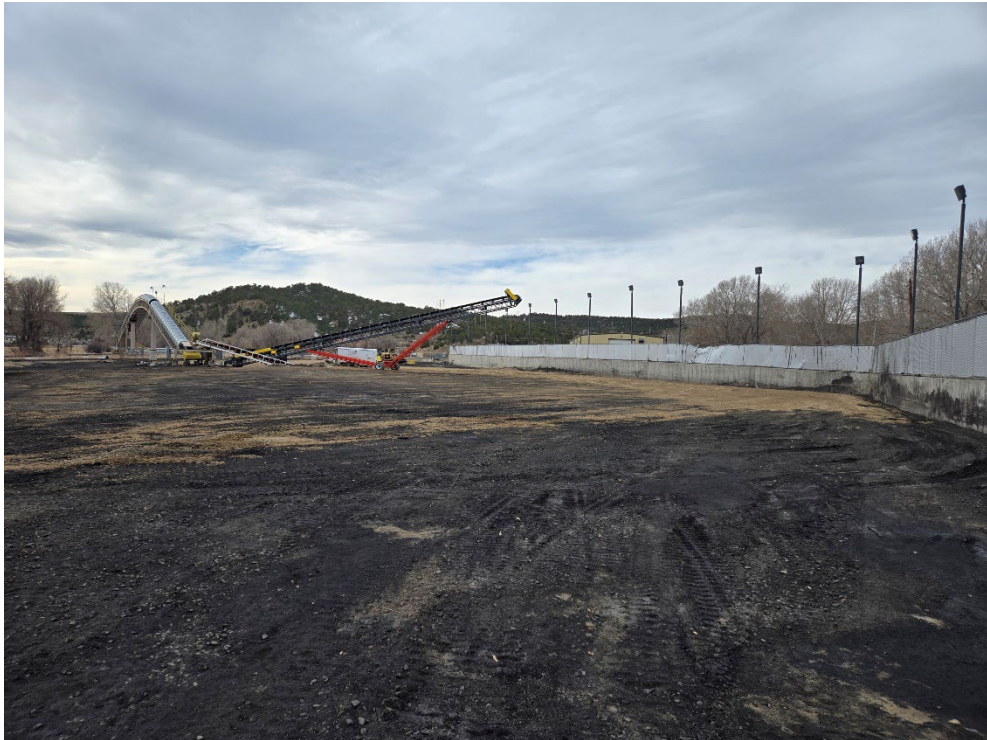
Photo 32: Looking west from near the office trailers at the coal remaining within the yard area at the Jansen Loadout.

- **Once an Operator for the New Elk permits is restored, they will need to clarify to the Division through a revision, the operational status of the Jansen Loadout in regard to the mining operation.**
