**MINERALS PROGRAM INSPECTION REPORT**  
**PHONE: (303) 866-3567**

| <b>MINE NAME:</b><br>Climax Mine | <b>MINE/PROSPECTING ID#:</b><br>M-1977-493 | <b>MINERAL:</b><br>Molybdenum | <b>COUNTY:</b><br>Lake, Summit |
| <b>INSPECTION TYPE:</b><br>Monitoring | <b>WEATHER:</b><br>Clear | <b>INSP. DATE:</b><br>December 12, 2024 | <b>INSP. TIME:</b><br>09:45 |

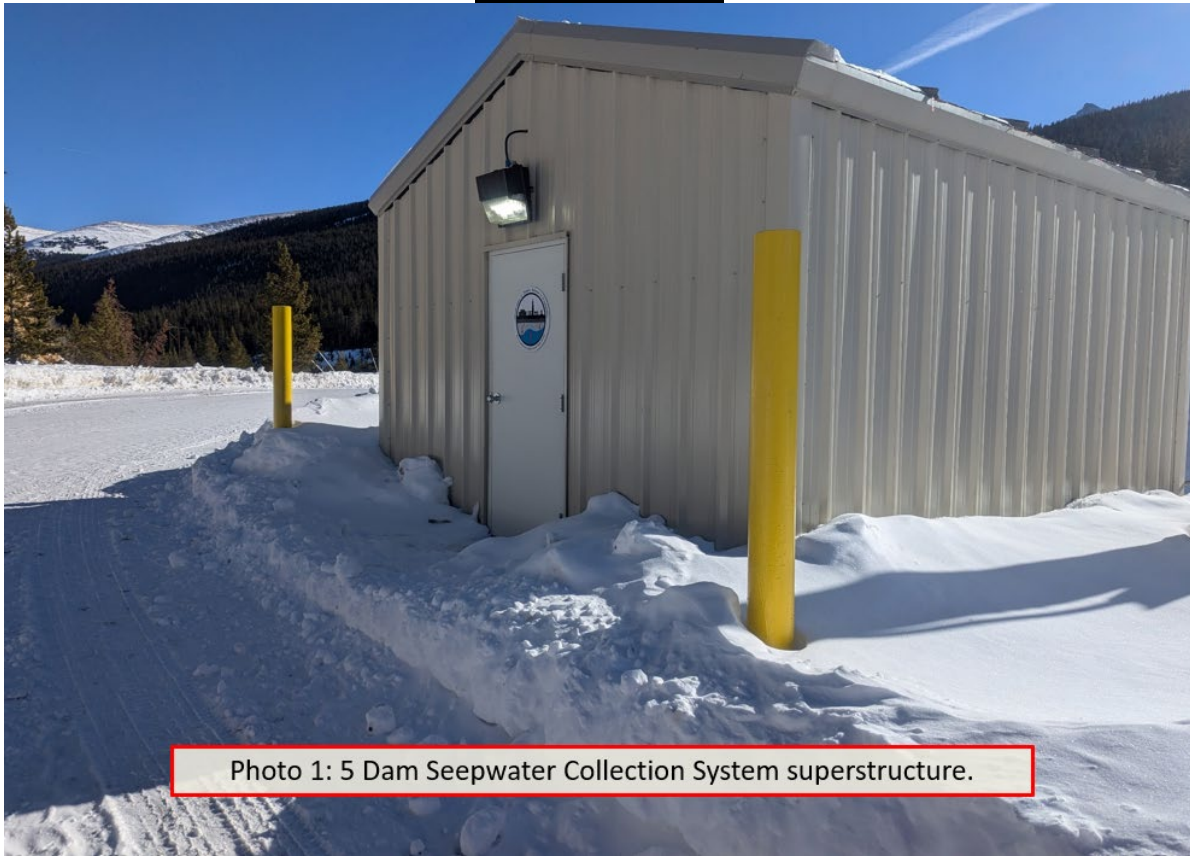
Completed building was observed. The pump operates off of a high-level alarm. Additionally, there are two inspections a day, one per shift to ensure all systems are functioning correctly. The discharge pipe that the pumped water flows through and into the clear pond was observed. The pipe is insulated and located beneath the road. No water was observed discharging at the time of the inspection but according to Mr. Ungers they have observed it operating intermittently meaning the system is functional. Photos 1-4

Photo 1: 5 Dam Seepwater Collection System superstructure.

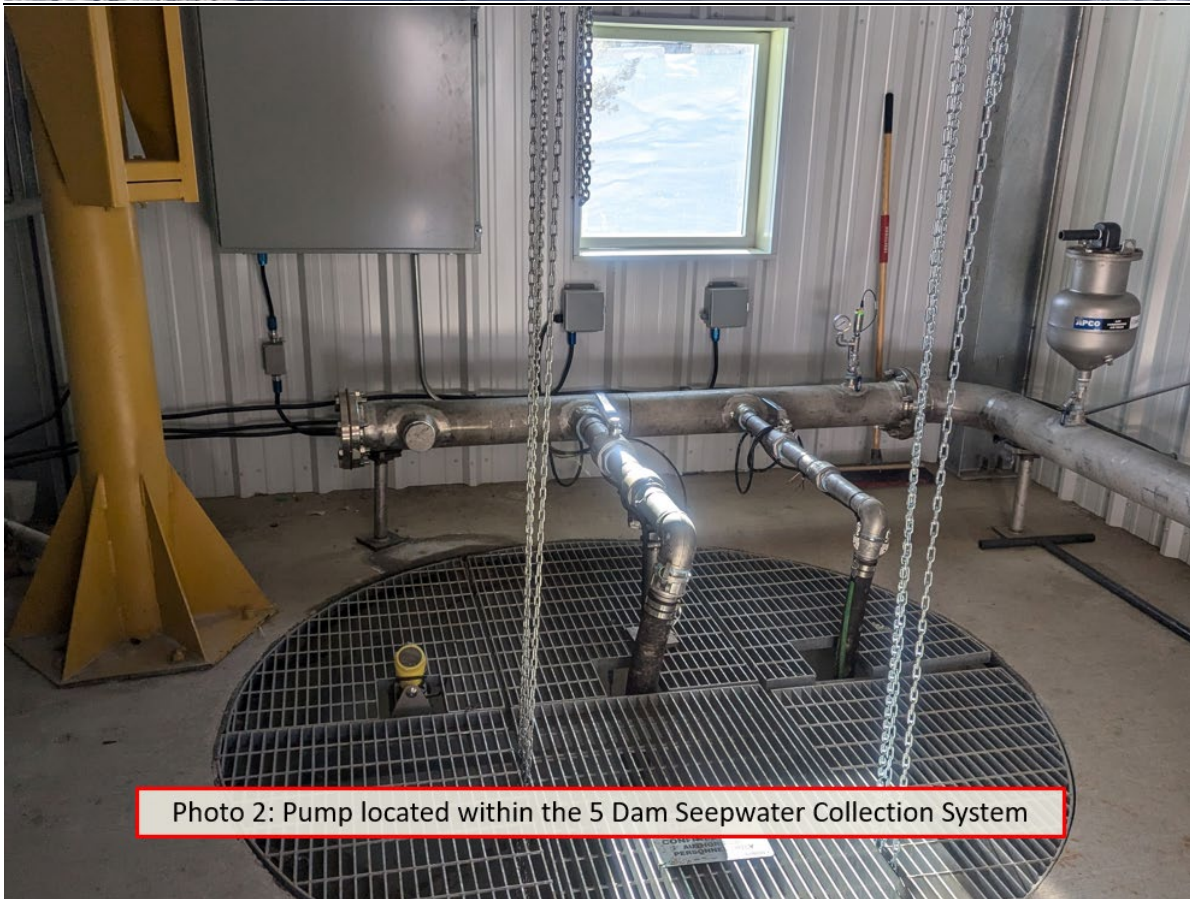
Photo 2: Pump located within the 5 Dam Seepwater Collection System

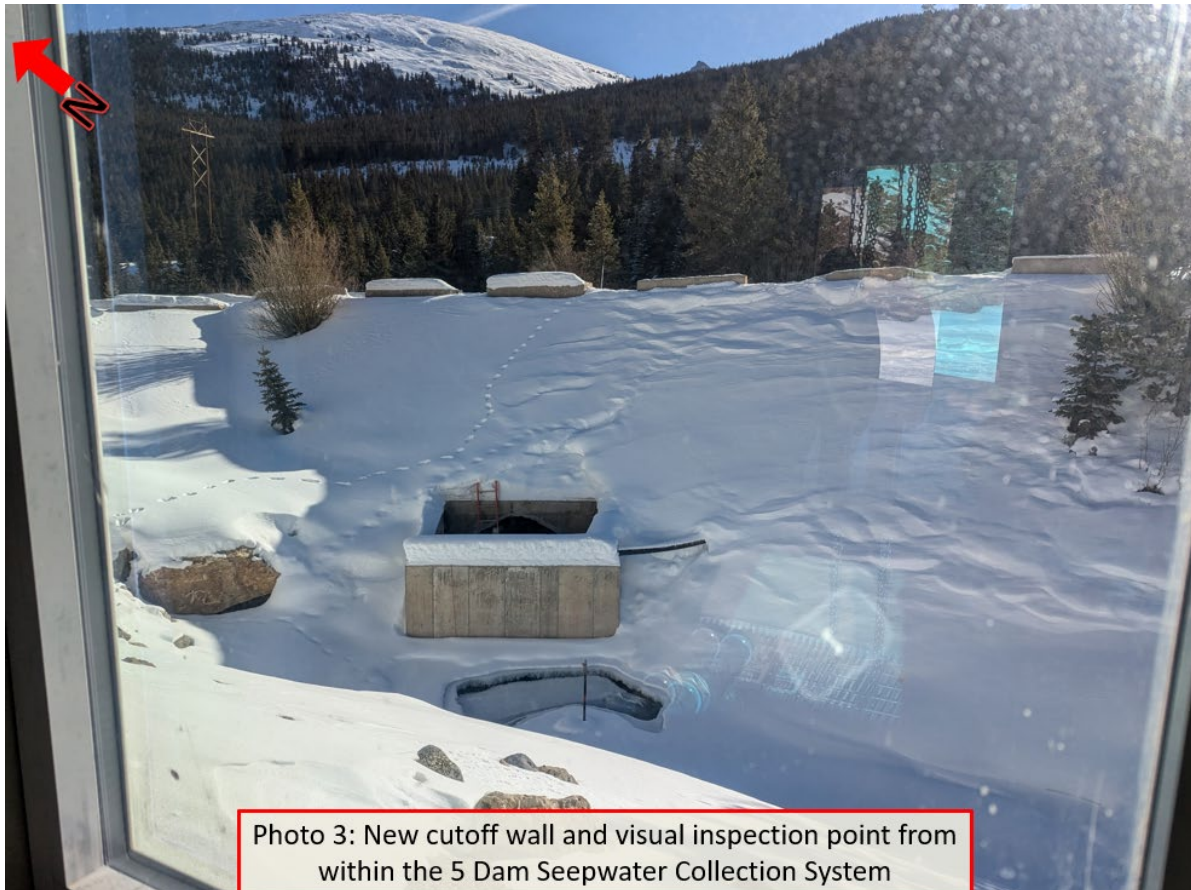
Photo 3: New cutoff wall and visual inspection point from within the 5 Dam Seepwater Collection System

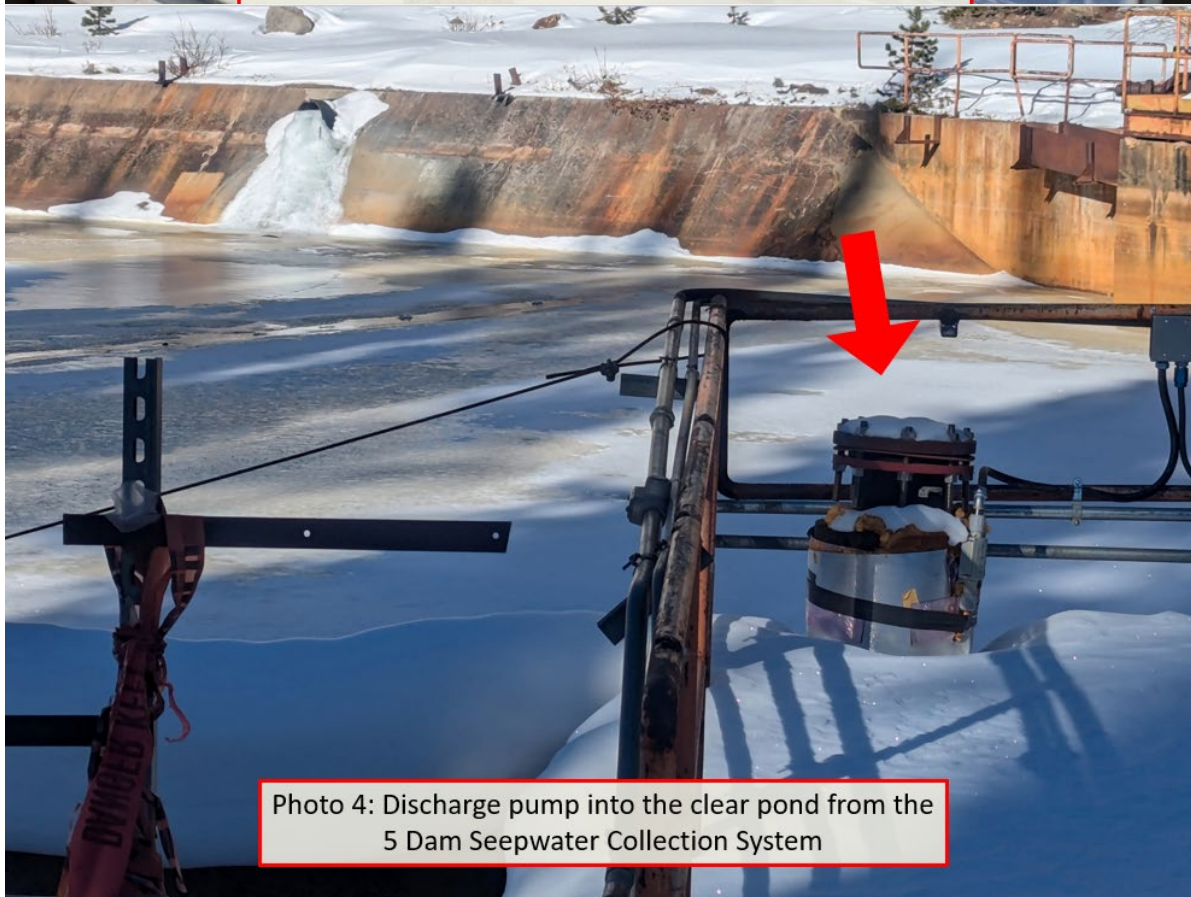
Photo 4: Discharge pump into the clear pond from the 5 Dam Seepwater Collection System

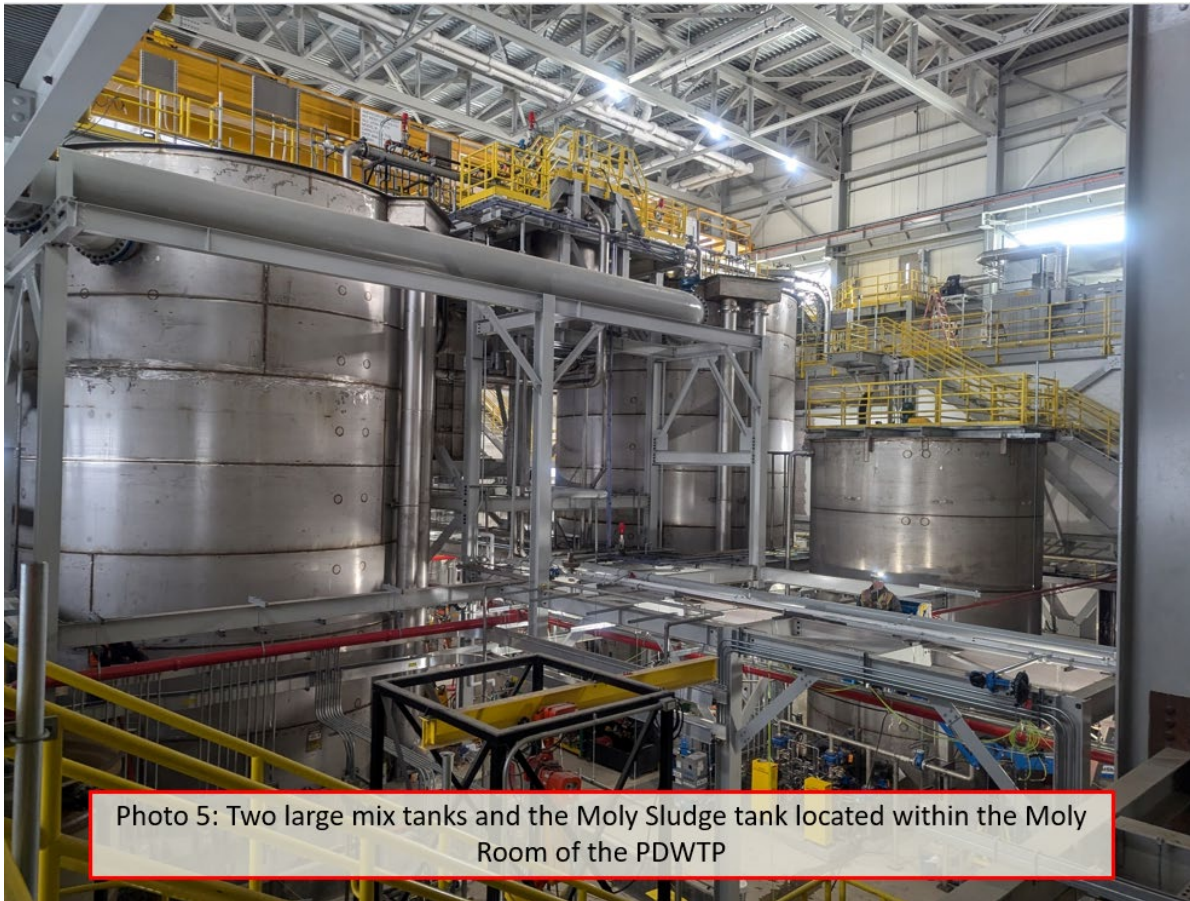
The new Moly building is nearly complete. The Ferric Sulfide (FeSo) mix tank located within the add-on Moly building. It takes FeSo in powder form from the silos outside and mixes it with the effluent water. There are two large Mix tanks located within the building. The FeSo works by dropping the pH of the water to drop out the Moly. The flocculant storage tanks were also observed. Piping was being coated (painted) during the inspection. All containments were dry. A smaller tank within the building consolidates the Moly Sludge before its transported to the Moly Sludge Cell TR-38. Photos 5 and 6.

Photo 5: Two large mix tanks and the Moly Sludge tank located within the Moly Room of the PDWTP

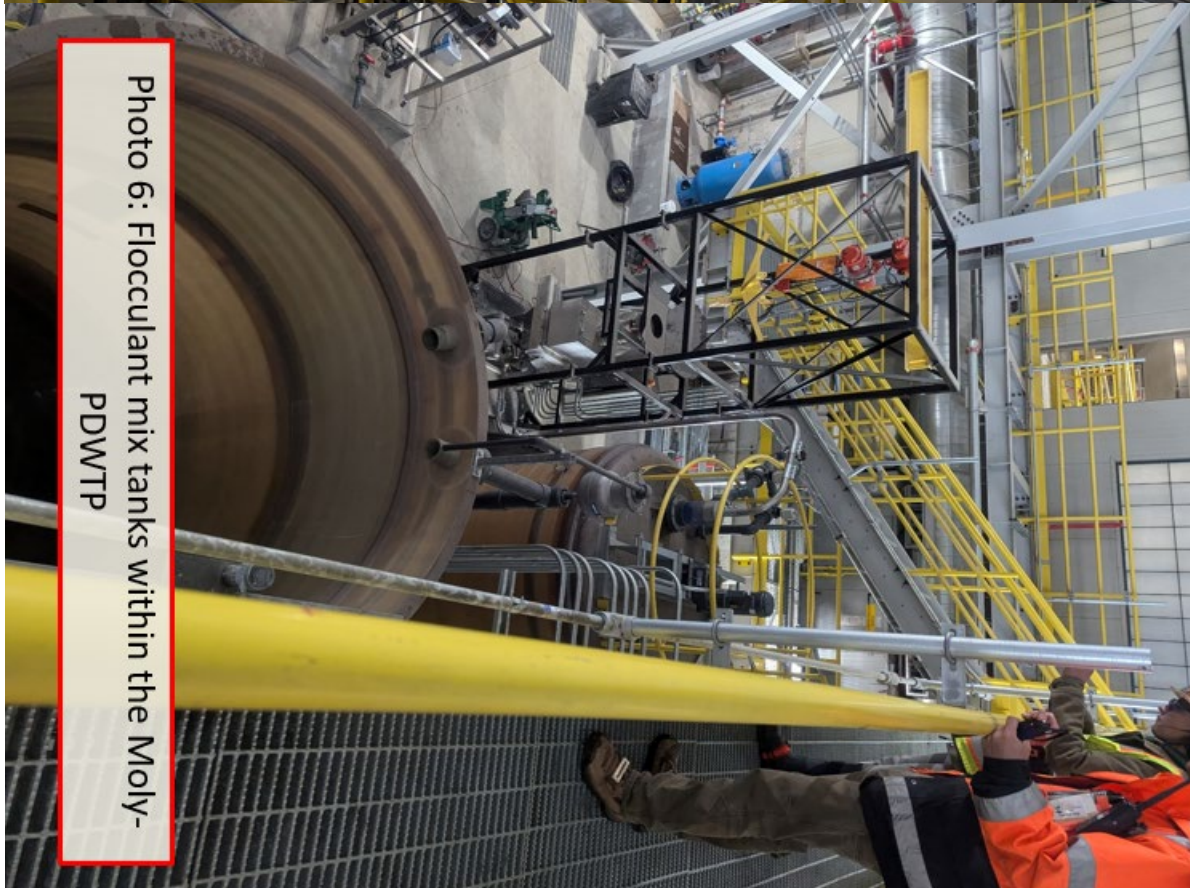
Photo 6: Flocculant mix tanks within the Moly-PDWTP

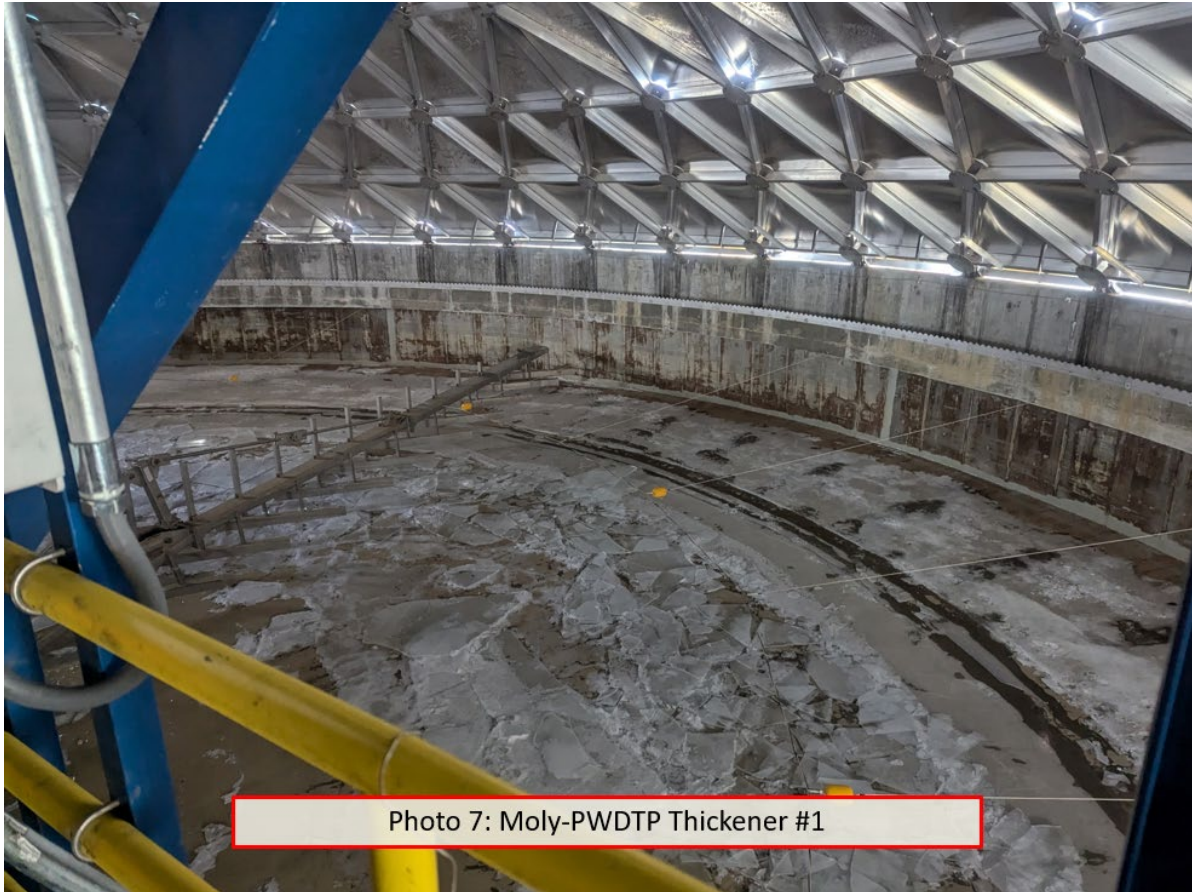
The clarifiers had some potable clean water in them as they were being tested. These clarifies function the same as the other PDWTP clarifiers, sludges settle to the bottom and treated water flows over the top. Two agitators 'stir' the water to help mix the water. Photos 7 and 8.

Photo 7: Moly-PWDTP Thickener #1

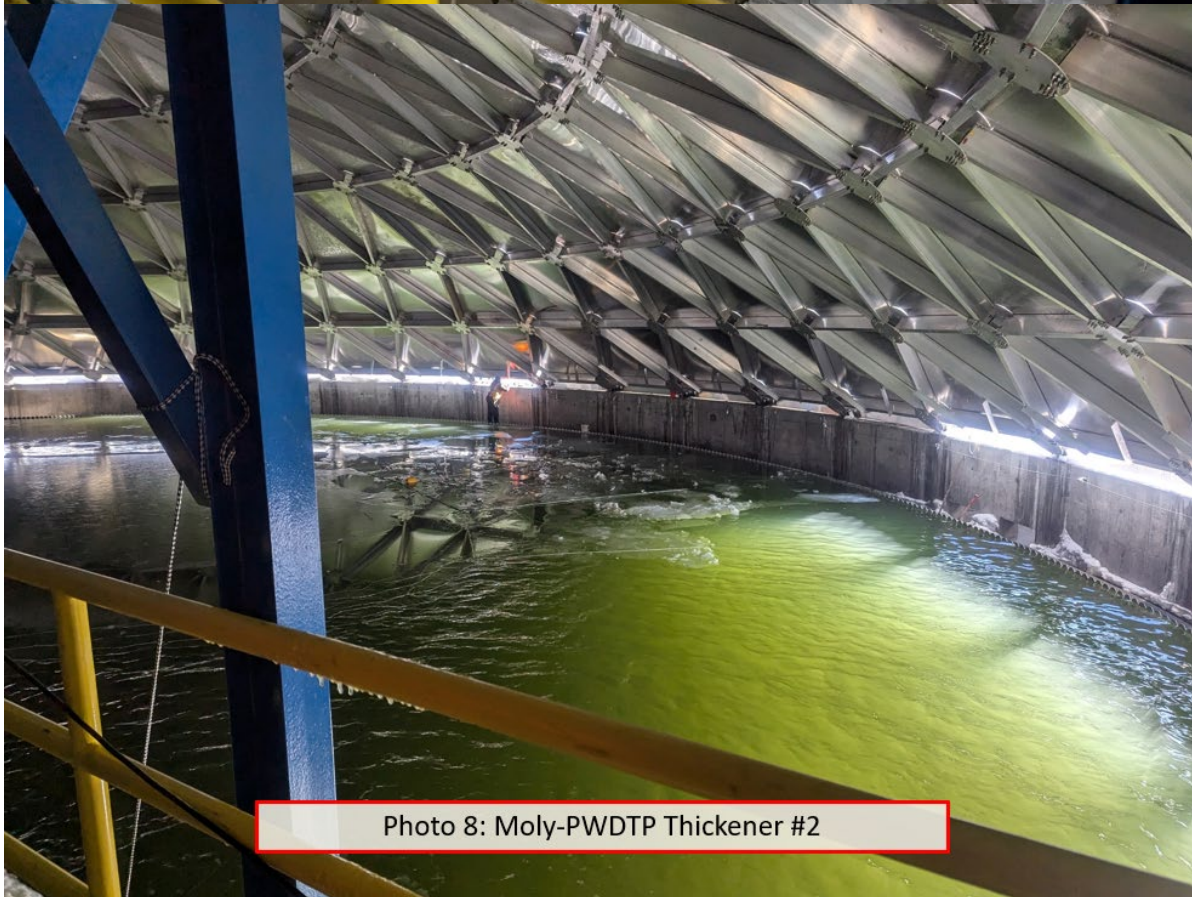
Photo 8: Moly-PWDTP Thickener #2

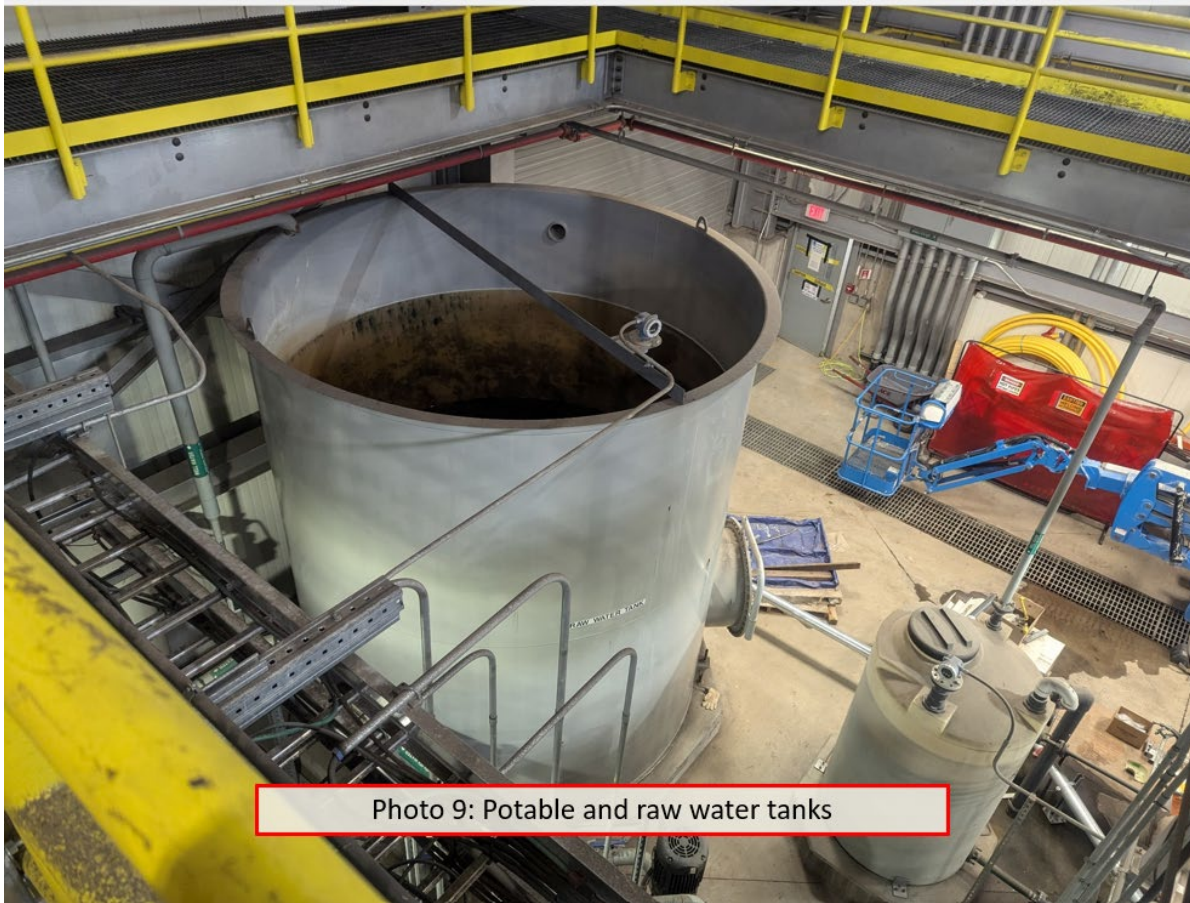
Observed were the potable clean water and raw water tanks. In floor sump systems were operating as designed. The filter press has a new awning over it. At the time of the inspection the filter press was not being utilized, sludges were transferred to the sludge cells for final dewatering. Once other construction activities slow Climax may revisit utilizing the filter press. The Lime slurry mixer tank hydrates powder lime stored in the silo outside. The mixer tanks now get bypassed. Previously effluent water entered the PDWTP at this location. Now

Photo 9: Potable and raw water tanks

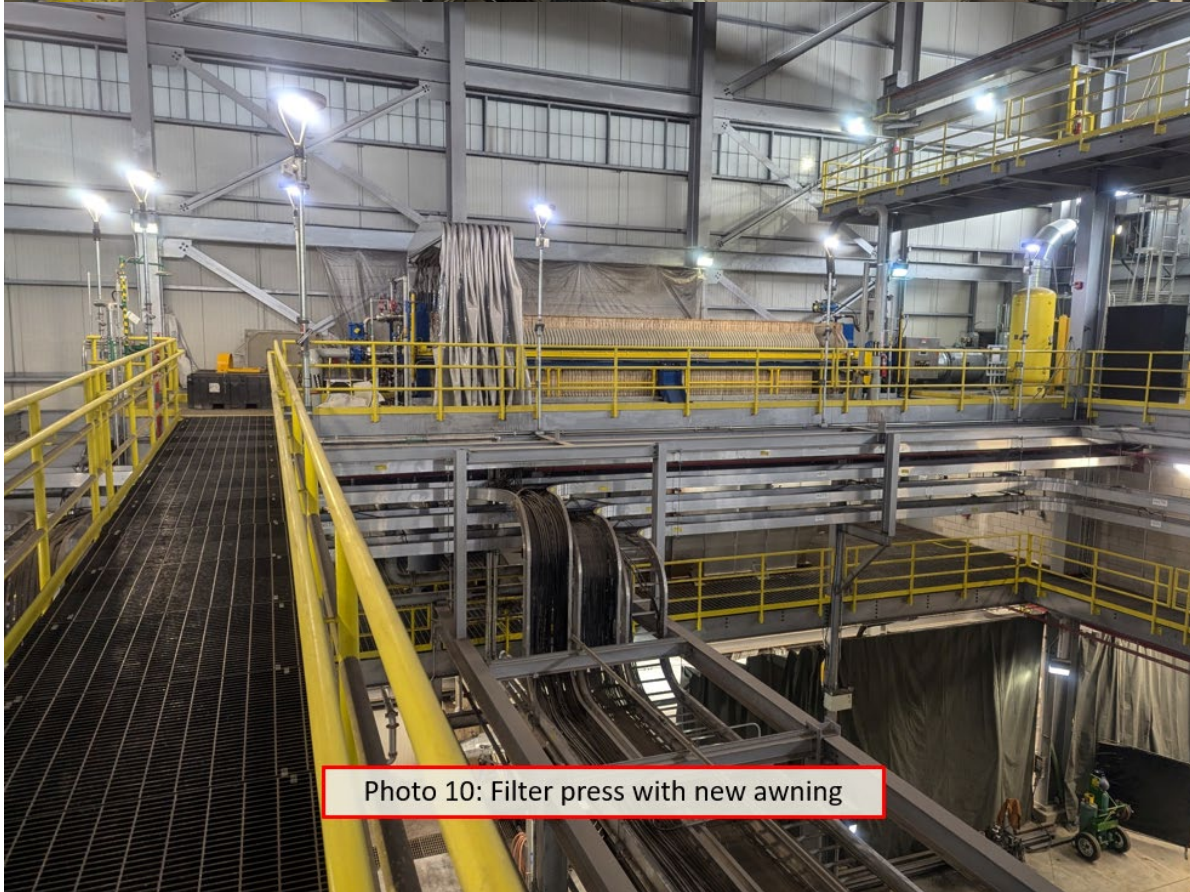
Photo 10: Filter press with new awning

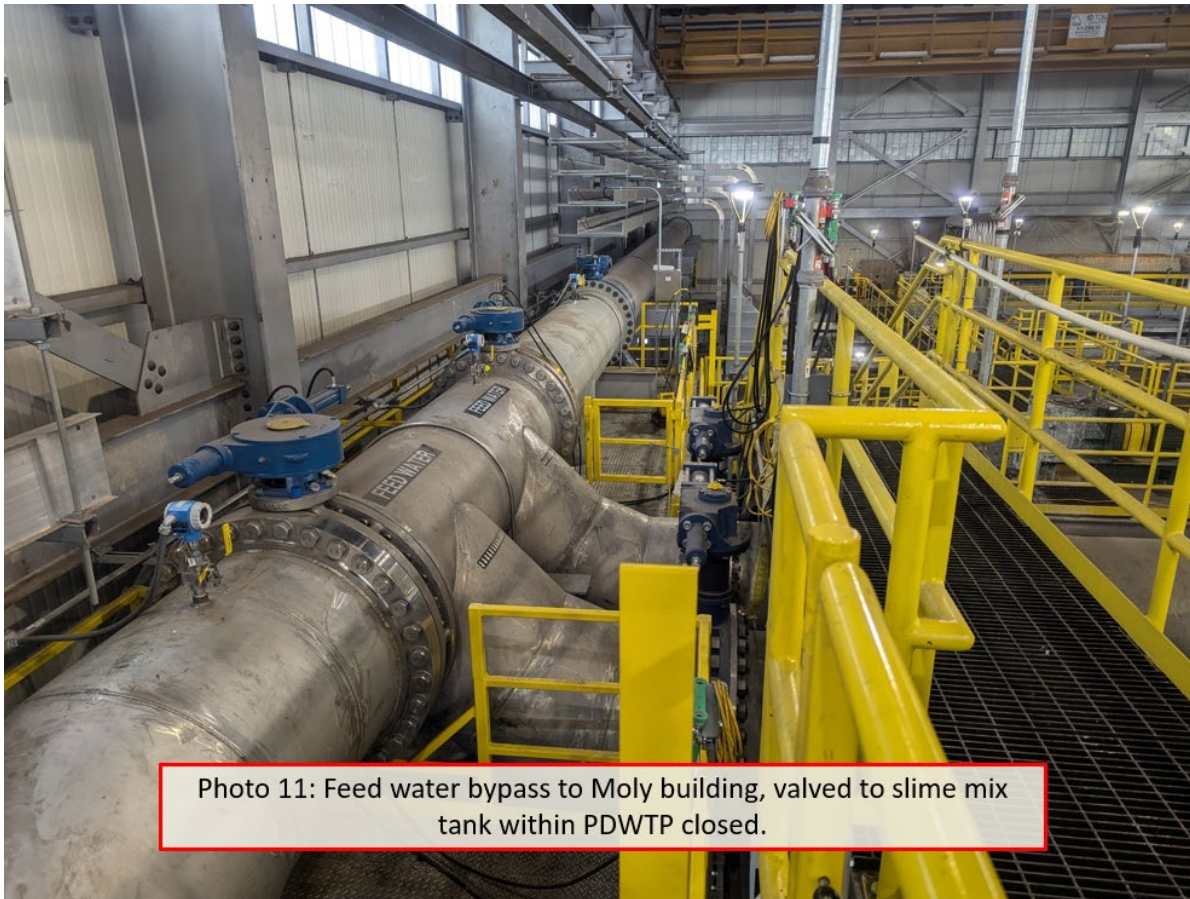
water goes to the Moly room first. There is a closed valve that diverts water to the Moly building. The water once treated in the moly room then is used to hydrate the lime, adjust the pH. The Sludge recycle tank holds sludges to allow them to continue to thicken until a desired density then the material goes to the waste tank and is periodically transferred to the sludge cell prior to being shipped off site. Photos 9-11.

Photo 11: Feed water bypass to Moly building, valved to slime mix tank within PDWTP closed.

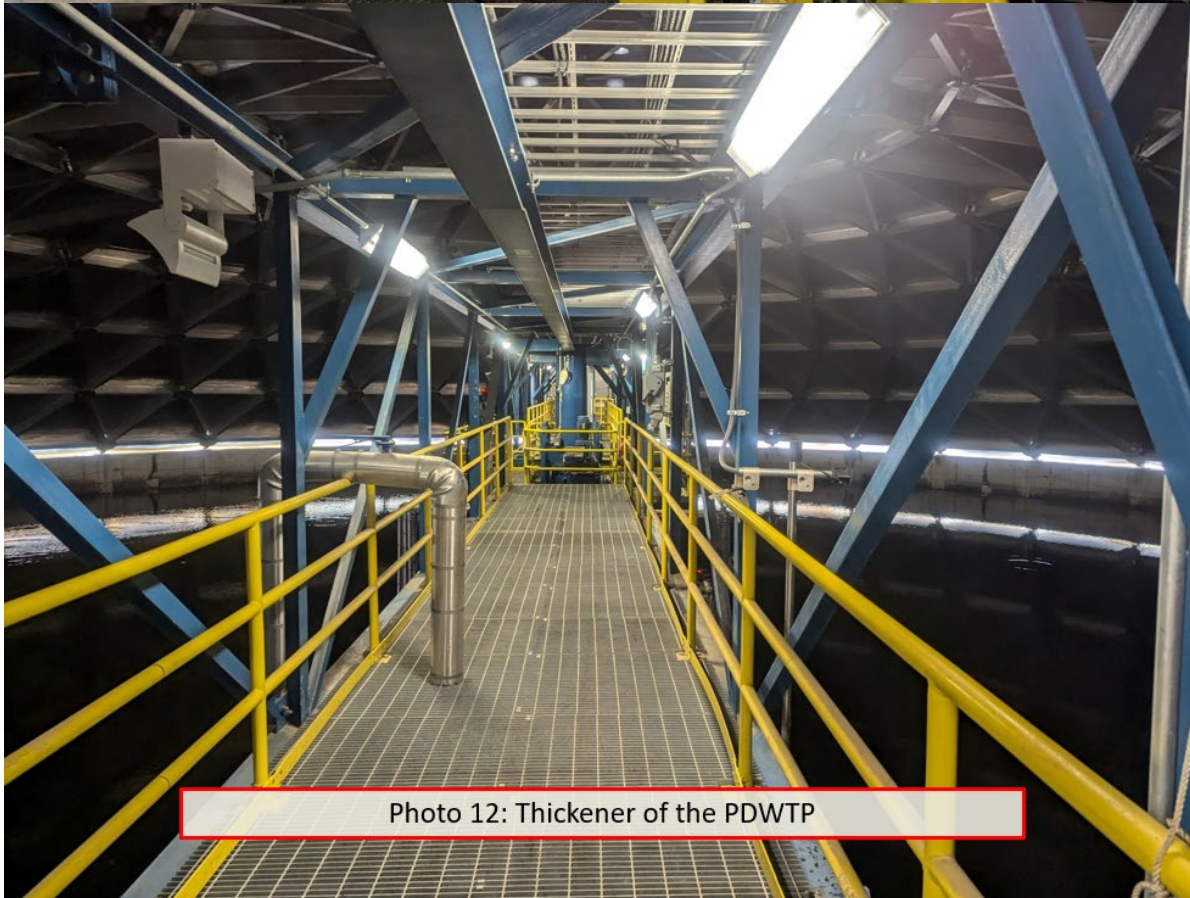
Thickeners were observed operating. This is the primary location that flocculants are added and can be dosed on demand. The flocculant is piped to the thickeners from the main building where they are stored and mixed. Photo 12.

Photo 12: Thickener of the PDWTP

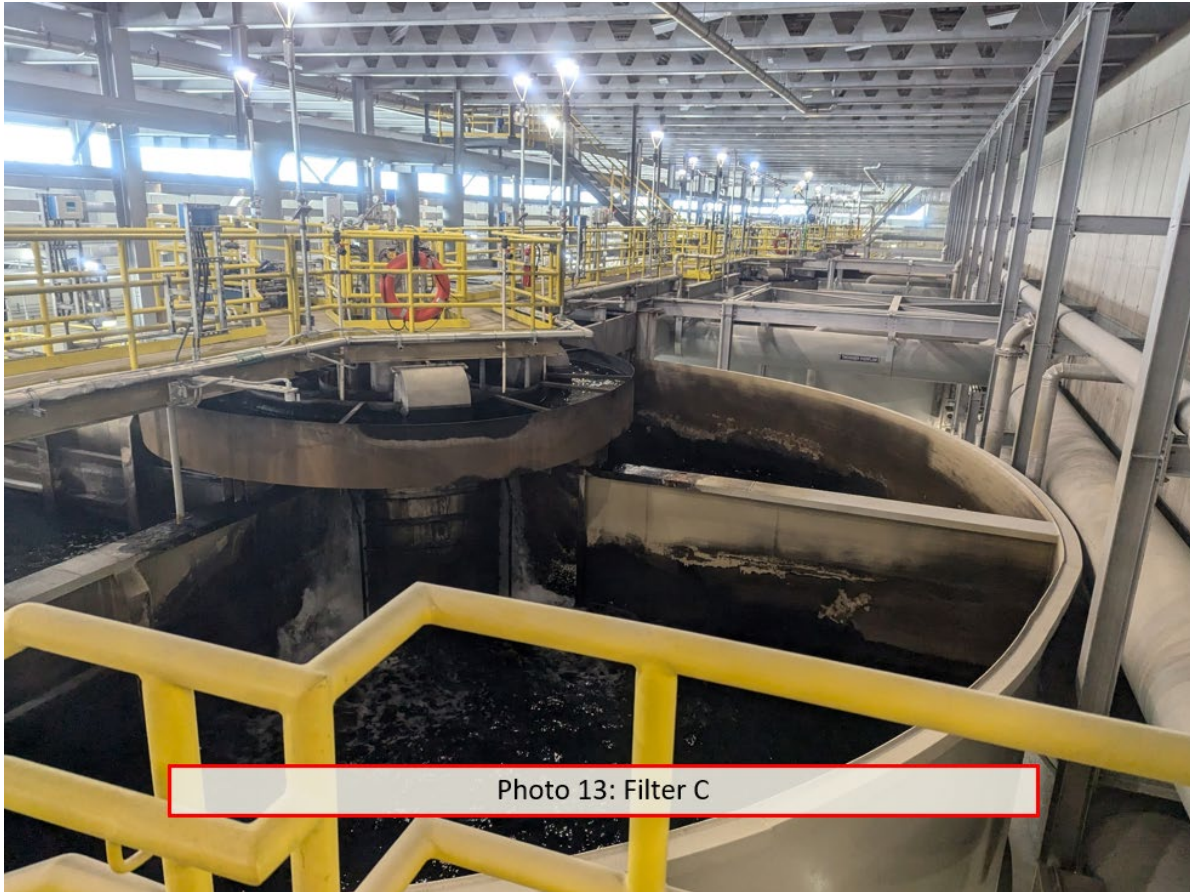
Photo 13: Filter C

From the thickeners water goes to one of the three filters. Water is top fed into the quadrant tanks. The bottom of the tank is a sand medium that the water filters through before exiting. Periodically the sand is backwashed. Mr. Ungers indicated that the sand medium has a 10 yr shelf life. It was recently tested since it's near the 10 year mark and it continues to function as designed. The sand will likely be replaced in the next year or so. At the time of the inspection filter A was not running.

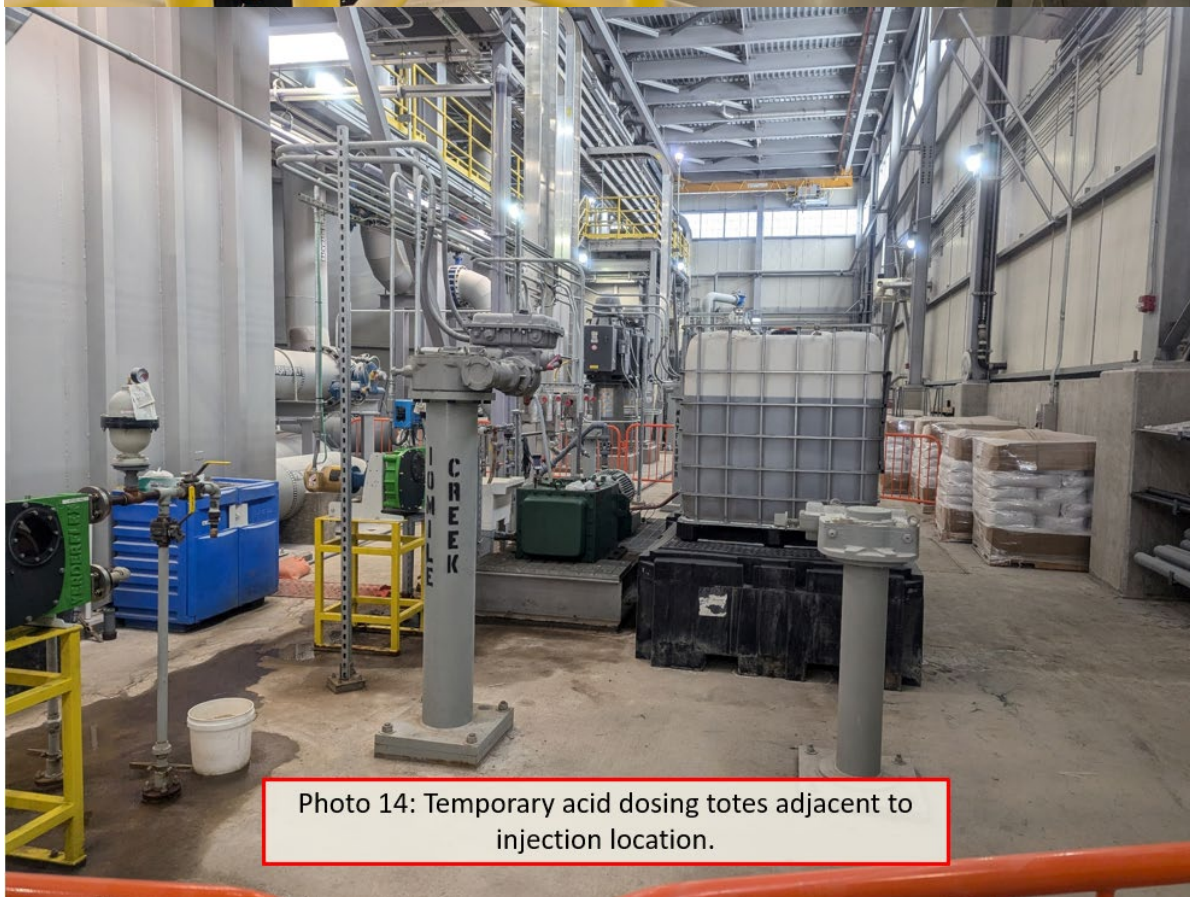
Recently the acid tank was cleaned out. Periodically the system would gum up and needed to be serviced. The excess acid that was previously in the acid room tank is located in secondary containment totes near the dosing location. Once all of the old product is used then Climax will go back to using the acid room and delivery line system. pH is the only real-time tracker for water. If water fails it gets auto diverted back into Mayflower rather than being discharged into Tenmile. Miscellaneous oils were observed within secondary containment. Overall the building appear well maintained. Photos 13-15

Photo 14: Temporary acid dosing totes adjacent to injection location.

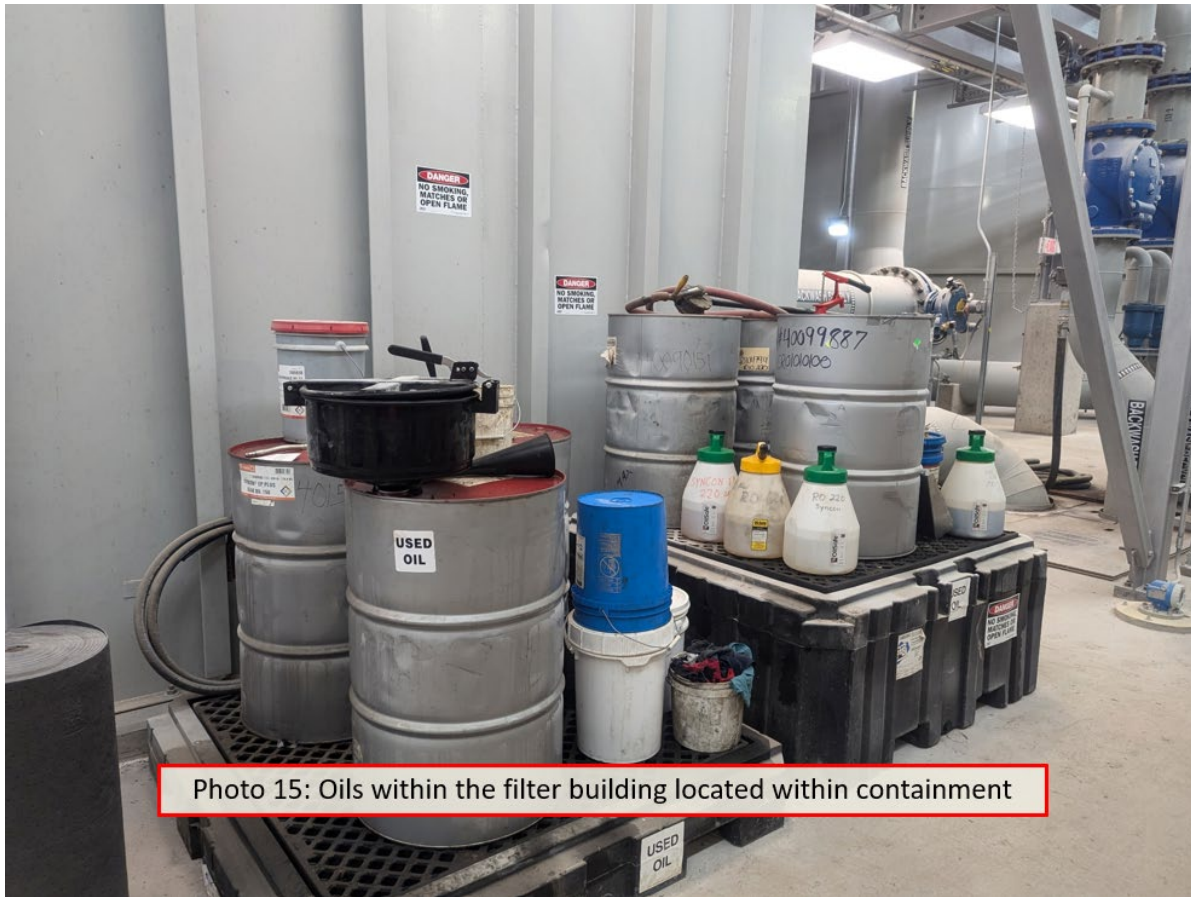
Photo 15: Oils within the filter building located within containment
