Roadside Mine, C-1981-041, December Complete Inspection Report

Permit Number: C-1981-041 Mine Name: Roadside Portals Operator: Snowcap Coal Company, Inc. Operator Address: MS Tonya Hammond 743 Horizon Court, Suite 334 Grand Junction, CO 81506	County: Mesa Operation Type: Underground Permit Status: Active Ownership: Private
	Operator Representative Present: Tonya Hammond
Operator Representative Signature: (Field Issuance Only)

Inspection Start Date: December 18, 2024 Inspection Start Time: 10:15 Inspection End Date: December 18, 2024 Inspection End Time: 11:10		Inspection Type: Coal Complete Inspection Inspection Reason: Normal I&E Program Weather: Clear	
Joint Inspection Agency: None		Joint Inspection Contacts: None	
Post Inspection Agency: None		Post Inspection Contacts: None	
Inspector(s): Clayton Wein	Inspector's Signature: <i>Clayton Wein</i>		
	Signature Date: 12/30/2024

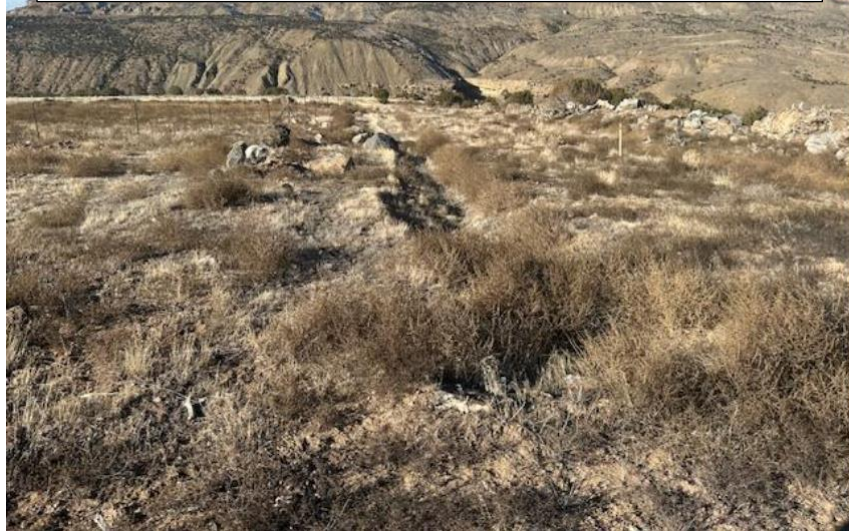
During the inspection, all of the landowner's irrigation lines were off. The trenches on Tract 70 and Tract 71 (Photo 1) were not receiving any water from the landowner's buried pipeline. There was no evidence of recent water application to these areas. The irrigation sprinklers on the landowner's middle field were also observed to be inactive.

Photo 1: The landowner's northwestern trench on Tract 71.

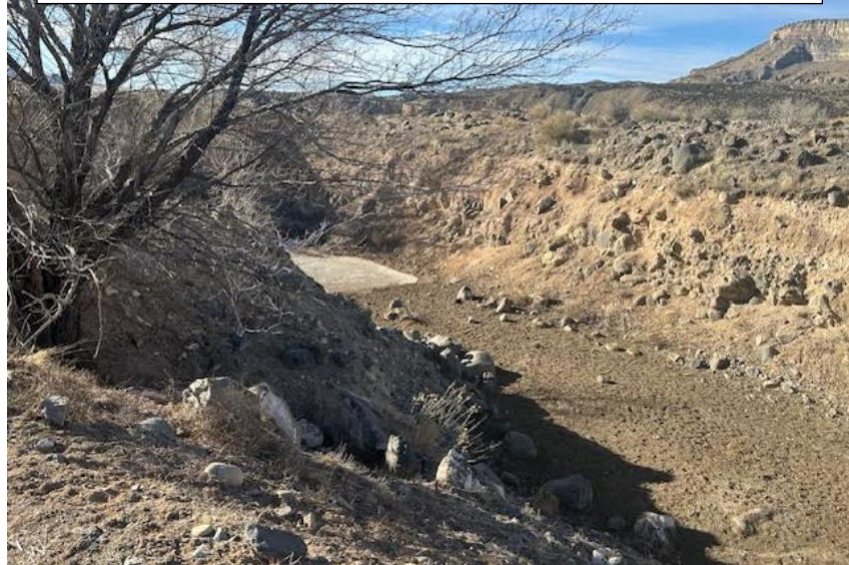
The Carey pit, located in the southwestern portion of Tract 71. The bottom of the pit was damp and holding a small amount of frozen water in it from precipitation events prior to the inspection (Photo 2). The inlet to the pit from the landowner's buried pipeline was dry. There was no indication of recent water application to the pit through the open trench.

Photo 2: The Carey Pit.

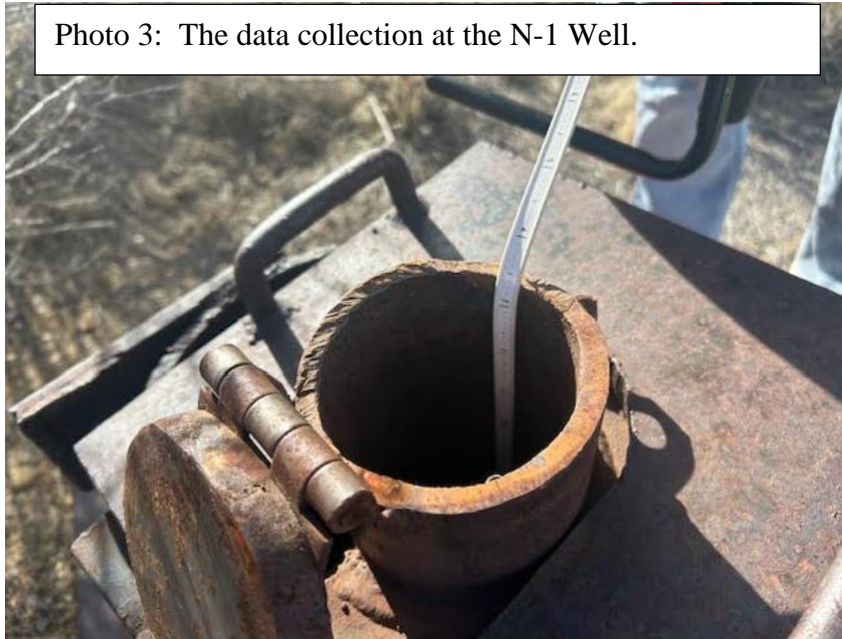
The N-1 well is located in the northeastern portion of the permit boundary. The well monitors the depth of the water in the old mine workings. During the inspection, a reading of the depth of the water from the surface was taken (Photo 3). The depth of the water was measured at 75.35 feet. This measurement was consistent with historical data obtained from the N-1 well. The well casing was in good repair and no blockages were identified.

Photo 3: The data collection at the N-1 Well.

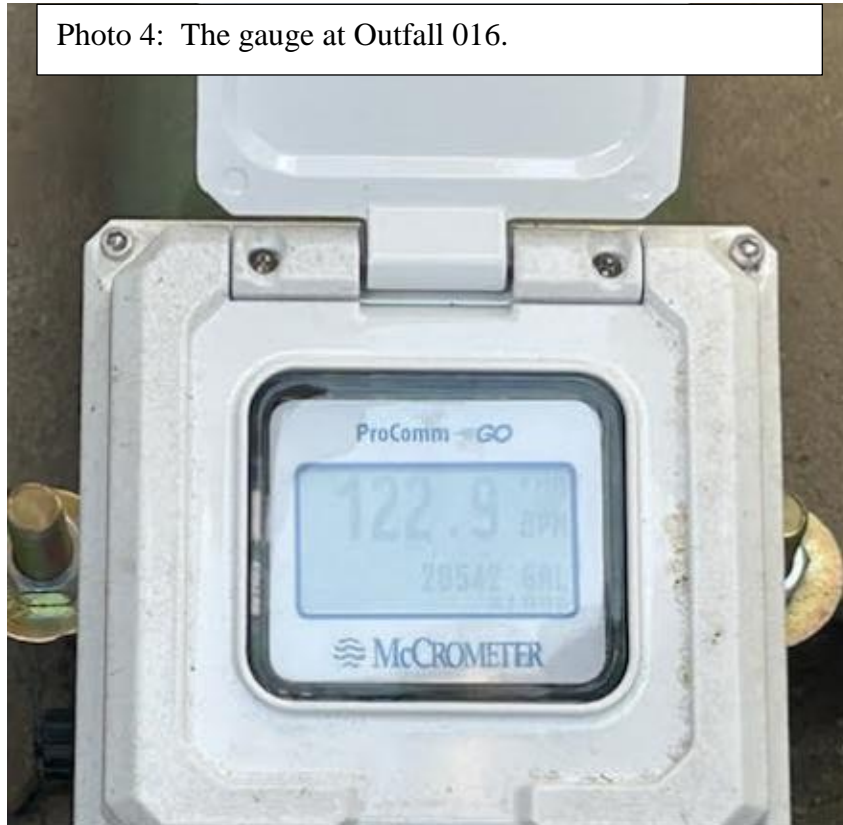
Discharge Monitoring Point 016 (outfall 016) is also located in the northeastern portion of the permit boundary. The outfall monitors discharge from the mine workings prior to entering the Colorado River. During the inspection the electronic gauge on the discharge outlet gave a reading of 122.9 gallons per minute (Photo 4). The reading was within the range of historical data obtained from the outfall. The outfall was stable with no erosional concerns. The discharge pipe was observed to be unobstructed.

Photo 4: The gauge at Outfall 016.

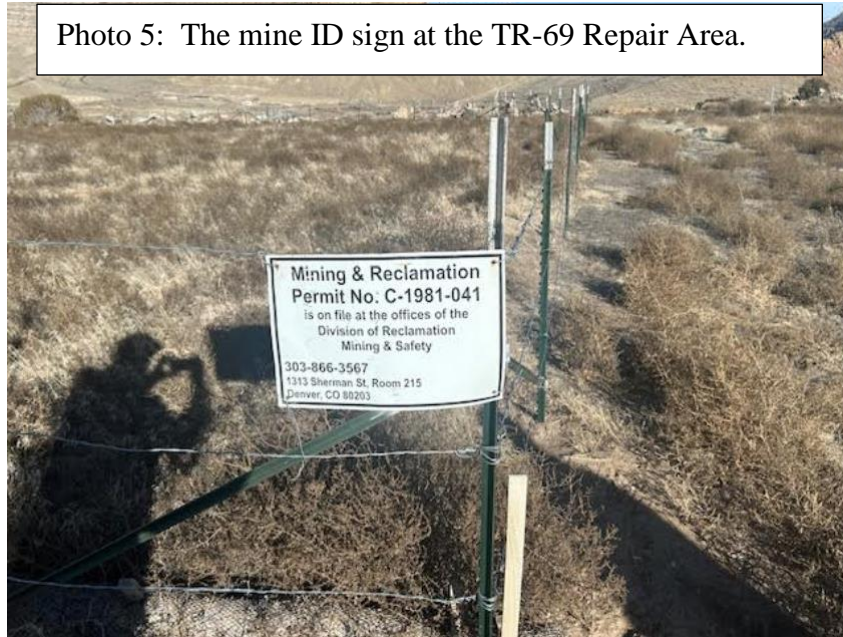
The remaining reclamation parcel at the Roadside Mine, referred to as the TR-69 Repair Area, is located in the northern portion of Tract 71. Which is within the western/northwestern portion of the permit boundary. The reclamation parcel is approximately 0.4 acres in size. There was a mine identification sign posted on the southeast corner of the reclamation parcel's fence (Photo 5). The mine ID sign was in good condition and posted in a clearly visible location. The perimeter fence for the TR-69 Repair Area was stable and in good condition. There are straw waddles located along the western portion of the reclamation parcel. The waddles were placed in this location to prevent excess sediment from leaving the disturbed area boundary. The straw waddles were intact and in good condition (Photo 6). There was no indication of sediment leaving the reclamation parcel. The reclaimed area was stable with no indications of erosional features (Photos 7 through 9). There were no observed signs of differential settling within the TR-69 Repair Area. Vegetation covered much of the parcel but was dormant for the winter season.

Photo 5: The mine ID sign at the TR-69 Repair Area.

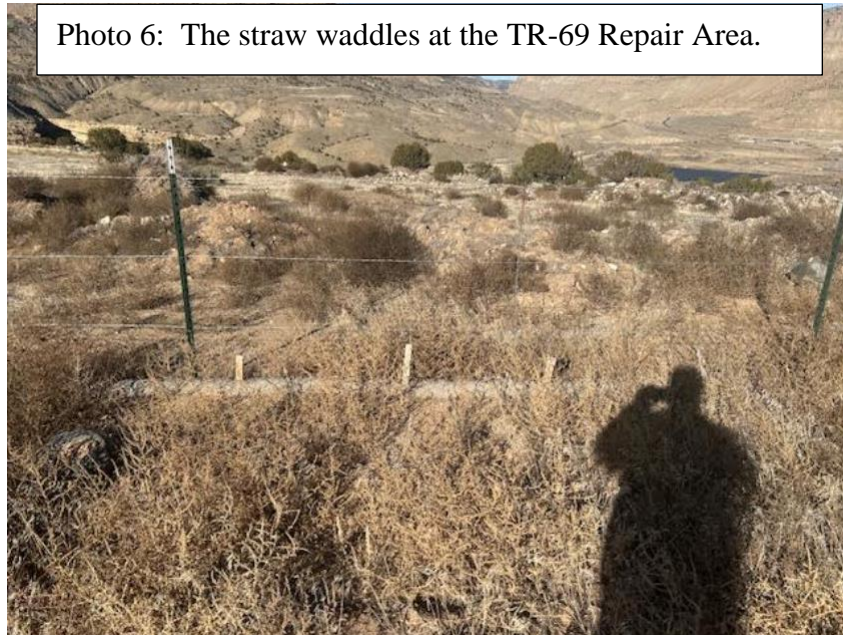
Photo 6: The straw waddles at the TR-69 Repair Area.

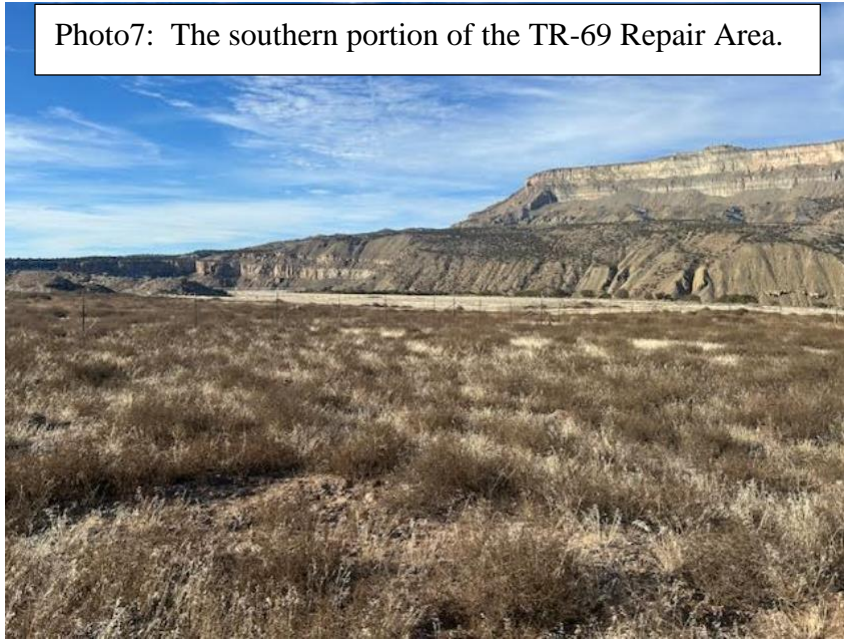
Photo7: The southern portion of the TR-69 Repair Area.

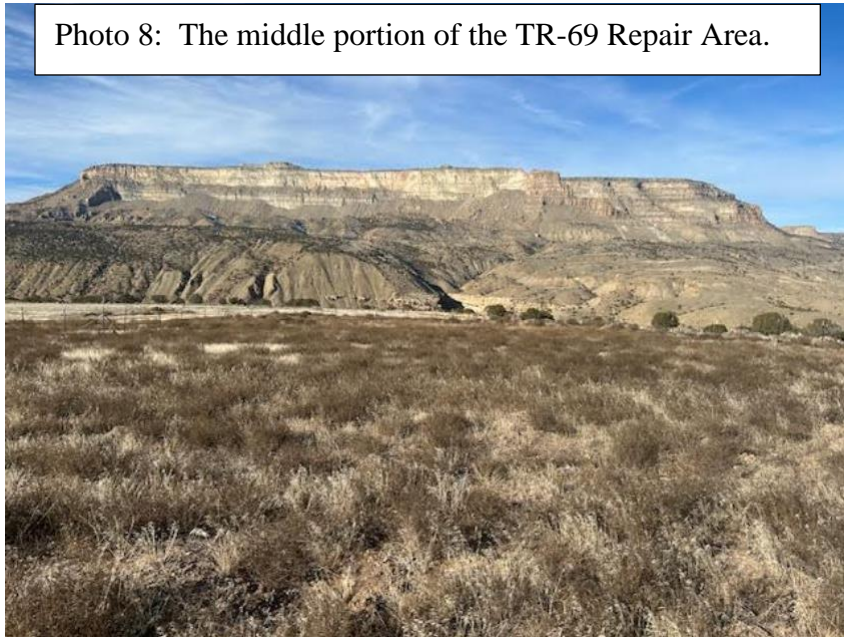
Photo 8: The middle portion of the TR-69 Repair Area.

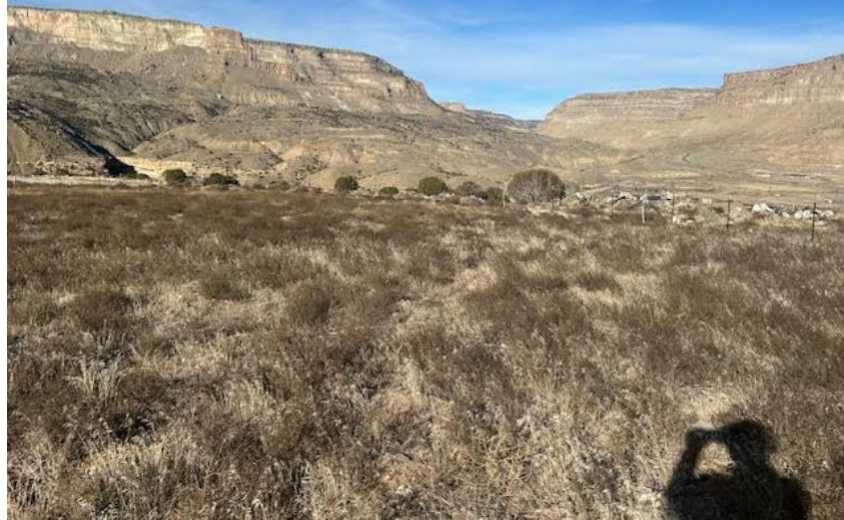
Photo 9: The northern portion of the TR-69 Repair Area.

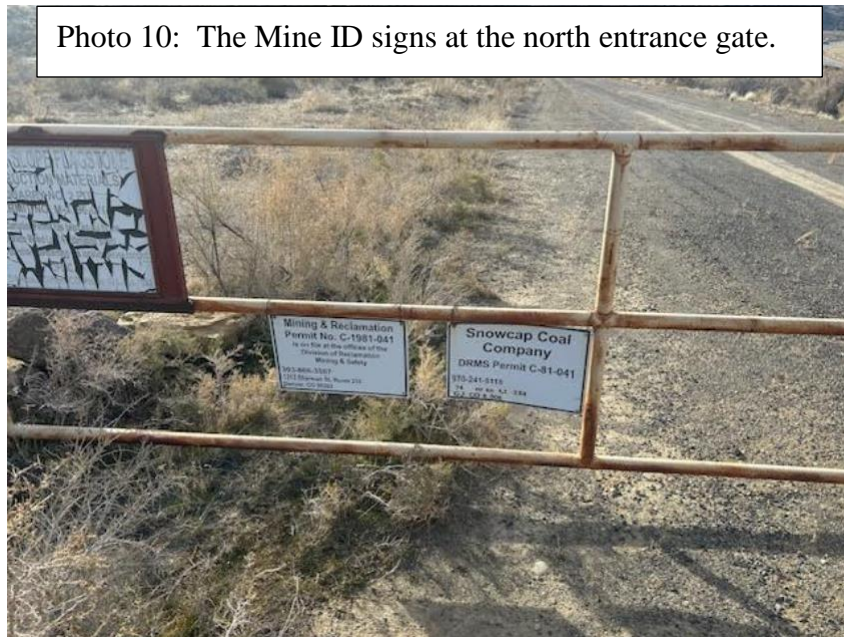
Mine identification signs were observed to be posted on the entrance to the permit boundary. The signs were placed on a locked gate at the northeastern entrance to the mine site (Photo 10). The signs were in good condition and posted in an easily viewable spot. Information including contact information for the permittee and the Division, as well as, the Mine's CDRMS permit number were posted on the signs.

Photo 10: The Mine ID signs at the north entrance gate.
