Inspection report for Keenesburg Strip Mine

PERMIT INFORMATION

Permit Number: C-1981-028 Mine Name: Keenesburg Strip Mine Operator: Coors Energy Company Operator Address: Mr. Ben Moline P.O. Box 4030 Golden, CO 80402	County: Weld Operation Type: Surface Permit Status: Permanent Cessation Ownership: Private
	Operator Representative Present: None
Operator Representative Signature: (Field Issuance Only)

INSPECTION INFORMATION

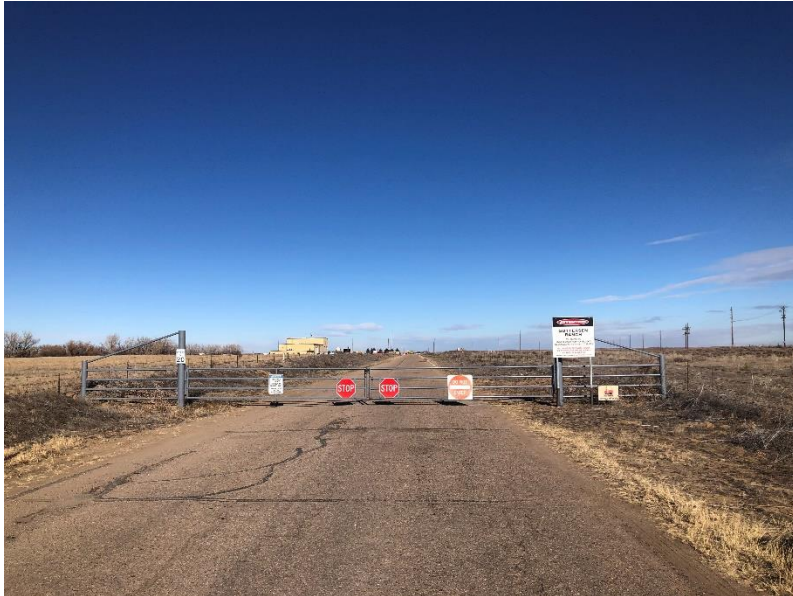
A partial inspection was conducted by Rob Zuber of DRMS on December 30, 2024. No Coors Energy Company (CEC) representative was present at the inspection, but Ben Moline of Coors Energy Company was contacted by telephone to discuss access issues at the site. The site was not accessible to the Division via the entrance road due to a locked gate on Weld County Road 59. Mr. Moline stated that he would discuss this with the landowner and then with the Division. The December 2024 inspection entailed walking the southeast corner of the site.

Locked gate on County Road 59

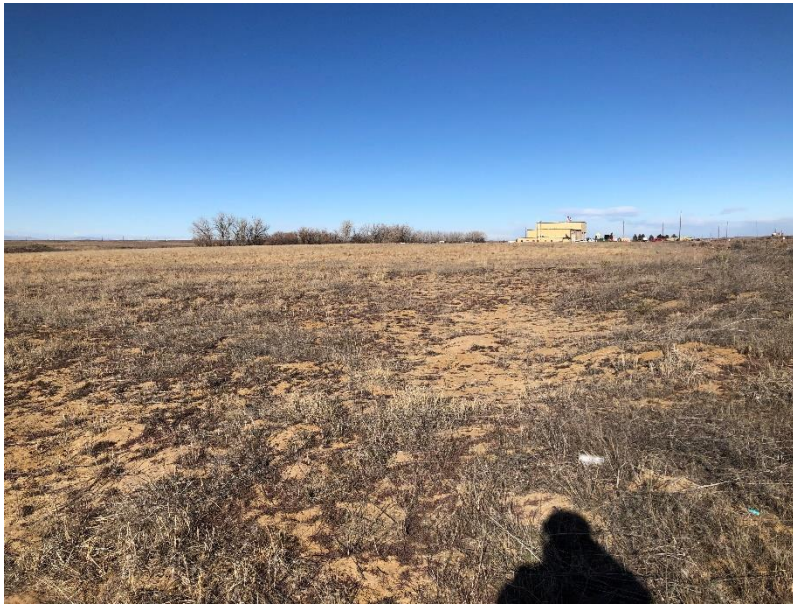
No erosion problems were seen on the parcels on the east side of the site, including Areas 34 and 38 (the southeast corner of the site), the reclaimed road by the dugout pond, Area 25, and Area 36 (observed from afar).

Looking northwest at Area 38

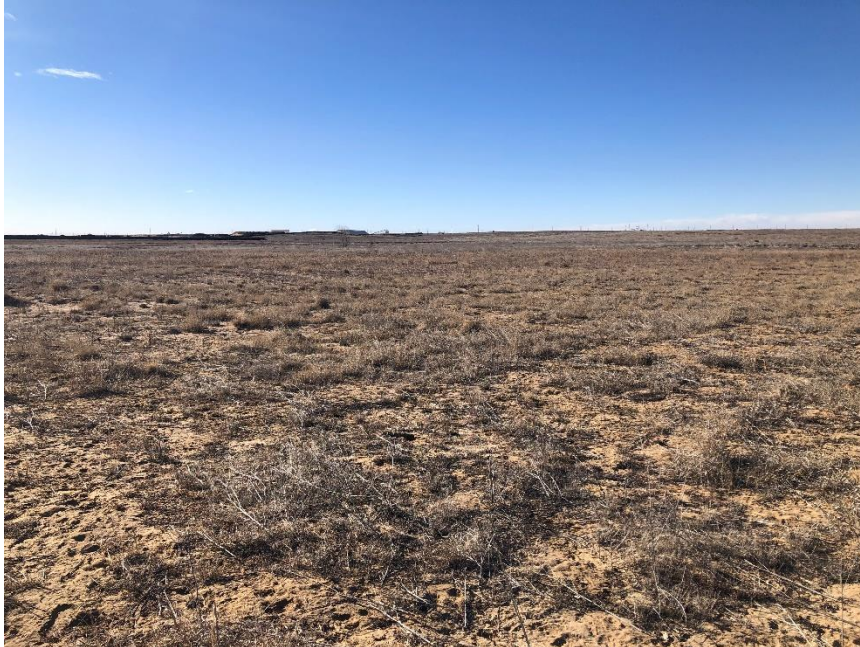
Looking southwest at Area 34

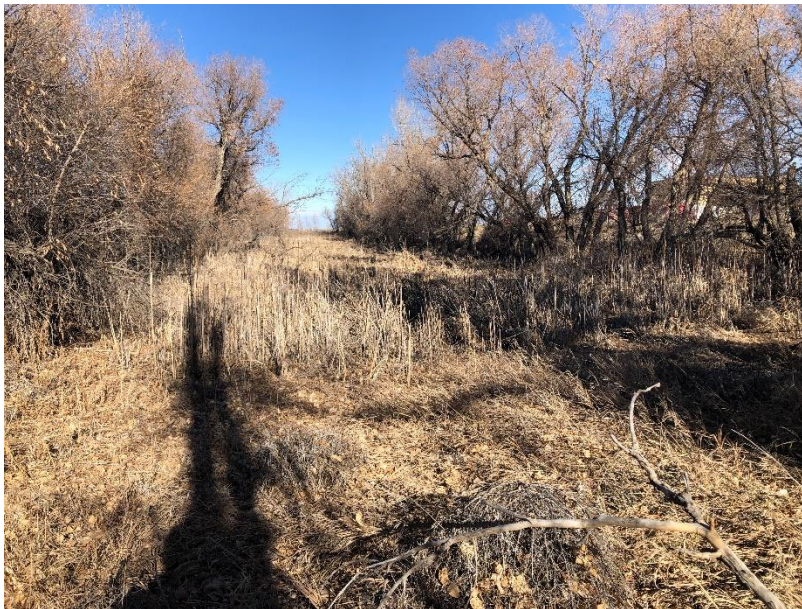
Several birds were seen at the Dugout Pond.

The Dugout Pond contained no visible water. No problems were observed.

Dugout Pond, looking north

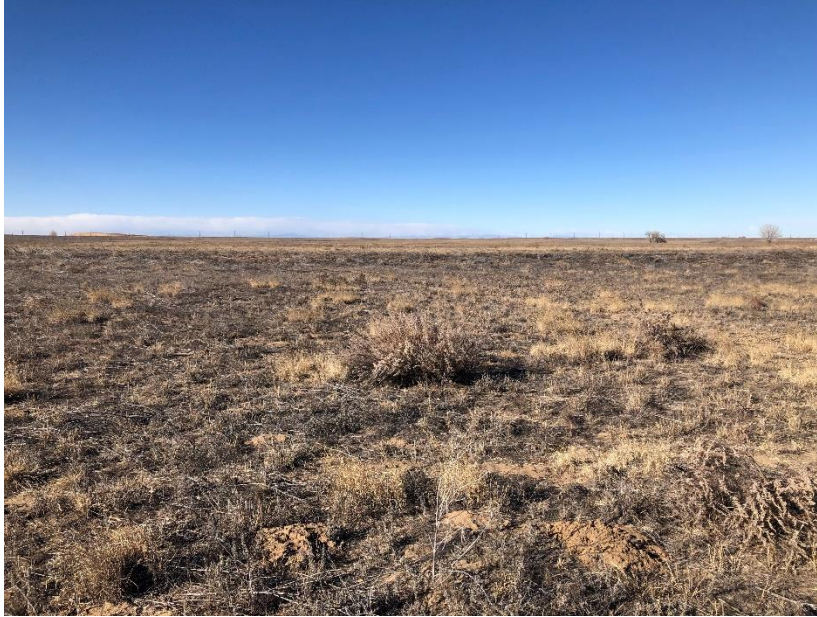
Looking west at Area 25 and areas beyond

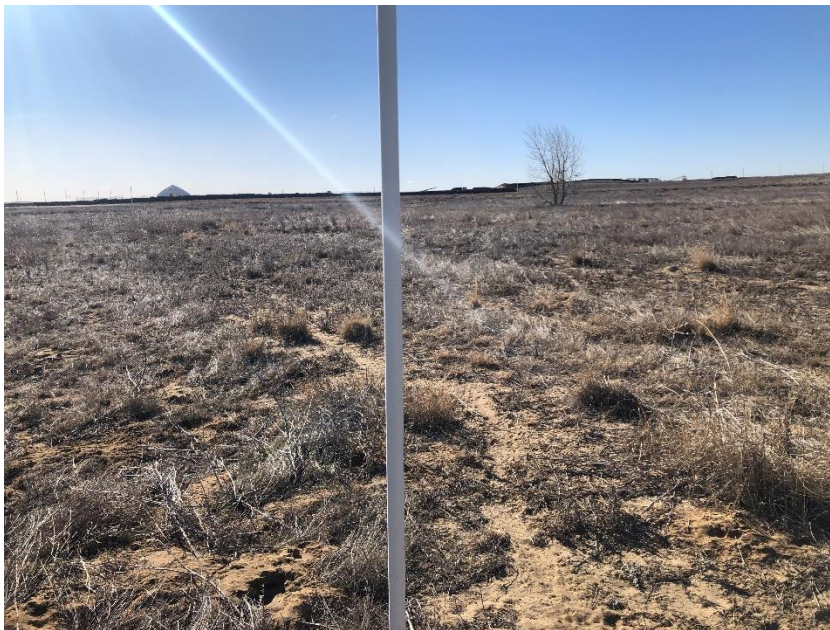
Boundary markers were observed at the southeast corner of the site, Area 34. The markers appeared to be in correct locations, as checked with GPS technology (Field Maps software on an iPhone). This includes the “peninsula” of the permit boundary that extends into Section 36 (Township 3 North, Range 64 West).

Boundary markers at south end of Area 34 (“peninsula” of boundary)
