## C-1981-008 New Horizon December 2024 Partial Inspection Report

**PERMIT INFORMATION**

<b>Permit Number:</b> C-1981-008 <b>Mine Name:</b> New Horizon Mine <b>Operator:</b> Elk Ridge Mining and Reclamation, LLC <b>Operator Address:</b> Mr Tony Tennyson P.O. Box 628 27646 West 5th Avenue Nucla, CO 81424	<b>County:</b> Montrose <b>Operation Type:</b> Surface <b>Permit Status:</b> Active <b>Ownership:</b> Private
	<b>Operator Representative Present:</b>  None
<b>Operator Representative Signature: (Field Issuance Only)</b>

<b>Inspection Start Date:</b> December 18, 2024 <b>Inspection Start Time:</b> 10:00 <b>Inspection End Date:</b> December 18, 2024 <b>Inspection End Time:</b> 10:42	<b>Inspection Type:</b> Coal Partial Inspection <b>Inspection Reason:</b> Normal I&E Program <b>Weather:</b> Clear
<b>Joint Inspection Agency:</b>  None	<b>Joint Inspection Contacts:</b>
<b>Post Inspection Agency:</b>  None	<b>Post Inspection Contacts:</b>
<b>Inspector(s):</b>  Lucas West	<b>Inspector's Signature:</b>

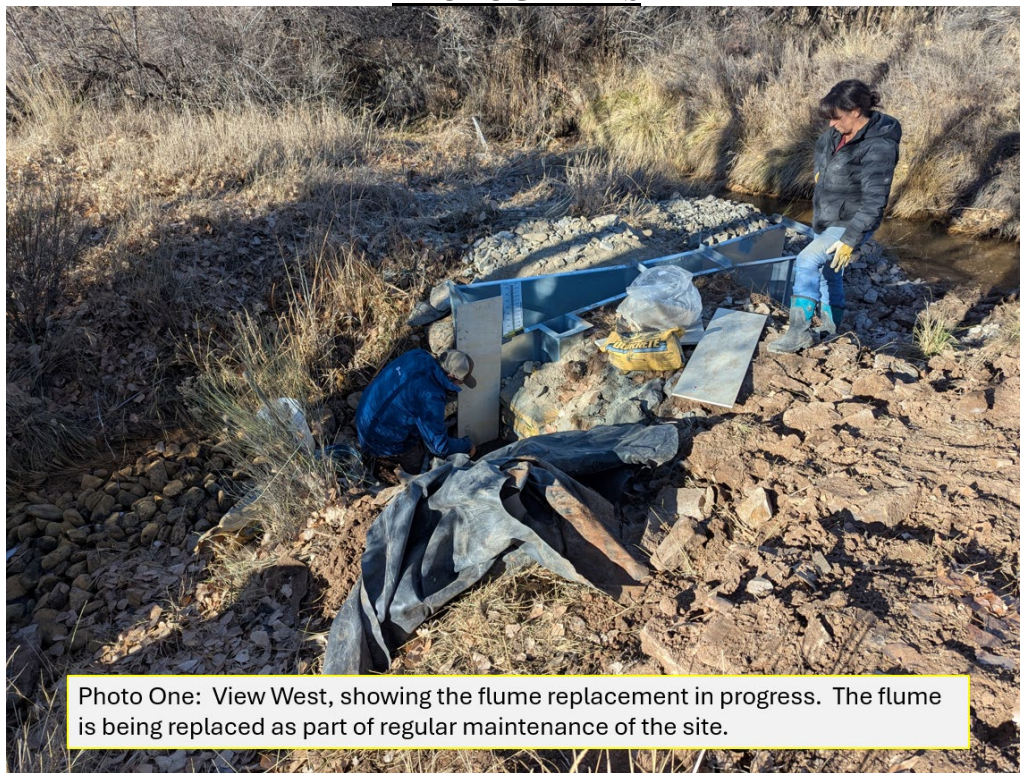
At the time of the inspection, activity was taking place at Pond 013. The activity taking place was a flume replacement for the outflow discharge from the pond. The replacement flume matches the exact size and specifications as the removed flume therefore not changing the details of the measurements. The flume replacement efforts can be seen in Photo One. To facilitate the flume replacement, the inflow pipes to Pond 013 had been closed, not allowing any water to enter the pond at the time of the replacement. The pipes were closed on December 16, 2024 and planned to be opened on December 20, 2024 once the replacement was complete. The remainder of the pond appeared to be stable and in good condition at the time of the inspection, as seen in Photo Two. Also, the rock lined drop structure on the Southeast side of the pond is also in good condition as seen in Photo Three. The drop structure was not flowing at the time of the inspection and showed no signs of recent flows.

Photo One: View West, showing the flume replacement in progress. The flume is being replaced as part of regular maintenance of the site.

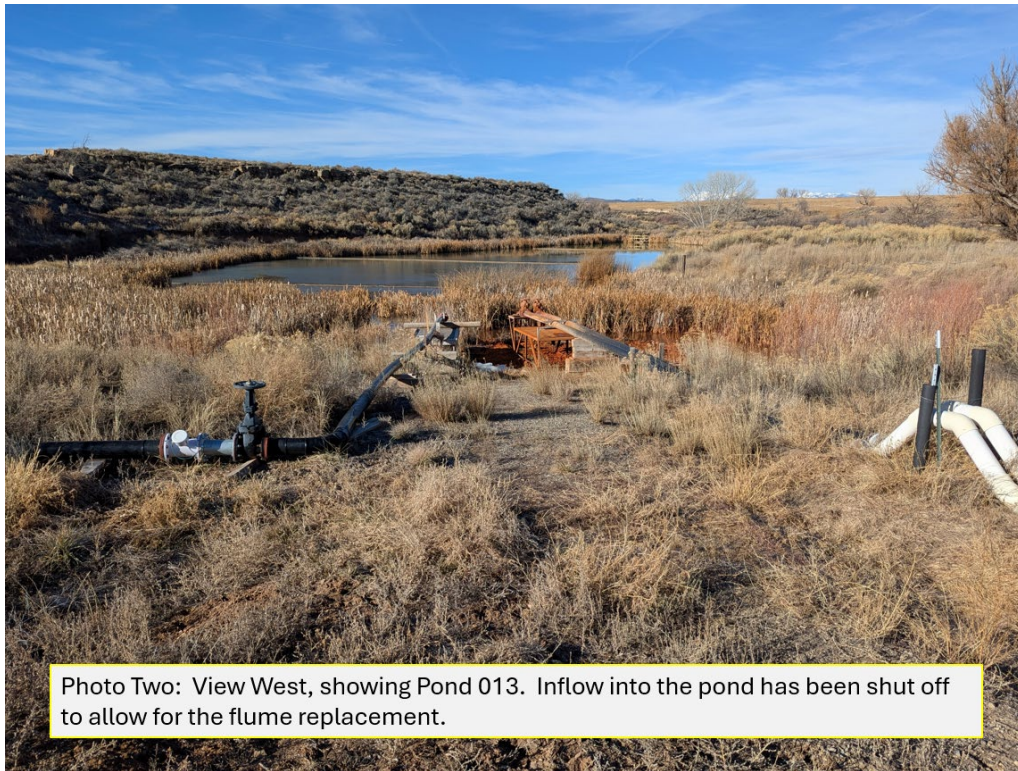
Photo Two: View West, showing Pond 013. Inflow into the pond has been shut off to allow for the flume replacement.

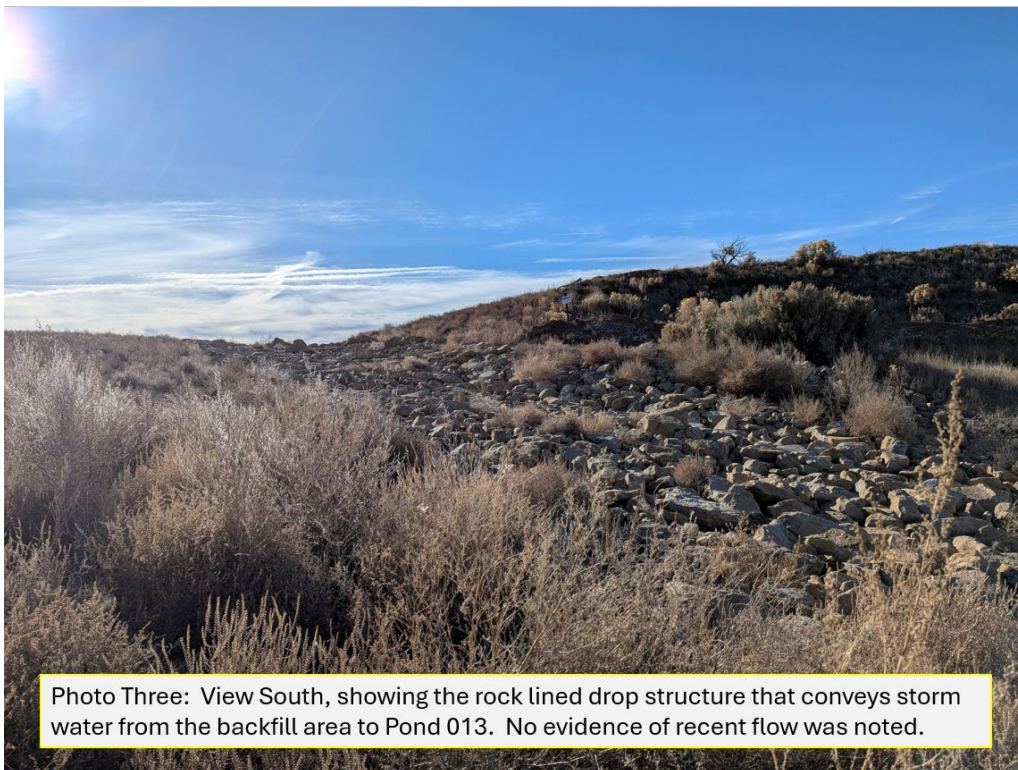
Photo Three: View South, showing the rock lined drop structure that conveys storm water from the backfill area to Pond 013. No evidence of recent flow was noted.

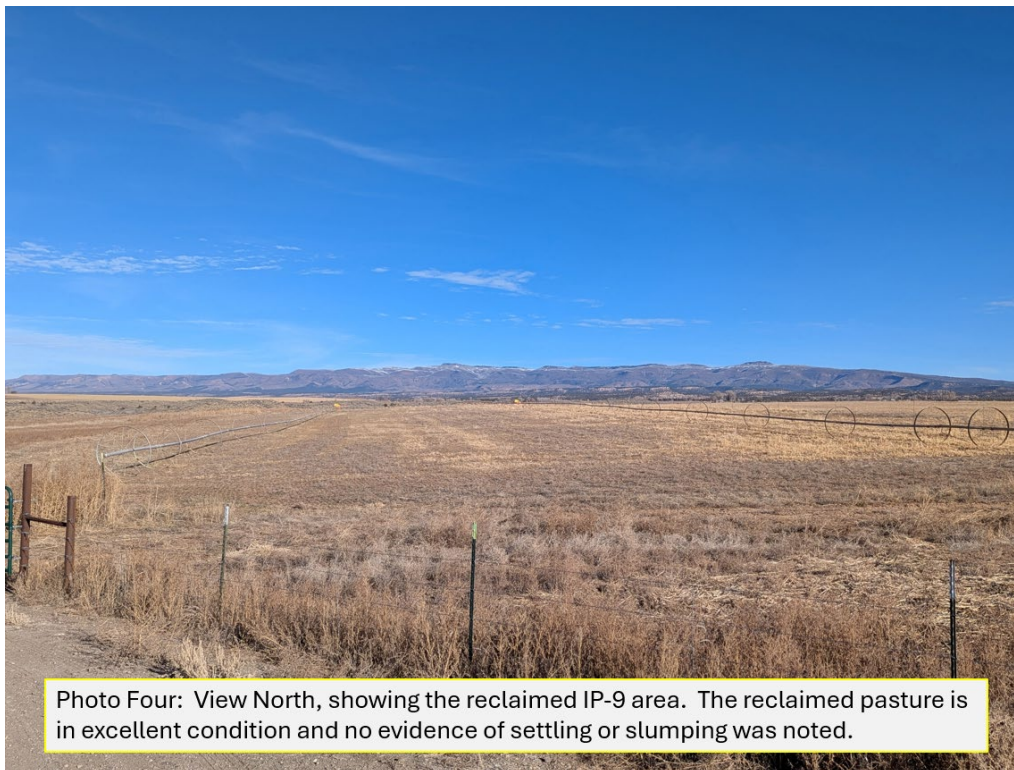
Adjacent to BB Road, near the Johnson Property Access Road the reclaimed parcels referred to as IP-11 and IP-9 were observed. The irrigated pastures are in excellent condition as seen in Photo Four. The fields are dormant for the winter, and no evidence of settling, slumping or erosion was noted.

Photo Four: View North, showing the reclaimed IP-9 area. The reclaimed pasture is in excellent condition and no evidence of settling or slumping was noted.

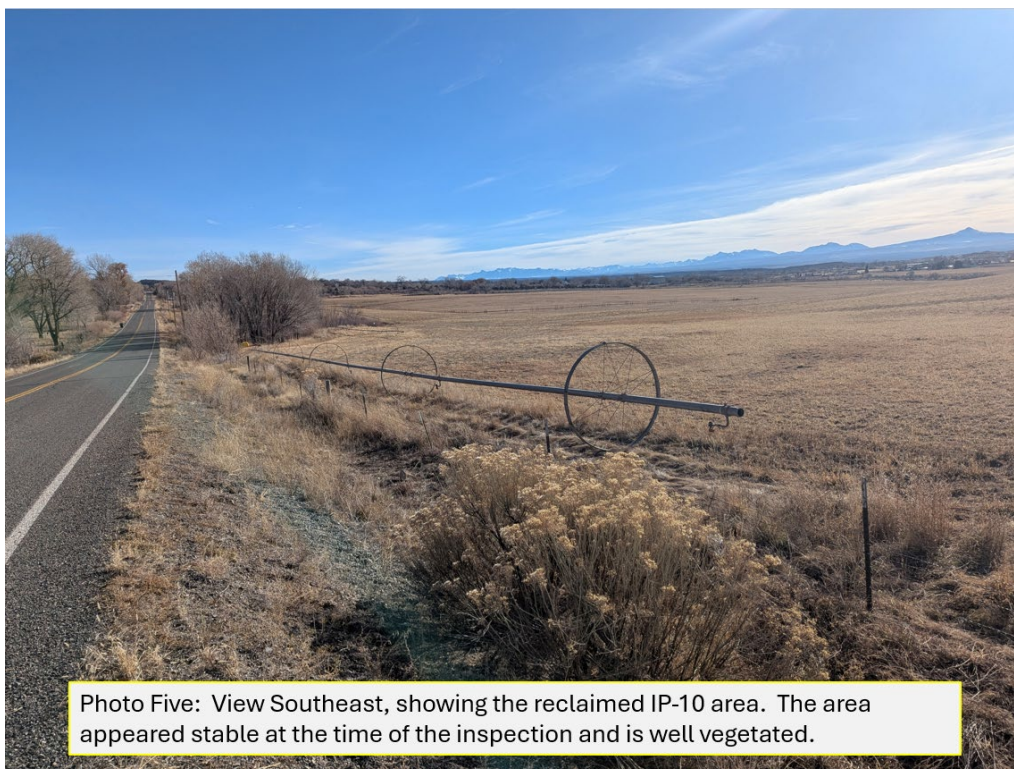
Additionally, the IP-10 area located just off BB road to the West of the BB and 2700 road intersection was observed to be in good condition. No settling or slumping was noted, and the vegetation is dense and stable at the time of the inspection. Examples of the IP-10 area can be seen in Photos Five and Six.

Photo Five: View Southeast, showing the reclaimed IP-10 area. The area appeared stable at the time of the inspection and is well vegetated.

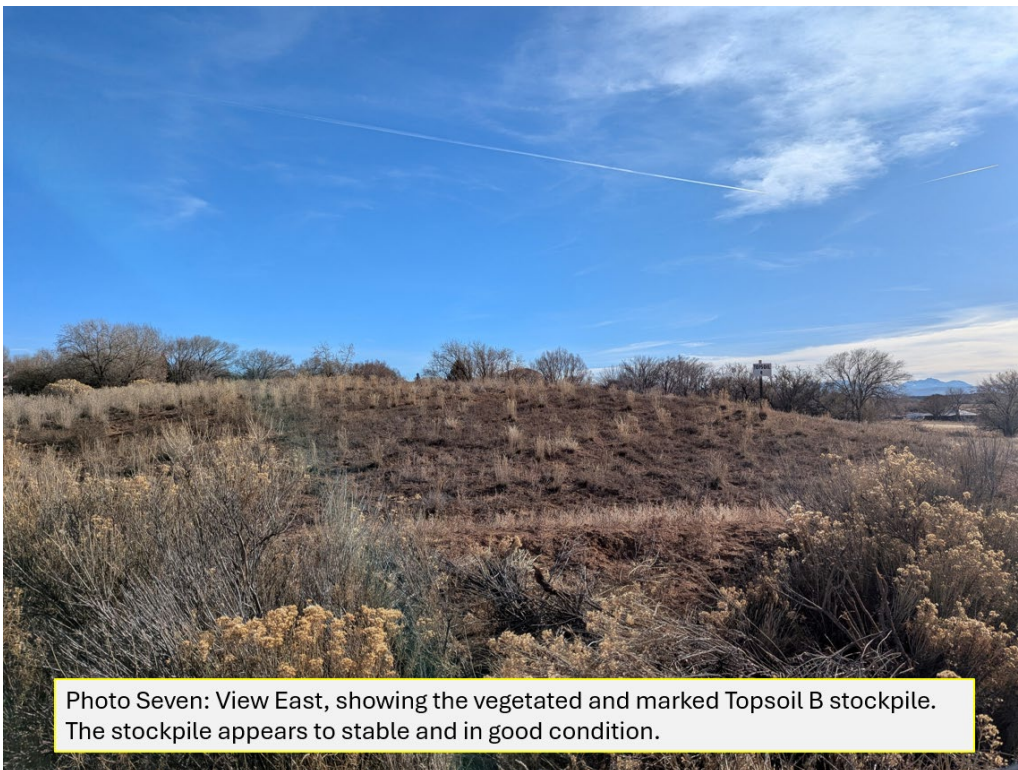
Also located at the facilities area are two topsoil stockpiles. Both topsoil stockpiles are in good condition, the Topsoil B stockpile is marked and well vegetated as evidenced in Photo Seven. Adjacent is the Topsoil Mixed stockpile that has had recent activity. The stockpile has had material removed for reclamation efforts and has been graded back to a stable configuration. The stockpile can be seen in Photo Eight.
