MINERALS PROGRAM INSPECTION REPORT
PHONE: (303) 866-3567

MINE NAME: Climax Mine	MINE/PROSPECTING ID#: M-1977-493	MINERAL: Molybdenum	COUNTY: Lake, Summit
INSPECTION TYPE: Aerial Inspection	INSPECTOR(S): Dustin Czapla / Brock Bowles	INSP. DATE: December 18, 2024	INSP. TIME: 10:30
OPERATOR: Climax Molybdenum Company	OPERATOR REPRESENTATIVE: NA	TYPE OF OPERATION: 112d-3 - Designated Mining Operation	
REASON FOR INSPECTION: Normal I&E Program	BOND CALCULATION TYPE: None	BOND AMOUNT: \$91,011,850.00	
DATE OF COMPLAINT: NA	POST INSP. CONTACTS: None	JOINT INSP. AGENCY: None	
WEATHER: Clear	INSPECTOR'S SIGNATURE:

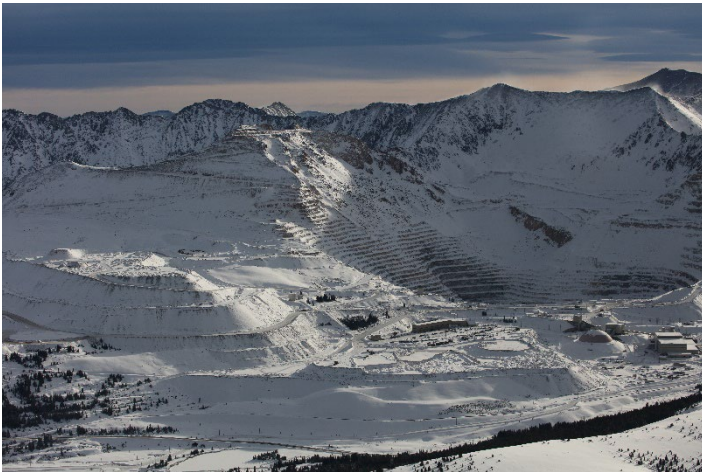
The Pit area was observed. Operations appear to be occurring according to approved plans. No problems were noted.

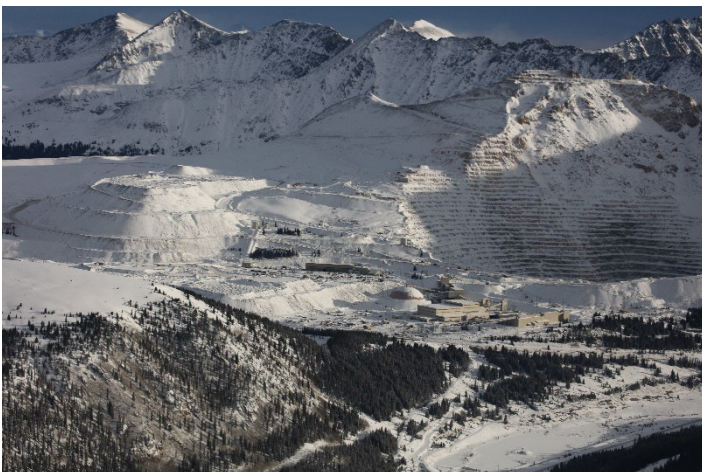
North 40 and McNulty OSF

The North 40 and McNulty OSF's were observed. No abnormal conditions were noted. OSF's appear to be functioning within the established design criteria.

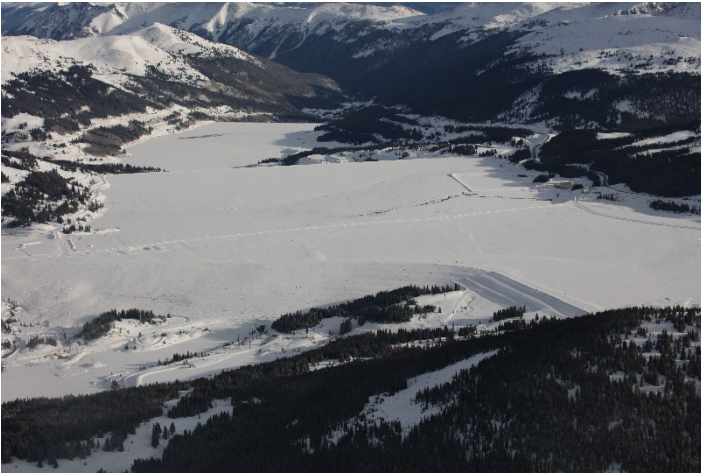
Robinson TSF/1 Dam

The Mayflower TSF and 5 Dam, Tenmile TSF and 3 Dam, Robinson TSF and 1 and 2 Dams, Robinson Lake, Eagle Park Reservoir and 4 Dam were observed. No abnormal conditions were noted. TSF's appear to be functioning within the established design criteria.
