MINERALS PROGRAM INSPECTION REPORT
PHONE: (303) 866-3567

MINE NAME: Bivens Pit	MINE/PROSPECTING ID#: M-1985-184	MINERAL: Sand and gravel	COUNTY: Larimer
INSPECTION TYPE: Monitoring	WEATHER: Clear	INSP. DATE: December 3, 2024	INSP. TIME: 11:00
OPERATOR: Bivens Trucking & Excavating, Inc.	OPERATOR REPRESENTATIVE: Aaron Bivens	TYPE OF OPERATION: 112c - Construction Regular Operation	
REASON FOR INSPECTION: Normal I&E Program	BOND CALCULATION TYPE:	BOND AMOUNT: \$40,000.00	
DATE OF COMPLAINT: NA	POST INSP. CONTACTS: None	JOINT INSP. AGENCY: None	
INSPECTOR(S): Joel Renfro	INSPECTOR'S SIGNATURE:

The Bivens Pit was inspected by Joel Renfro with the Division of Reclamation, Mining and Safety (DRMS/Division) on December 3, 2024 as a part of the Divisions regular monitoring program. Aaron Bivens with Bivens Trucking & Excavating, Inc. was present during the inspection. The Bivens Pit is located about 1.5 miles northwest of Fort Collins, CO in Larimer County. Access to this site is from the south of Willox Lane. The weather was clear at the time of inspection. **Photos 1-10** are included with this report.

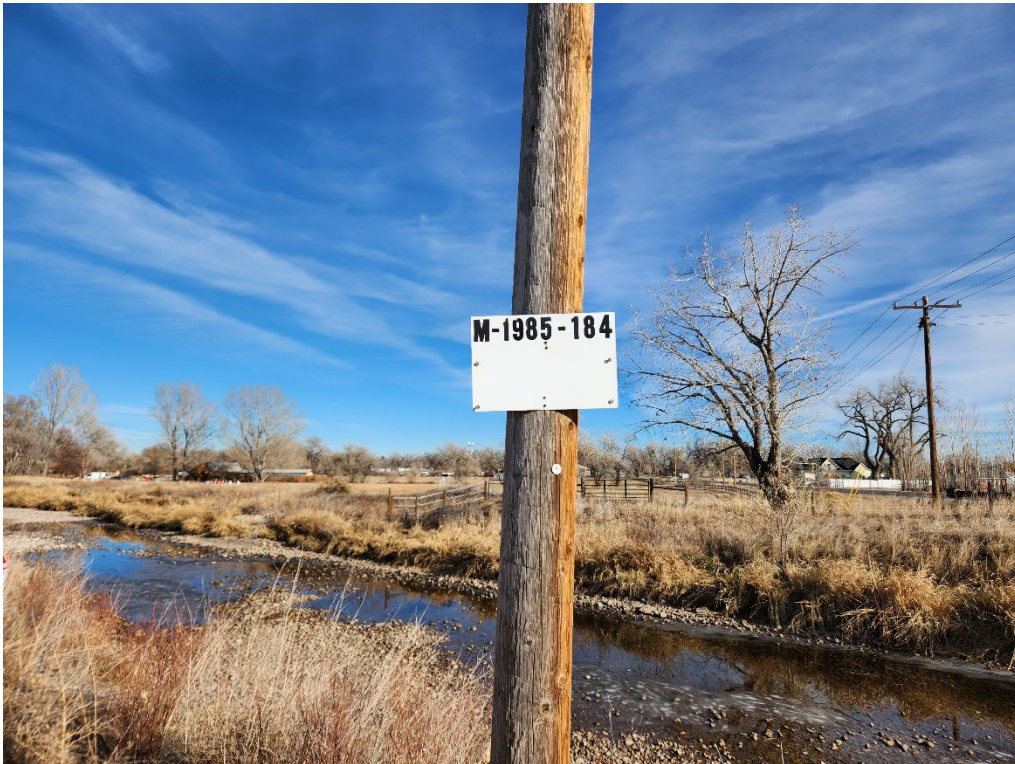
The operator was informed on-site that they would need to replace the current mine entrance sign which is in compliance with Rule 3.1.12 Signs and Markers, which they did the following week. Attached is an image of the new sign that the operator put up before this inspection report went out.

Photo 1. Mine entrance sign, which has been replaced since the inspection, looking north.

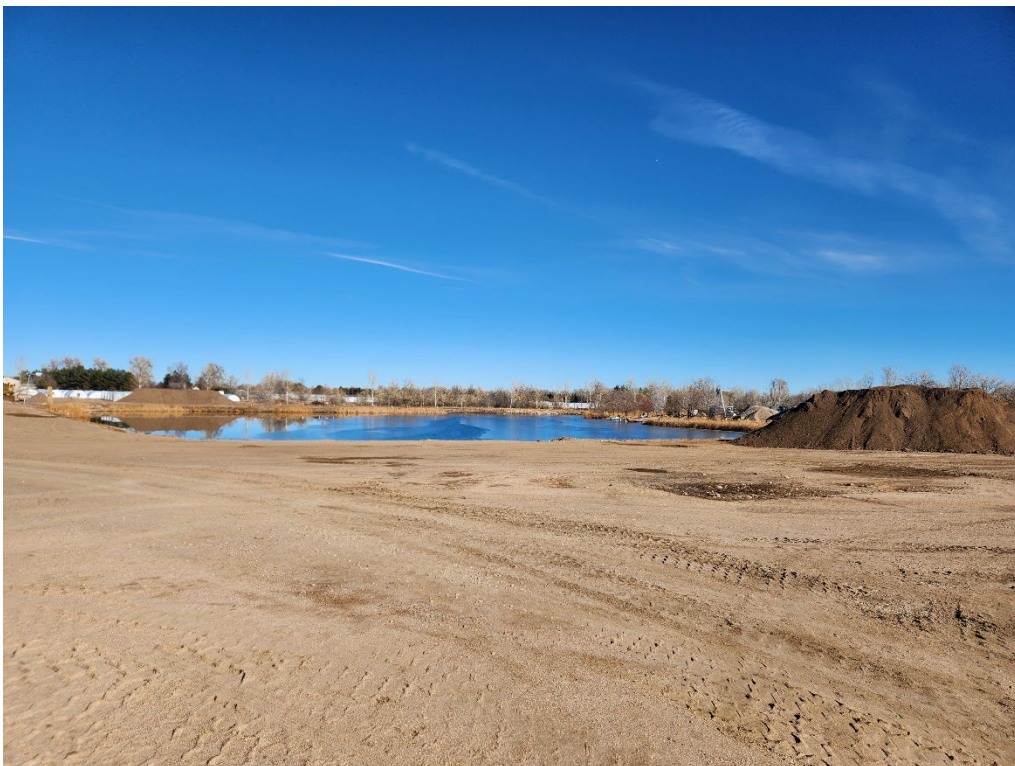
The operator wishes to expand their pit and mine out about 1.3 acres south of the pond. However, in order to effectively mine this out they will need to dewater the area. There are no active dewatering permits for this operation, but the operator expressed interest in obtaining one. They are aware that a permit needs to be obtained with the Colorado Department of Public Health and Environment (CDPHE) and that they cannot dewater until one is obtained.

Photo 2. Area south of the pond that may still be mined, looking north.

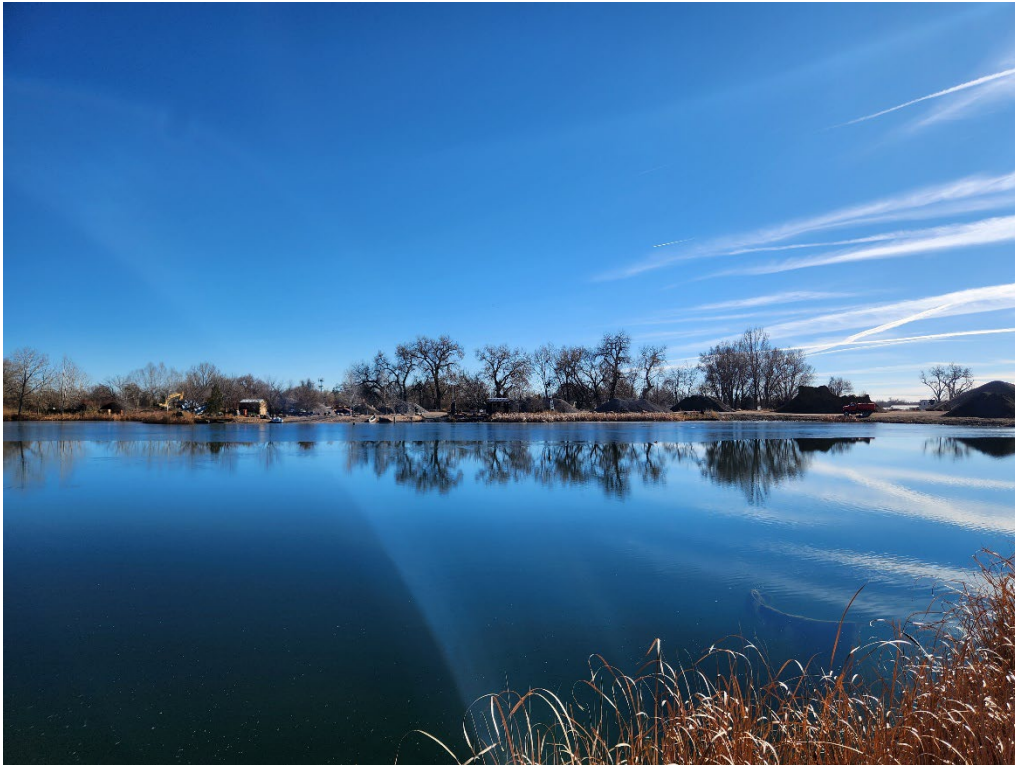
Photo 3. Pond on site, looking east.

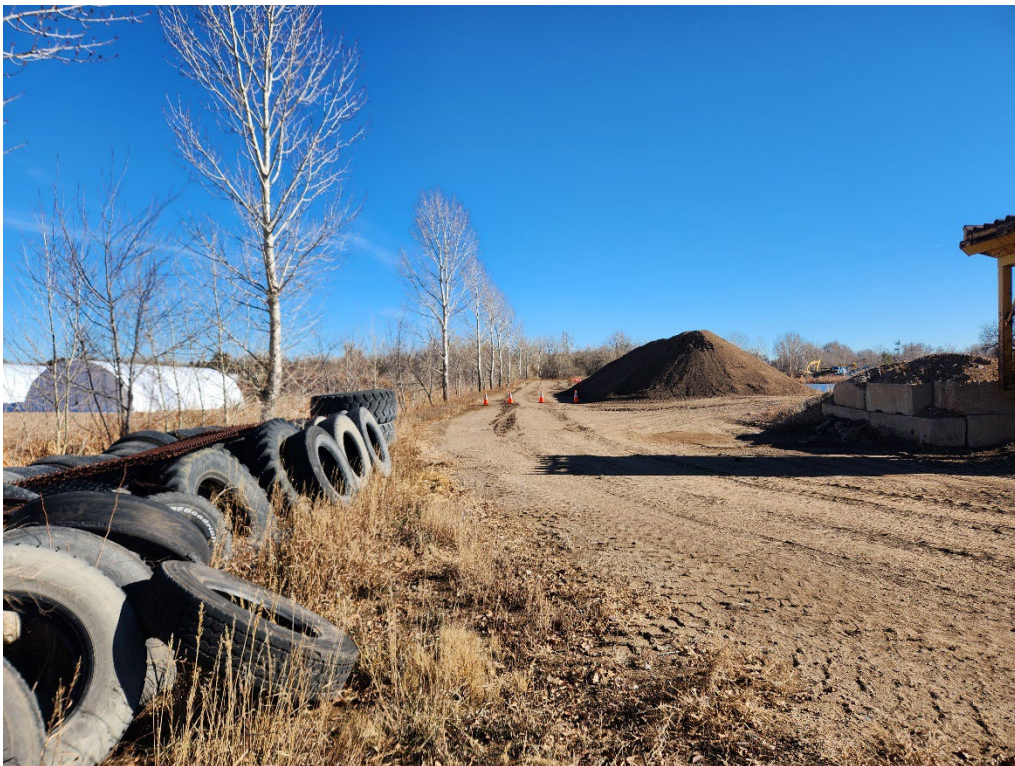
Photo 4. Site access road in the northwest corner, looking east.

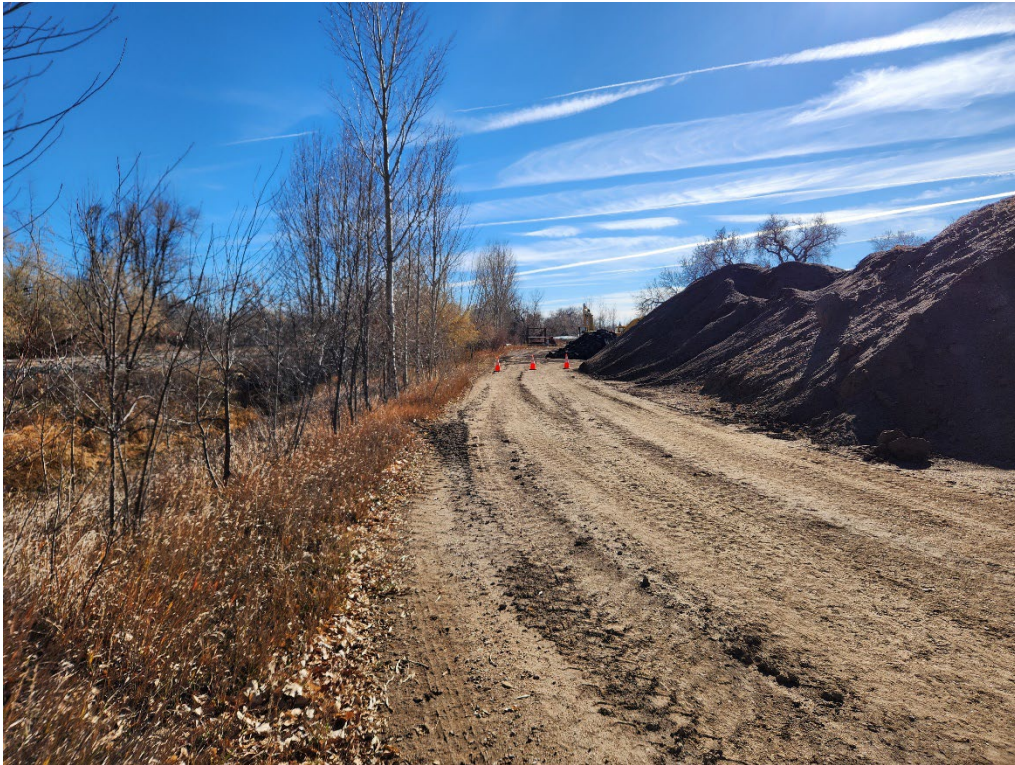
Photo 5. Access road in the east of the site, material stockpiles to the right, looking south.

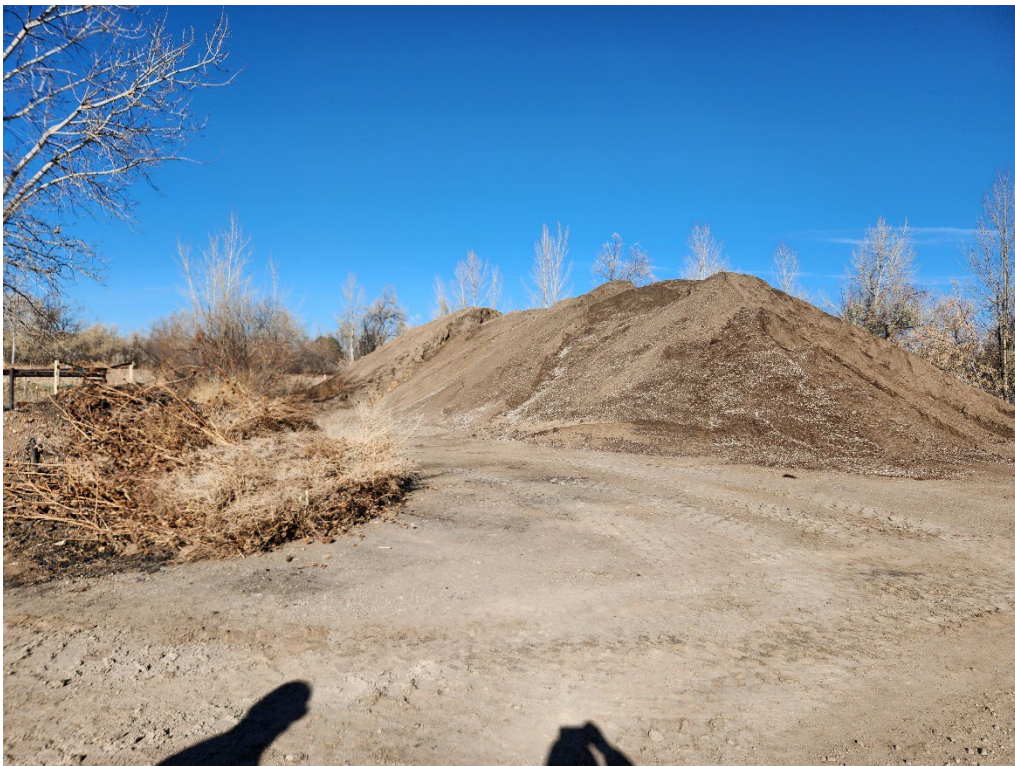
Photo 6. Topsoil stockpile, looking northwest.

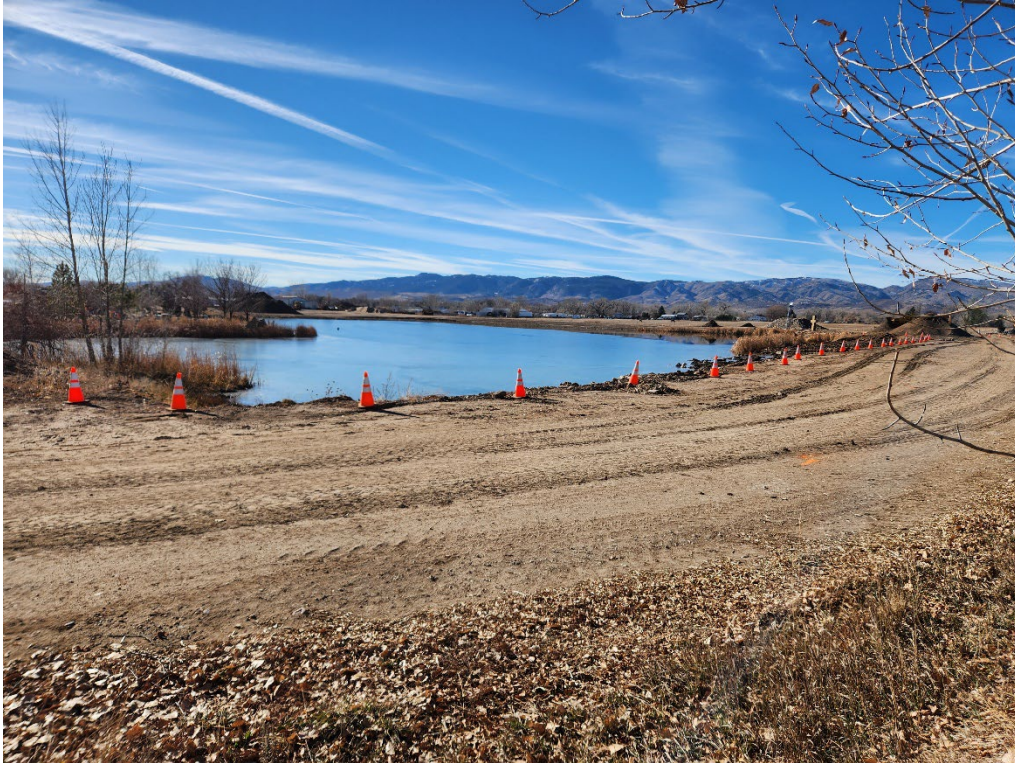
Photo 7. The northern area of the pond that will be backfilled and graded, looking southwest.

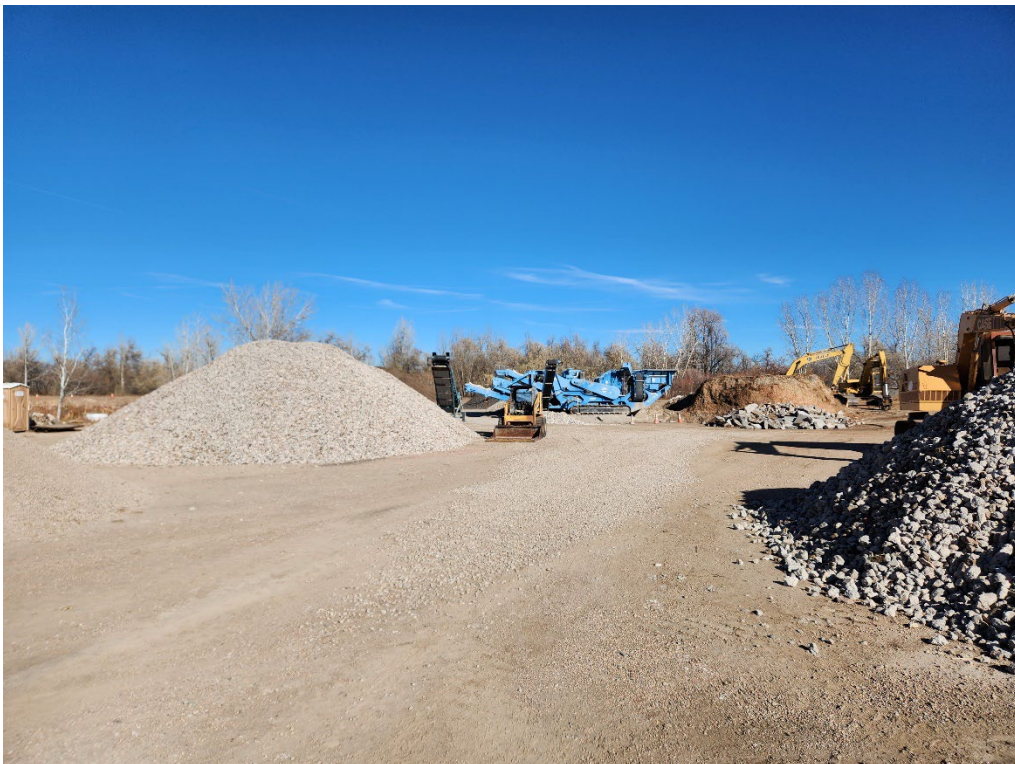
Photo 8. Material stockpiles in the eastern portion of the site, looking north.

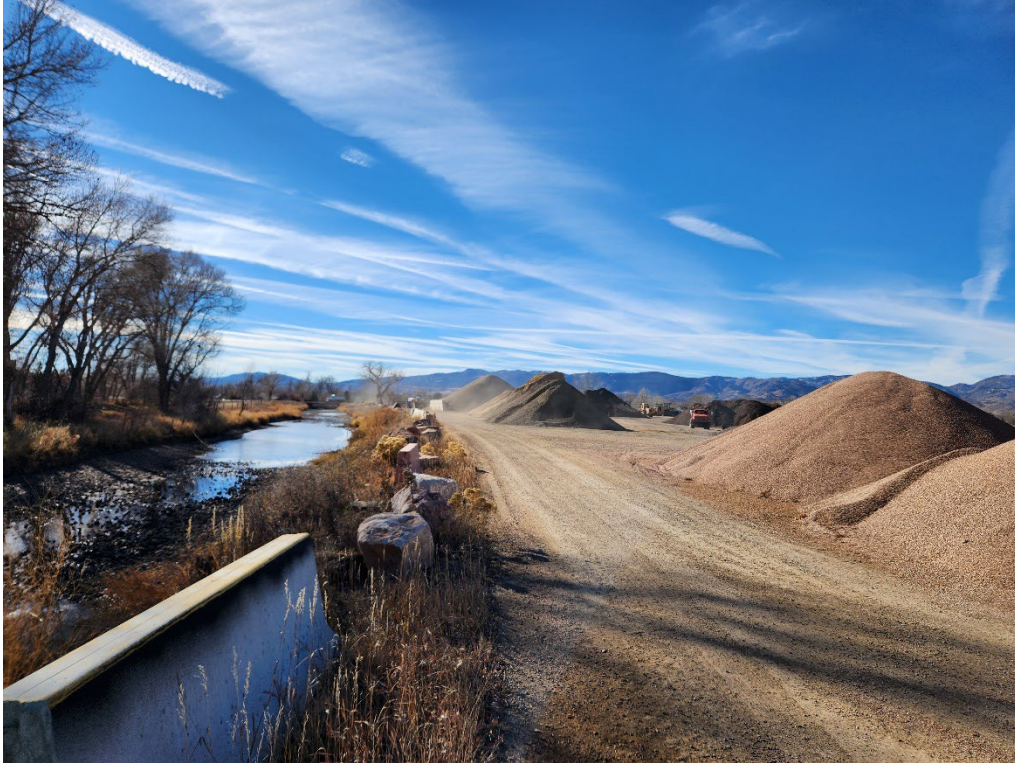
Photo 9. Eastern edge of the site, looking south.

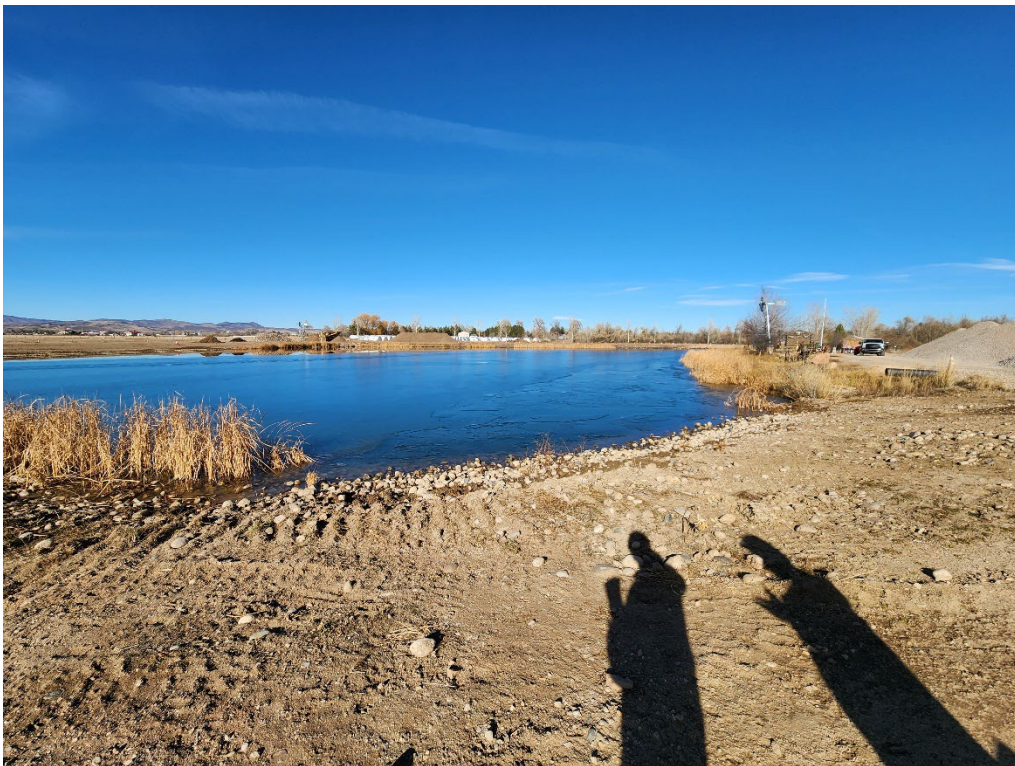
Photo 10. Southeastern corner of the pond, looking north.
