MINERALS PROGRAM INSPECTION REPORT
PHONE: (303) 866-3567

MINE NAME: Siloam Mine	MINE/PROSPECTING ID#: M-1977-326	MINERAL: Clay (general) and ag	COUNTY: Pueblo
INSPECTION TYPE: Monitoring	WEATHER: Clear	INSP. DATE: December 5, 2024	INSP. TIME: 12:45
OPERATOR: General Shale Brick, Inc.	OPERATOR REPRESENTATIVE: Mr. Jason McGraw	TYPE OF OPERATION: 110c - Construction Limited Impact	
REASON FOR INSPECTION: Normal I&E Program	BOND CALCULATION TYPE: Complete Bond	BOND AMOUNT: \$28,000.00	
DATE OF COMPLAINT: NA	POST INSP. CONTACTS: None	JOINT INSP. AGENCY: None	
INSPECTOR(S): Jocelyn Carter Ursula Armstrong	INSPECTOR'S SIGNATURE:

The inspection of the Siloam Mine, Permit No. M-1977-326, was conducted by Jocelyn Carter and Ursula Armstrong on behalf of the Division of Reclamation, Mining, and Safety (Division/DRMS). Siloam Mine is operated by General Shale Brick, Inc. and Jason McGraw was present for the inspection. The inspection took place during the afternoon and the weather was clear with cool temperatures and some snow on the ground.

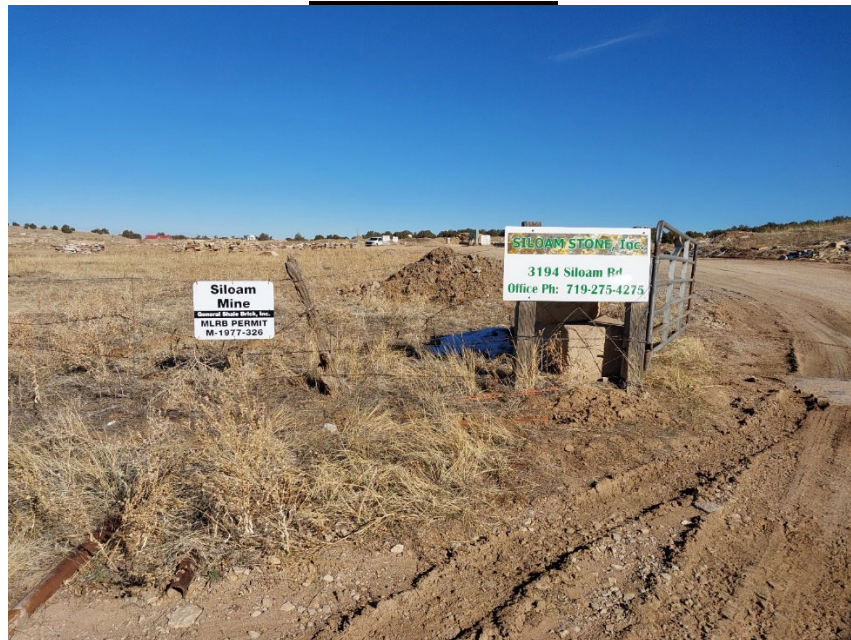
There is a sign at the entrance of the mine site that meets the requirements of Rule 3.1.12(1), see Photo #1.

Photo #1: Mine sign in accordance with Rule 3.1.12(1).

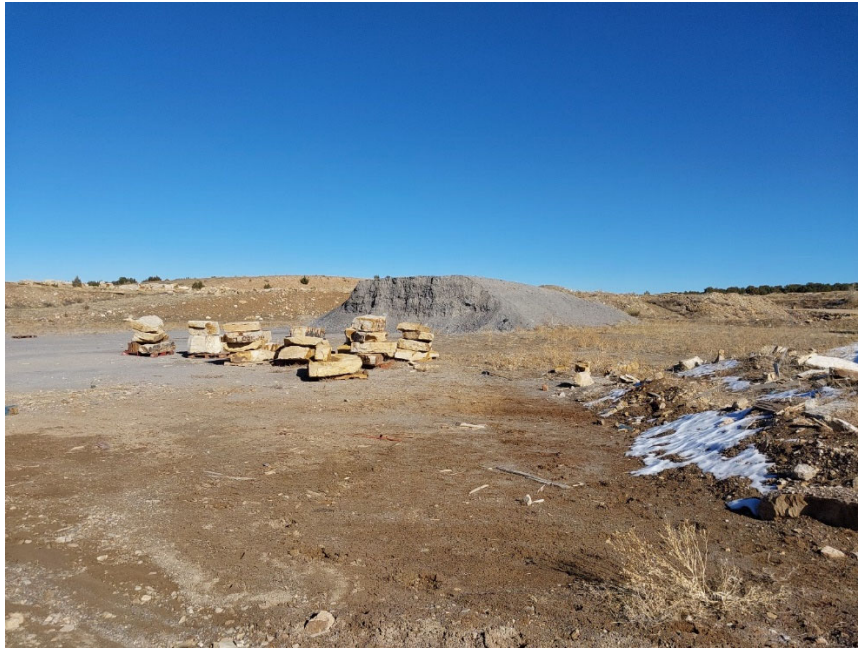
Photo #2: Product stockpile, the grey clay, viewed from the west looking east.

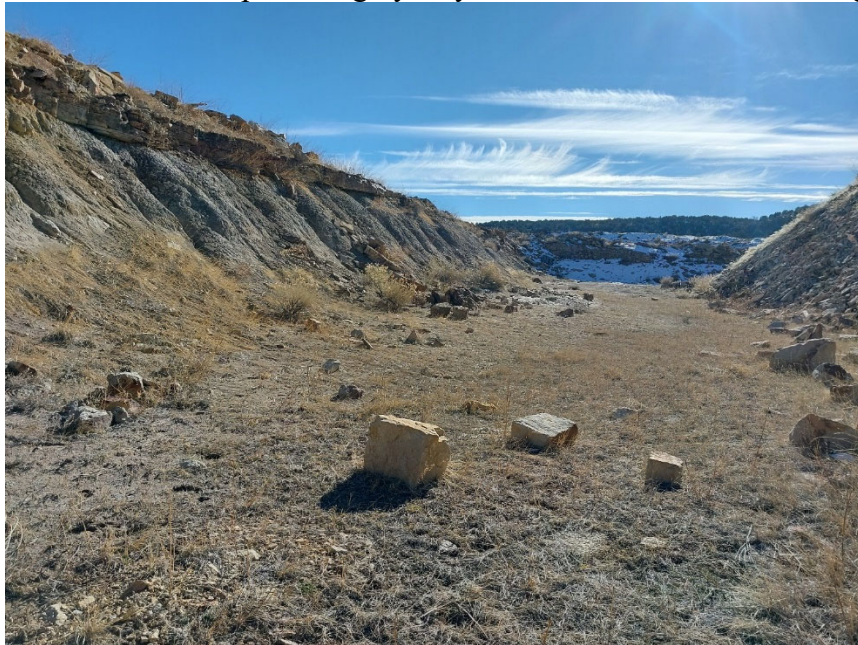
Photo #3: Highwall seen on the left side of the photo, photo taken from the pit floor looking southwest.

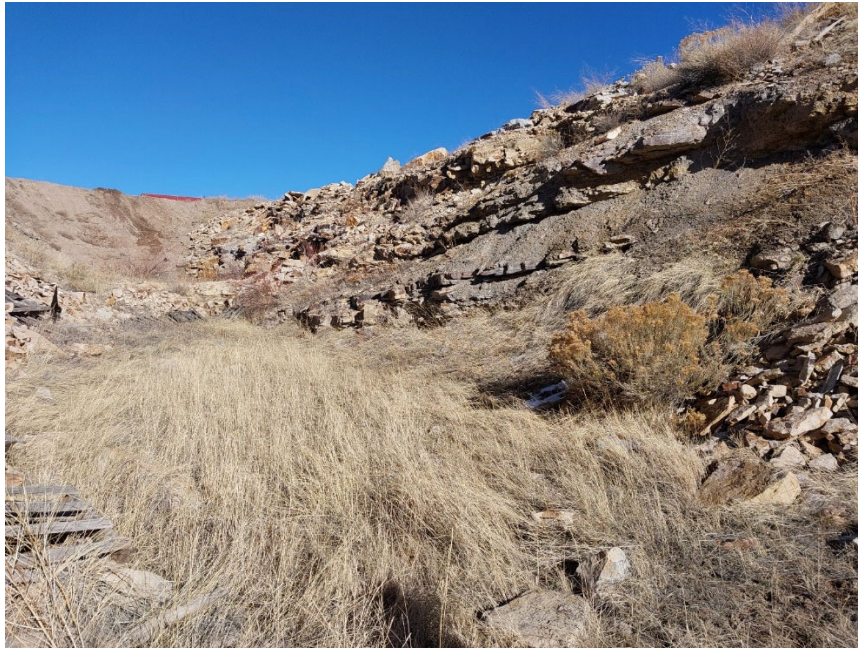
Photo #4: Highwall seen on the right side of the photo, photo taken from the pit floor looking northeast.

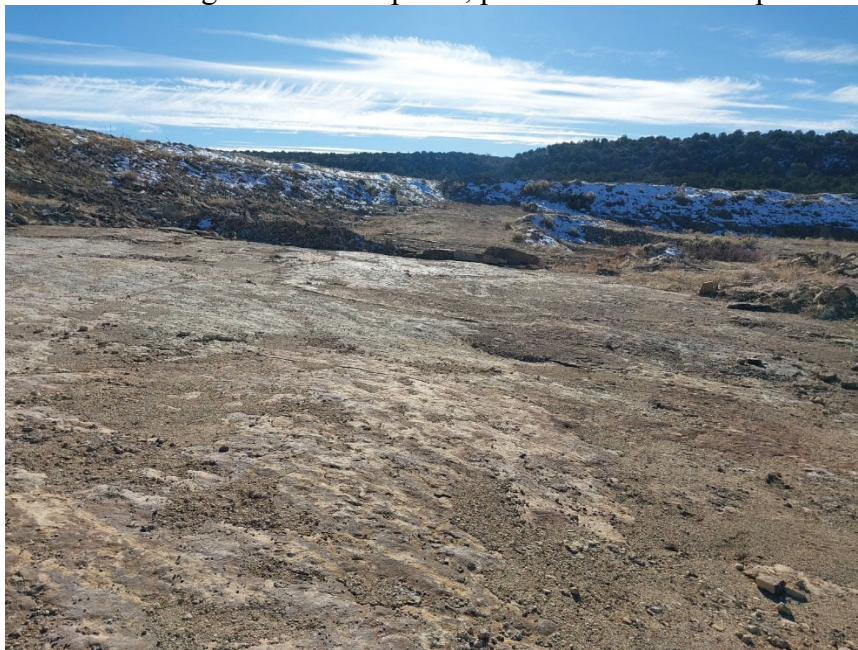
Photo #5: View above the working highwall for this permit, standing on the capstone layer. Looking to the southwest, the highwall seen in this photo is attributed to disturbance from the Bedrock Mine #1 operation.

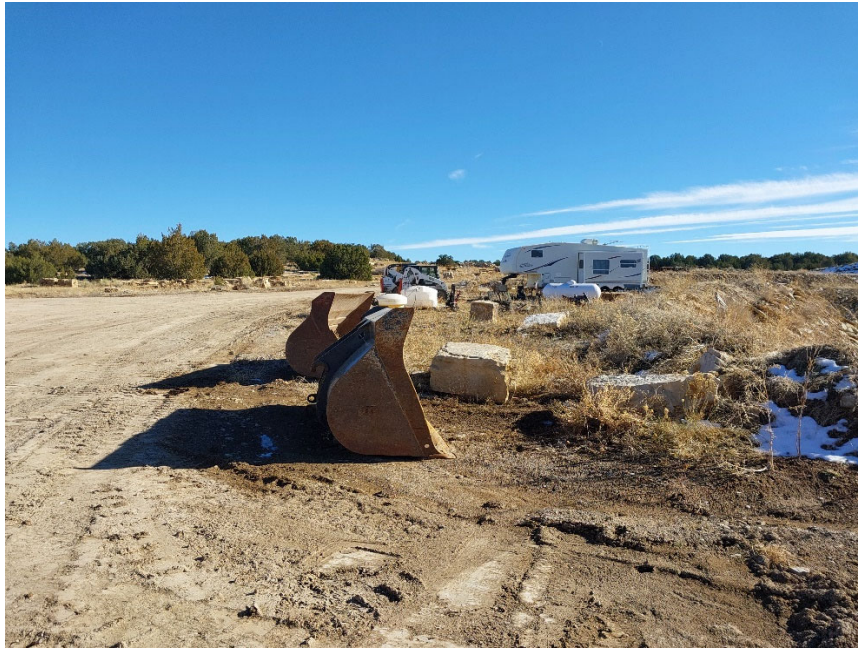
Photo #6: Equipment located on the northeast section of the permitted area; looking to the southeast.

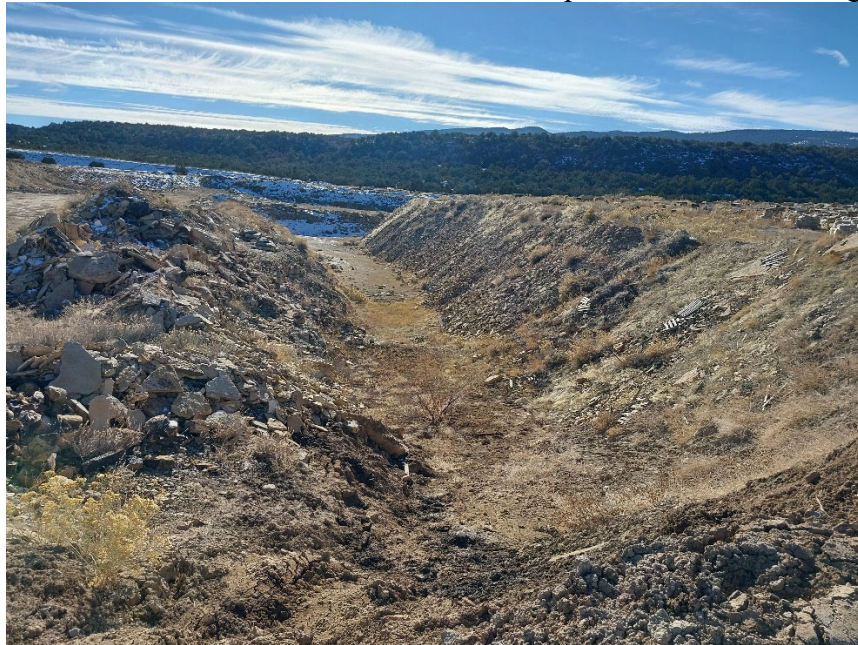
Photo #7: From the northern section of the permit area looking to the south-southwest. The bedrock Mine #1 highwall, the capstone layer above the gray clay, the Siloam Mine highwall, and the pit floor can be seen on the left side of the photo. On the right side of the photo, the area above the pit floor is used for storage of product material for the other two mines operated by Siloam Stone, Inc.
