Lorencito Canyon Mine C-1996-084, December 2024 Inspection Report

Division of Reclamation,
Mining and Safety

Permit Number: C-1996-084 Mine Name: Lorencito Canyon Mine Operator: New Elk Coal Company, LLC Operator Address: Mr. John Terry 12250 Highway 12 Weston, CO 81091	County: Las Animas Operation Type: Surface Permit Status: Permanent Cessation Ownership: Private
	Operator Representative Present: None
Operator Representative Signature: (Field Issuance Only)

Inspection Start Date: December 18, 2024 Inspection Start Time: 09:14 Inspection End Date: December 18, 2024 Inspection End Time: 10:57	Inspection Type: Coal Partial Inspection Inspection Reason: Normal I&E Program Weather: Clear
Joint Inspection Agency: None	Joint Inspection Contacts:
Post Inspection Agency: None	Post Inspection Contacts:
Inspector(s): Amber M. Gibson	Inspector's Signature:

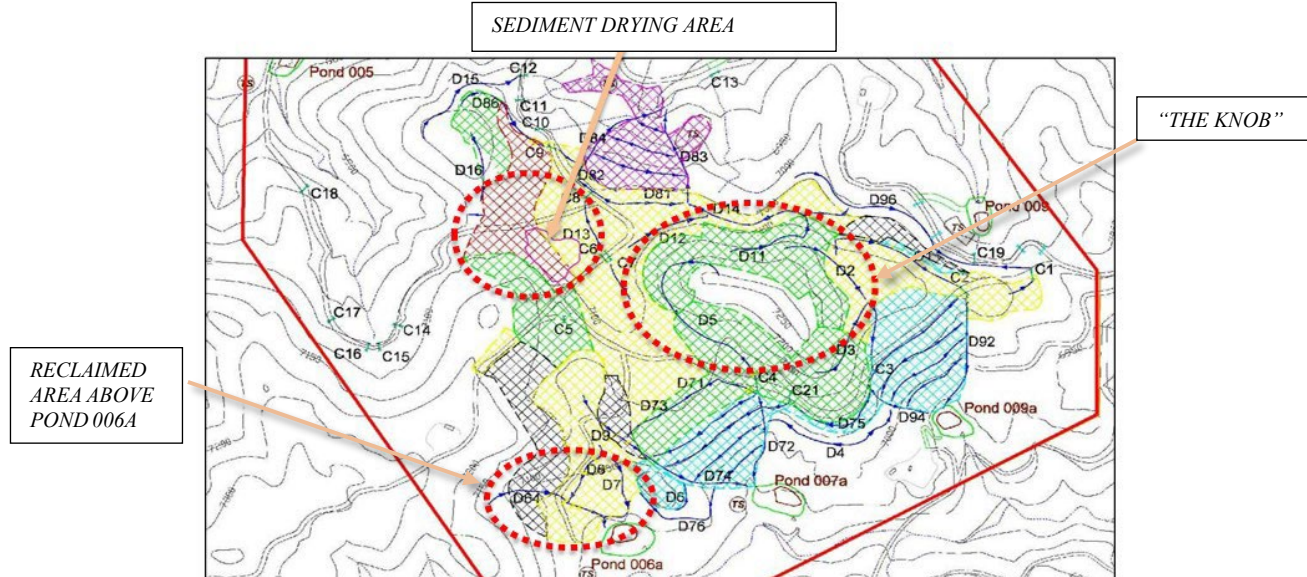
4. The following items pertain to ongoing erosional issues in the areas shown in Figure 1, that pursuant to Rule 4.14.6 need to be addressed. A Technical Revision will be required to expand on the current Rill and Gully plan in the PAP. **The Operator shall submit the technical revision, obtain approval, repair the erosion, and stabilize the slopes pursuant to the approved plan by December 31, 2024.**

FIGURE 1. AREAS WHERE RILLS, GULLIES AND SPARSE VEGETATION HAS BEEN FOUND TO BE A PERSISTENT PROBLEM AT THE SITE ARE WITHIN THE DOTTED CIRCLE AREAS. BACKGROUND IMAGE IS THE 2020 ANNUAL REPORT MAP.

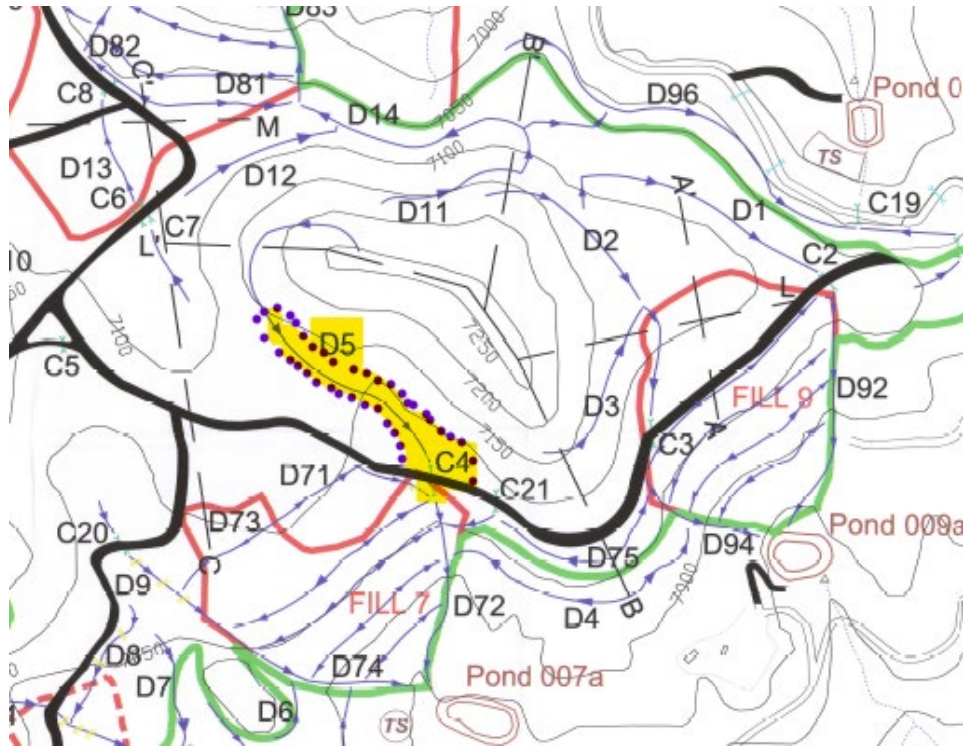
- Ditch D5:
 - Ditch D5 is located on the southside of a previously disturbed area referred to as "The Knob" (Figure 2). The Knob is north of Fill 7 and north of the road. Check dams are located throughout D5, and a small sediment catchment area is located at the base of the ditch that leads to culvert C4 (Photo 5). The check dams are full and need to be cleaned, and a few need to be repaired (Photos 6-8). The catchment basin also has an increased sediment load, however C4 appears to still be clear at this time (Photo 9). Still, the Operator **shall clean the sediment out of the check dams and the catchment basin located within D5, north of C4.**

Figure 2: Excerpt from Map 2.05.3-7 Lorencito Canyon Mine Culverts and Ditches. Highlighted and surrounded by purple dots is the approximate area that Photos 5 - 10 were taken.

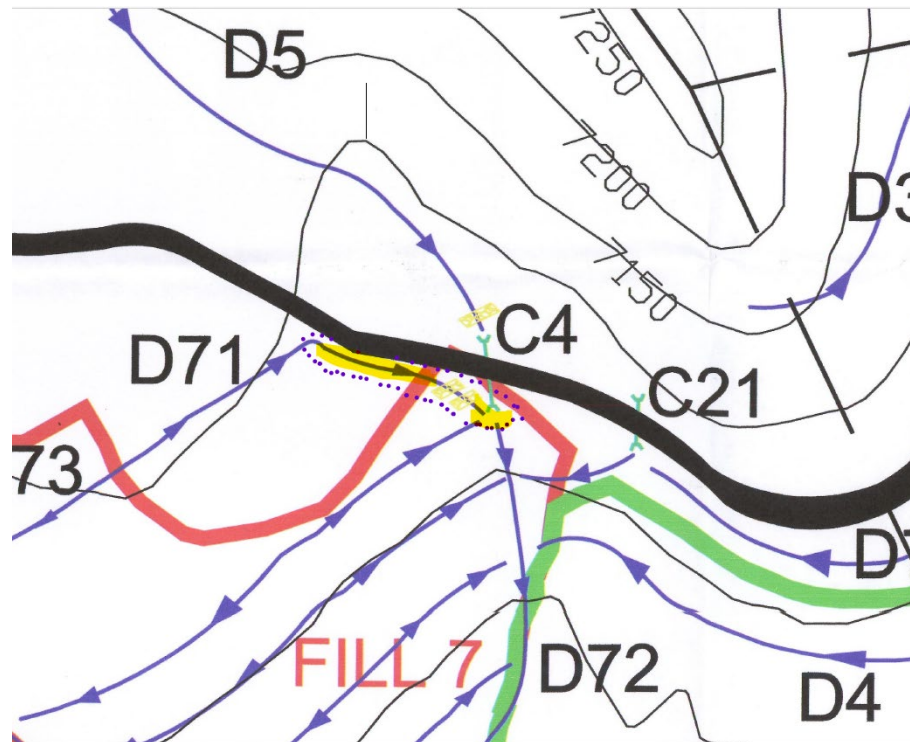
- Ditch D71:
 - D71, located along the southside of the road and north side of Fill 7, empties at the west side of the outlet for C4 (Figure 3 & Photo 12). The check dams within D71 are nearly full of sediment (Photo 13). **The Operator shall clean the sediment from the check dams within D71 and ensure the dams are functioning appropriately.**

Figure 3: Excerpt from Map 2.05.3-7 Lorencito Canyon Mine Culverts and Ditches. Highlighted and surrounded by purple dots is the approximate area that Photos 11 - 13 were taken.

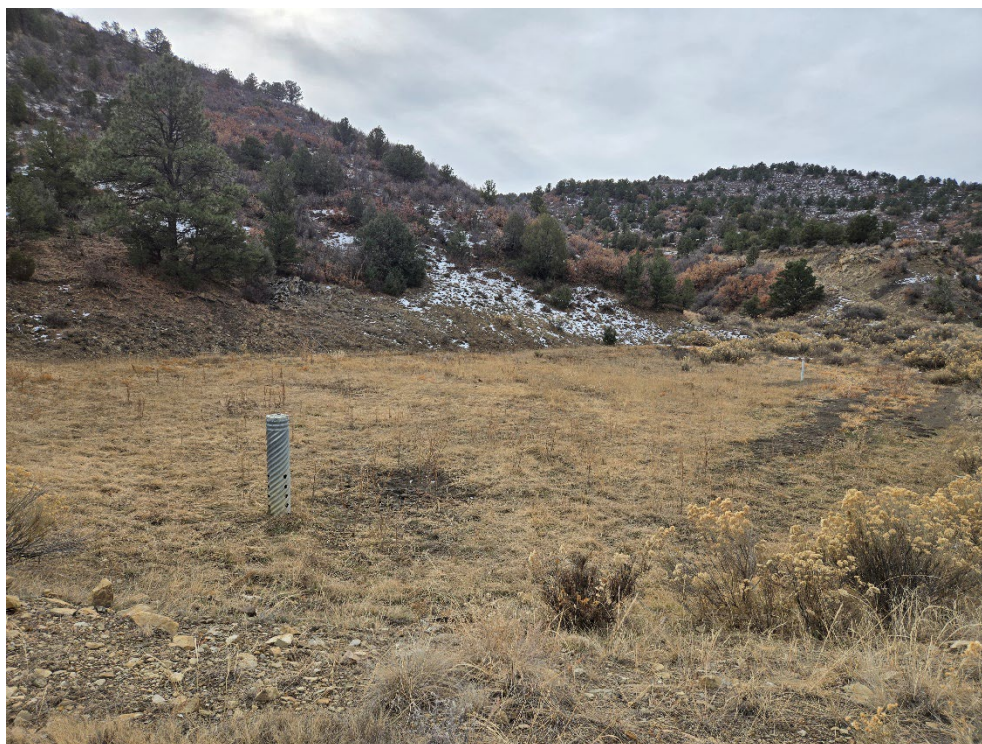
- Pond 005:
 - The pond was dry at the time of the inspection. (Photo 1).
 - The pond embankment appeared to be stable and vegetated.
 - The primary and emergency spillways appeared clear and functional.

Photo 1: Pond 005

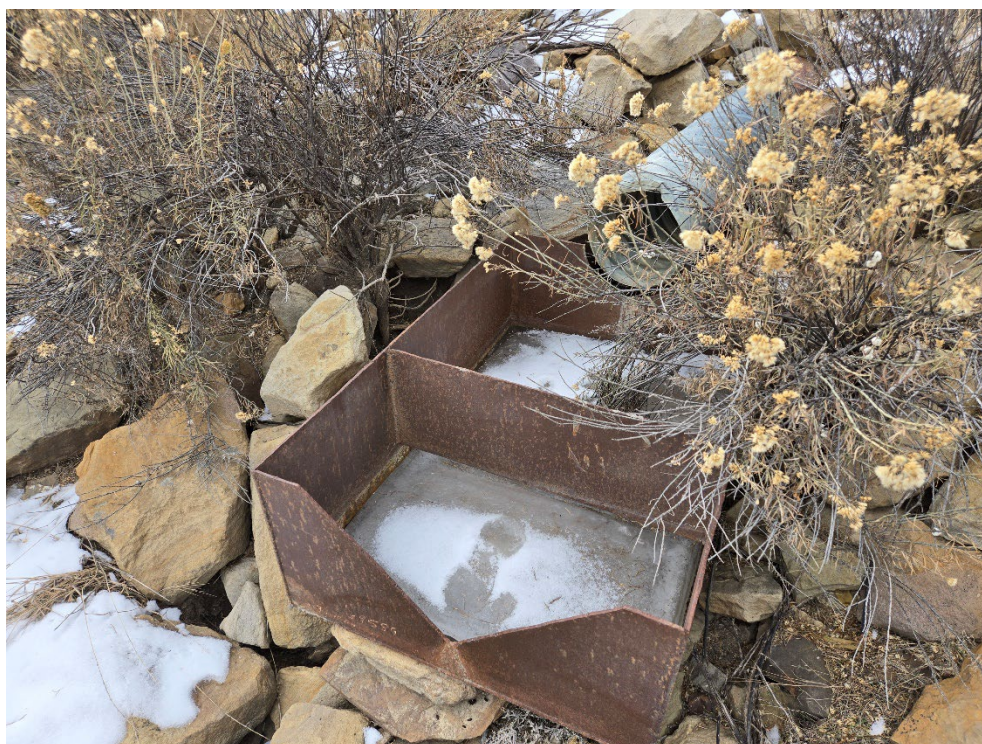
- The flume contained some frozen water and was not discharging (Photo 2).
- Pond 008:
 - The pond contained water at the time of the inspection (Photo 3).

Photo 2: Flume at Pond 005.

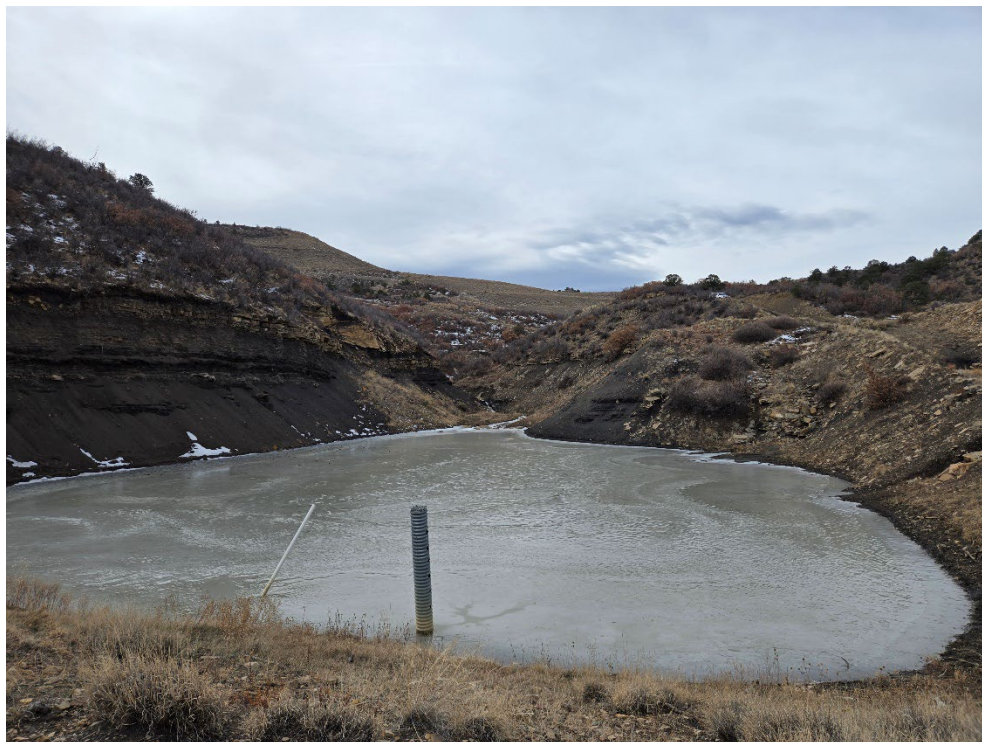
2. The majority of Pond 008's embankment was stable and vegetated, however, the west bank contains some erosion rills and gullies. The erosion appears to have been caused by run-off from the roads above and down to the pond. **Pursuant to Rule 4.05.5(1)(c), the Operator shall repair the erosion and stabilize the west bank of Pond 008.** The Operator stated that they will likely install additional rock berms along the western-most road to help prevent run-off from running down the slopes and into the pond. The

Photo 3: Looking south at Pond 008.

- The primary and emergency spillways appeared clear and functional.
 - Some of the state listed noxious weed, Mullein, observed along the west bank of Pond 008 were treated by the Operator during the June inspection. However, more were observed during the August-December inspections. **The Operator shall treat/remove Mullein within this area.**

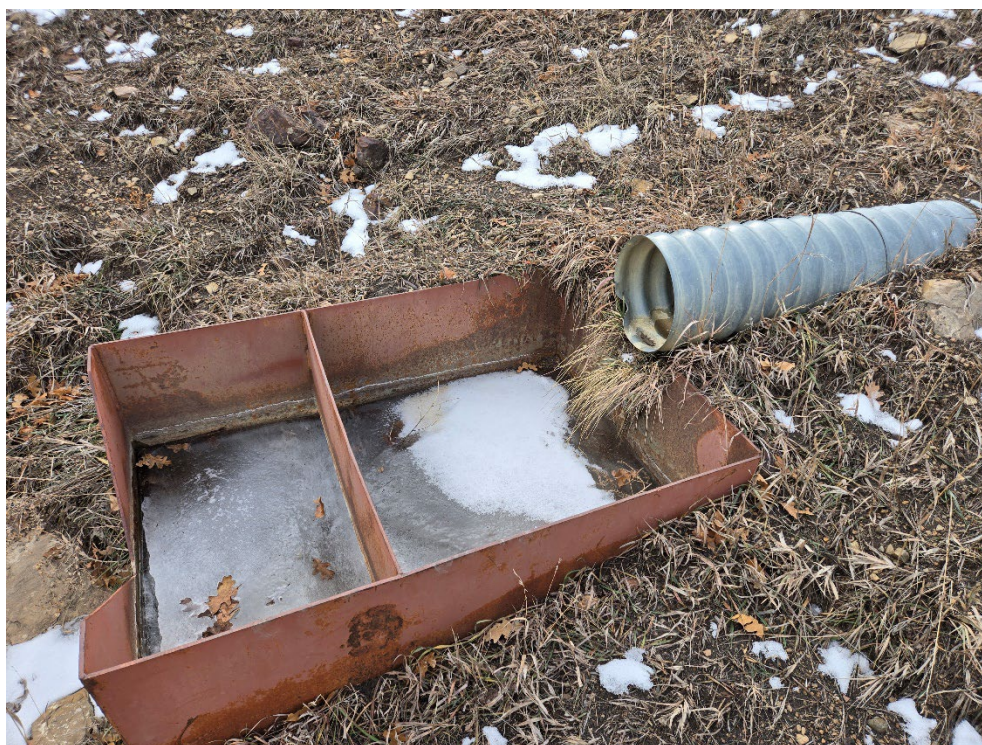
- The flume contained frozen water but was not discharging at the time of the inspection (Photo 4).
 - The pond embankment still requires maintenance (see Item #2 in the outstanding maintenance items list on the first page of this report).

Photo 4: Flume at Pond 008.

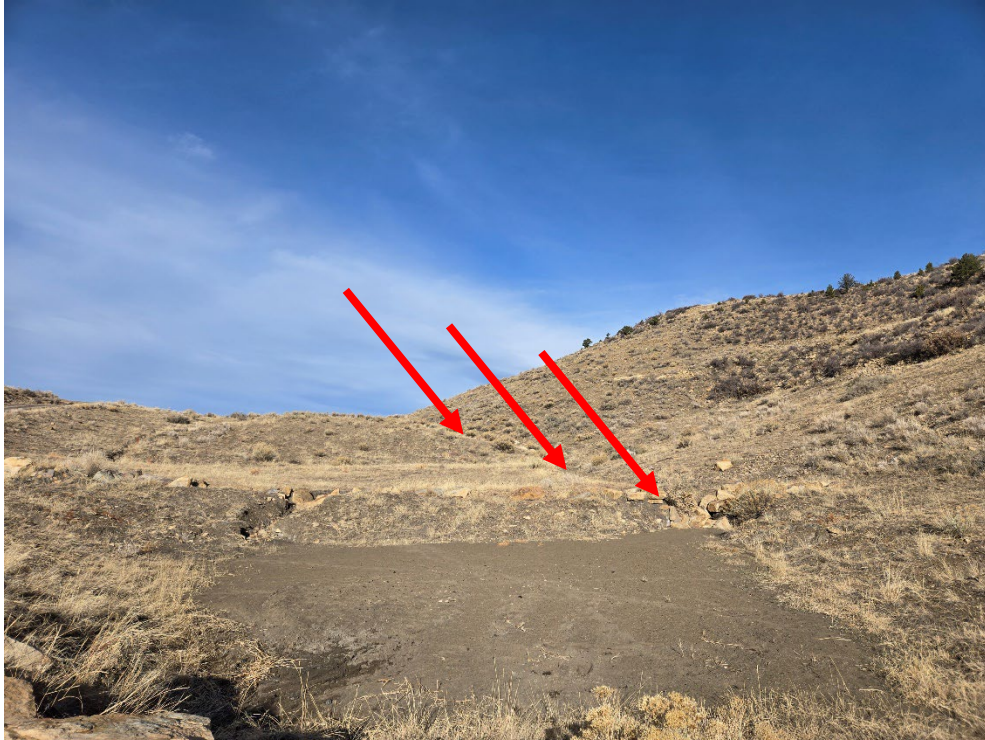
Photo 5: Looking northwest at the catchment basin located south of The Knob and north of C4. The arrows point to Ditch D5 along the southside of The Knob.

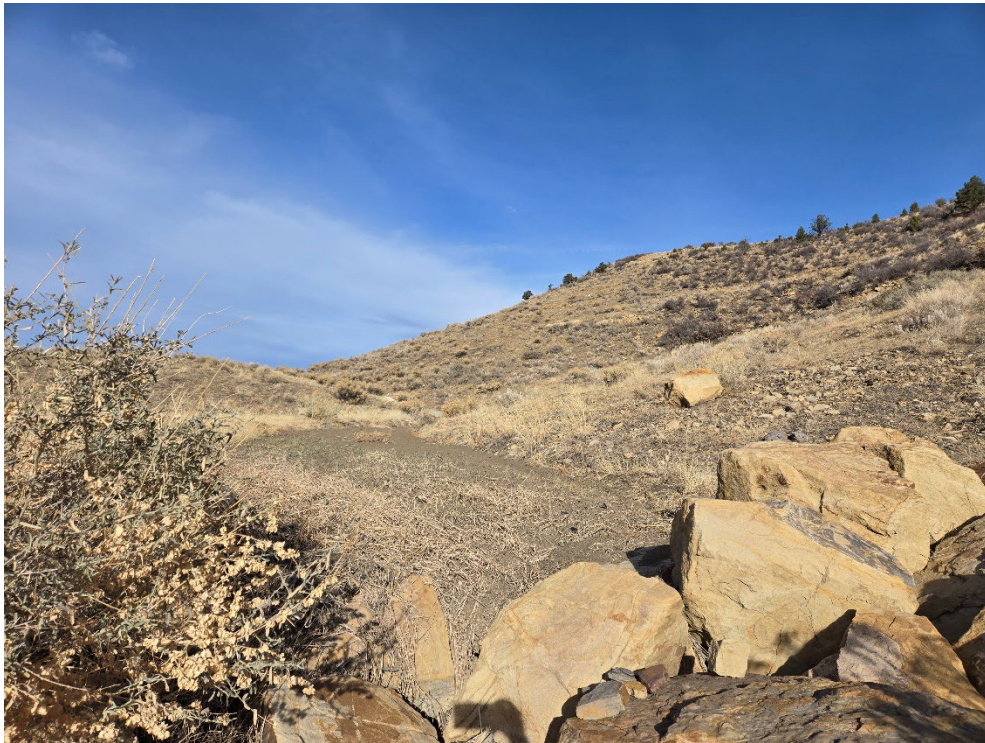
Photo 6: Looking west from a check dam located within D5 at the sediment deposition within D5.

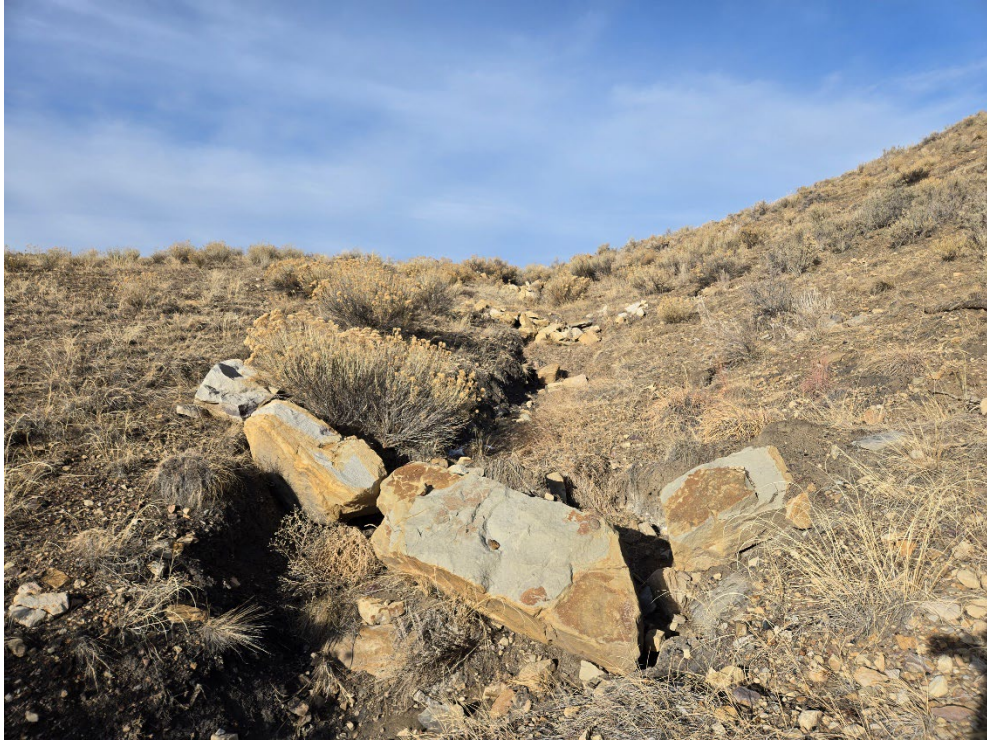
Photo 7: Looking further west along D5 at the check dams. Some of the structures have failed and need to be repaired.

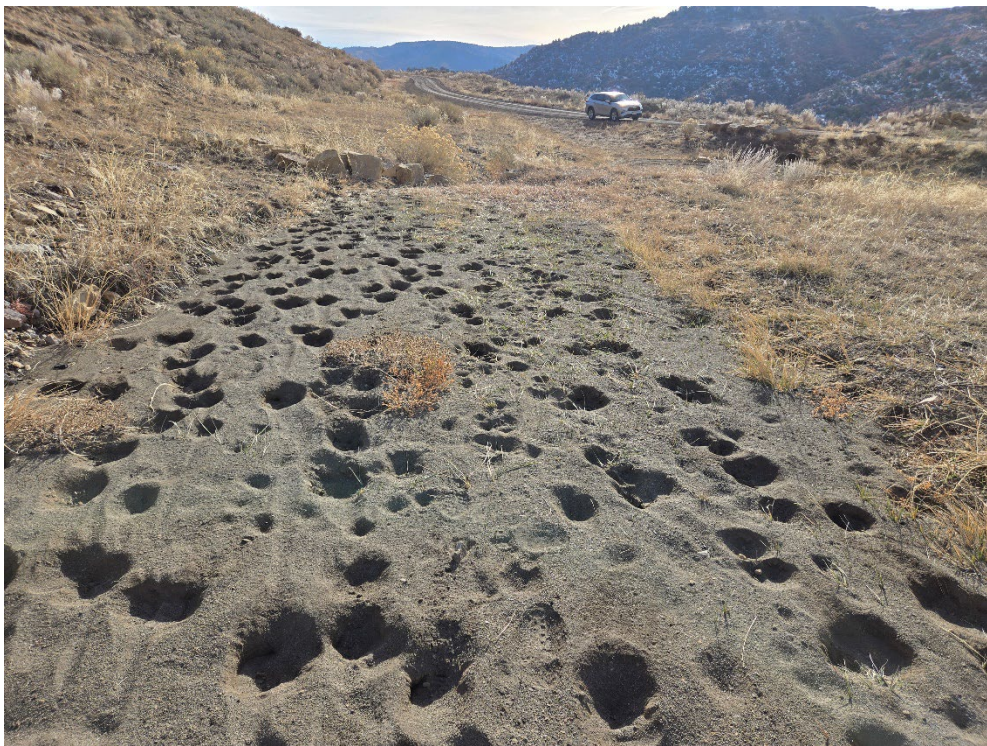
Photo 8: Looking towards the end of D5 (basin area), at the excess amount of sediment deposited within D5.

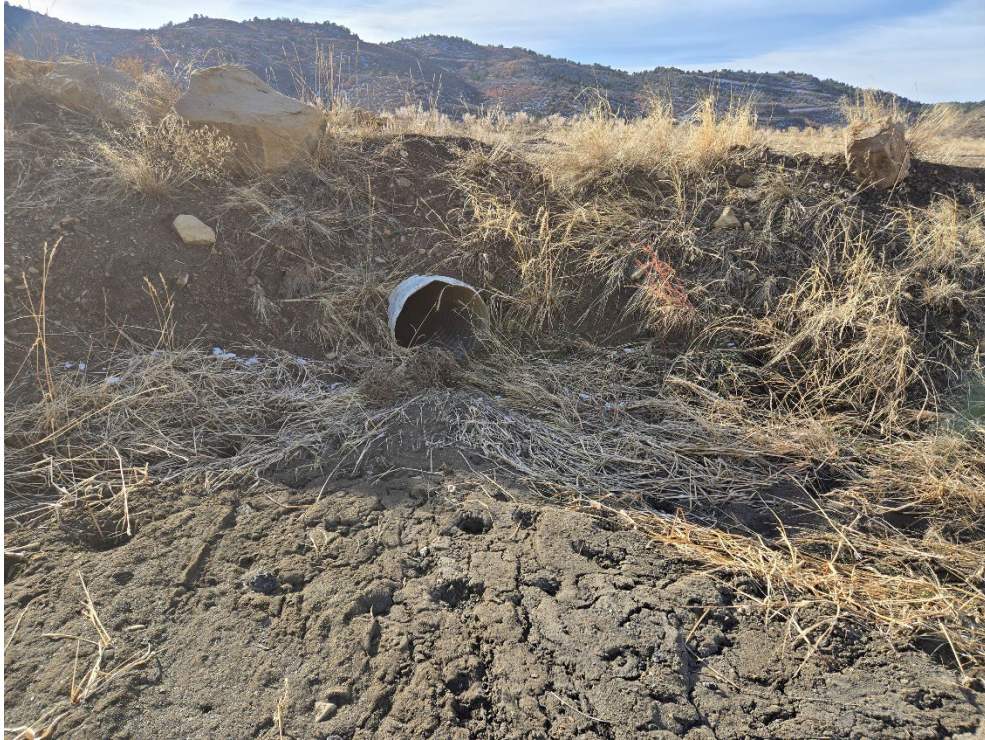
Photo 9: Looking south at the inlet for C4, located on the south side of the catchment basin area at the end of D5.

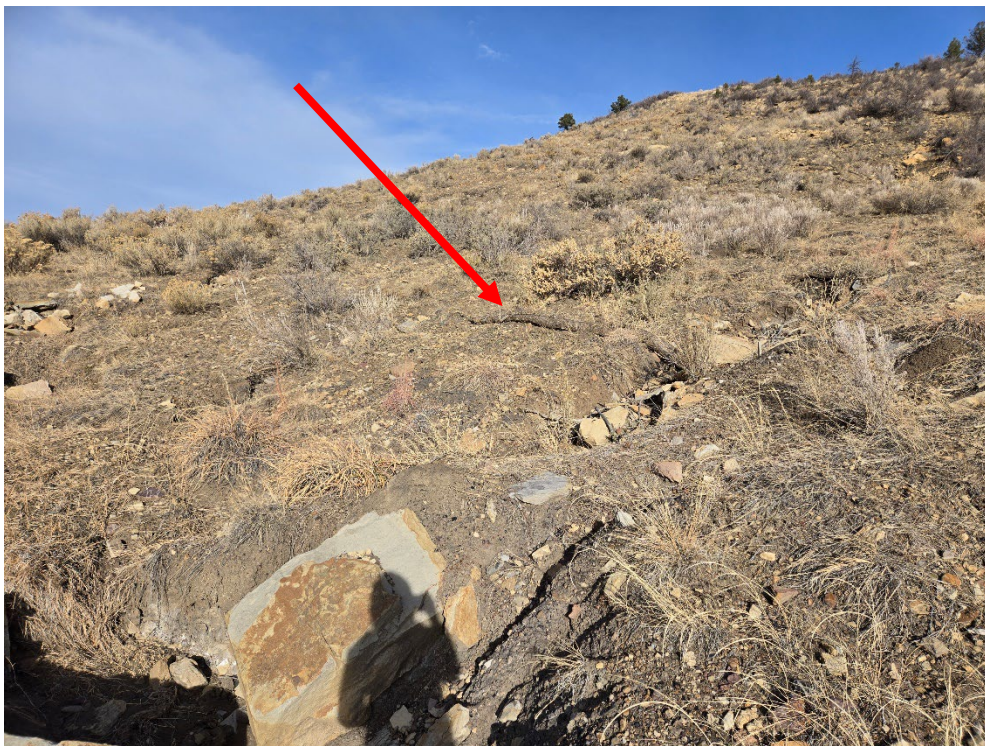
- Some areas along the south-facing slope of The Knob appear to also be contributing to the increased sediment in D5. Some of these areas appear to have been partially addressed in the past through the use of BMPs such as straw wattles, rip rap, and branches (Photo 10). However, **the Operator shall implement additional sediment control mechanisms on these slopes to control erosion and reduce sediment build up in D5.**

Photo 10: Looking upslope at previous attempts to address erosion on the slopes located above D5. Arrow indicates location of a straw wattle.

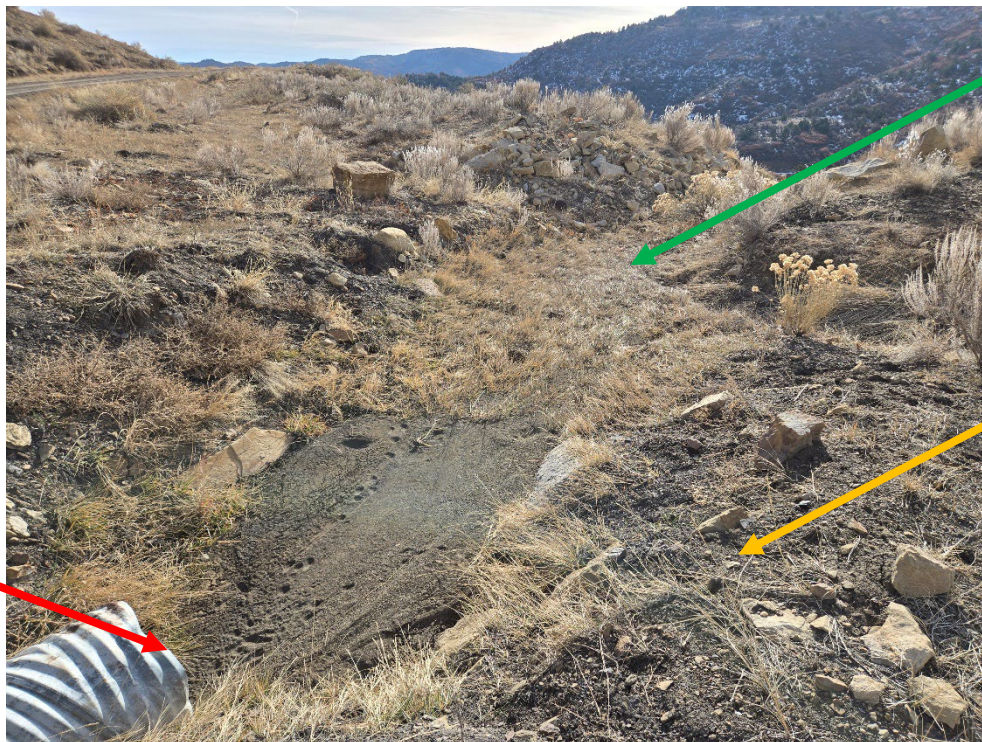
- Culvert C4:
 - The outlet for C4 is located on the south side of the culvert and leads into Ditch D72 along the east side of Fill 7 (Photo 11). Sediment has been deposited at the outlet of C4 and has covered small portion of vegetation at the top of Ditch D72. **The Operator shall monitor this area and ensure that sediment deposition in this area is controlled. To help retain the vegetation established in the area, removing the excess sediment may be warranted in the near future.**

Photo 11: Looking southeast at the outlet for C4 (red arrow). The yellow arrow indicates the termination of Ditch D71. The green arrow indicates the beginning of D72.

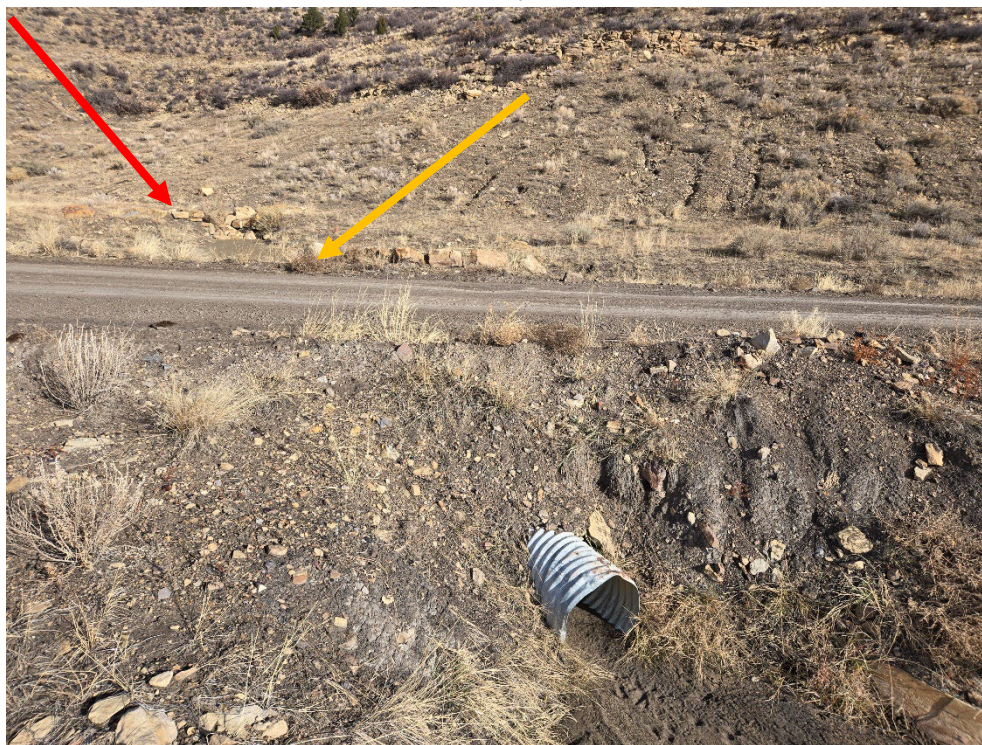
Photo 12: Looking northwest at the outlet for C4. The red arrow indicates the location of D5. The yellow arrow indicates the approximate location of the inlet for C4.

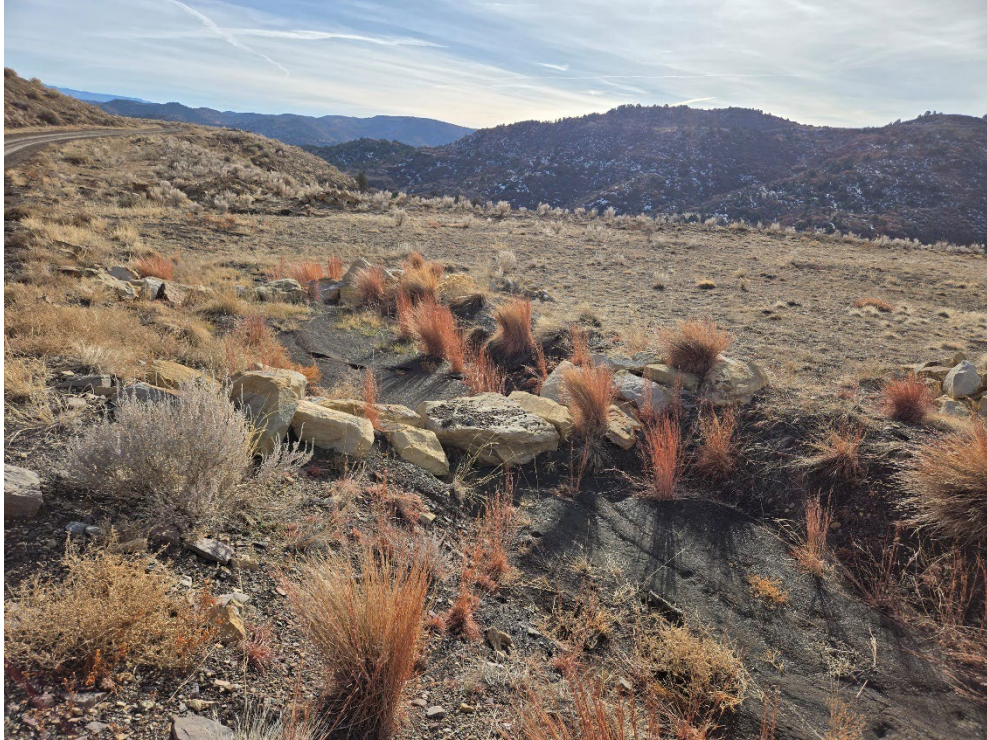
Photo 13: Looking northeast along the check dams in D71, leading to culvert C4.

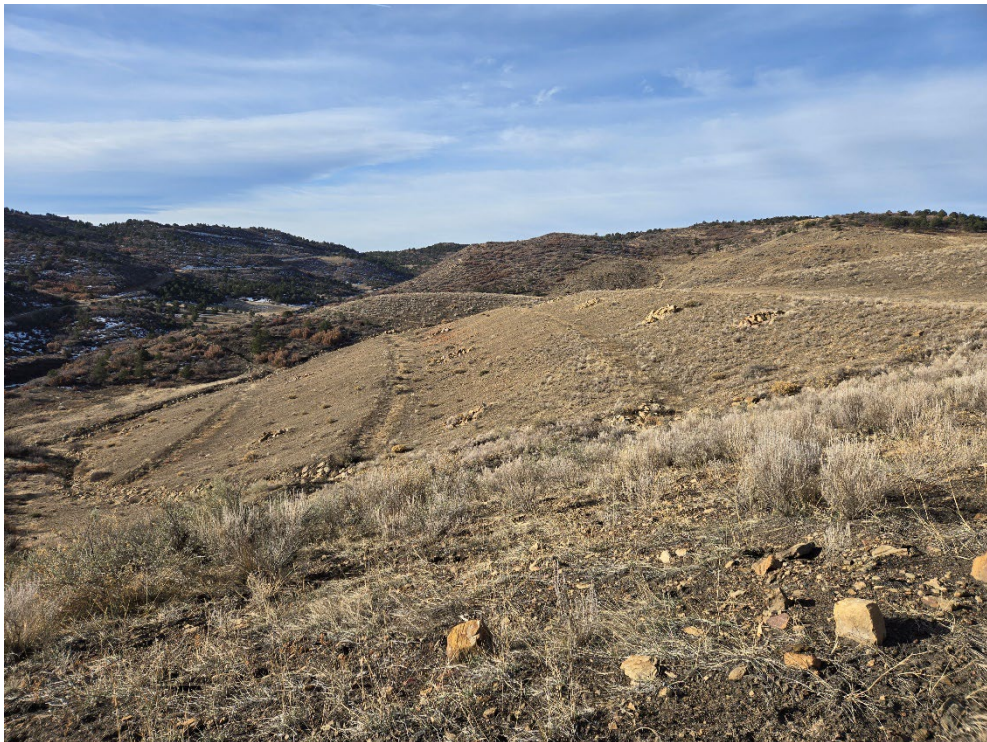
- Fill 7 was observed. Fill 7 was well vegetated and appeared stable (Photo 14).
- Fill 8 was observed. Fill 8 was well vegetated and appeared stable (Photo 15).

Photo 14: Looking southwest across Fill 7.

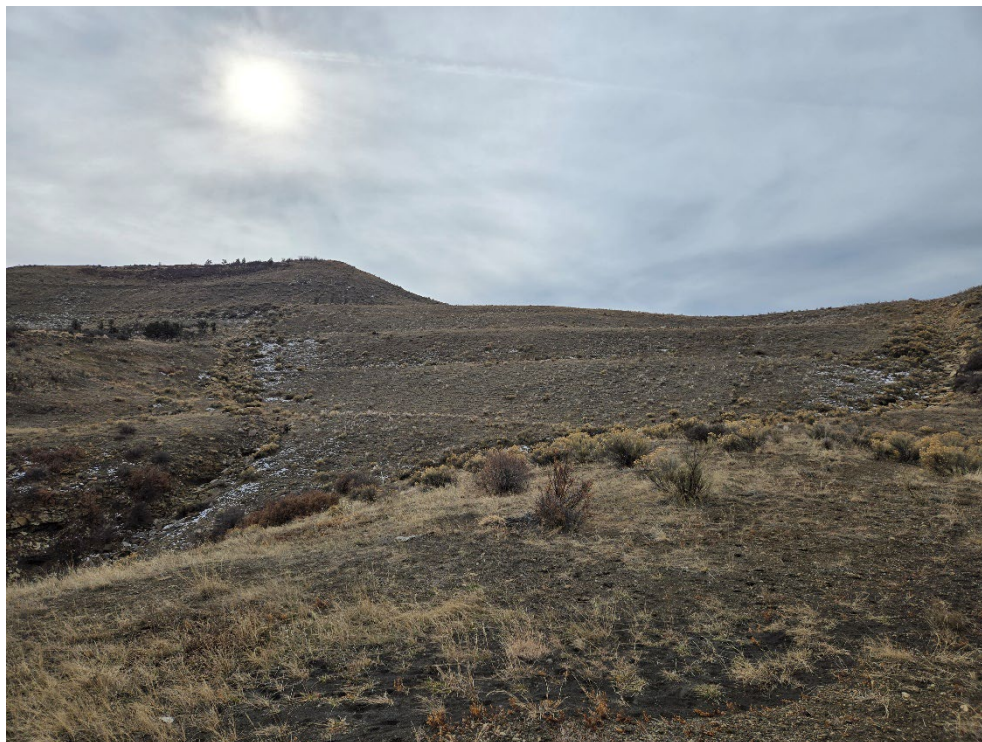
Photo 15: Looking south at Fill 8.

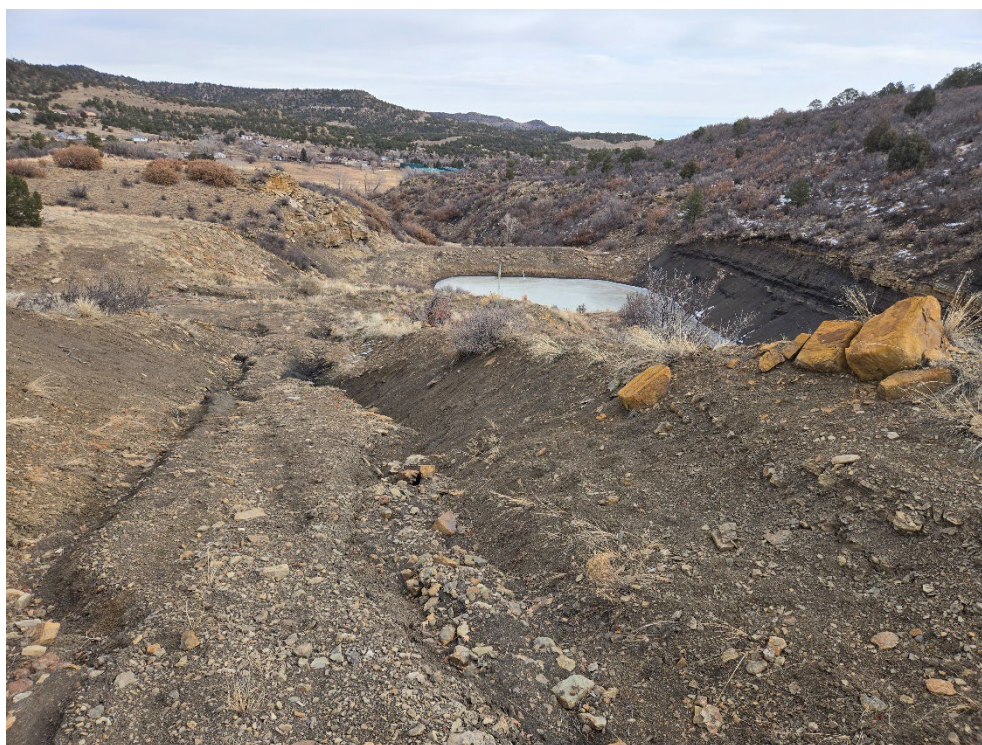
- See ongoing maintenance Item #2 and #3. The road leading down into Pond 008 has some ruts that will require repairs. The ruts* and divots in the road to Pond 008 make vehicle access to the pond difficult and not advisable (Photo 16). *These are planned to be addressed at the time the west bank is stabilized.

Photo 16: Looking north, down the access road to Pond 008.

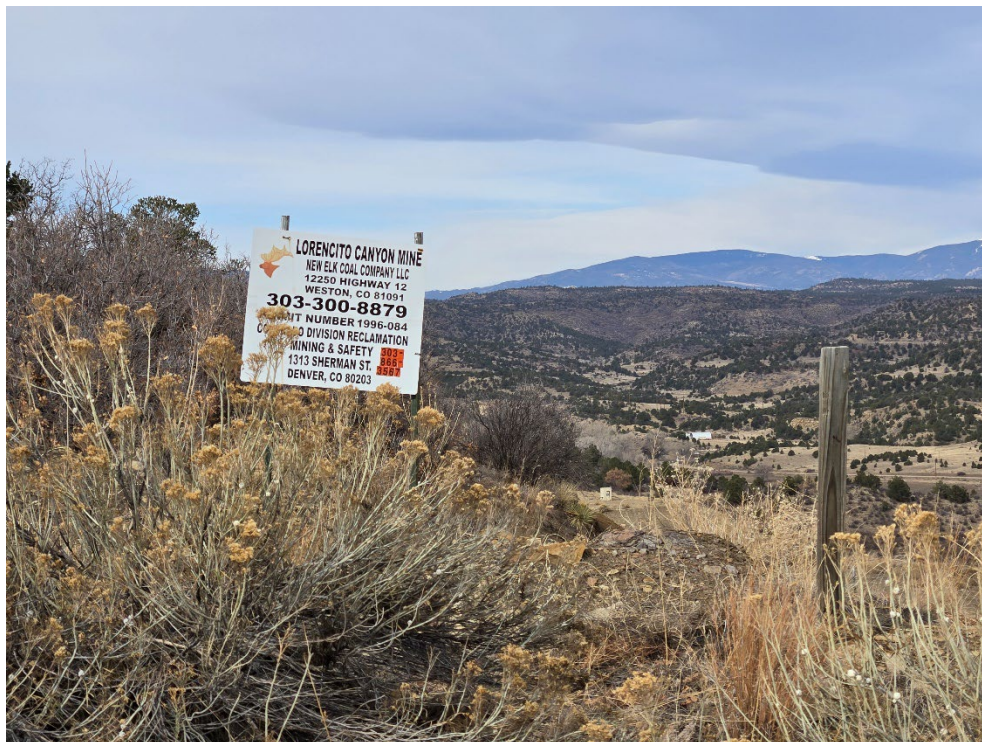
- Mine signs were posted at road entrances and at the entrance to the permit boundary in compliance with Rule 4.02 (Photo 17).

Photo 17: Mine sign
