MINERALS PROGRAM INSPECTION REPORT
PHONE: (303) 866-3567

MINE NAME: Hay Camp Pit	MINE/PROSPECTING ID#: M-1990-025	MINERAL: Gravel	COUNTY: Montezuma
INSPECTION TYPE: Monitoring	WEATHER: Clear	INSP. DATE: December 10, 2024	INSP. TIME: 14:00
OPERATOR: Montezuma County	OPERATOR REPRESENTATIVE: Rob Englehart	TYPE OF OPERATION: 112c - Construction Regular Operation	
REASON FOR INSPECTION: Normal I&E Program	BOND CALCULATION TYPE: None	BOND AMOUNT: \$0.00	
DATE OF COMPLAINT: NA	POST INSP. CONTACTS: None	JOINT INSP. AGENCY: None	
INSPECTOR(S): Todd Jesse	INSPECTOR'S SIGNATURE:

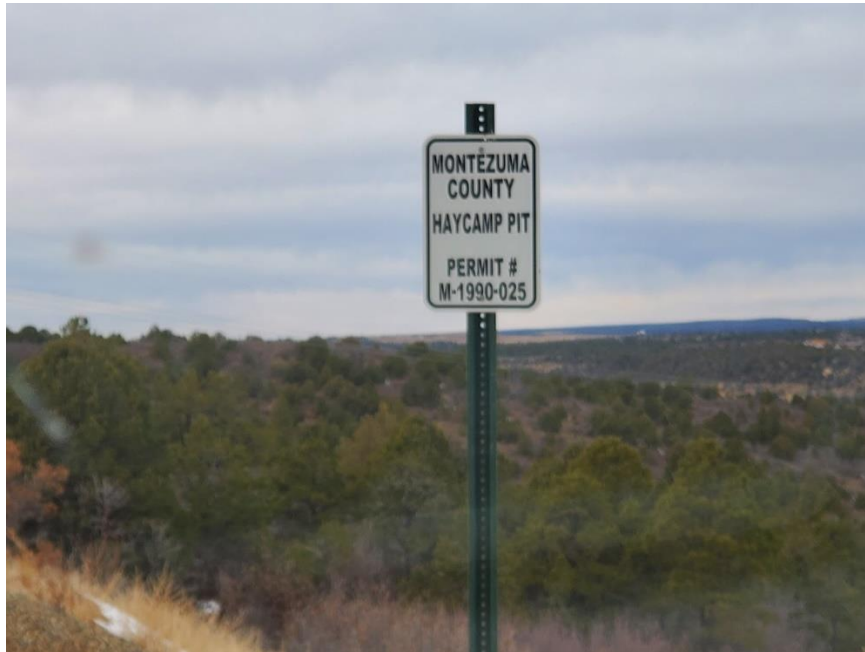
The sign and affected area boundary markers are in place and in compliance with Rule 3.1.12. The permit boundary is marked with fence lines as well as earthen berms that are easily identifiable. The Mine ID sign is placed at the entrance to the site.

Photo 1 – View to the west of Mine ID sign.

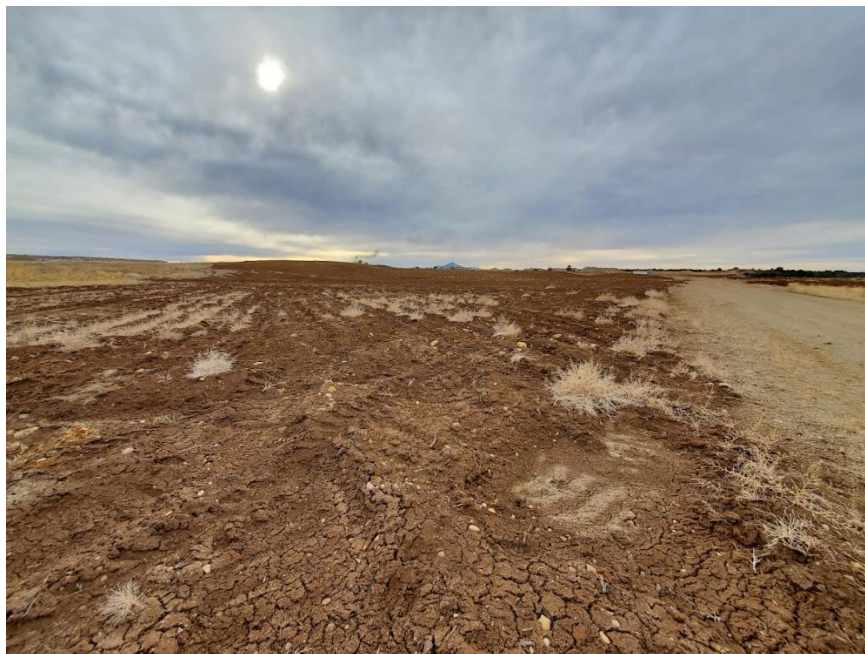
Mining is being conducted in accordance with the approved mining plan. Mining is advancing to the west and the eastern portions of the permit area have been reclaimed. The operator is stripping overburden and topsoil as they mine and storing them for use in reclamation. Product stockpiles are located within the permit boundary. Portions of the permit that have been mined out now have topsoil spread on them and have been seeded.

Photo 2 – View to the west of area that has been seeded this fall.

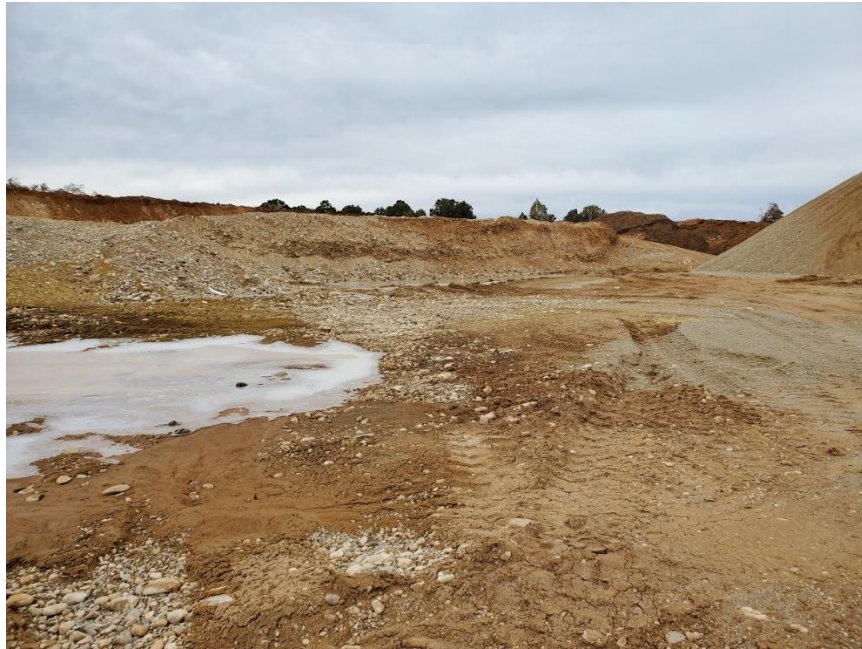
Photo 3 – View to the west of mining area.

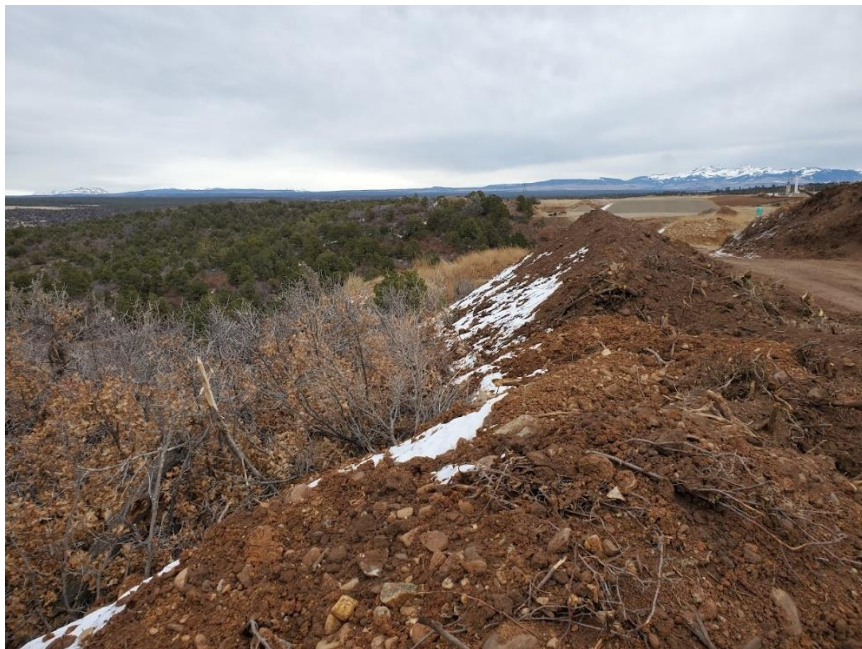
Photo 4 – View to the east of berm that marks the northern boundary.

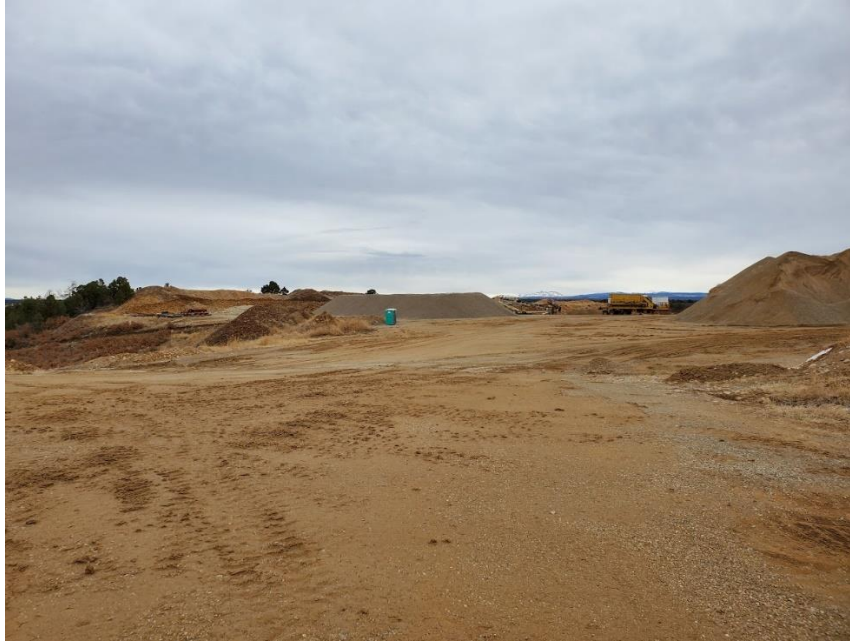
Photo 5 – View to the west of laydown area and product stockpiles in permit area.
