MINERALS PROGRAM INSPECTION REPORT
PHONE: (303) 866-3567

MINE NAME: Tozer Pit	MINE/PROSPECTING ID#: M-1978-107	MINERAL: Sand and gravel	COUNTY: Montezuma
INSPECTION TYPE: Monitoring	WEATHER: Cloudy	INSP. DATE: December 10, 2024	INSP. TIME: 12:30
OPERATOR: Montezuma County	OPERATOR REPRESENTATIVE: Rob Englehart	TYPE OF OPERATION: 112c - Construction Regular Operation	
REASON FOR INSPECTION: Normal I&E Program	BOND CALCULATION TYPE: None	BOND AMOUNT: \$0.00	
DATE OF COMPLAINT: NA	POST INSP. CONTACTS: None	JOINT INSP. AGENCY: None	
INSPECTOR(S): Todd Jesse	INSPECTOR'S SIGNATURE:

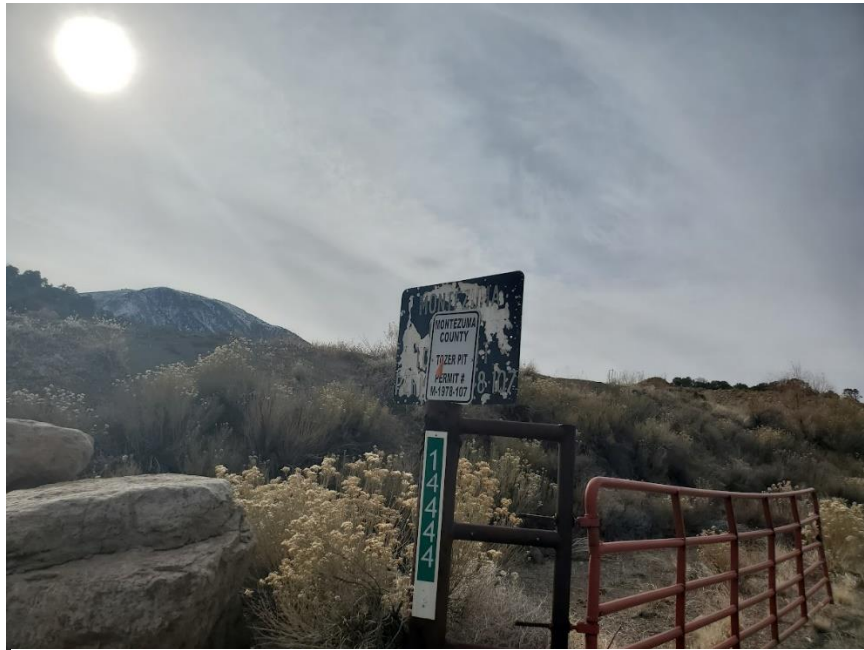
The sign and affected area boundary markers are in place and in compliance with Rule 3.1.12. The permit boundary is marked with fence lines as well as earthen berms that are easily identifiable. The Mine ID sign is placed at the entrance to the site.

Photo 1 – View to the south of proper Mine ID at the entrance to the site.

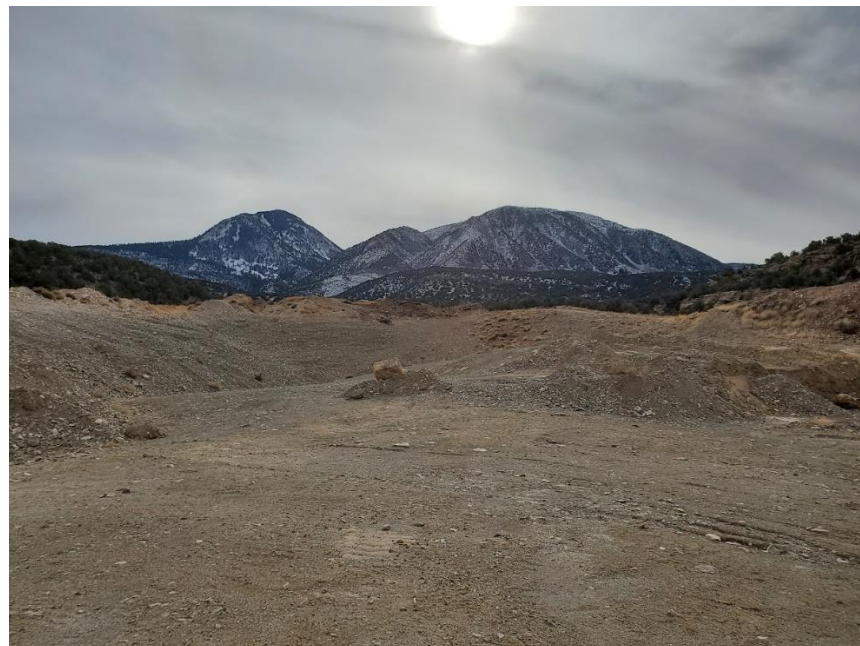
Mining is being conducted in accordance with the approved mining plan. The mine site consists of an upper area where mining takes places and a lower area where processing and stockpiles are places. The two areas are connected with a road and conveyor. Mining is advancing to the south. Once those reserves are extracted, the operator will mine towards the north towards the site entrance off Rd G. The operator is stripping overburden and topsoil as they mine and storing them for use in reclamation. Product stockpiles are located within the permit boundary.

Photo 2 – View to the south of the mining area.

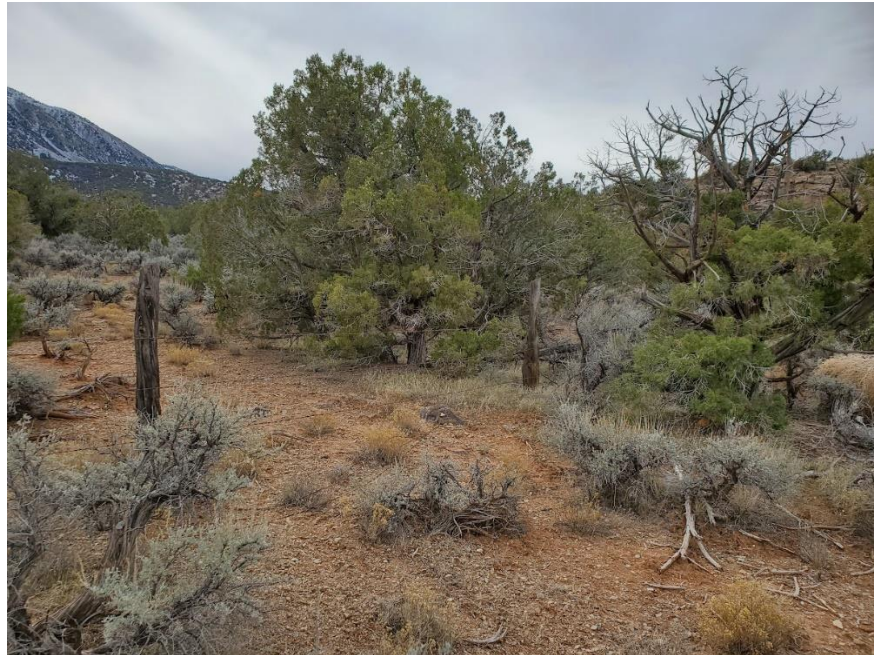
Photo 3 – View to the south of undisturbed area. Fence marks the southern permit boundary.

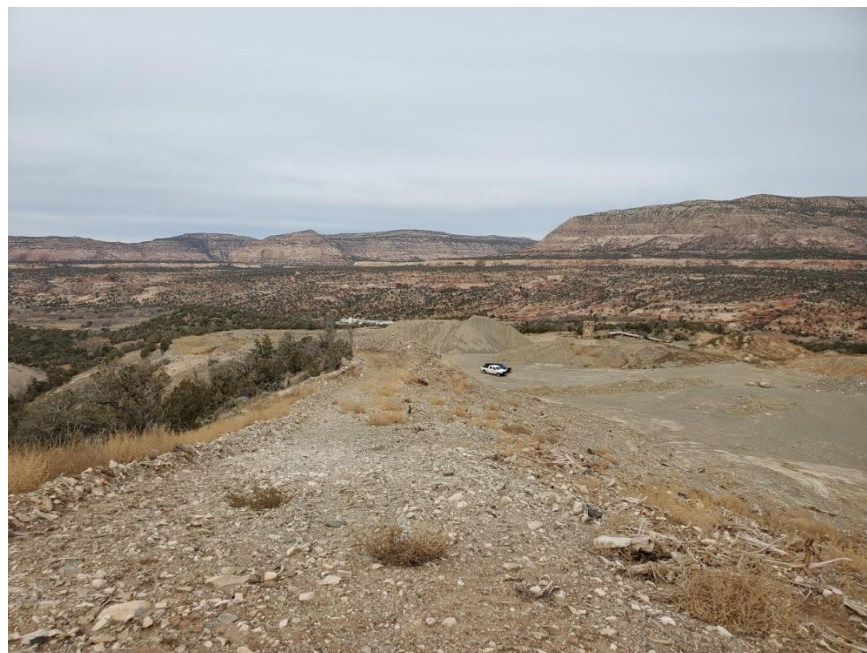
Photo 4 – View to the north along berm that marks affected area boundary.

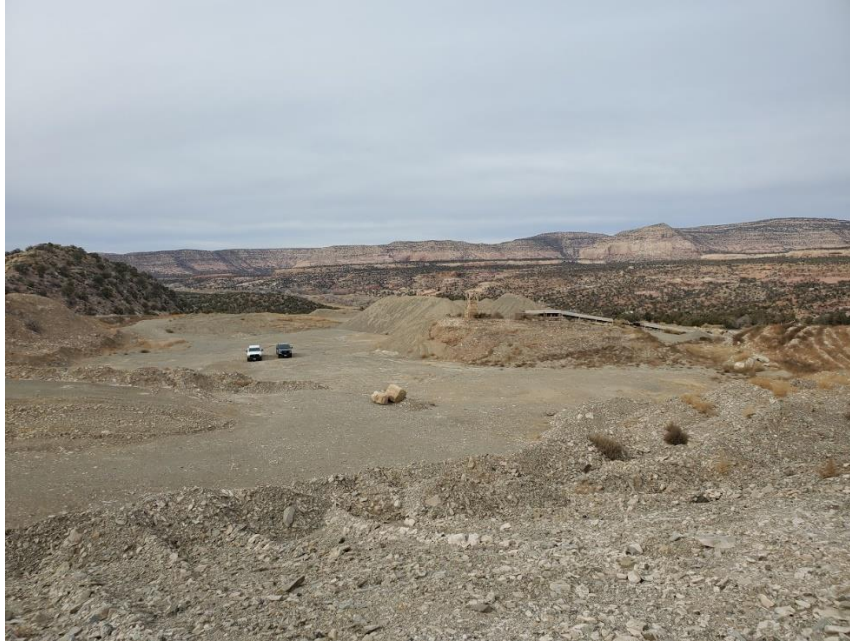
There is no groundwater exposed within the permit boundary. No meteoric water was observed to be pooled within the disturbed area. Stormwater is contained within the disturbance area by berms. Ditches are free of obstruction and able to convey water. Minor erosional features were noted in stockpiles near the conveyor, but material is contained to the local area.

Photo 5 – View to the northwest of screening area and conveyor.

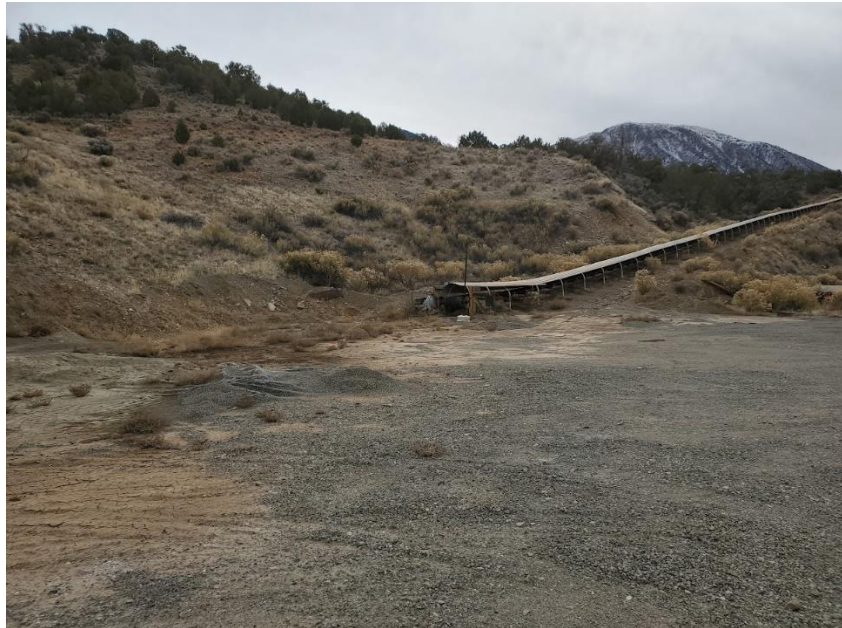
Photo 6 – View to the south of the conveyor at the
