MINERALS PROGRAM INSPECTION REPORT
PHONE: (303) 866-3567

MINE NAME: Ormiston Gravel Pit	MINE/PROSPECTING ID#: M-1999-077	MINERAL: Aggregate	COUNTY: Dolores
INSPECTION TYPE: Monitoring	WEATHER: Clear	INSP. DATE: December 10, 2024	INSP. TIME: 11:00
OPERATOR: Montezuma County	OPERATOR REPRESENTATIVE: Rob Englehart	TYPE OF OPERATION: 112c - Construction Regular Operation	
REASON FOR INSPECTION: Normal I&E Program	BOND CALCULATION TYPE: None	BOND AMOUNT: \$0.00	
DATE OF COMPLAINT: NA	POST INSP. CONTACTS: None	JOINT INSP. AGENCY: None	
INSPECTOR(S): Todd Jesse	INSPECTOR'S SIGNATURE:

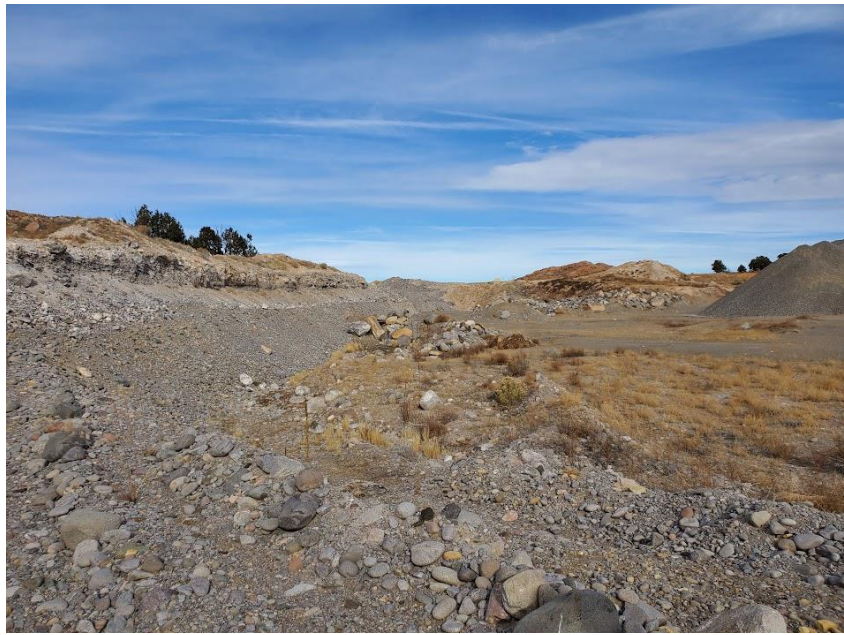
Photo 2 – View to the north of the mining area and highwall.

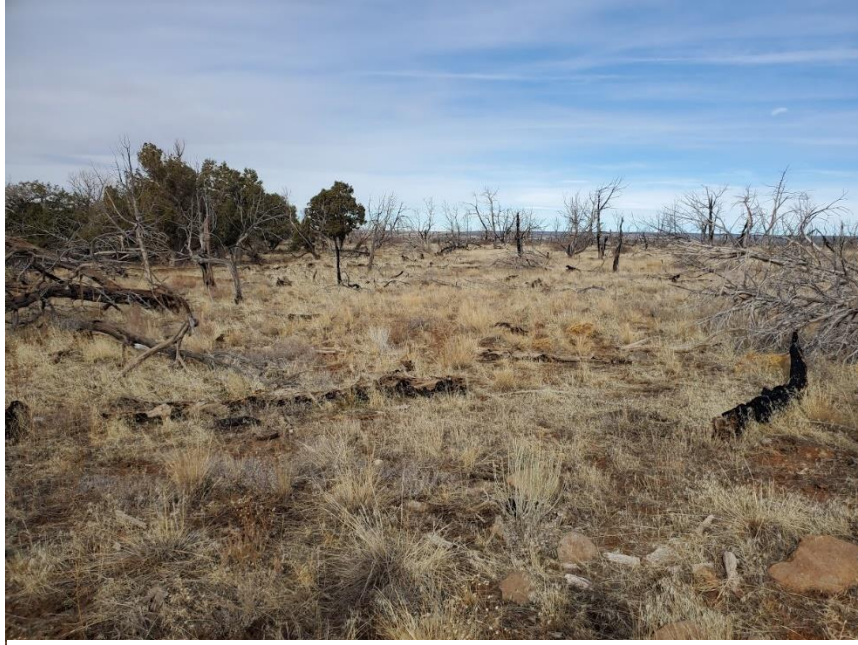
Photo 3 – View to the northwest of undisturbed portions of the permit boundary.

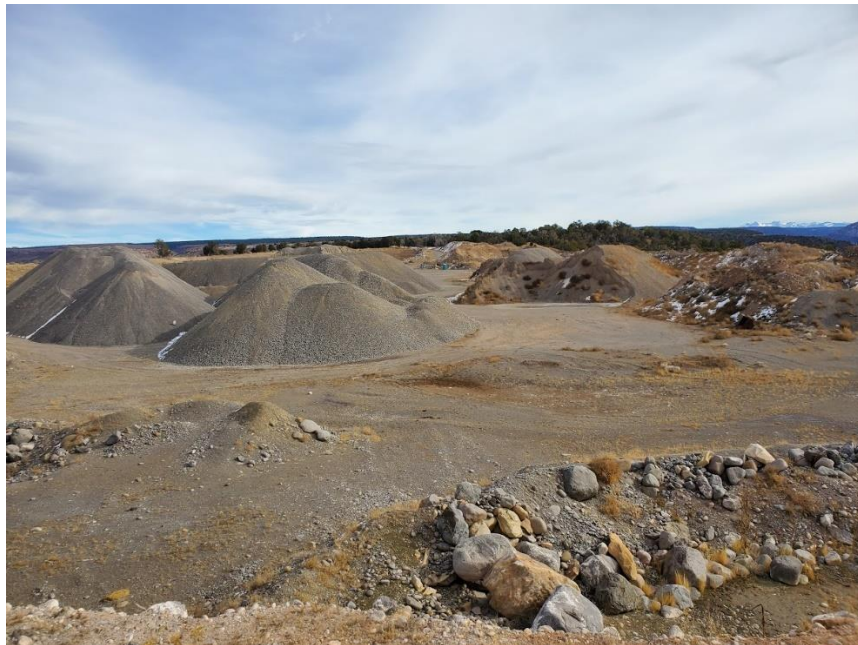
Photo 4 – View to the northeast of product stockpiles with the permit area.
