**MINERALS PROGRAM INSPECTION REPORT**  
**PHONE: (303) 866-3567**

| <b>MINE NAME:</b><br>Ted Franciscotti Pit #1 | <b>MINE/PROSPECTING ID#:</b><br>M-2007-006 | <b>MINERAL:</b><br>Sand and gravel | <b>COUNTY:</b><br>Huerfano |
| <b>INSPECTION TYPE:</b><br>Monitoring | <b>WEATHER:</b><br>Cloudy | <b>INSP. DATE:</b><br>December 17, 2024 | <b>INSP. TIME:</b><br>10:40 |
| <b>OPERATOR:</b><br>Fremont Paving & Redi-Mix, Inc. | <b>OPERATOR REPRESENTATIVE:</b><br>Jodi Schreiber | <b>TYPE OF OPERATION:</b><br>112c - Construction Regular Operation | |

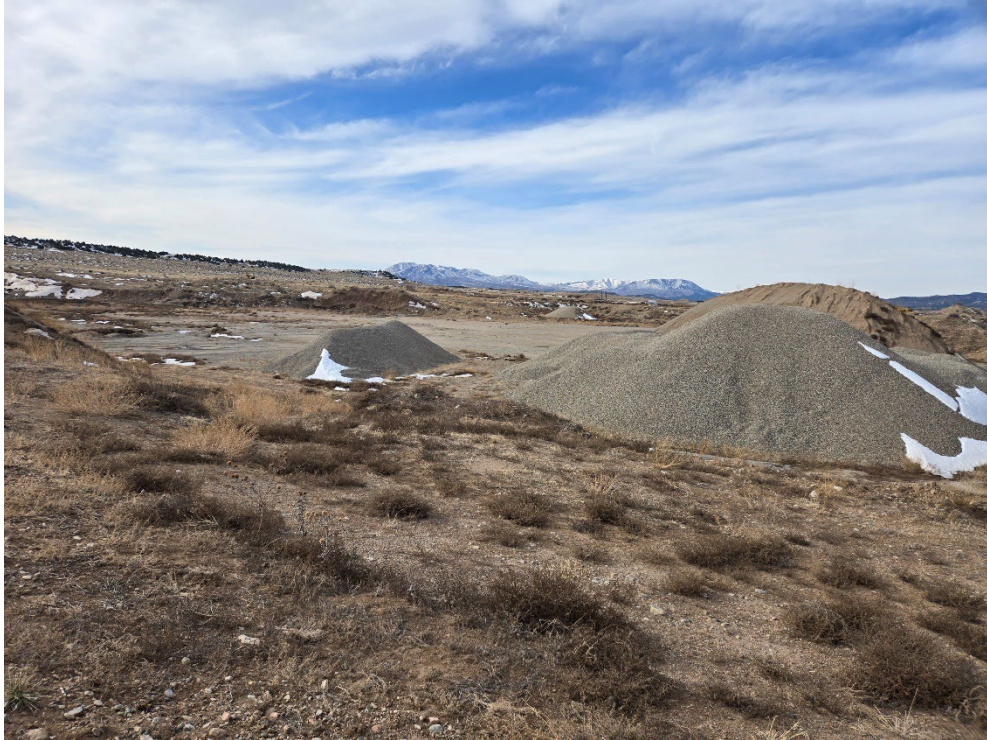
**Photo 1:** Looking southwest from the eastern perimeter of the permit into the Operator's active pit area. Pictured are some product stockpiles on the pit floor.

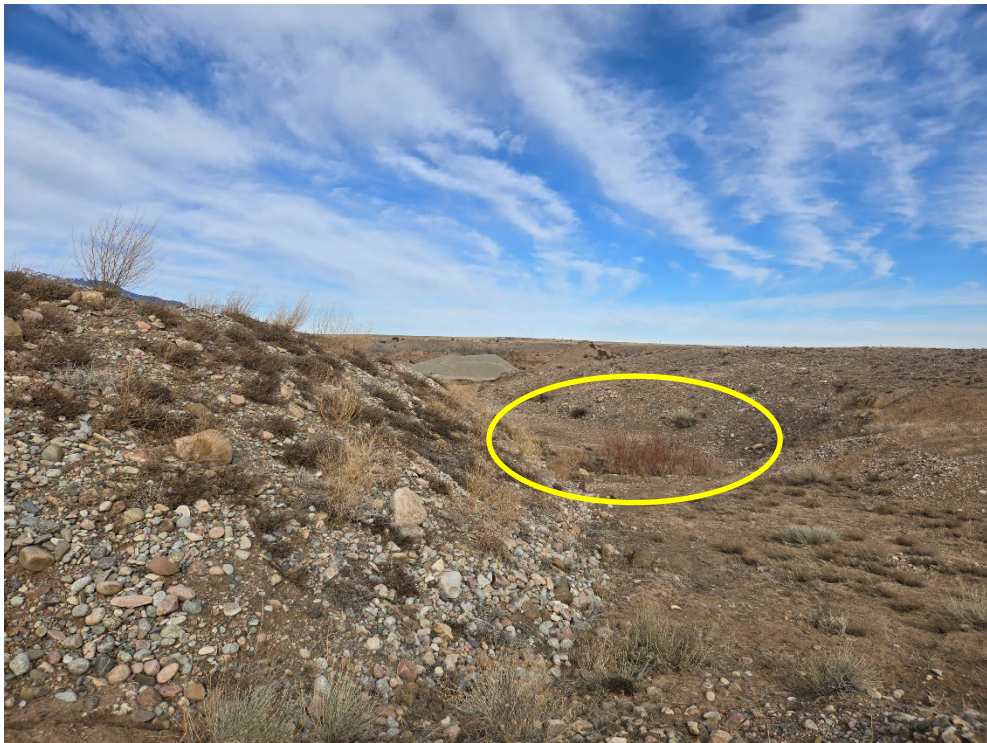
**PROBLEM:** Tamarisk (salt cedar) trees are present within, or have volunteered into, the permit area and are becoming established. This is a problem for failure to employ weed control methods for a state listed noxious weed species within the permitted area, and to reduce the spread of weeds to nearby areas as required by Section 3.1.10 (6) of the rule.

**Photo 2:** Looking northeast into the pit from the southside of the active pit area. Pictured in the foreground is an overburden/historic spoil pile, circled are a few Tamarisk trees, and in the background is a product stockpile.

**CORRECTIVE ACTIONS:** The Operator shall implement the existing weed control plan and provide the Division with photo evidence indicating that the weeds have been eradicated by the corrective action date.

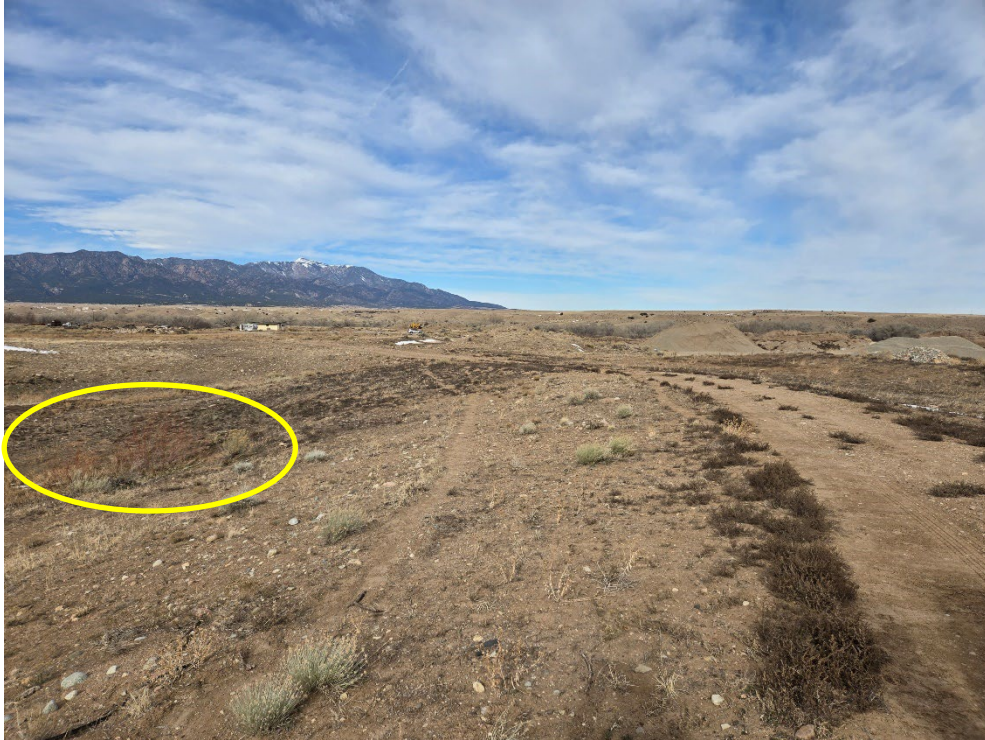
**Photo 3:** Looking northwest along the road that separates the Operator's active area (right) from the southwestern-most historic mining area (left). Circled are some Tamarisk trees.

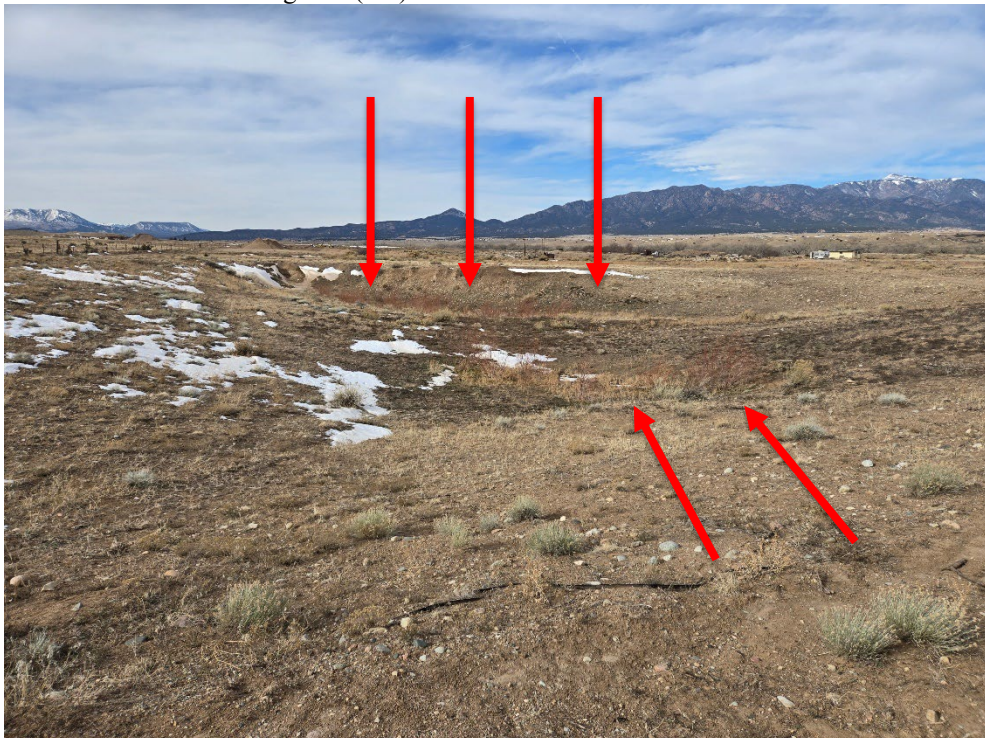
**Photo 4:** Looking west at the southwestern-most historic mining area. The arrows point to some Tamarisk trees.

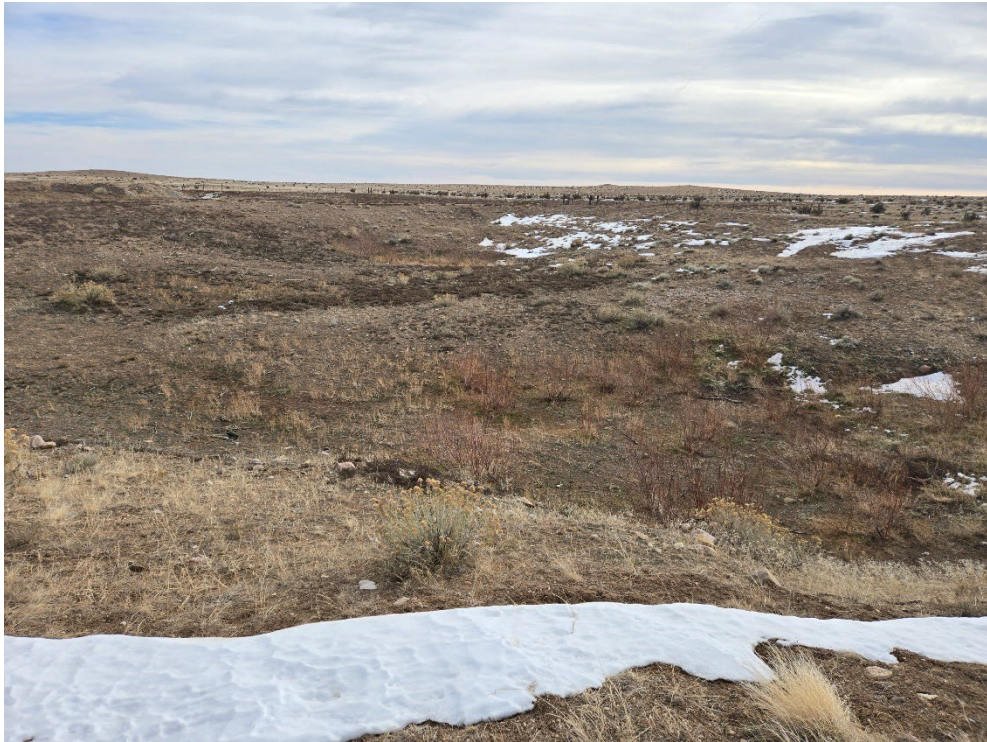
**Photo 5:** Looking south at the southwestern-most historic mining area. Some Tamarisk trees are pictured in the middle and right side of the photo.

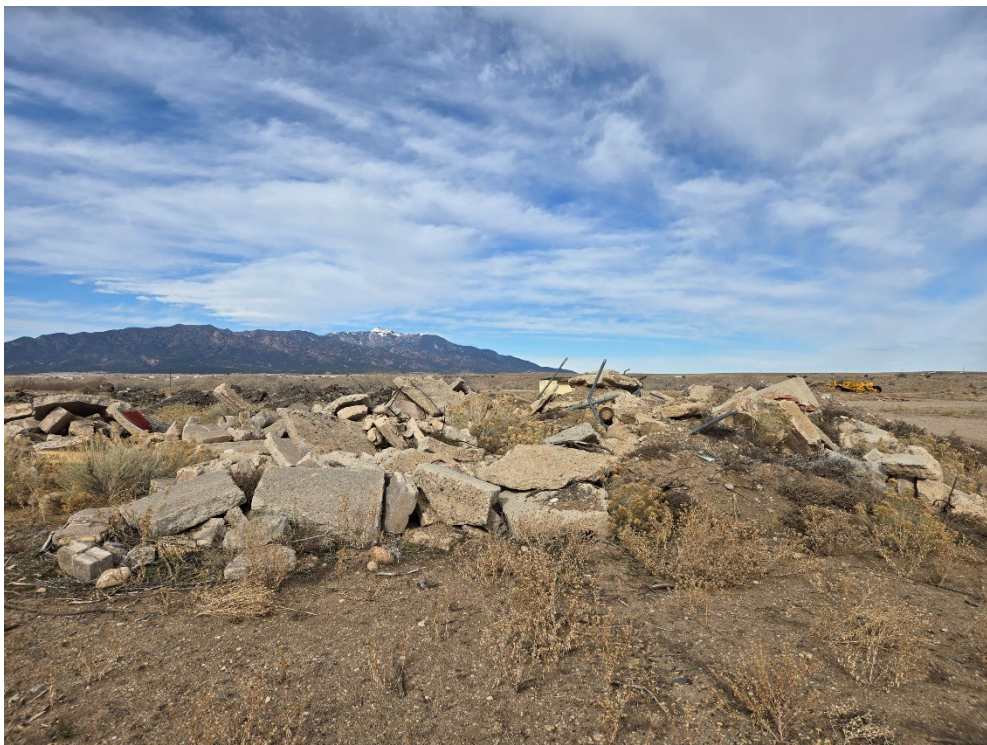
**Photo 6:** Looking north at concrete stockpiles.

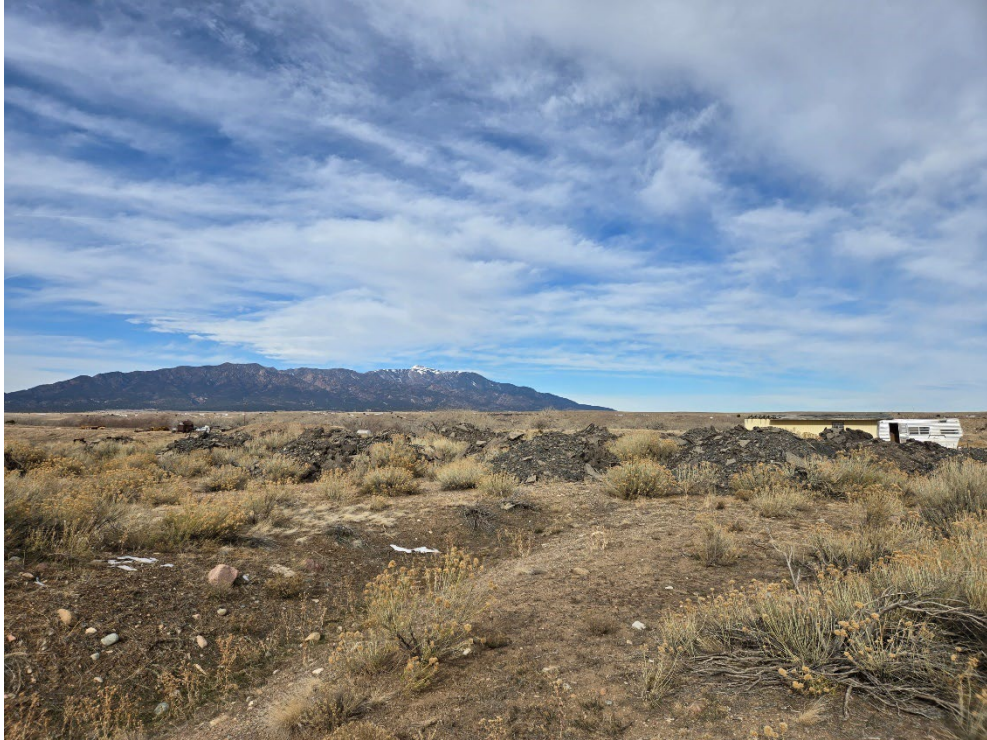
**Photo 7:** Looking north at asphalt stockpiles.

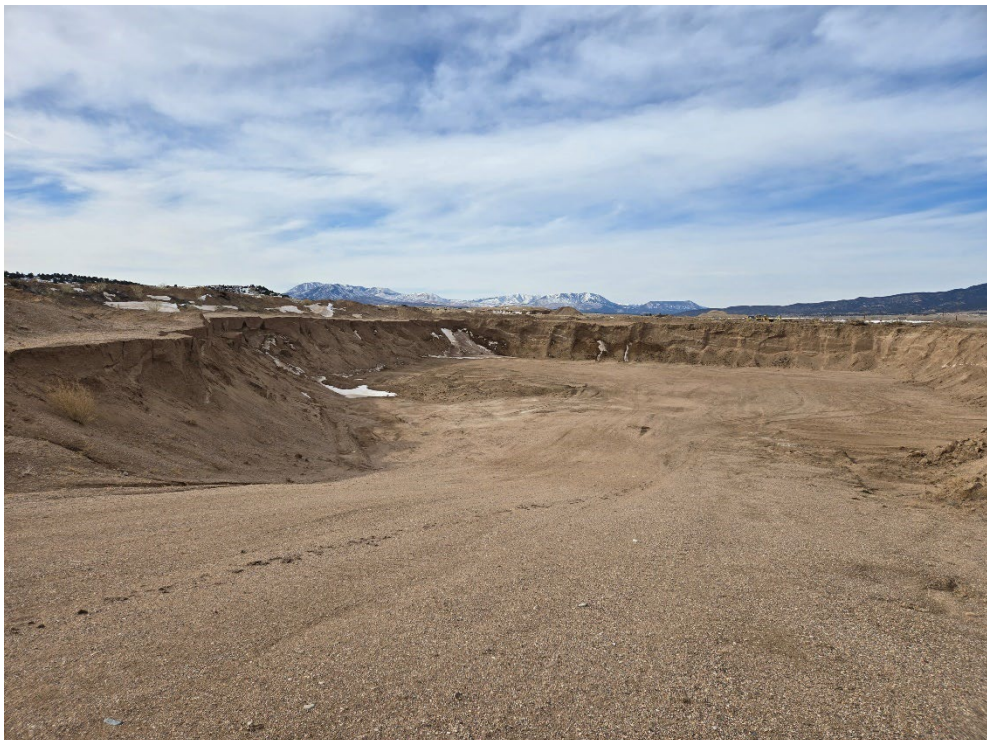
**Photo 8:** Looking west at the working face within the landowner's excavated area.

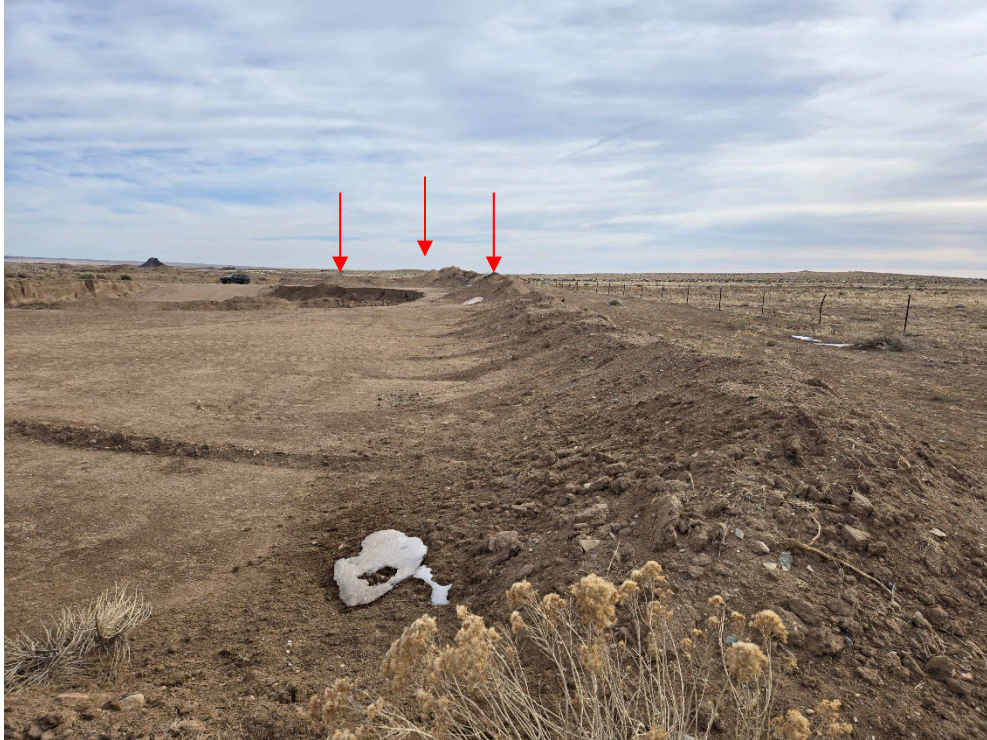
**Photo 9:** Looking east along the south boundary of the landowner's pit disturbance. The arrows point to possible topsoil stockpiles.

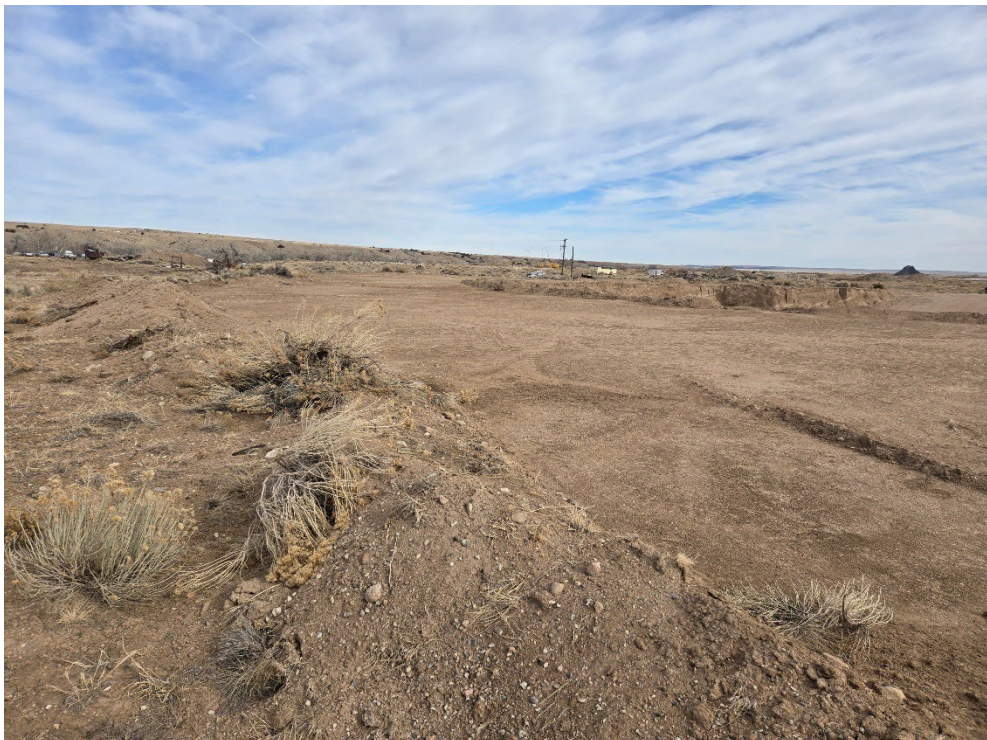
the Phase 1 (Photo 23). Along the southside of the landowner's pit, there appears to be either topsoil or overburden stockpiled (Photo 10). Because the Operator is responsible for reclaiming mining activities within the permitted boundary, the Operator shall ensure that there is enough topsoil preserved to replace it at a depth of at least six inches (per the reclamation plan) across the site.

**Photo 10:** Looking north along the west boundary of the landowner's pit disturbance.

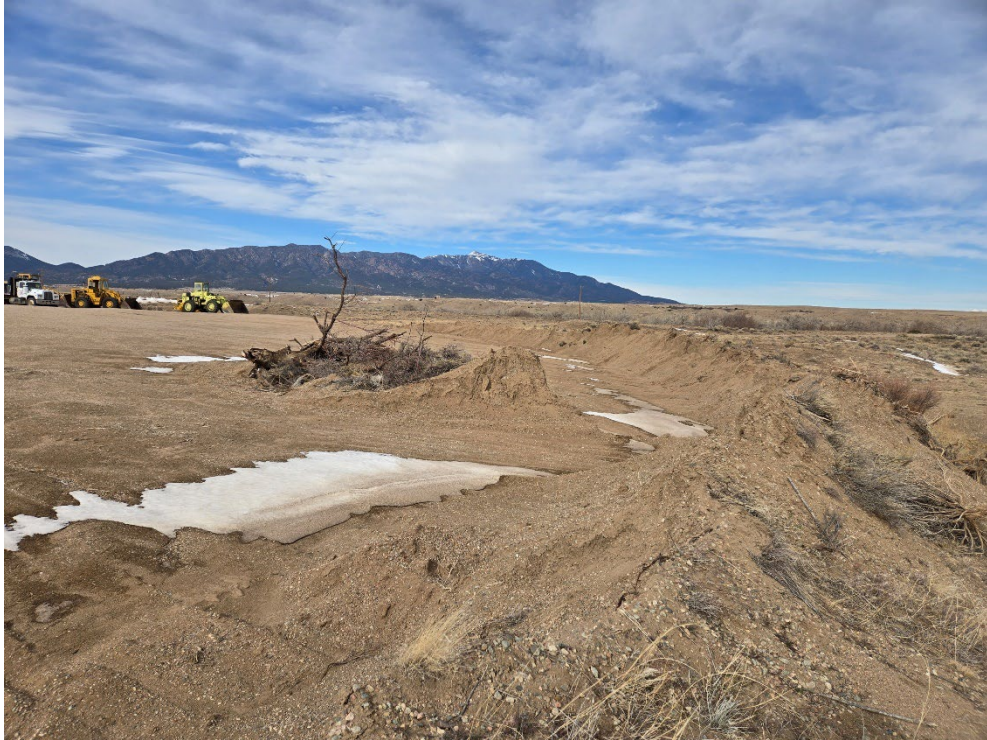
**Photo 11:** Looking north along the west edge of the remaining Reject Pile. To the west of the remaining pile, there is what appears to be an equipment storage area with the landowner's equipment.

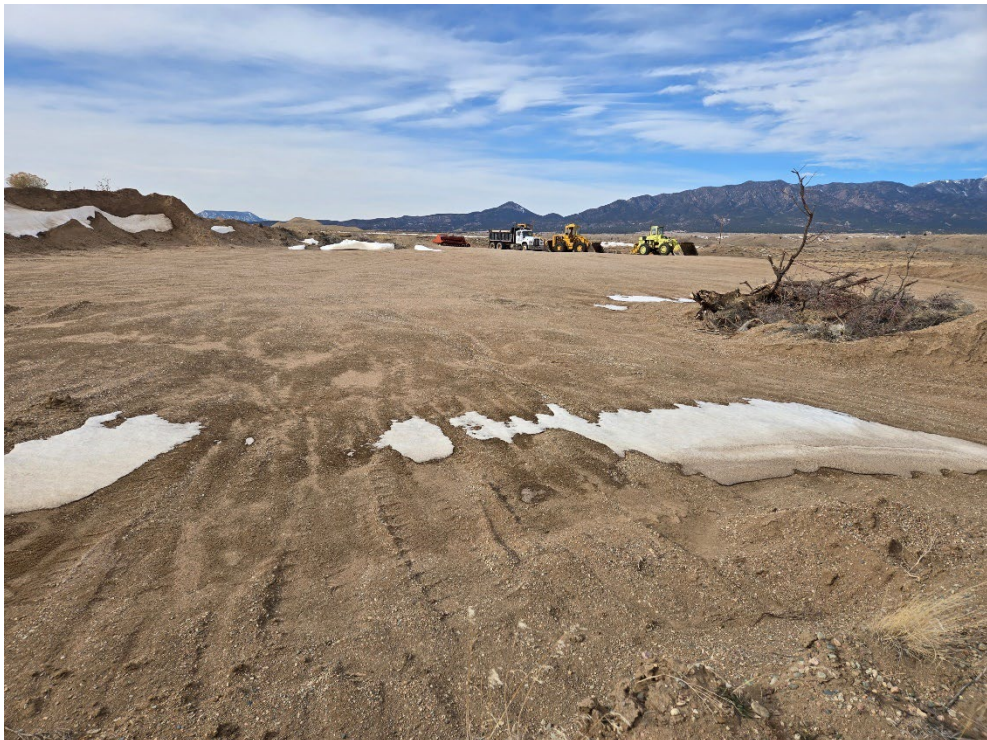
**Photo 12:** Looking west at the south edge of the remaining Reject Pile and at the equipment storage area within the Reject Pile area.

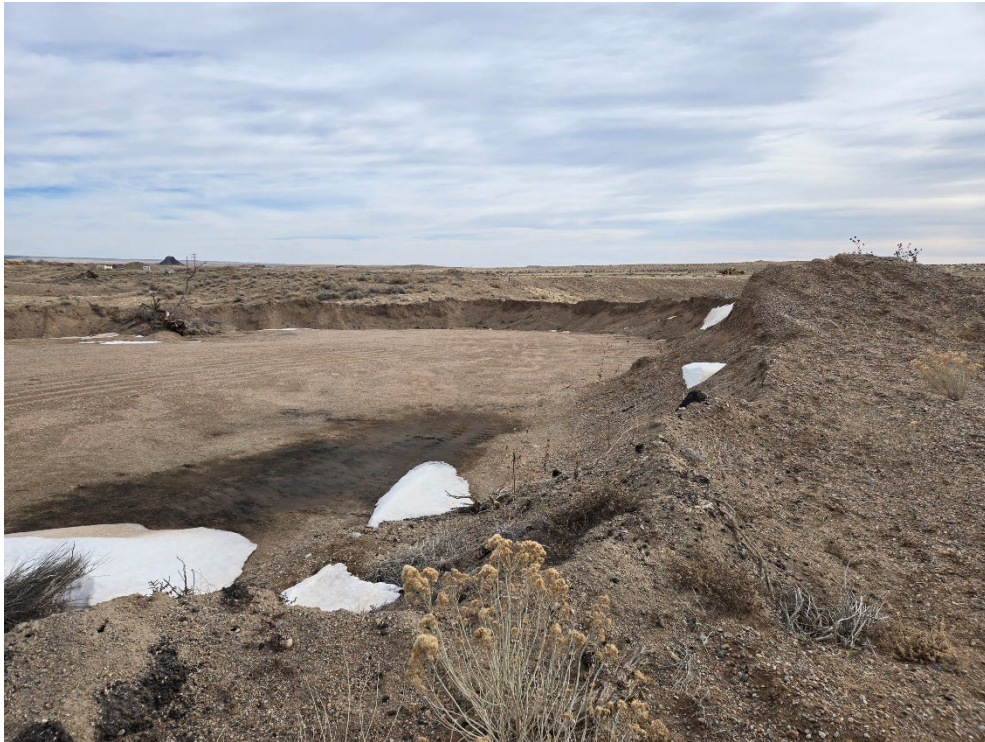
**PROBLEM:** A fuel spill has occurred at the site which has impacted soils.

To the west of the remaining Reject Pile Area, where the landowner has some equipment stored, a small spill was observed (Photo 13). The spill appeared to be spilt fuel and therefore has been **cited as a problem above**. The Operator shall ensure that the spill is cleaned and shall submit photo evidence to the Division that this has been done by the corrective action date.

**Photo 13:** Looking southeast at the spill within the Reject Pile area.

**CORRECTIVE ACTIONS:** The Operator shall remediate the spill and submit a final report to the Division containing at least the following information:

- 1.) A description of how the spill was cleaned up containing at a minimum - the appropriate maps, volumes removed, and photo documentation.
- 2.) Evidence that the contaminated soil was disposed of by an approved method (such as sent to an approved landfill, land farming, recycling center, etc.).

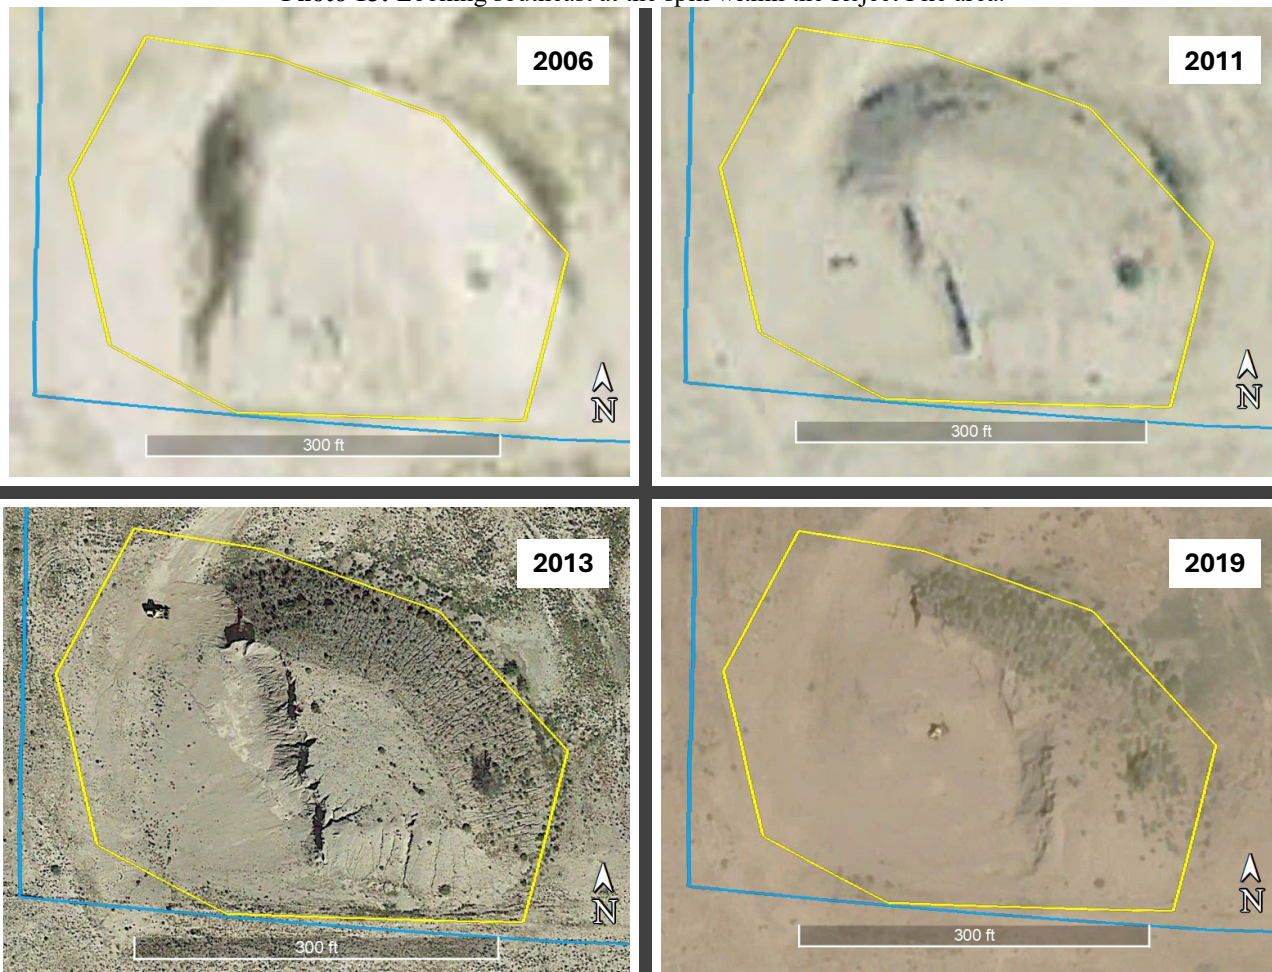
**Figure 1:** Figure shows the gradual depletion of the Reject material in the Huskin Reject Pile area from 2006-2019 using Google Earth aerial imagery. See Map 2c for more recent imagery of the pile from ArcGIS Online.

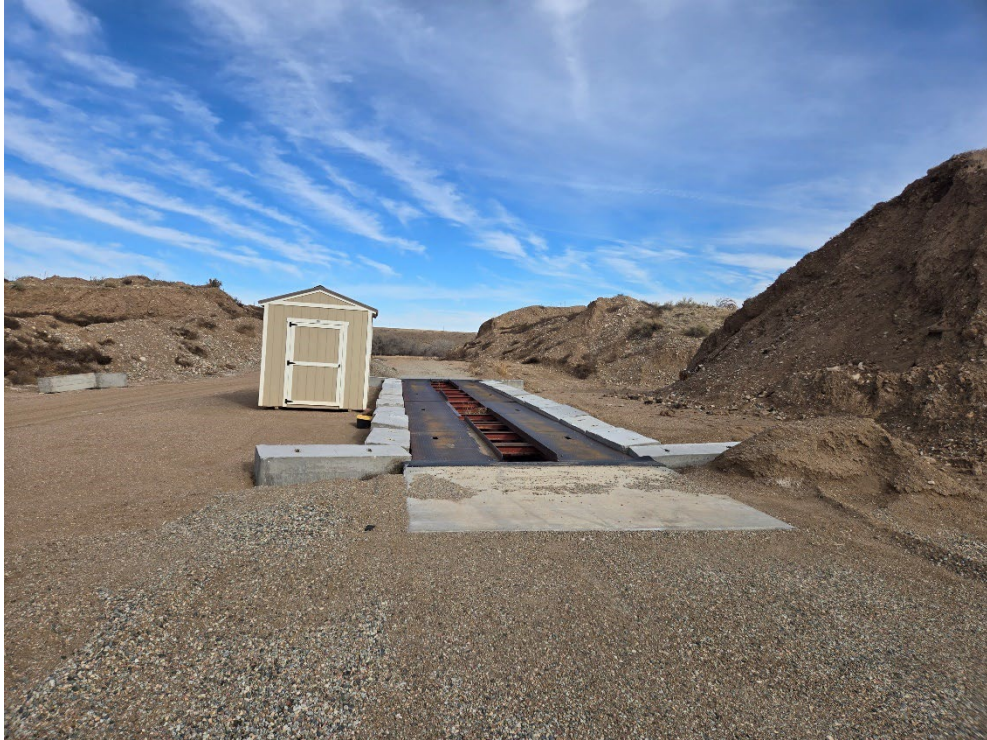
**Photo 14:** Looking north at the new truck scale and scale house constructed in 2023.

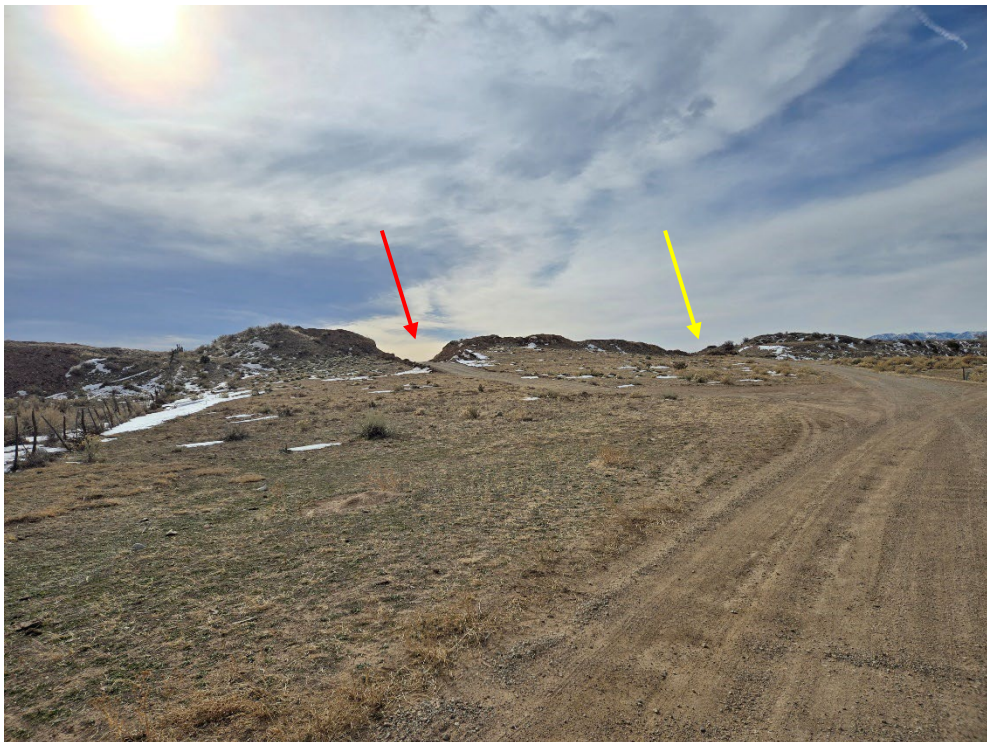
**Photo 15:** Looking south toward the pit from County Road 640/613. The yellow arrow points to the current access road. The red arrow points to the new road that leads to the scale.

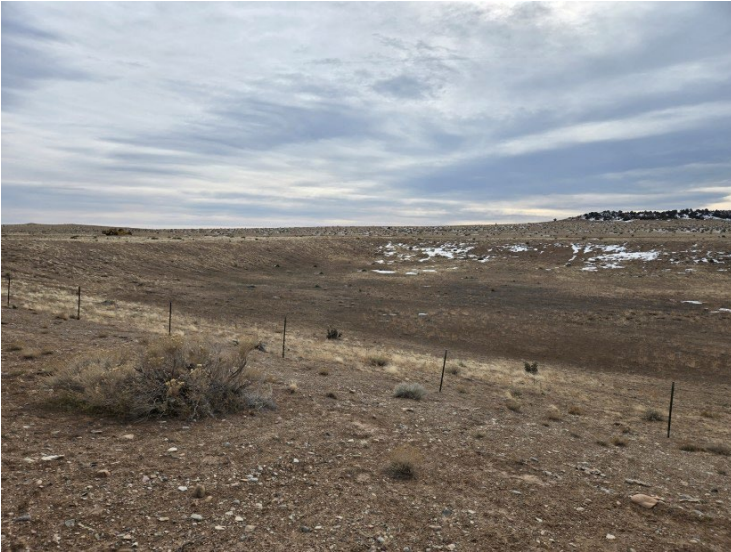
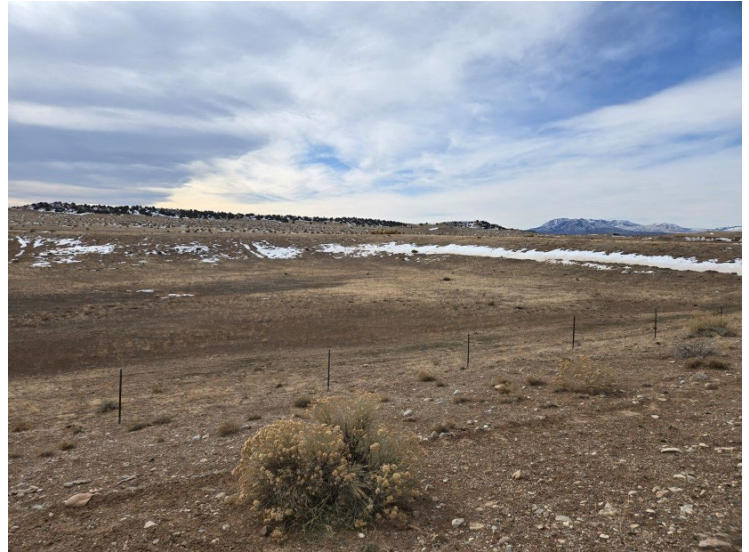
**Photo 16:** (Left) Looking southeast at the east side of one of the reclaimed pits in the Huskin 111 area. (Right) Looking southwest at the west side of one of the reclaimed pits in the Huskin 111 area.

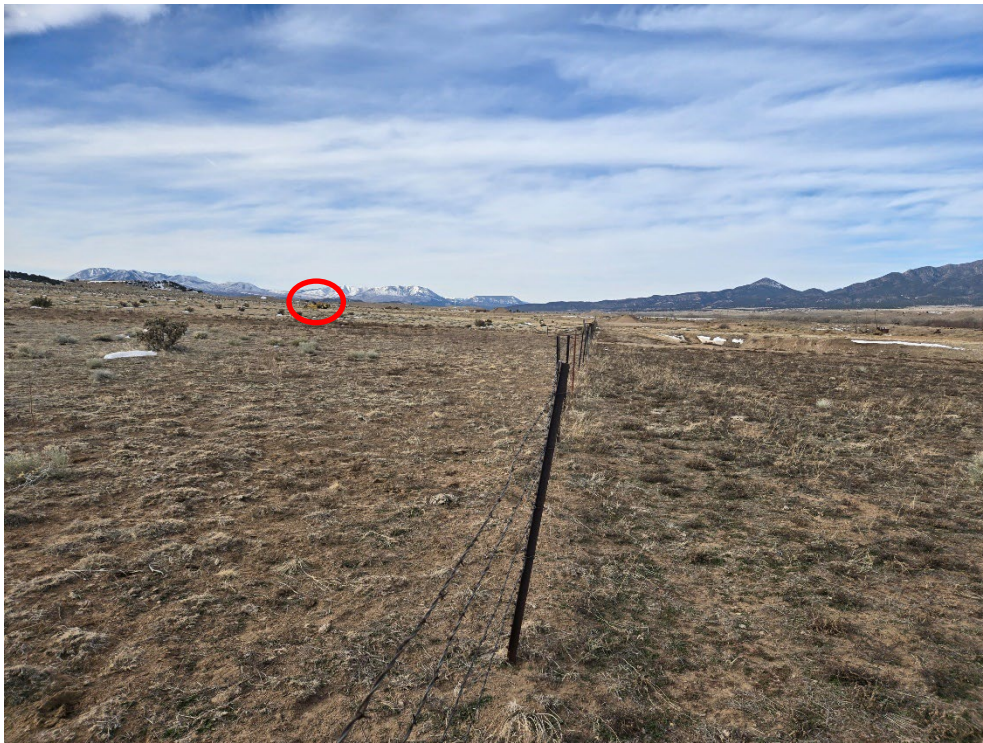
**Photo 17:** Looking west along the fence separating the 111 area from the north side of Phase 1. Circled is a piece of equipment owned by the landowner within the 111 area.

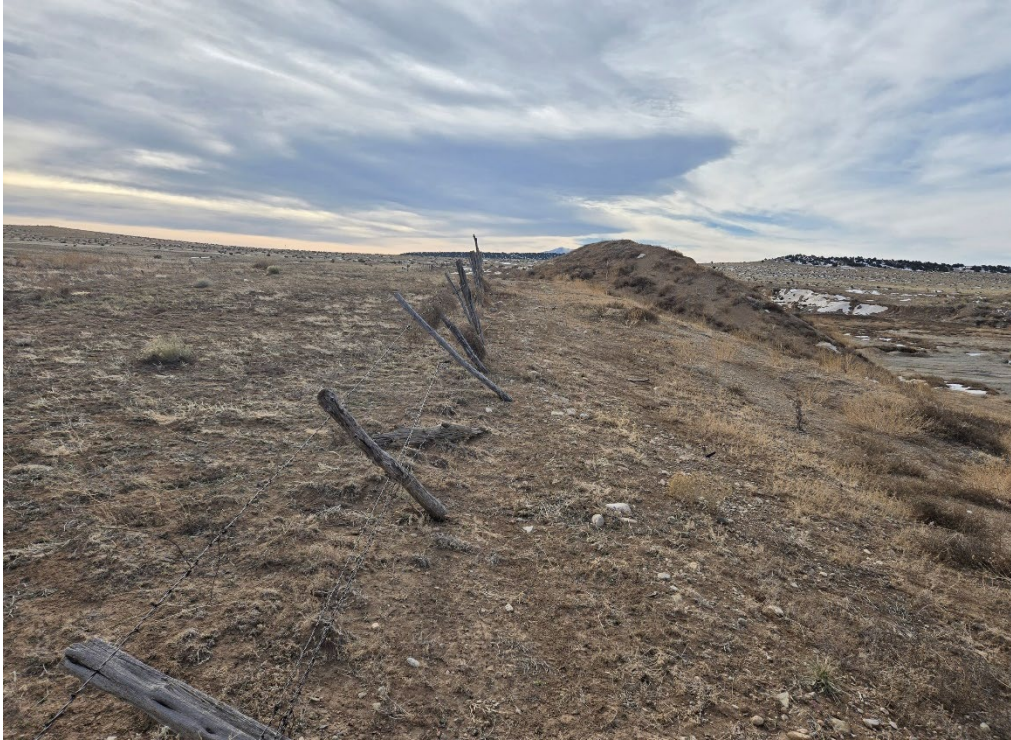
**Photo 18:** Looking south along the fence line on the east side of the permit boundary. The stockpile pictured along the edge is the topsoil pile in Photo 23.

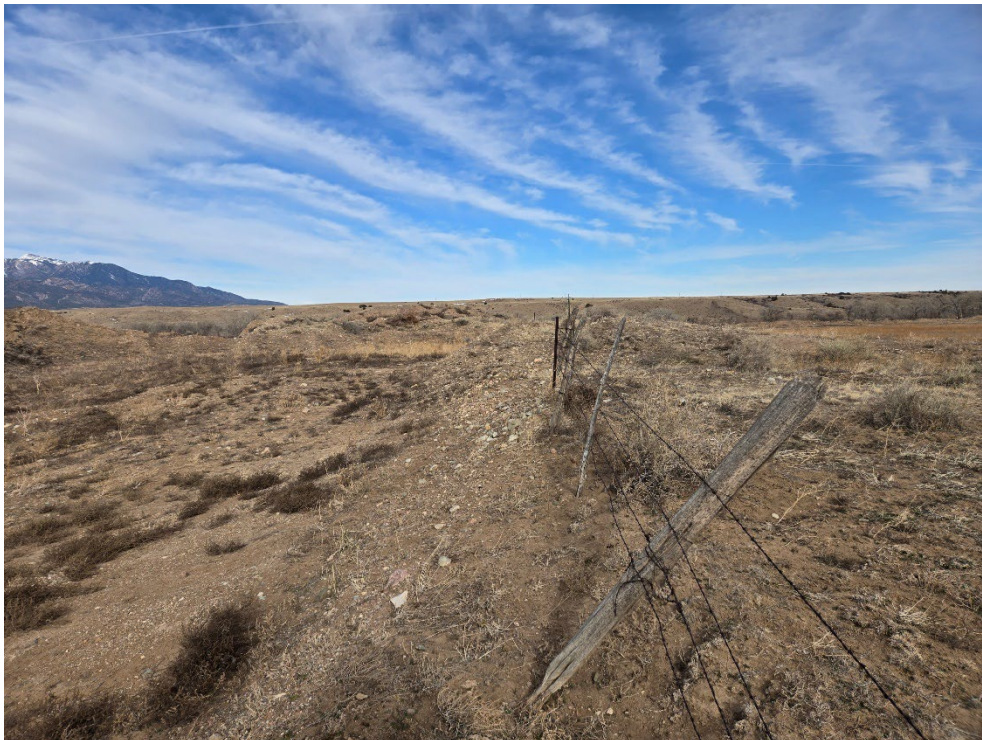
**Photo 19:** Looking north along the fence line on the east side of the permit boundary. Areas along the fence line in this portion, and down to the pit floor, do not exceed a 2H:1V slope.

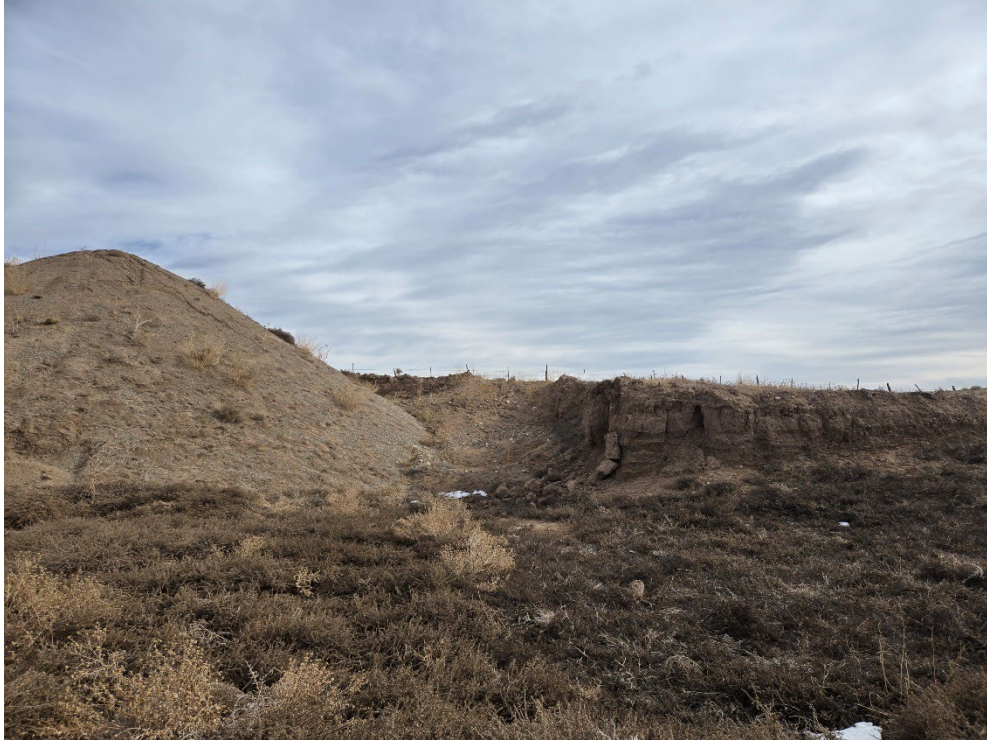
**Photo 20:** Looking east at an area along the east fence line within the Operator's pit where a small (~3 foot) portion of highwall remains.

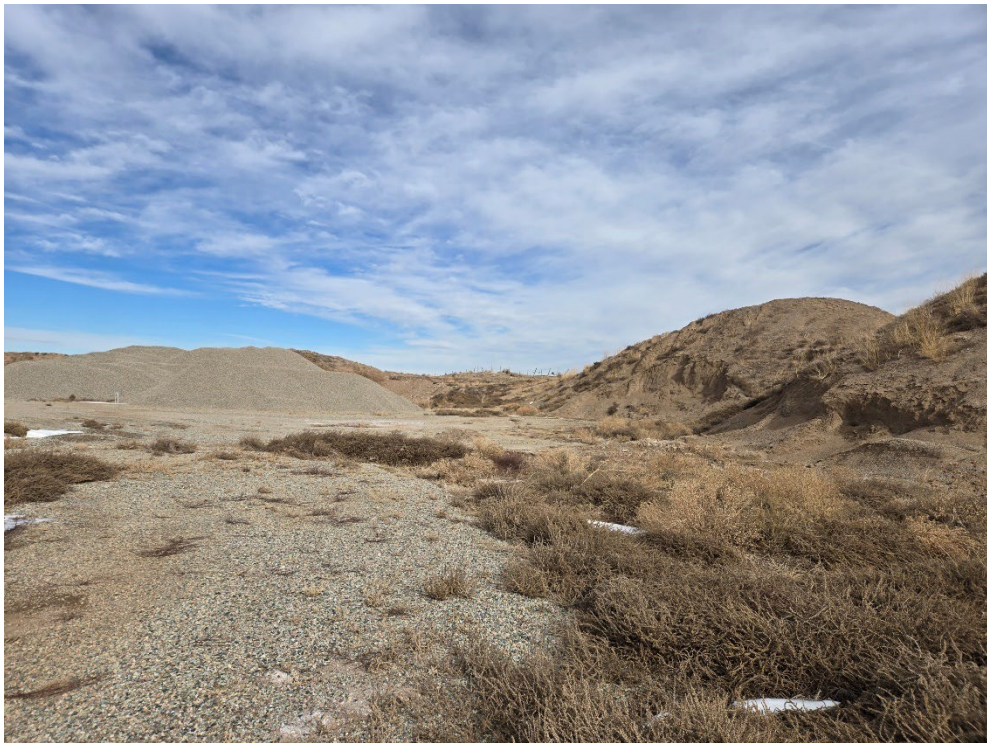
**Photo 21:** Looking north into the Operator's active mining area at product, overburden, and some topsoil stockpiles. Most of the edges around the pit have been sloped or have stockpiles against them.

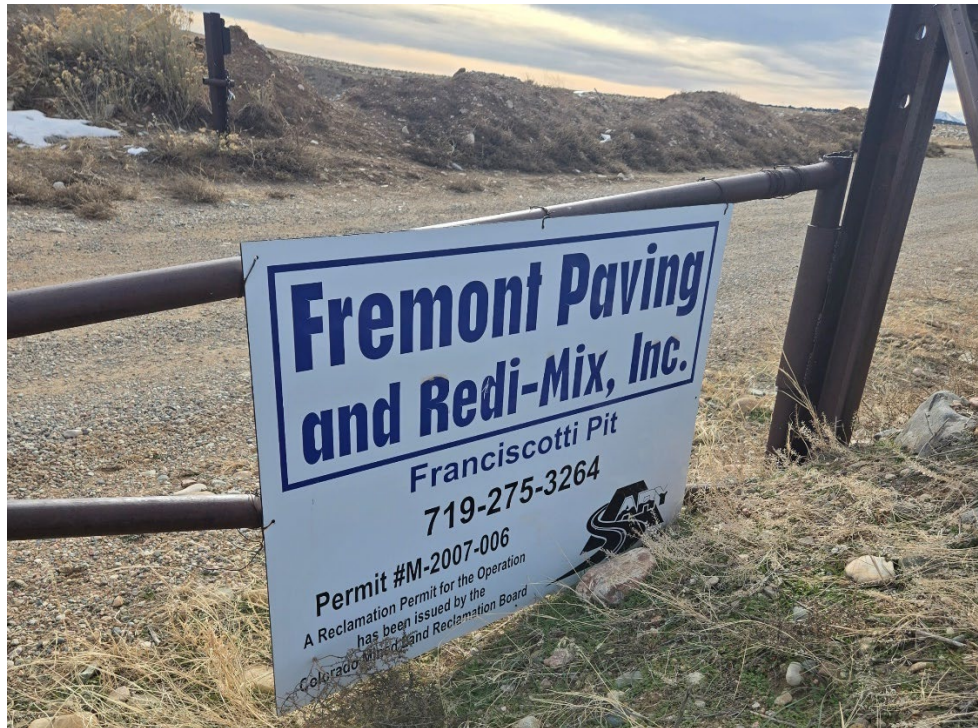
A mine sign was posted at the entrance to the site in compliance with Rule 3.1.12(1) (Photo 22).

**Photo 22:** Mine sign located along the current access road at the entrance to the site.

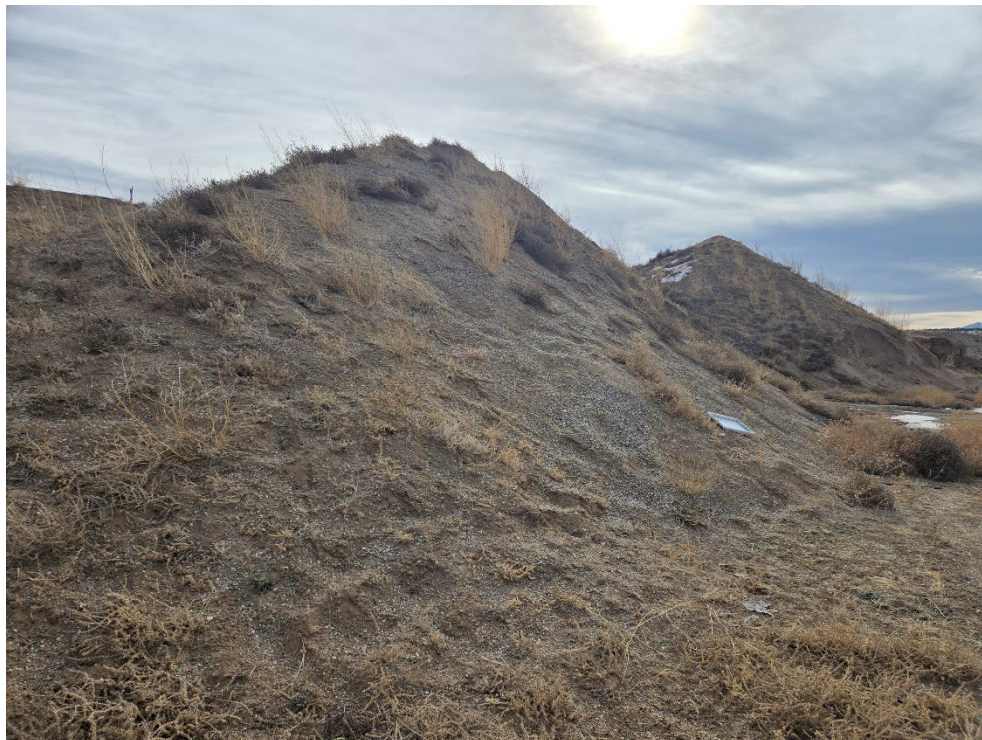
Topsoil piles were observed along the east sides and above the pit walls, within the north and northeast side of

**Photo 23:** Looking southeast at the topsoil piles within the Operator's active area.

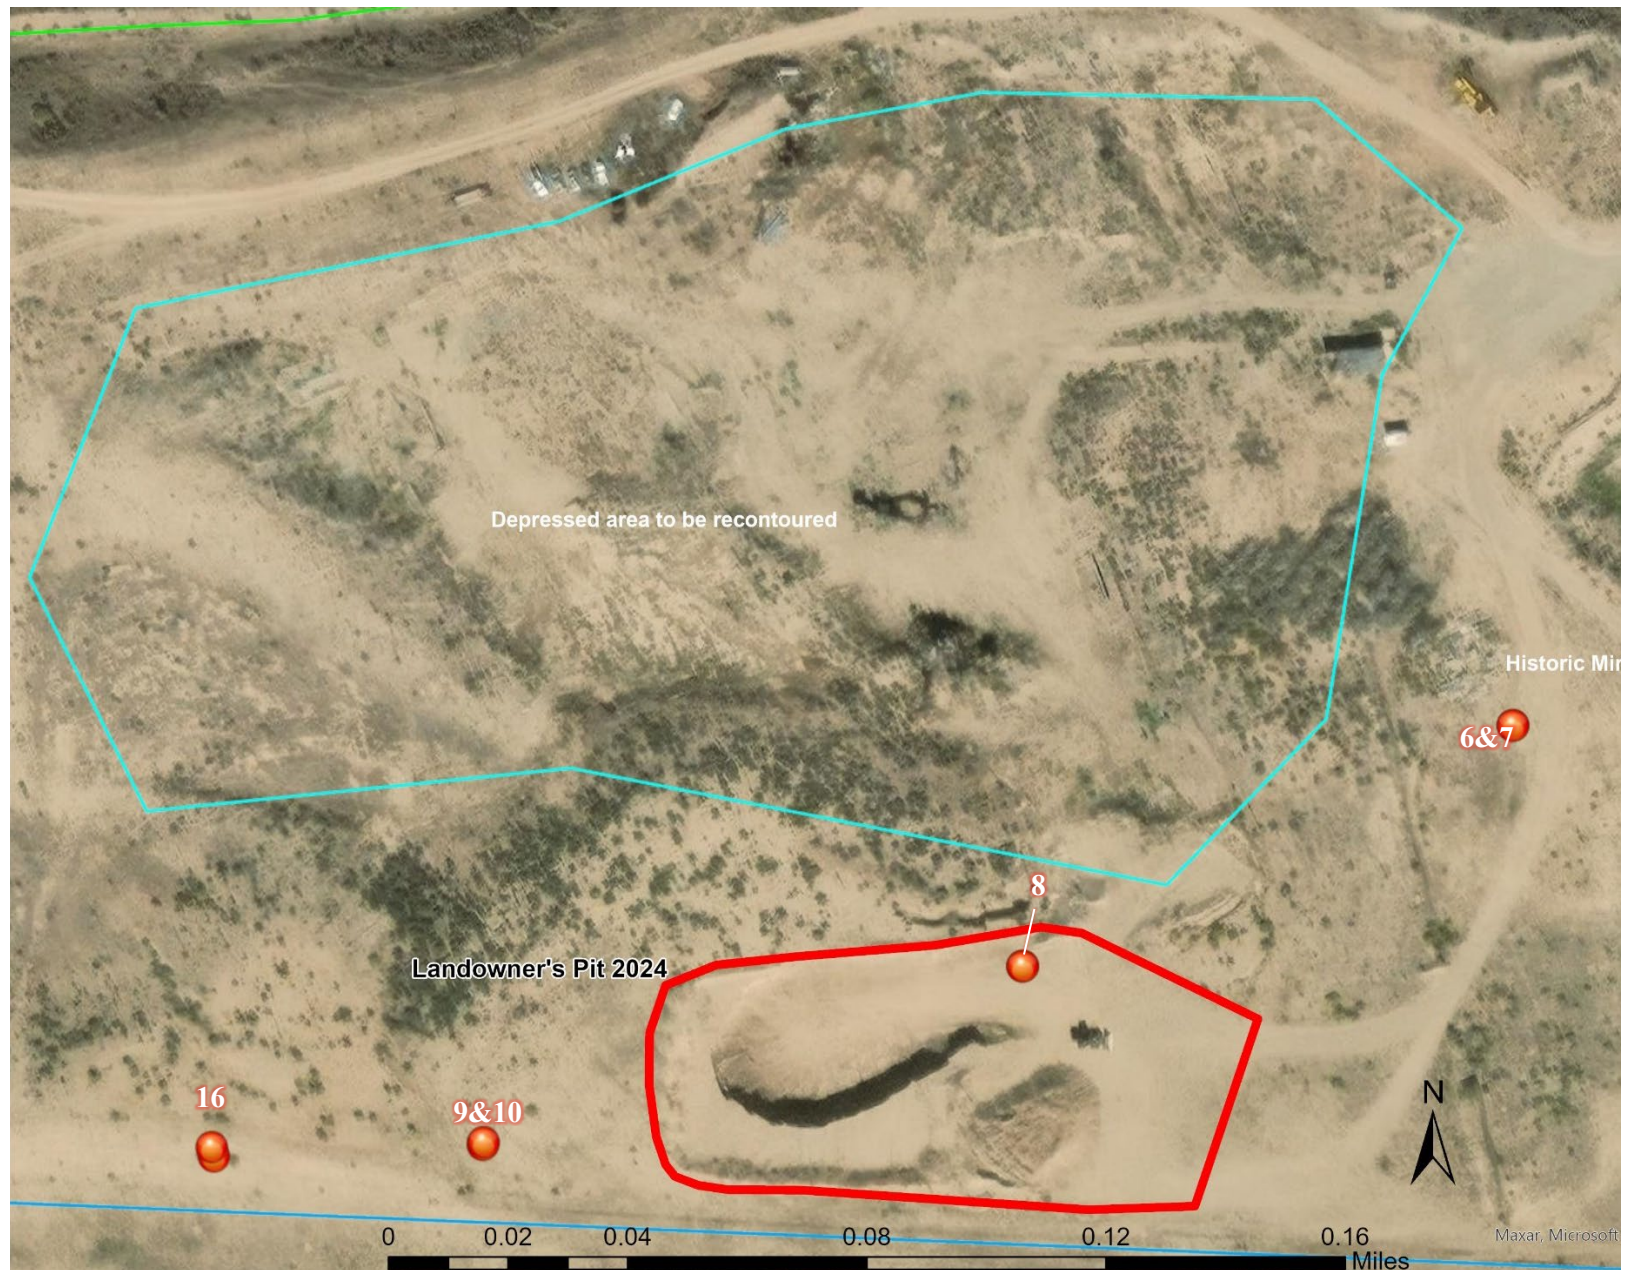
**Map 2b:** Close up of the current Depressed Area that needs to be recontoured on the northside of Phase 1, the landowner's pit, and the location where concrete and asphalt are stockpiled (Photos 6 and 7).
