**MINERALS PROGRAM INSPECTION REPORT**  
**PHONE: (303) 866-3567**

| <b>MINE NAME:</b><br>Ted Franciscotti Pit #1 | <b>MINE/PROSPECTING ID#:</b><br>M-2007-006 | <b>MINERAL:</b><br>Sand and gravel | <b>COUNTY:</b><br>Huerfano |
| <b>INSPECTION TYPE:</b><br>Monitoring | <b>WEATHER:</b><br>Cloudy | <b>INSP. DATE:</b><br>December 17, 2024 | <b>INSP. TIME:</b><br>10:40 |
| <b>OPERATOR:</b><br>Fremont Paving & Redi-Mix, Inc. | <b>OPERATOR REPRESENTATIVE:</b><br>Jodi Schreiber | <b>TYPE OF OPERATION:</b><br>112c - Construction Regular Operation | |

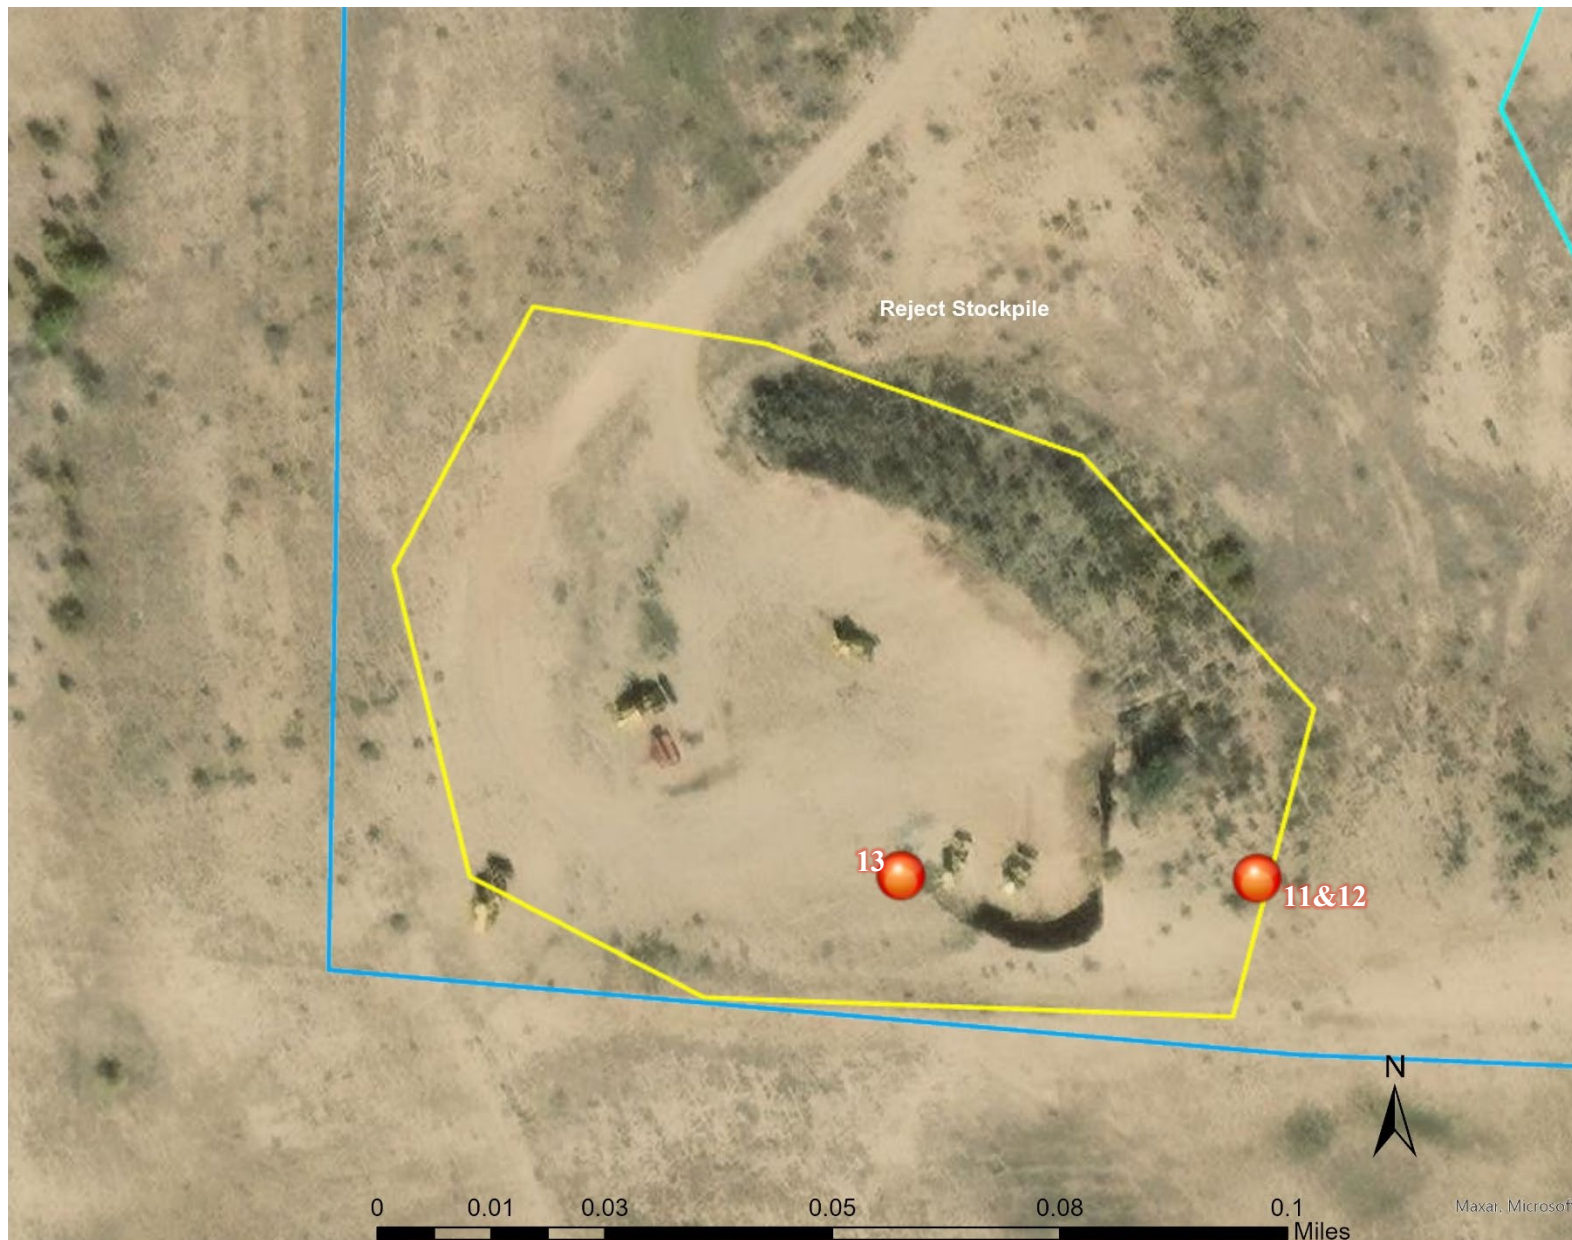
**Map 2c:** Close up of the current Huskin Reject Pile Area that has been slowly depleted by the landowner throughout the years (see Figure 1).
